DATE: September 27, 1996
TO: J. E. Law, Sitewide Actions, Bldg. T893A, X4842
FROM: *ALP* A. L. Primrose, Sitewide Actions, Bldg. T893A, X4385
SUBJECT: IHSS 118.1 - CARBON TETRACHLORIDE SPILL SITE - ALP-004-96

IHSS 118.1 CARBON TETRACHLORIDE SPILL SITE

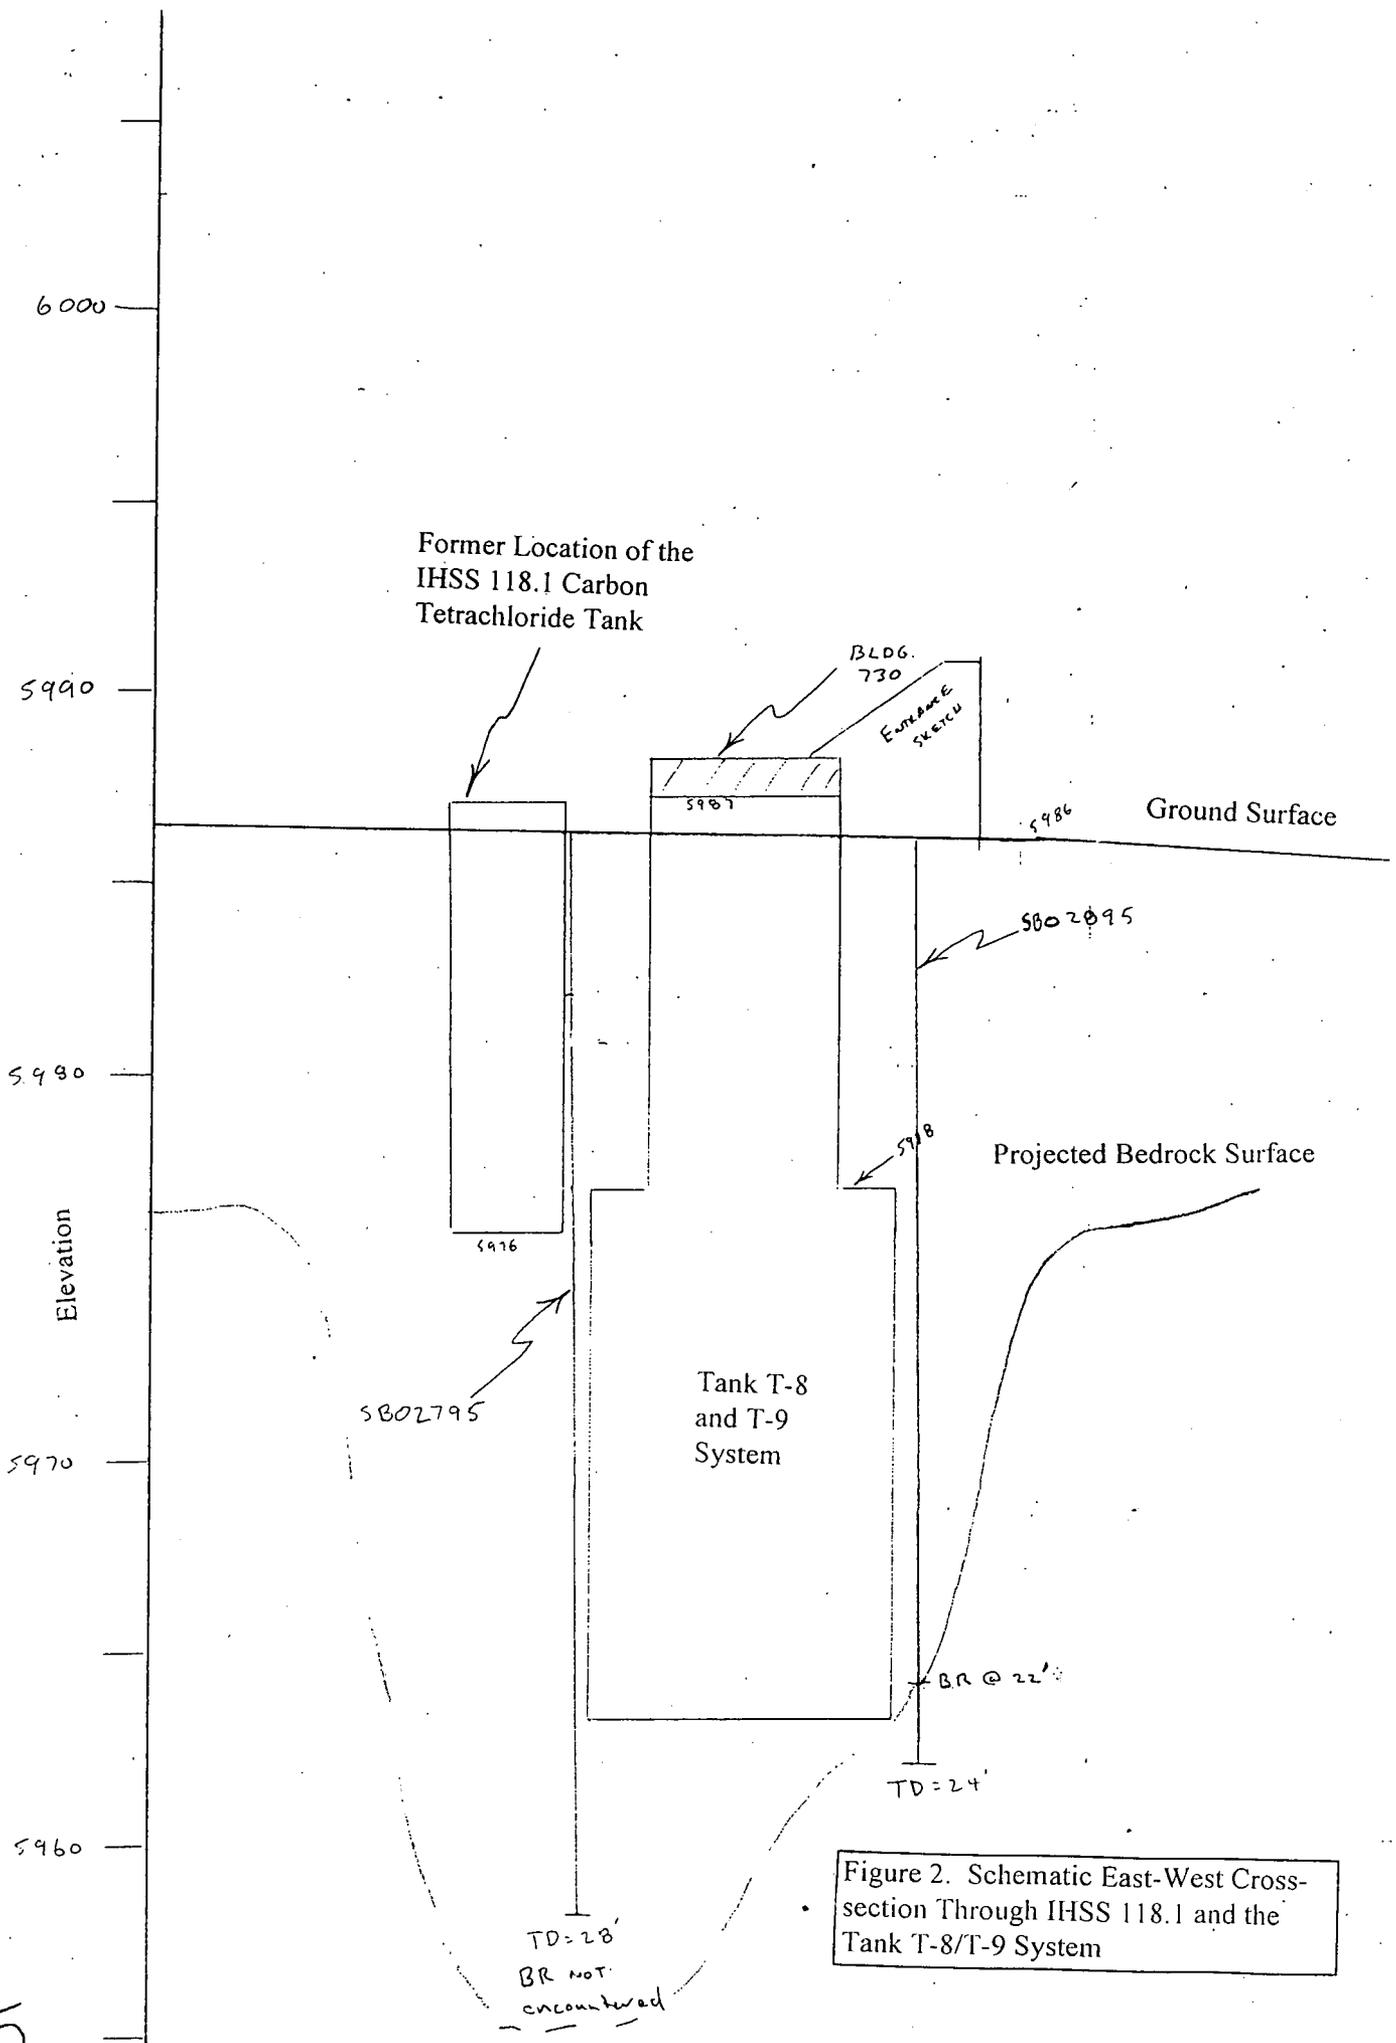
Figure 2. Schematic East-West Cross-section Through IHSS 118.1 and the Tank T-8/T-9 System

The excavation for the Tank Systems was completed in 1955; prior to installation of the carbon tetrachloride tank in 1977. The excavation is deeper and immediately east of the former location of the carbon tetrachloride underground storage tank (Figure 1). The east-west cross section for this area (Figure 2) shows the relative position of these tanks.

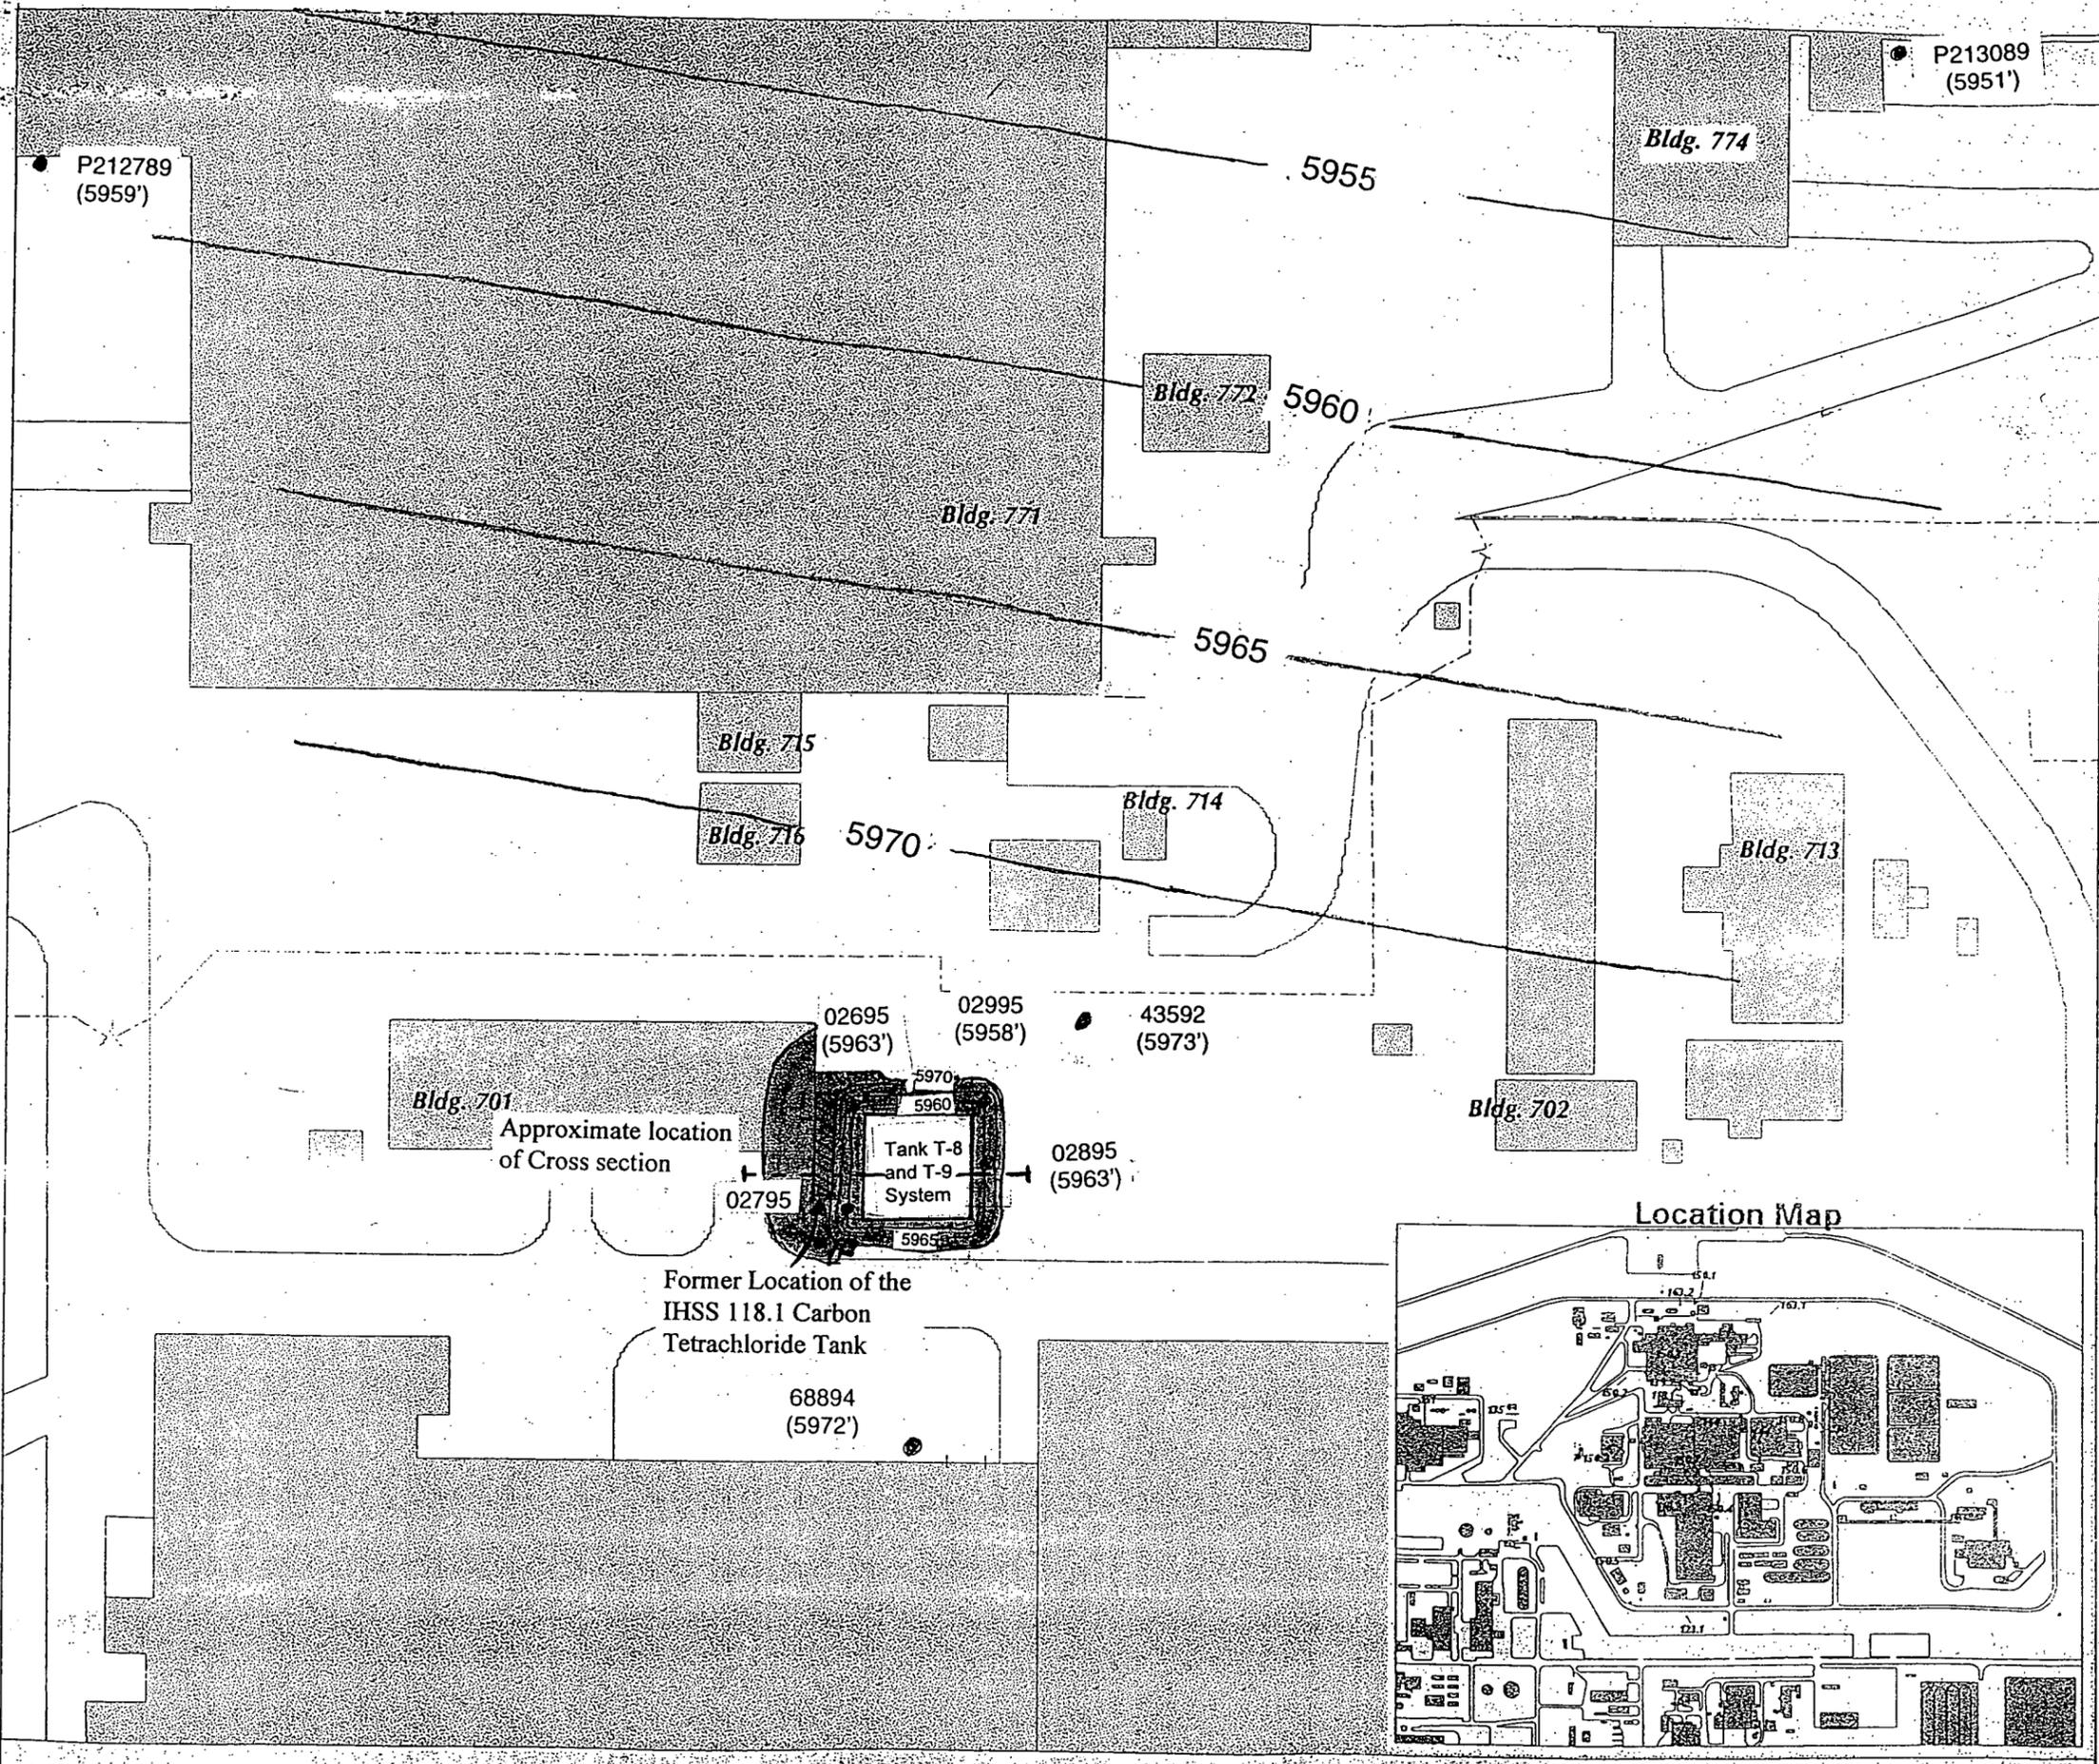
Figure 1

The recent OU 9 Phase I Remedial Investigation found free-phase carbon tetrachloride in the subsurface soil and groundwater in the vicinity of IHSS 118.1. Soil borings were drilled near the four corners of the Tank Systems, and all borings intercepted free-phase carbon tetrachloride, (Figure 1) (DOE 1995). When a water sample was collected at this location, the liquid separated into two, distinct phases. Other volatile organic compounds (VOCs) may be present, but are likely to be masked by the high concentrations of carbon tetrachloride.

Very few data points are available to determine the present configuration of the bedrock surface. However, a bedrock surface contour map of this area using all available data is shown on Figure 1. It appears that the excavation for the Tank Systems is the dominant bedrock surface feature in the area. It is assumed that the construction to install the Tank Systems excavated as little material as was necessary to meet the requirements of safety and to minimize costs and waste. This probably resulted in a minimally sloped, steep-sided excavation 10 to 25 feet wider than the Tank Systems, with a bedrock surface approximately 10 to 20 feet deeper than the surrounding area.

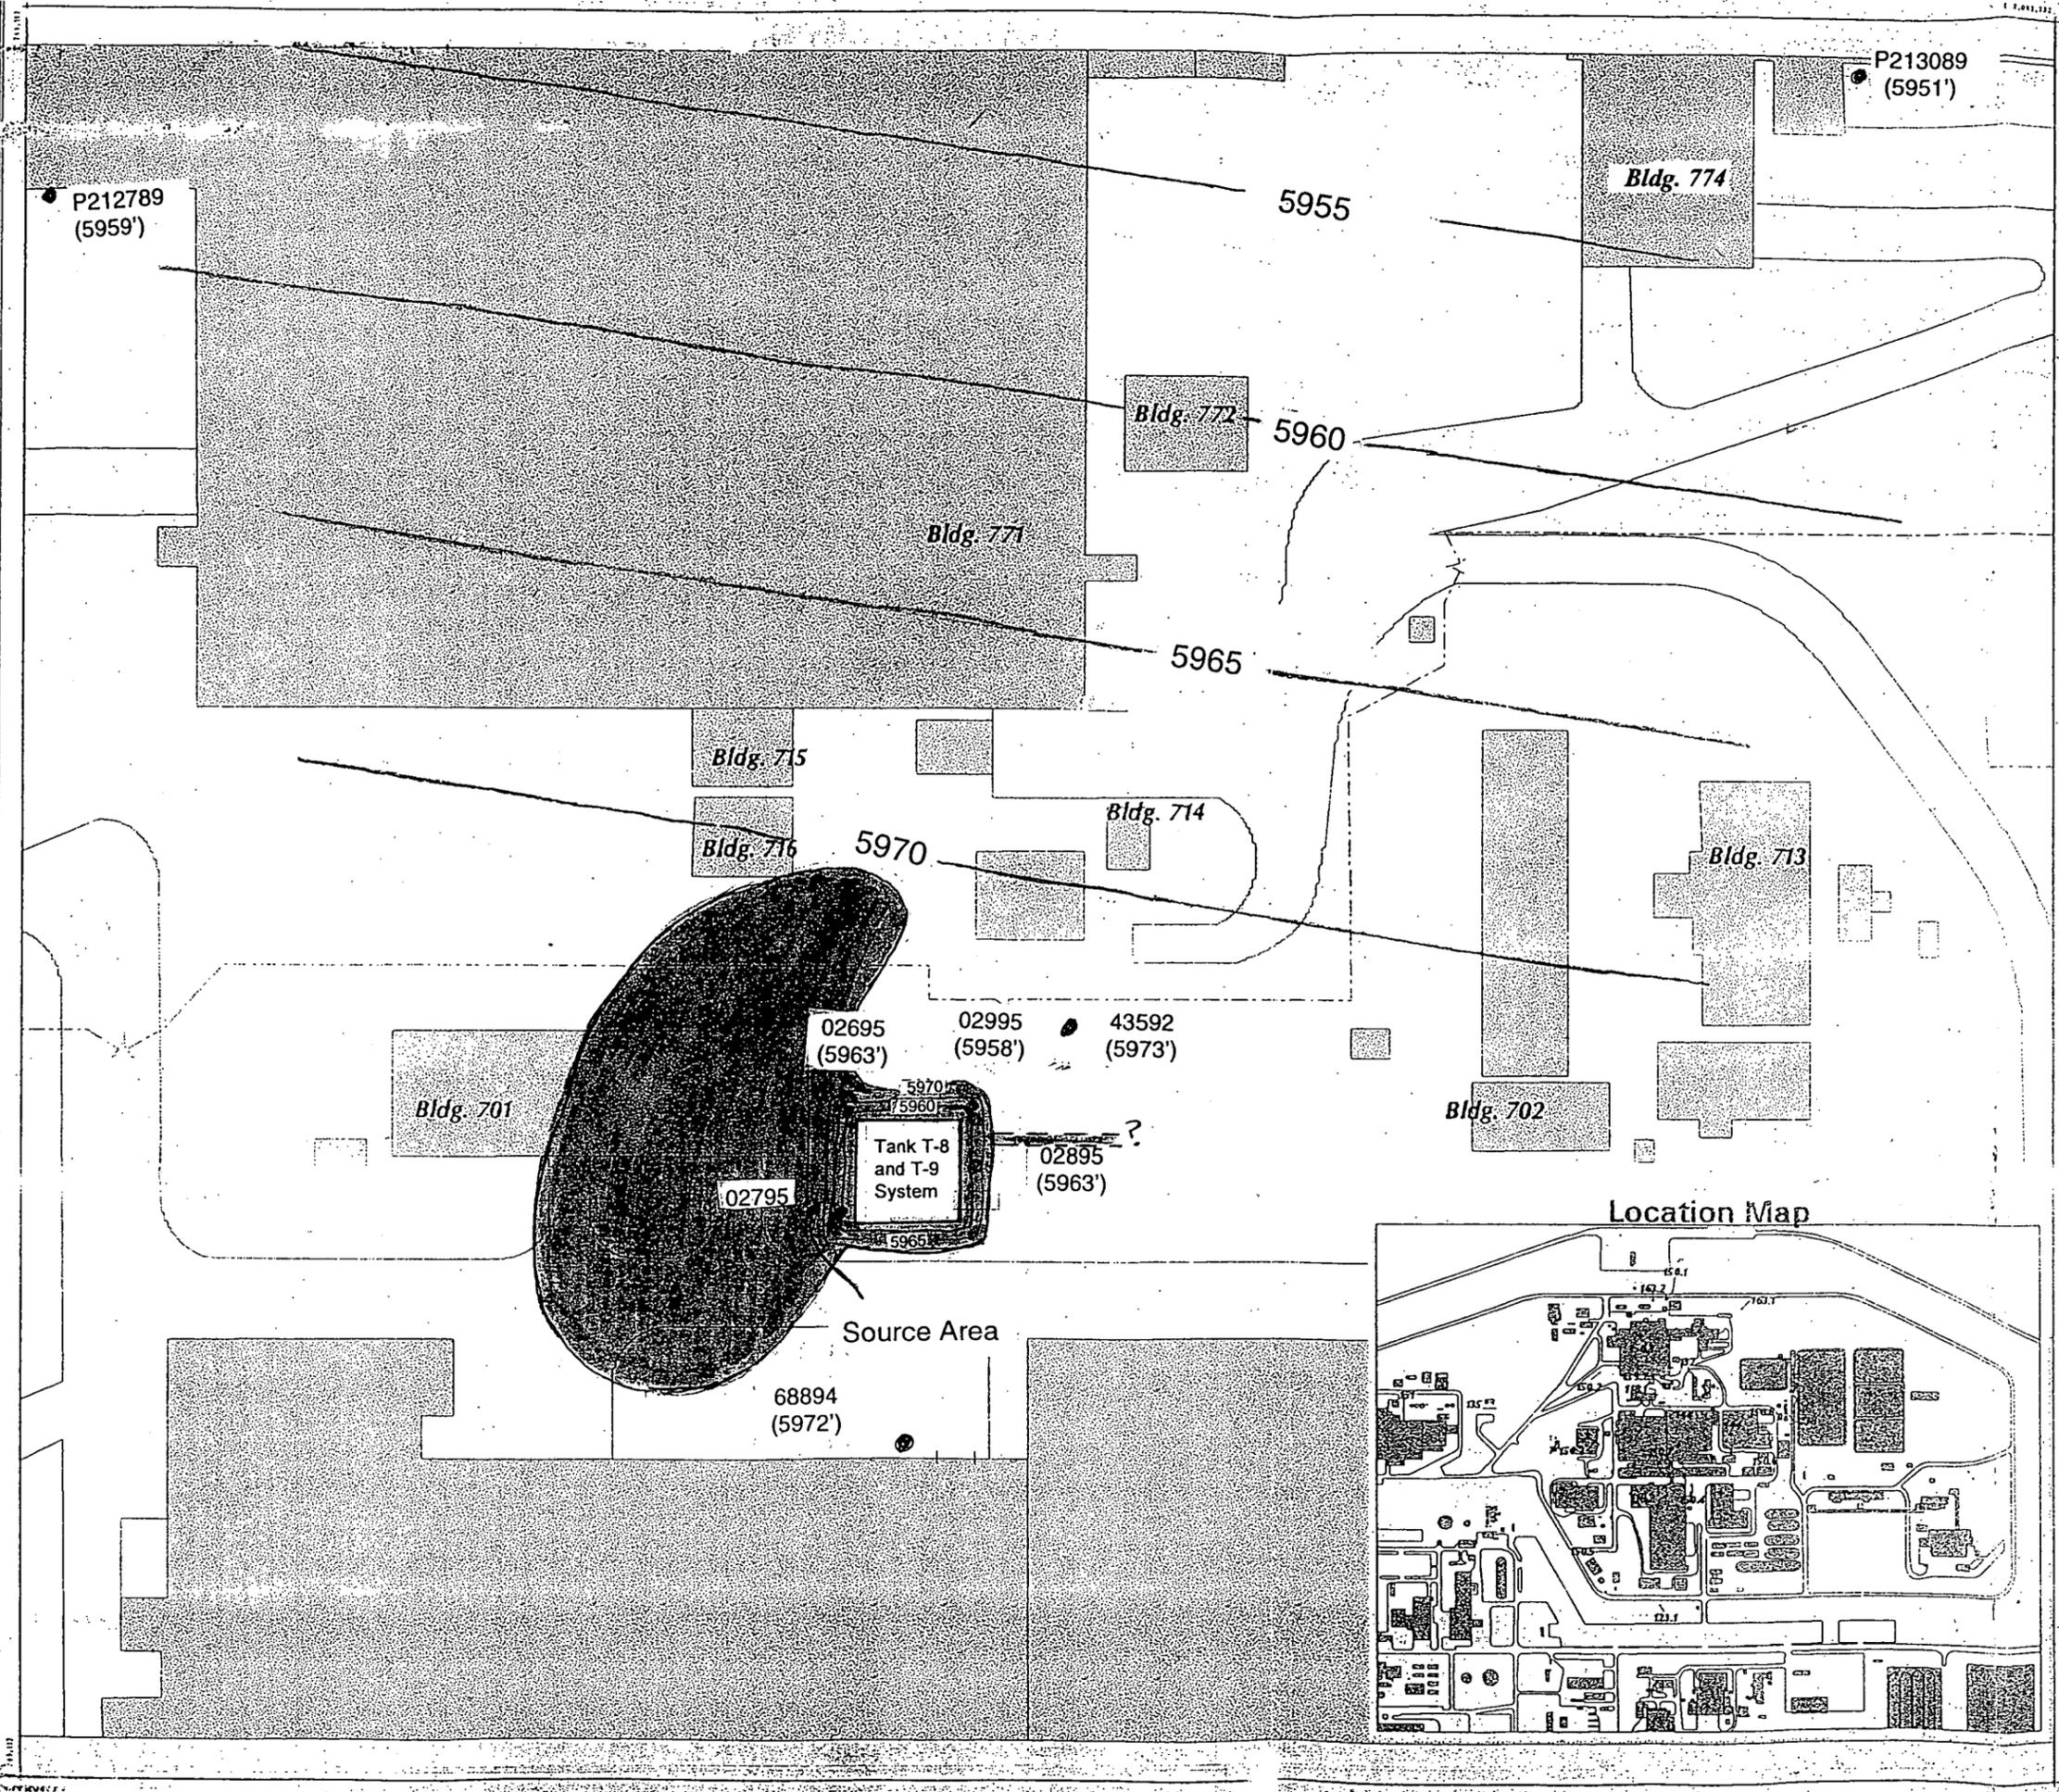
Figure 3
Estimated Maximum
Extent
of DNAPL Plume

Most of the carbon tetrachloride resulting from surface spills and leakage from the underground storage tank is expected to have migrated downward into the excavation surrounding the Tank Systems. If sufficient material was spilled to completely fill this excavation, the excess material is expected to flow eastward possibly along the process waste line excavation, and also toward Buildings 771 and 774. Based on existing borehole data, Figure 1 depicts the minimal expected extent of free product in this area. Figure 3 depicts the maximum extent of free product in the vicinity of IHSS 118.1. Differences between these maps are based on the amount of carbon tetrachloride spilled.

The minimum expected extent is based on the assumed size and location of the excavation for the Tank System, and the behavior of carbon tetrachloride in the subsurface. Depending on the size of the excavation, and the volume of material spilled, there is a possibility that carbon tetrachloride has overtopped this excavation and spread out as a much larger contaminant plume to the north and south. The extent of the free product would be controlled by bedrock structures, utility corridors and variations within the fill and alluvium.
