Department of Energy
Office of Legacy Management

SUBJECT: Status Report of Steps Taken Regarding Monitoring Results at Surface Water Point of Evaluation (POE) SW027

Report of Steps Taken Regarding Monitoring Results at Surface Water Point of Evaluation (POE) SW027

August 31, 2010

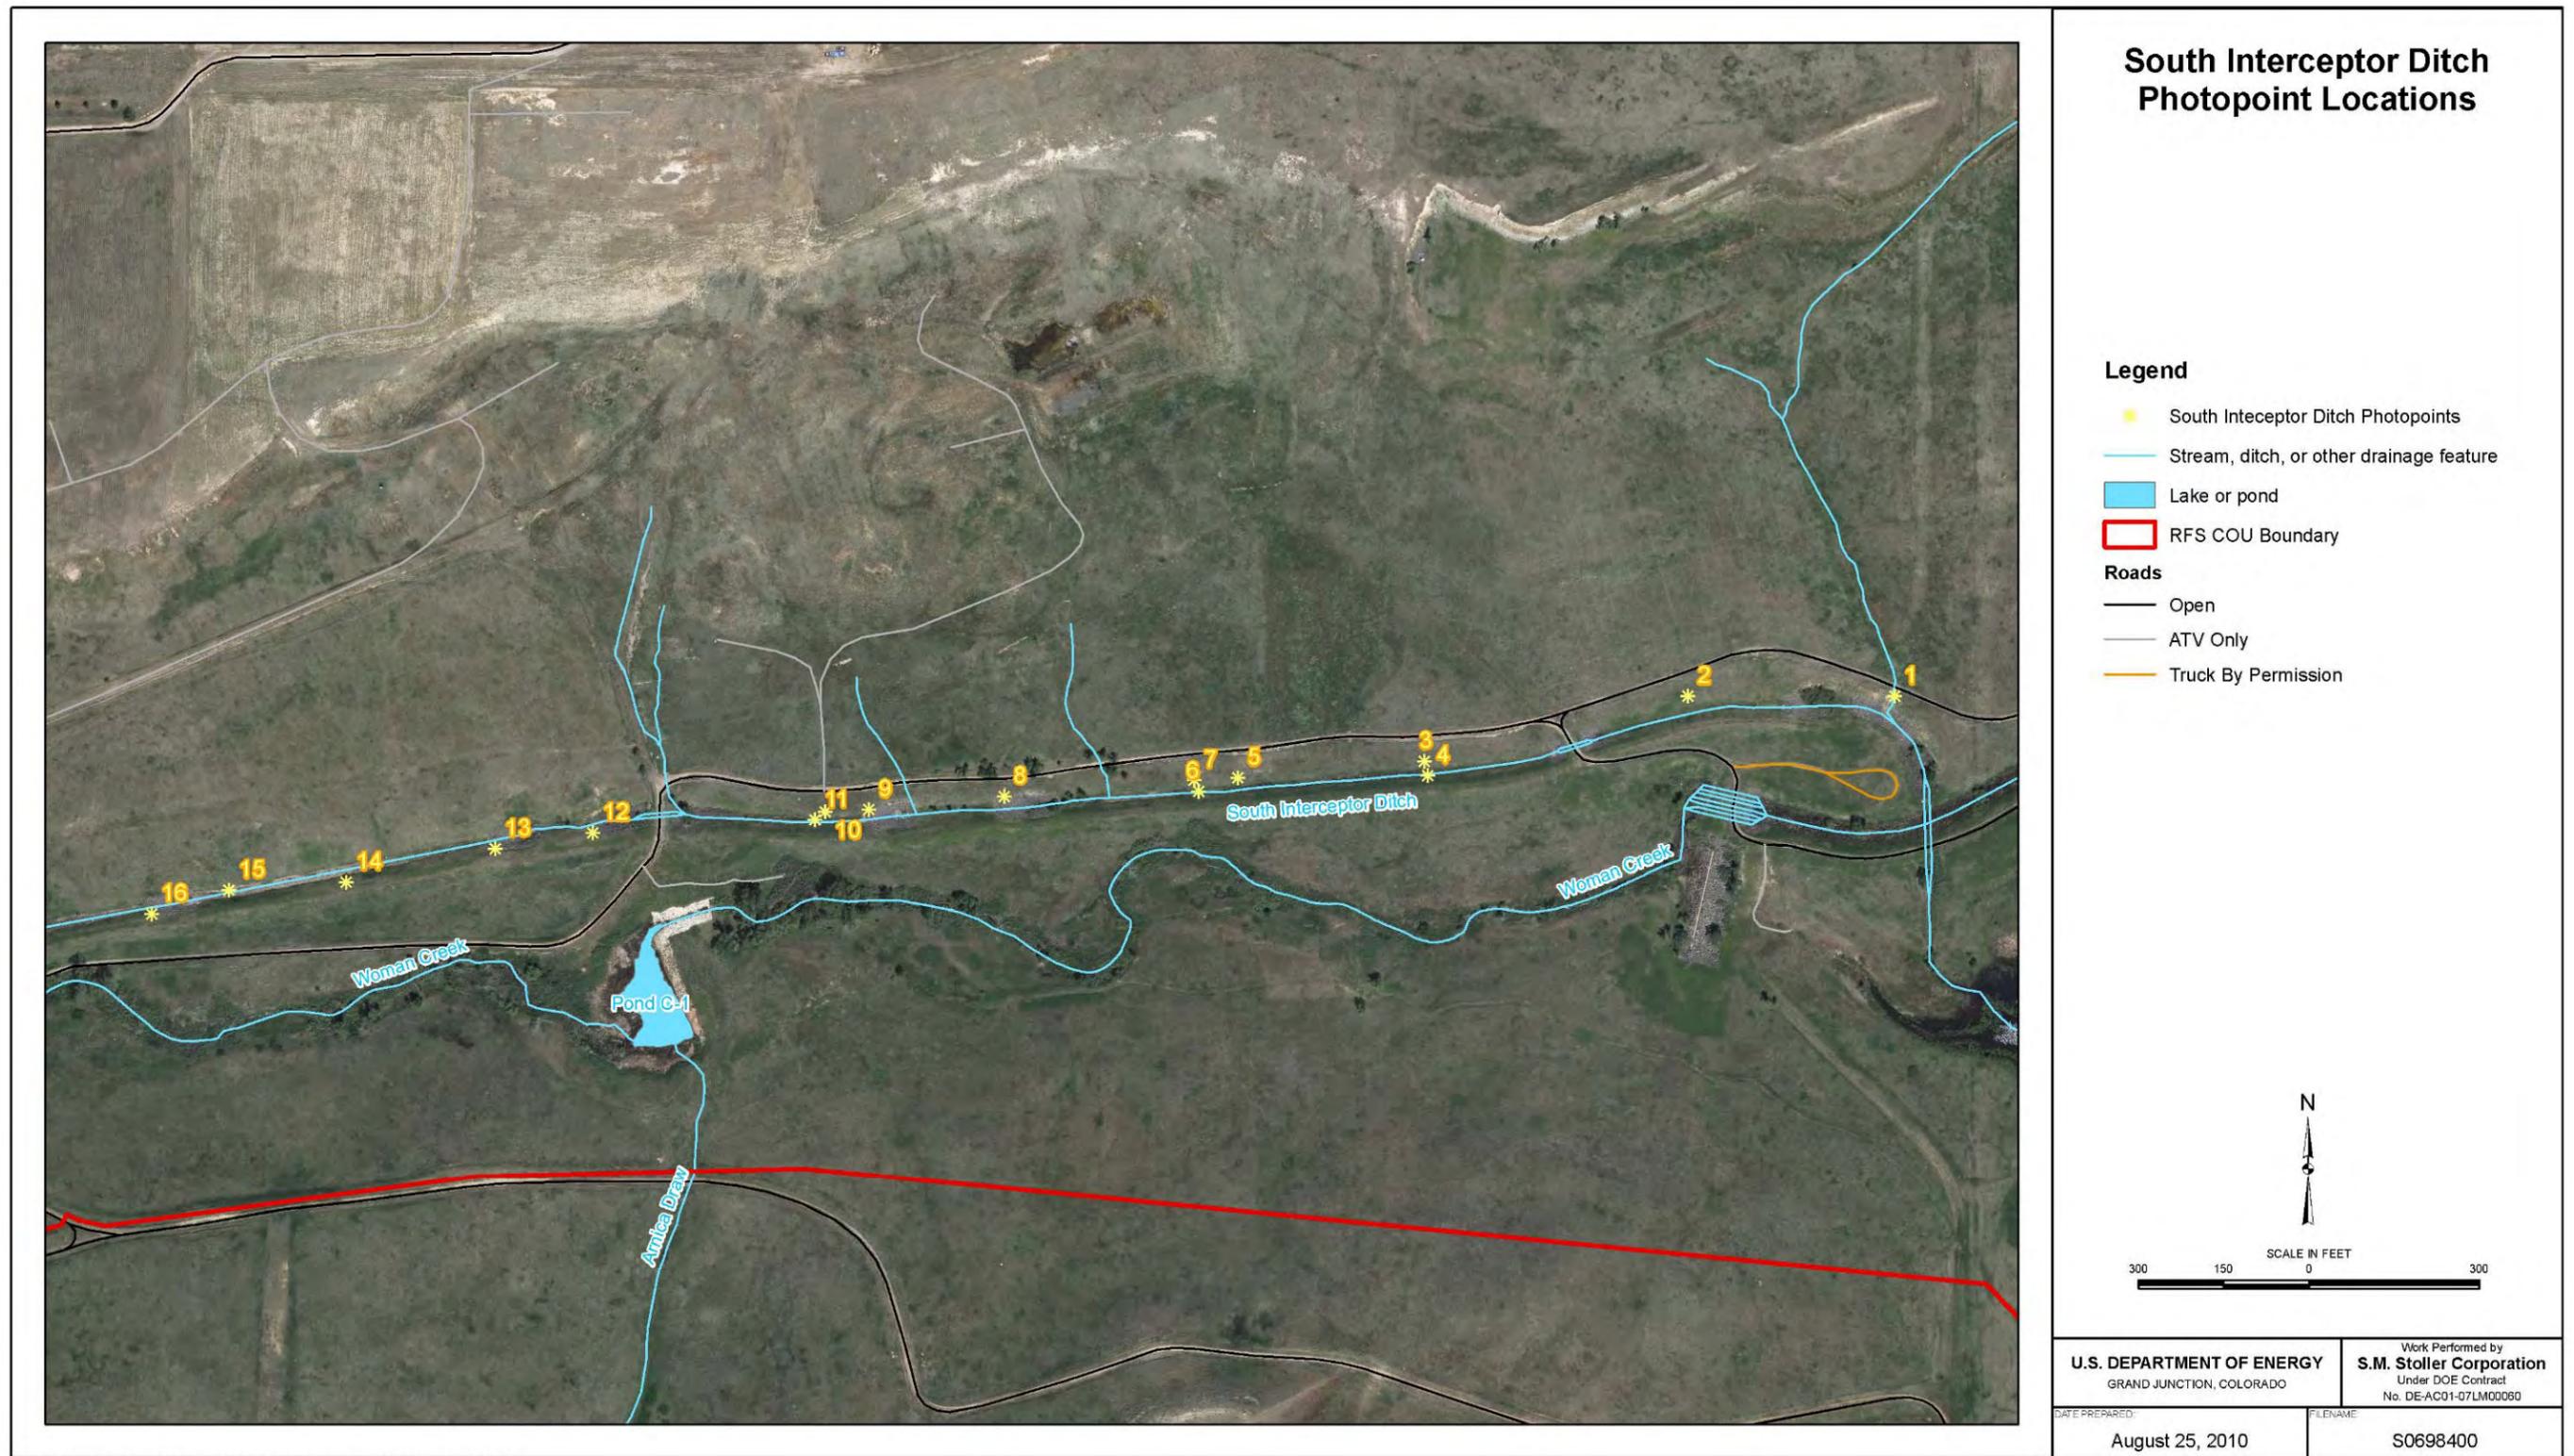
Figure 5. SID Photopoints

The SID channel is covered with areas of riprap, vegetation, and vegetation debris, which limit movement of sediment within the SID. Site personnel inspected areas of the SID during the June visits and conducted an additional walk-down of the SID area on August 23, 2010. The conditions in the SID were documented during the August visit with photographs taken from locations identified by field global-positioning system coordinates. Figure 5 shows the photograph (Photopoint) locations. Figures 6, 7, and 8 are photographs that illustrate the types of cover in the SID channel. Inspectors also noted that the SID channel banks had good stands of vegetation, and there were no conditions that indicate significant erosion, such as gullyng or washouts, or conditions that are precursors to significant erosion on the channel banks.

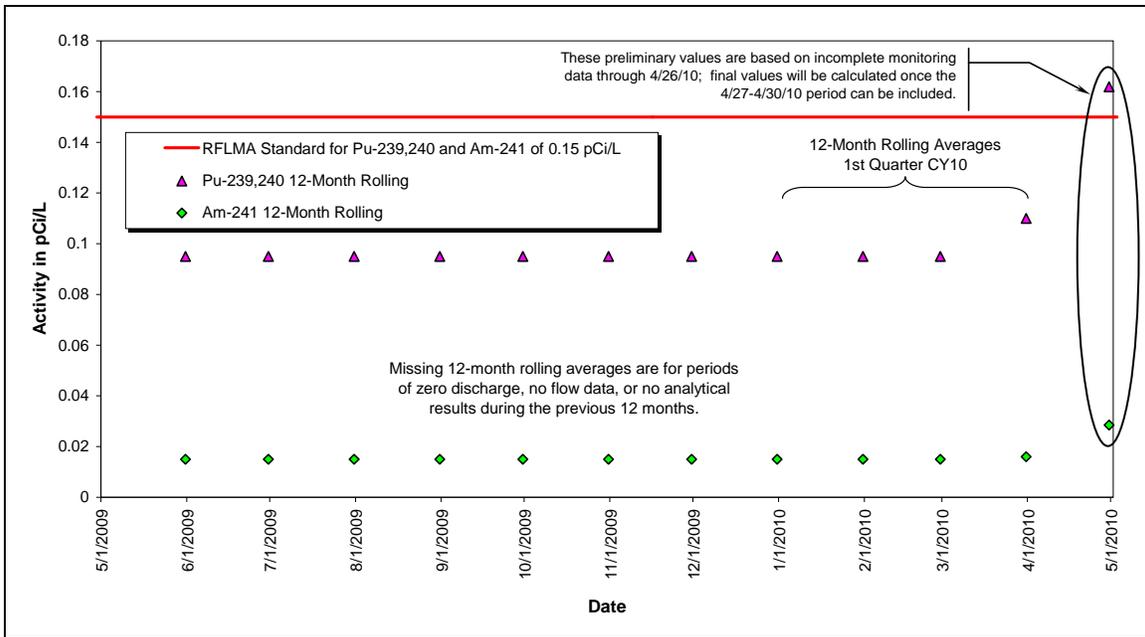
Figure 6. Data for SW027

Although there is normally no water flowing at SW027, heavy runoff during late April 2010 generated the two highest analytical results. Plutonium concentration in a subsequent sample collected April 26, 2010, was 0.029 pCi/L, which indicates that Pu levels have decreased. Sampling at SW027 is accomplished using automated samplers that collect continuous flow-paced composites; the composites are filled based on the availability of water flow. The SW027 composite that was started on April 27, 2010, is still in progress as of August 31, because the composite bottle does not yet contain enough sample volume to conduct a valid analysis. Therefore, the 12-month rolling average for the end of April 2010 cannot be calculated at this time. However, based on the results available through April 26, 2010, DOE has made preliminary notification that the April 2010 12-month rolling average for Pu is expected to be just above the 0.15 pCi/L standard. Figure 6 shows the 12-month rolling average calculated for SW027 with sample results up to April 26, 2010.

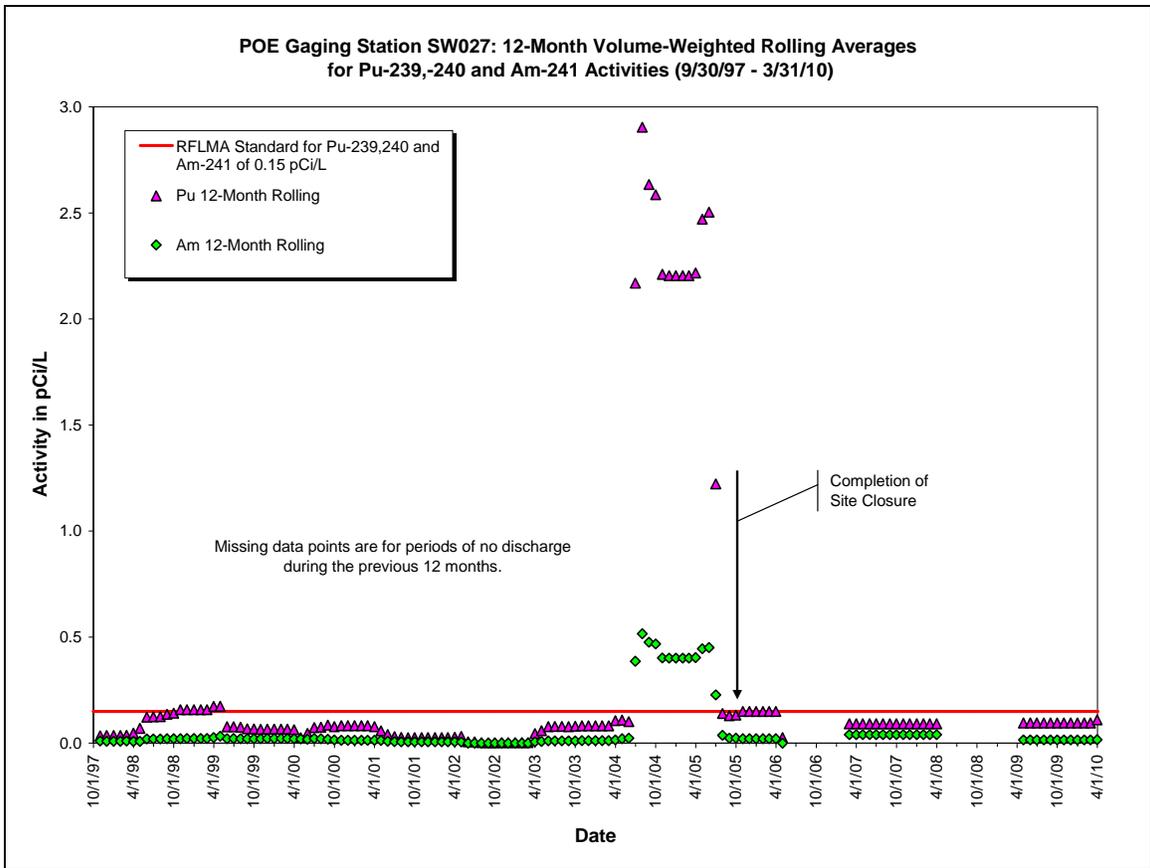
Figure 7 shows discharge volumes at SW027, and Figure 8 shows 12-month rolling average results at SW027. While the recent SW027 results indicate that the RFLMA standard for Pu will be exceeded when the April 2010, 12-month rolling average can be calculated, these results are within historical variability and do not indicate a previously unknown source or transport mechanism.

Figure 8. 12-Month Rolling Averages at SW027
