# QUARTERLY UPDATE

FOR OCTOBER 1, 1992 THROUGH JANUARY 1, 1993

## HISTORICAL RELEASE REPORT (HRR)

EG&G ROCKY FLATS, INC.

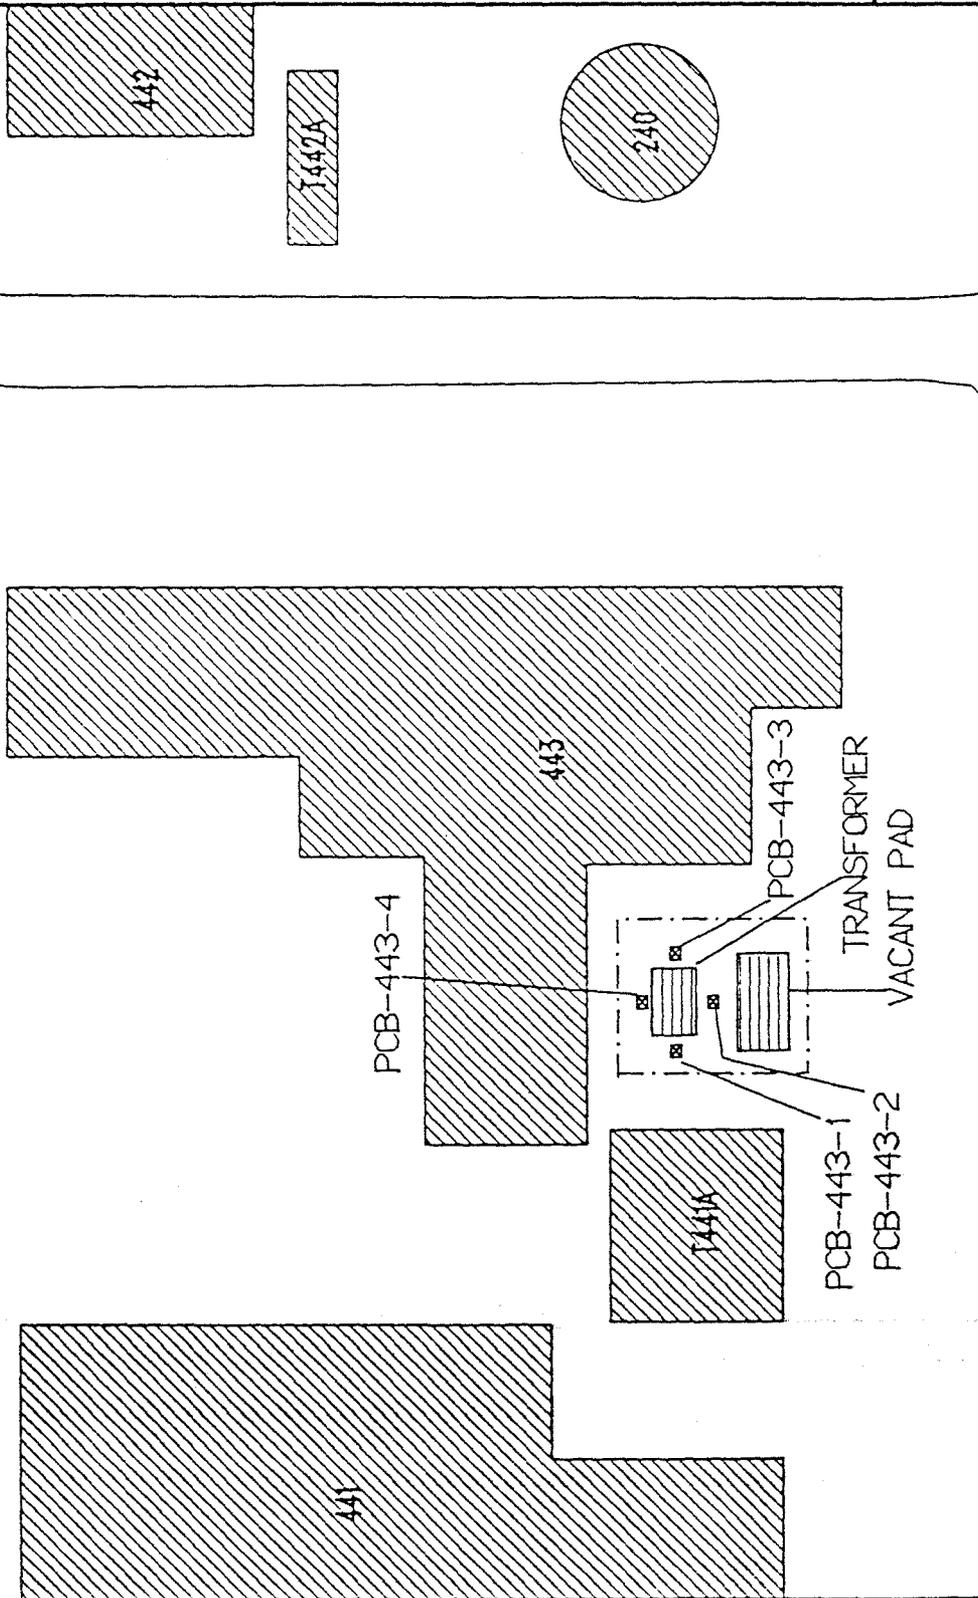
SITE No. 443-2  
(special)

Transformer 443-2 is located near the southwest corner of Building 443. The transformer was observed leaking small quantities of oil during a routine inspection in April of 1992. The area is surrounded by a concrete berm and restricted by a fence.

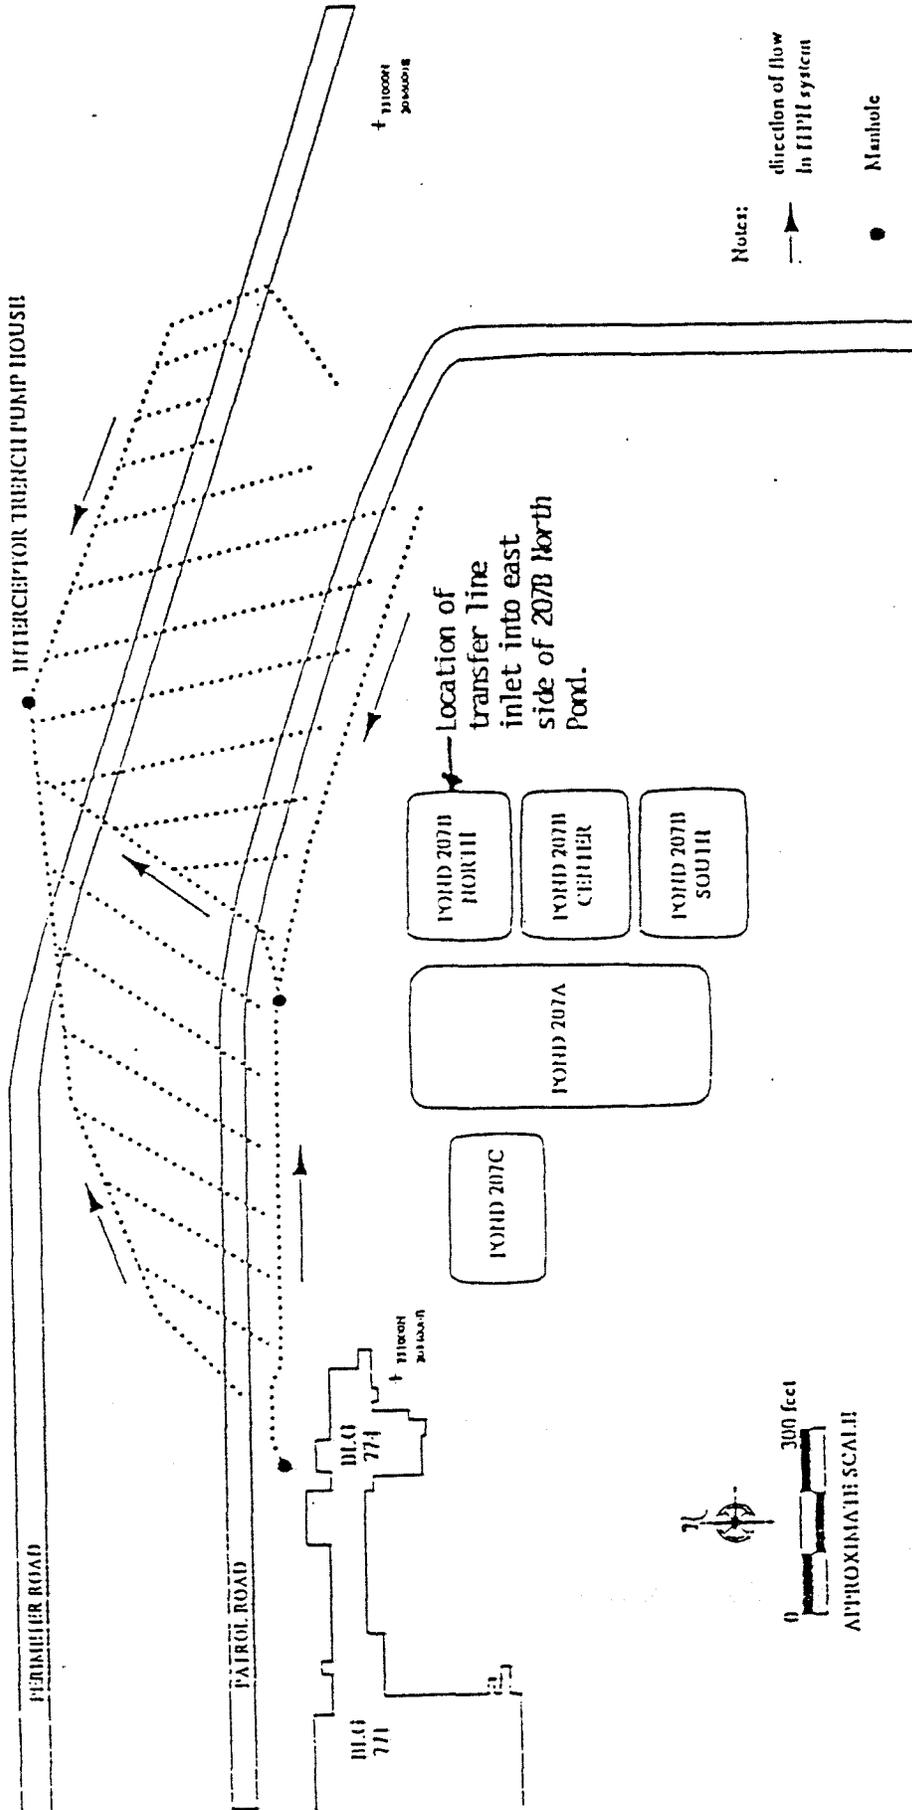
FIGURE 1

The release occurred at 1:45 a.m. on Monday, November 30, 1992. The 2' to 3' long section of the drain hose that was connected to the end of the inlet pipe to the 207B North Pond had frozen during several days of sub zero weather and caused a back pressure in the pipe when the interceptor central sump pump began to pump water into the Pond. The 3" diameter pipe that connects the central sump to 207B North Pond separated (the pipe did not break) at a 3" coupling joint that was installed many years prior to this incident.

In the early 1980's, the original system was replaced by a more extensive french drain system which is known as the ITPH system. This system was designed primarily to collect subsurface water. The system was extended in 1982 to include a new french drain that paralleled the old Patrol Road. This new french drain was designed and built with gravel backfill from the drain to the surface so that it would collect both groundwater and surface water flow. This extension also provided for the collection of the footing drain flows from Buildings 771 and 774. The present configuration of the ITPH system is shown in Figure 1.

As a contributing cause, the investigation revealed that the separated joint had not been properly made during the installation. The wrong type and an inadequate amount of glue had been used (the pipe is constructed of PVC) and the coupling was not installed properly when it was first installed many years ago.

Approximately 490 gallons of interceptor trench water was released to the east exterior side of the berm and flowed east and north within the area covered by the ITPH system. The released material was not directly recoverable because it soaked into the soil. Due to the location of the release (upgradient of the ITPH system in an area previously identified to possibly be contaminated due to past releases from the Solar Evaporation Ponds), no action was taken to immediately recover the material. The area impacted by the release will be included in the quarterly update of the Historical Release Report as a recommendation that the impact of this release to the environment be sampled, characterized, and possibly remediated as part of the IAG activities.

The interceptor sump pump was de-energized immediately after the leak was discovered. Personnel disconnected the drain hose from the end of the pipe and reinstalled the pipe. A water tight rubber-to-steel coupling clamp was installed on the pipe to allow continued operation of the Central Sump System. The pump was re-energized and the run-off collection system was returned to normal operation. The coupling clamp is being inspected every four hours until the weather temperature increases to allow a permanently cemented 3" diameter coupling be installed at the pipe joint.
