QUARTERLY UPDATE

FOR APRIL 1, 1994 THROUGH
JUNE 30, 1994

HISTORICAL RELEASE REPORT (HRR)

EG&G ROCKY FLATS INC

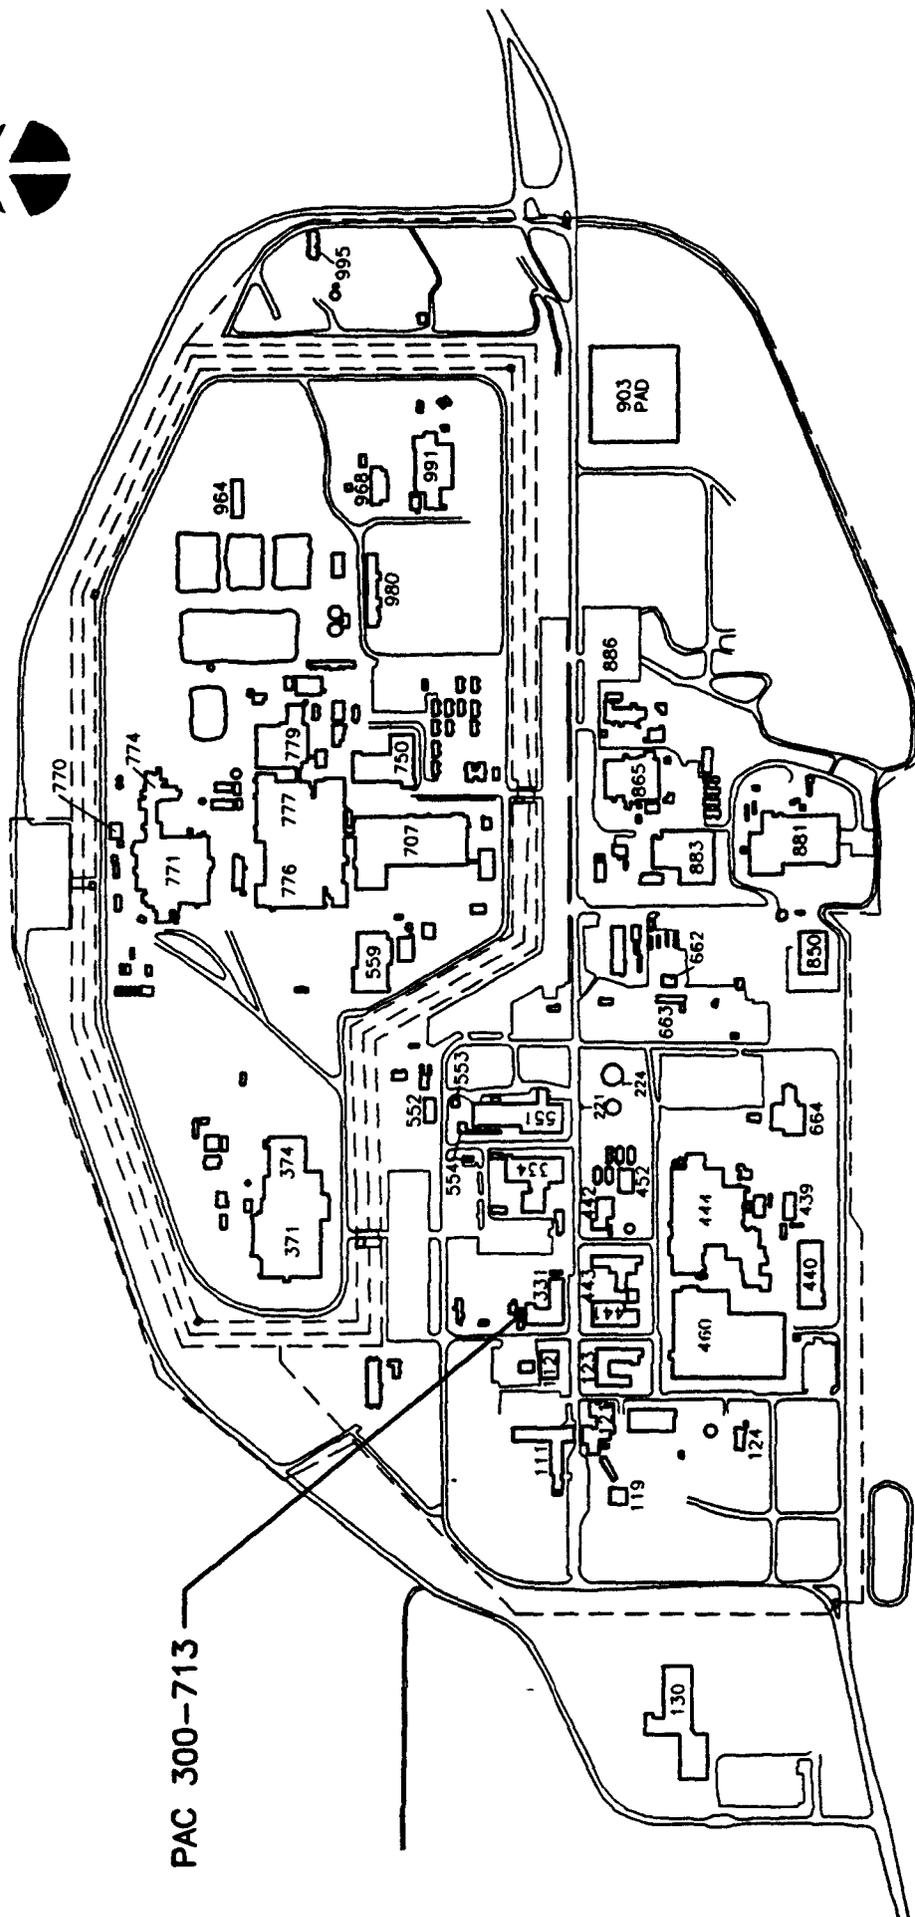
FIGURE 1
PAC 300-713

At approximately 3 45 p m on May 17, 1994, one to two cups of a liquid characterized as a hazardous waste due to corrosivity leaked from a trash compactor truck onto pavement north of Building 331. The spill was identified when a green liquid was observed to be leaking from a parked truck onto the asphalt outside of the Garage¹. The location of this spill is shown on Figure 1 following this narrative as well as on the PAC map in Section 4 0.

One to two cups of Mariko® was released to the pavement. Typically asphalt and road surfaces are not free of cracks or gaps and are not considered to be adequate secondary containment due to the possibility of a migration path to the environment. However, in this case, the small amount of RCRA-regulated hazardous waste material that was released to the asphalt surface was adequately absorbed by Oil-Dri® and therefore no longer presents a significant actual or potential hazard to human health or the environment.¹

No further action is recommended for this incident based on the small quantity of Mariko® released and its recovery by absorption with Oil-Dri®.¹

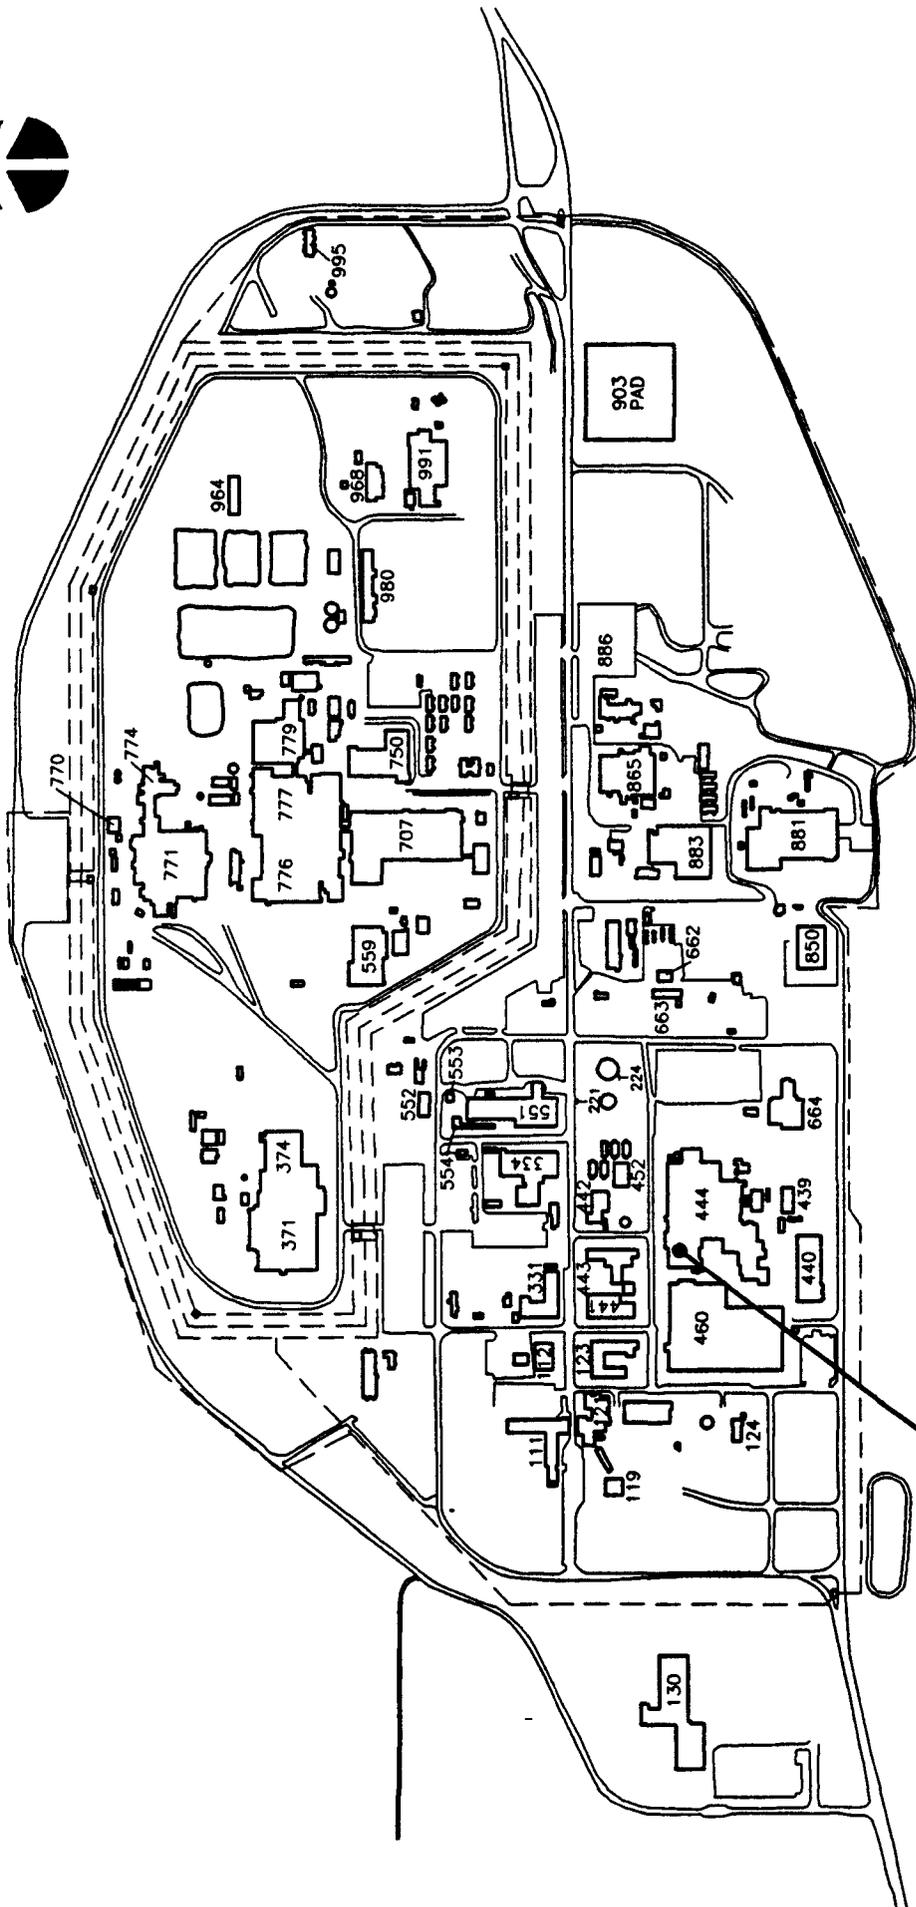
FIGURE 2
PAC 400-814

At approximately 12 00 p m on May 17, 1994, a Stationary Operating Engineer (SOE) noticed the presence of oil under an air conditioning unit on the roof of Building 444 Upon further investigation of the compressor cabinet unit, the SOE found additional oil The total volume detected totalled approximately two gallons This oil was suspected to be contaminated with levels of cadmium and lead above Toxicity Characteristic Leaching Procedure (TCLP) regulatory limits based on results from laboratory samples previously taken from other air conditioning equipment The source of the leak was determined to be a hole in a copper line to a pressure control device The hole was at a point where another copper line crossed at a 90 degree angle directly on top of the lower line The hole apparently was due to abrasion from vibration between the two lines An undetermined amount of Freon 22, a non-hazardous waste, was also released¹ The location of this spill is shown on Figure 2 following this narrative as well as on the PAC map in Section 4 0

Approximately two gallons of compressor oil and an undetermined amount of Freon 22 were released to the roof of Building 444 Validated analytical results from a sample of the refrigerant compressor oil released to the roof indicate that the released material is not a hazardous waste These data are contained in Table 1 on the following page

No further action is recommended at this site based on the non-hazardous characterization of the spill material and prompt cleanup.

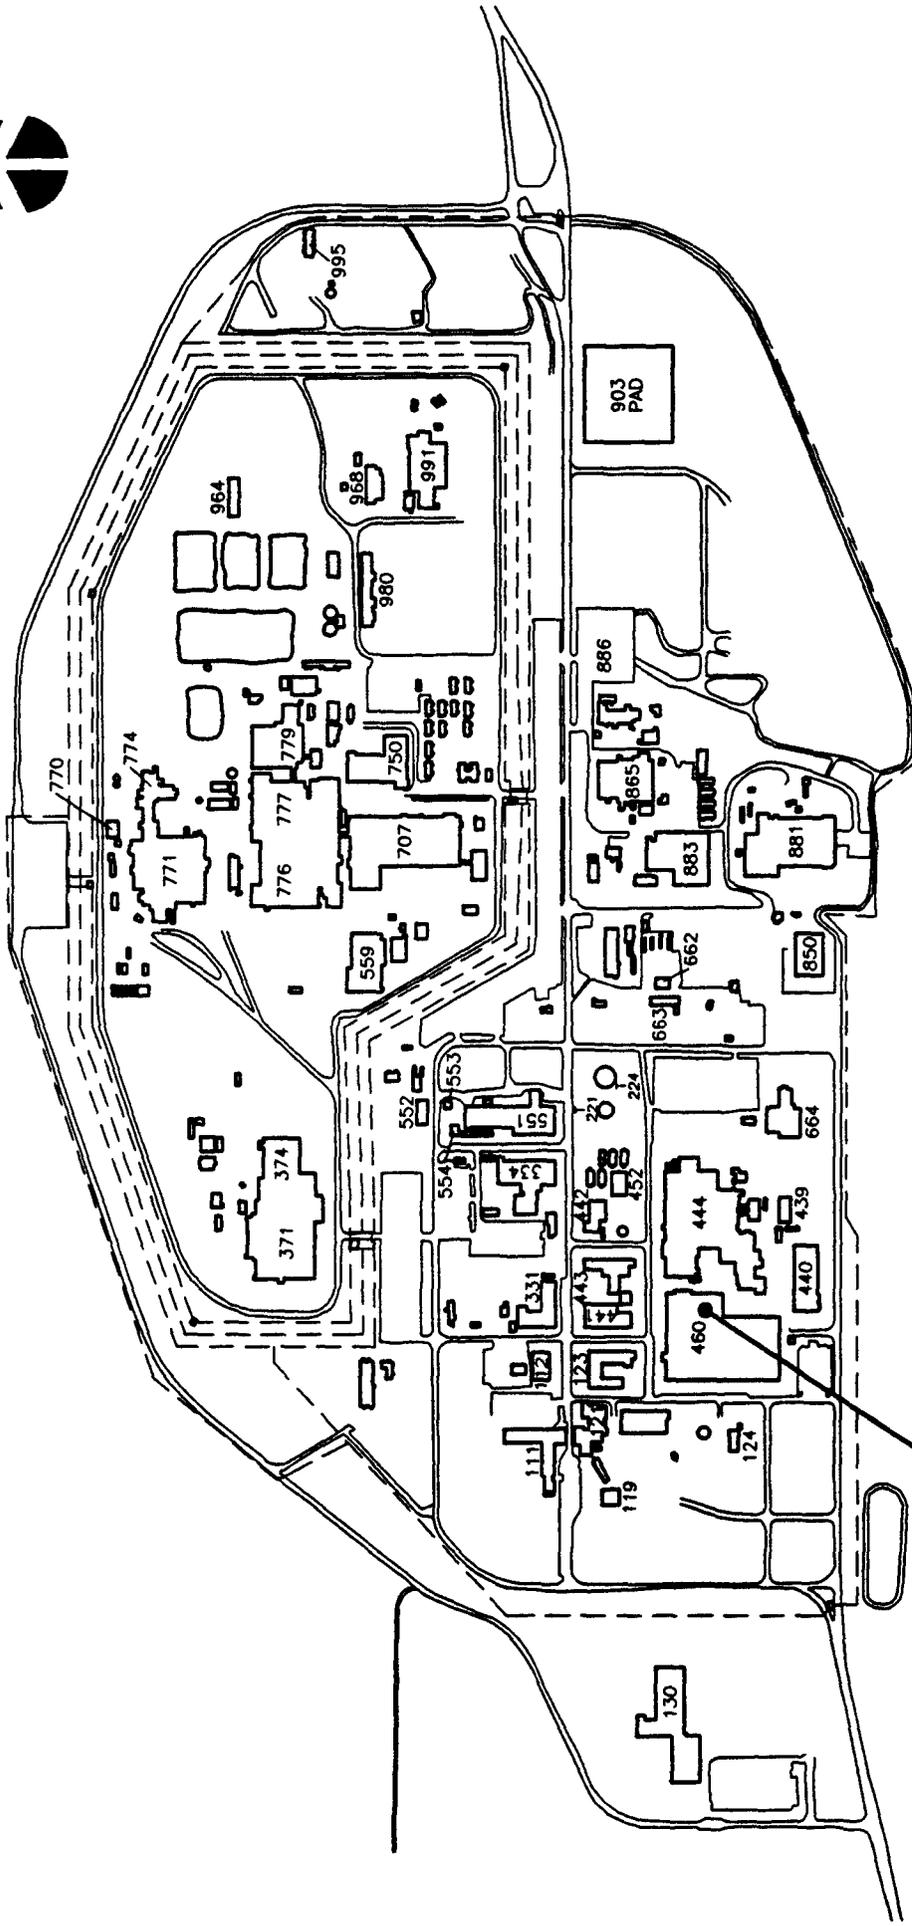
FIGURE 3
PAC 400-815

At 3 05 p m on June 29, 1994, a maintenance person discovered a release of approximately 1,800 gallons of process waste water into the secondary containment pit of Sump Tank ST-5 (RCRA Unit 40 15) located in Room 140 of Building 460. Initial surveillance indicated that the Hypalon liner in the pit leaked, filling the associated leak-detection sight tube three-fourths full of hazardous process waste water. In addition, approximately one-half to three-fourths inches of water were present in the surrounding bermed area. No leakage had been observed during the RCRA custodian's inspection on the previous day, June 28, at 9 30 a m ¹

Preliminary sample results indicated that cadmium levels were likely present above RCRA regulatory levels for toxicity. The validated analytical data confirmed that cadmium exceeded the TCLP limit for toxicity in both the pit and the sight tube. Based on the analytical data, no other RCRA metals exceeded TCLP limits or exhibited the characteristic of corrosivity.² The source of the cadmium is believed to be from residual Non-Destructive Testing film developer process waste which was last placed into the process waste system on June 28, 1994. The developer waste water drains to the tank in Pit #2. Since Sump Tank ST-2 pumping is automatic, it is unknown when the solution from this tank was transferred to Tank T-3.¹

On June 30, 1994, maintenance tested the hypalon liner in the pit for leakage. Three small areas in the liner indicated leakage paths. The liner was also visually inspected and two additional small areas were found near the top of the pit where the liner had separated.¹

Due to the relatively low level of cadmium found in the released liquid and the minimal risk to the environment, the following corrective actions are planned: the Hypalon liner will be repaired, an additional tank will be placed inside the existing tank for double containment and a person will be stationed at the tank during liquid transfer operations to immediately identify any abnormal conditions. After production is shut down (estimated September 1994), the pit liner will be removed to allow inspection of the concrete surfaces for cracks and gaps. A written report will be issued to Colorado Department of Health (CDH) documenting the results of the inspection of the concrete pit upon removal of the liner and subsequent actions.¹

It is recommended that further action at this site be post-poned until post-production status is attained in Building 460, expected to be September of 1994. Based on the results of the planned post-production inspection of the pit, further action may be required at that time ¹
