SWD-012-92
November 2, 1992

A Description of Rocky Flats Foundation Drains

Environmental Management
Surface Water Division

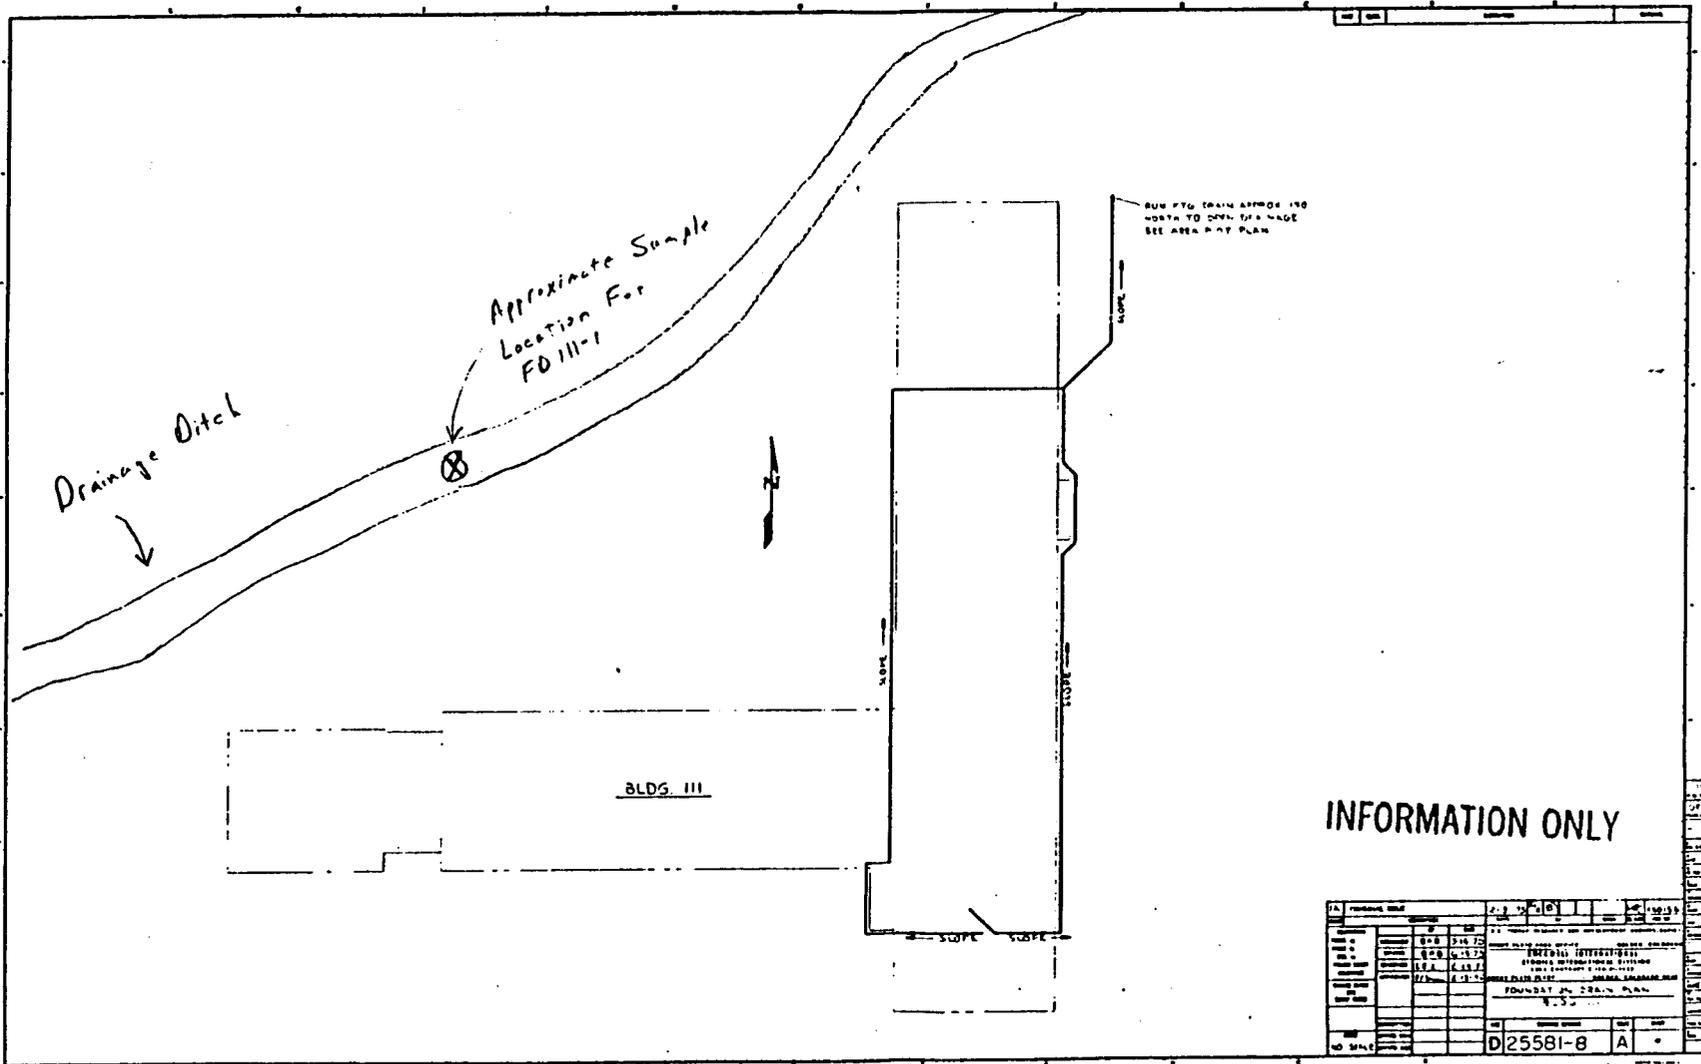
Figure 2: Building 111 Foundation Drain Plan

Figure 1 is a drawing showing several foundation drain outfall locations. Figure 2 is a Building 111 foundation drain plan drawing. Both Figures 1 and 2 show the outfall for the Building 111 foundation drain (FD111-1) in a location north of the northeast corner of the building. This location description is consistent with Table 1 (1977). Recent field inspections of this Table 1 location reveal no potential foundation drain outfalls. Table 2 (1981) describes the foundation drain sampling location as being north of the northwest corner of the building. Table 3 (1983) is consistent with Table 2, as is the sampling location used for the past several years. This sampling location is identified on Figure 2, and has involved taking a sample from within the drainage ditch since a foundation drain discharge location has not been specifically identified.

Recent inspection of the Building 111 basement reveals a building sump which is believed to be a Building 111 foundation drain collection point. This sump is located in the southeast portion of the building. The discharge is pumped through a line that exits through the south end

It appears that FD111-1 was rerouted to the new storm drain location or to the sanitary sewer as a result of construction activities in the area. The Site Utility Plan Drawings for Building 111 do not show a Building 111 foundation drain.

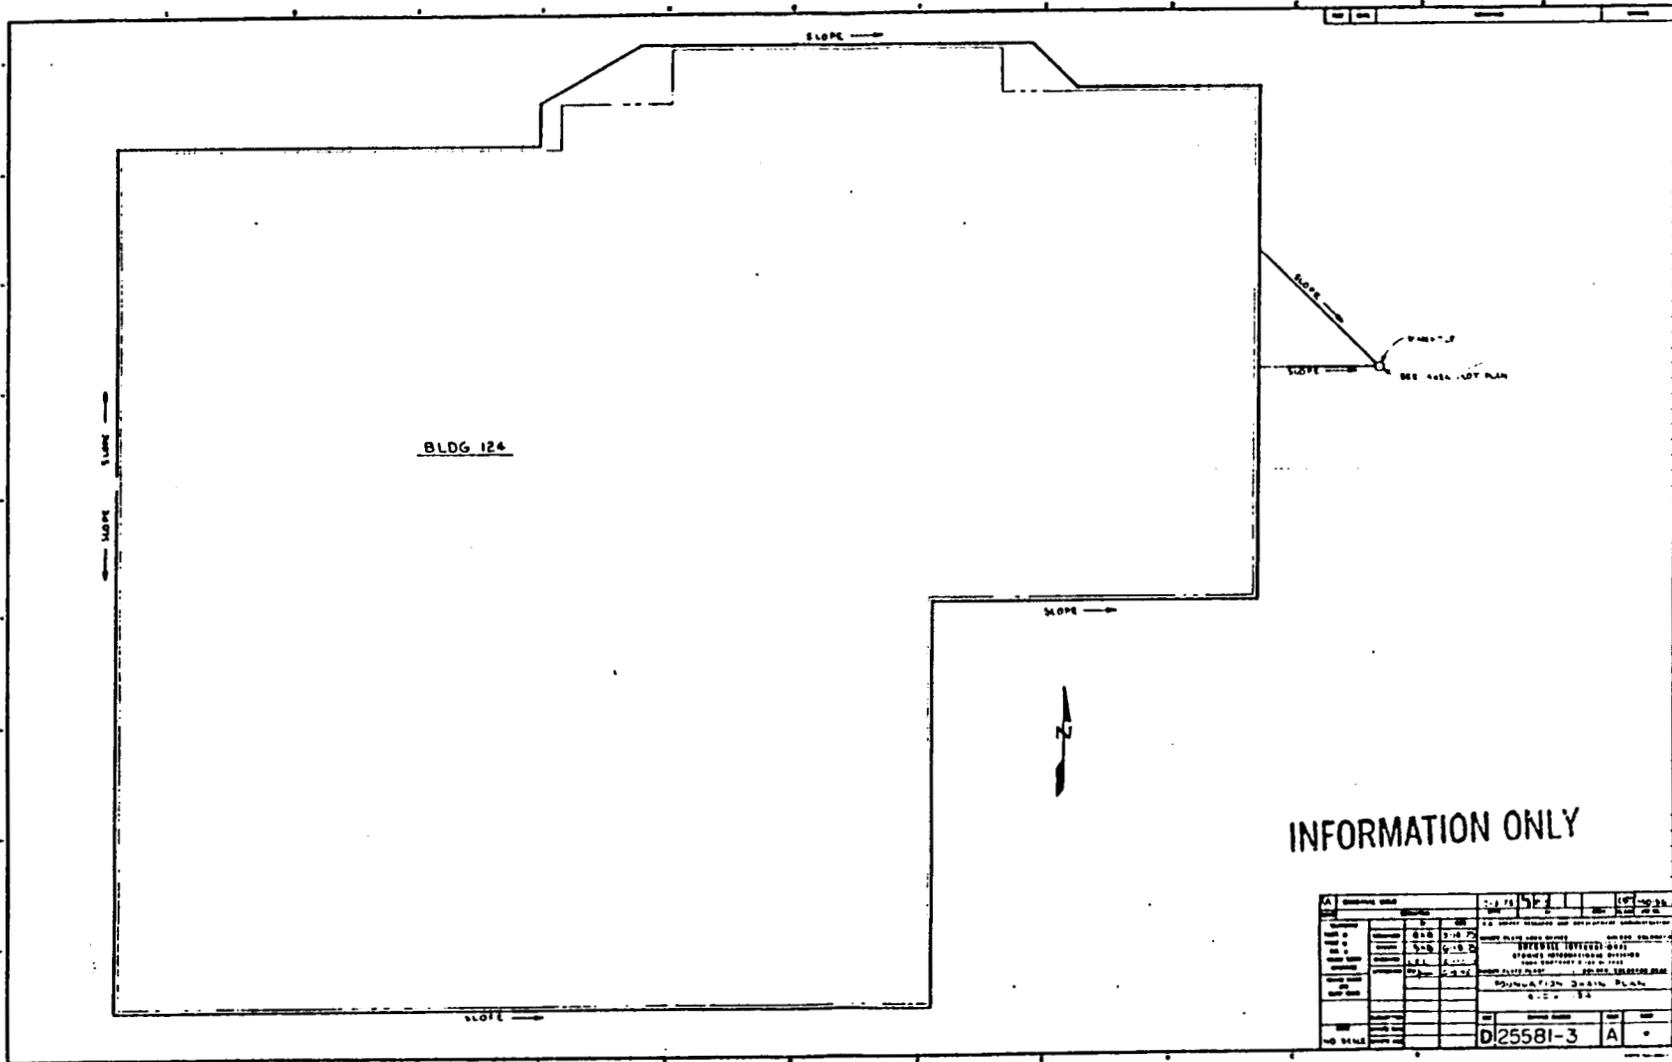
Figure 3: Building 124 Foundation Drain Plan

Figure 3 is a Building 124 foundation drain plan. This figure shows a Building 124 foundation drain collection point to the east of the building and is consistent with the Figure 1 discharge location for Building 124. The Site Utility Plan Drawing for Building 124 does not show a foundation drain as described by Figures 1 and 3. A foundation drain is not referenced in Tables 1, 2, 3, or 4. A building representative has reported that this foundation drain has been taken out of service.

There does not appear to be any IHSS's or historical releases that would contaminate groundwater reaching the Building 124 foundation drain, if it were still in existence. Building 124 is the drinking water treatment plant and a fuel tank may represent the only threat of contaminating the groundwater in the area around this building.

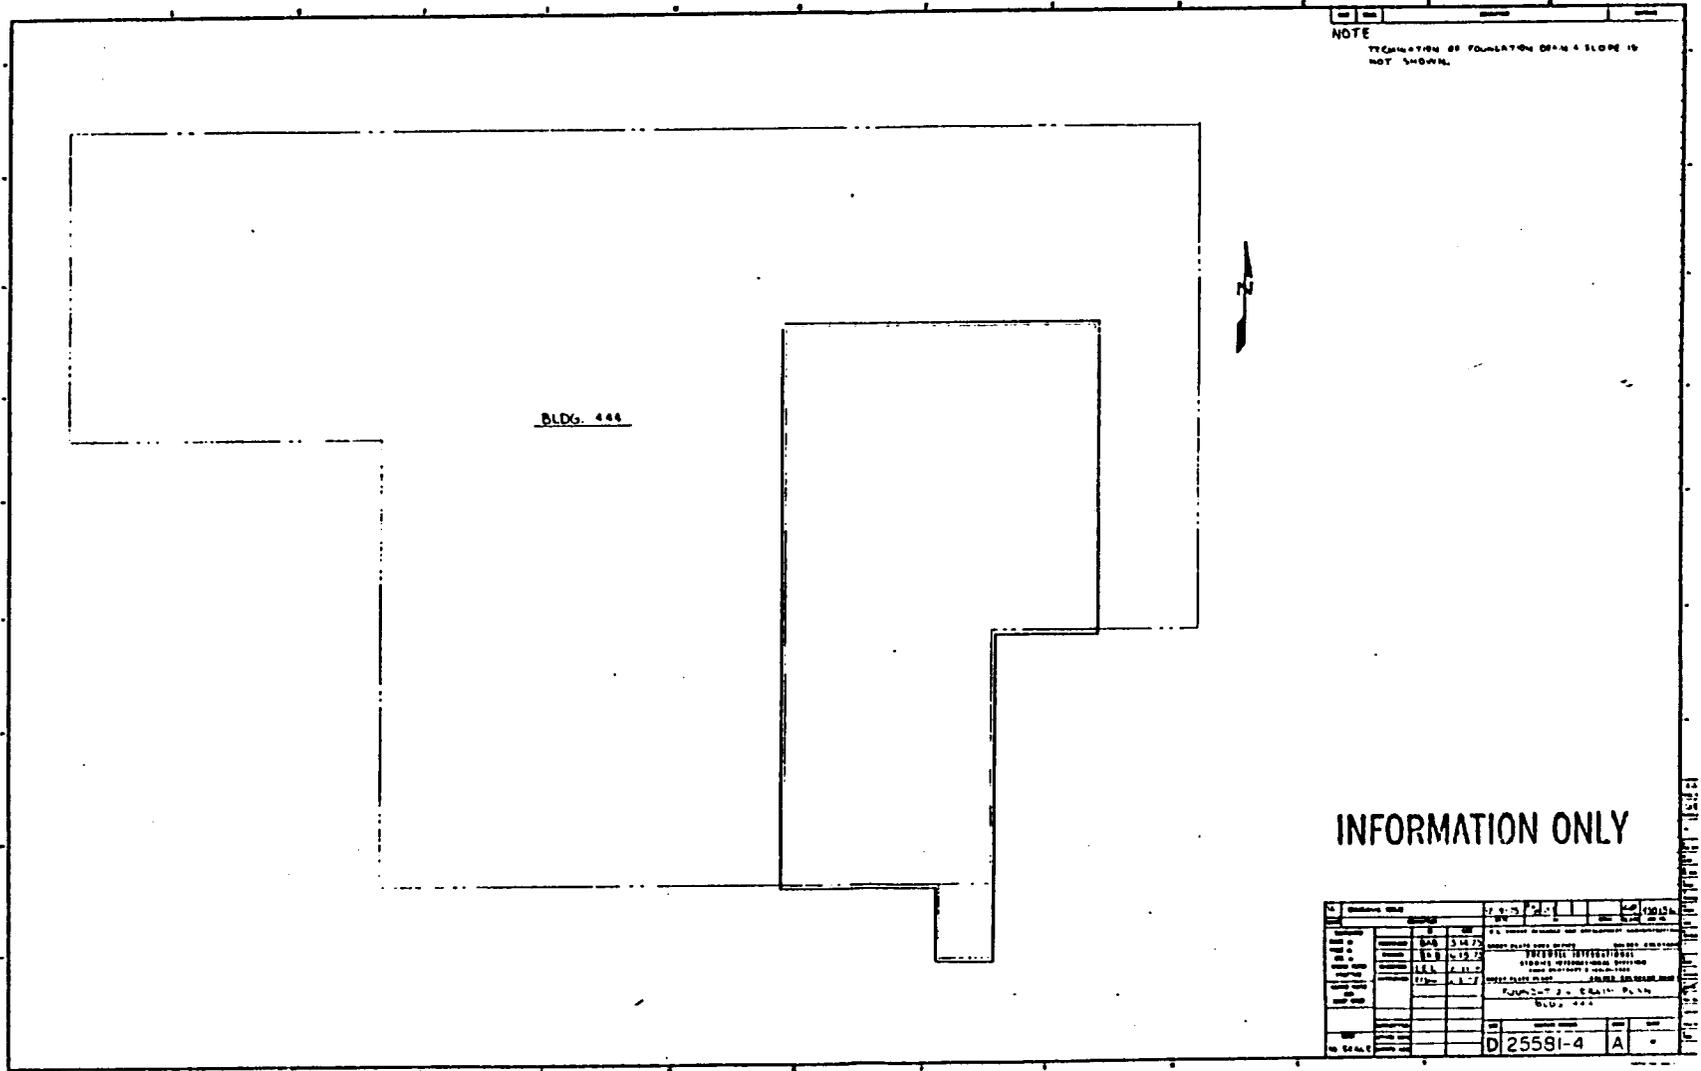
Figure 5: Building 444 Foundation Drain Plan

Figure 5 is the Foundation Drain Plan Drawing for Building 444. This figure does not show an outfall routing, possibly because of collection within BS444-2. The question is: "are there, or has there ever been, two foundation drain outfalls associated with Building 444, or is FD444-1 a foundation drain for the basement of Building 447 (Building 447 is attached to Building 444), or is it actually a foundation drain for Building 440 as indicated by Figure 1?" Unfortunately, this report does not answer this question.

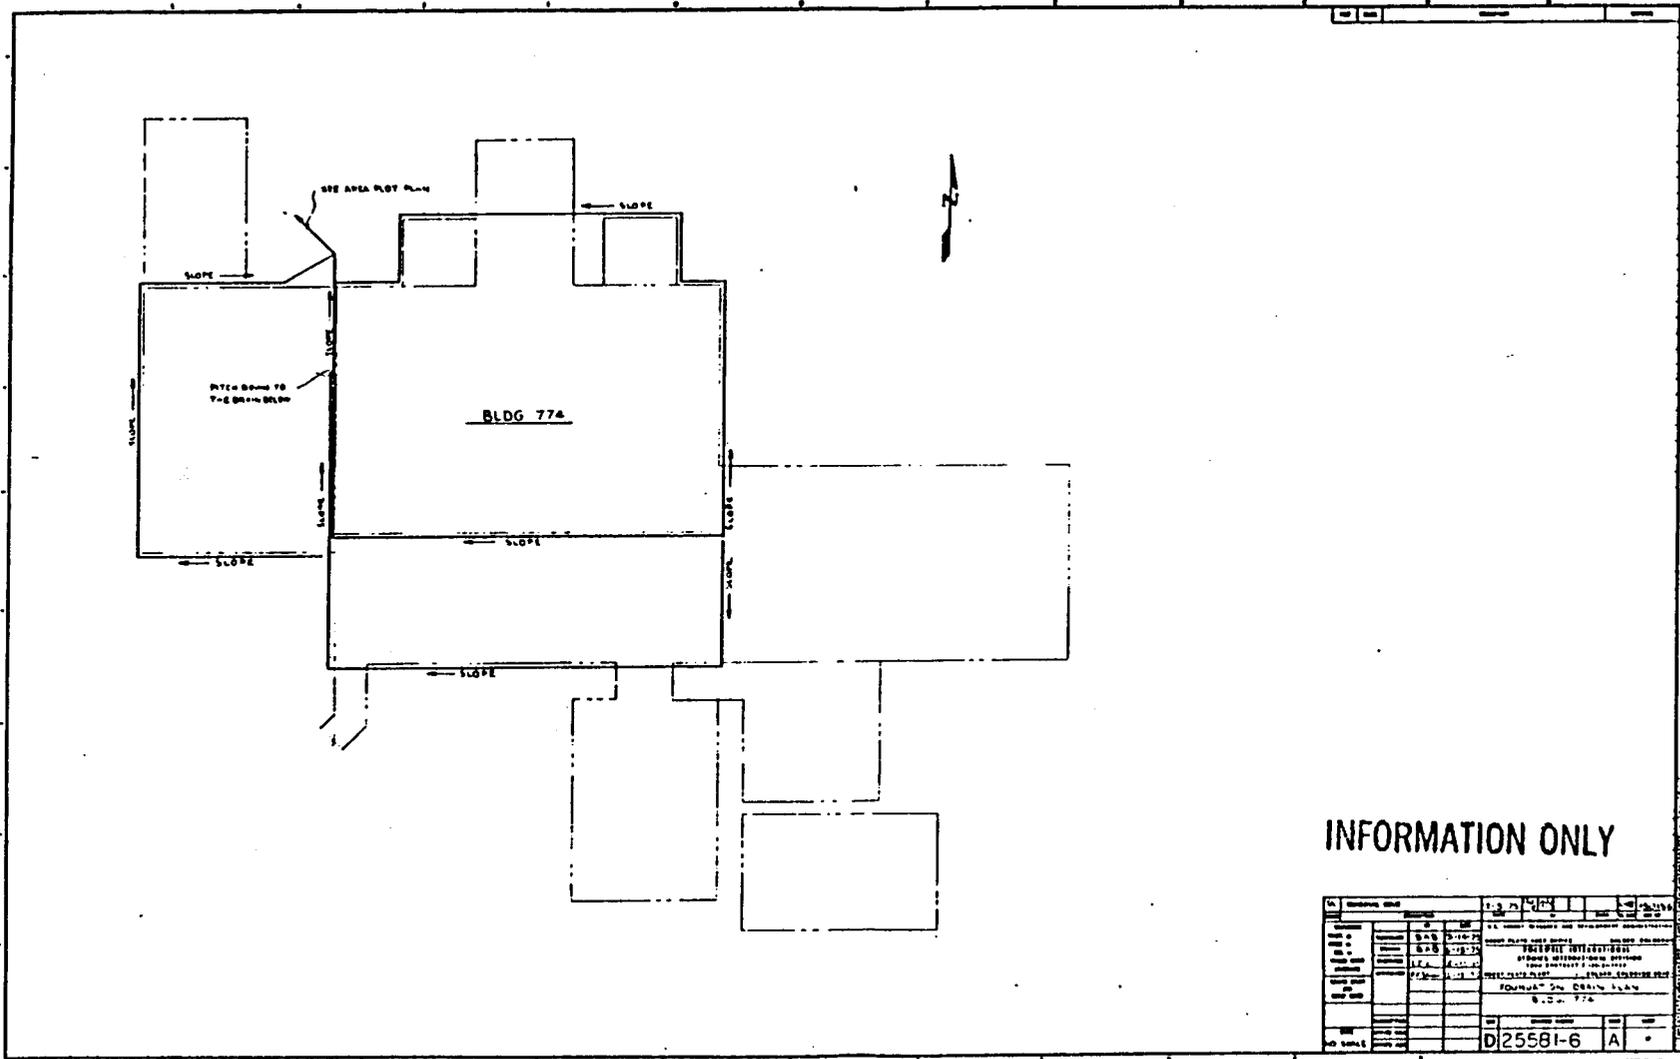
Figure 8: Building 774 Foundation Drain Plan

Figure 8 is a foundation drain plan drawing for the Building 774 foundation drain. This foundation drain is not shown on Figure 1. The Table 1 and 2 FD774-1 sampling location description is presumably for this foundation drain outfall. This location is further clarified in Table 3 and Attachment 2 as being the drain east of the storm drain just east of Building 770. This new description implies that some or all of the previous sampling may have been from the storm drain just east of Building 770. The Table 4 sample location is consistent with Table 3.

Outfall Location 2: This is the FD774-1 sample location per Tables 3 and 4, and therefore should represent the Figure 8 foundation drain outfall, although there is the possibility that this foundation drain was tied into Foundation Drain A should be considered. There is very minor flow through this metal culvert during dry conditions.

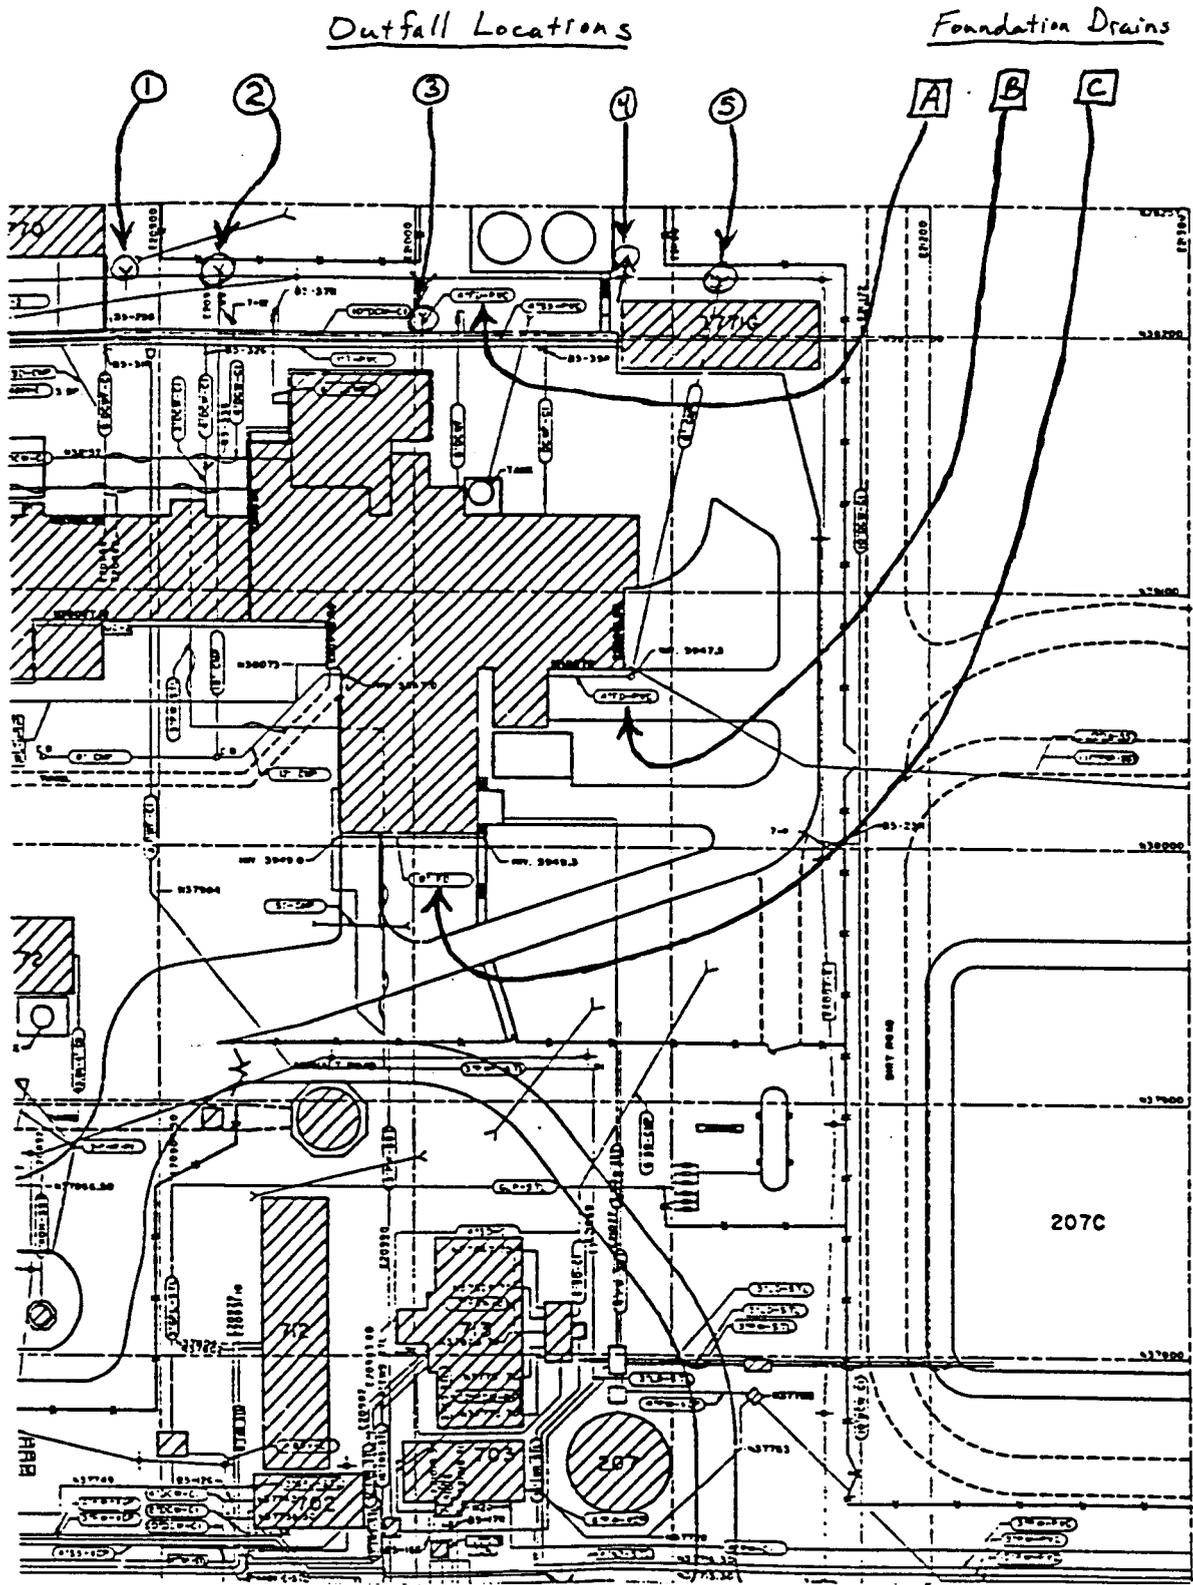
Figure 9: Buildings 774 Foundation Drain And Flow Outfalls

Figure 9 is a copied section from the Site Utility Plan Drawing for Building 774. Five outfall locations will be discussed in reference to this figure. These locations will be referred to as Outfall Locations 1 through 5. These locations are labelled on Figure 9. The Site Utility Plan Drawing identifies three foundation drains associated with Building 774. These locations will be referred to as Foundation Drains A through C, and are labelled on Figure 9. The foundation drain system shown by Figure 8 is not shown in the 1980 Utility Plan or the 1990 Site Utility Plan Drawing copied for Figure 9. Figure 8 does not include Foundation Drains A through C presumably because they were installed as part of the post-1975 Building 774 additions. The following is a discussion of the five Figure 9 outfall locations:

Outfall Location 1: This is a metal culvert that was sketched in on Figure 9 since it is not shown on the utility plans. According to Attachment 2 and Table 3, this appears to be the drain just east of Building 770 where sampling is not to take place since it is just a storm drain. Recent inspections reveal a constant flow of water, approximately one gallon per minute, through this drain during dry conditions. It is unknown if this represents water from a foundation drain, from general groundwater seepage into the buried section of the culvert, or is from a leaking water line.

Outfall Location 3: This is the outfall for Foundation Drain A. Revealed through discussions with building personnel, this drain was unintentionally blocked off when an addition was put on the northern part of Building 774, resulting in groundwater leakage into Building 774. This groundwater is collected in a sump and pumped to process waste. It is unknown if the drain is completely blocked or not. No flows were noted during recent inspections.

Outfall Location 4: This is a PVC pipe not shown on the Site Utility Plan Drawing. It is not known if this storm drain, is tied into a foundation drain, or serves another purpose.

Outfall Location 5: This is the outfall for Foundation Drain B. This outfall has been dry during recent inspections of the area.

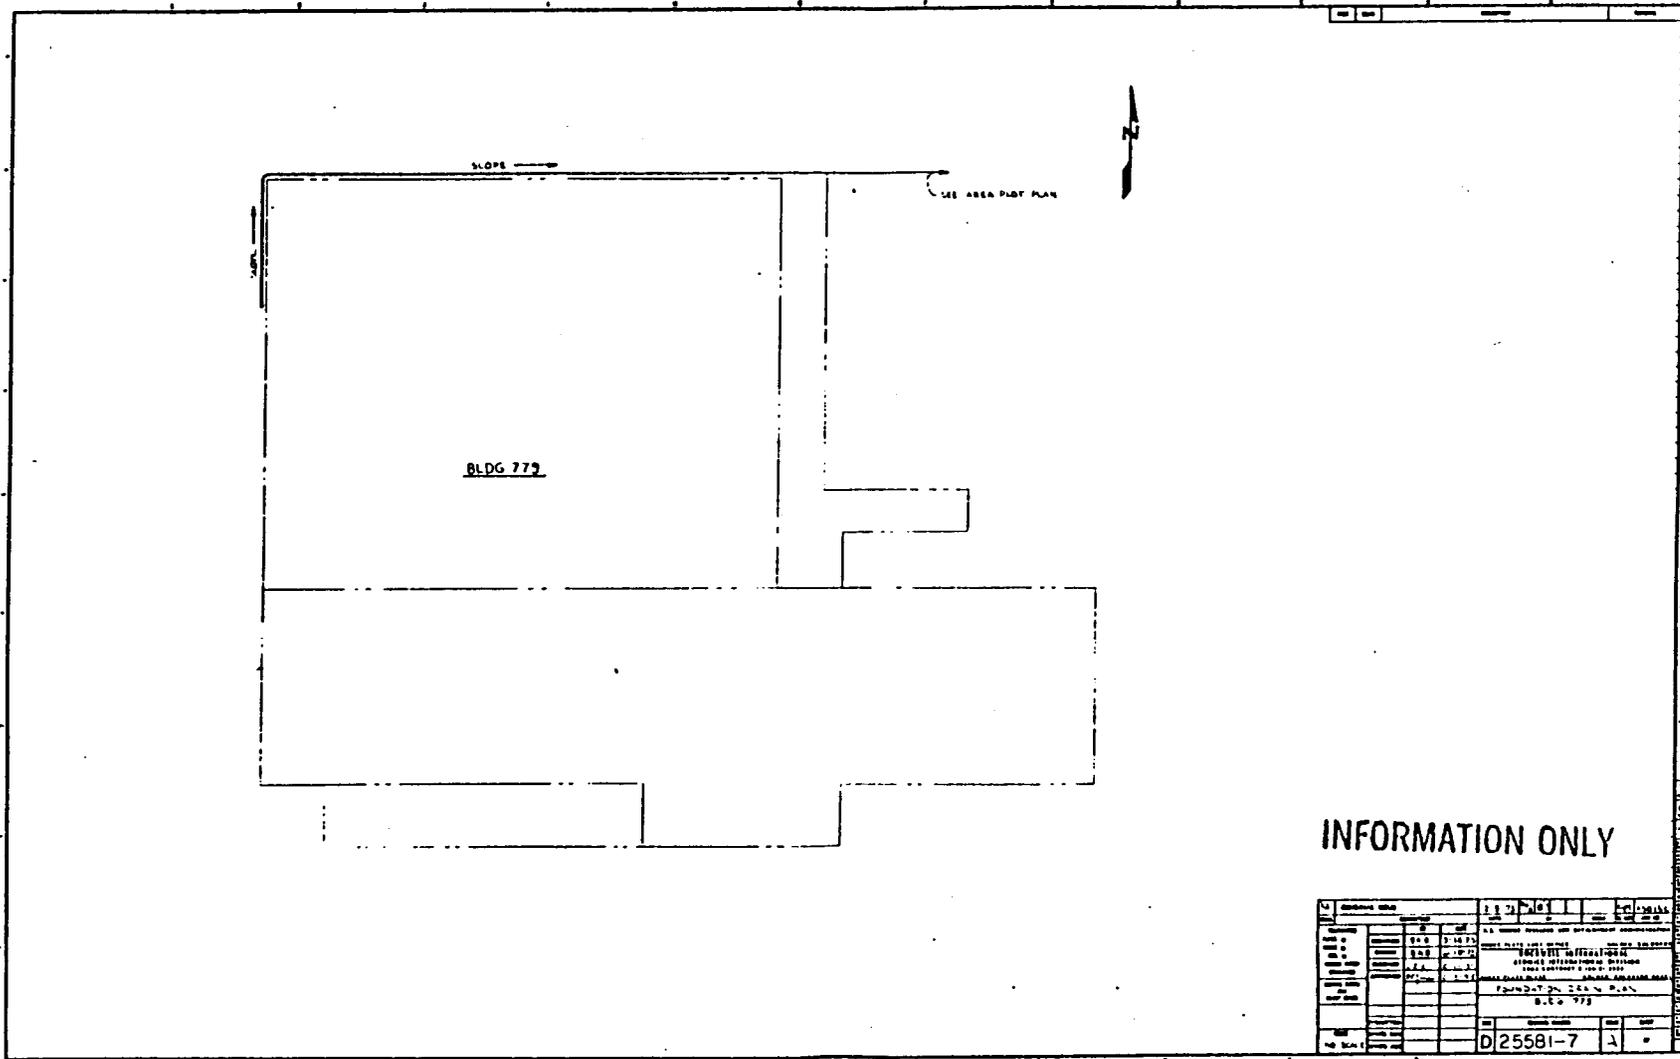
Figure 10: Building 779 Foundation Drain Plan

Figure 1 shows an outfall location for the Building 779 foundation drain (FD779-1) which is also a storm drain discharge location according to the Site Utility Plan Drawings. Figure 10 is a foundation drain plan drawing for Building 779 showing the foundation drain routing in a direction consistent with Figure 1. Tables 2, 3, and 4 FD779-1 locations are all consistent with Figure 1. None of the Site Utility Plan Drawings for Building 779 and the area around Building 779 show a Building 779 foundation drain.

There is a possibility that this foundation drain has been sealed off or rerouted possibly from construction activities. Even if the existing FD779-1 outfall is correct, a better sampling location would be worth pursuing to avoid mixing of the foundation drain discharge with storm water runoff prior to sampling.

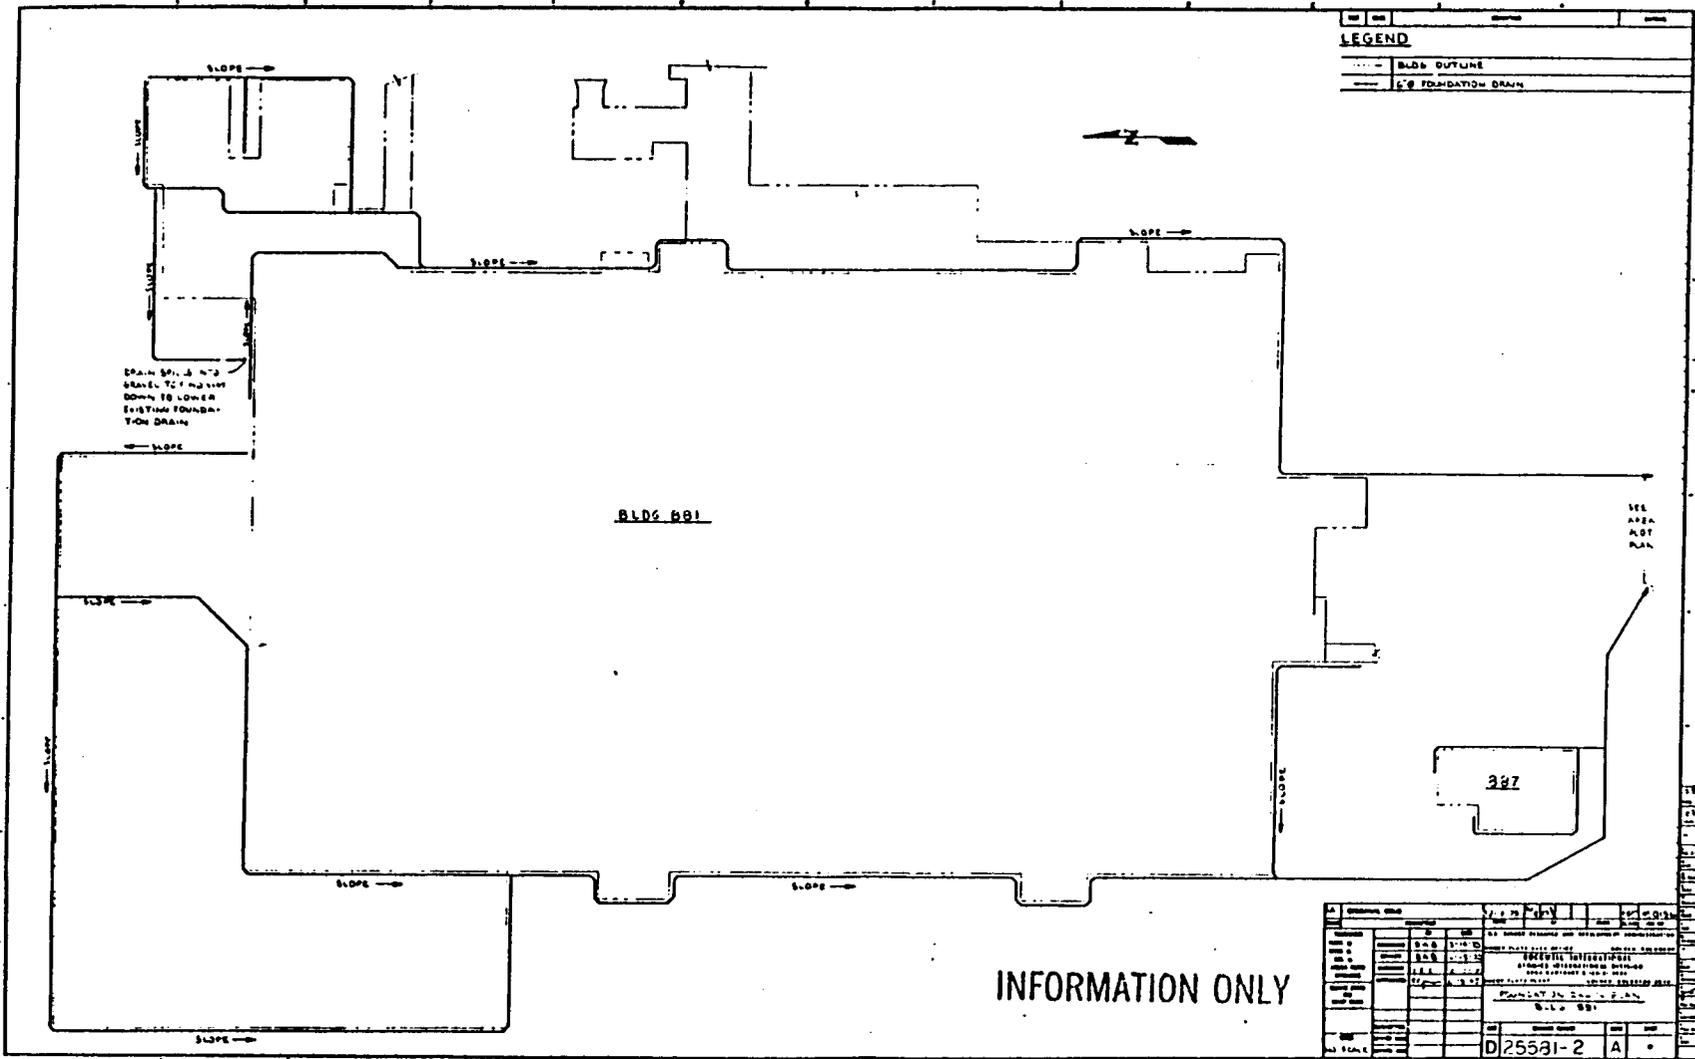
Figure 11: Building 881 Foundation Drain Plan

Figure 1 shows an outfall location for the Building 881 foundation drain (FD881-1), and Figure 11 is the Foundation Drain Plan Drawing for the foundation drain system around Building 881. This foundation drain also wraps around Building 887 per Figure 11. Figure 1 and 11 are consistent with the foundation system layout shown by the Site Utility Plans Drawing except in the area of Building 887, where the utility plans only show the foundation drain route along the south side of Building 887. According to utility plans the drain discharge routing then turns north to an access location which was verified during recent surveillance of the area, and finally heads in a direction consistent with the Figure 11 discharge routing. The two discharge routes shown by Figure 11 join together before daylighting. This final FD881-1 discharge has recently been routed into a treatment system as part of Operable Unit Number 1 operations.

BS881-2, which is no longer sampled per Attachment 2, is located at the bottom of an elevator shaft. BS 881-3 is no longer sampled per Attachment 2. It is possible that both BS 881-2 and BS881-3 are part of a foundation drain system, and will be further investigated as part of the Drain Identification Study.
