**OPERABLE UNIT 9,  
SITE SCOPING REPORT  
VOLUME 6 - PHOTO HISTORY REPORT**

**MOUND PLANT  
MIAMISBURG, OHIO**

February 1992

**Department of Energy  
Albuquerque Field Office**

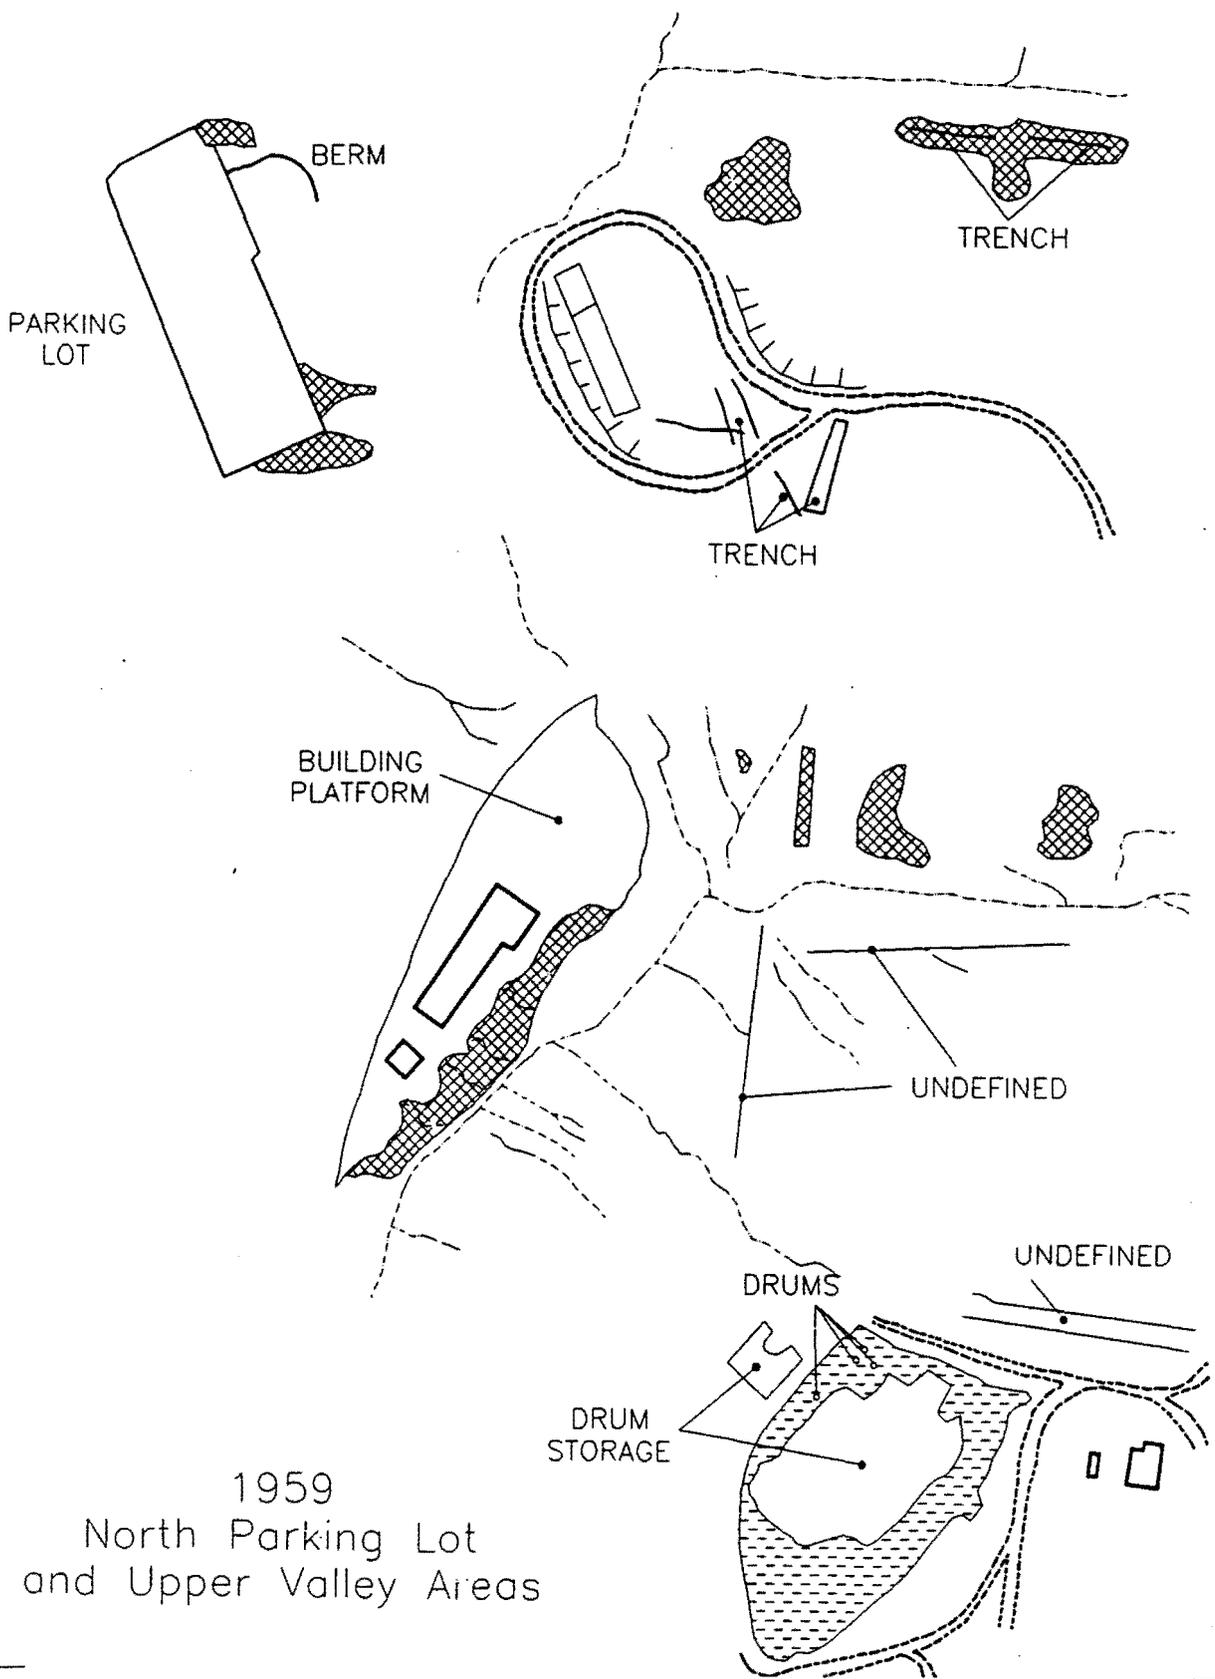
Figure 4.2. Interpretive map of Northern Study Area - 1959.

In the 1959 photos of this area (Figure 4.2), several small areas of disturbed soil bordering the northern and southeastern corners of the small parking lot are evident. The area east of the road leading to this small paved parking lot contains a large circular depression encircled by a dirt road. The western portion of this depression exhibits evidence of a foundation of a preexisting structure backed on the west by a steep excavation in the form of a retaining wall or berm. Trenching is evident to the southeast of this feature along both sides of the dirt road. To the immediate northeast of the depression is a disturbed area, roughly circular in outline. A trench bordered by excavation dirt is situated in the far northeastern portion of this area.

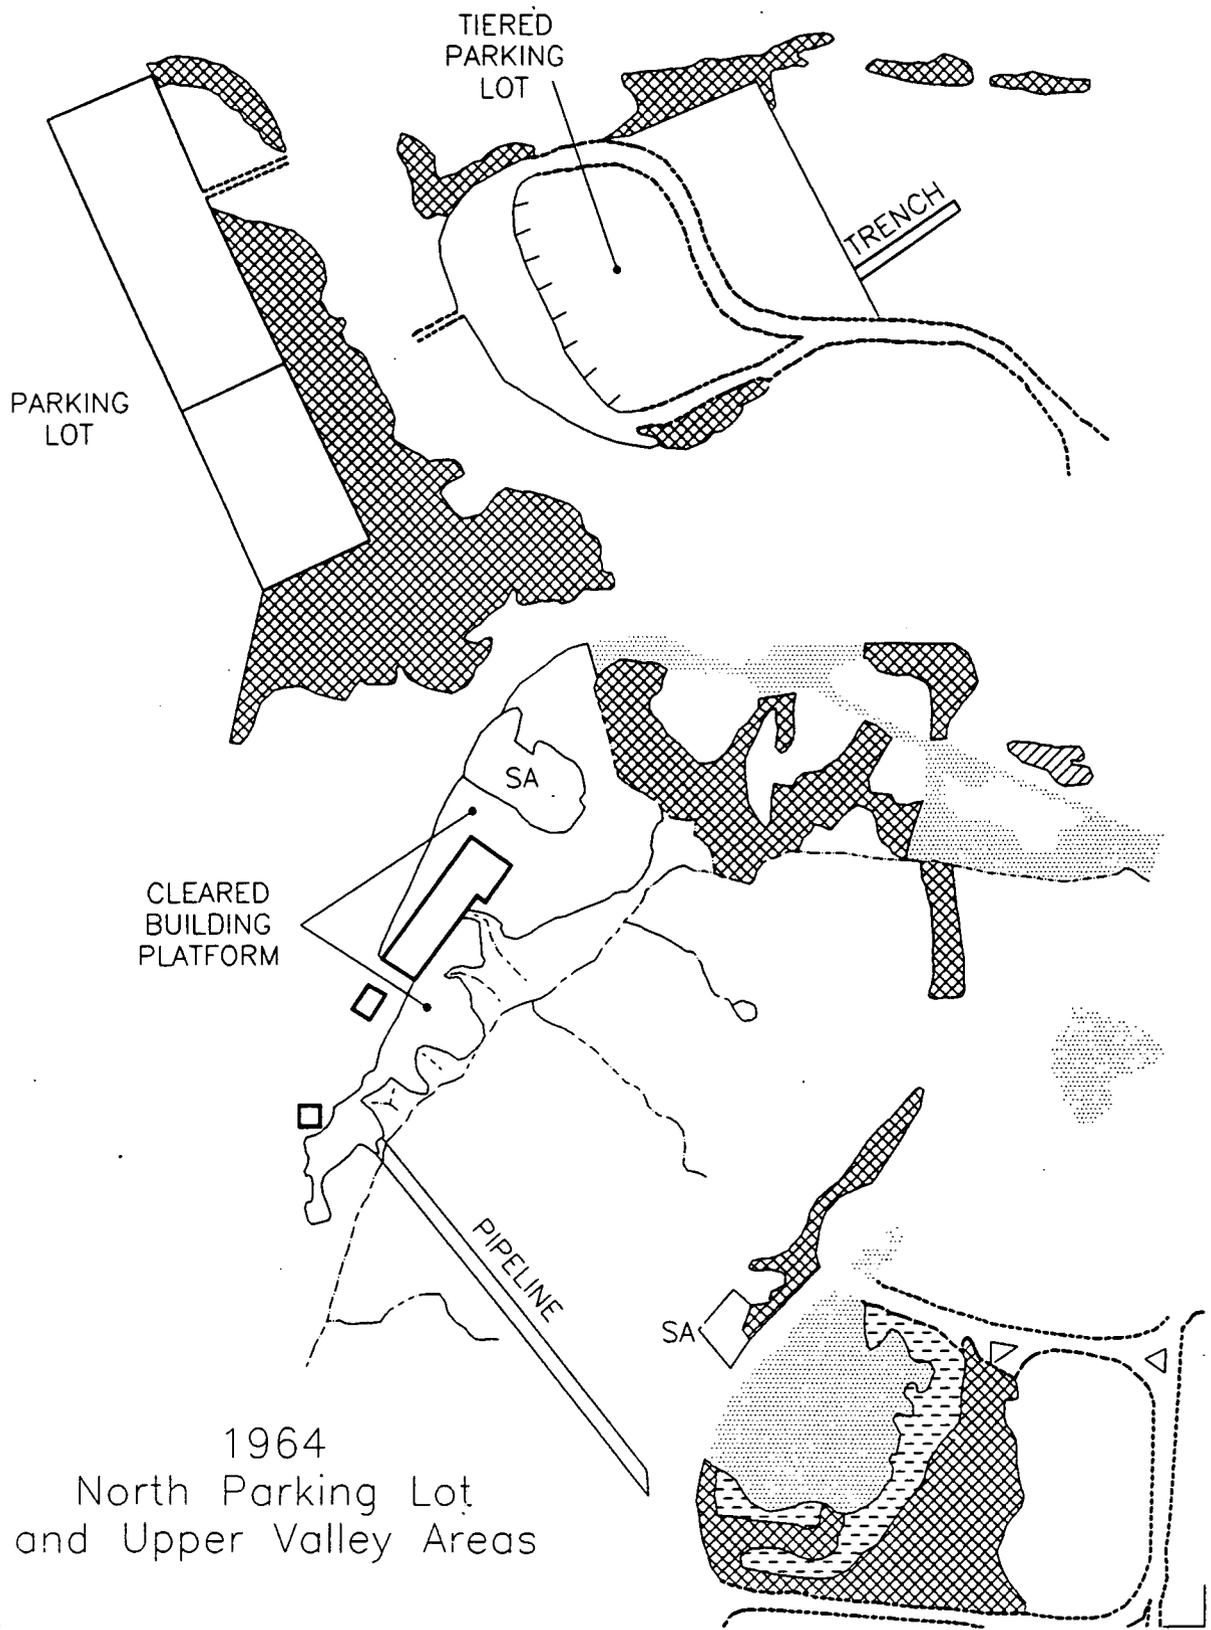
Figure 4.3. Interpretive map of Northern Study Area - 1964.

The small paved parking lot identified in the 1959 photograph was extended to the south in unpaved form by 1964, resulting in regrading of the hilltop surface and extensive areas of disturbance bordering the new lot (Figure 4.3). In the parking area to the east, this circular depression becomes a paved, three-tiered parking lot and access road. Areas of disturbance border the parking lot on the north and south. Leading from the southeast corner of the lowest tier of the parking lot is a linear trench oriented northeast to southwest. Areas of disturbance bordering the 1959 trench to the northeast are smaller but still evident in the 1964 photograph.

The building platform extends to the southeast in the 1964 photograph with resultant in-filling to the drainage channel (Figure 4.3). However, most of the drainage remains intact. An extensive, irregular pattern of surface disturbance, including cleared and disturbed areas, occurs to the north of the drainage. A smaller linear pattern of disturbed soil also projects from here to the south. The surface of the large drum storage area visible in 1959 is completely cleared in the 1964 photograph. The cleared surface of the smaller drum storage area in the 1959 photograph is still evident in 1964. The road configuration around the location of the 1959 drum storage area has been slightly altered with the easternmost road extended to near the limits of the plant site. A northwest-southeast oriented pipeline crosses the southern end of the entire area and remains through 1981.

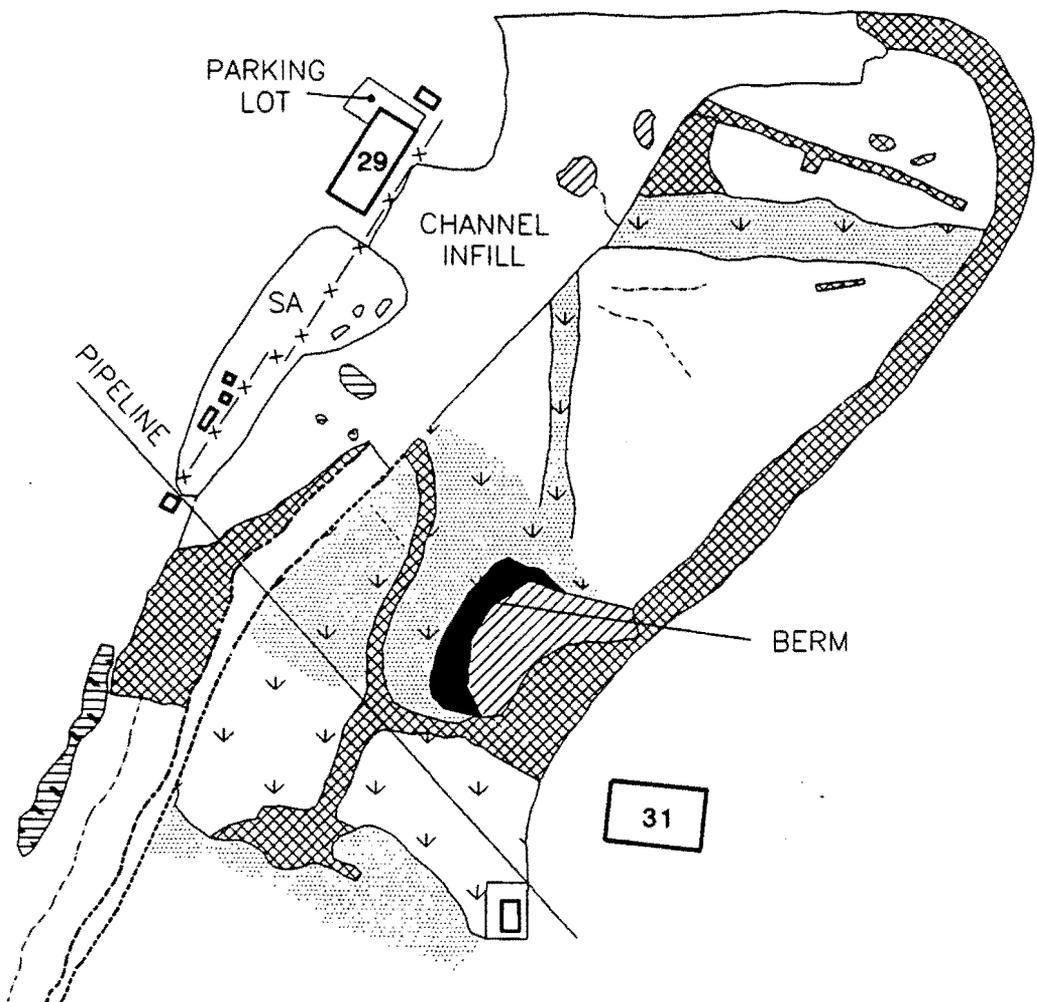
Figure 4.4. Interpretive map of Northern Study Area - 1968.

The small paved parking lot near the guard house (Figure 4.4) had been paved by 1968. The hillslopes east and south of this parking lot have been regraded. All previous evidence of surface disturbance have been obscured. This parking lot continues in use with no major changes in 1973, 1975, 1979, and 1981.

By 1968, channel in-filling has proceeded to the extent that an extensive building platform has been constructed to the west of the old drainage course, partially obscuring the drainage (Figure 4.4). The buildings on the 1964 platform have been replaced, with Building 29 situated farther to the north in an area identified as a storage area in 1964. Storage of materials is evident south of this building along the platform and some piles of material are present on the channel in-fill platform. An area of disturbed soil lies north of the remaining intact drainage, which is bordered on the west by an area of debris. The eastern portion of the North Valley Area is crossed by linear patterns of disturbed or cleared and re-vegetated areas. The site of the smaller drum storage area in 1959 has now been completely graded, resulting in a large pile of dirt lying just north of the road. Downslope from this feature and bordering it on the northeast is a C-shaped earthen berm the width of the dirt pile. Across the road, Building 31 has been constructed on a site that had been used for drum storage in 1959.

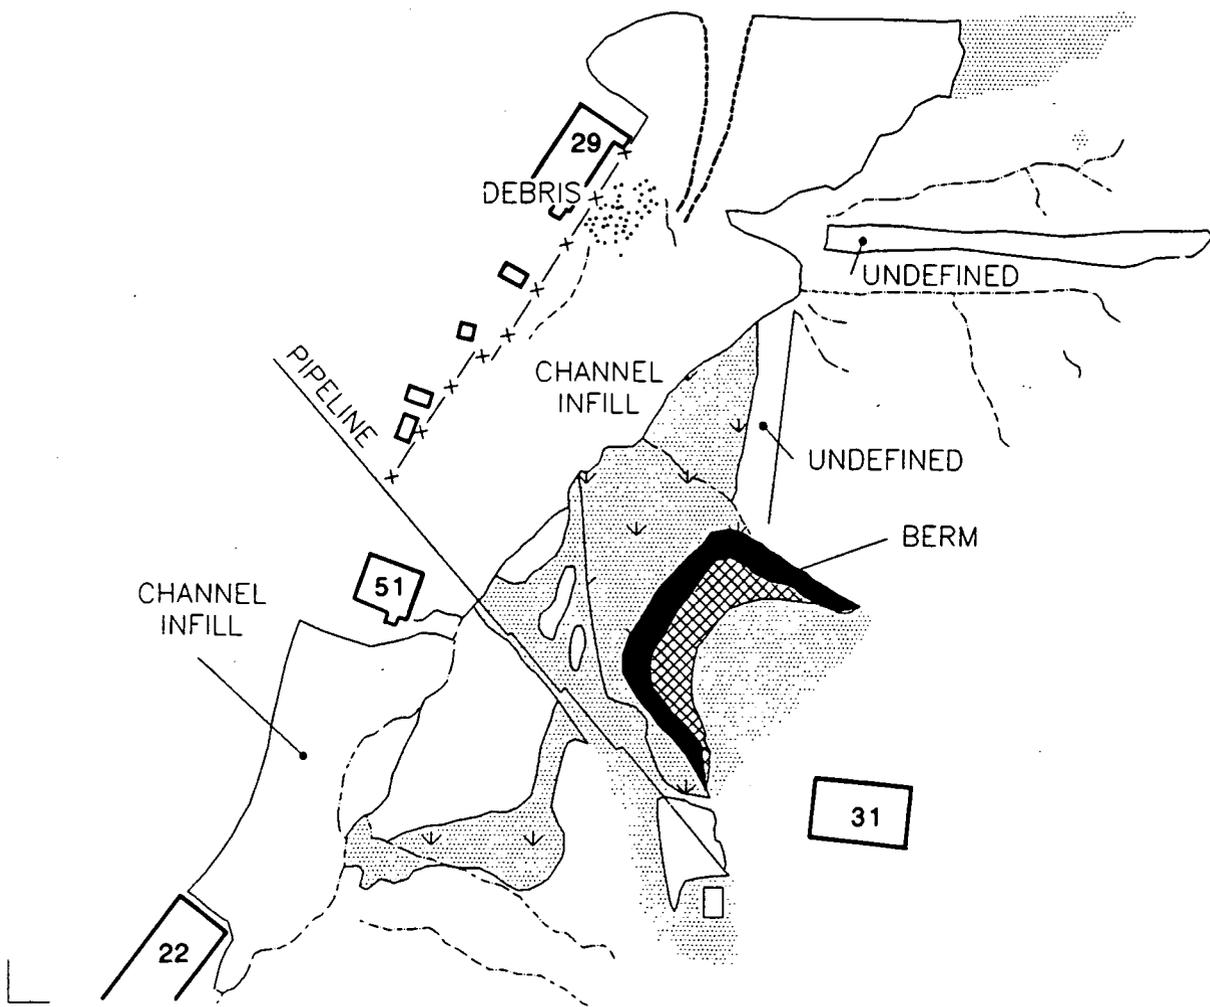
Figure 4.5. Interpretive map of Northern Study Area - 1973.

The 1973 photograph reveals continued channel in-filling to the south with the course of the original drainage completely obscured above Building 22 (Figure 4.5). Building 51 is constructed south of the

pipeline. Debris is evident on the channel in-fill surface behind the buildings and a new road enters the area on the north where none existed in 1968. The large dirt pile northeast of Building 31 in 1968 has been leveled resulting in a platform and disturbed slope which continue to be bordered by a large earthen berm. Re-vegetated and cleared linearities remain evident to the east of the old drainage course, and shallow drainages flow to the northwest and west down this slope.

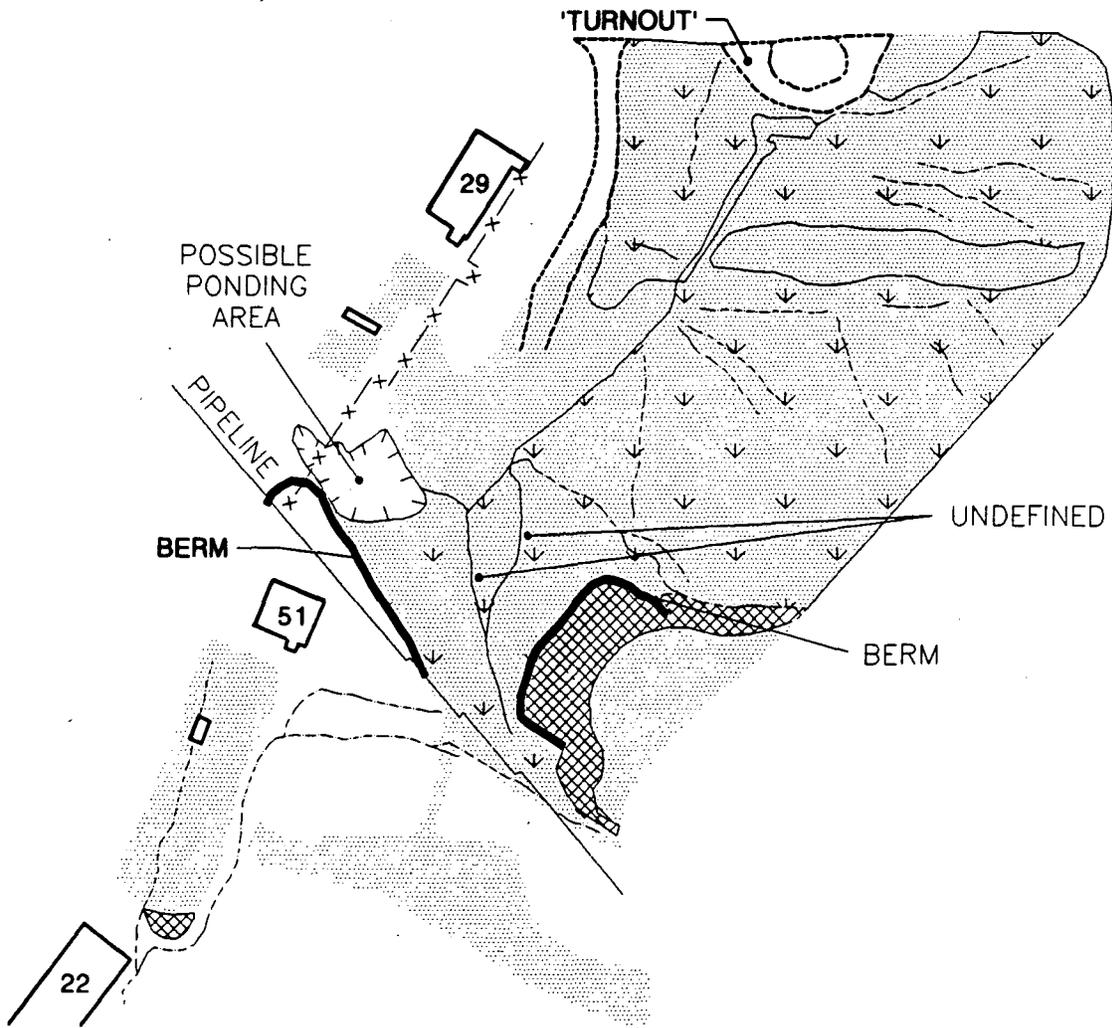
Figure 4.6. Interpretive map of Northern Study Area - 1975.

Large portions of the platform formed by channel in-fill are re-vegetated by 1975 (Figure 4.6), but the central valley area behind the buildings still appears cleared. The drainage channel appears to have reestablished itself north of Building 22 and a berm now exists north of Building 51 that forms the southern edge of a drainage impoundment. In-filling continues near Building 22. A large cleared surface now exists between Buildings 51 and 22. Two large cleared areas are situated at the top and bottom of the eastern side of the North Valley Area. Numerous small drainages flow to the north and west down this slope. A new road "turnout" is in use along the main road at the northern end of the area. Two undefined channels are situated downslope from the berm on the east.

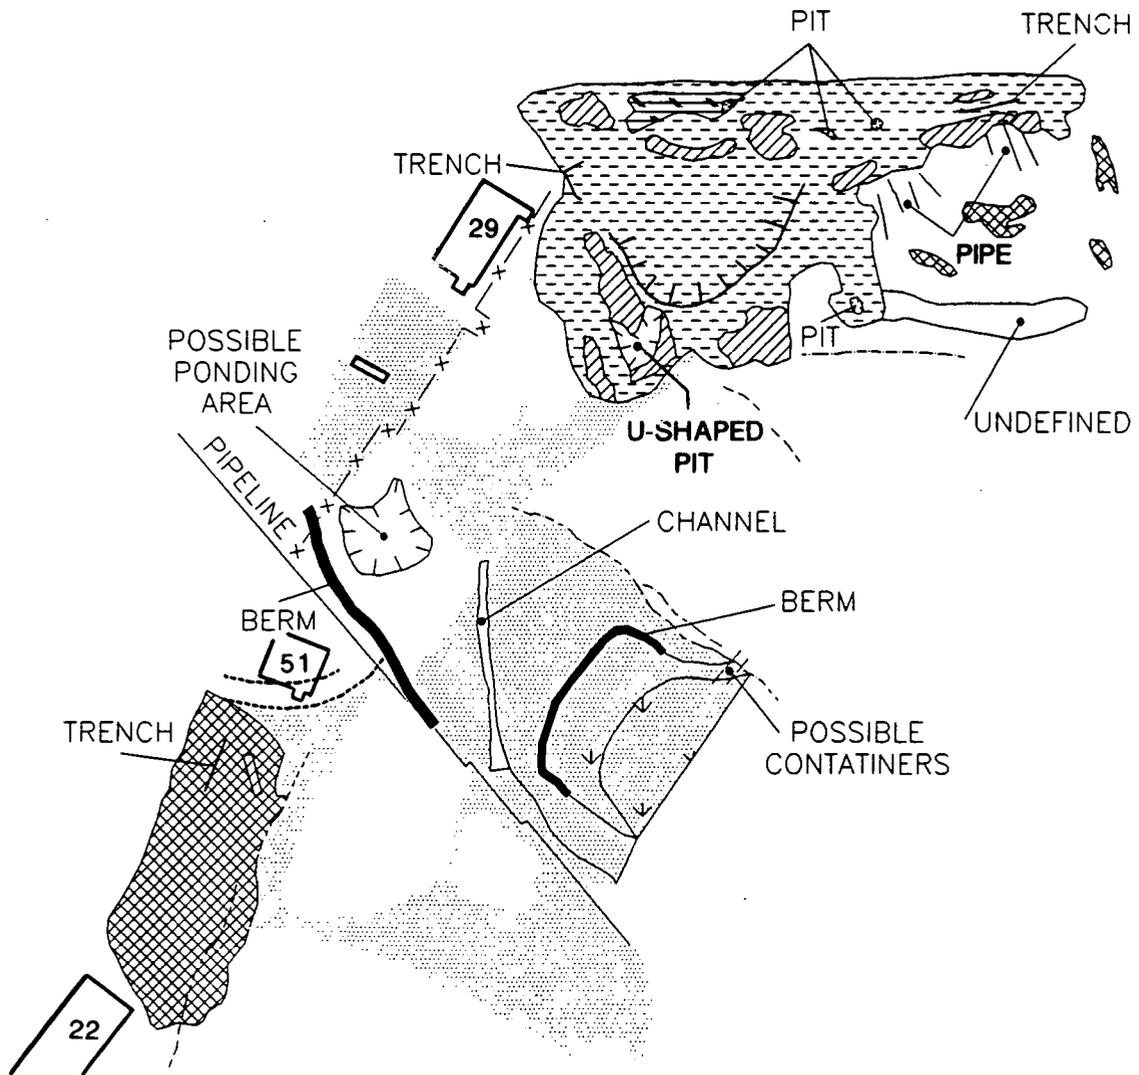
Figure 4.7. Interpretive map of Northern Study Area - 1979.

Construction of the asphalt-lined pond and surrounding utilities trenches is evident in 1979 (Figure 4.7). The installation of a sanitary sewerline is evident as four small pits are situated in the excavation area along with a larger U-shaped pit in the southwestern corner of this area. One linear and one L-shaped trench are also evident. Bordering the pits and trenches are ten piles of excavated fill and one linear debris pile along the southern edge of the road leading to Building 29. Lines of pipe, or the impressions left behind by these objects on the ground, occur on the eastern edge of the excavation area and on the northern edge of the bermed platform to the south. A large, semi-circular, excavated depression is evident that appears to be the origins of the asphalt-lined pond. Smaller disturbed areas lie to the east and one undefined linearity borders the area of main excavation activity on the southeast. Small west-flowing drainages cut the slope to the southeast of the excavation area. Much of the remaining in-fill platform has been heavily re-vegetated, although some cleared areas can be seen on the central and southern portions of the platform. The drainage impoundment and berm are still evident north of Building 51. Between Buildings 51 and 22, the in-fill platform is disturbed with a trench and associated dirt pile at its northern end. The re-established drainage cuts through this disturbed area and flows to the southwest. Several areas that have been cleared of heavy vegetation occur to the south and southeast of Building 51.

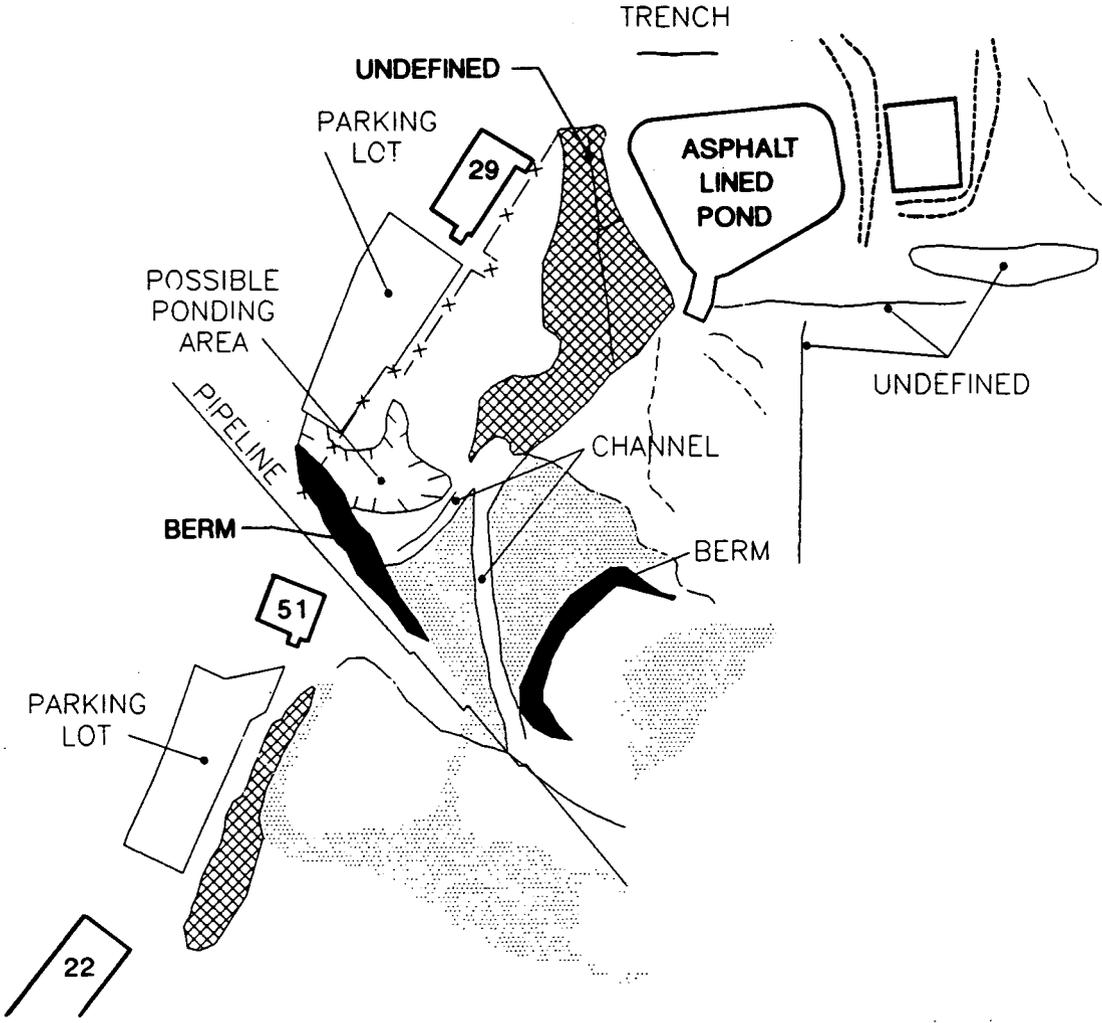
Figure 4.8. Interpretive map of Northern Study Area - 1981.

By 1981, the asphalt-lined pond has been constructed within the former excavation area and a new building constructed to the east (Figure 4.8). Building 61 was subsequently enlarged to its present configuration in the mid-1980s. A disturbed area occurs to the southwest of the pond and is bisected by a narrow, undefined linear feature. Two other undefined linear features lie to the east, as does a larger, east-west oriented, linear-shaped feature. A formal parking lot is established south of Building 29 at the previous site of a cleared building platform in 1979. In all years after 1959, small structures were present in

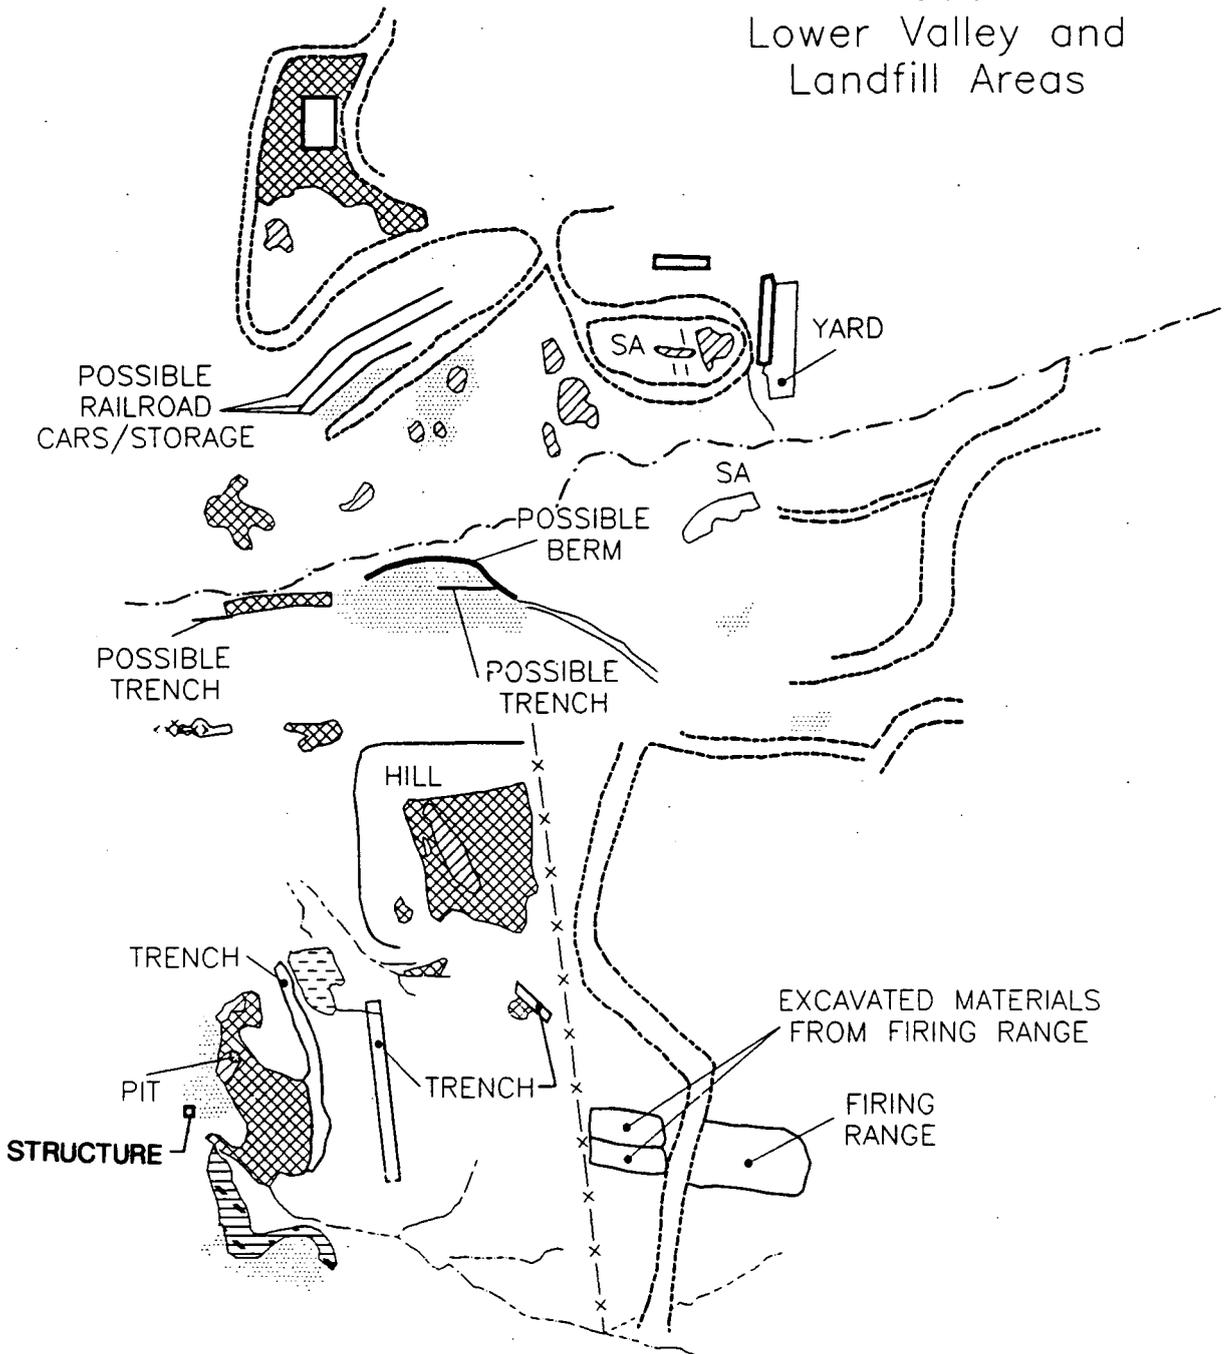
Figure 4.9. Interpretive map of Southern Study Area - 1959.

The landfill area is located in the southern half of the Southern Study Area in the west-central portion of Mount Plant (Figure 2.1). The landfill area is currently comprised of the overflow pond and the site sanitary landfill that overlies the historic landfill. Landfill activity (Figure 4.9) in the 1959 photograph appears to include two parallel trenches. The easternmost trench appears as an obscured linear feature with a small cleared area on its western side. With the exception of this cleared area, there is no evidence of recent surface disturbance. The western trench appears as a sharply defined, slightly irregular linear feature. An irregularly-shaped excavated area occurs at the northern end of this trench, and it is bordered on the west by a disturbed slope that appears to be the landfill access road. At the top of the slope is the landfill entrance and a cleared surface containing a single container or small structure. Several piles and a pit occur within the disturbed area and smoke appears to be rising. Drainage into the 1959 landfill is from the east. At the southwestern corner of the Landfill Area between the road and the drainage ravine is another cleared area bordering the road. To the north of this cleared area and to the south of the drainage, in what may be a natural trough, the slope has been disturbed and appears to contain debris. A large part of the hill top in the northeastern portion of the landfill area has been cleared and contains an elongate dirt pile and smaller associated pile. A small trench outline with an associated disturbed area lies to the south. Other smaller disturbed areas lie along the southern border of the hill and to the north along the road. A fence line and S-shaped road bed border the landfill area on the east. Excavated material from the construction of the firing range appears to border opposite sides of this road to the south.

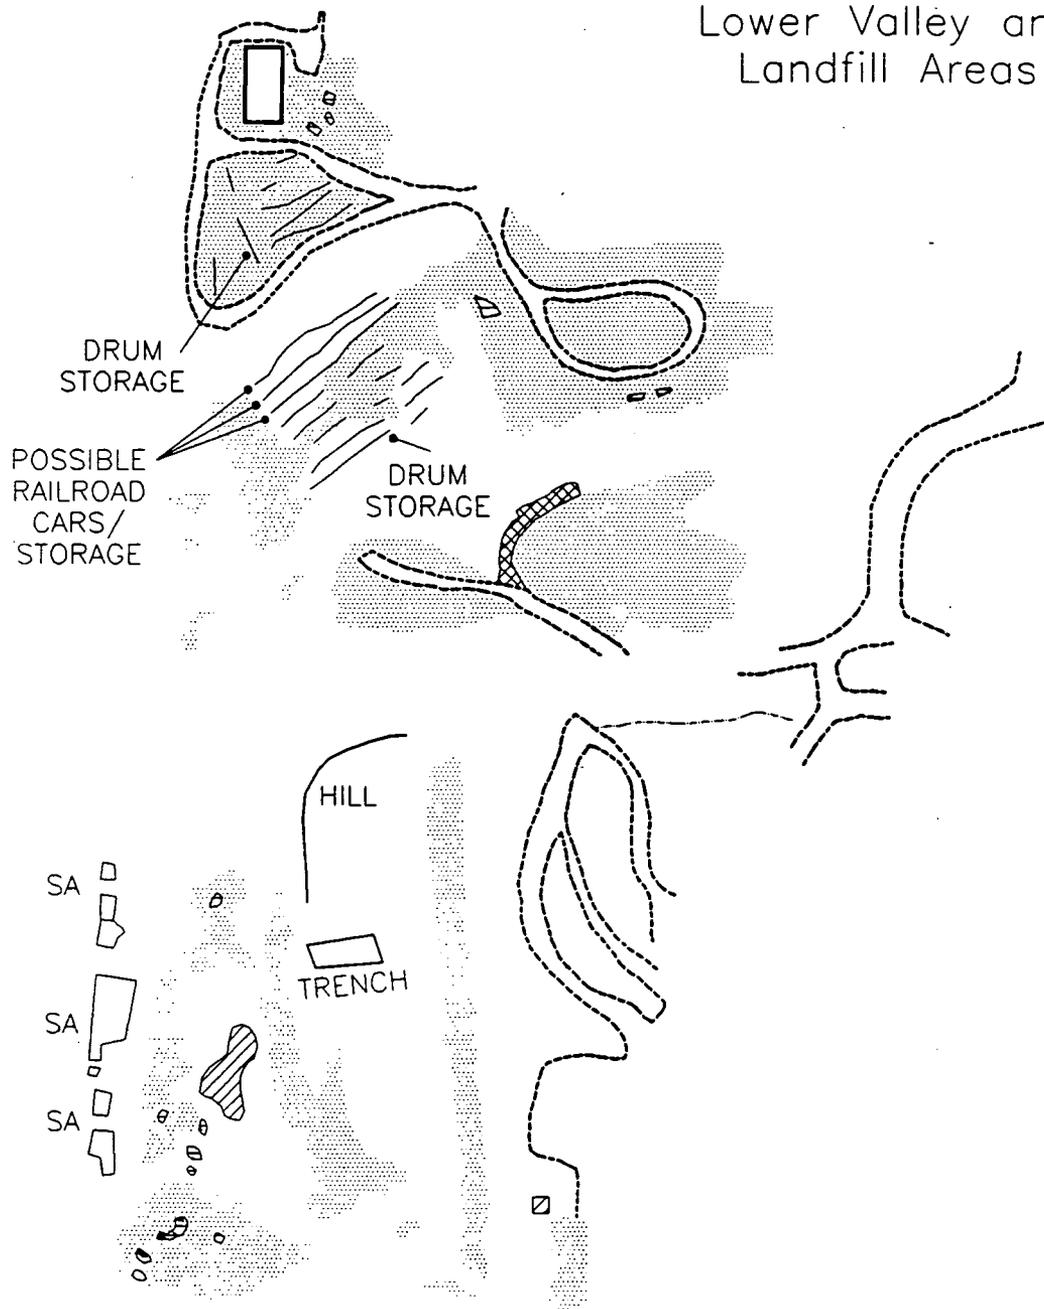
Figure 4.10. Interpretive map of Southern Study Area - 1964.

In the 1964 photograph, although on a much smaller scale, a long clearing has been exposed immediately west and parallel to the 1959 fence line (Figure 4.10). A large cleared surface extends across the location of the excavated firing range materials and the 1959 S-shaped road. Cleared areas in the landfill are expanded, possibly by excavation. They border the western and southern edges of the landfill and extend over the current southwest junction of the road as shown on the base map (Figure 4.10). Container storage is evident along the western edge of the road, and debris or debris piles are present in cleared areas to the east of the roadway. Regrading of the entire 1959 landfill area is evident by 1964 as the eastern trench and western trench identified in the 1959 photograph are no longer evident. A large elongated pile of materials in the central portion of the landfill is surrounded by clearings. A broad east-west trench appears to the northeast of the cleared areas. Smoke is evident in the area.

In 1964, the large clearing south of the drainage ditch is still visible (Figure 4.10) with a road or trail leading across it to the west. The small clearing is no longer sharply defined, but there are three small disturbed areas in its former location. Lying to the east and upslope from the large clearing is another large cleared surface. Disturbed soil borders it on a northwest-facing slope. To the north of the drainage, the 1959 storage area has been cleared of materials and the area around the encircling road has been cleared. Some debris is present to the south of this road. South of the railroad, to the west of the former storage area, are multiple lines of storage containers on a cleared surface. Storage containers are also evident in a storage area north of the railroad.

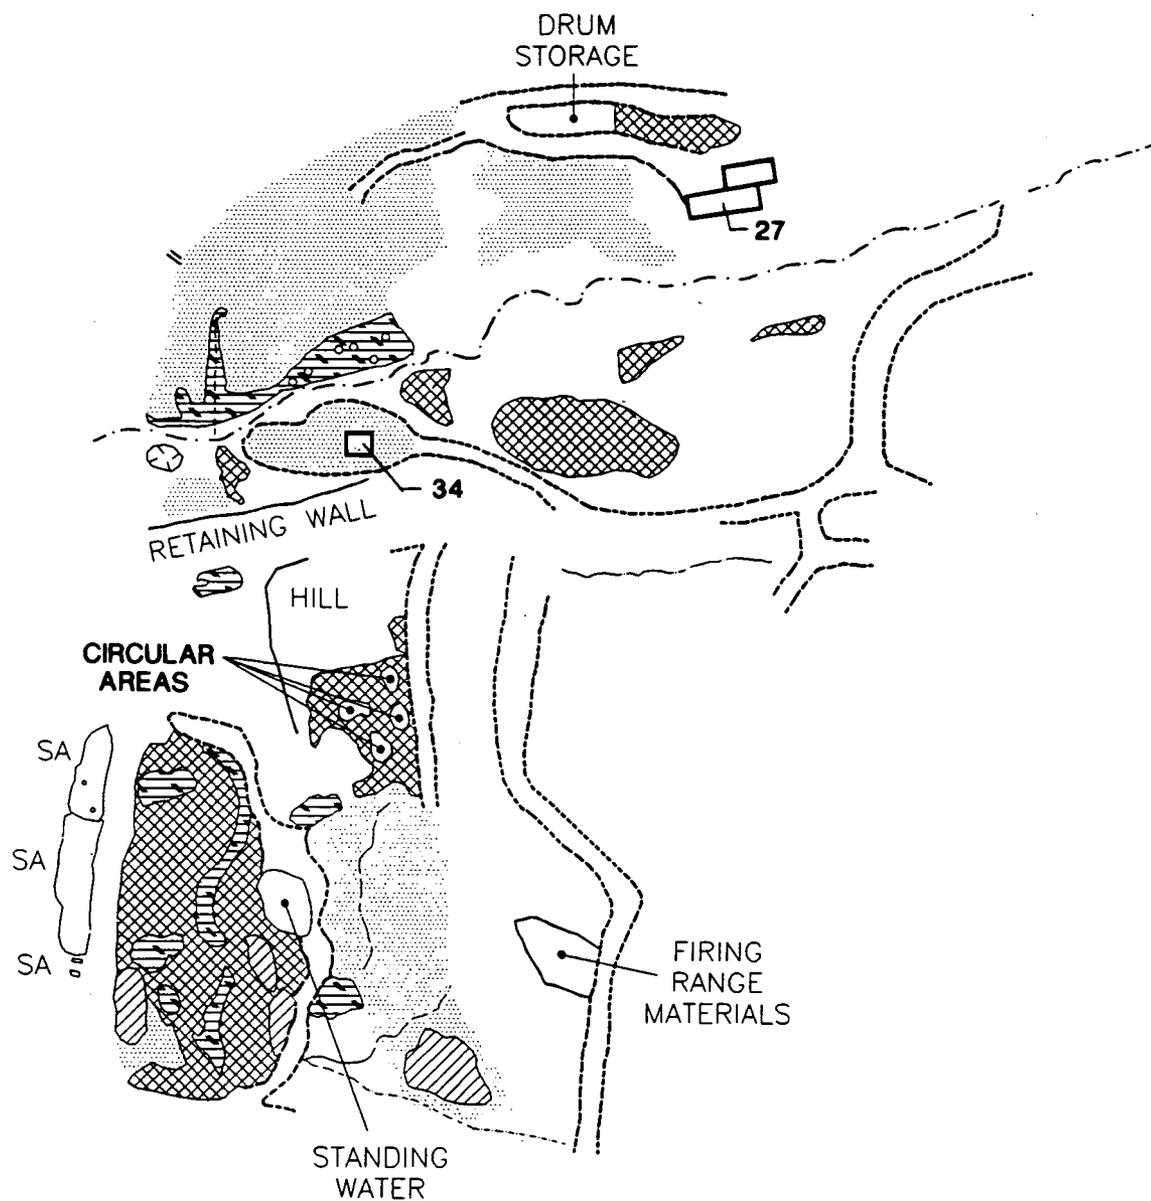
Figure 4.11. Interpretive map of Southern Study Area - 1968.

Activities visible in the 1968 photograph are extensive and varied (Figure 4.11). A new access road extends north on the hillside to meet the main road. Bordering the western edge of the new access road in the northern part of the landfill is a disturbed hill top surface containing unidentified circular areas. This road provides access to a large cleared surface in the central portion of the landfill. Drainage is evident across this surface to the south, and a massive pile of fill is situated on the southern end of this cleared area. The cleared area is bordered on the west by another new road, which provides access from the south. This new road continues north around the northwestern rim of a pool of standing water and then trends to the northwest to meet the main roadway along the western edge of the landfill. West of this access road and pool is an extensive disturbed surface that includes debris piles and piles of fill. Storage areas containing debris and storage drums are located between the fence line and landfill area. Surface debris, possibly in the form of drums, is contained in the storage areas and in debris piles in the landfill. The old S-shaped road on the east appears to be re-established, and additional fill from the firing range can be seen near the southern end. Drainage from the east slopes continues to flow into the center of the landfill.

Building 34 is established in the clearing south of the drainage in the 1968 photograph (Figure 4.11). The large cleared surface to the east in the 1964 photograph now appears smaller in areal extent and includes areas of disturbance or vegetation near the center. Farther to the west of the cleared surface holding Building 34 is an area of disturbed soil, possibly on a slope, bordering a small, semi-circular, flat, cleared surface. The straight, upslope edge of the semicircle is backed by a linear east-west excavation, possibly in the form of a retaining wall. A small circular depression is visible on the northwestern edge of this cleared surface. Three areas of disturbed soil lie to the north of the main road (Figure 4.11). Former storage areas to the north of the drainage ditch appear to be cleared. Building 27 is established by 1968. A new drum storage area is located to the northwest of Building 27 at a road intersection. The large drum storage area evident in the 1964 aerial photograph south of the railroad, is cleared and its surface expanded. No containers are evident. It is bordered on the south by a disturbed surface and slope and is cut on the west by a short drainage channel.

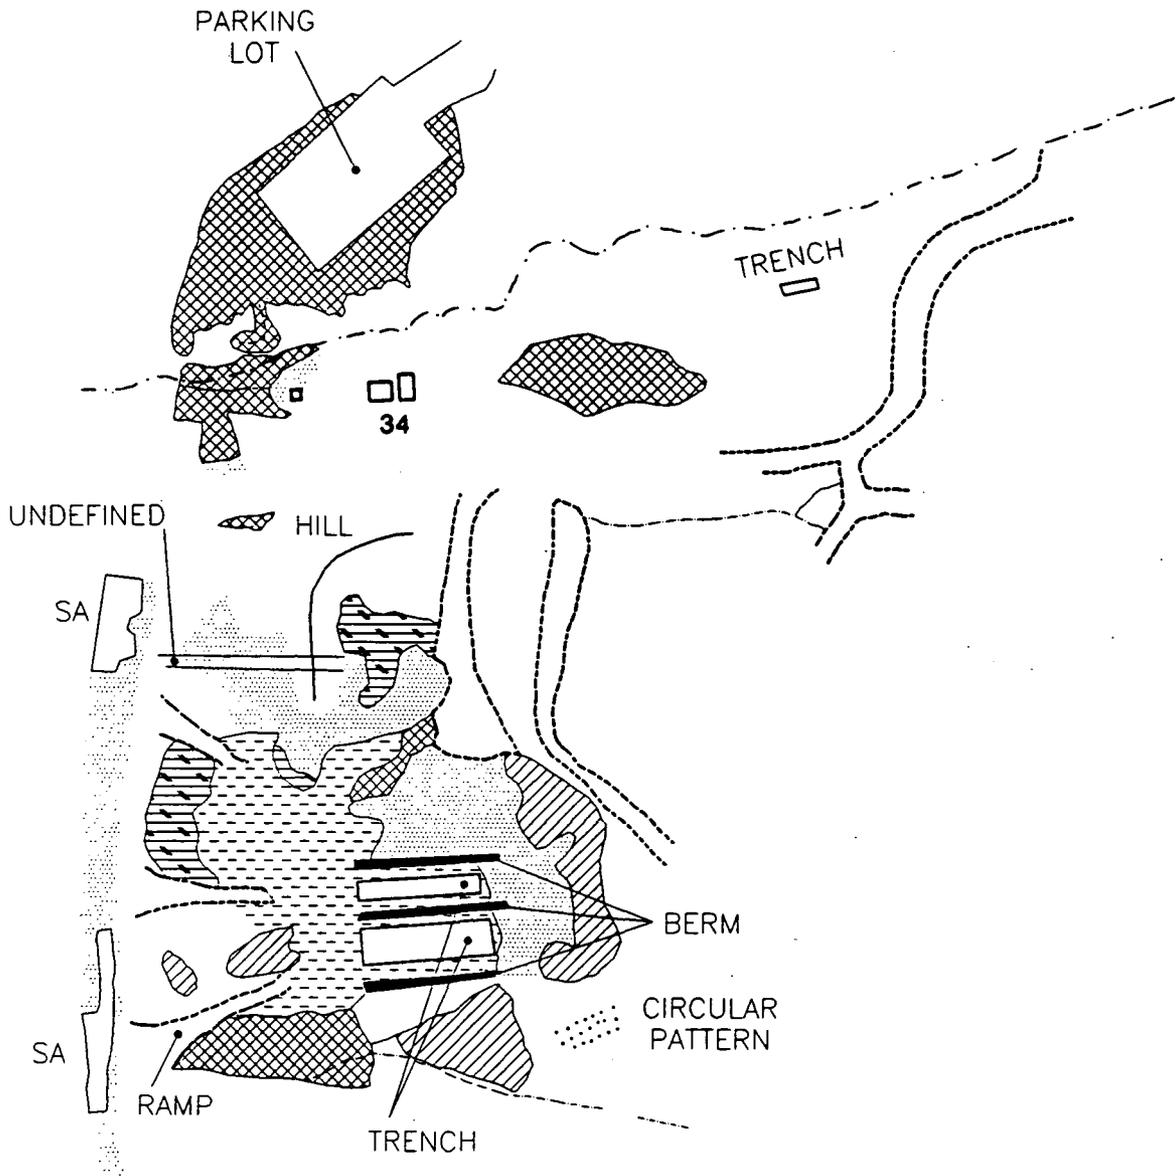
Figure 4.12. Interpretive map of Southern Study Area - 1973.

Formal trenching in the landfill is evident in the 1973 photograph (Figure 4.12). Two trenches bordered on the north and south by three berms have been excavated. Massive piles of fill occur along the eastern edge of the upper level of the landfill, and piles of fill border a southern ramp. The access road established from the north (evident in the 1968 photograph) continues to provide access to the upper level of the landfill on the east. Three roads, one of which appears to be a constructed ramp, provide access to the western lower level of the landfill. The pile of material present on the southern end of the cleared surface in the 1968 photograph remains on the southern edge of the landfill. Cleared surfaces extend north of the main excavation area onto the hill and slope. Debris piles are located on the hilltop. Storage continues between the road and the fence line in the form of drums or other containers. Drums or other containers are also visible in an area of debris between the two northernmost landfill access roads on the west. Southeast of the landfill cells is an undefined pattern of multiple small circles that may be other storage containers. An undefined linear feature intersects the hillslope above the landfill from the west.

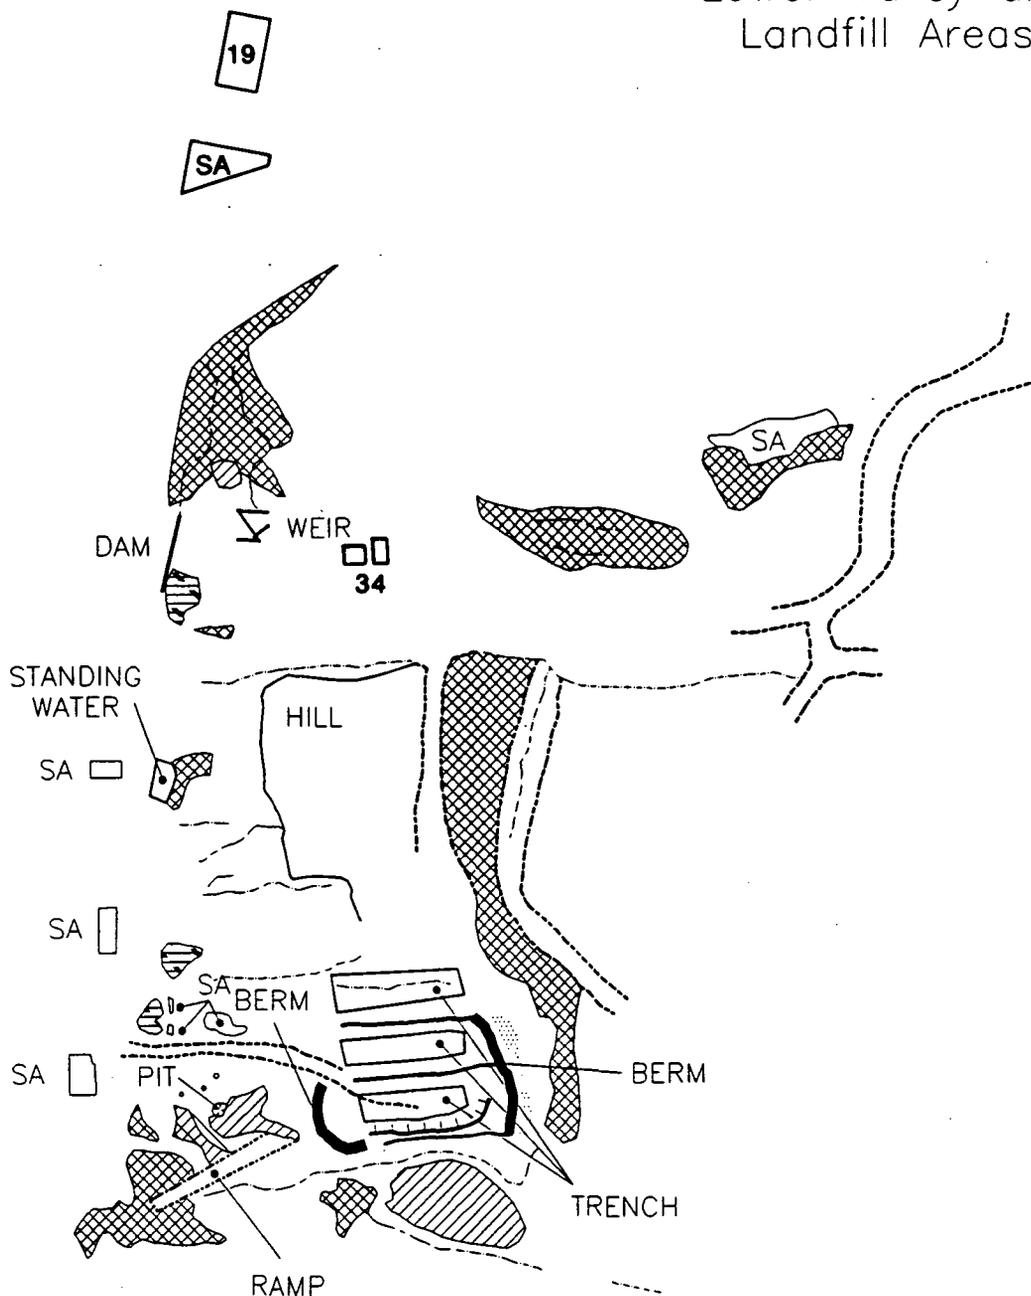
Figure 4.13. Interpretive map of Southern Study Area - 1975.

By 1975, three landfill cells have been established (Figure 4.13), and the northernmost cell has been partial filled. Berms separate all three cells and an additional C-shaped berm is located at the western end of the lower (southernmost) cell. A roadway extends into this lower cell. Remnants of the southern access ramp are still visible. Piles of debris are located along the western edge of the landfill and standing drums are visible in storage areas along the access road to the lower cell. A large pile of fill with a pit excavated into its western end borders the access ramp on the north. Flooding on the western end of this ramp appears to have breached the southwestern junction of the main road. Storage of containers and materials is still

evident on the western side of the main road east of the fence line. Ponding occurs, possibly in a small excavation that borders the main road in the northeast.

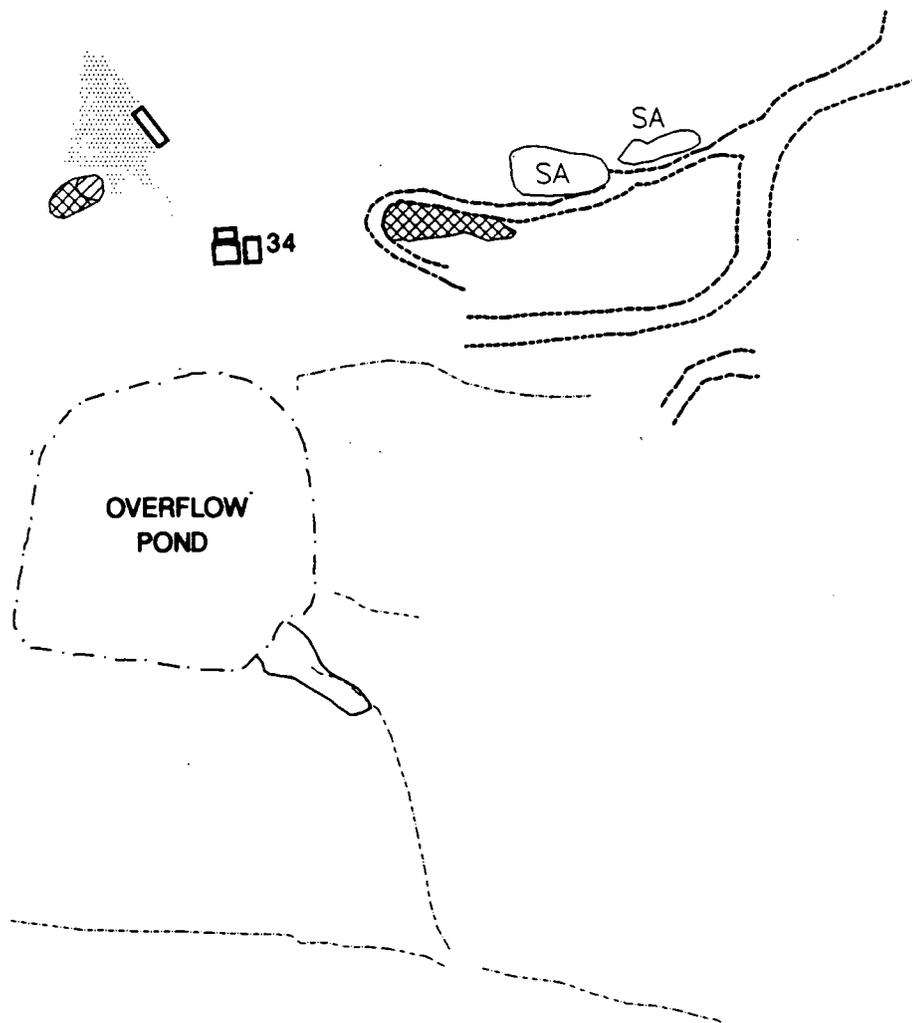
Figure 4.15. Interpretive map of Southern Study Area - 1981.

In 1981 photographs, the area of the hillslope east of Building 34 has been graded and planted, or naturally re-vegetated (Figure 4.15). A small area of former disturbance is still evident here. Storage areas (south of Building 27 and the drainage ditch) are still in active use. The cleared surface and pile north of the drainage ditch remain evident.
