**OPERABLE UNIT 9,  
SITE SCOPING REPORT  
VOLUME 6 - PHOTO HISTORY REPORT**

**MOUND PLANT  
MIAMISBURG, OHIO**

February 1992

**Department of Energy  
Albuquerque Field Office**

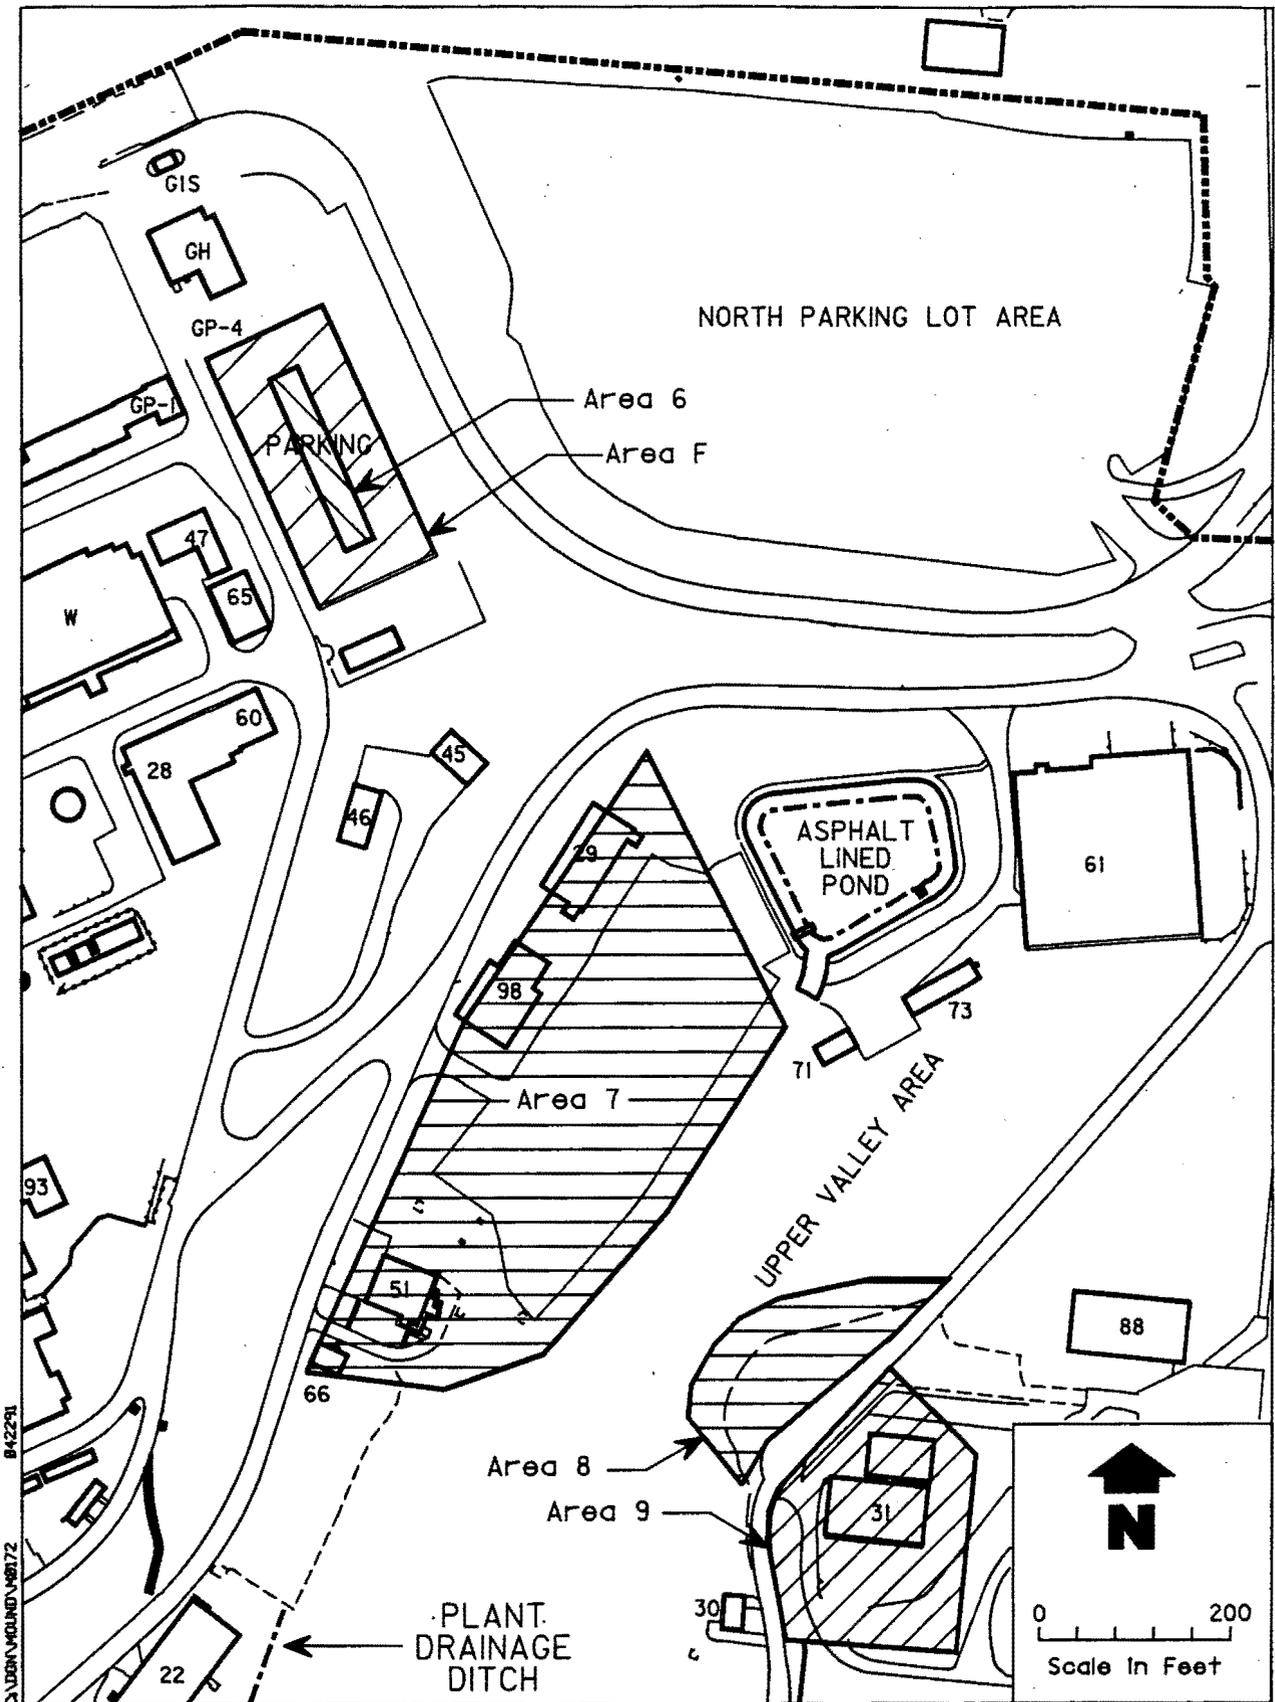
Figure 5.1. Areas of interest to the ER Program in the Northern Study Area.

The north parking area includes two parking lots that date back to the beginnings of the plant. Minor disposal activities are known to have occurred in the smaller lot to the west (Figure 5.1), but not in the larger lot to the east. During plant construction in the mid to late 1940s, wooden office buildings in the larger lot to the east were used as construction headquarters. These buildings were later used for a brief period of time as administration buildings for the plant (DOE 1986). The large circular feature in the 1959 through 1964 photo sequence is the remnant of the parking lot and circular drive around the buildings. The buildings were razed in the mid-1950s. The east-west trending trench in the far northeast portion of the larger parking lot is known to be a drainage control structure that even today shows remnants of its position. It was constructed simply to alleviate surface water runoff to the private properties to the north of the sloped catchment area now occupied by the large parking lot. No knowledge exists about the smaller trenches that appear around the circular drive in the 1959 through 1964 photo sequences.

The smaller parking lot in the northwest portion of the study area has had some history of waste disposal (Table V.1). It was reported that in 1963 110 gallons of chromium plating bath was dumped in a trench in the area now covered by the small parking lot (DOE 1986). The trench is now known as Area F. No

indications of the location of the trench was found during this investigation. In 1964 sand contaminated with polonium-210 was reportedly disposed of in the area of the parking lot. This sandblasting waste is now known as Area 6. Unless the sand was incorporated into the fill material used to enlarge the small parking lot, no indications of its disposal can be documented by this investigation.

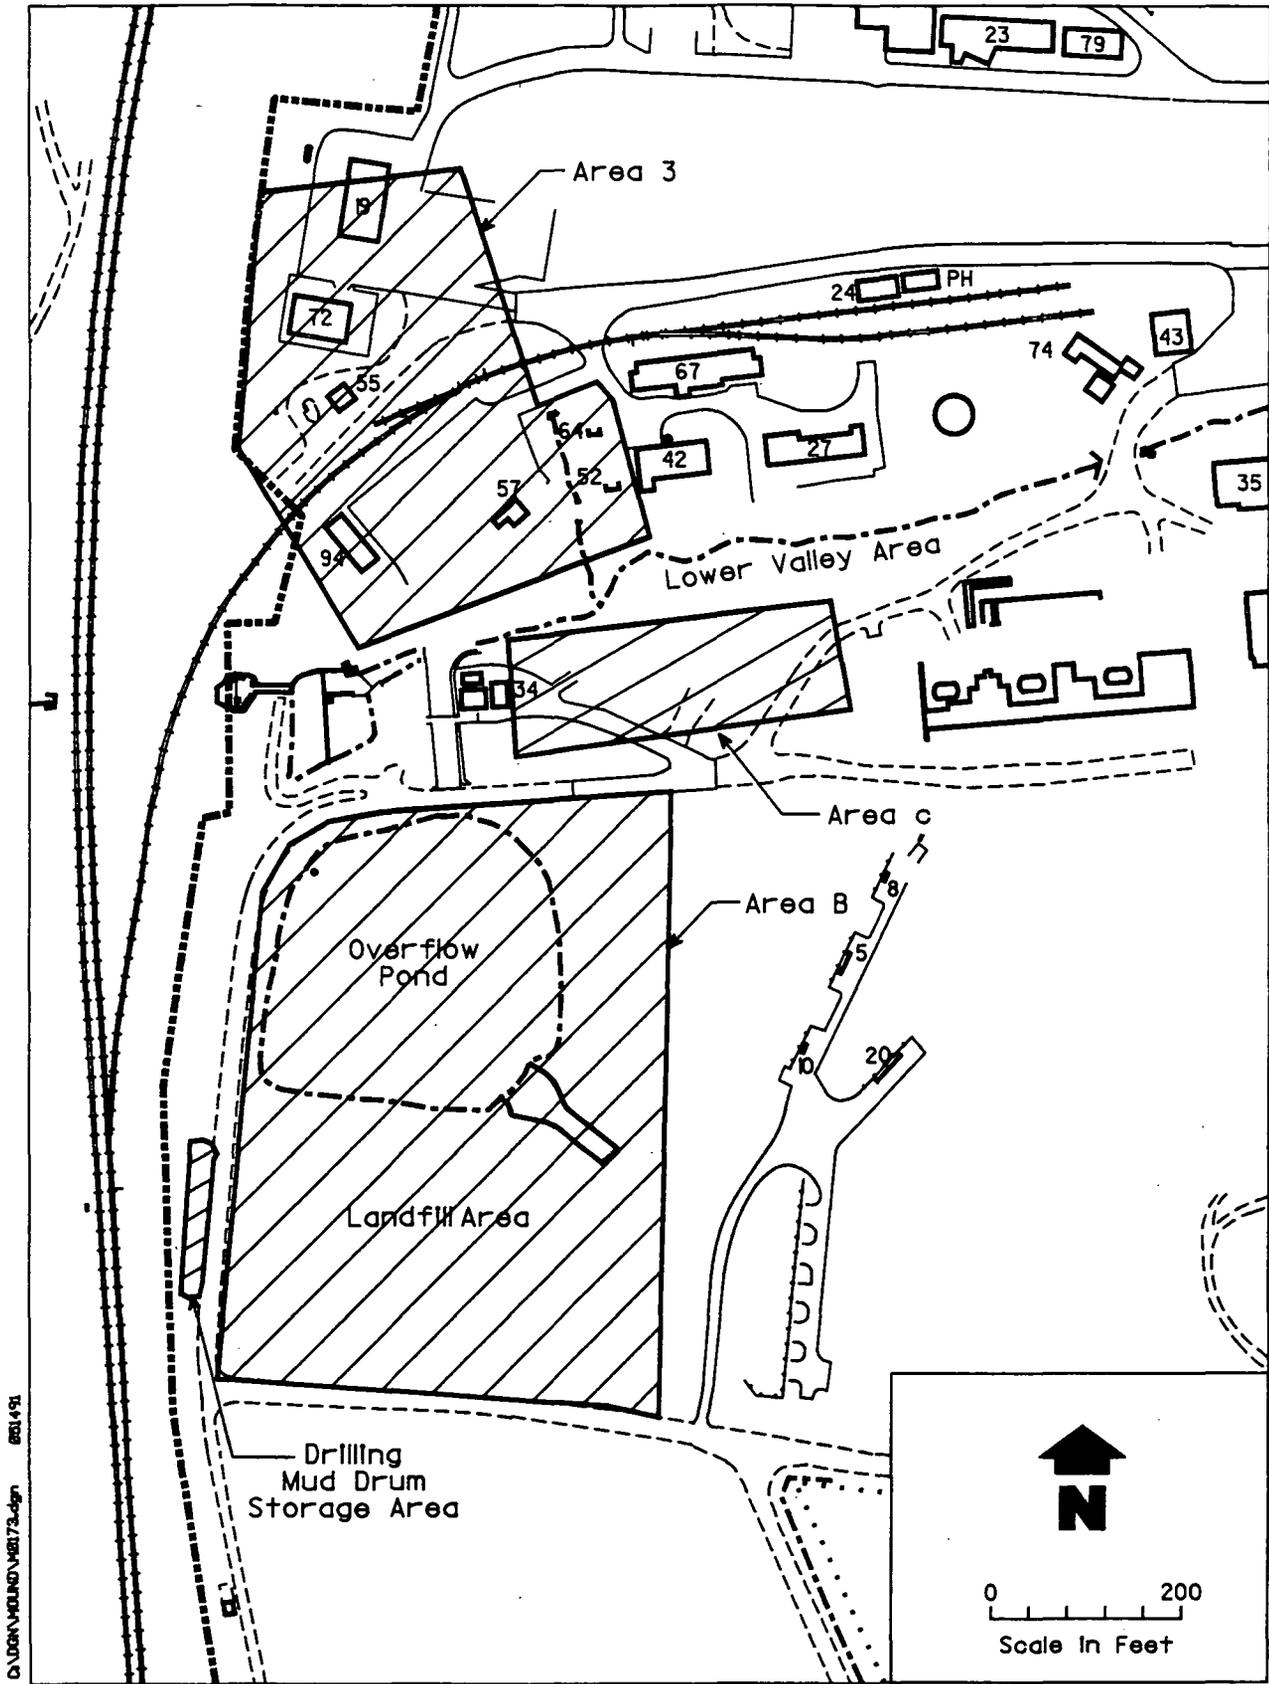
Figure 5.2. Areas of interest to the ER Program in the Southern Study Area.

The landfill area includes the location of the historic and site sanitary landfills and the overflow pond. These sites are now collectively known as Area B (Figure 5.2). The historic landfill was used for waste disposal by Mound Plant from 1948 to 1977 (Table V.3). A comprehensive description of the use and history is contained in the Area B, Operable Unit 1, Technical Memorandum: History of Area B (DOE 1991b). Administrative and laboratory wastes including paper, glass, wood, plastics, kitchen garbage, bottled urine samples, as well as possibly chemicals including beryllium, mercury, trichloroethene, carbon tetrachloride, evacuated nickel carbonyl gas cylinders, photoprocessing solutions, plating wastes and small quantities of polychlorinated biphenyls (PCB) oils were dumped and burned almost weekly. This investigation indicates that from 1959 to 1968 most of the open burning and general dumping took place in the southwestern

portion of the landfill area, north and east of the existing roads. In fact, the 1959 photographs indicate that excavation activities extended into the present road intersection. By 1964 the roadway was backfilled enough to permit through traffic, but was subjected to periodic flooding from the east. The burial of many thousands of crushed, empty, thorium ore drums probably extended under the current road intersection (DOE 1991b, 1991c). This investigation indicates that the activities of open burning and general waste and burned trash burial during the period prior to 1968 were limited to central and southwestern portions of Area B. Figure 5.3 presents an updated interpretation of the geometry at Area B from evidence presented in this report.

The north-trending trench (1959) in the middle of the historic landfill may have been filled with trash when it was covered over by 1968. No other indications of this trench appear to exist other than the photo record. The east-west trending landfill cells (trenches) that appear in 1973 are described in the History of Area B (DOE 1991b) and resulted from a ban on open burning imposed by the State of Ohio in 1969. This investigation indicates that the landfill cells installed in 1973 were placed in an area that had not been previously used for trash disposal. Some of the disturbed areas near the southernmost cell were, in previous years, possibly gravel pit extractions, as the area provided some gravel resources.
