Burris Park, California, Site Long-Term Surveillance and Maintenance Plan

September 2016

U.S. DEPARTMENT OF
ENERGY

Legacy
Management

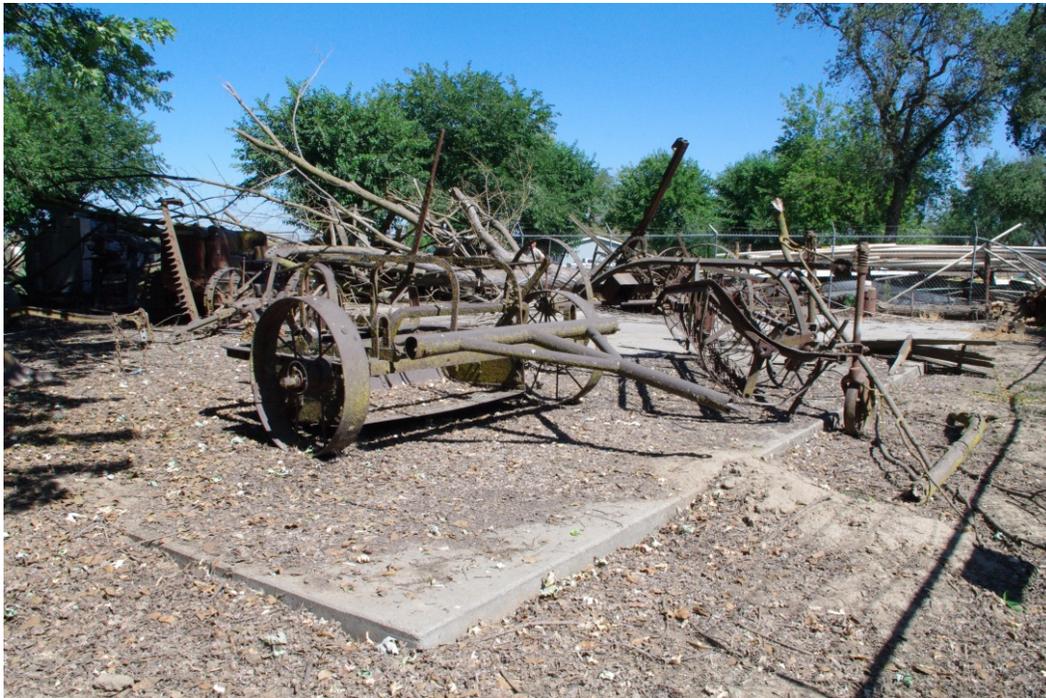
Figure 2. Burris Park, California, Site (Interior Fence), July 2014

In 2013, UC Berkeley staff contacted LM to discuss maintenance needs at the site. Representatives of LM visited the BPS on January 22, 2014, and observed that the fenced area was in disrepair. The protective concrete slab capping the ⁹⁰Sr test plots was covered with broken tree limbs and debris. Some pieces of the farm exhibit and a section of the chain-link fence surrounding the protective slab were crushed from fallen dead trees within the fenced area.

The site contained four large maple trees: two were alive and two were dead and had fallen over. UC Berkeley collected over 100 grams of sample for each tree from 10 to 15 borings per tree. Samples were collected using multiple cores from different portions of the tree, at varying heights and perimeter locations to reduce errors associated with possible distributional heterogeneity of deposited ⁹⁰Sr. UC Berkeley analyzed composite core samples as well as samples of branches and bark from the live and dead trees to determine if they were contaminated as a result of fixed ⁹⁰Sr. UC Berkeley also selected a tree, distant from the research area and of an equivalent age and species, to collect background samples of core, bark, and branches using the same sampling and analytical methods. The sampling plans and analytical data resulted in a determination that at least two of the trees contained very low concentrations of ⁹⁰Sr from bio-uptake. LM subsequently removed the four trees in September 2014 and disposed of them at a facility licensed to receive ⁹⁰Sr. LM also repaired the fence, requested that the county remove the old farm equipment from the pad, and updated the signage to reflect LM's contact information (See Figures 2 and 3).

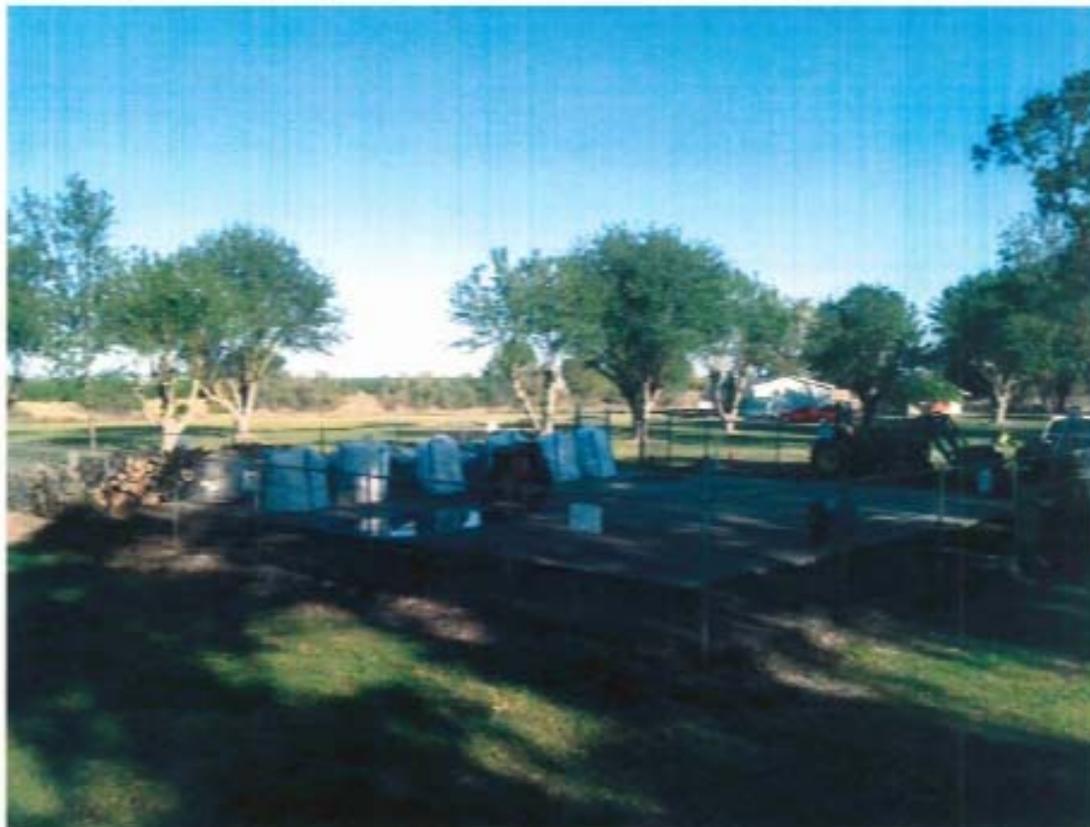
Figure 3. Southwest Corner of Site After Maintenance Activities, Looking Northeast, April 2015
