The following is an account of the facts pertaining to the existence of a radioactive waste disposal site on the property of W.R.Grace & Co. at Curtis Bay, Maryland. Although there exists limited documentation supporting some of the information most of it relies on the recollection of individuals who were involved in the work. Also attached is a description of the chemical process which generated the waste material, a plat of the W.R.Grace & Co. property, and aerial photographs of the site in question.

PLAT OF W.R.GRACE & CO. PROPERTY

AERIAL PHOTOGRAPHS

RADIATION STATUS
OF
W.R.GRACE & CO.
DAVISON CHEMICAL DIVISION
CURTIS BAY PLANT WASTE DEPOSIT AREA

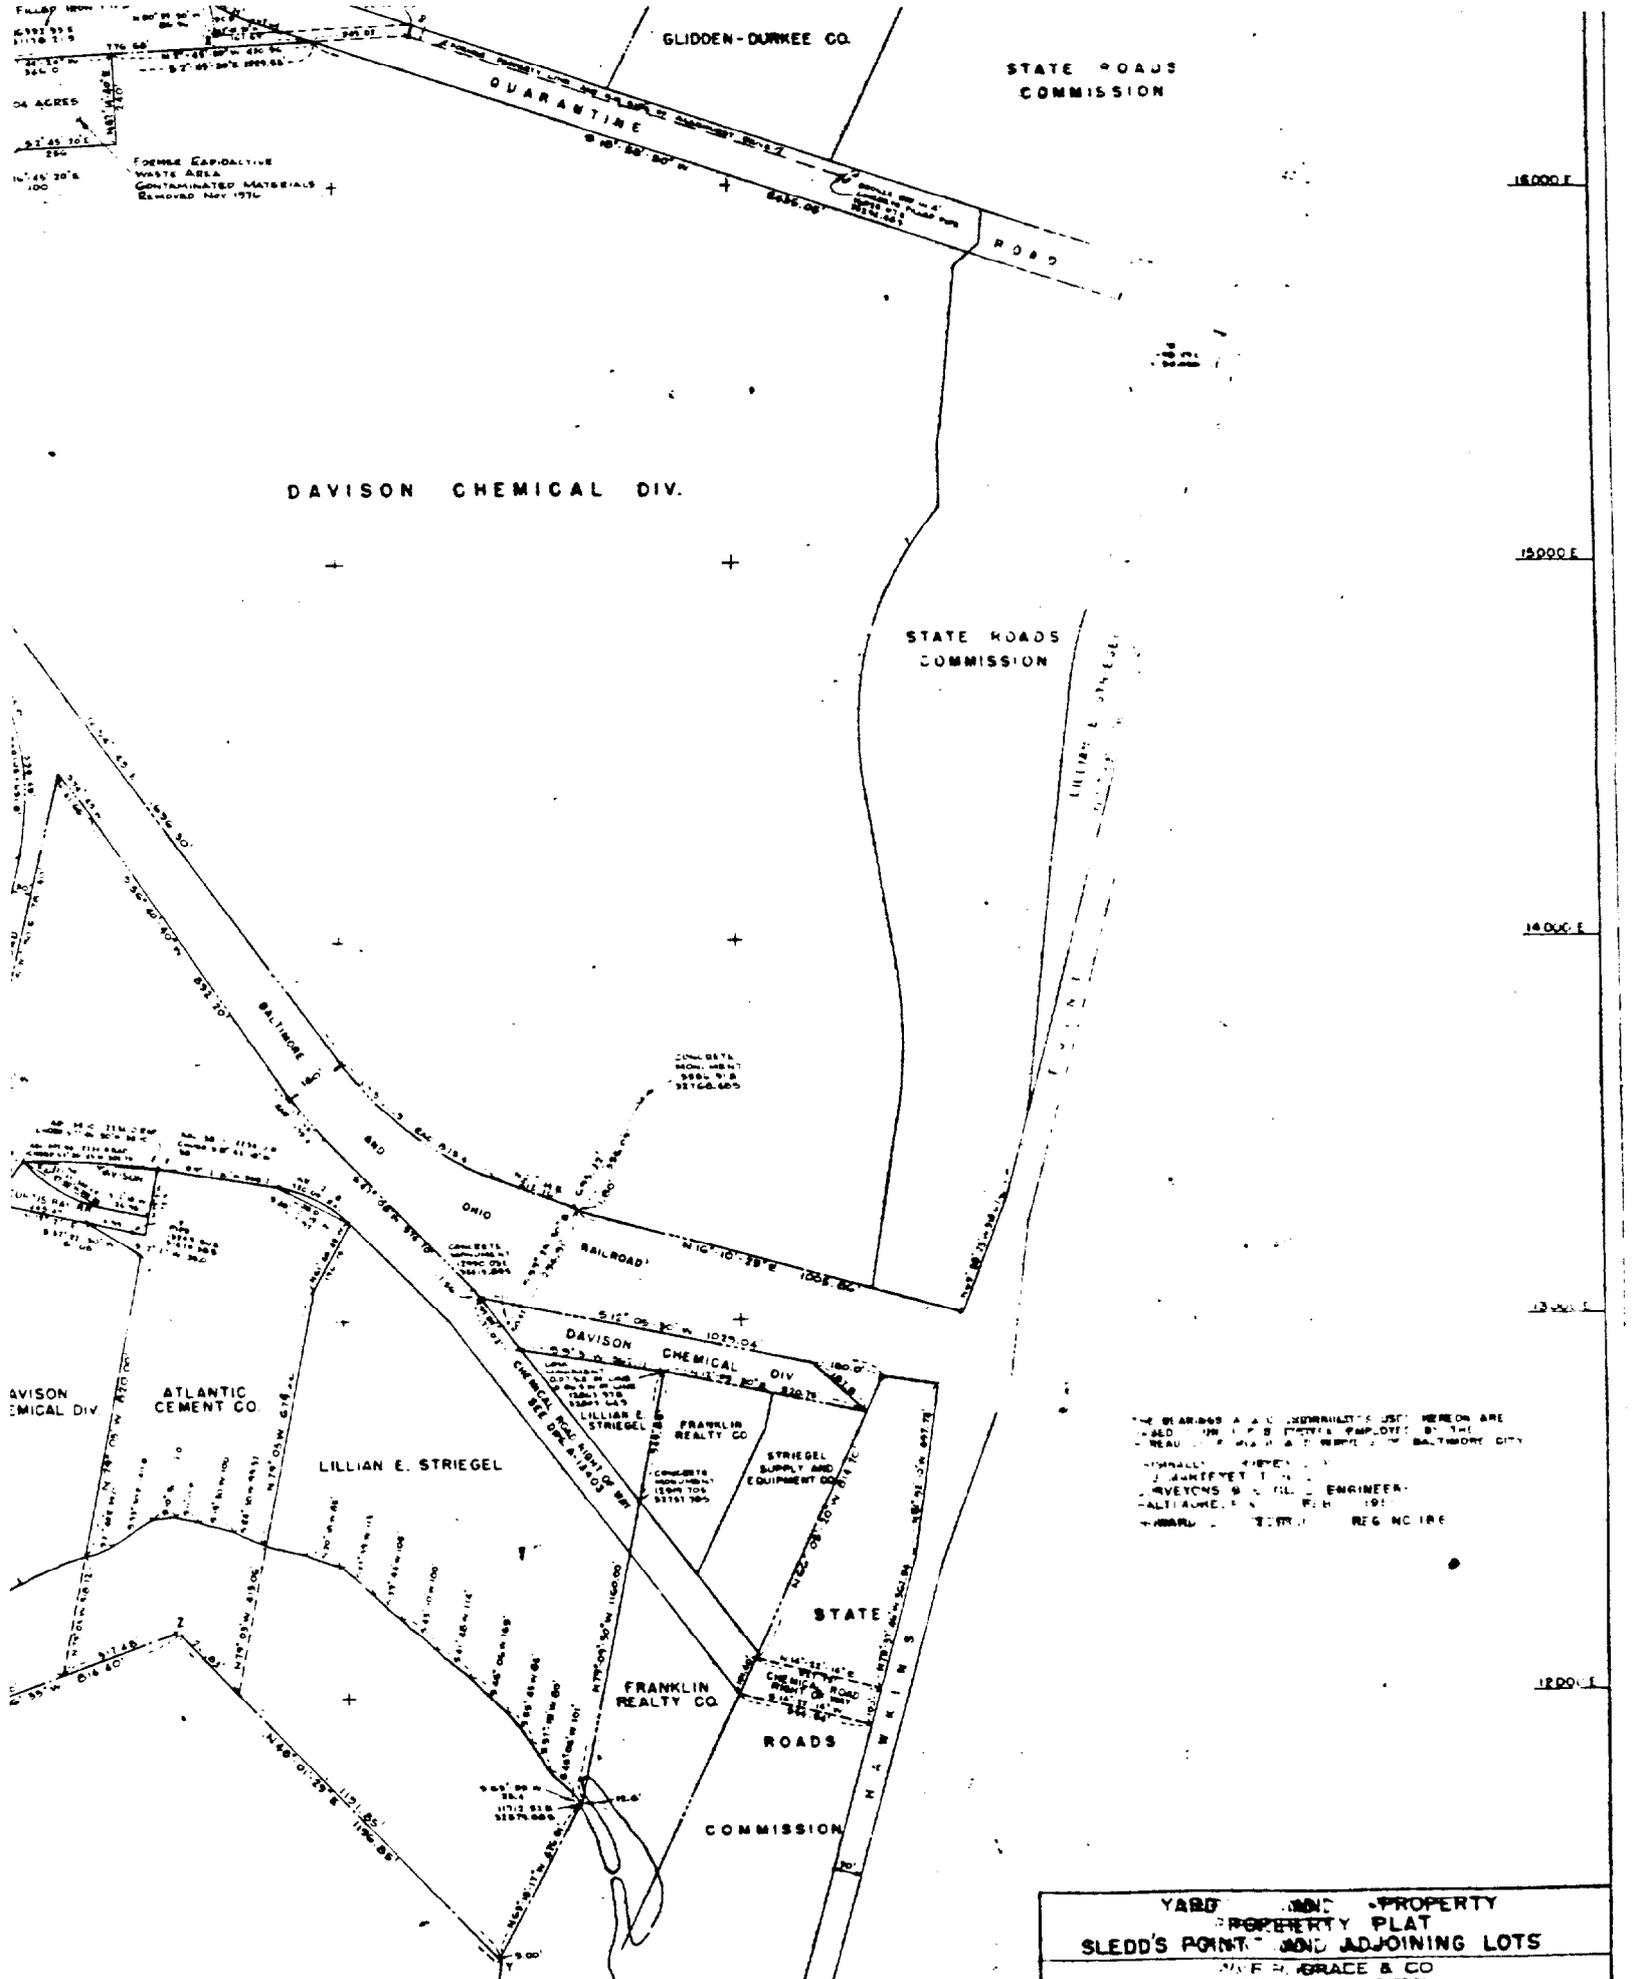
DRAWING No **A-13400**
 DATE SEPT 10, 1976

The disposal sites are entirely contained within the shaded area but do not necessarily include this entire area

6327 575
 5170 215
 04 ACRES
 52° 45' 20" E
 280'
 10° 45' 20" S
 100'
 FORMER RADIOACTIVE
 WASTE AREA
 CONTAMINATED MATERIALS
 REMOVED NOV 1970

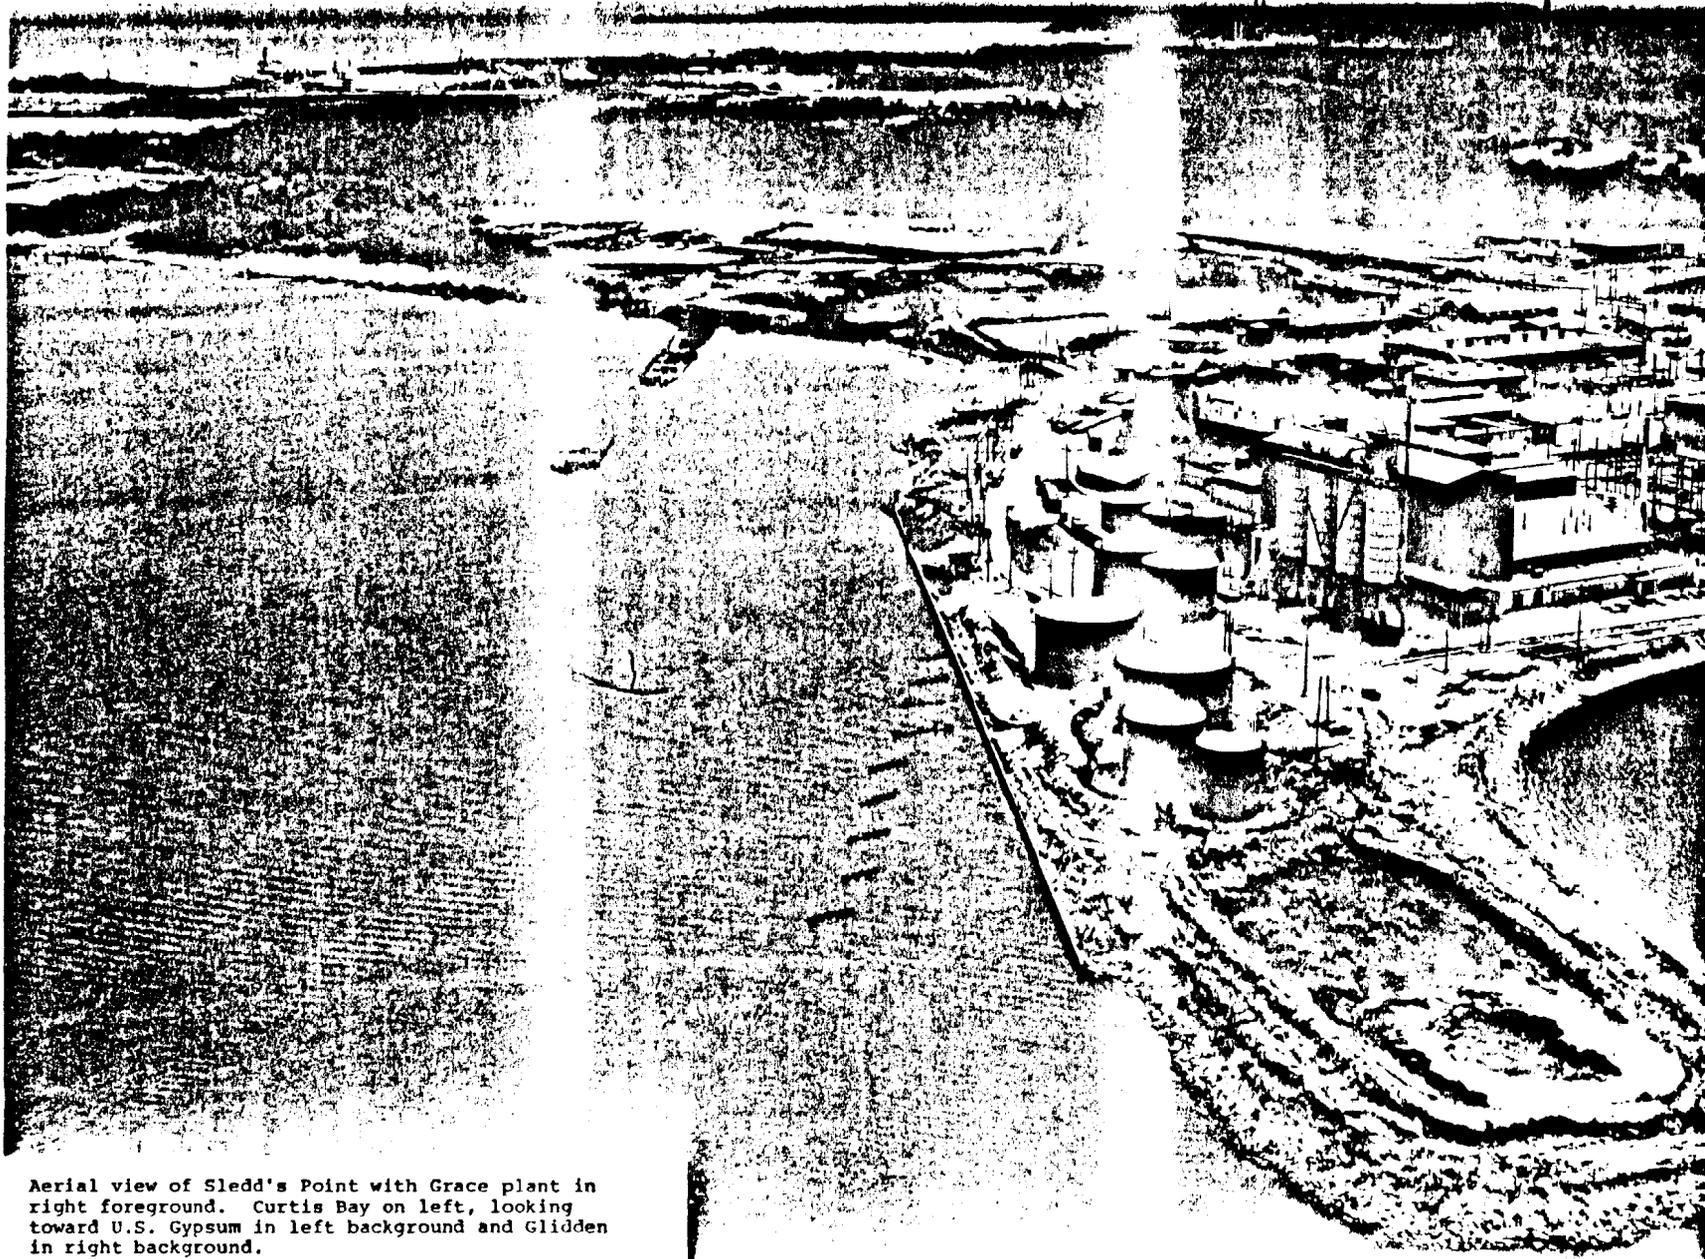
7108-103

Aerial view of Sledd's Point with Grace plant in right foreground. Curtis Bay on left, looking toward U.S. Gypsum in left background and Glidden in right background.

GENERAL OVERALL AERIAL VIEW (CURTIS BAY ON LEFT, CURTIS CREEK ON RIGHT.)

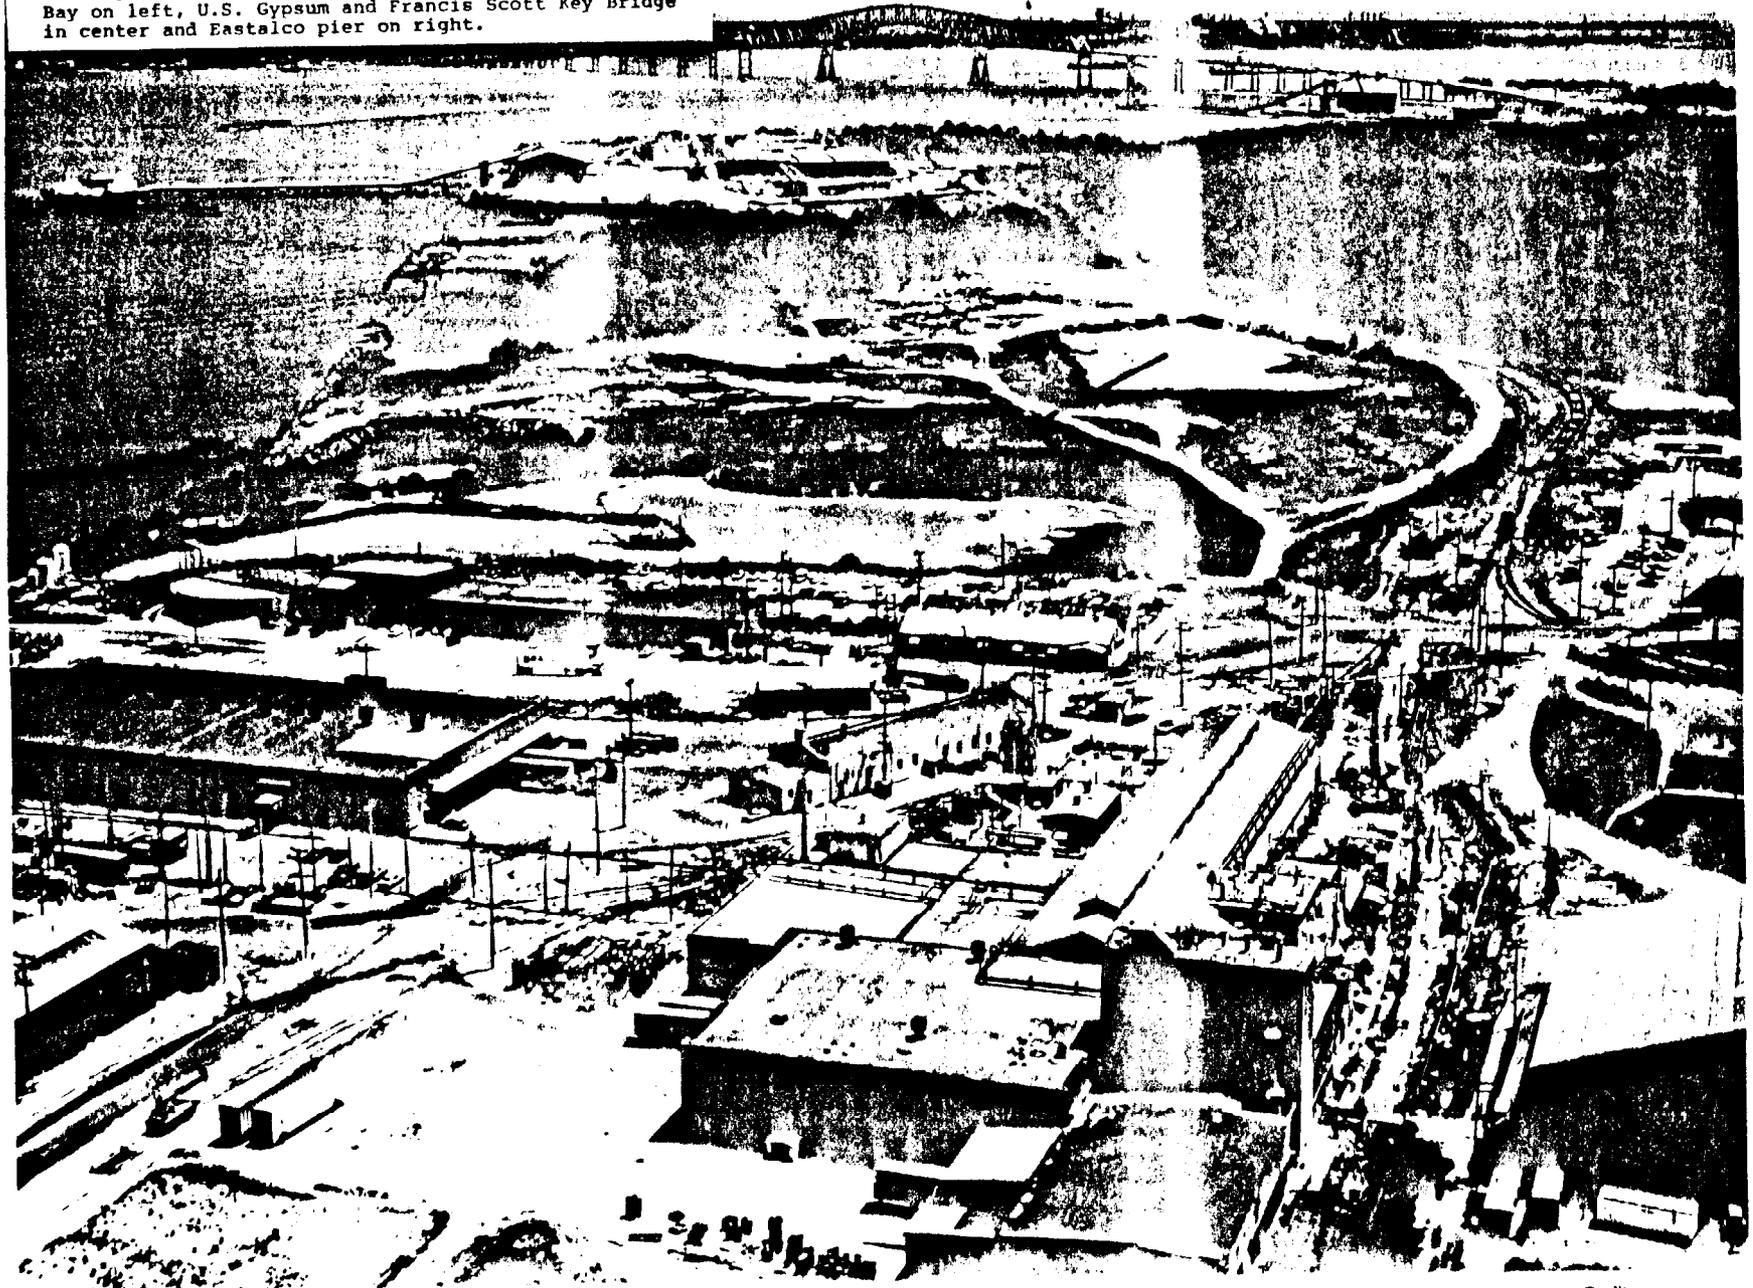
7108-112

Aerial view of Grace plant in entire foreground.
Herring Pond in center. Background includes Curtis
Bay on left, U.S. Gypsum and Francis Scott Key Bridge
in center and Eastalco pier on right.

**AERIAL VIEW APPROACHING FROM THE WEST (CURTIS BAY PRODUCTION
FACILITIES IN FOREGROUND.)**

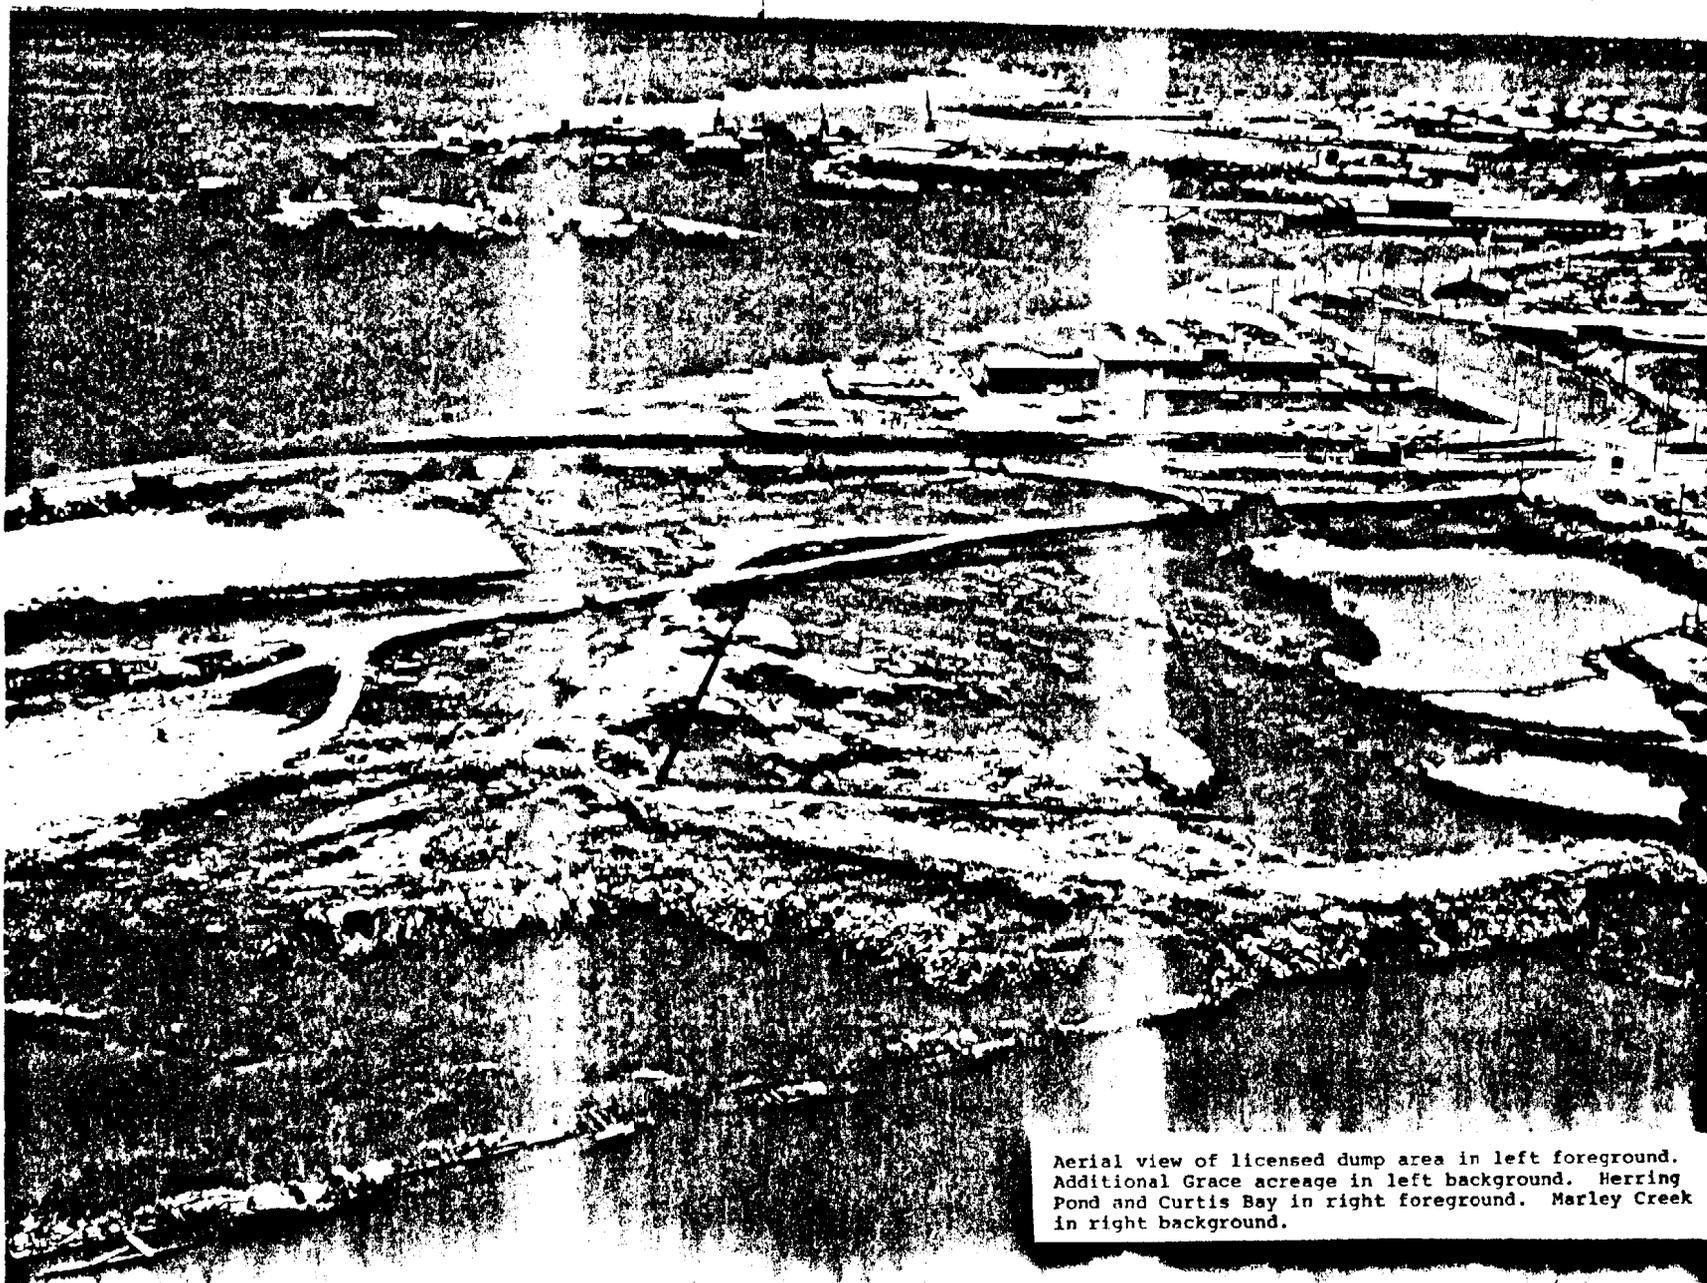
7108-106

Aerial view of licensed dump area in left foreground. Additional Grace acreage in left background. Herring Pond and Curtis Bay in right foreground. Marley Creek in right background.

AERIAL VIEW FROM THE NORTH (CURTIS BAY.)

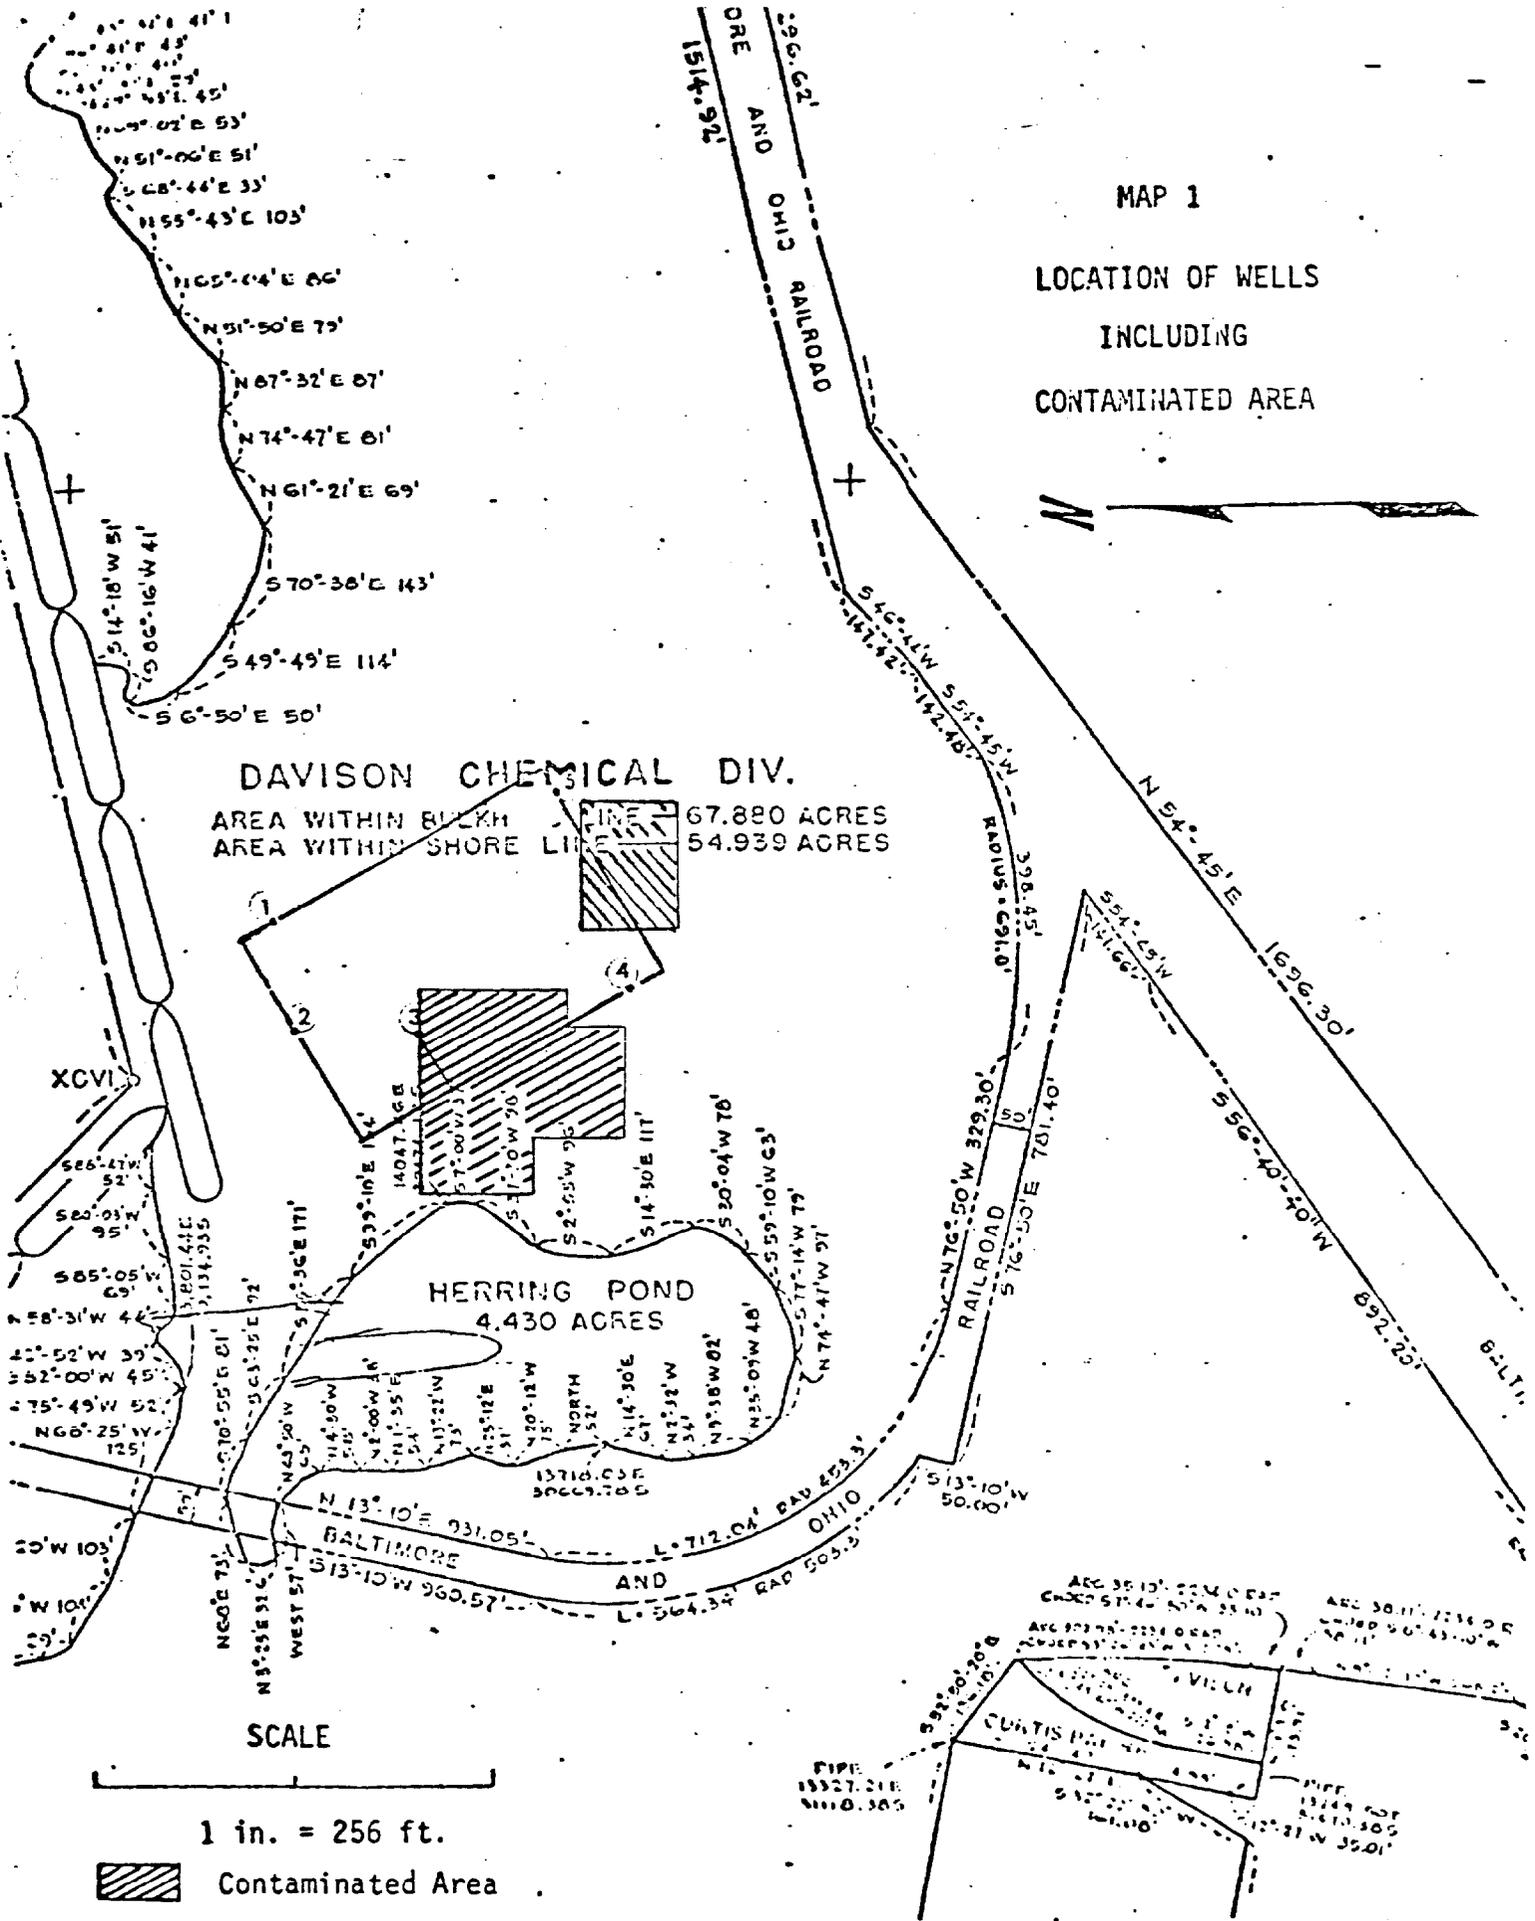
MAP 1
 LOCATION OF WELLS
 INCLUDING
 CONTAMINATED AREA

A Radiation Survey of the surface area was conducted with a portable survey meter calibrated with ^{137}Cs as standard and the measurements ranged from a highest point of 17 mr/hour to background level. The diagrams showing surface radiation are attached. (Attachments A, B, C)

In order to assess dispersion of the radioactive material in the site augered core samples were taken in five locations. The core sample locations (1-5) are shown in Attachment A. Twenty one samples were taken from different depths and different strata in order to characterize the vertical profile of the deposit site. From evaluation of these samples, the vertical profile of the site was constructed as shown in Attachment D. Radioactive material is dispersed in multi-colored fine to coarse sand and industrial waste zones as defined in Attachment D. The twenty one samples were analyzed for gross gamma activity. The results of the analysis, as shown in Attachment E, indicate that the radioactive material is not uniformly deposited throughout the site.

It is estimated that the total volume of waste material possibly contaminated with monazite residue in the two locations outlined in Attachment A is 504,000 cubic feet and 200,000 cubic feet respectively.

Contaminated Area

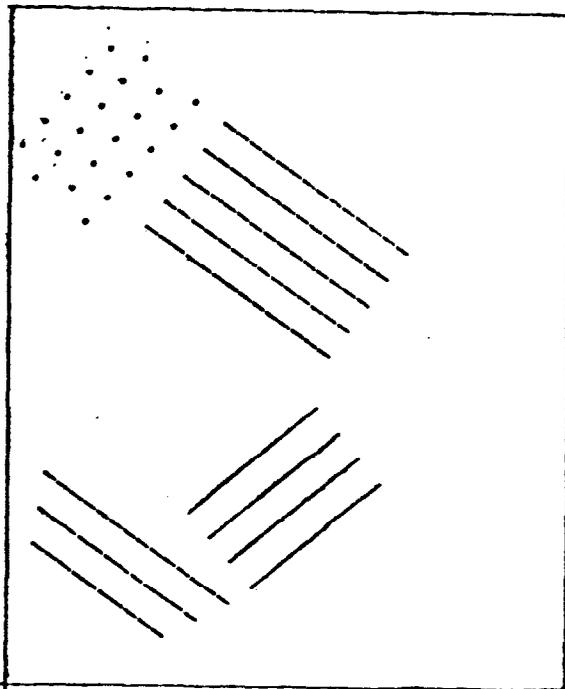
ATTACHMENT B

The measurements and their ranges indicate that the radioactive material is spottily dispersed throughout the deposit site; therefore it is difficult to estimate the exact quantity of radioactive material which is present.

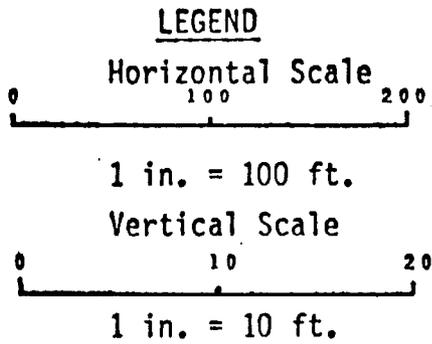
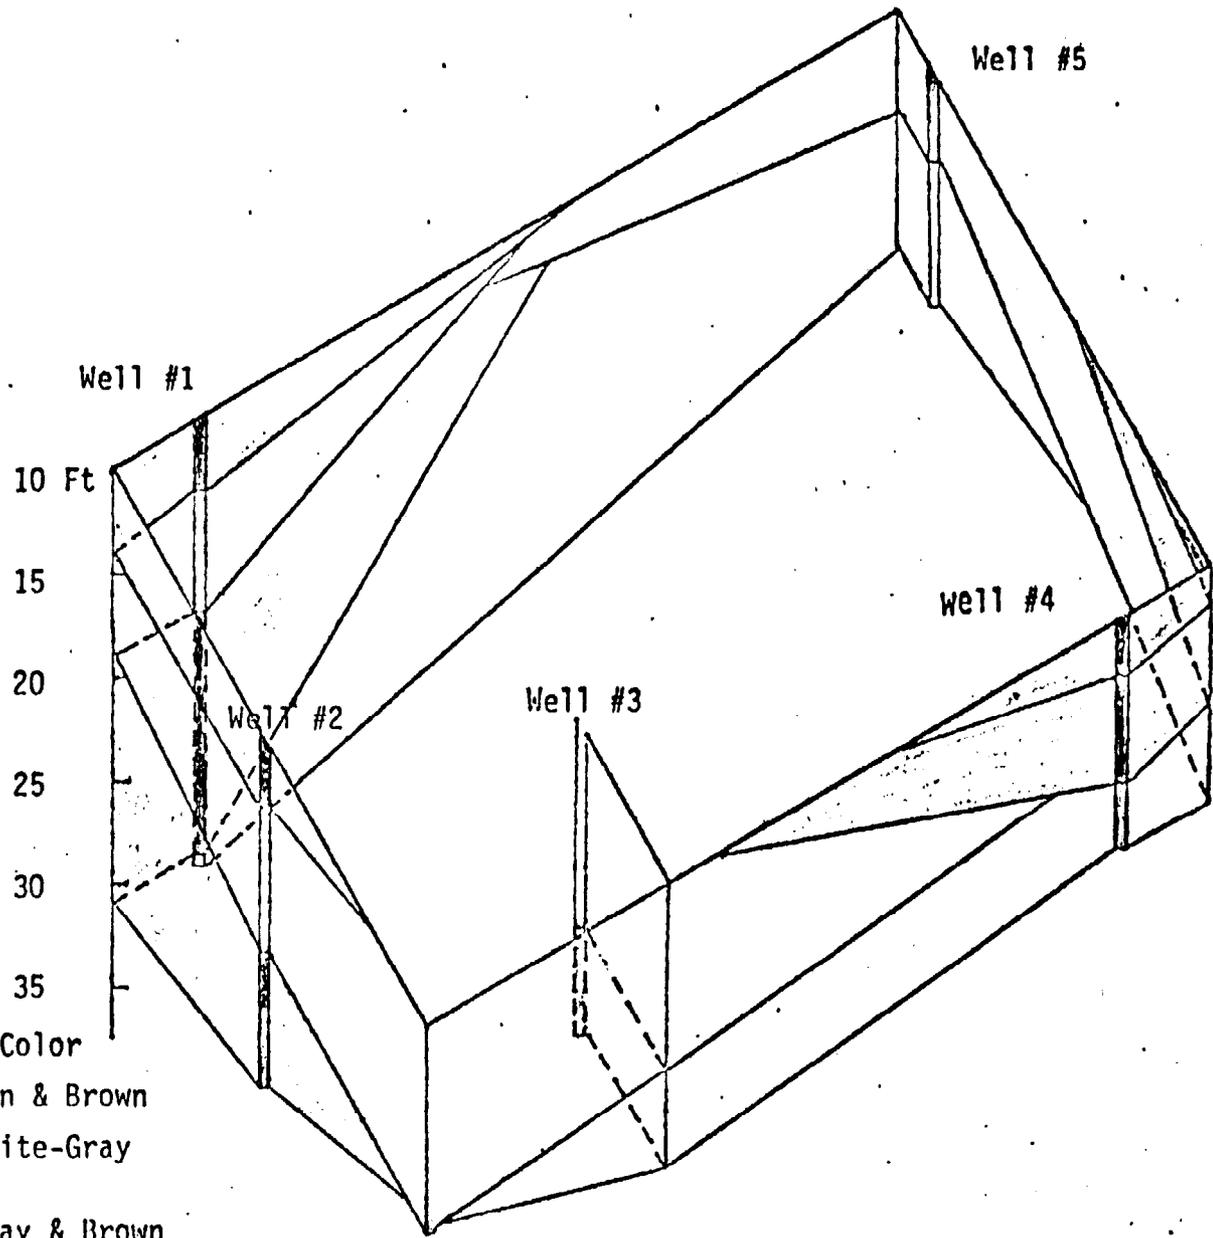
MAP 2
 SECTIONAL DIAGRAM SHOWING
 PRINCIPAL FILL MATERIAL
 ADJACENT TO THE DAVISON
 CHEMICAL COMPANY

Symbol	Material	Color
	Fine to Coarse Sand	Tan & Brown
	Industrial Waste	White-Gray
	Organic Silt (w/lenses-fine silt)	Gray & Brown
	Fine Sand	Orange
	Fine to Coarse Sand	Multi-Colored
	Soil Fill	Brown & Black
	Coal Fill (w/inclusions-Ind. Waste)	Gray & Black

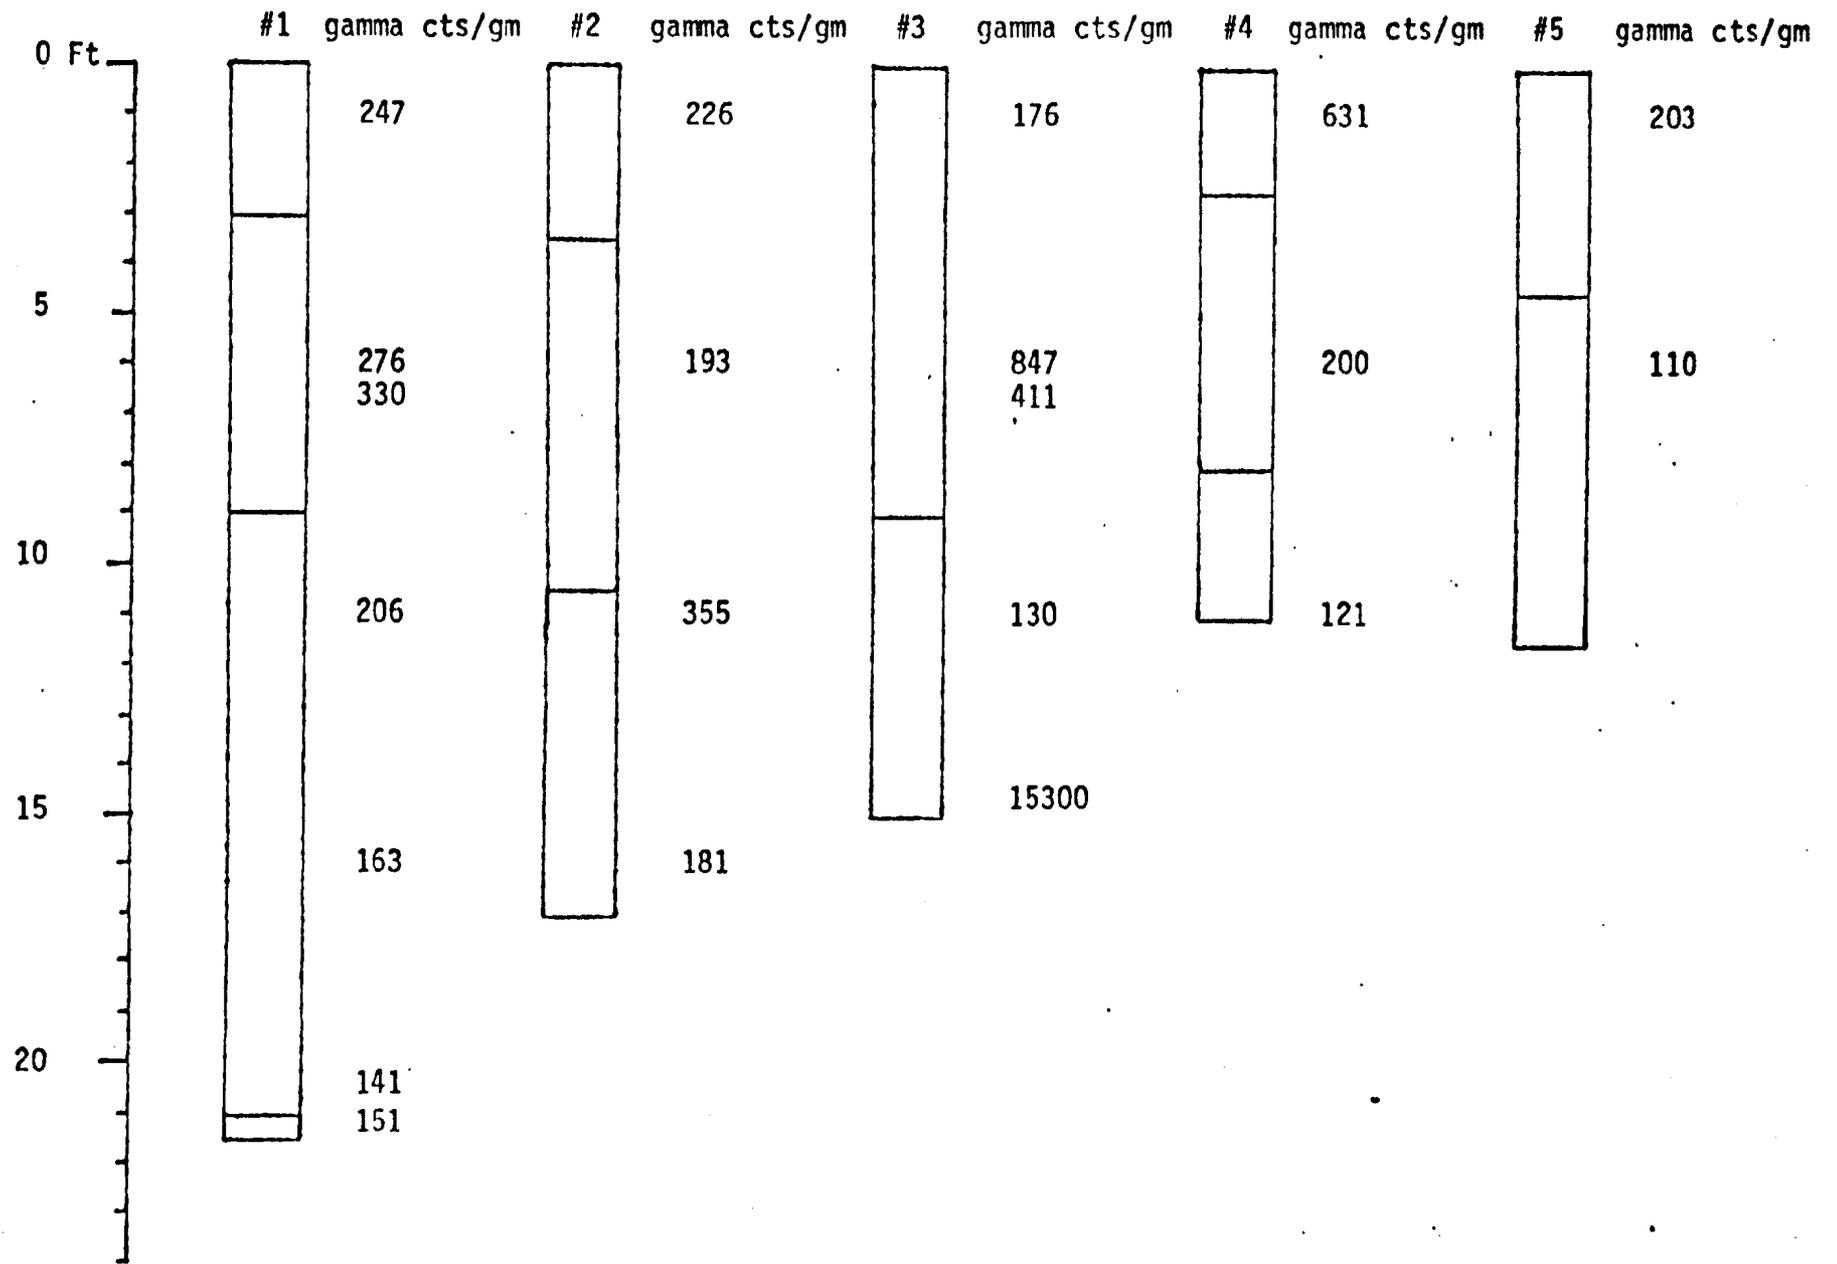
ATTACHMENT E

The distribution of radioactive material in the deposit area indicates that there is no certain concentration gradient. The absence of concentration gradient vertically or horizontally indicates the radioactive materials in the deposit to be very insoluble and immobile. Study of the cracking processes used by W.R.Grace & Co. to produce the radioactive waste deposited in the study area verifies the immobility of the radioactive material. The majority of the material deposited consists of monazite residues which are insoluble. Radioactive material at the deposit area may only be migrated by physical mechanisms such as erosion; however, the rocky barren substrate in the vicinity render erosion unlikely.
