## 6.0 Grand Junction, Colorado, Disposal Site

### 6.1 Compliance Summary

The Grand Junction, Colorado, Uranium Mill Tailings Radiation Control Act (UMTRCA) Title I Disposal Site was inspected on March 23, 2011. The disposal cell and all associated surface water diversion and drainage structures were in good condition and functioning as designed. A portion of the disposal cell remains open and is operated by the U.S. Department of Energy (DOE) to receive additional low-level radioactive waste materials from various sources. The annual inspection requirement applies only to the closed and completed portion of the disposal cell and the surrounding site.

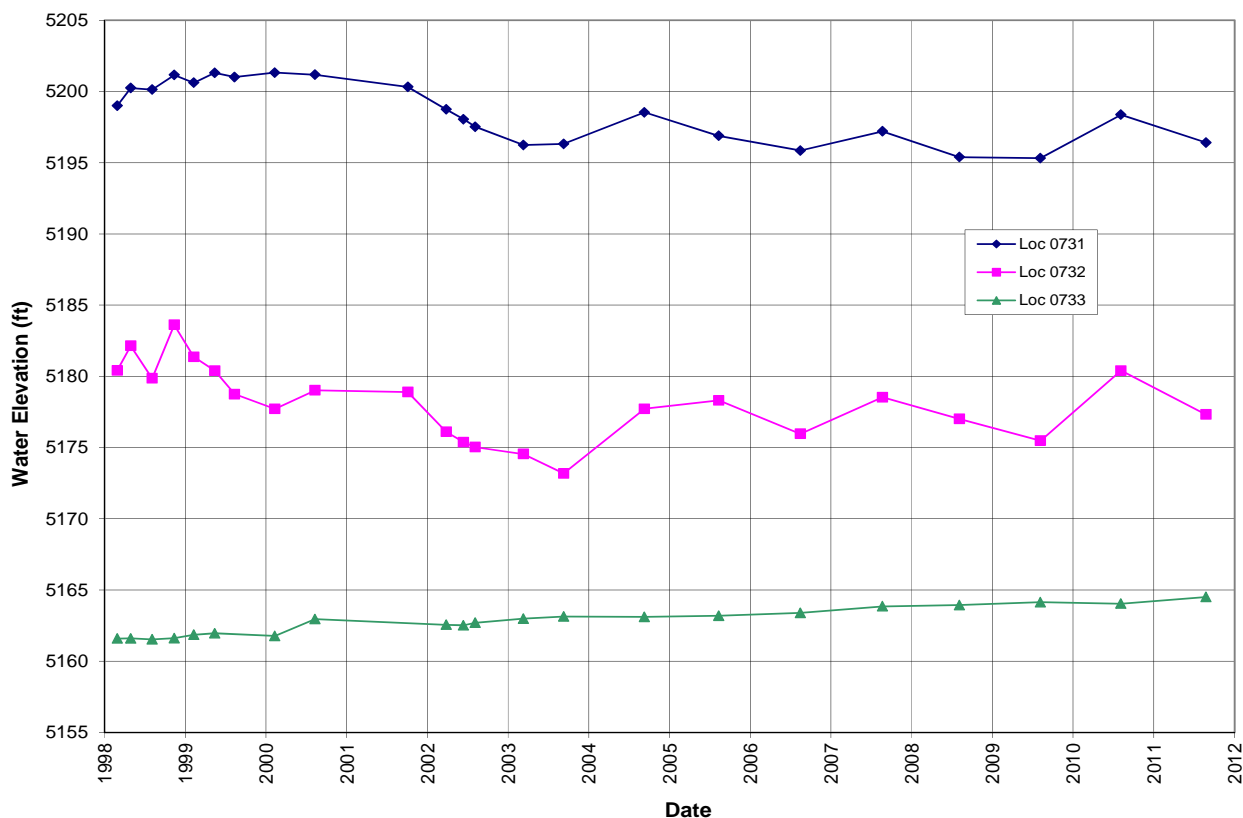
Figure 6–2. Water-Level Measurements at the Grand Junction Disposal Site

**Groundwater-Level Monitoring**—Static water-level measurements are obtained from each well before water quality samples are collected (Figure 6–2). In September 2006, a datalogger was installed in each well to obtain continuous water-level measurements (at a 4-hour interval).

Since 1998, the water level in disposal cell well 0733 has risen approximately 2.9 feet and has remained significantly lower than the water levels in the two paleochannels wells (0731 and 0732) (Figure 6–2). Water levels within the two paleochannels wells are approximately equal to 1998 levels. The trends for wells 0731 and 0732 have been slightly decreasing, with level fluctuations that range from 2 to 5 feet. Given these elevations, groundwater at the base of the disposal cell at well 0733 has no potential to migrate to the paleochannels at wells 0731 and 0732.

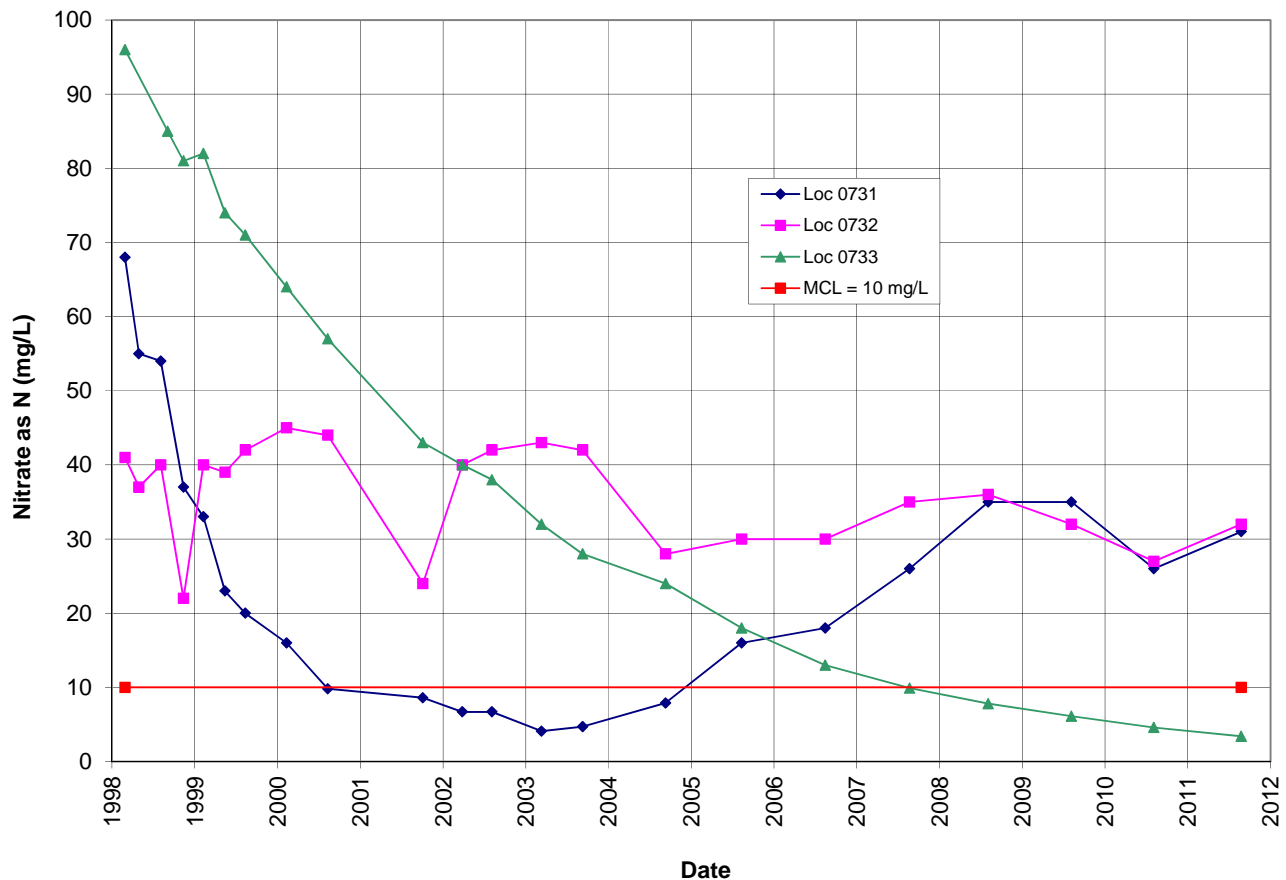
Figure 6–3. Time-Concentration Plots of Nitrate (as Nitrogen) in Groundwater at the Grand Junction Disposal Site

Nitrate (as nitrogen) concentrations in groundwater continued to exceed the MCL of 10 mg/L in the paleochannel monitoring wells (0731 and 0732) through 2011 (Figure 6–3). Concentrations

in well 0731, following an initial steep downward trend, remained below the MCL from 2000 through 2004. In 2005 and continuing through 2011, concentrations steadily increased and remain above the MCL. Concentrations in well 0732, though varied, have consistently remained above the MCL since 1998. Concentrations in well 0733 continued a significant downward trend, dropping below the MCL in 2006, and reaching a low of 3.4 mg/L in 2011. Historically, the highest concentration of nitrate (96 mg/L) occurred in 1998 from disposal cell well 0733. In 2011, the concentration of nitrate has increased slightly, and the nitrate levels in both paleochannel monitoring wells are very similar: 31 mg/L in well 0731 and 32 mg/L in well 0732.

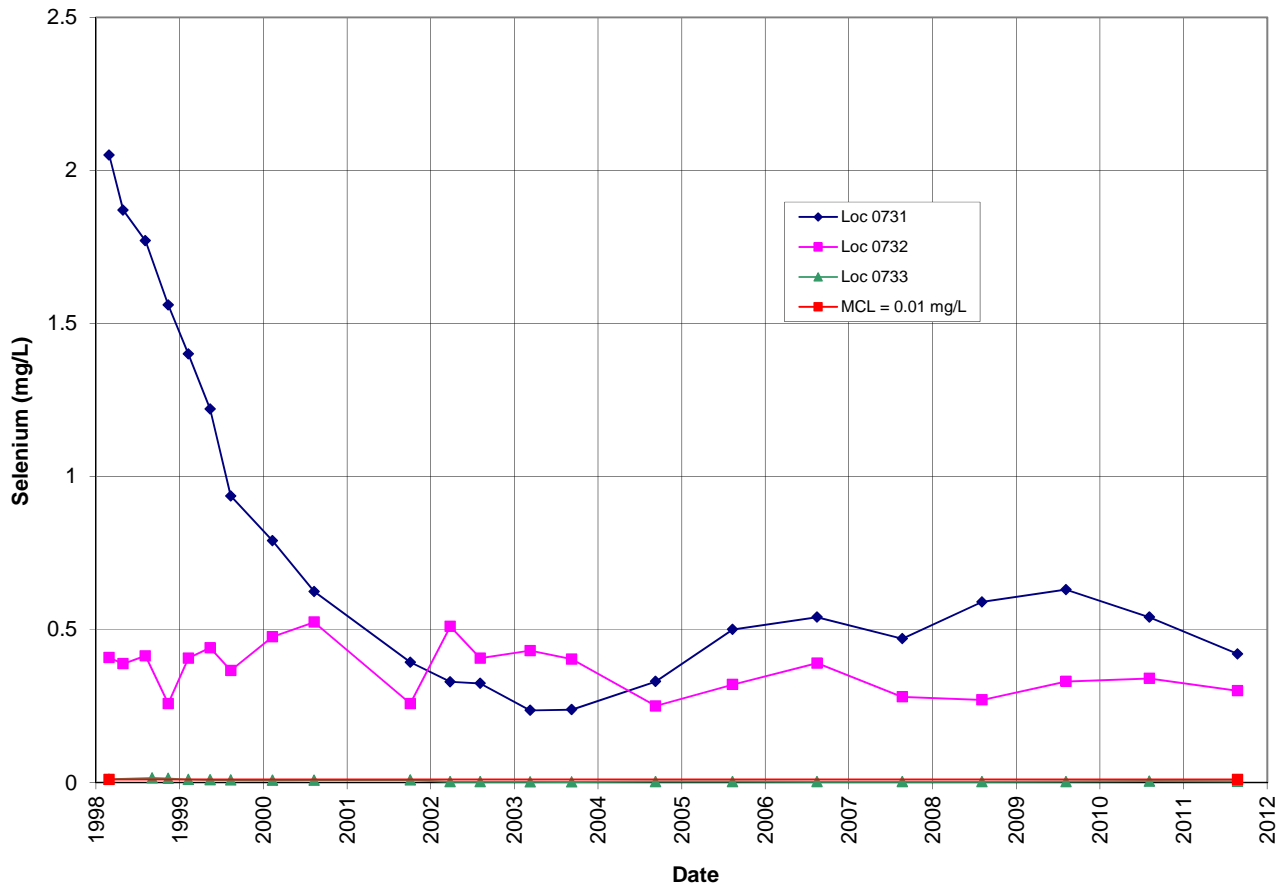
Figure 6-4. Time-Concentration Plots of Selenium in Groundwater at the Grand Junction Disposal Site

Selenium occurs naturally in the Mancos Shale deposits that underlie the disposal cell, and may be the cause of the elevated concentrations reported in both paleochannel monitoring wells (0731 and 0732). Selenium concentrations continued to exceed the MCL of 0.01 mg/L in the paleochannel wells (Figure 6–4). Concentrations in well 0731 displayed a sharp decreasing trend, and the decreasing trend continued until 2003, when a slight upward trend began. Selenium concentrations in well 0731 have decreased since 2009. Concentrations in well 0732 continue to display no trend. In well 0733, the selenium concentration of 0.0038 mg/L remained well below the standard, with no trend evident.

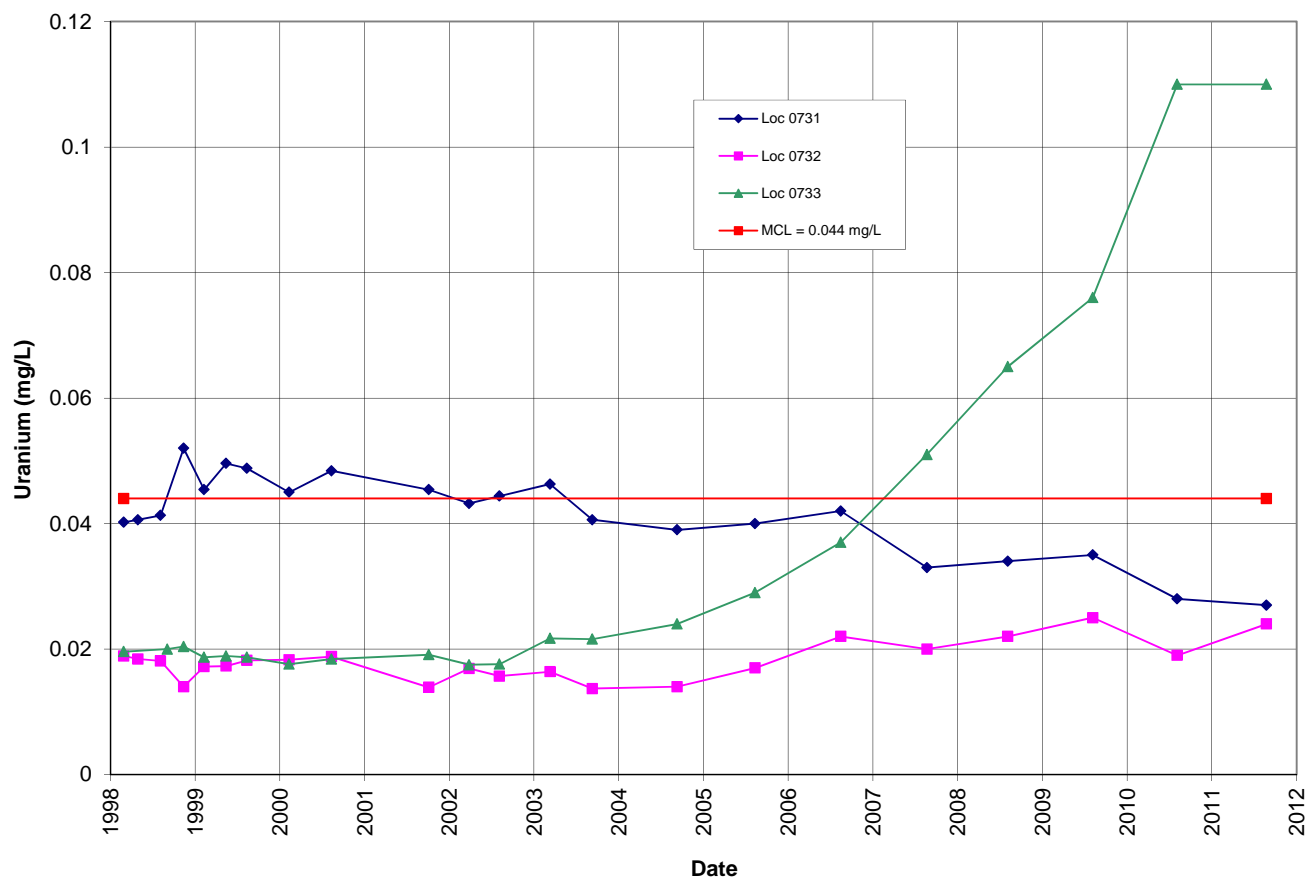
Figure 6-5. Time-Concentration Plots of Uranium in Groundwater at the Grand Junction Disposal Site

Uranium concentrations in groundwater were below the MCL of 0.044 mg/L in paleochannel wells 0731 and 0732, and were above the MCL in well 0733 (Figure 6-5). Concentrations in well 0731, after an initial increase above the MCL, have displayed a decreasing trend that continued in 2011. Concentrations in well 0732 have remained relatively consistent. Concentrations in well 0733 remained relatively consistent through 2003, at which time an upward trend began, which has leveled off at 0.11 mg/L for the 2010 and 2011 sampling events.

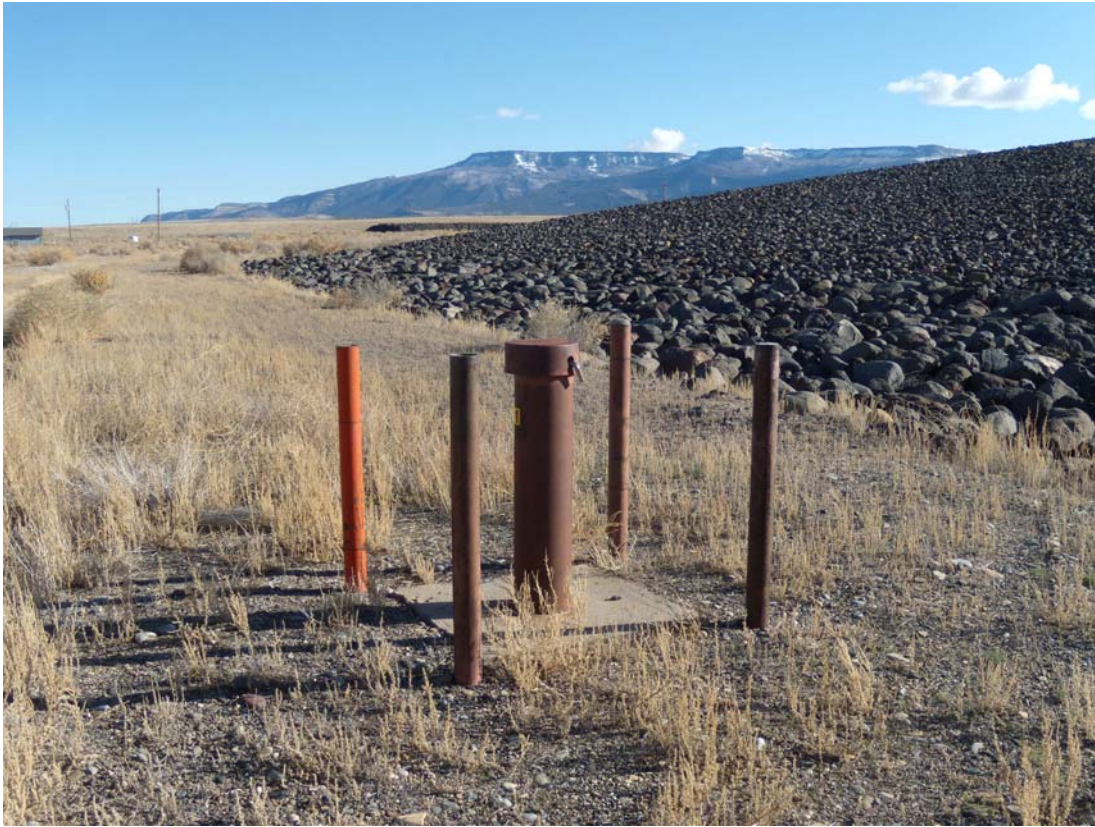
**Monitoring Wells**—The groundwater monitoring network consists of three monitoring wells. All three are inside the site boundary. The wells were secure and in excellent condition (PL-1).

*GRJ 3/2011. PL-1. Monitoring well 0731 near the northwest corner of the disposal cell.*

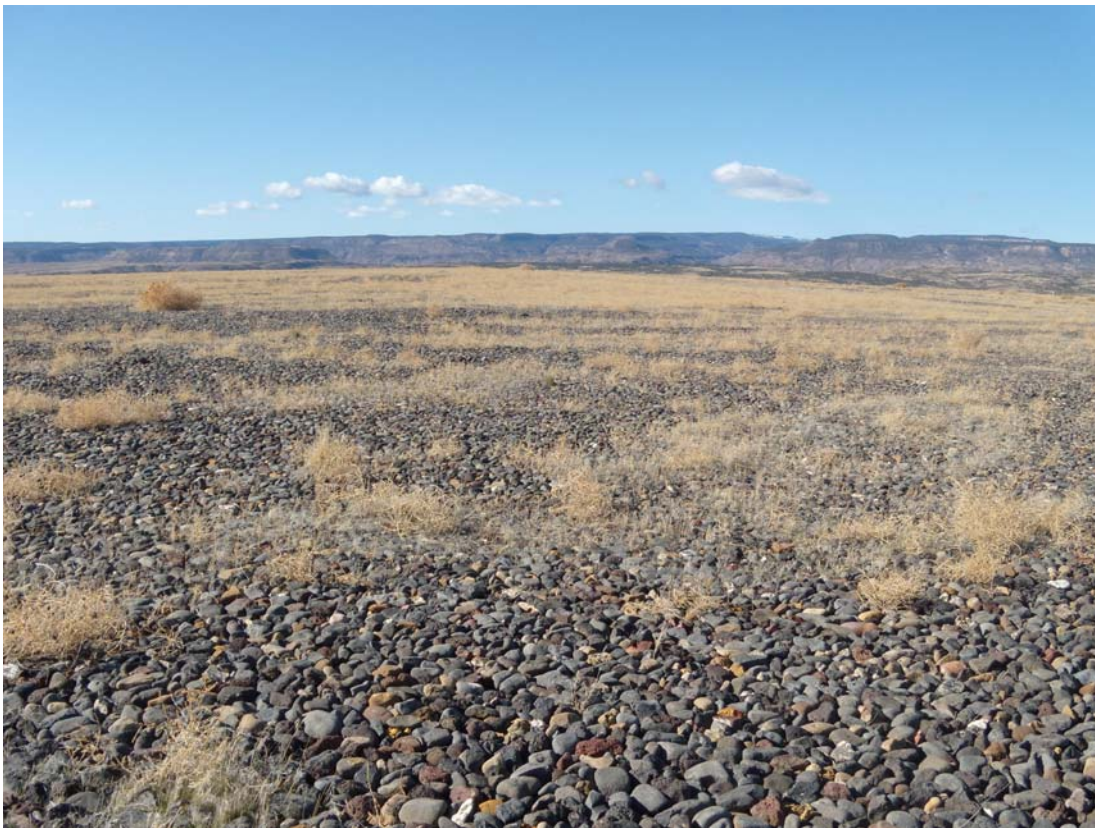
**Closed Portion of the Disposal Cell**—Basalt riprap covers the top and side slopes of the disposal cell. The rock is durable and in excellent condition. There is no evidence of slope instability. The cover was in excellent condition with no evidence of settling or erosion (PL-2).

*GRJ 3/2011. PL-2. Northeast corner of the disposal cell cover.*

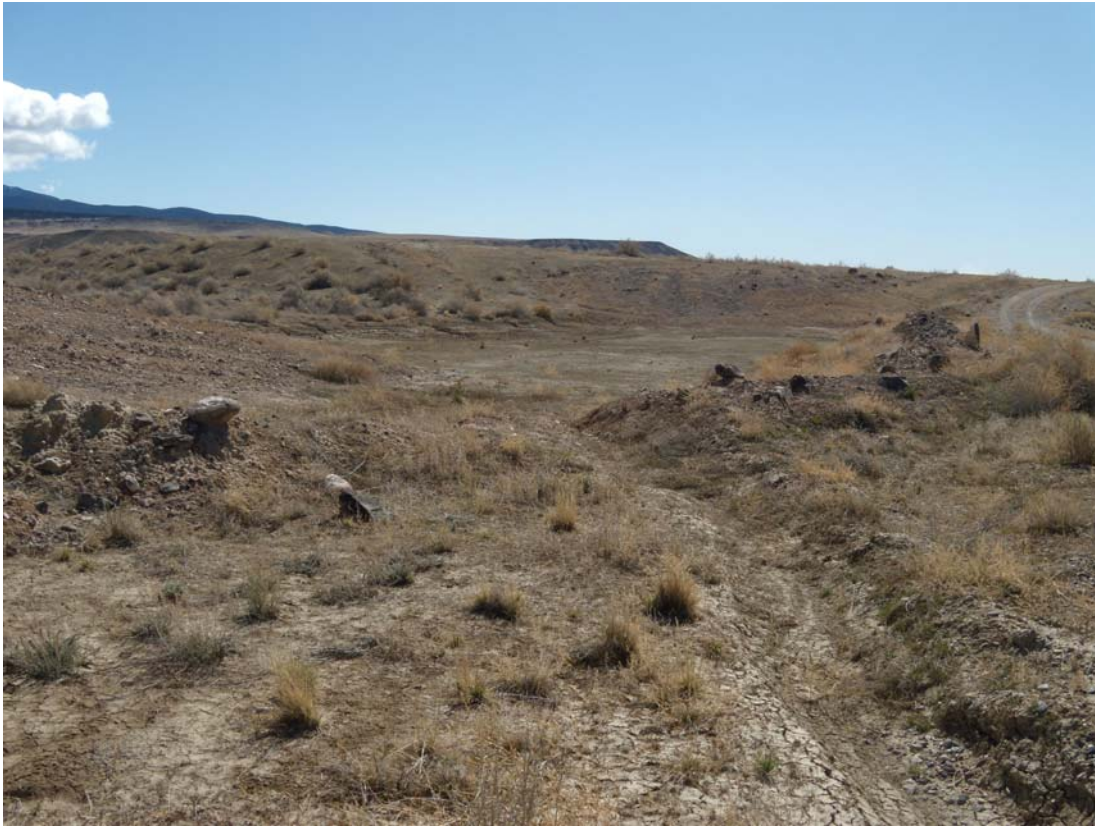
Other drainage features at the site include north and south storm water collection ditches, the north storm water retention pond, and a storm water and sediment collection pond on the east side of the south diversion channel (PL-3). These small drainage features control storm water runoff primarily from the various cover materials stockpiled on the northern and eastern portions of the disposal site property. The north storm water collection ditch also captures storm water run-on from a large catchment area north and east of the disposal site. The ditches and ponds are functioning as designed.

*GRJ 3/2011. PL-3. East storm water and sediment collection pond.*

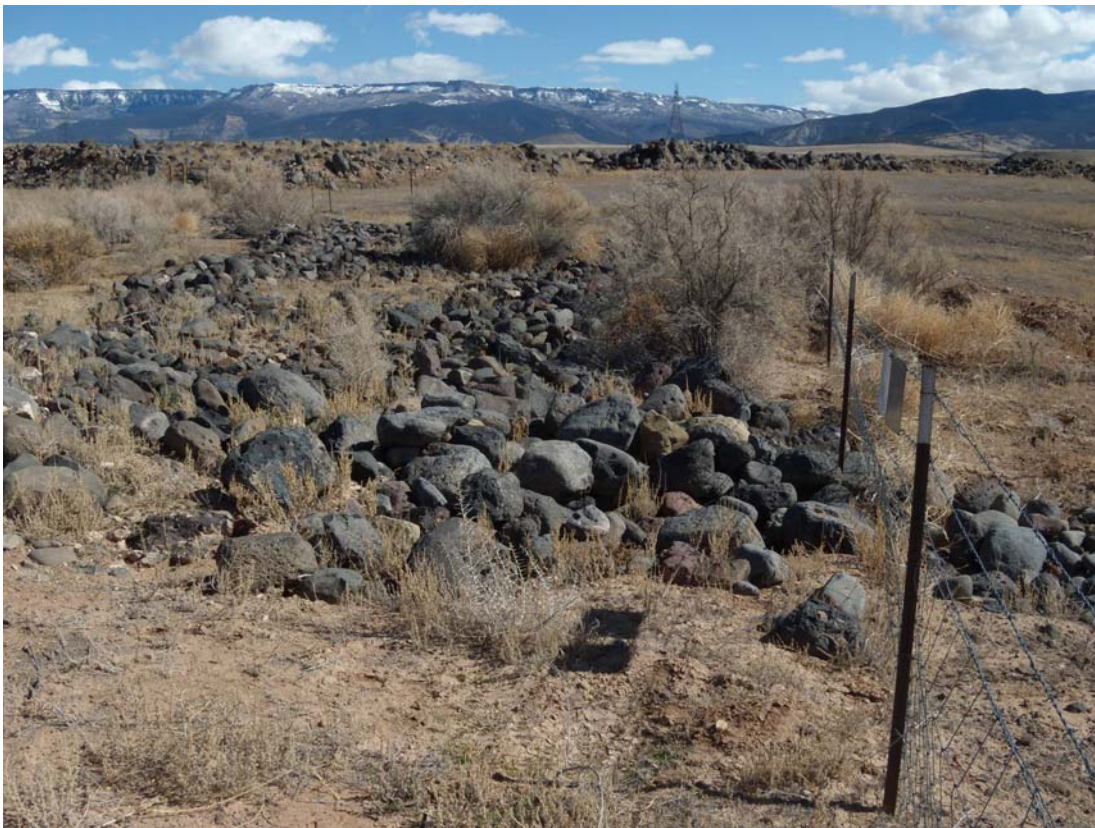
**Site Perimeter**—A location of active erosion near the southeast corner of the perimeter fence was repaired in 2009. The area was regraded, basalt boulders were installed to reduce erosion, and a drainage ditch to redirect runoff was constructed. No new erosion was apparent (PL-4). A gully is present along the south perimeter fence (near perimeter sign P8) on the fringe of a riprap-armored drainage area. It does not appear to be actively eroding at this time. At some point, the gully may erode beneath one or more of the line posts; however, the fence and posts were taut and stable at the time of the inspection.

*GRJ 3/2011. PL-4. Riprap erosion protection near the southeast corner of the perimeter fence.*
