Monticello National Priorities List Sites Federal Facilities Agreement (FFA) Quarterly Report: April 1–June 30, 2009

This report summarizes project status and activities implemented April through June 2009, and provides a schedule of near-term activities for the Monticello Mill Tailings Site (MMTS) and the Monticello Vicinity Properties (MVP) sites. This report also includes disposal cell and Pond 4 leachate collection data, quarterly site inspection reports, site meteorological data, and a performance summary for the ex situ groundwater treatment system.

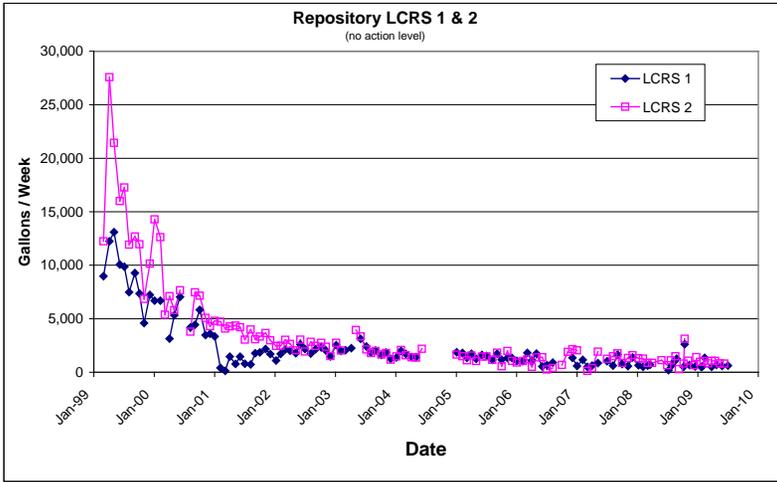
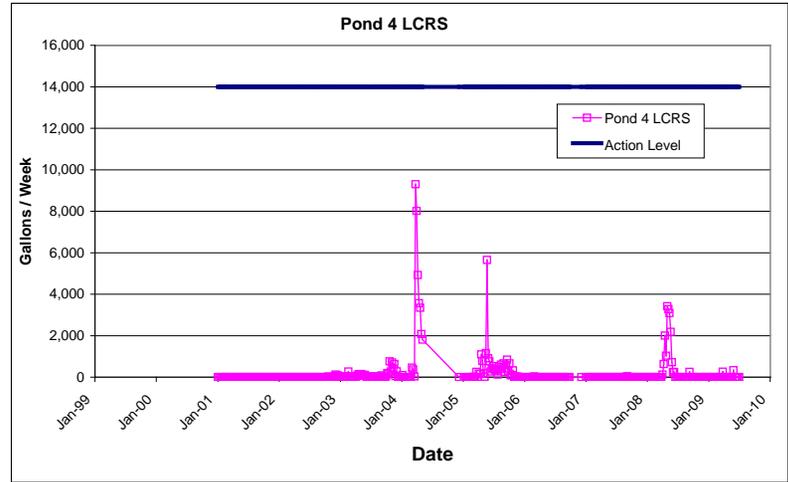
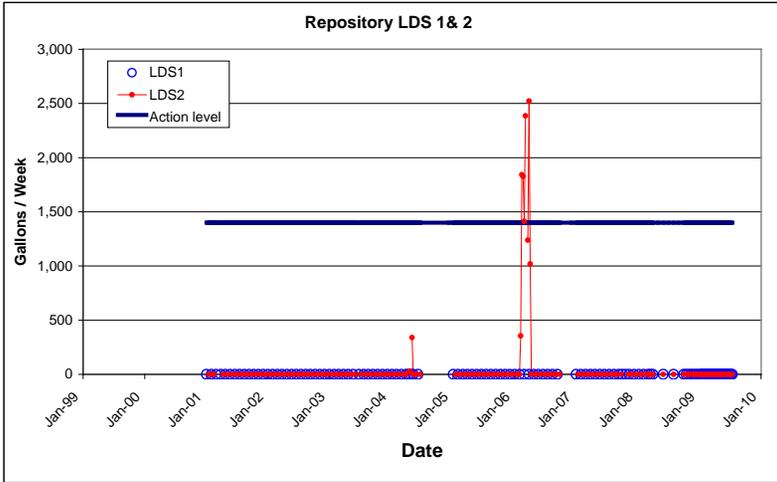
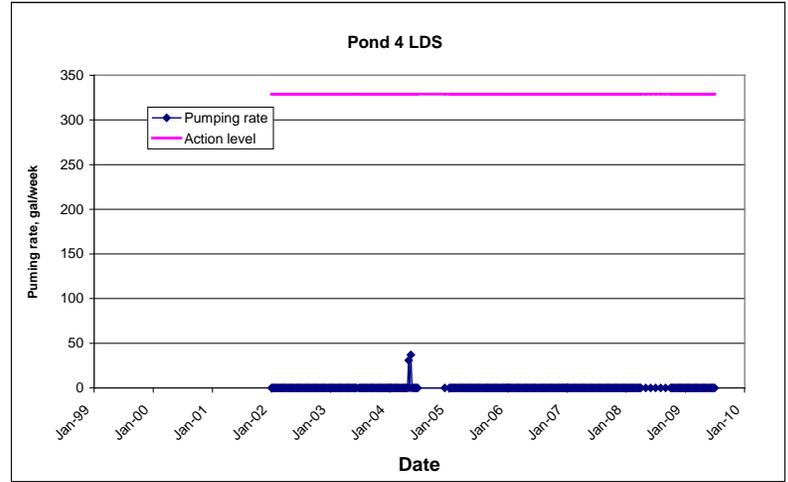
Graphs Showing Performance History for Repository and Pond 4 Leachate Collection and Recovery System (LCRS) and Leak Detection System (LDS)

- Repository leachate collection in the upper sumps (Leachate Collection and Recovery System [LCRS]) was normal for the quarter. Leachate continues to decrease in quantity from approximately 30,000 gallons per week in 2000 to current values of about 1,000 gallons per week per sump (see attached graph).

- Pond 4 LCRS operation was normal (no water collected during the quarter).
- Disposal cell and Pond 4 leachate collection in the lower sumps (Leachate Detection System [LDS]) remains at zero (see attached graphs).
