**Pinellas Environmental Restoration Project**

**Interim Remedial Action  
for Source Removal at the  
Northeast Site**

**Final Report**

**September 2009**

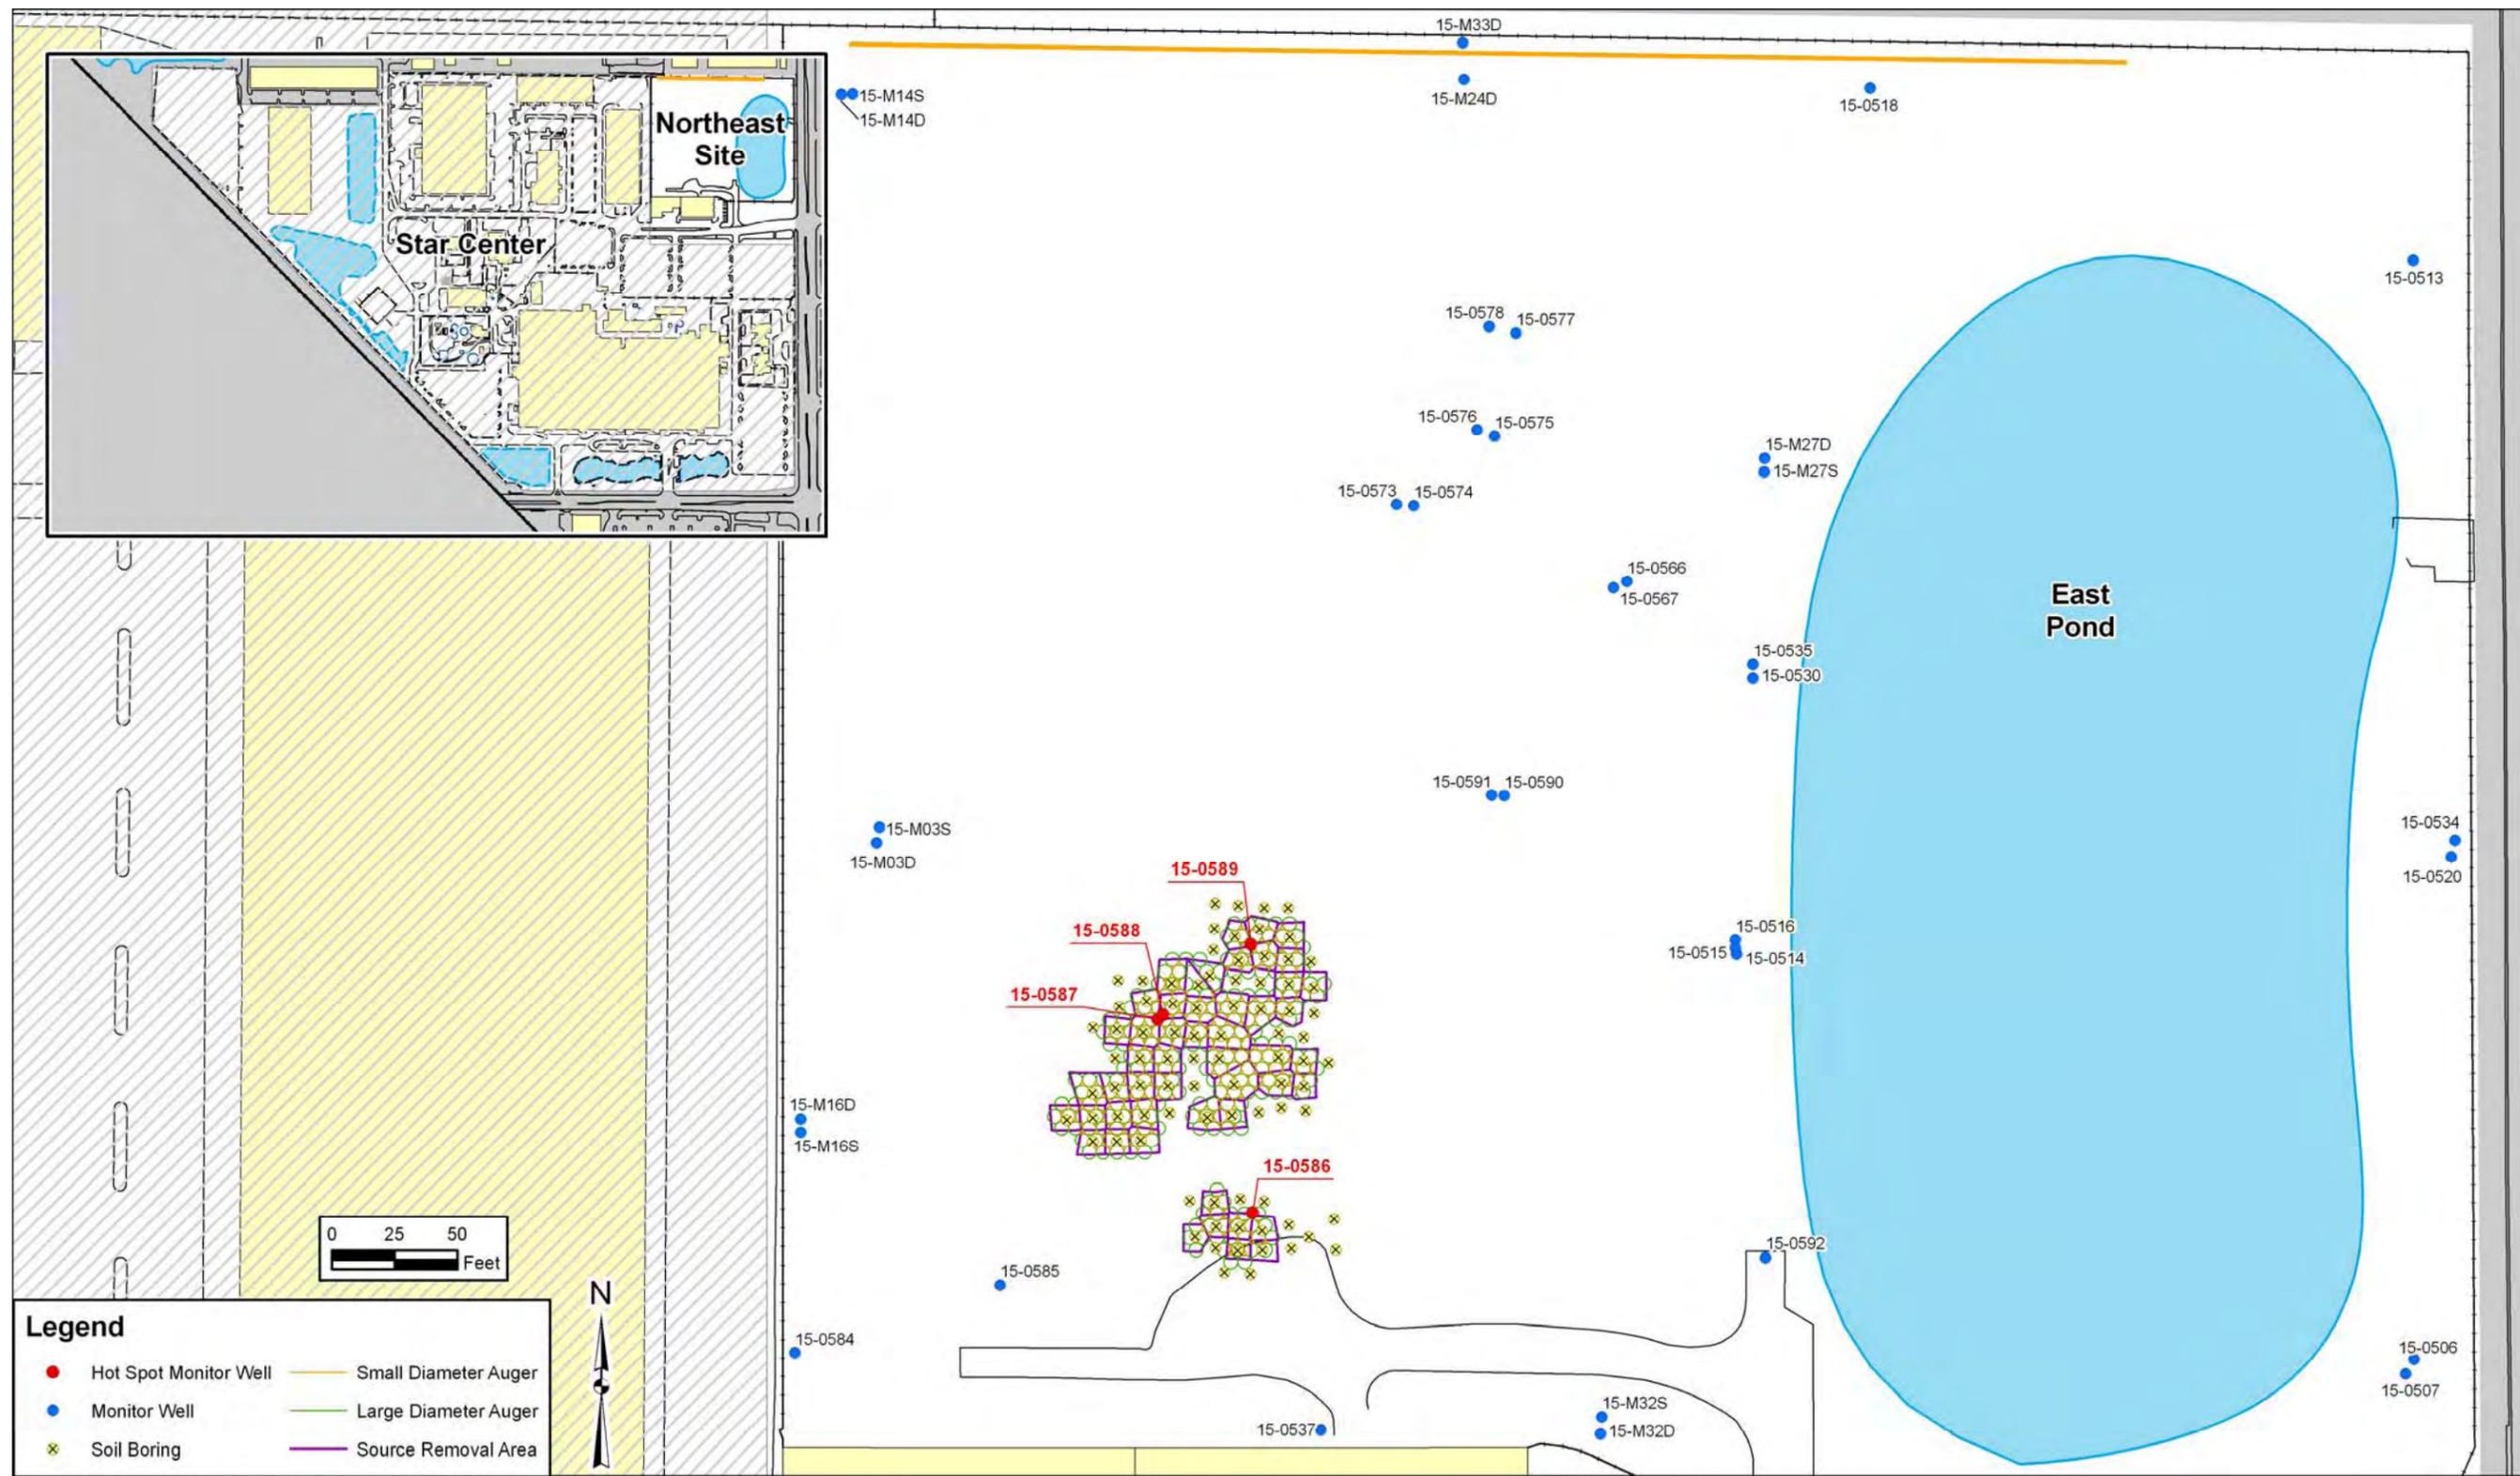
Figure 2. Location of Source Areas at the Northeast Site

Two distinct contaminant source areas were apparent—one to the north around monitoring wells PIN15–0587 and –0589 (the North Source Area) and one to the south around monitoring well PIN15–0586 (the South Source Area). Figure 2 shows the location of the source areas on the Northeast Site. Thiessen polygons were applied to divide the source areas into cells that surround each soil boring. Source area interval and depth to Hawthorn for each excavation cell is listed in Table 2. In general, the highest contaminant concentrations were found within the lower 5 ft of the surficial sediments, although elevated concentrations were also found at shallow depths within the surficial sediments and a few feet into the Hawthorn as well. The surface area of the source areas was 5,621 square ft, or 0.13 acre.

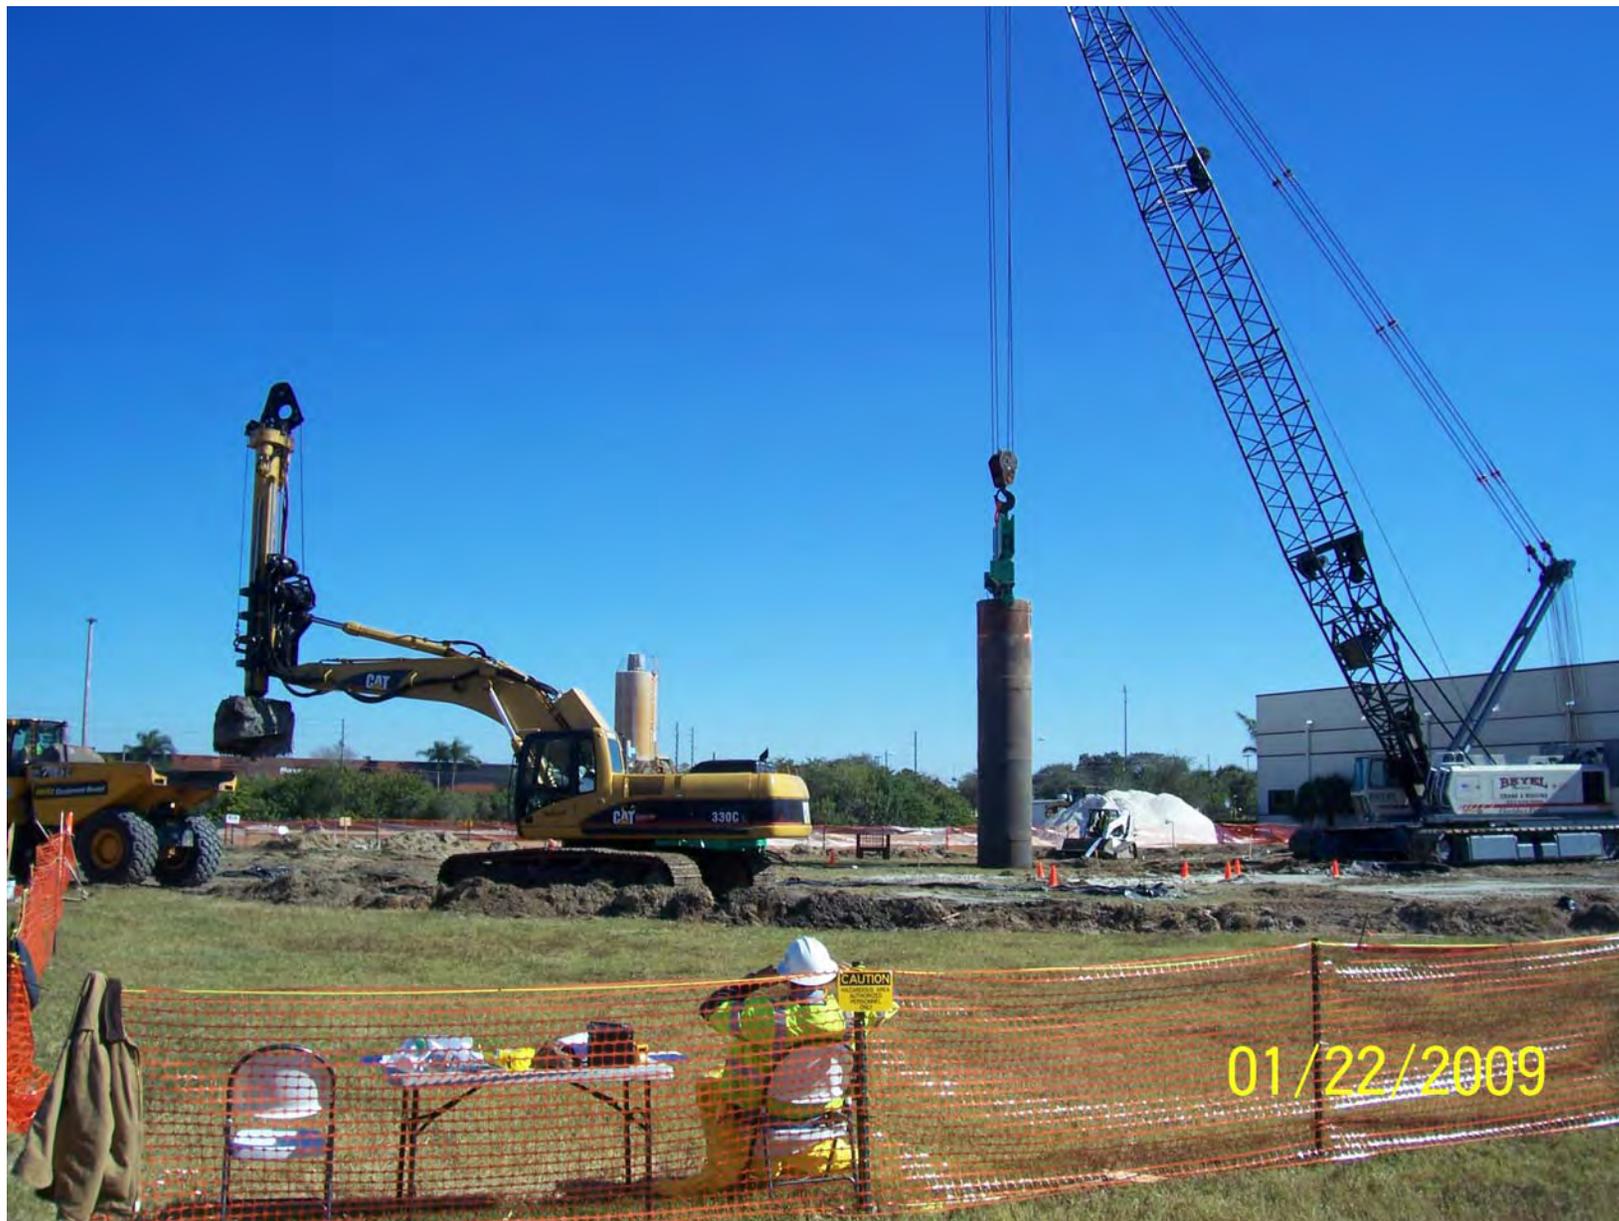
Figure 3. Photo of LDA Activities at the Northeast Site

The LDA method involved first driving a 35-ft-long, 66-inch inside diameter steel casing into the ground using a vibratory hammer attached to a crane, then using a 60-inch-diameter auger to excavate the soil from inside the casing (Figure 3). The casing prevents the collapse of the surrounding soils into the boring and prevents groundwater from flowing into the boring. Most auger borings extended into the Hawthorn, but the steel casing was not driven more than a few feet into the Hawthorn because the Hawthorn did not collapse into the uncased boring, and little or no groundwater entered the boring from the Hawthorn. Use of the vibratory hammer as the

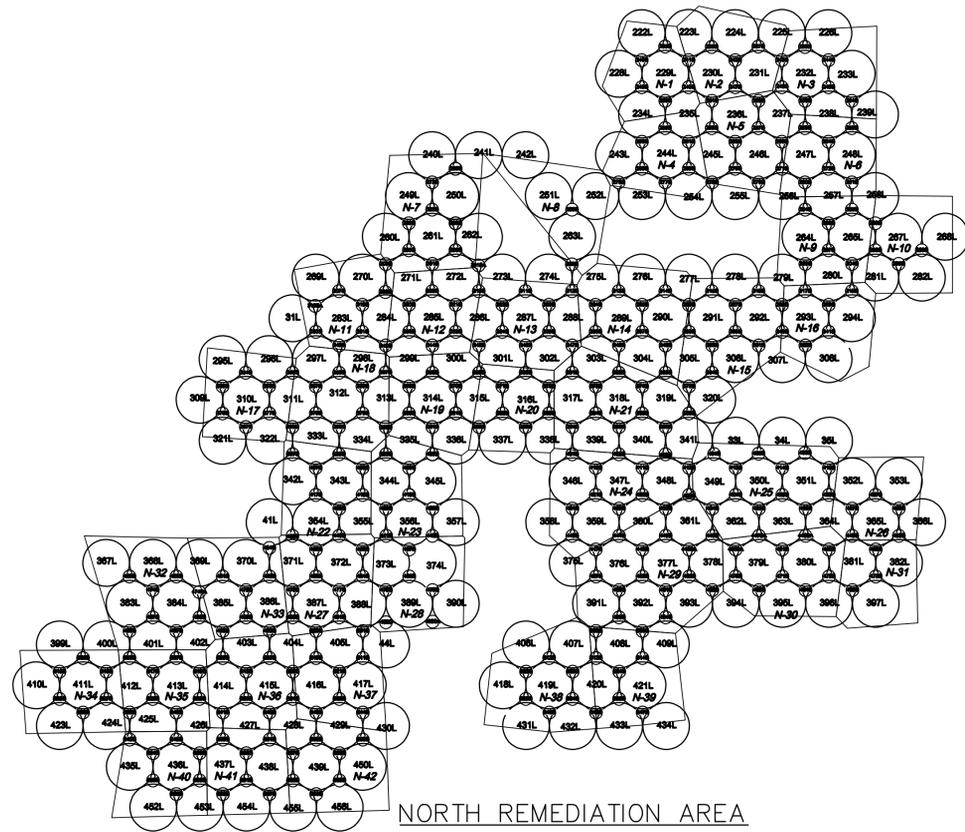
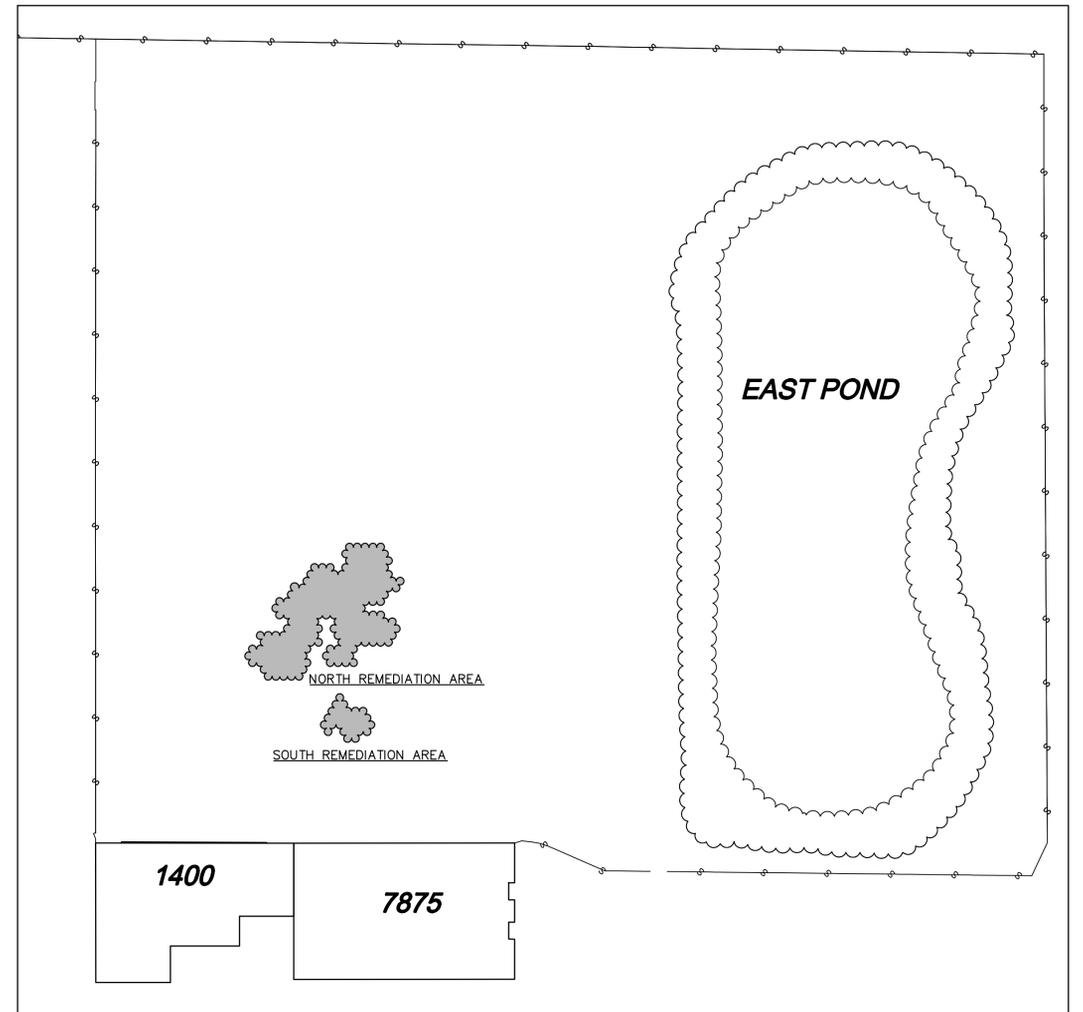
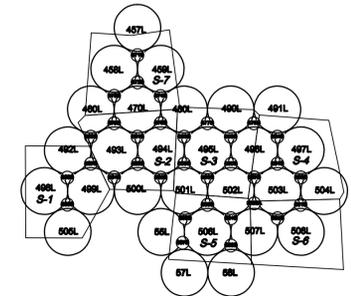
The as-built auger layout is shown on Plate 1. The large circles represent the locations of 66-inch-diameter auger borings, and the small circles represent the locations of 16-inch-diameter auger borings. A total of 243 large-diameter borings and 337 small-diameter borings were installed. All the large-diameter borings were completed first, and subsequently all the small-diameter borings were completed.

As described in Section 2.3, the source areas were divided into excavation cells based on characterization data. The excavation cell layout was provided to WRS, and WRS designed the auger layout. Source area interval and depth to Hawthorn for each excavation cell is listed in Table 2, and the excavation cells are shown on Plate 1.

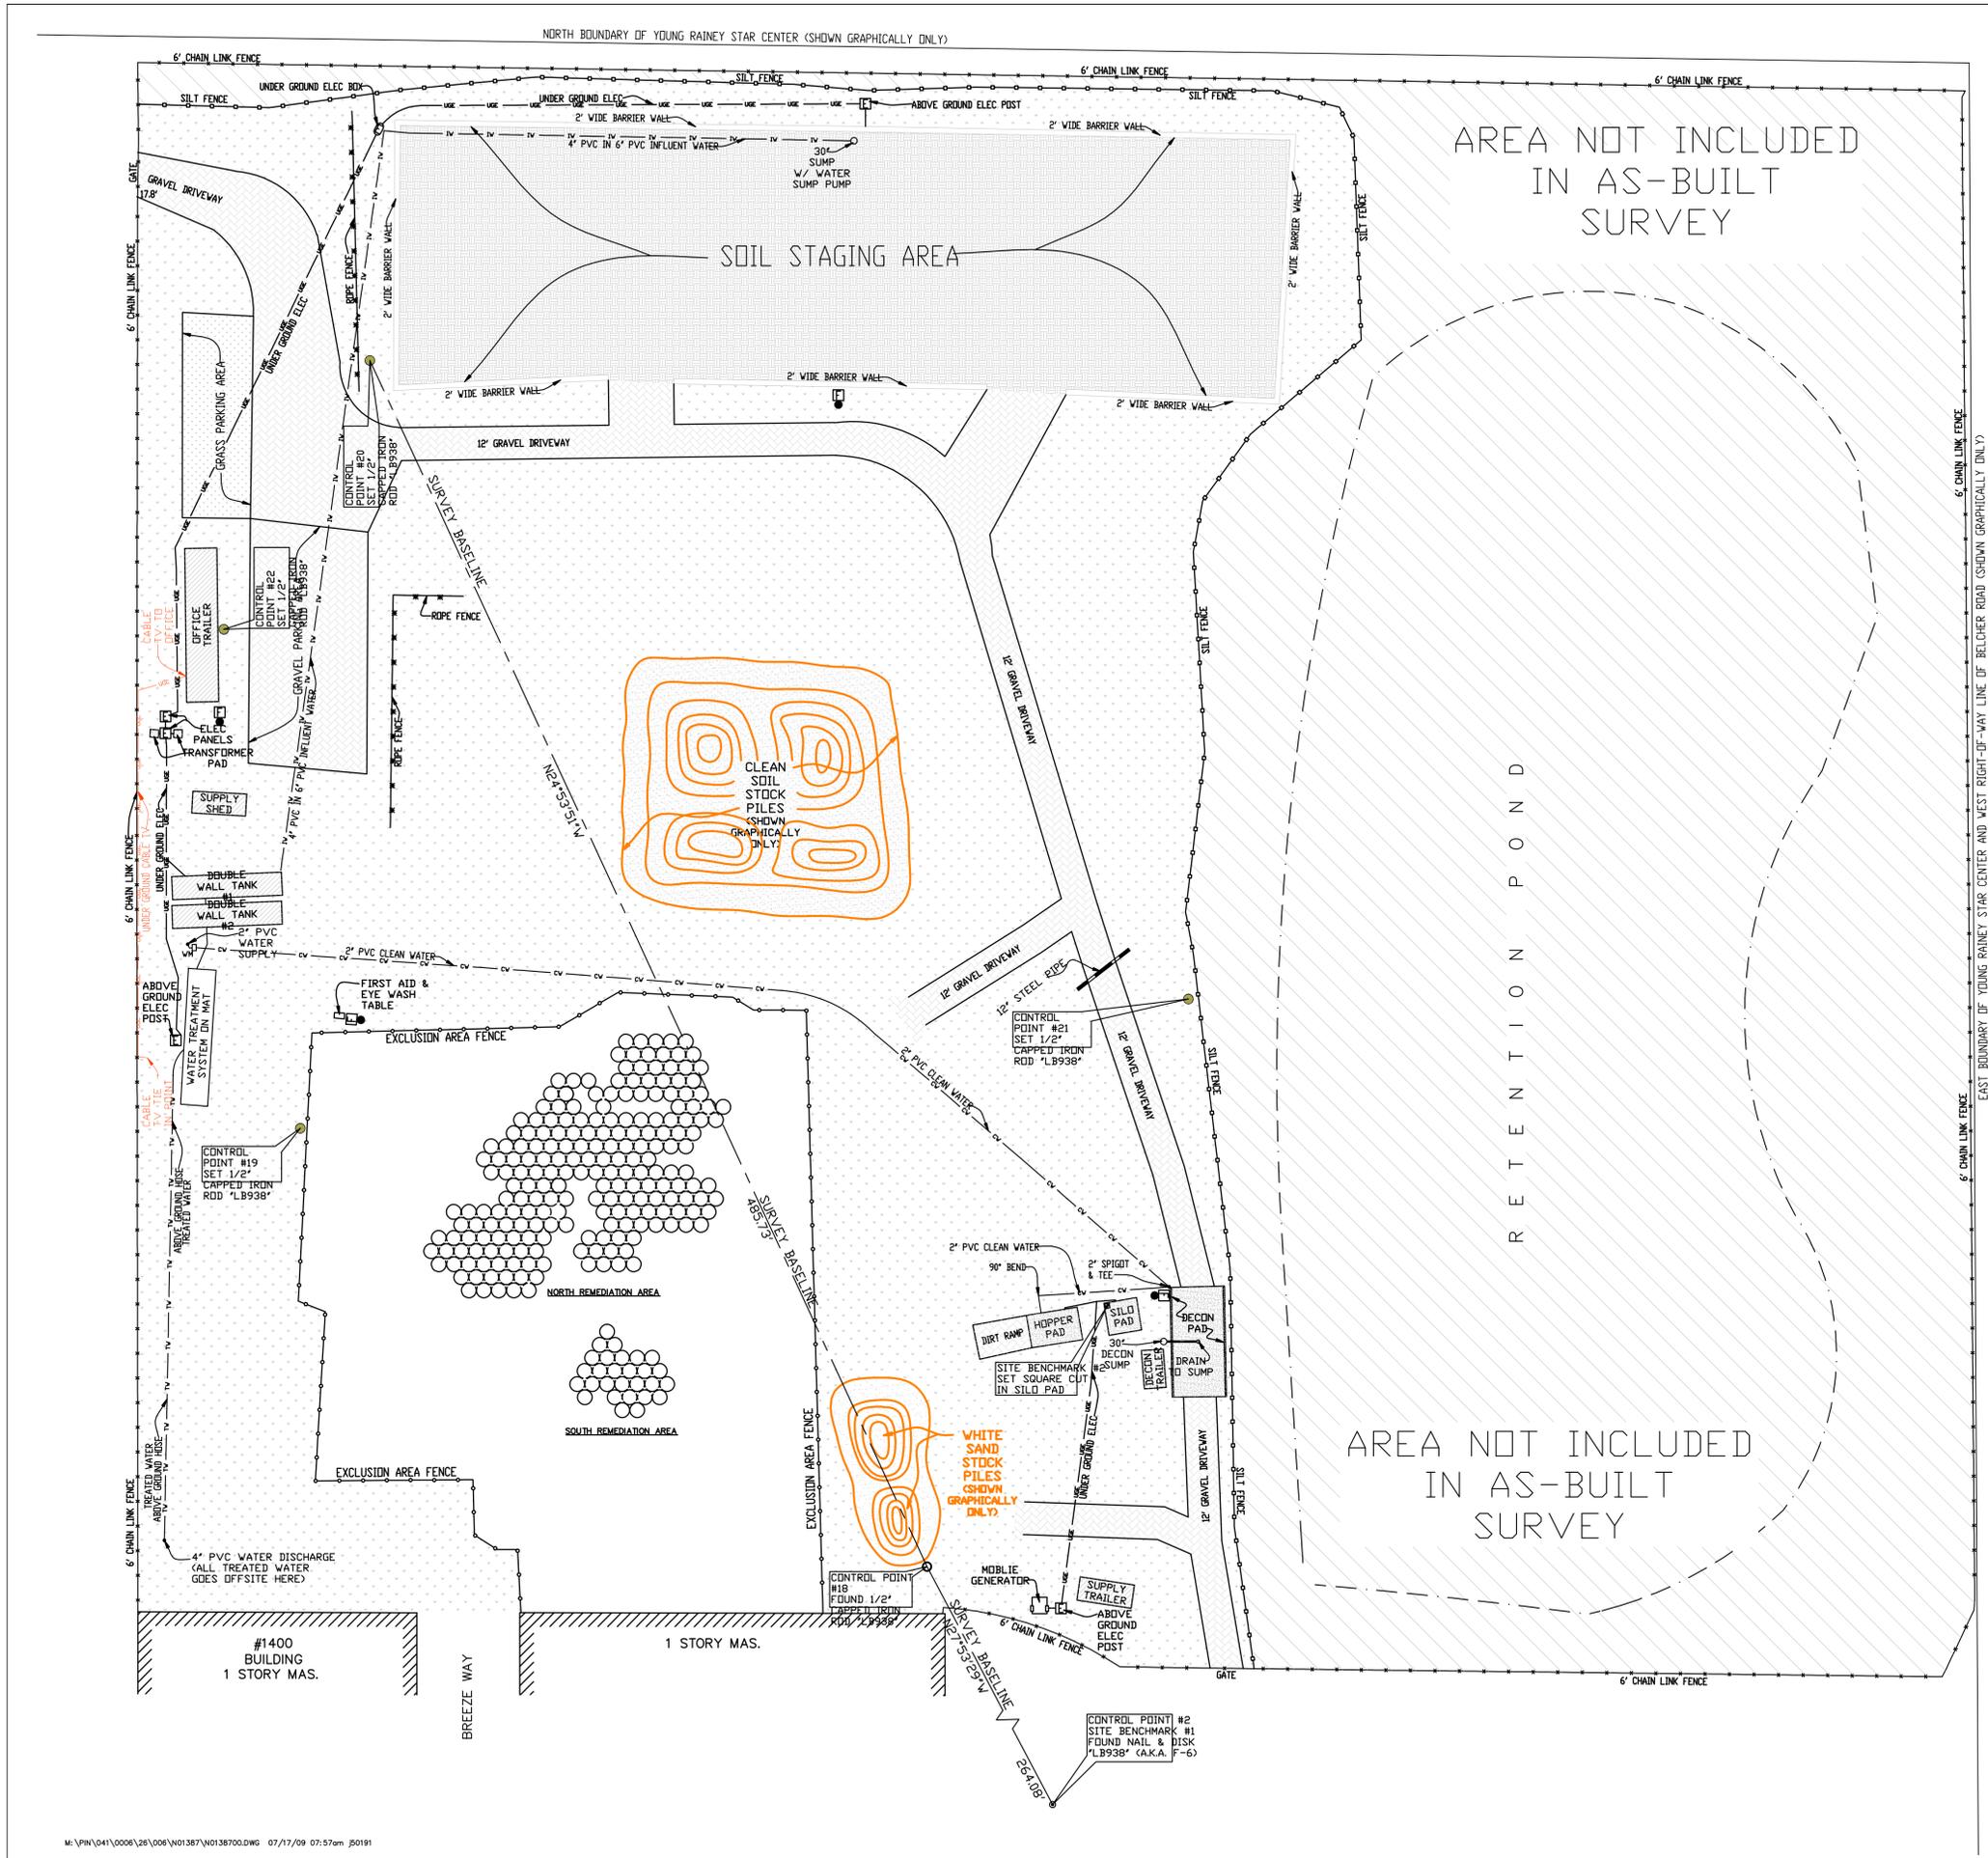
The site layout is shown on Plate 2. Northeast Site ingress/egress occurred using both the southeast and northwest gates. However, only truck material deliveries and disposal trucks were allowed through the southeast entrance. The northwest entrance was limited to employees, normal deliveries, and visitors.

A decontamination area was established close to the southeast entrance of the Northeast Site. Decontamination pads were constructed of a minimum 3,000-psi strength concrete reinforced with fiber and welded wire mesh. The pad was 20 ft by 40 ft and 6 inches thick with curbs along each length. The pad was sloped to a central catch basin that contained a submersible pump. The pump's discharge hose was routed through a conduit and discharged into a 200-gallon tank. A decontamination trailer equipped with lockers and showers was stationed next to the decontamination pad. Accumulated water was processed through the on-site water treatment systems.

As required by the Pinellas County Building and Development Department, WRS submitted an engineered site plan. The site plan included a single-wide office trailer and a crew trailer located along the west boundary of the site; a water treatment system that included two 21,000-gallon steel frac tanks, sand filters, and an air stripper located along the west boundary of the site; the flowable fill batch plant, consisting of a silo, hopper, conveyor, and scale located at the southeast corner of the site; and soil stockpile pads located on the northern portion of the site.
