Overview of the First Quarter 2010 Surveillance and Maintenance Report for the LM Rocky Flats Site

Surface Water Monitoring and Operations

Pond Operations – First Quarter 2010

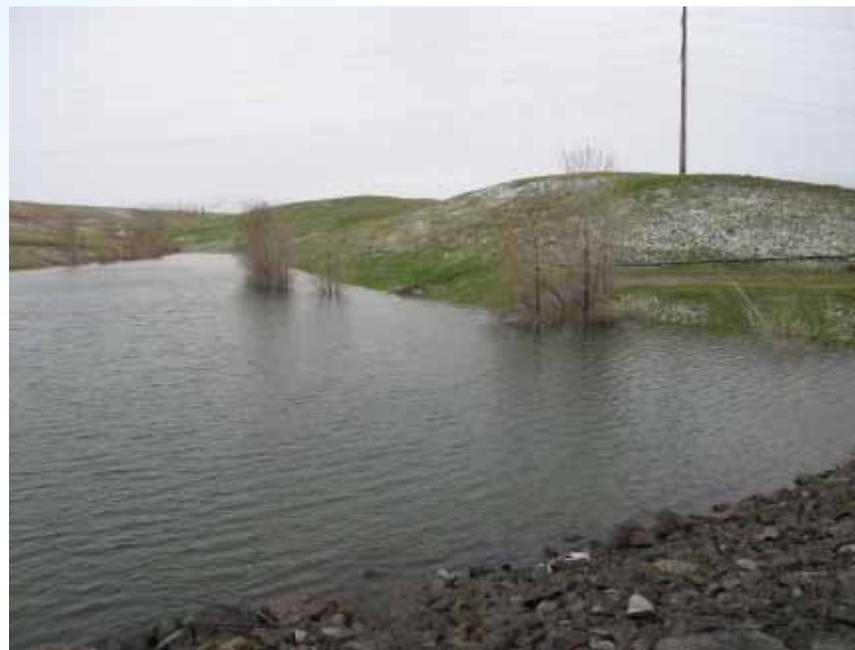
August 17, 2010, Pond Levels

- Landfill (20.9 percent)
- A-3 (2.6 percent)
- A-4 (28.3 percent)
- B-5 (24.3 percent)
- C-2 (3.9 percent)

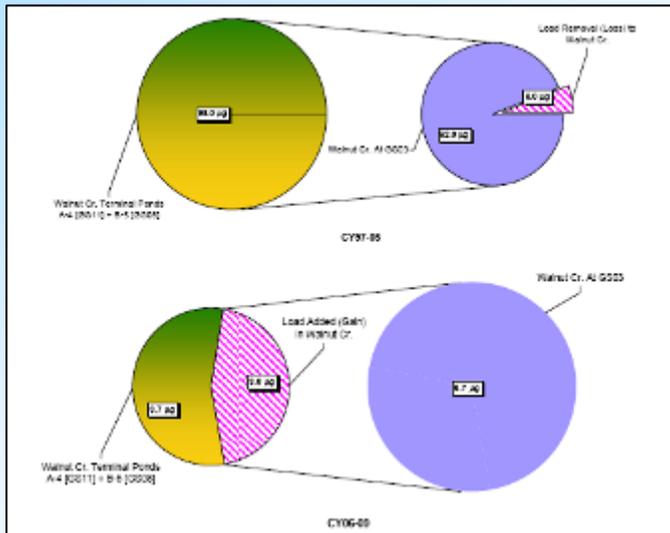
Figure 3-134. Relative Average Annual Pu Load Totals at GS03, GS08, and GS11

- Postclosure concentrations remain within historic variability and have decreased significantly
- Loading has decreased significantly
- Insignificant contribution to sediment concentrations

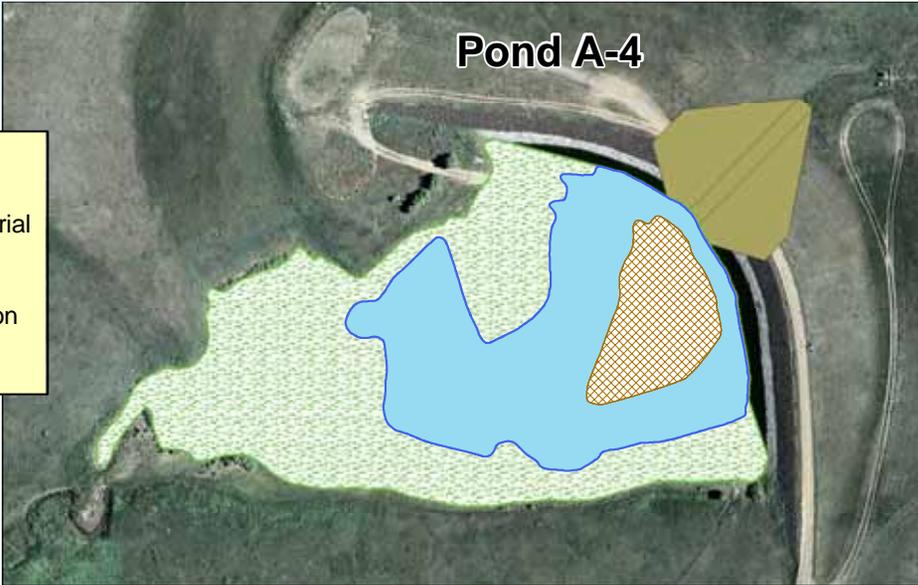
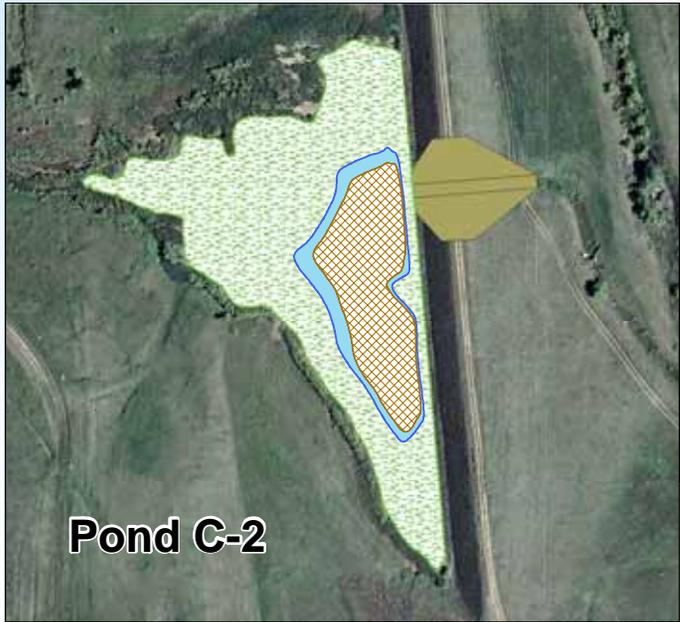
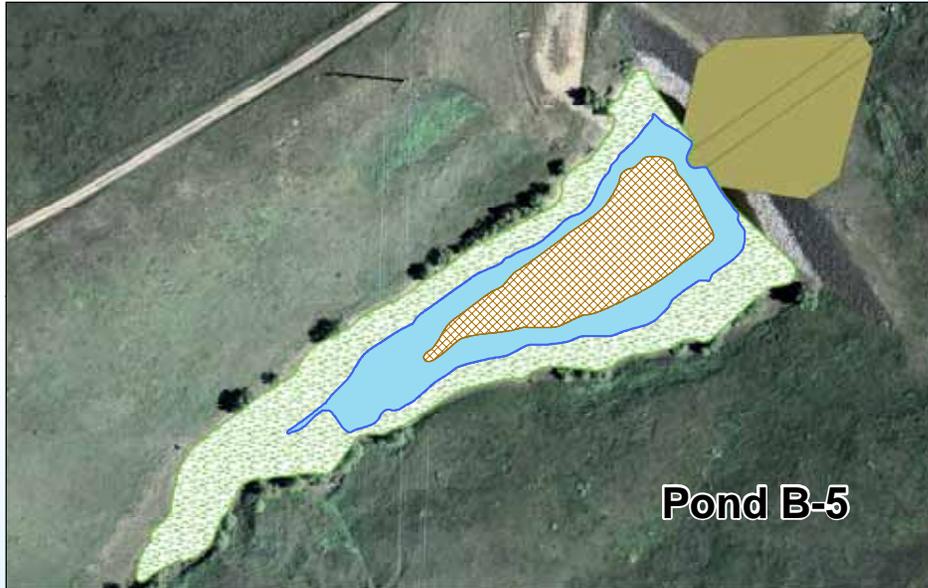
Conceptual Dam Breach Design

Pond Bottom Area to be Filled with Embankment Material
-

Pond Level During Flow Through Operation
-

Area to be Revegetated During Flow Through Operation
-

Breach Channel

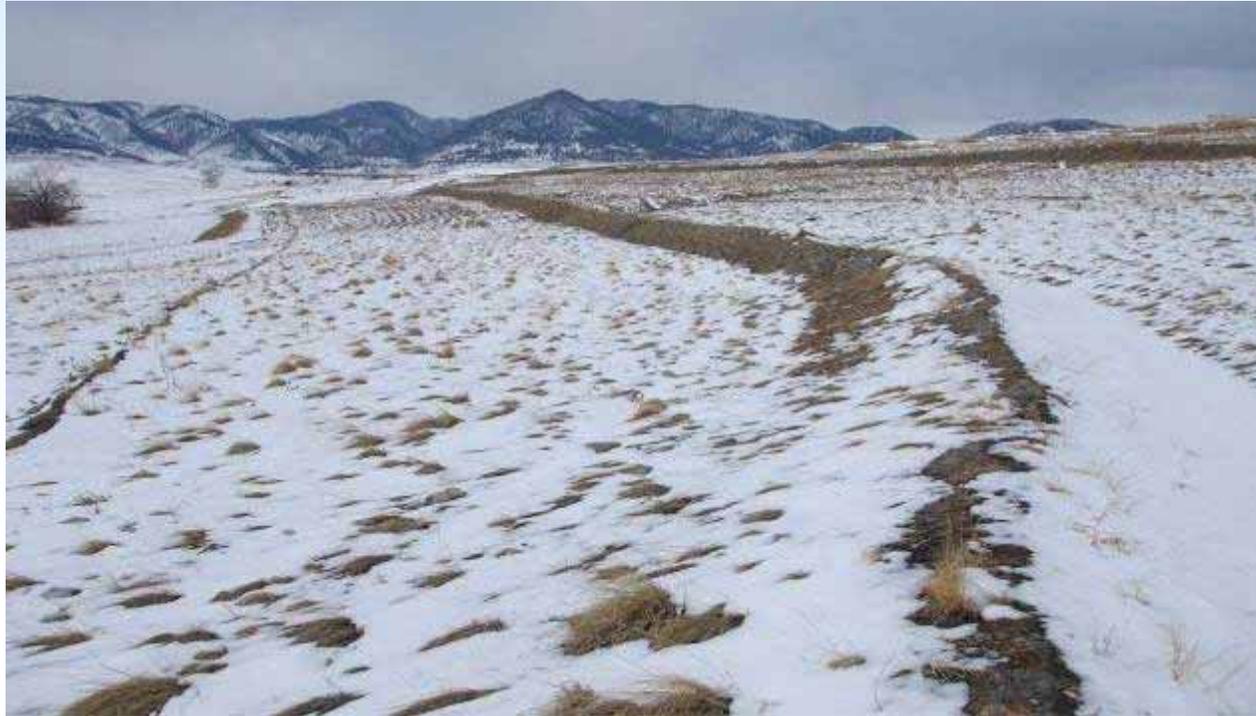
OLF Seeps

- Seep 4 had some surface expression, but did not show any surface flow; this is due to the rock drain that was installed in 2009
- Seep 8 flowed at a rate of 2 to 5 gpm throughout the first quarter
- The rock drain located at the base of the West Perimeter Channel was flowing at a rate of 0.5 gpm during the January inspection; flow increased to 2 to 4 gpm during the February and March inspections

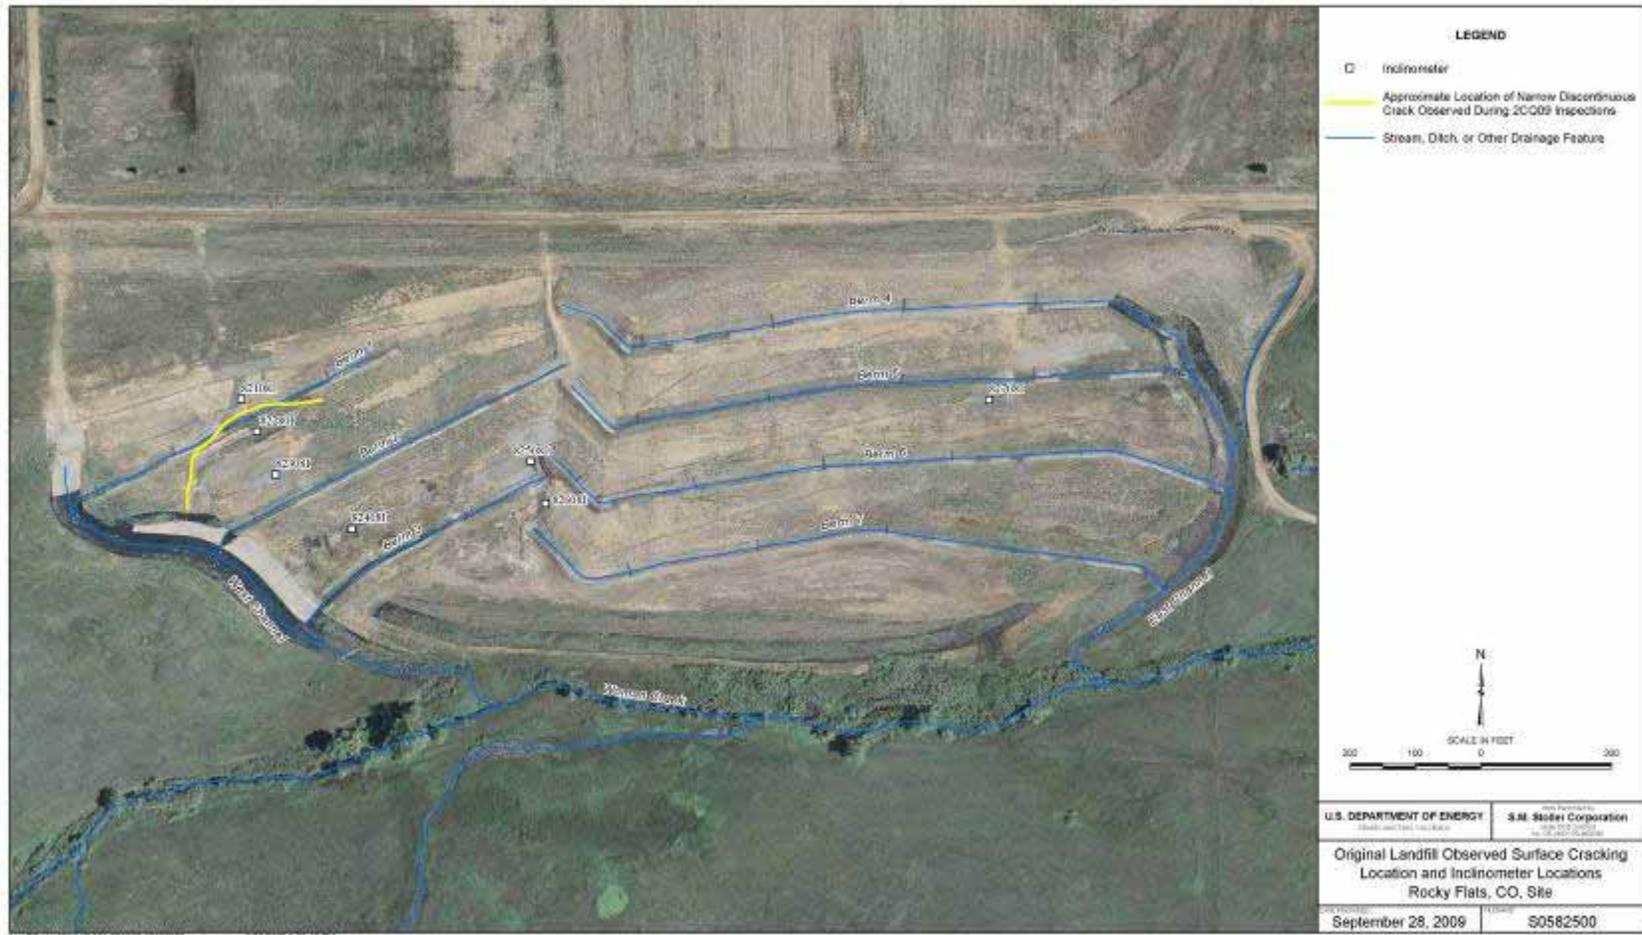
OLF Observed Crack Location

- A small hairline crack that ran through the top and south face of Berm 1 was noted on March 30; the crack was filled and compacted with Rocky Flats alluvium the same day
- The end of Berm 7 was observed as having slumped into the Eastern Perimeter Channel during the March 30 inspection; the area was too wet to perform any immediate repairs
- Berm 7 repair completed in June 2009

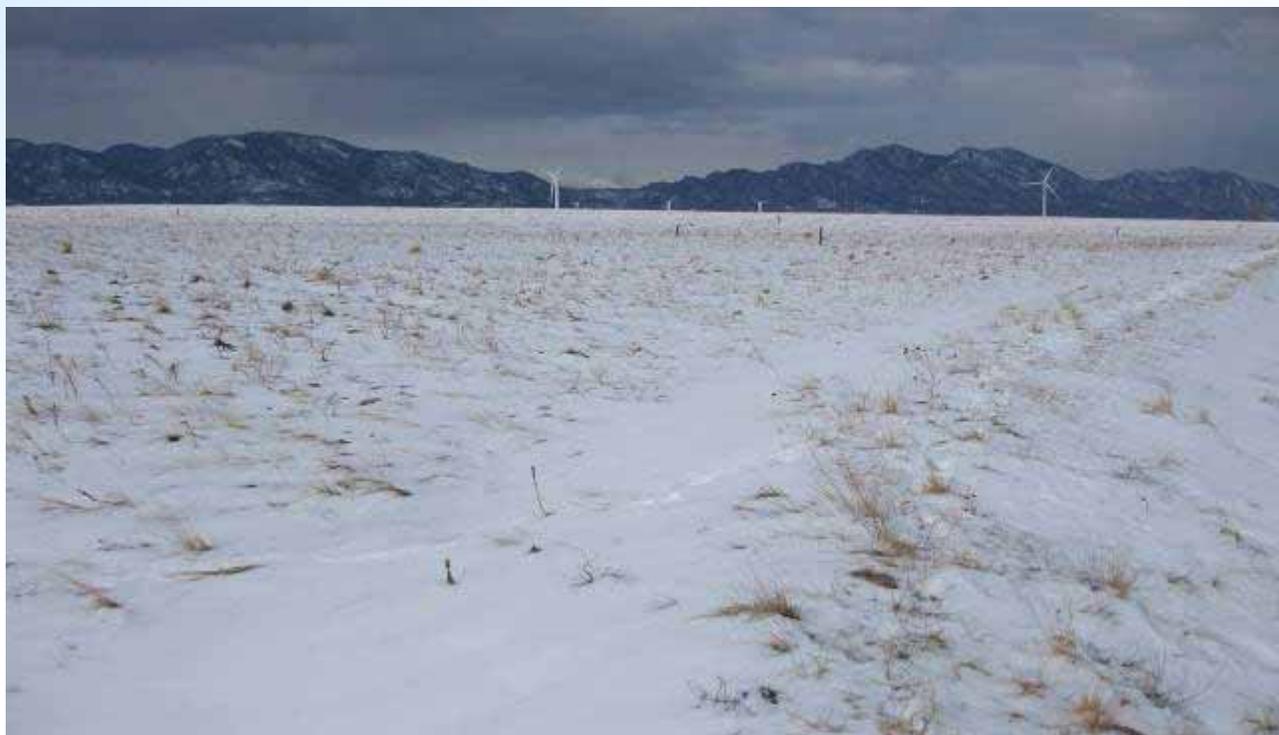
- The quarterly inspection was completed on February 25
- No areas of concern were observed
- The vegetation inspection was completed on February 17

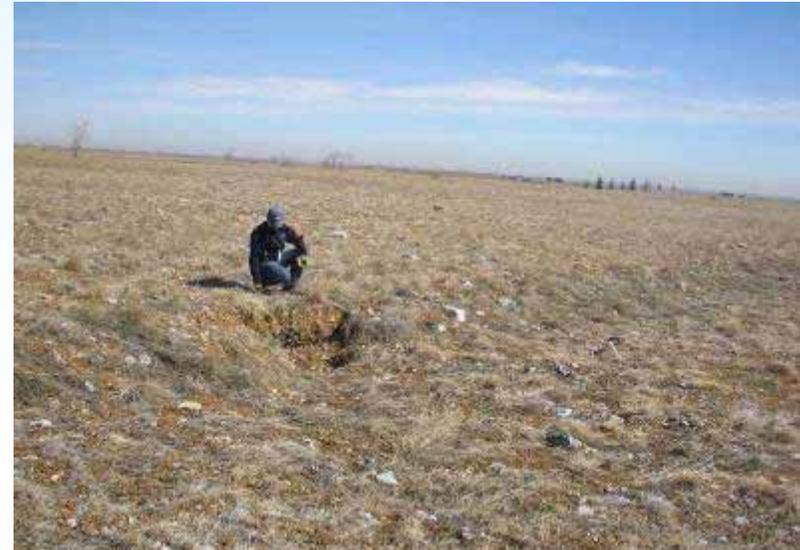
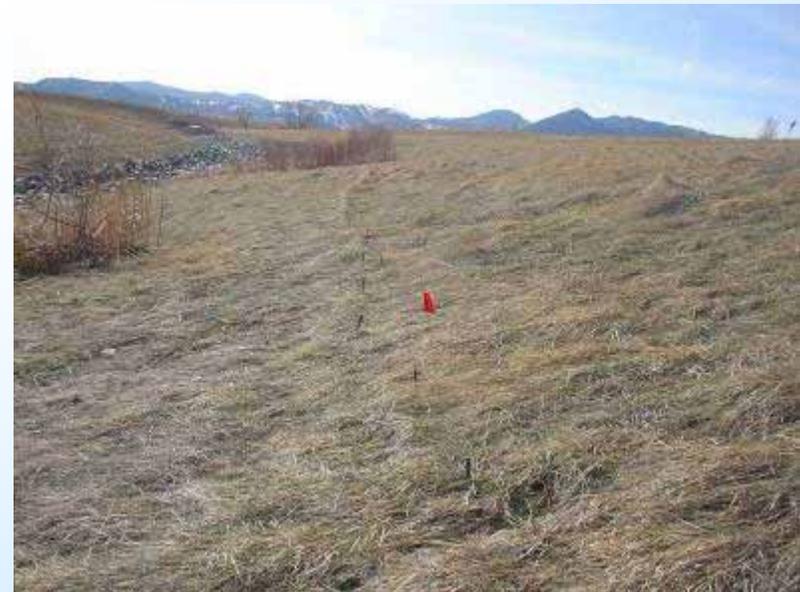
Annual Inspection

- No significant erosion noted – minor holes and surface debris
 - Very limited aerial extent – holes filled in
 - Debris and trash collected or flagged for pick up
- No adverse biological conditions noted
- No evidence of IC violations
- Signs in place
