### ***Technical Memorandum Regarding Instrumentation and Monitoring at the Rocky Flats OLF***

## Technical Memorandum

<b>To:</b>	Mr. Rick DiSalvo	<b>From:</b>	Lance Heyer, EI Thomas A. Chapel, PE
<b>Company:</b>	S. M. Stoller Corporation	<b>Date:</b>	March 30, 2012
<b>Re:</b>	Instrumentation and Monitoring, Rocky Flats OLF	<b>Tt Project #:</b>	114-181750

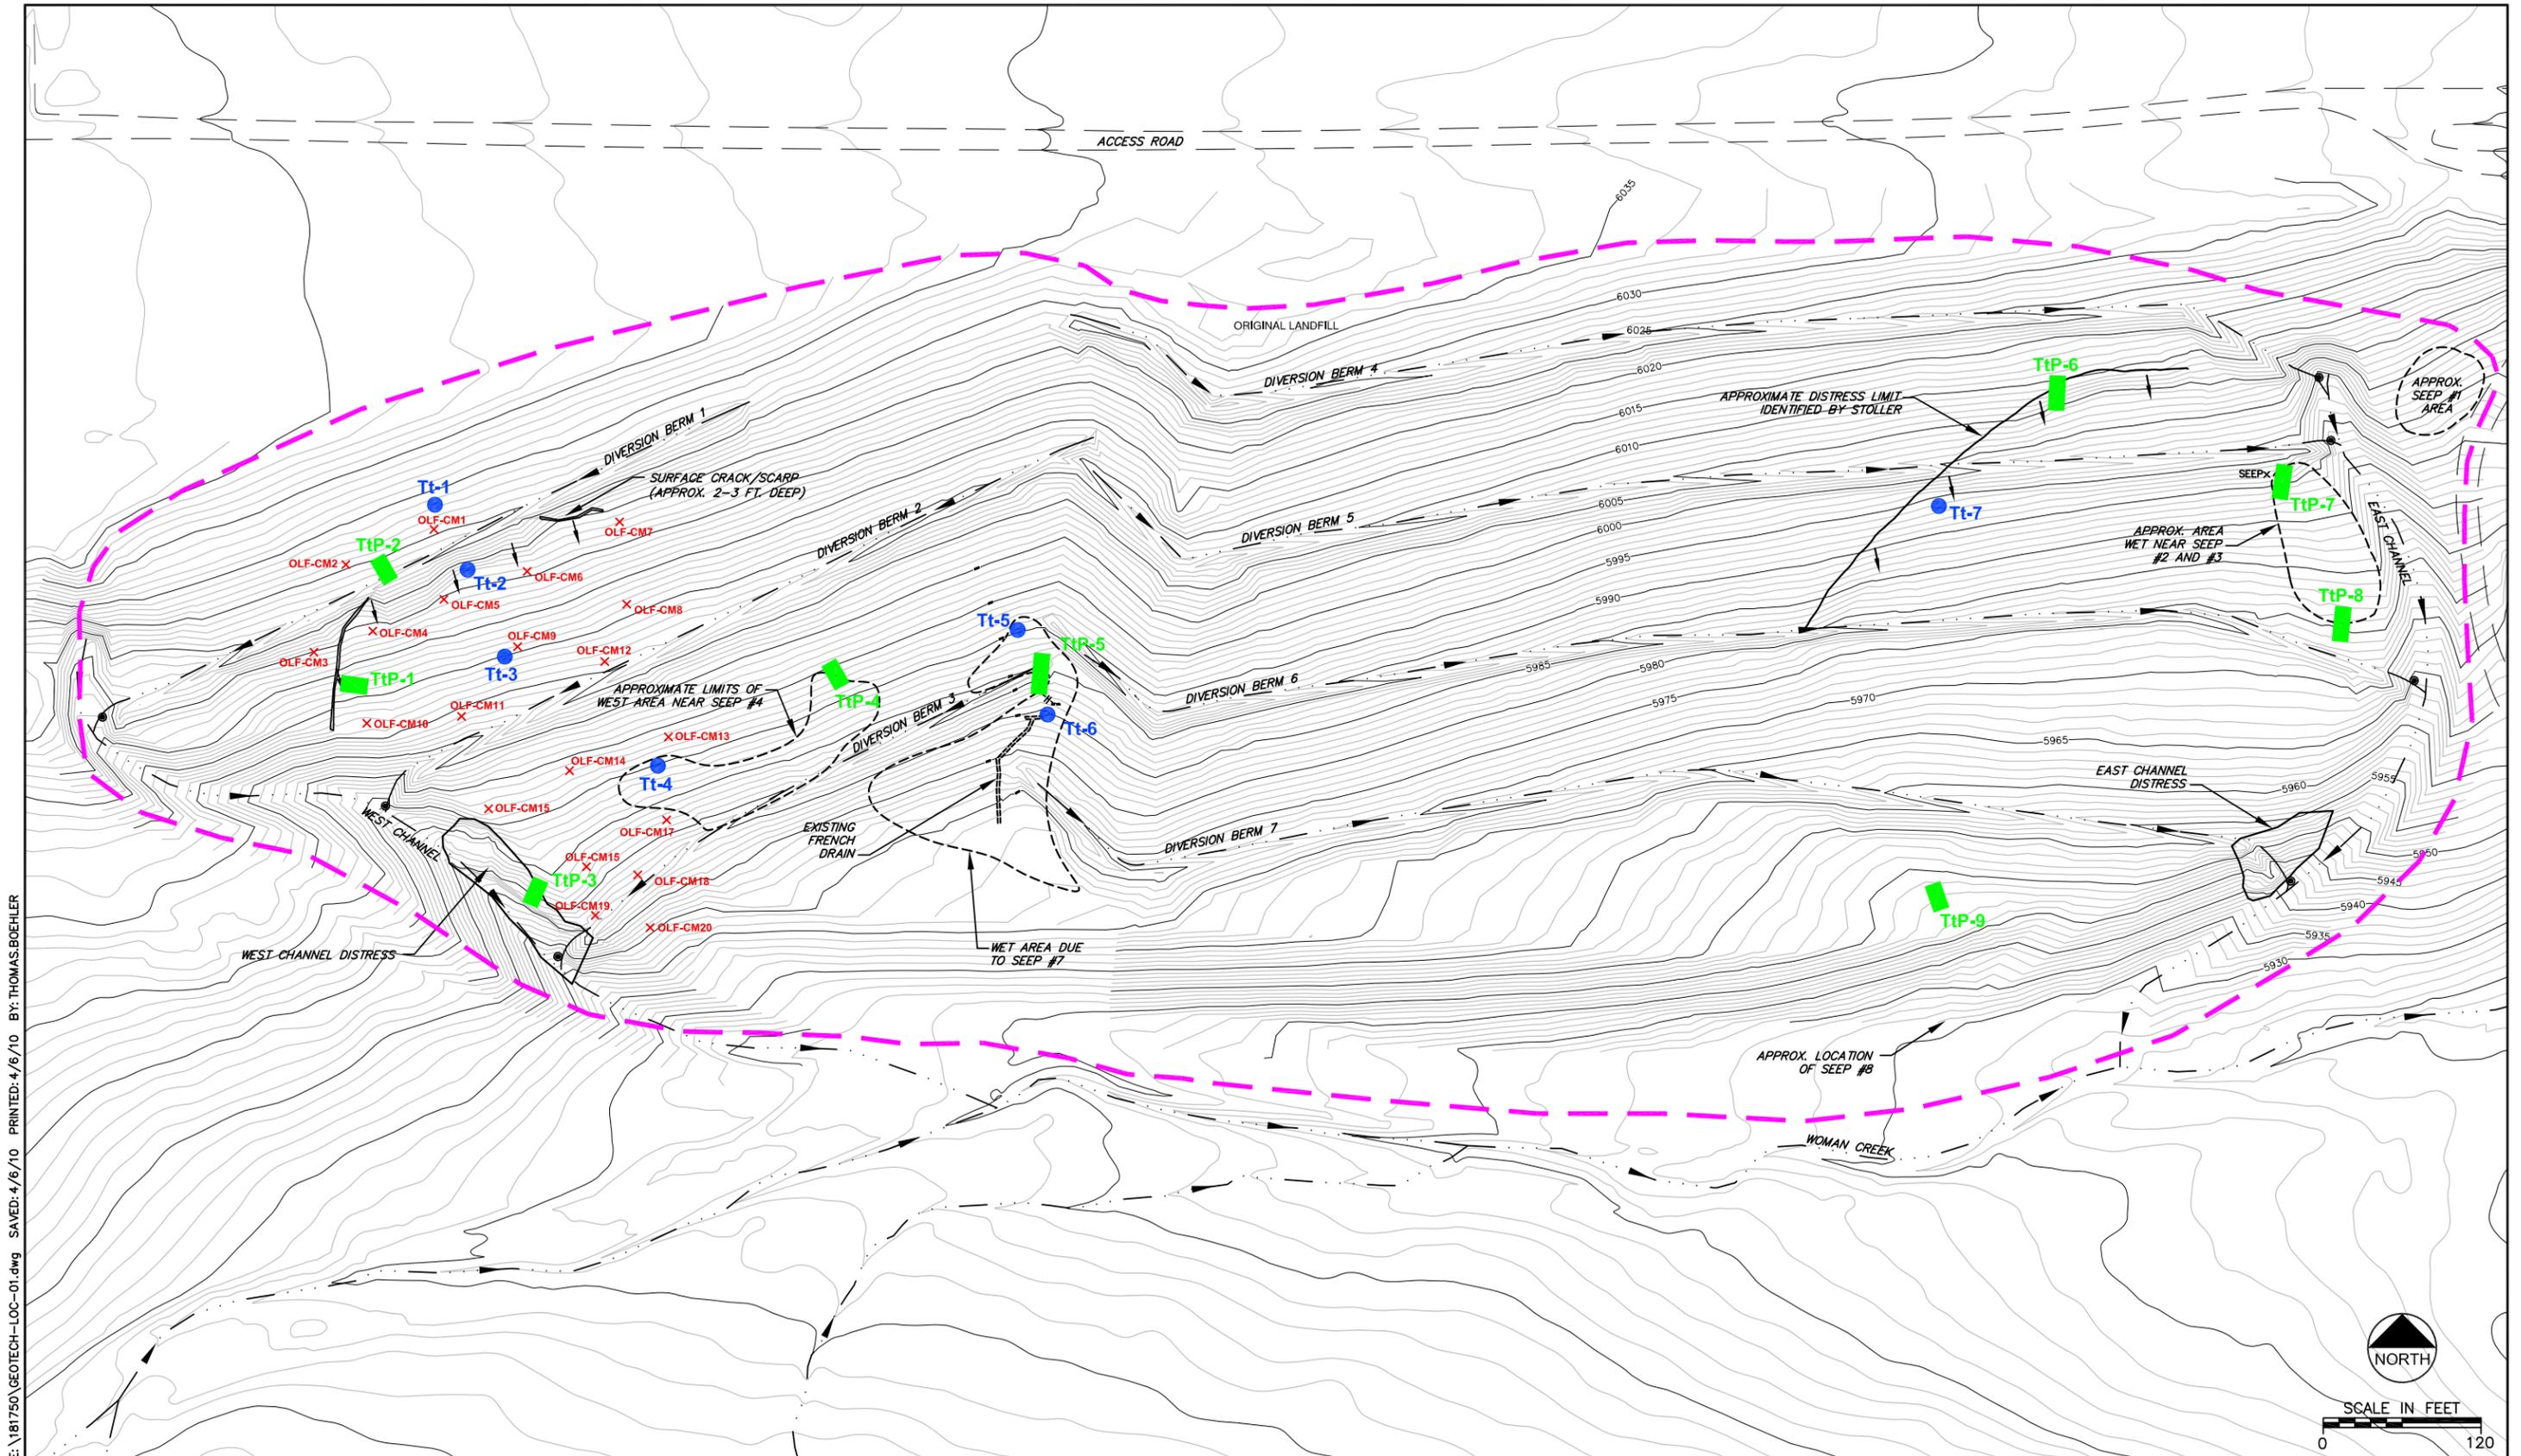
**Figure 1**  
**Plan View of OLF Site**

Minor localized surface cracking, differential settlement, slumping and subsidence has been previously documented at the site, and similar minor distress may have continued during 2011, albeit to a lesser extent. Figure 1, Plan View of OLF Site, shows the locations of the localized cracking, slumping and settling, seeps, test pits for the 2008 geotechnical investigation and the inclinometers. A summary of performance of the instruments prior to this reporting is provided in the following sections for clarity.

The Location of each borehole instrumented with piezometers and inclinometers is shown on Figure 1. The specifics of each borehole/piezometer/inclinometer are discussed below when significant changes occurred during the reporting interval. A lack of comment on a particular time interval indicates that the performance of the instrumentation during the intervening period was not interpreted as being significant, or was reported during a previous interval. Graphs showing the water levels measured by piezometers and movement of each axis of the inclinometers are shown in Attachment A. In cases where unusually erratic and/or widely variable piezometer data resulted in a difficult to read graph, some of the data points were removed from the graphs to improve clarity. For completeness, data without these points removed are also presented in Attachment C.

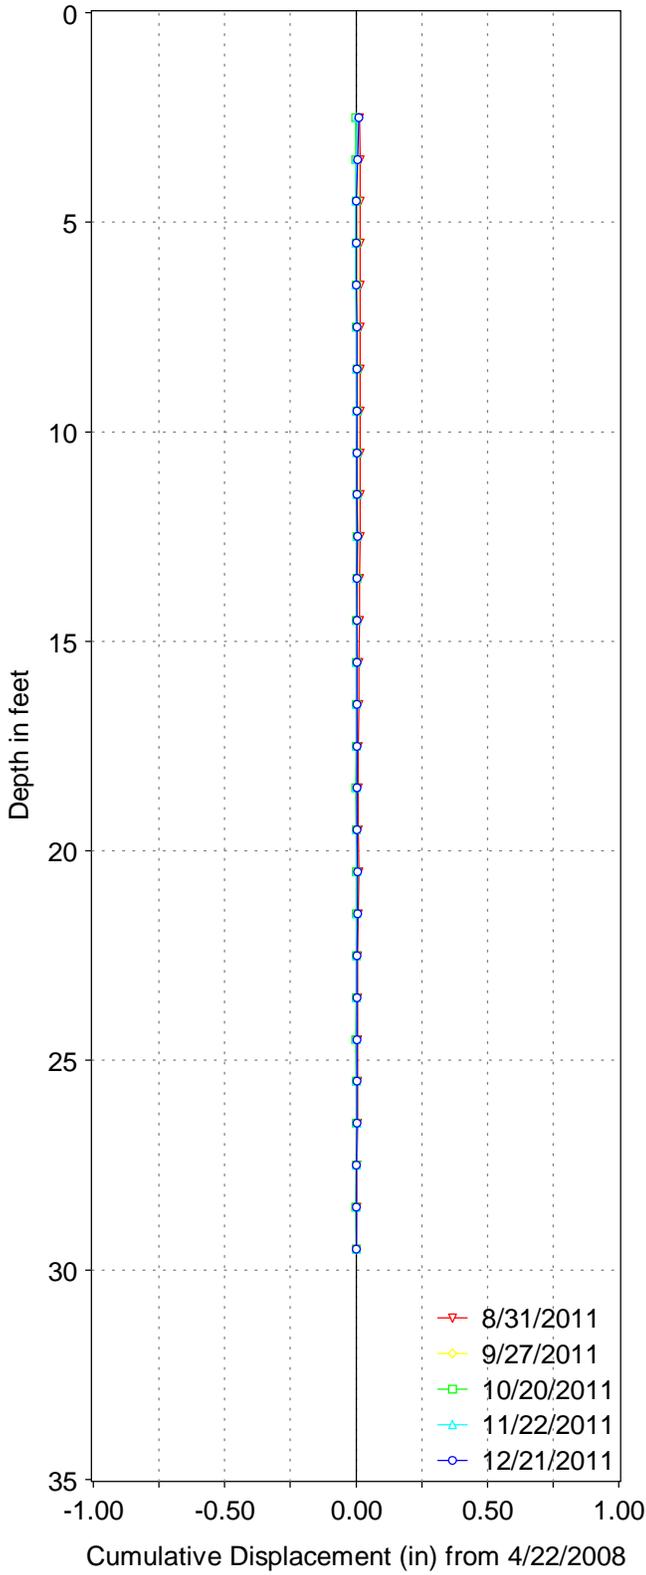
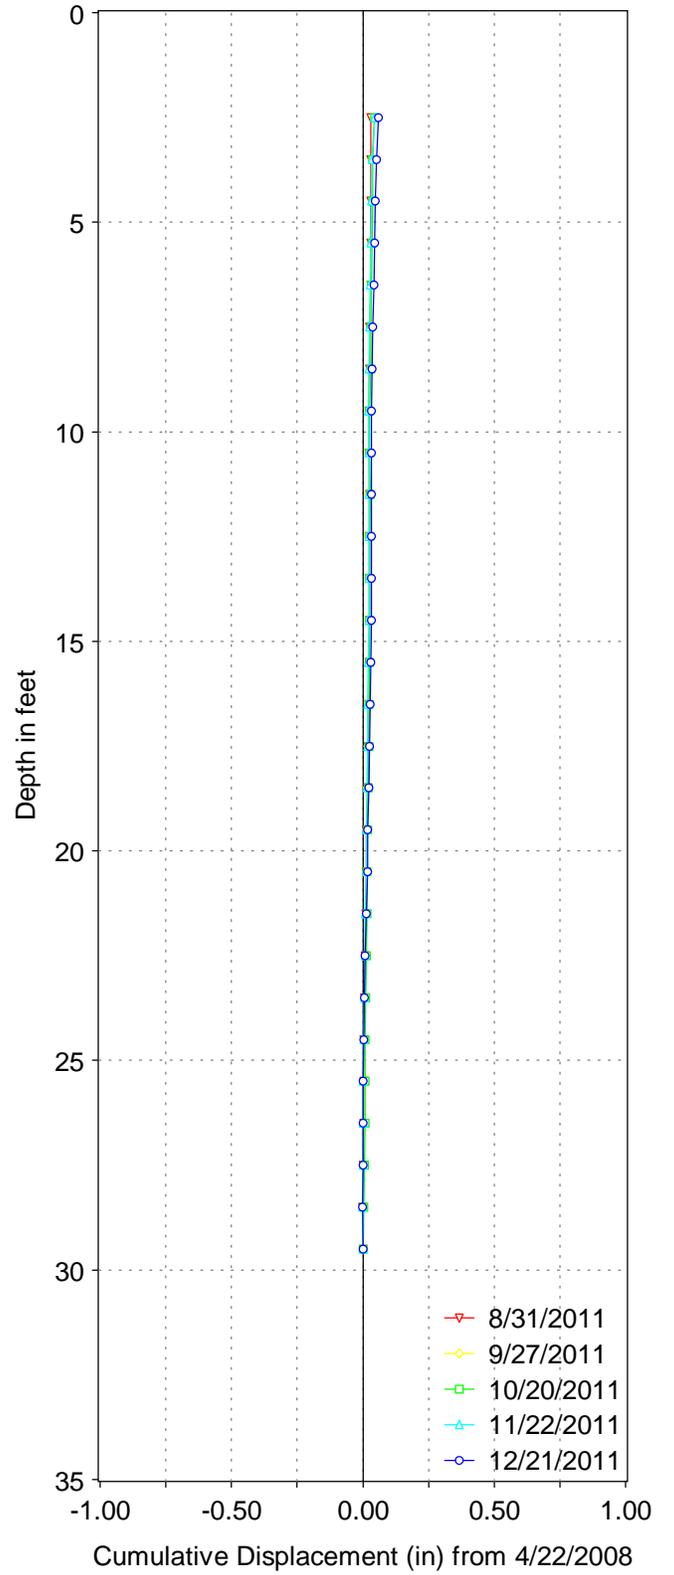
Borehole Tt-1

Bad Data: 8/30/10, 9/9/10, 9/30/10, 1/26/11, 6/30/11

Tt-1. Tt-1 was intentionally placed outside of the historical slide area. As was noted in the 2010 Technical Memorandum, there does not appear to be a relationship between piezometer readings and inclinometer readings for Tt-1. The inclusion of the 2011 data continues to support this conclusion. There is a very small increase in movement in the direction of the B-axis of the inclinometer.

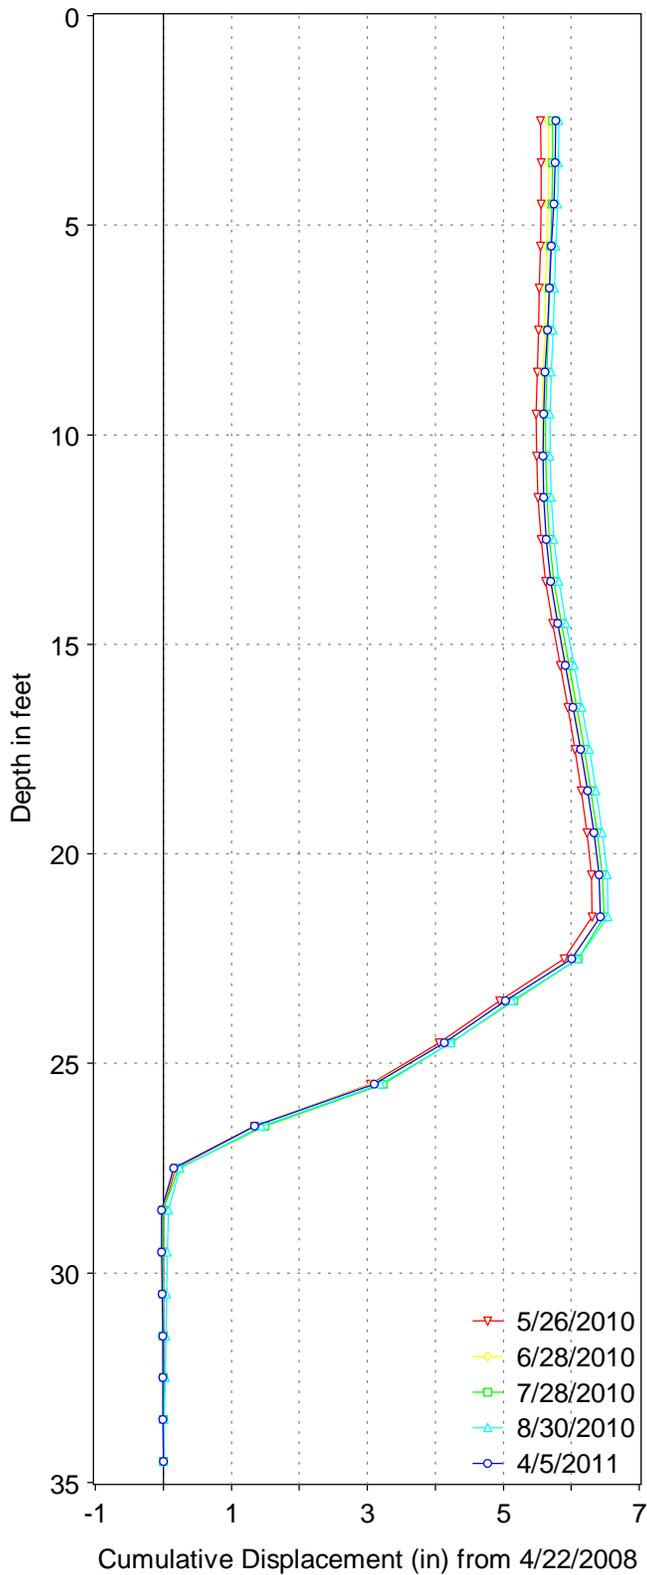
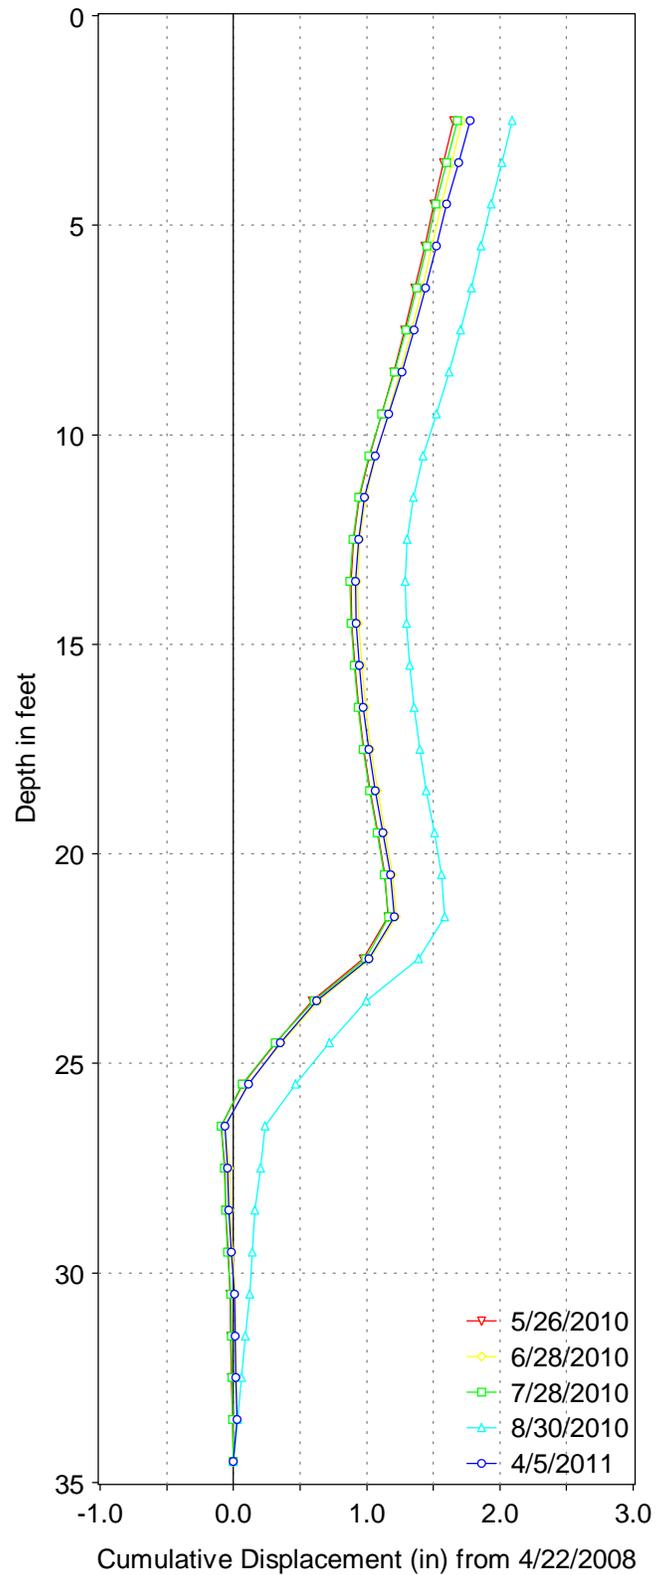
Borehole Tt-2

Initial depth 34ft; could not consistently read to 34ft after 8/19/09

Bad Data: 9/30/10, 10/28/10, 11/18/10

Inclinometer Tt-2 was installed to a depth of 34 feet. Sometime after the August 19, 2009 reading, slope movement resulted in inclinometer tube deformation or breakage and the inclinometer could not be read below a depth of 25 feet. Therefore, subsequent readings have been taken to a depth of 25 feet.

Tt-2. The inclinometer readings for Tt-2 showed movements starting in May 2008 and continuing to 1.4 inches on the A-axis on July 22, 2009. This followed a spike in the high water level on 6/12/09. Readings for both A and B-axes show total movement to date of 2.7 inches on the A-axis and 1.8 inches on the B-axis. Little movement occurred between 4/26/2011 and 12/21/2011.

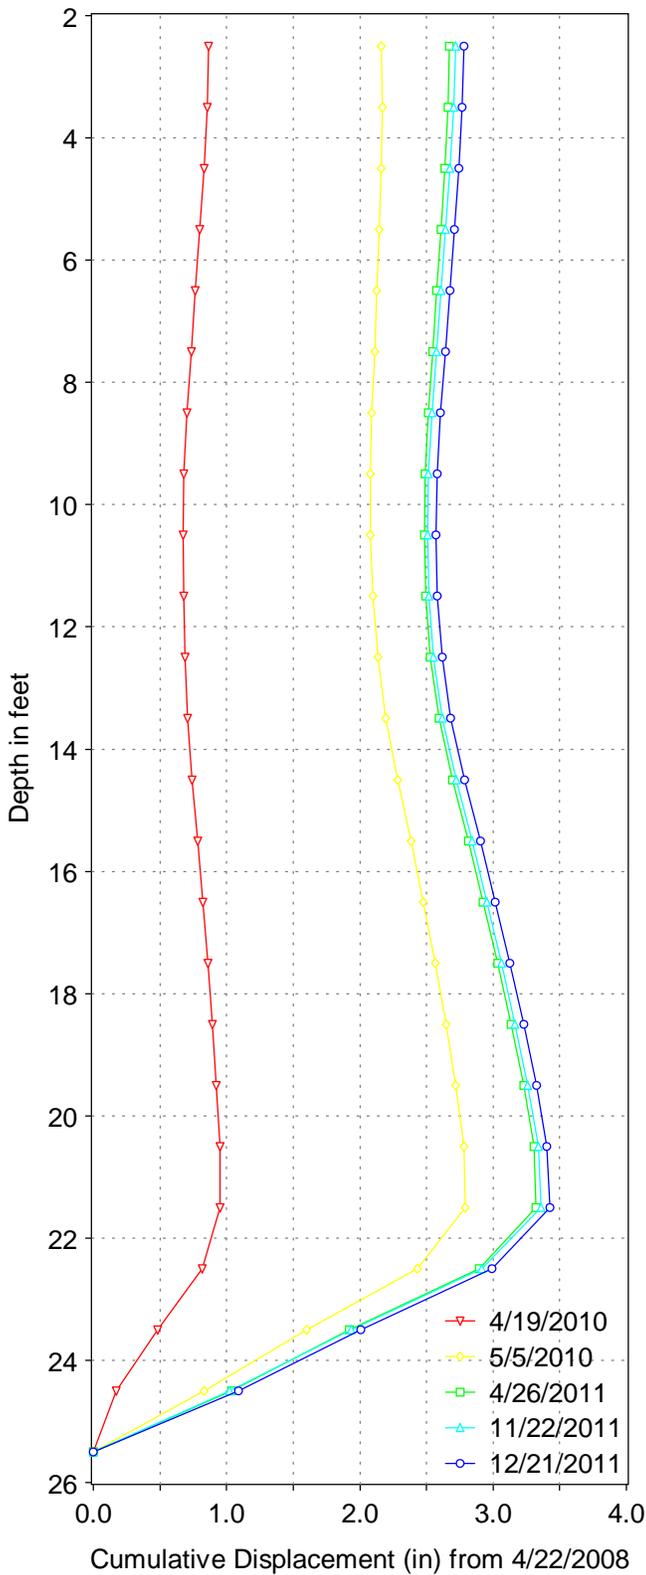
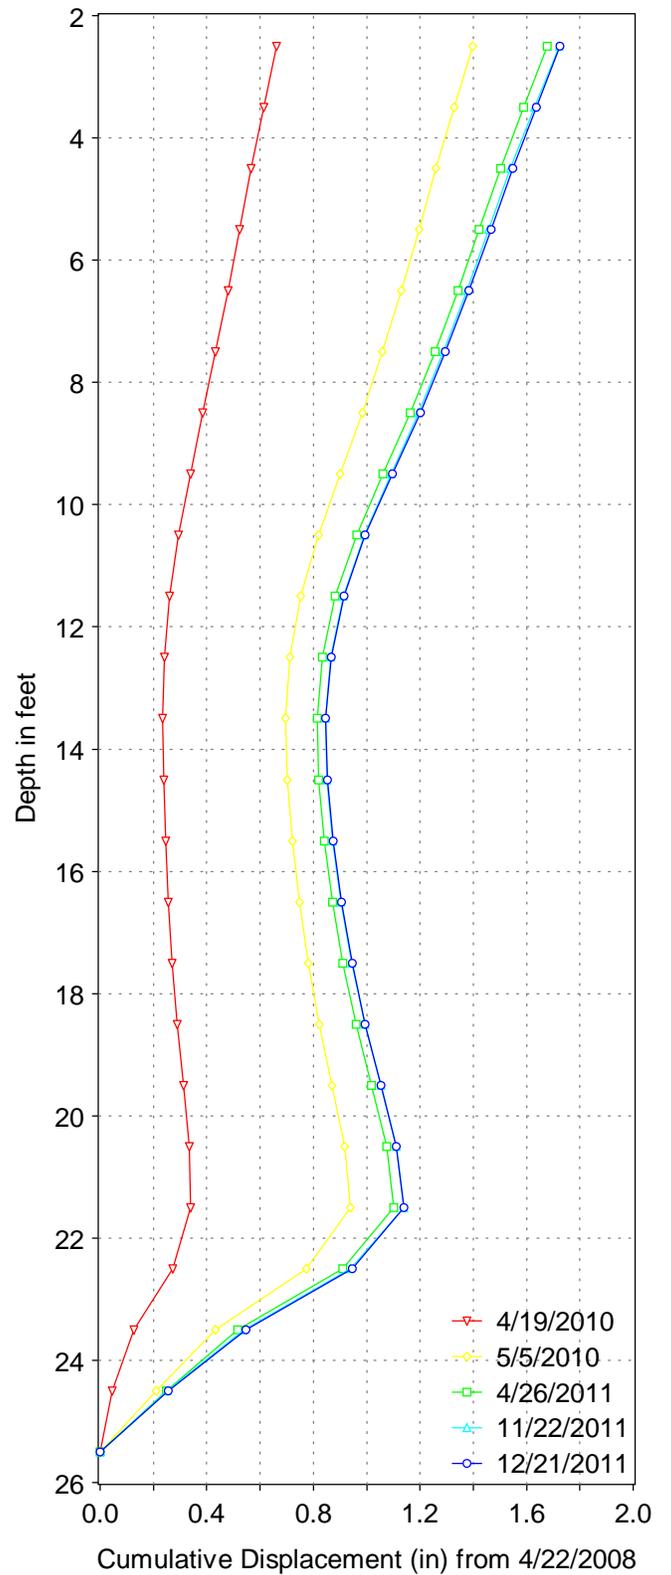
Borehole Tt-2

initial depth 34ft; this plot shows readings to 25ft

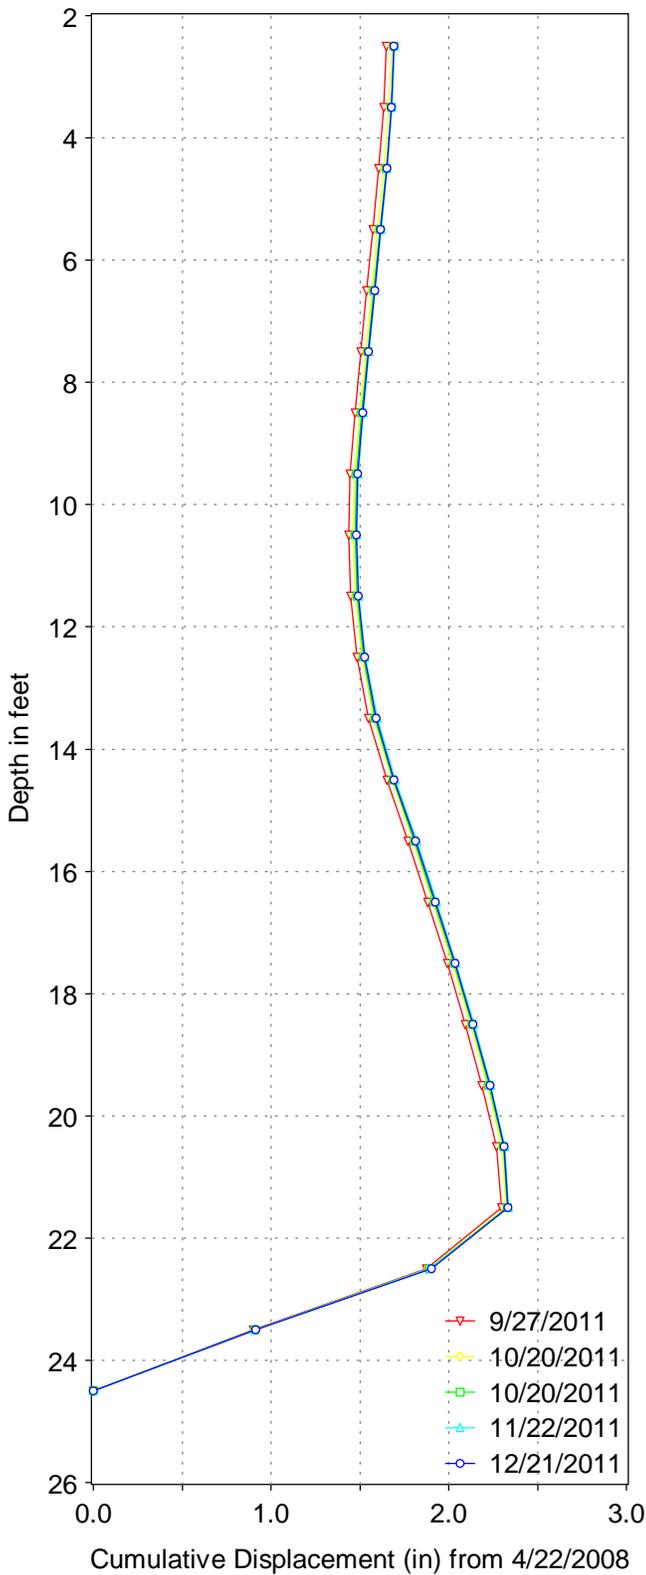
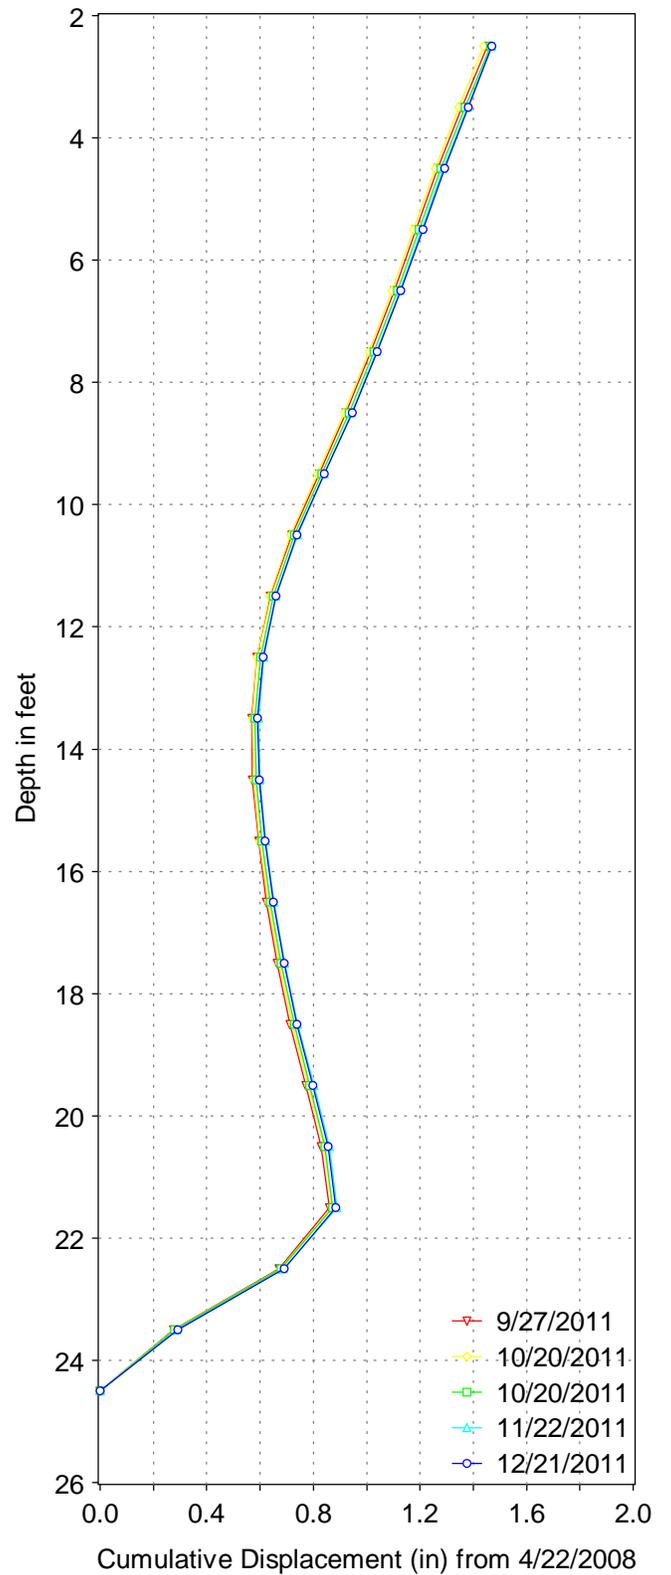
Borehole Tt-2

Initial depth 34ft; this plot shows readings to 24ft

Bad Data: 9/30/10, 10/28/10, 11/18/10, 1/26/11

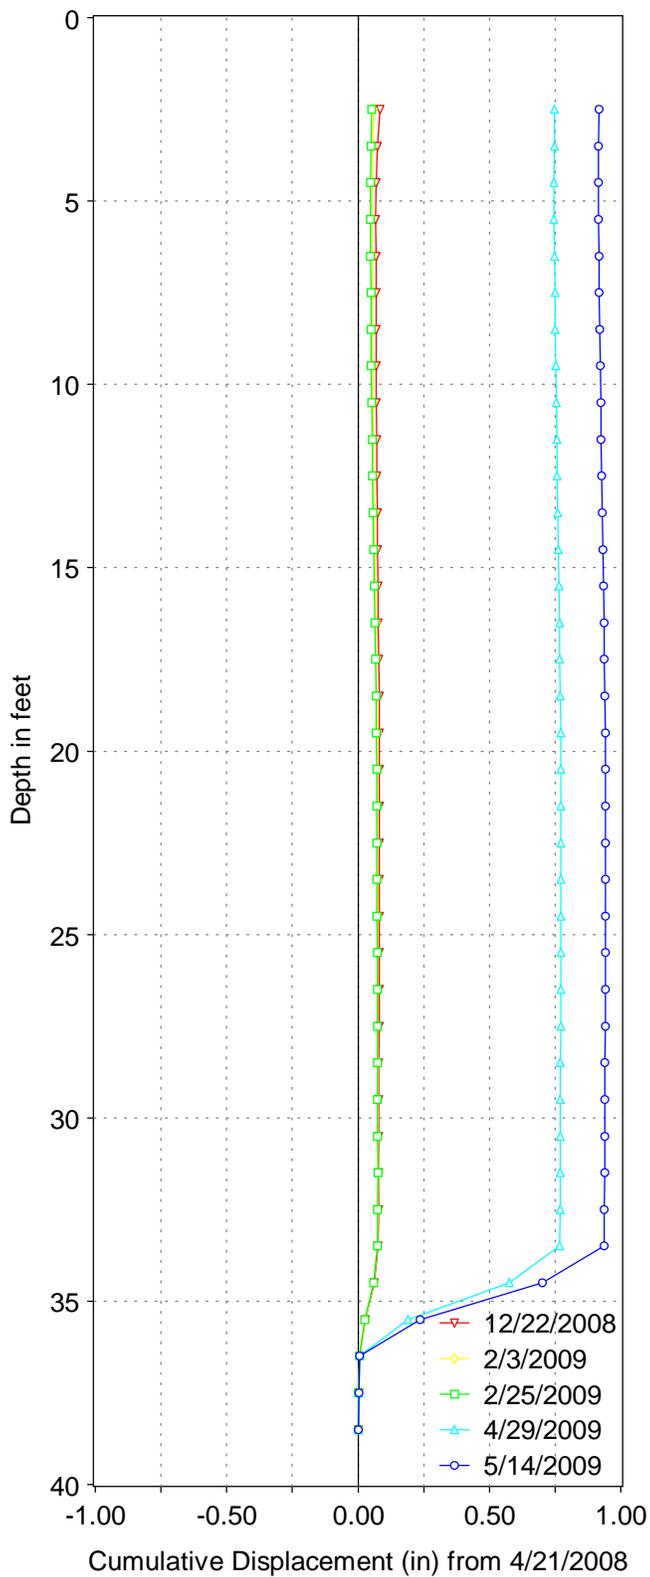
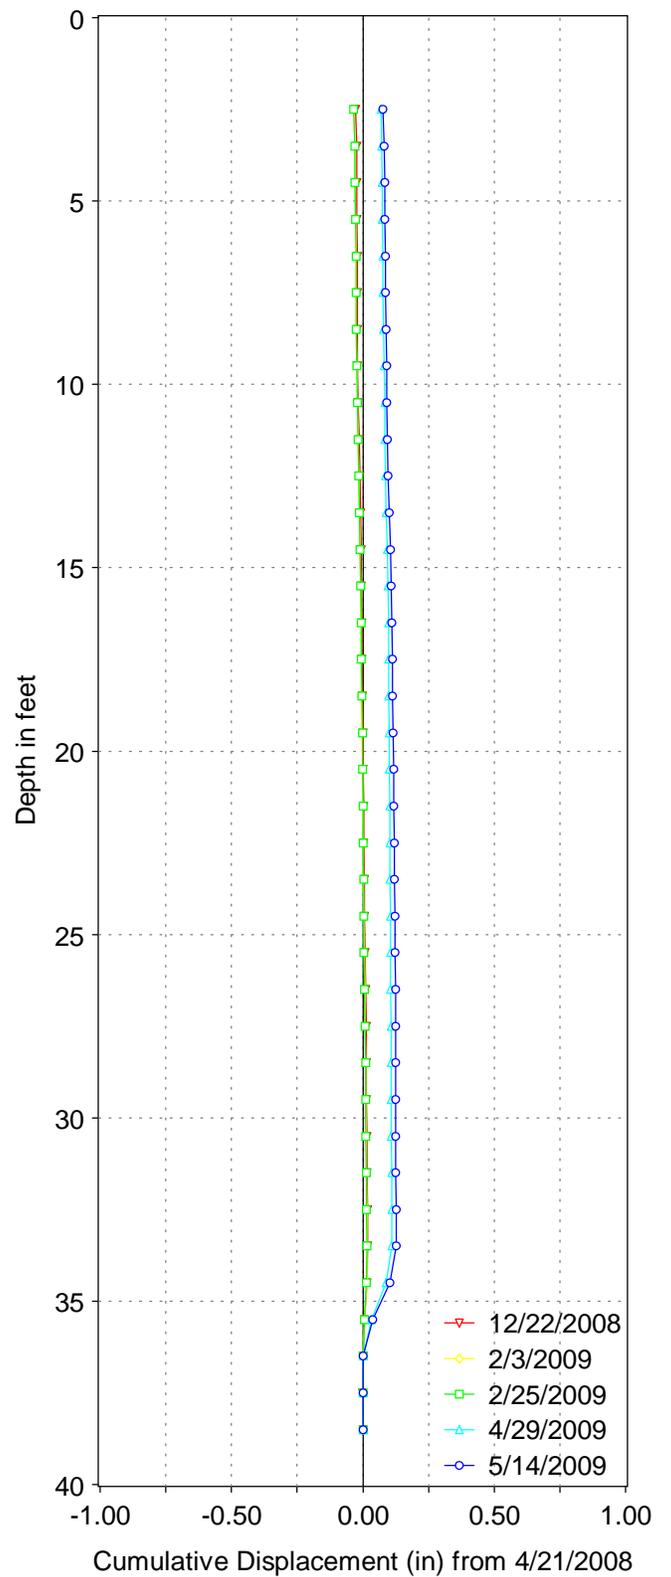
Borehole Tt-3

Initial depth 38ft; could not read past 33ft after 5/14/09

Inclinometer Tt-3 was installed to a depth of 38 feet. Slope movement at this location also resulted in inclinometer tube deformation or breakage, and the inclinometer could not be read below a depth of 33 feet. Therefore, subsequent readings have been taken to a depth of 33 feet.

Tt-3. The piezometer data collected in 2010 is erroneous and indicates that the piezometer in Tt-3 is no longer functioning. The inclinometer data show that negligible movement occurred between 8/31/2011 and 12/21/2011.

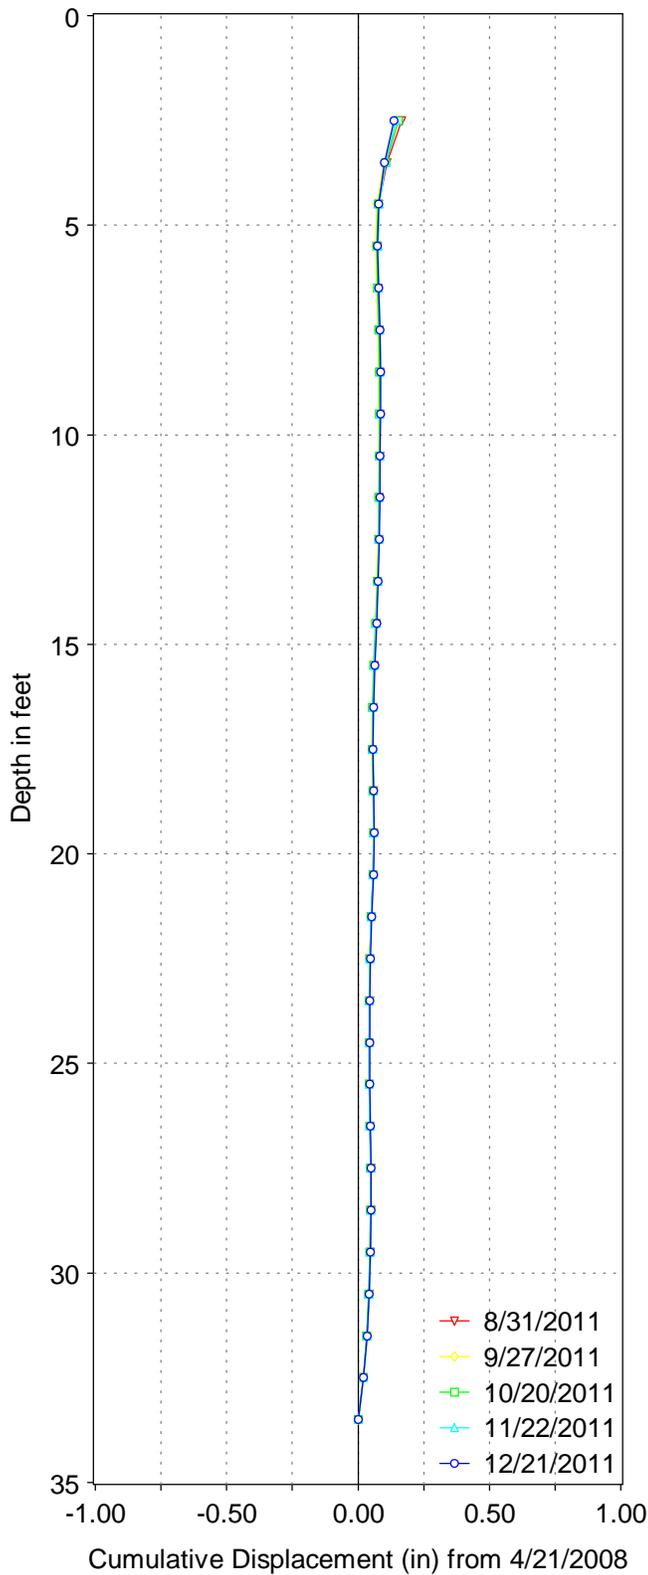
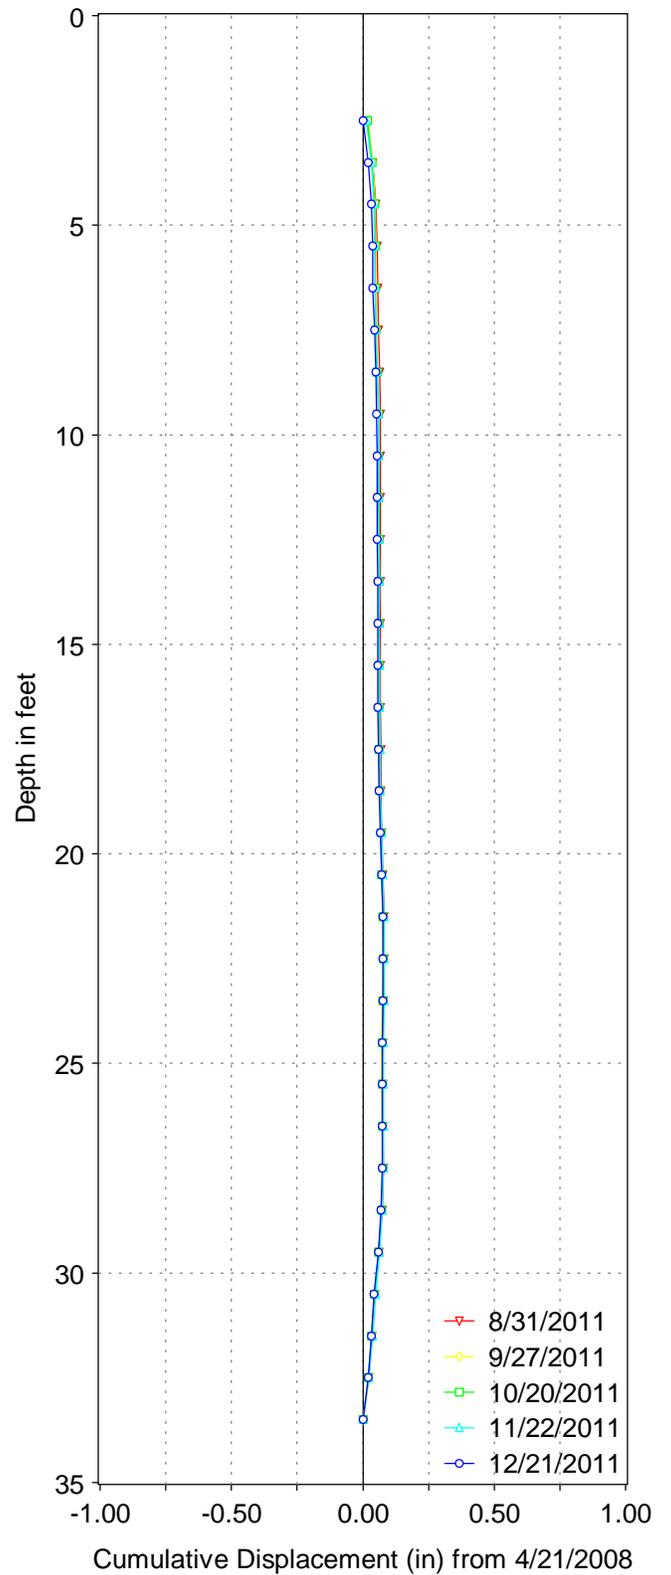
Borehole Tt-3

Initial depth 38ft; could not read past 33ft after 5/14/09

Bad Data: 8/30/10, 9/9/10, 9/30/10

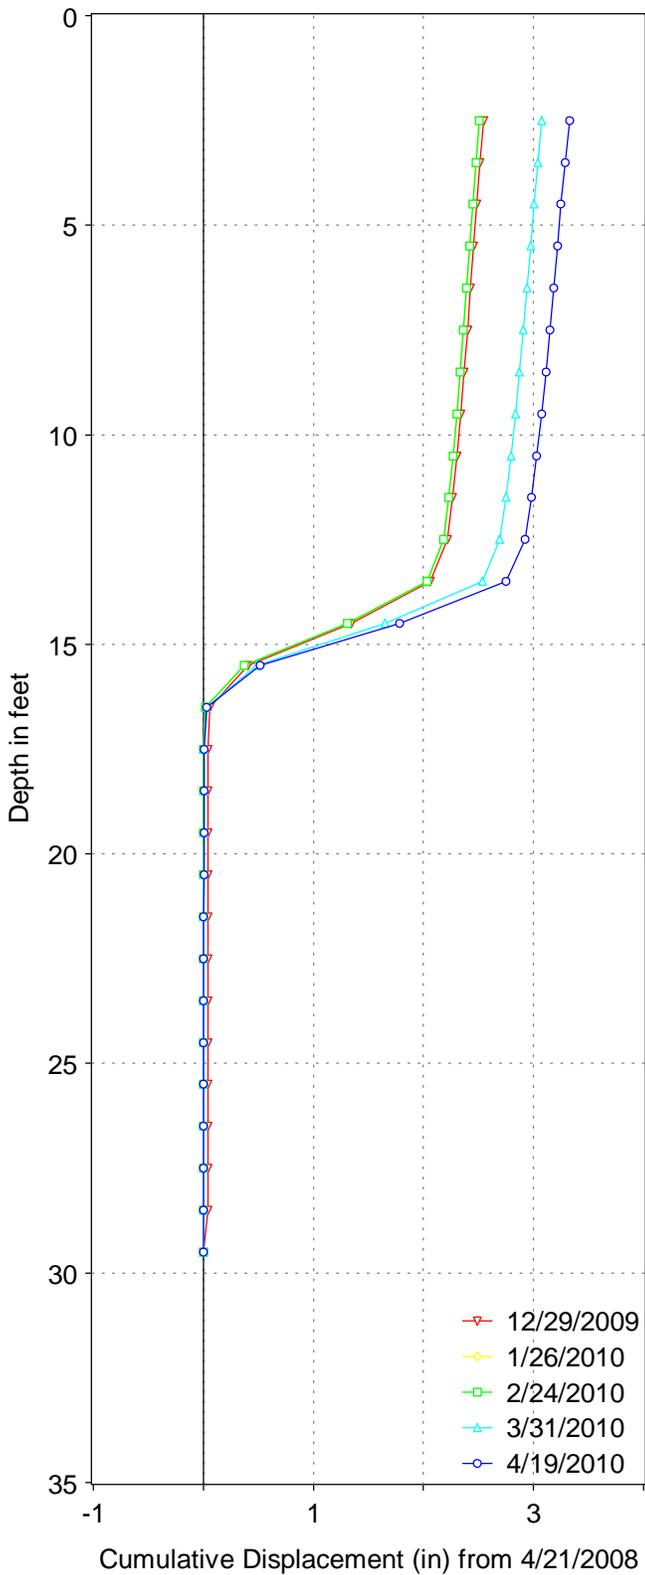
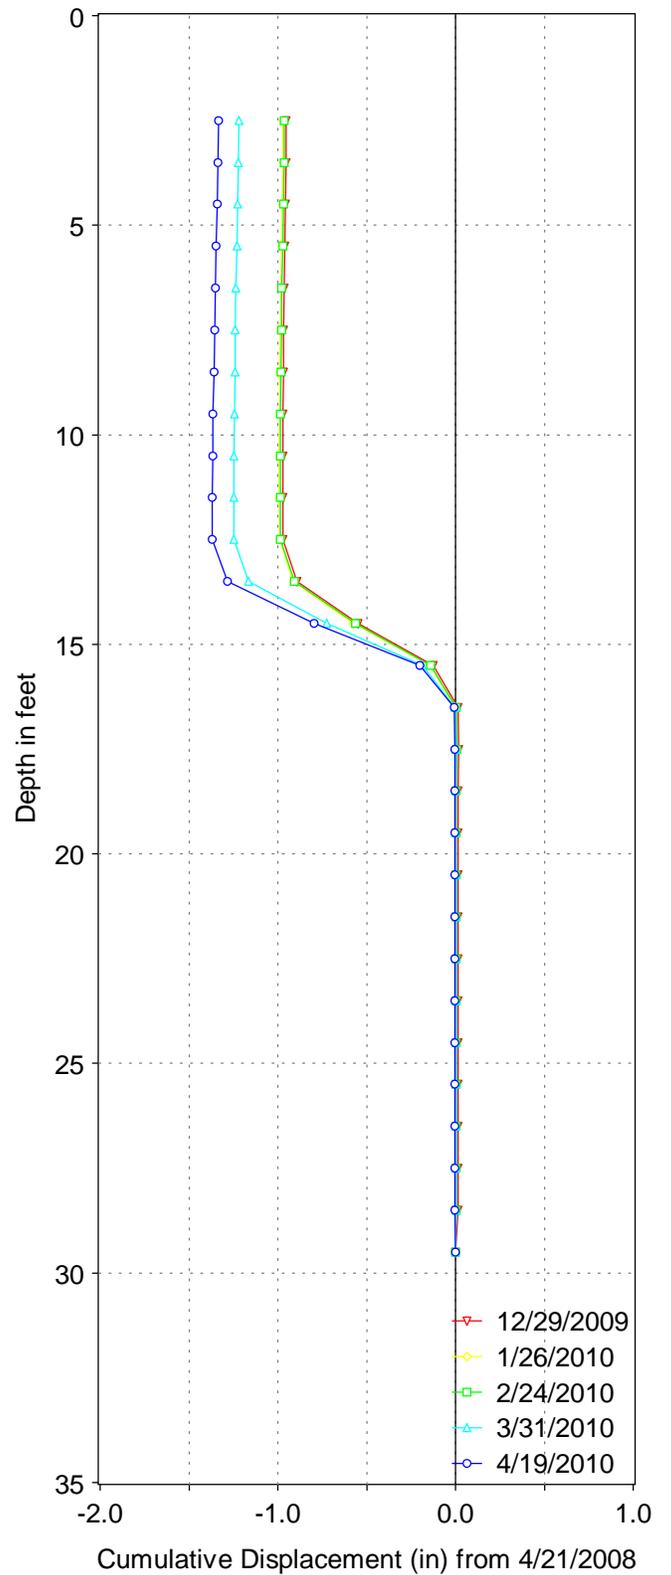
Borehole Tt-4

Initial depth 29ft; could not be read past 13ft after 4/19/10

After April 19, 2010, the inclinometer probe could not be lowered beyond the 13 foot level in Tt-4.

Tt-4. The inclinometer readings in Tt-4 show movement in both axes starting in May 2009 and peaking in April 2010. The movement in both directions lagged behind a large increase in water level that occurred in the late spring and early summer of 2009. The movement in 2010 peaked again in June in both directions due to precipitation in April. Movement was nearly negligible during 2011.

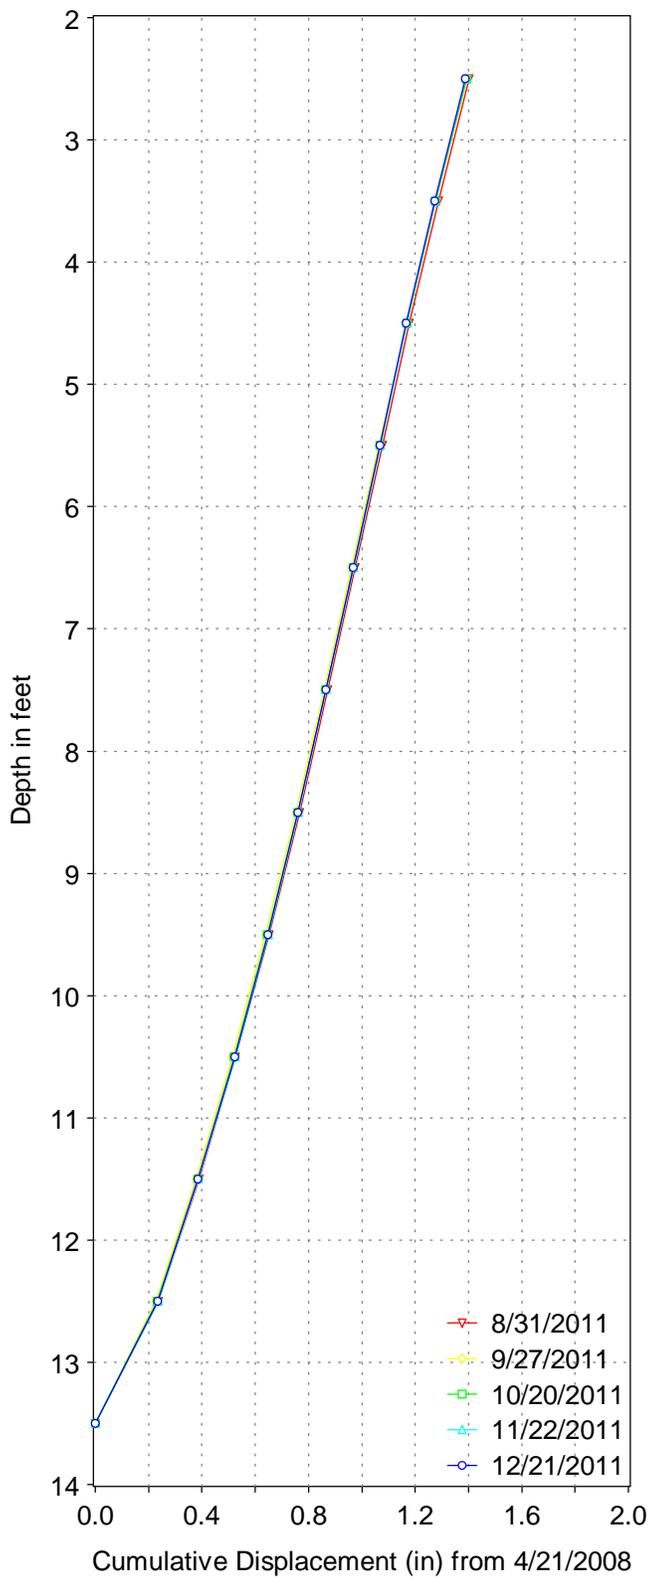
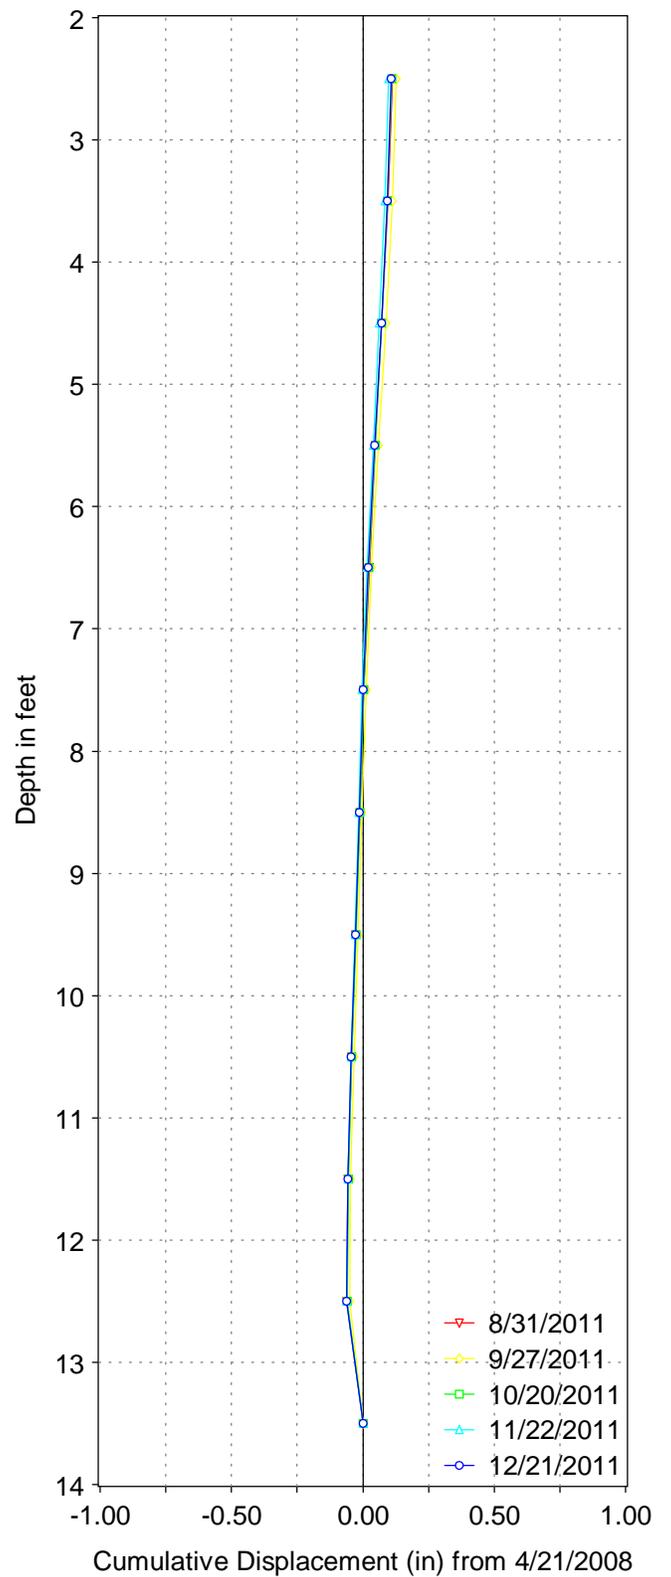
Borehole Tt-4

Initial depth 29ft; this plot shows readings to 13ft

Bad Data: 8/30/10, 9/30/10, 11/18/10
