### ***Technical Memorandum Regarding Instrumentation and Monitoring at the Rocky Flats OLF***

## Technical Memorandum

<b>To:</b>	Mr. Rick DiSalvo	<b>From:</b>	Lance Heyer, EI Thomas A. Chapel, PE
<b>Company:</b>	S. M. Stoller Corporation	<b>Date:</b>	March 30, 2012
<b>Re:</b>	Instrumentation and Monitoring, Rocky Flats OLF	<b>Tt Project #:</b>	114-181750

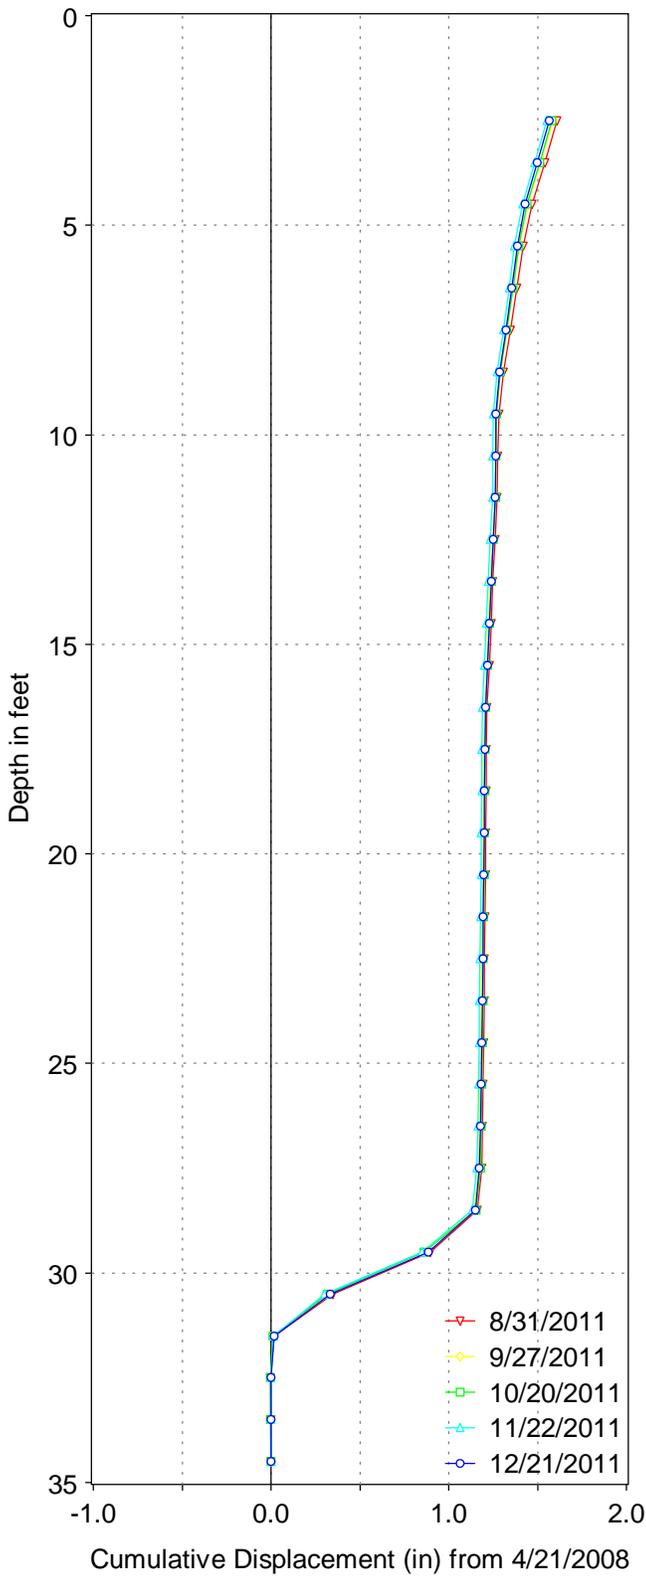
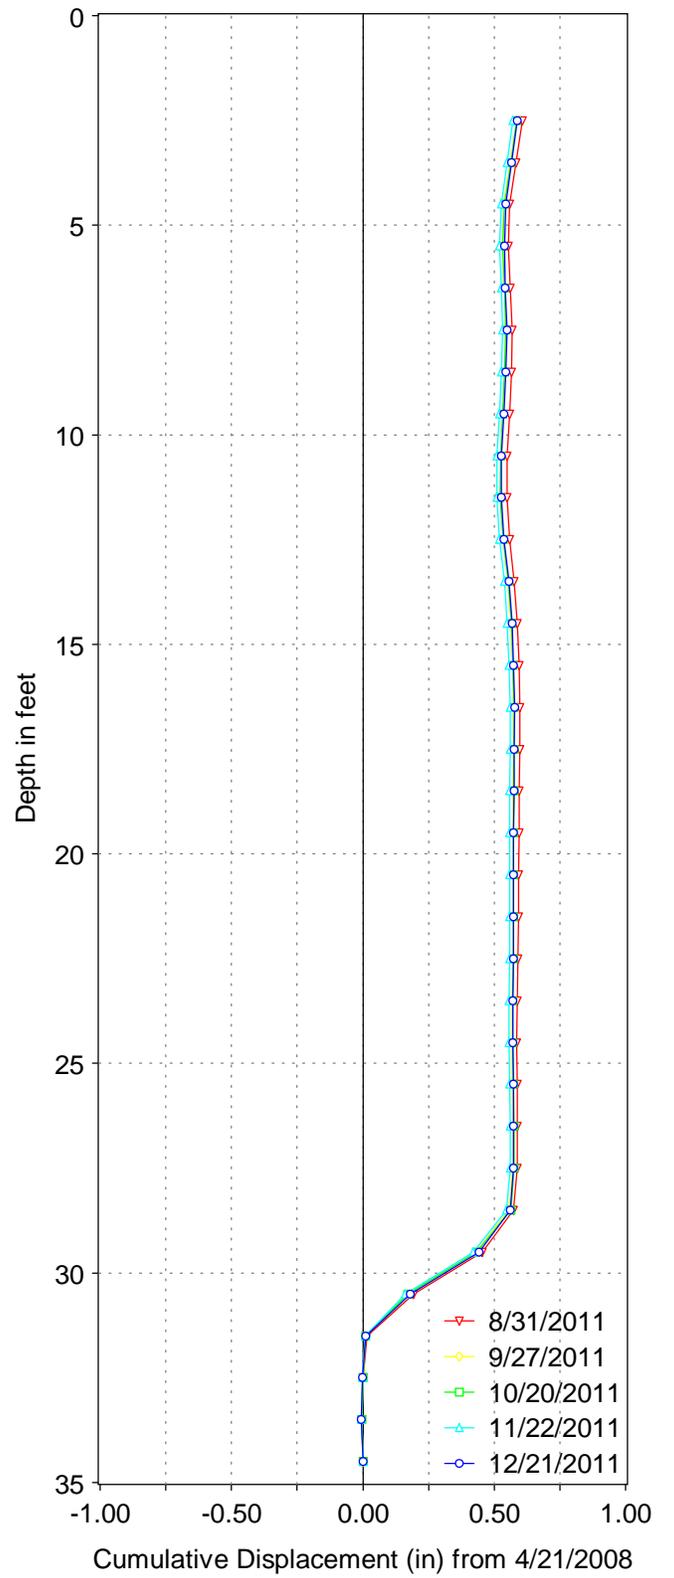
Borehole Tt-5

Bad Data: 8/30/10, 9/30/10, 11/18/10

Tt-5. In 2010 the inclinometer showed an increase in movement in both directions with a peak in the summer. The piezometer data show a sharp increase in the water level during this time period, although the magnitude of the water level increase suggests that the piezometer data are erroneous. The general correlation between a water level increase and inclinometer movement is consistent. Piezometer readings were erratic over the majority of 2011, however the movement recorded by the inclinometer follows the trend of increasing water level indicated by the piezometer.

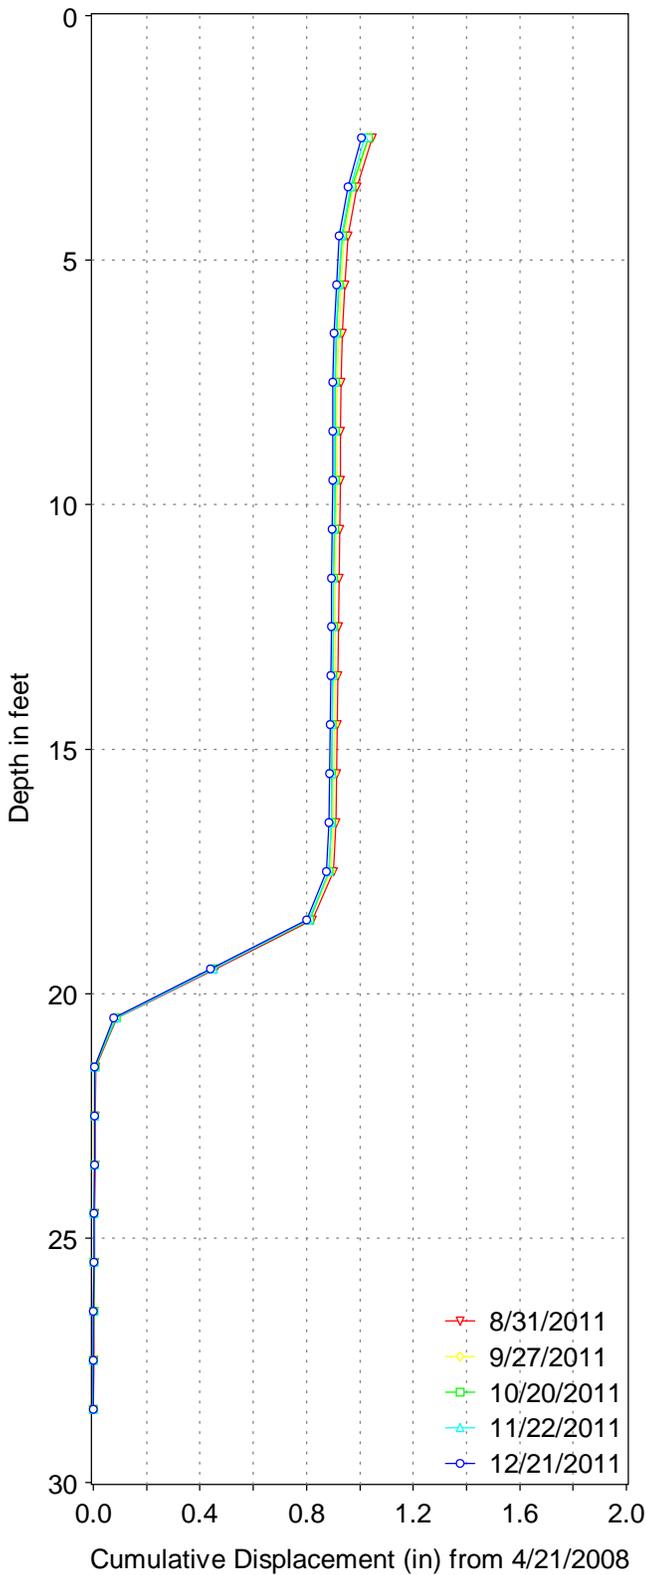
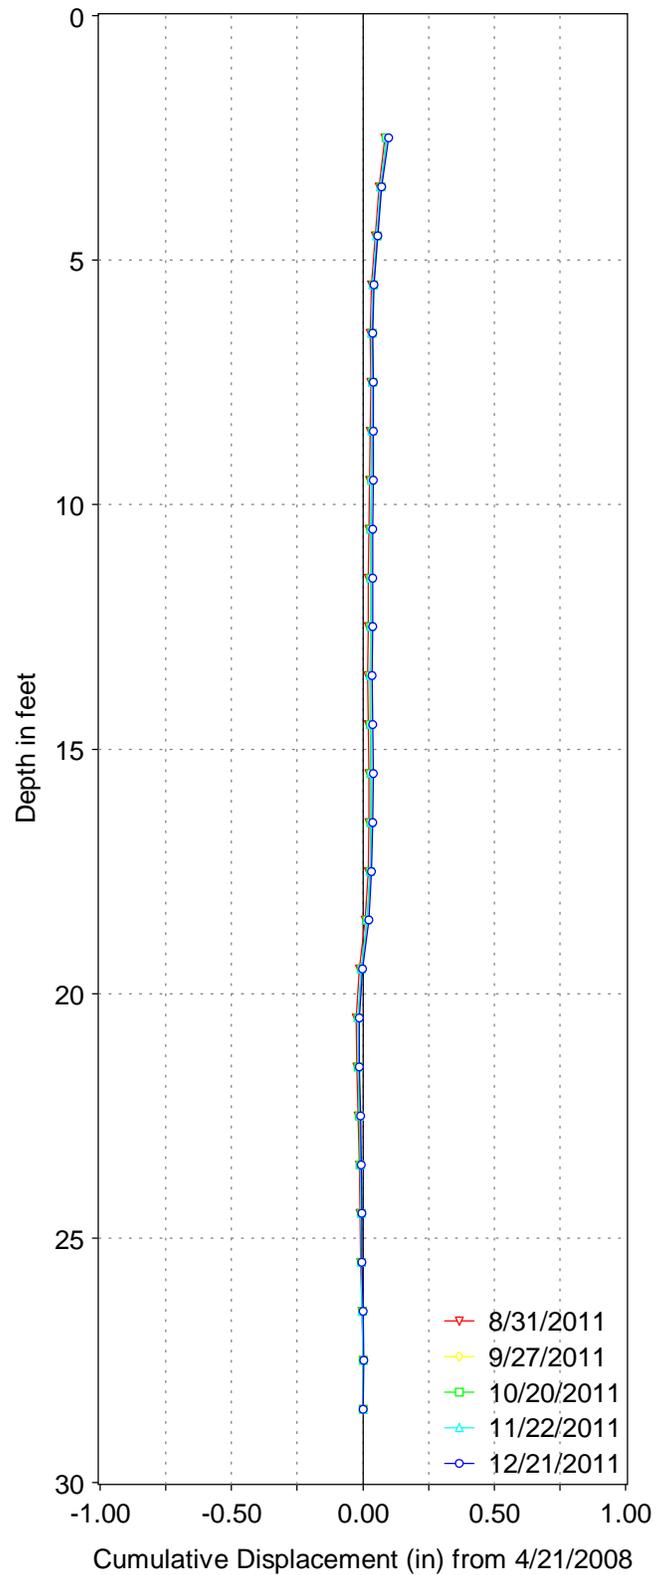
Borehole Tt-6

Bad Data: 8/30/10, 9/30/10

Tt-6. Following significant movement in the spring of 2010, subsequent movement and water level changes were small. However, an increase in recorded movement that occurred between February 2011 and August 2011 appears related to an increase in water level recorded during the same period.

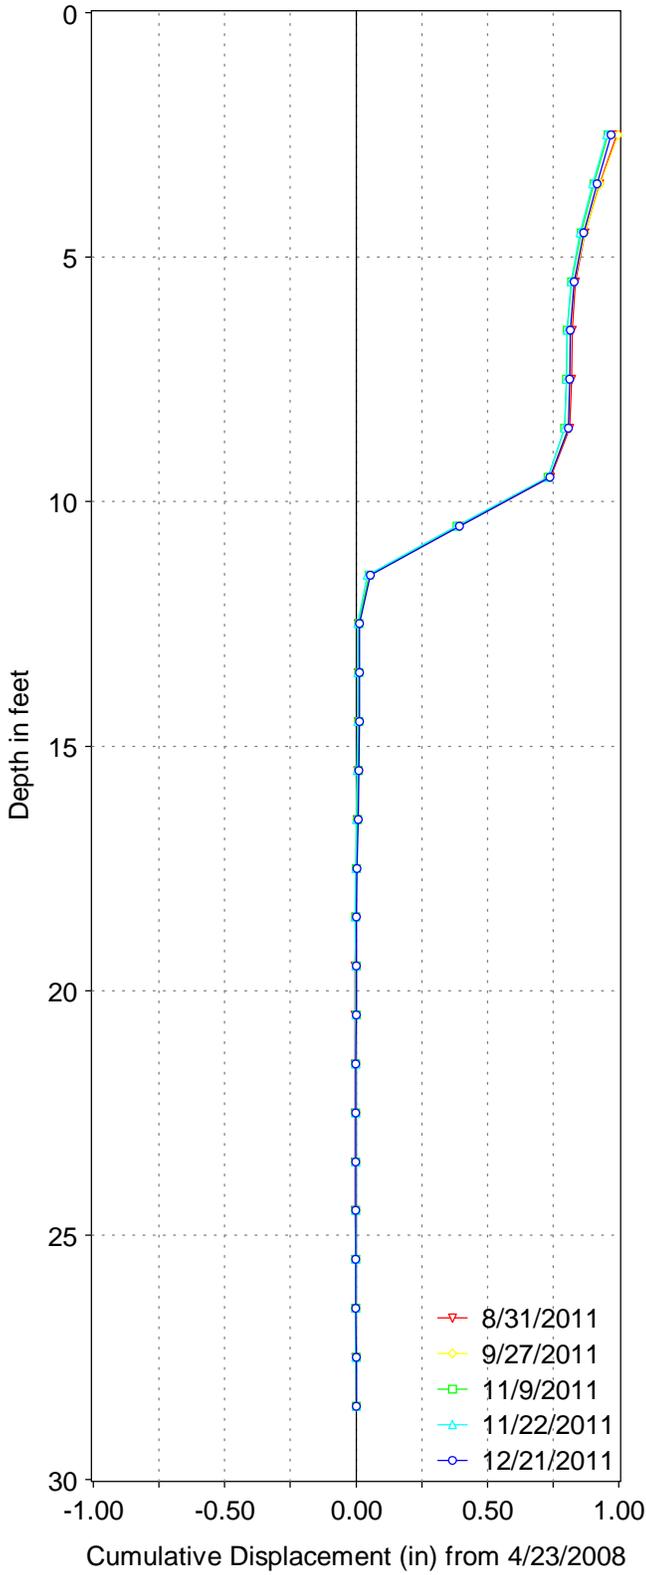
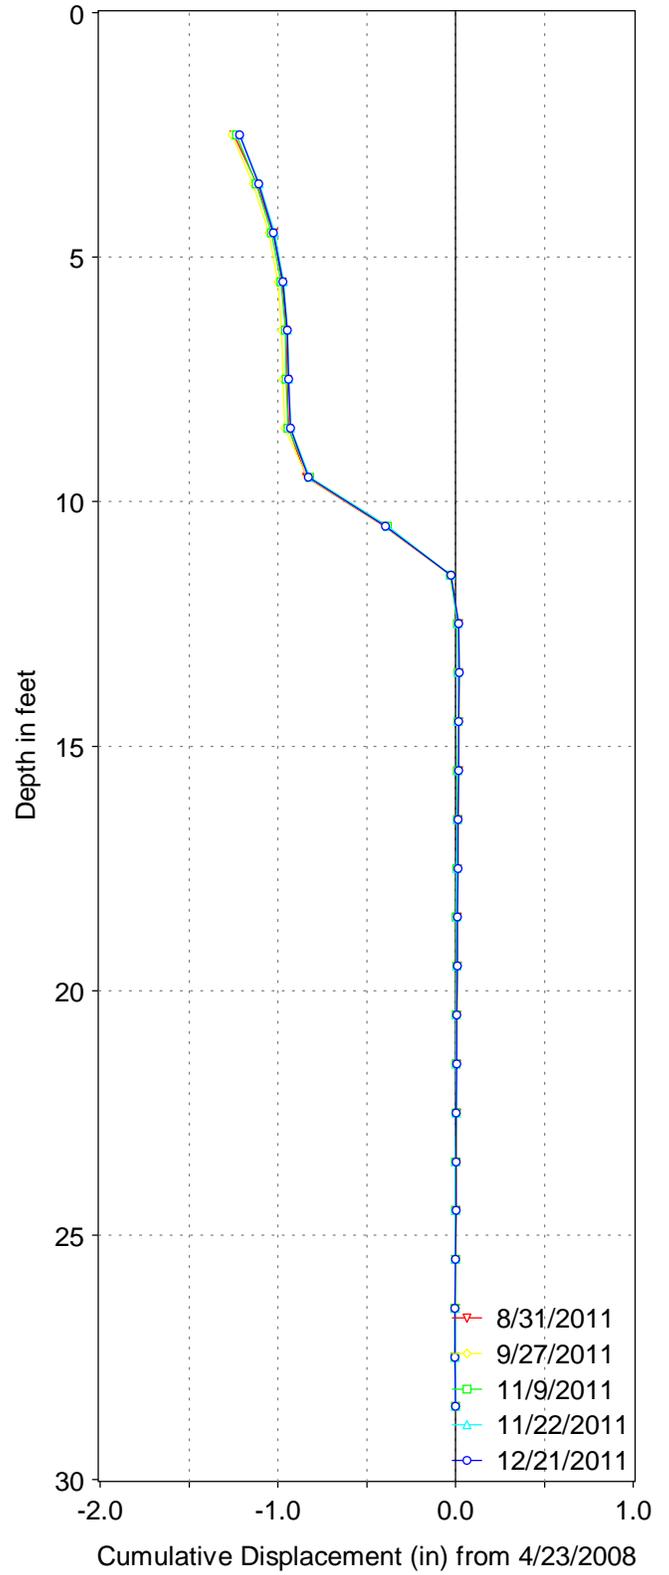
Borehole Tt-7

Bad Data: 8/30/10, 9/30/10, 1/26/11, 2/22/11, 4/26/11

Tt-7. Overall, there has been a general trend for an increase in movement along the A- and B-axes. During 2011 the inclinometer indicated insignificant movement and piezometer measurements were erratic.

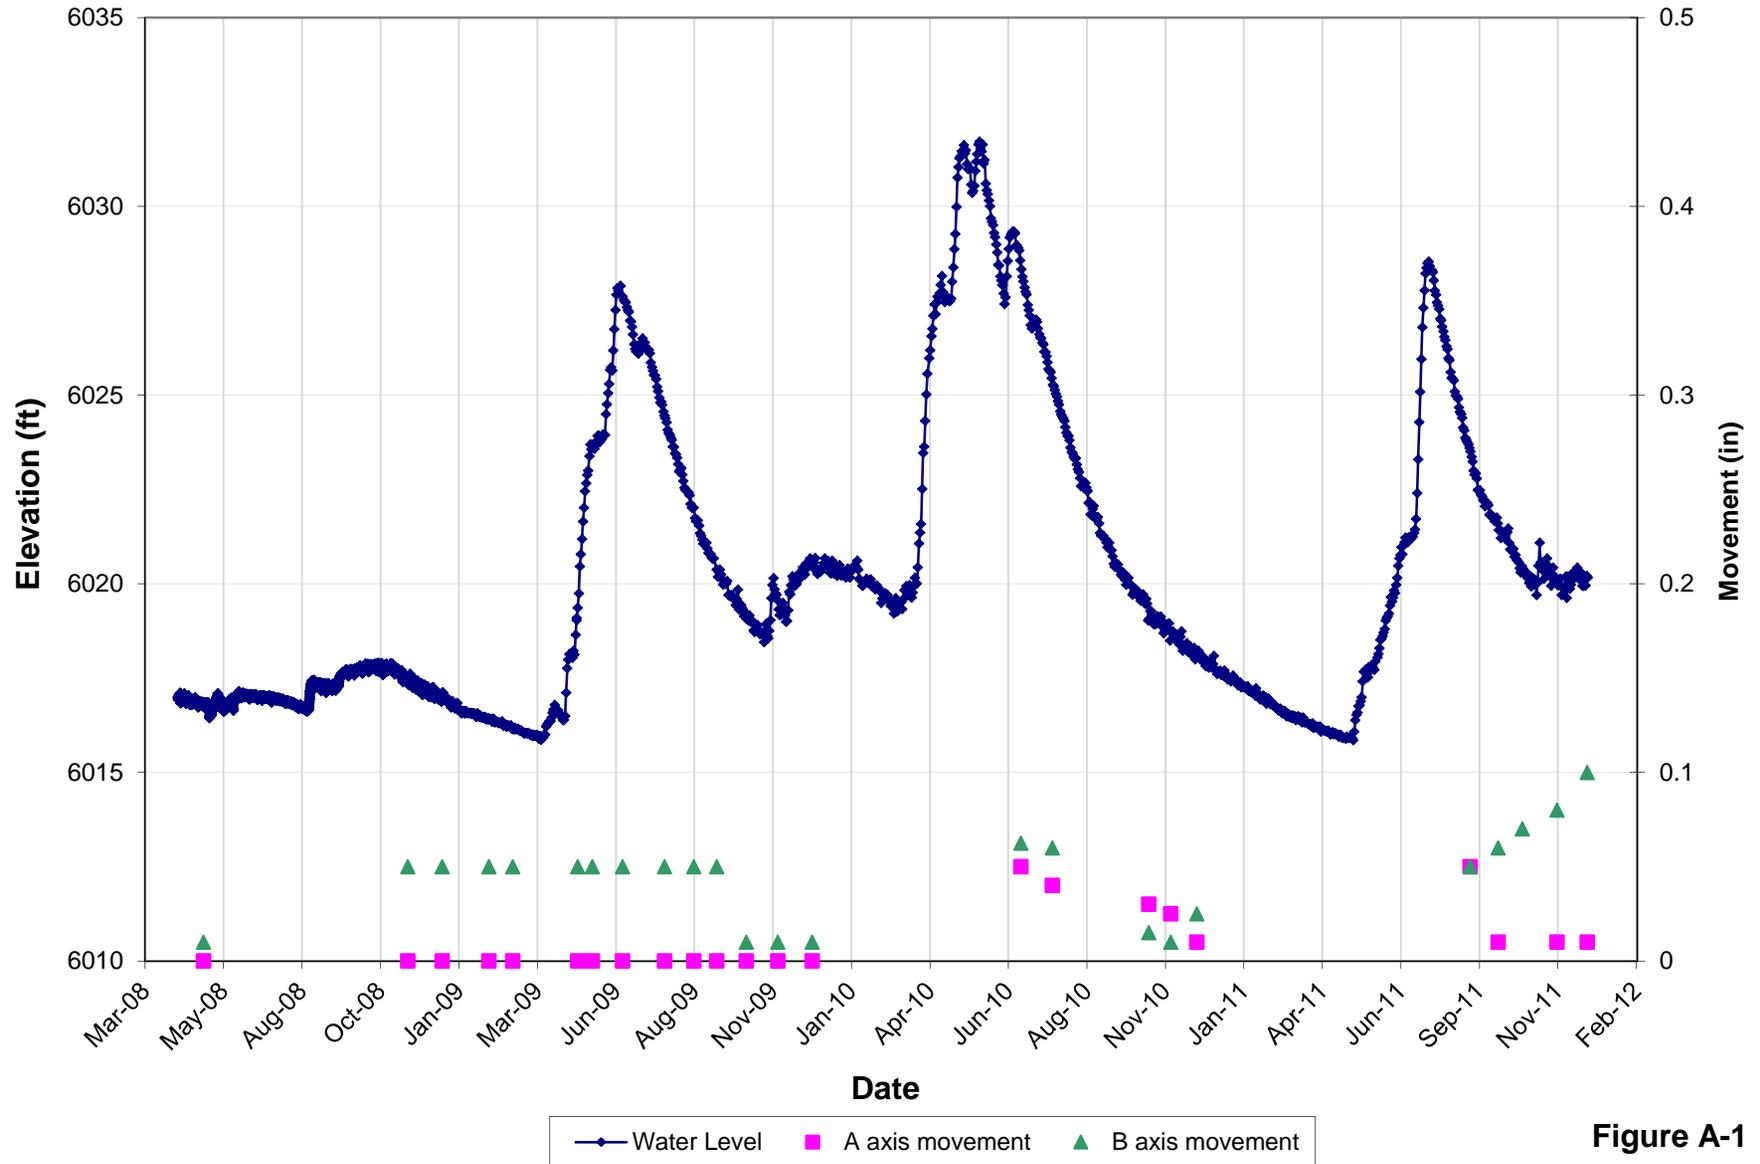
**Figure A-1**

Tt-1. Tt-1 was intentionally placed outside of the historical slide area. As was noted in the 2010 Technical Memorandum, there does not appear to be a relationship between piezometer readings and inclinometer readings for Tt-1. The inclusion of the 2011 data continues to support this conclusion. There is a very small increase in movement in the direction of the B-axis of the inclinometer.

### Filtered Inclinometer and Piezometer Data: Tt-1

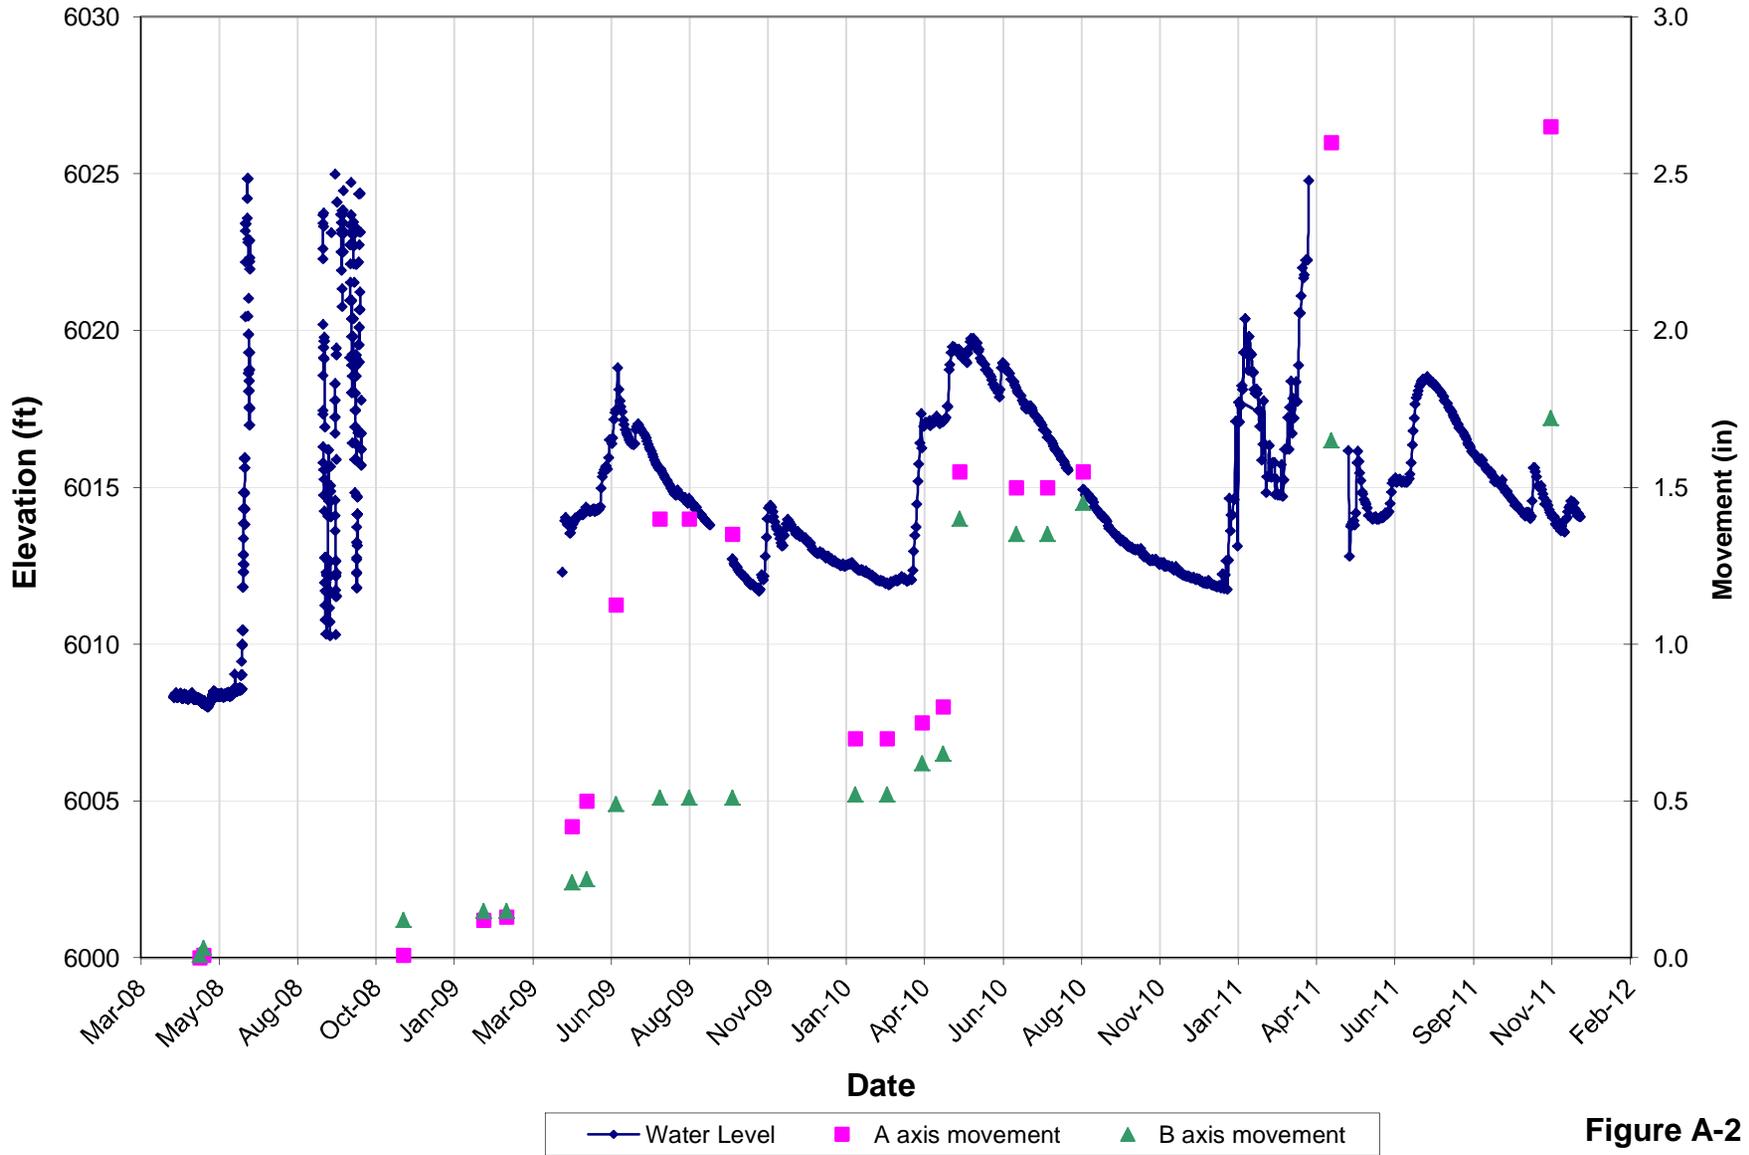
**Figure A-2**

Tt-2. The inclinometer readings for Tt-2 showed movements starting in May 2008 and continuing to 1.4 inches on the A-axis on July 22, 2009. This followed a spike in the high water level on 6/12/09. Readings for both A and B-axes show total movement to date of 2.7 inches on the A-axis and 1.8 inches on the B-axis. Little movement occurred between 4/26/2011 and 12/21/2011.

### Filtered Inclinomometer and Piezometer Data: Tt-2

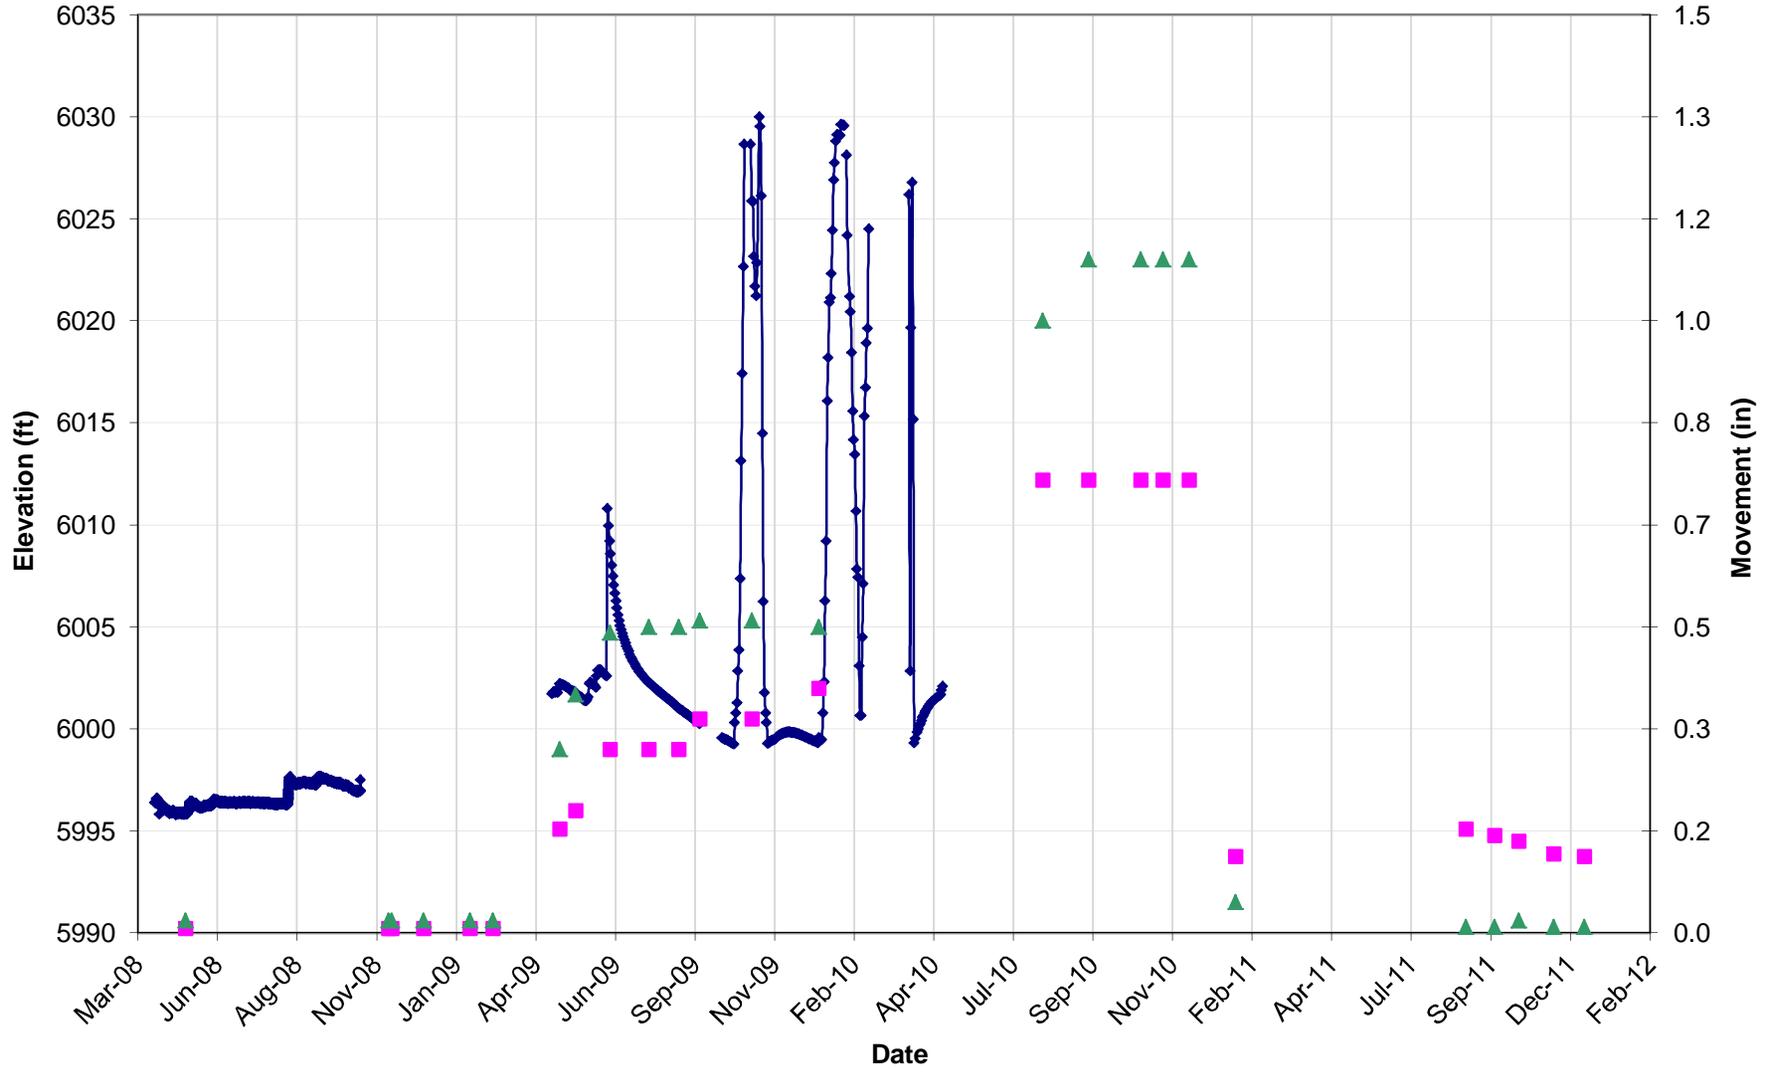
**Figure A-3**

Tt-3. The piezometer data collected in 2010 is erroneous and indicates that the piezometer in Tt-3 is no longer functioning. The inclinometer data show that negligible movement occurred between 8/31/2011 and 12/21/2011.

### Filtered Inclinometer and Piezometer Data: Tt-3

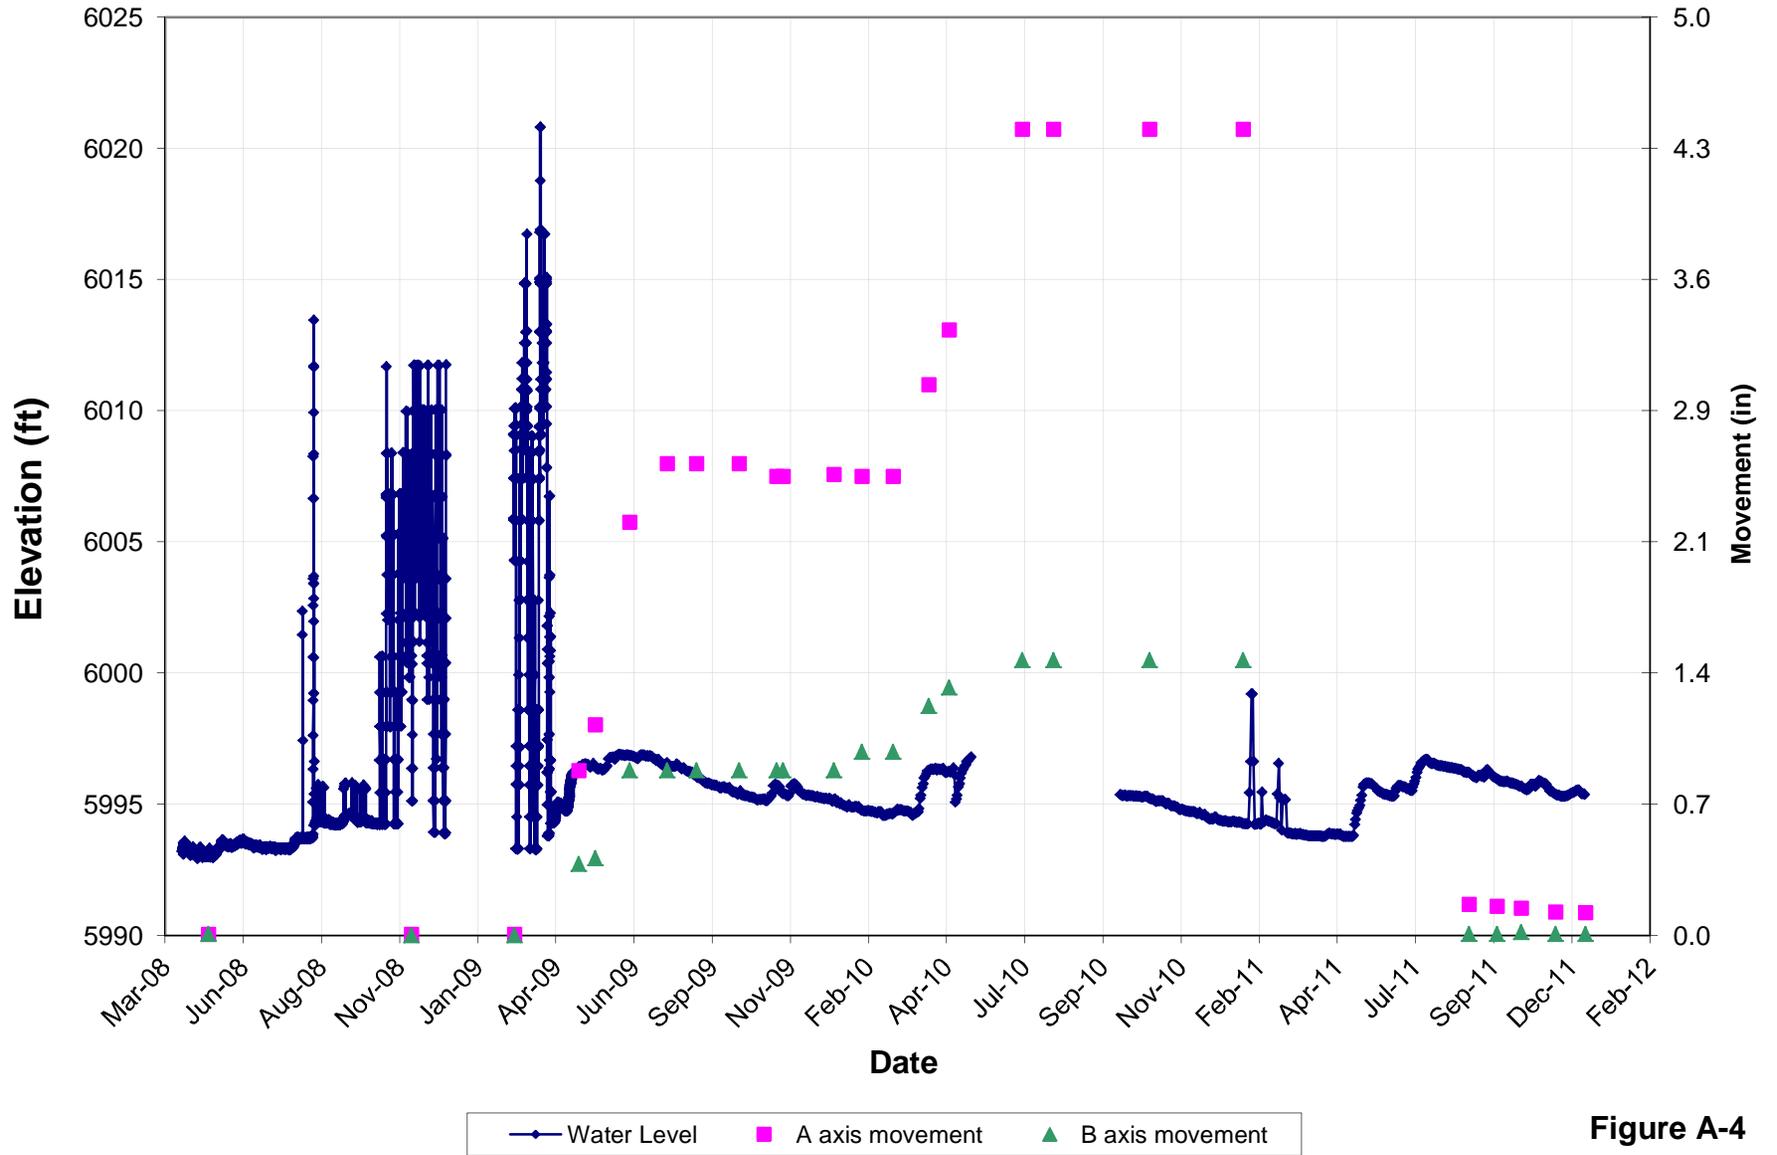
**Figure A-4**

Tt-4. The inclinometer readings in Tt-4 show movement in both axes starting in May 2009 and peaking in April 2010. The movement in both directions lagged behind a large increase in water level that occurred in the late spring and early summer of 2009. The movement in 2010 peaked again in June in both directions due to precipitation in April. Movement was nearly negligible during 2011.

### Filtered Inclinometer and Piezometer Data: Tt-4

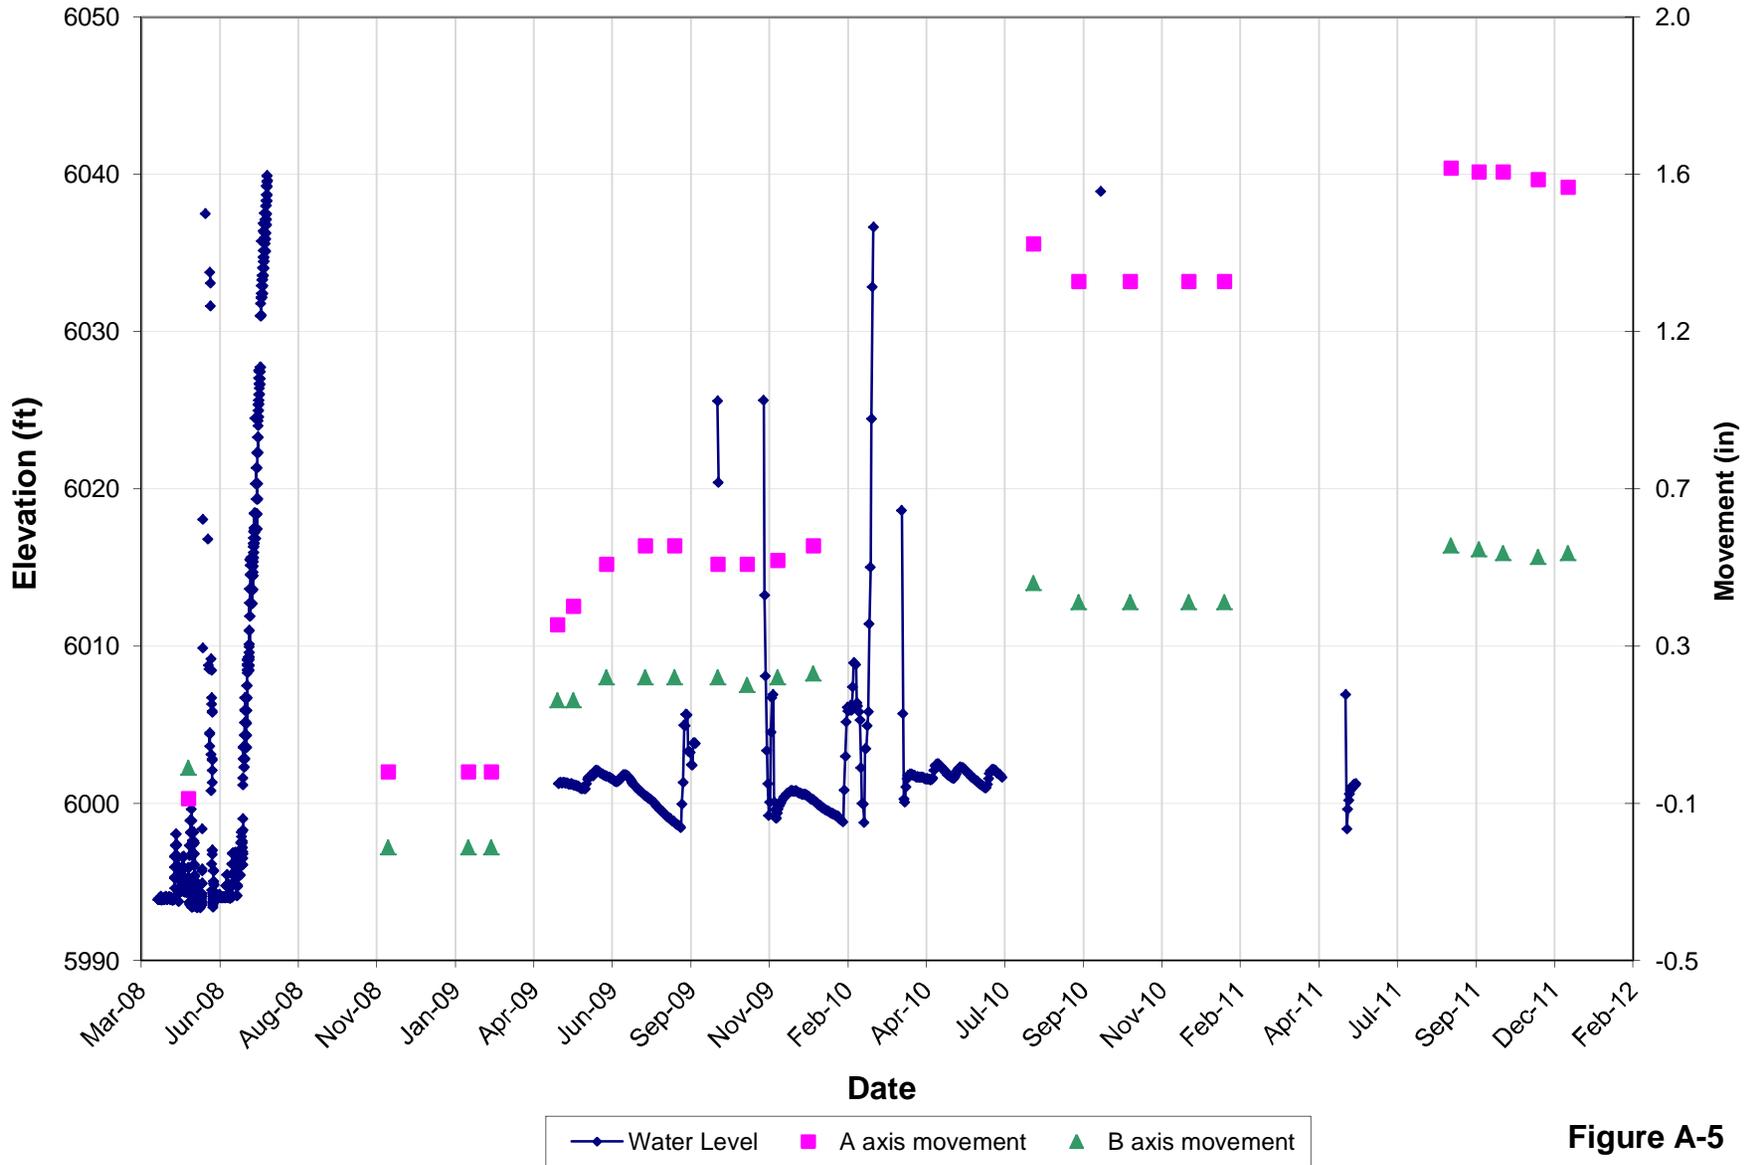
Figure A-5

### Filtered Inclinomometer and Piezometer Data: Tt-5

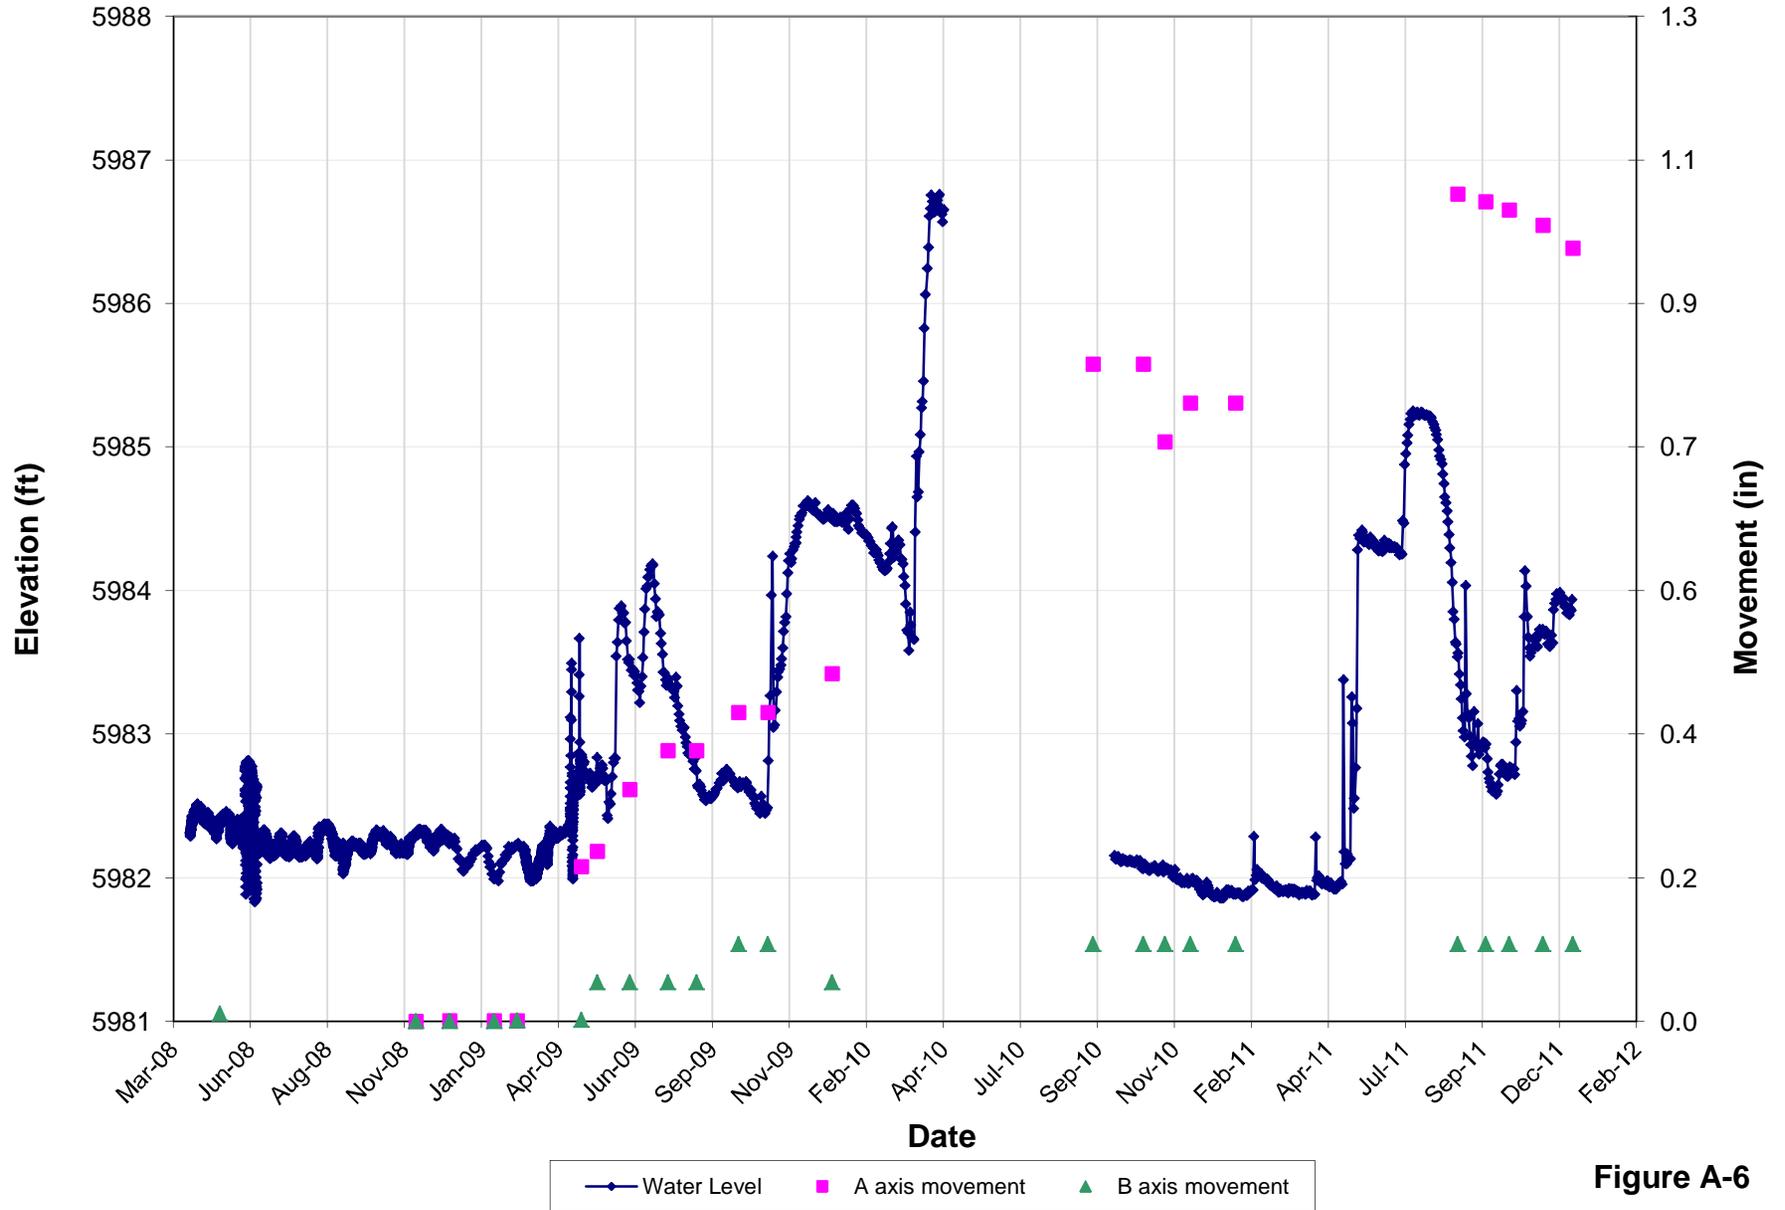
Figure A-6

### Filtered Inclinometer and Piezometer Data: Tt-6

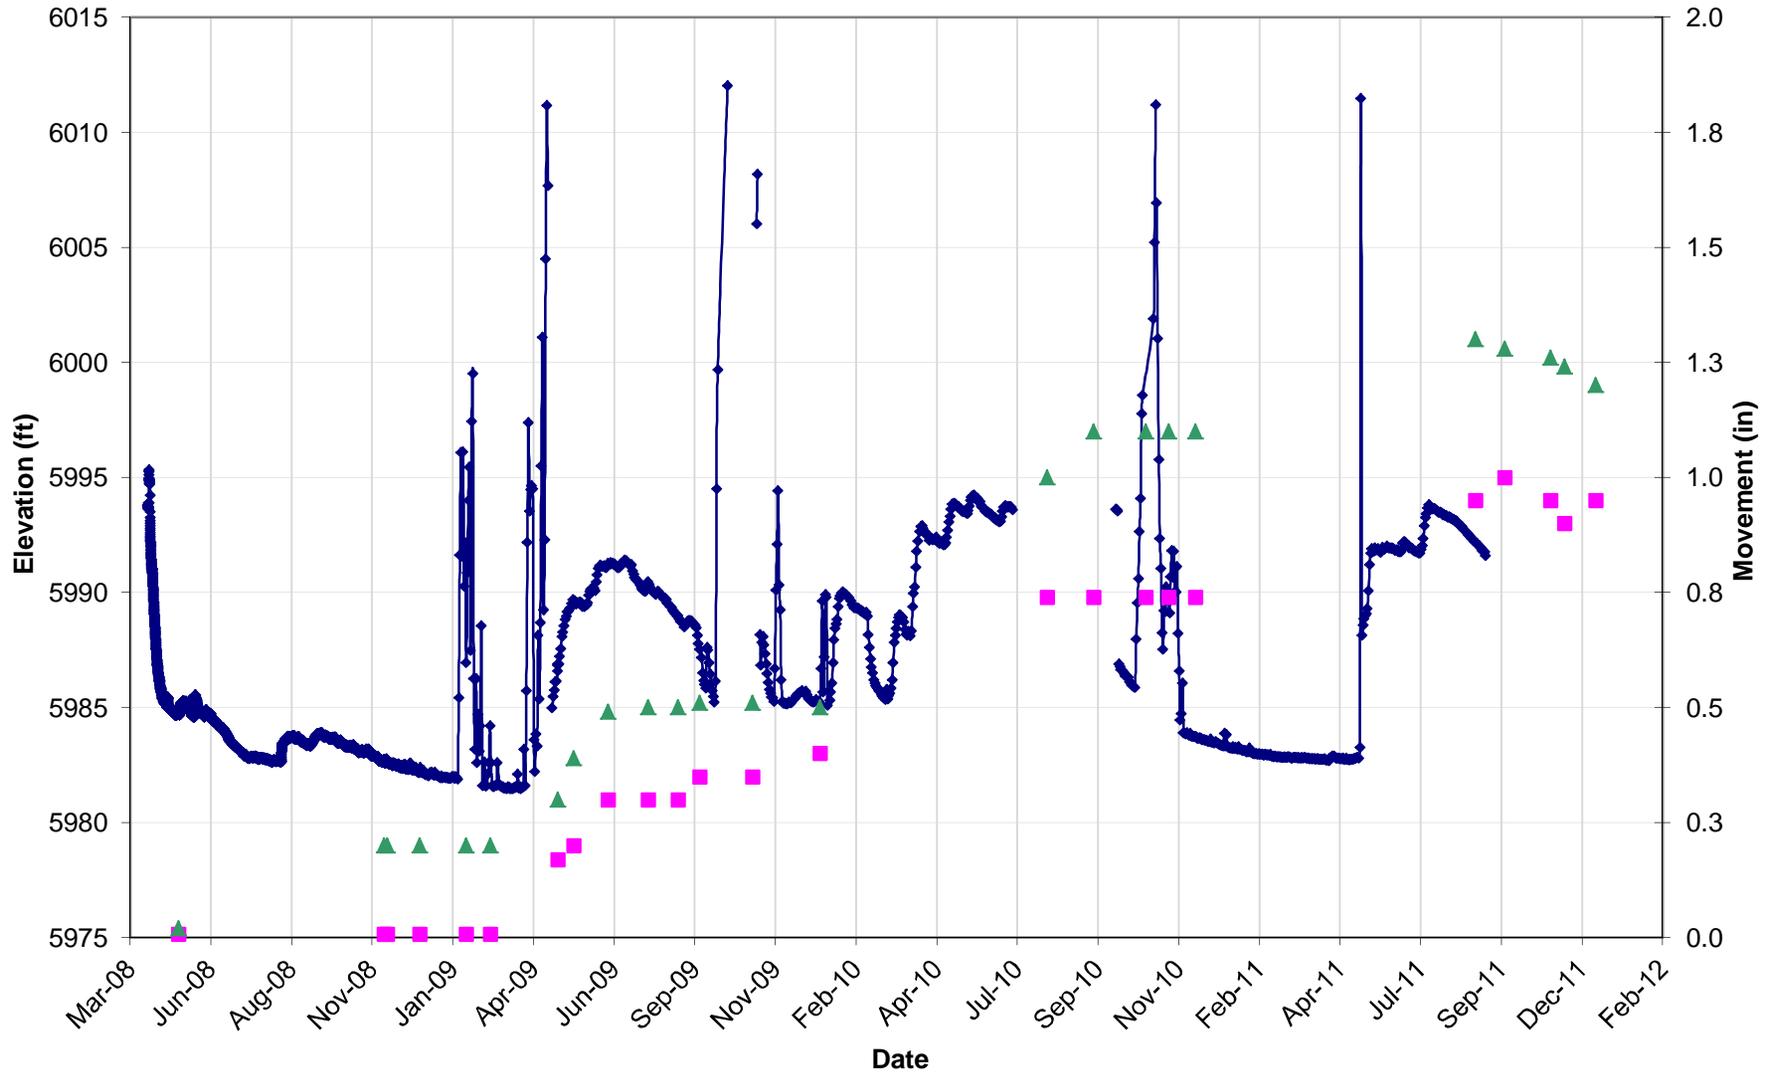
**Figure A-7**

### Filtered Inclinometer and Piezometer Data: Tt-7
