### ***Technical Memorandum Regarding Instrumentation and Monitoring at the Rocky Flats OLF***

## Technical Memorandum

<b>To:</b>	Mr. Rick DiSalvo	<b>From:</b>	Lance Heyer, EI Thomas A. Chapel, PE
<b>Company:</b>	S. M. Stoller Corporation	<b>Date:</b>	March 30, 2012
<b>Re:</b>	Instrumentation and Monitoring, Rocky Flats OLF	<b>Tt Project #:</b>	114-181750

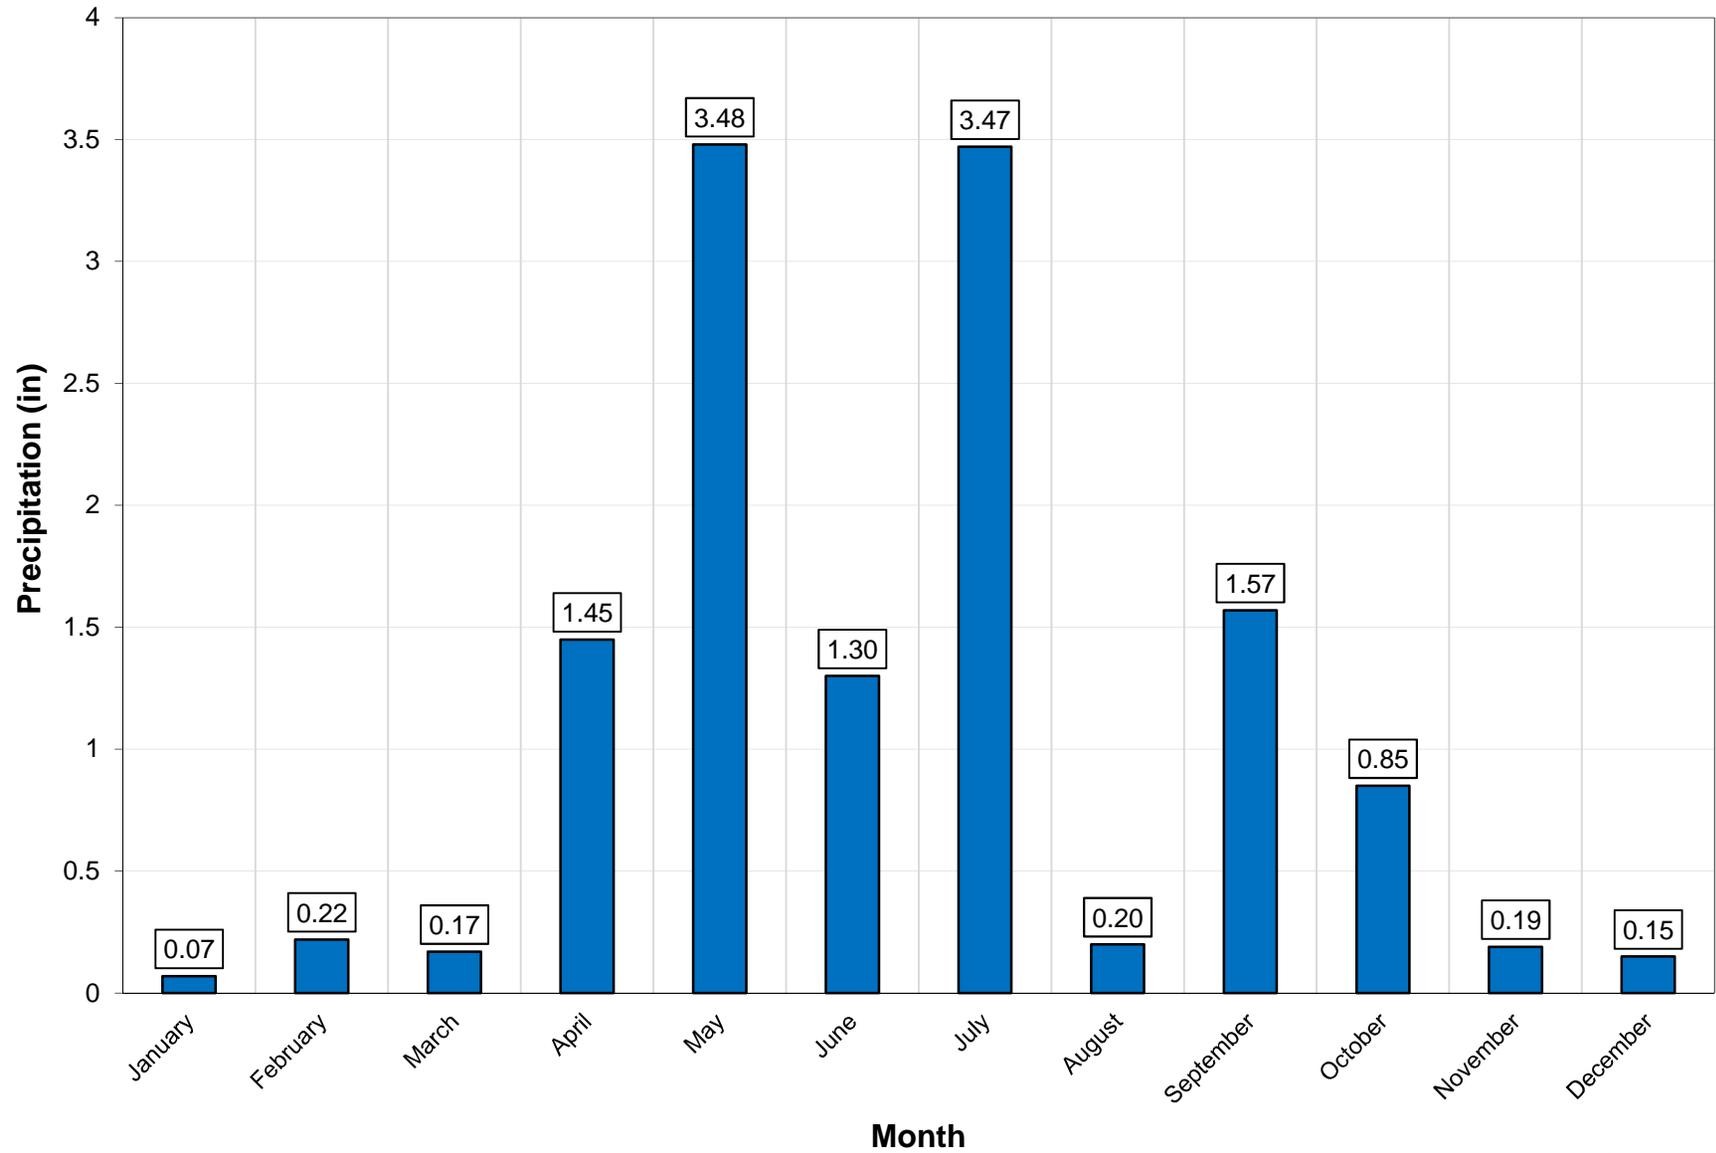
Figure B-1

The precipitation in the area was measured by S.M. Stoller using on-site devices during the period of record for the inclinometers and piezometers. S.M. Stoller has noted that some inaccuracy of the measurements is likely during events when significant snowfall accumulates on the devices. When significant snow accumulates some of the snow may blow or fall off the device instead of accumulating in the device. Graphs prepared by S.M. Stoller show monthly average precipitation values for 2011 are included in Attachment B. In general, the graphs show that during the period of record for these piezometers and inclinometers, precipitation at the site was higher between April and September and lower between October and March.

# Precipitation by Month 2011
