Revegetation of 903 Pad and Lip Areas at Rocky Flats

Rocky Flats Stewardship Council Meeting
September 10, 2012

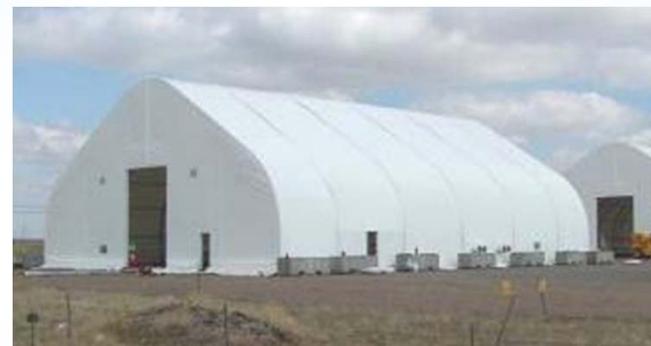
903 Pad – Weather Enclosures

- “Tents” used to enclose excavation areas
- Removed 32,000 tons of soil
 - 900 grams of Pu
 - Clean fill added on top
- Air, water quality – continually compliant
- Completed December 2003

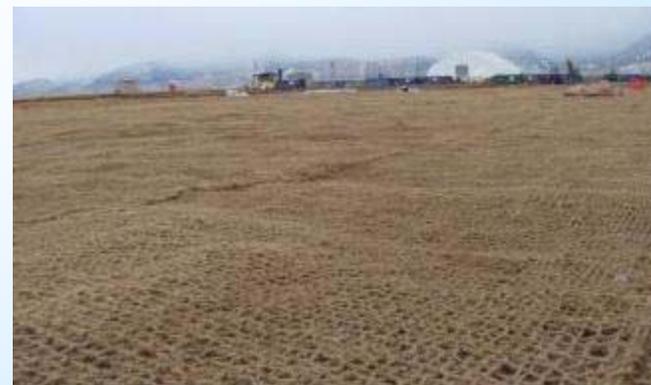
Lip Area – Erosion “Blankets”

- Remove soil > 50 pCi/g
- Approximately 34 acres
- Stringent dust and erosion controls
- Completed September 2004

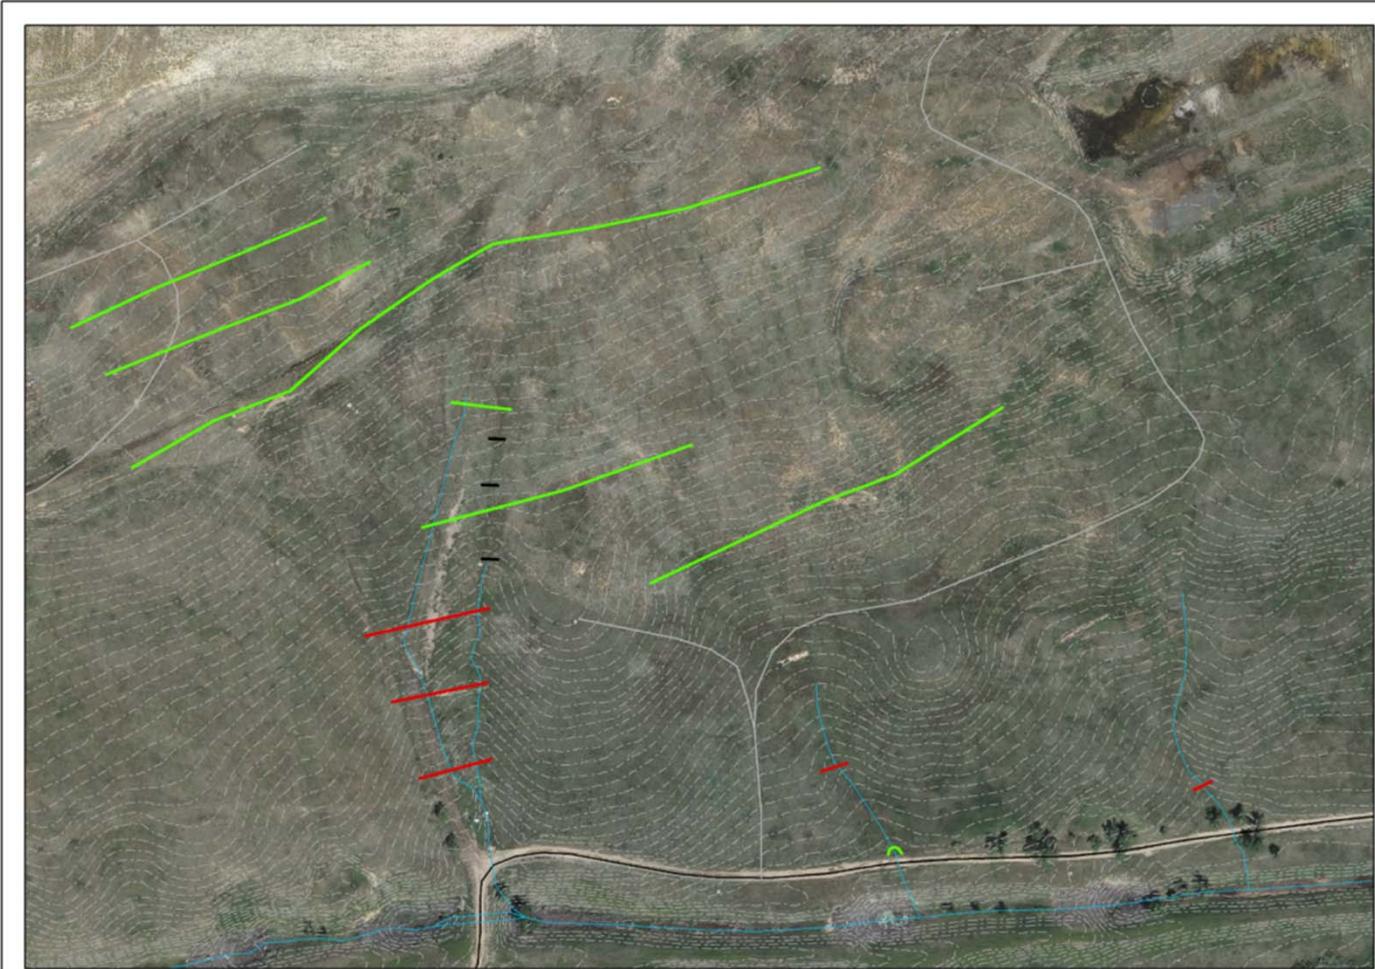
903 Lip Erosion Control Plan

Wattle Lengths (approx.)
 9 inch = 2150 feet
 20 inch = 355 feet

- The 12-month rolling average for plutonium-239/240 at SW027 initially exceeded the RFLMA surface water standard on April 30, 2010
- The vegetation and erosion controls on the hillside and South Interceptor Ditch (SID) were evaluated
- Interseeding of selected locations with lower foliar vegetation cover was conducted on hillside on June 23, 2010
- Additional erosion controls (Filtrex Siltsoxx wattles – filled with wood chips, compost, and seed) were installed on hillside in December 2010
- Sparsely vegetated areas within the SID were reseeded and had erosion mat placed in December 2010

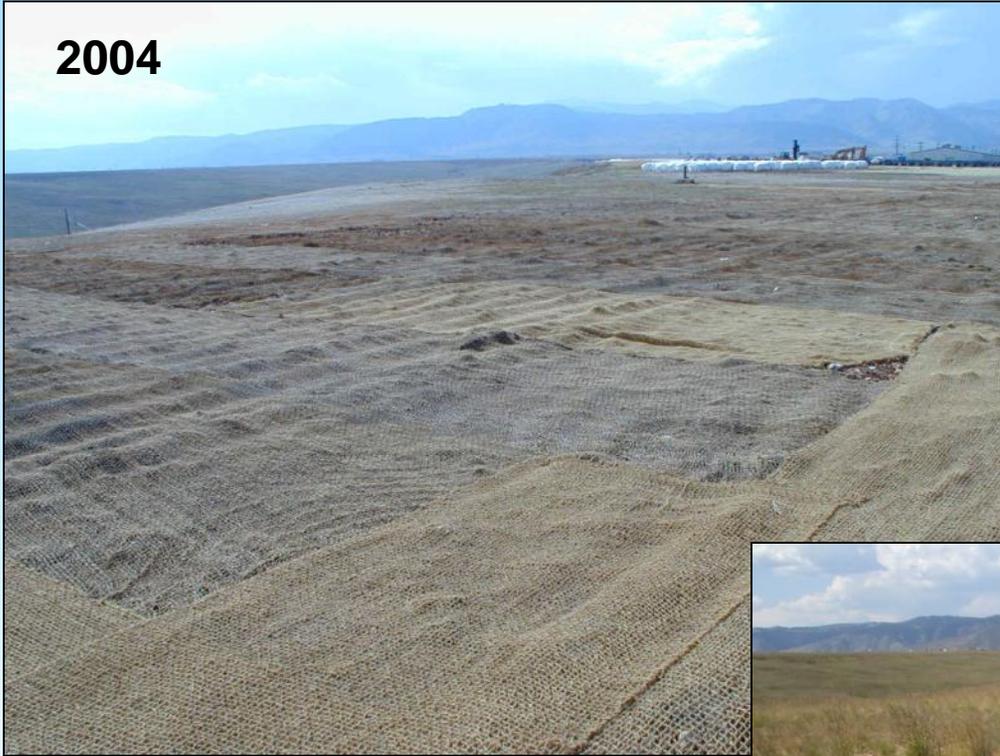
2004

903 Lip Area Revegetation

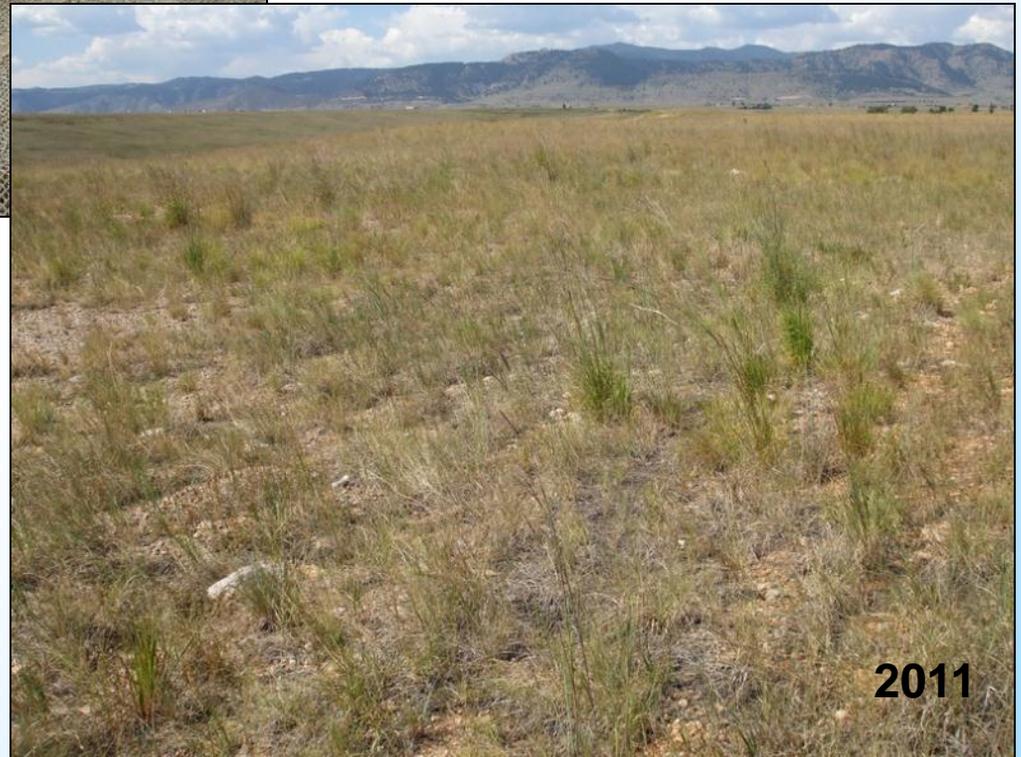
2011

**Additional soil placed on
903 pad and area east
of pad in 2007**

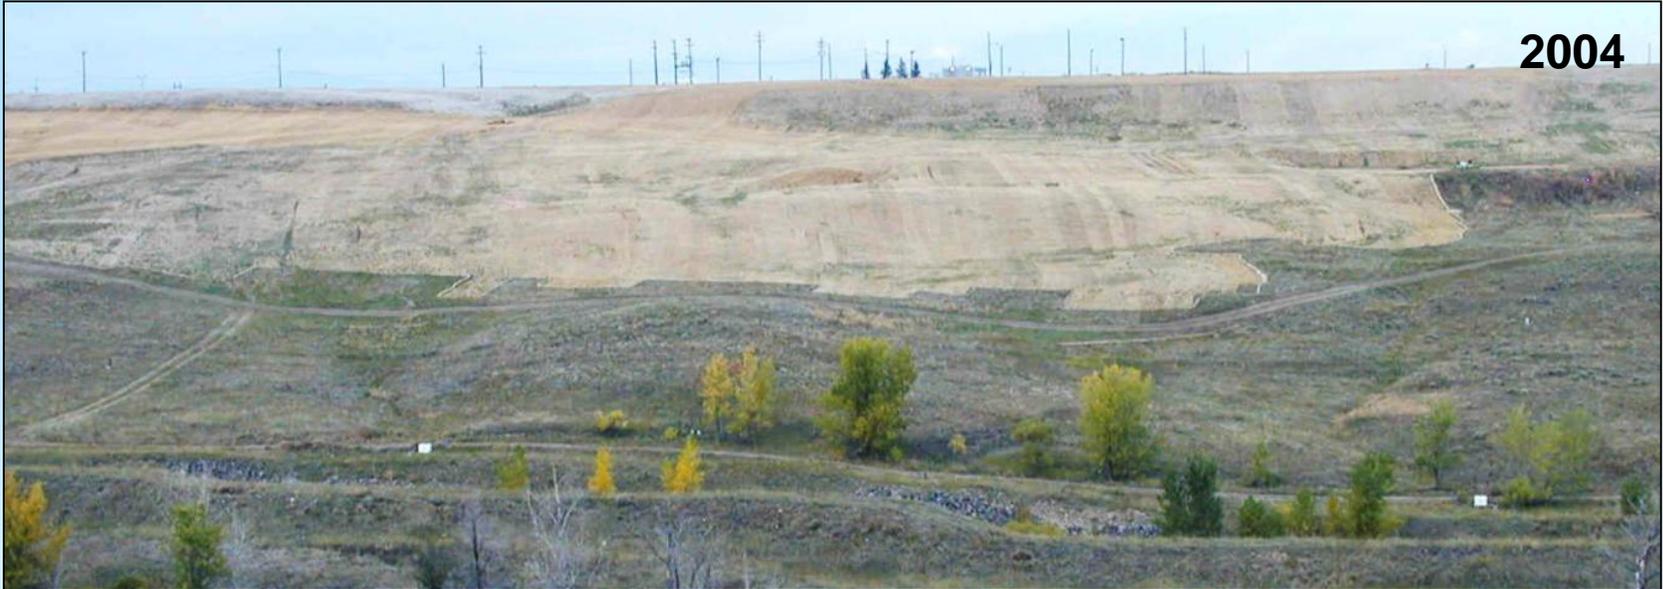
2004

903 Lip Area Revegetation

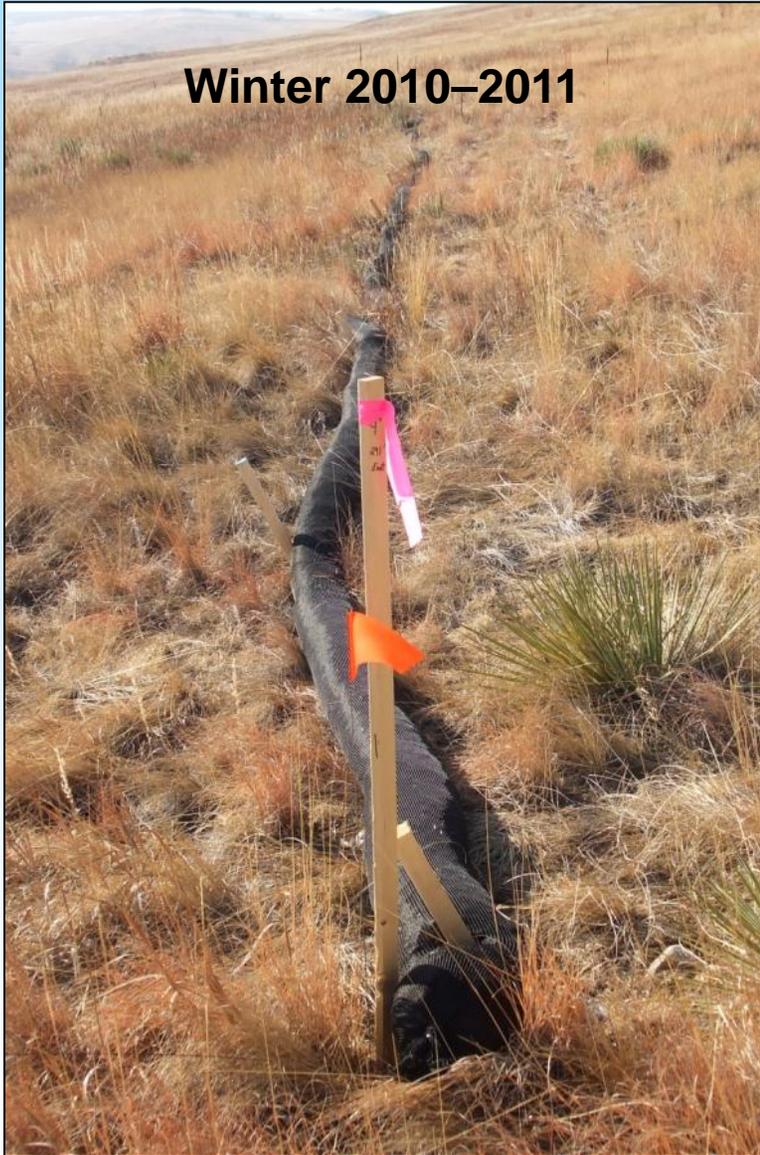
Winter 2010–2011

Filtrex Siltsoxx wattles placed on hillside

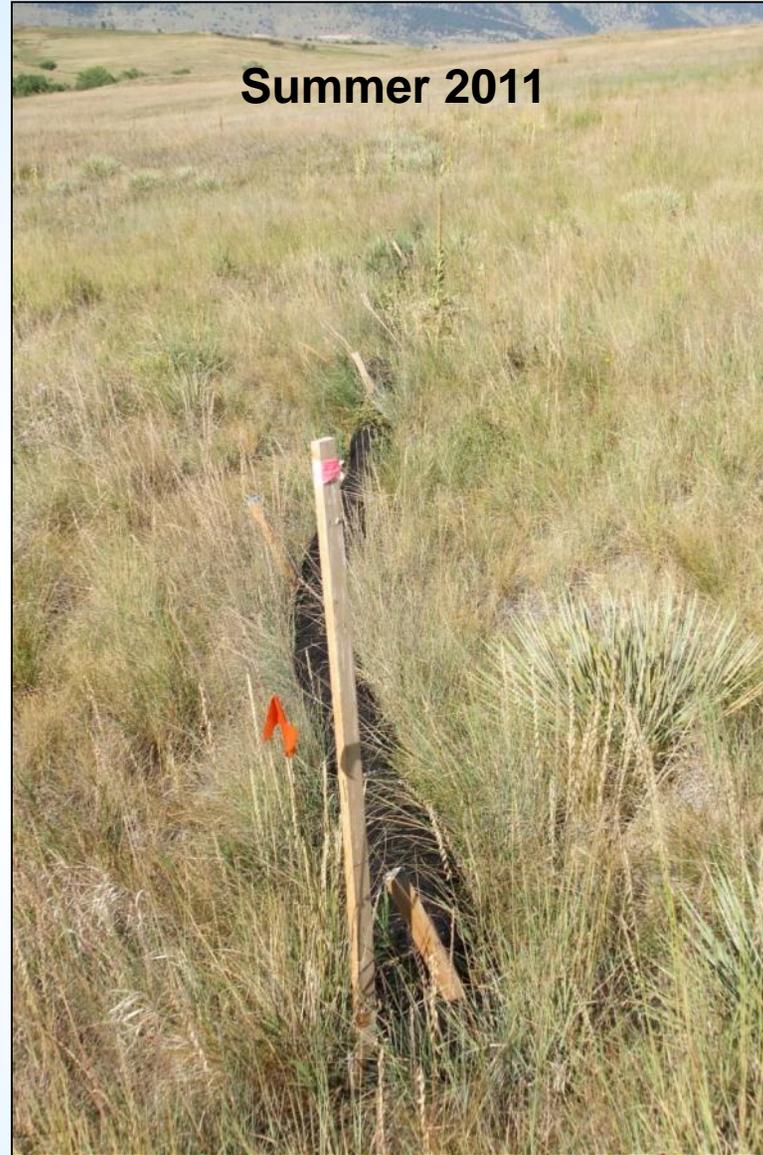
Summer 2011

- Increased vegetation cover on hillside
- Filtrex Siltsoxx wattles in place and holding up. Vegetation grown up around wattles and coming up through wattles.
- SID vegetation increasing and erosion mats holding up in place
- Vegetation-related recommendations
 - Include SW027 drainage area in 2012 annual inspection and revegetation surveys. Continue interseeding as appropriate.

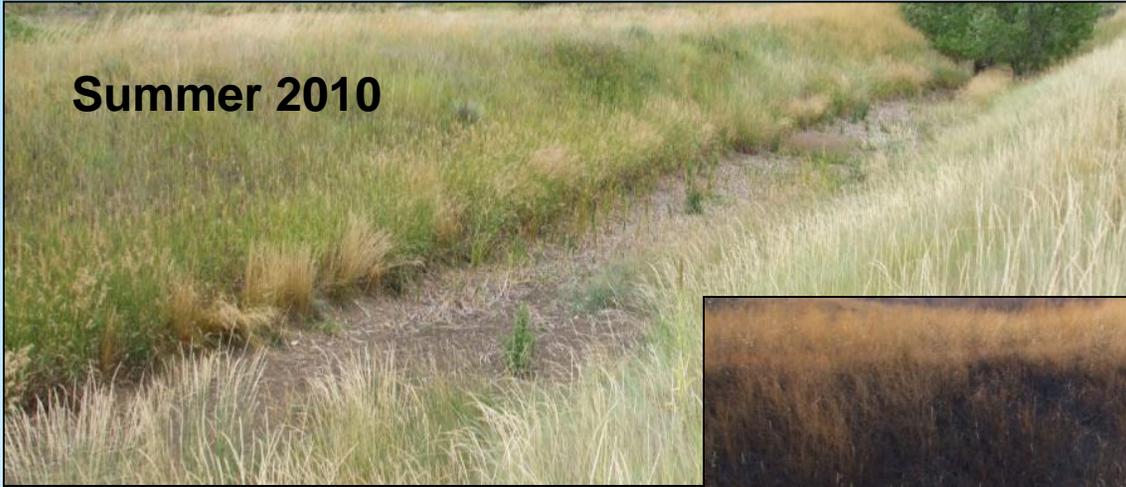
Summer 2010

SID Erosion Controls and Revegetation

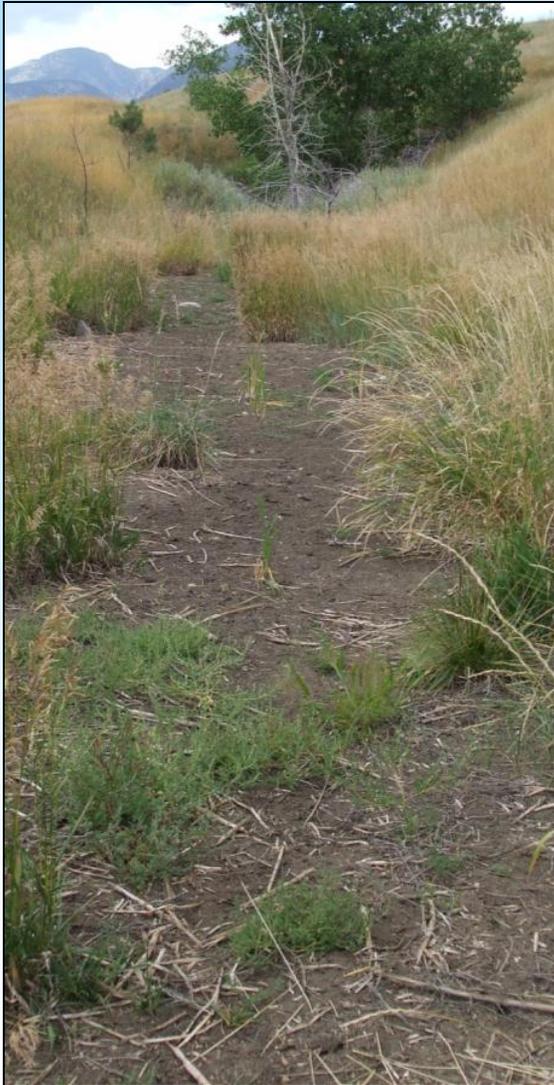
Summer 2010

SID Erosion Controls and Revegetation
