Dynamic and Static Response of  
the Government Oil Shale Mine at  
Rifle, Colorado, to the Rulison  
Event

UNITED STATES  
DEPARTMENT OF THE INTERIOR  
BUREAU OF MINES

February 2, 1970

DYNAMIC AND STATIC RESPONSE OF THE GOVERNMENT  
OIL SHALE MINE AT RIFLE, COLORADO,  
TO THE RULISON EVENT

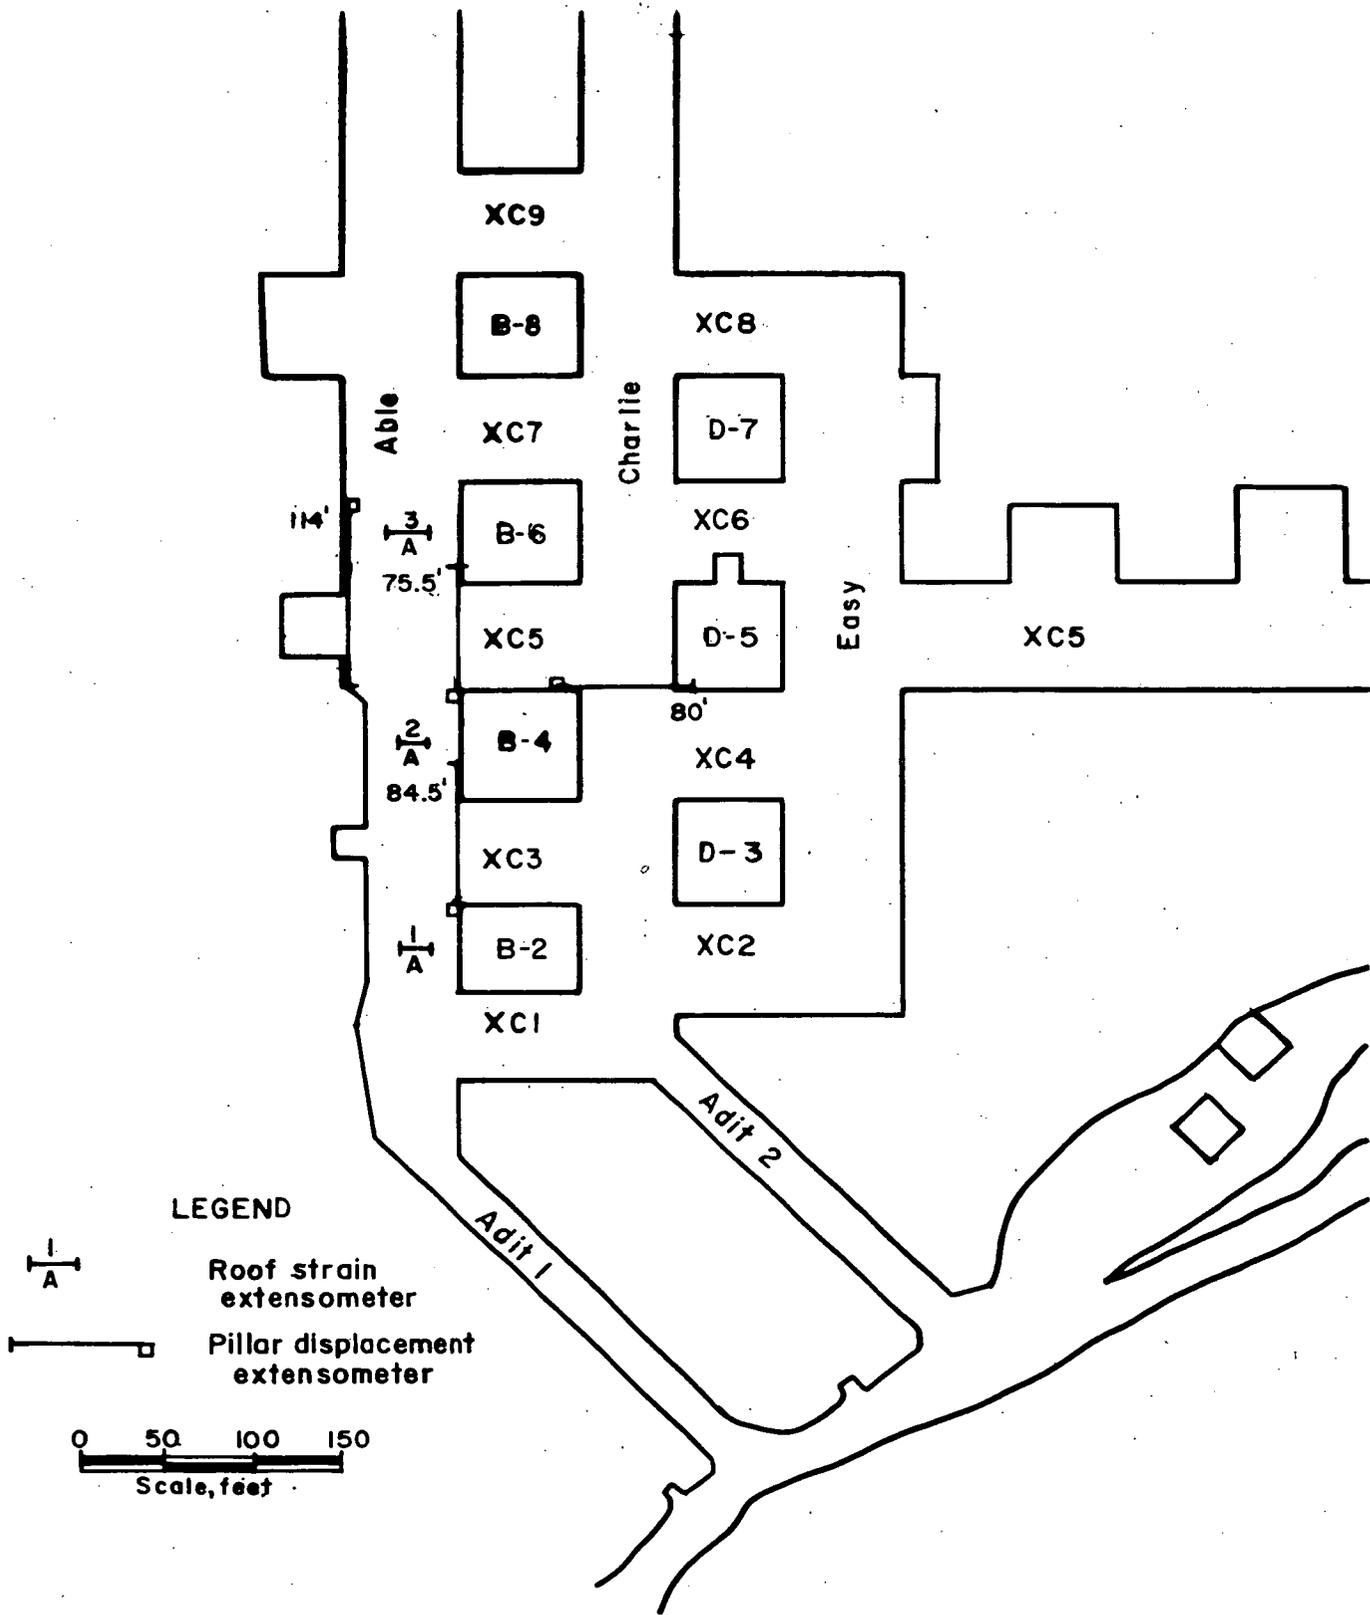
FIGURE 3.-Idealized Plan Map of the Oil Shale Mine Showing Location of Pillar and Roof Strain Instruments.

Three extensometers were installed between pillars. Their locations and measured distances are shown in figure 3. Pillar B-4 was selected as a reference pillar. Extensometer wires connected pillars B-2, B-6, and D-5 to the reference pillar.

Roof strain extensometers were installed in the roof along Able drift near stations 1A, 2A, and 3A (see Fig. 3). The extensometer consists of a rod anchored at one point on the roof, and a fixed reference point anchored 36 inches from the other anchor. An adjustable reference point and a linear, variable differential transformer (LVDT) are located near the fixed reference point (see Fig. 4). The reproducibility of the extensometer measurement is about 20  $\mu$  inches. Therefore, the strain sensitivity is  $\frac{20 \times 10^{-6} \text{ in}}{36 \text{ in}}$  or  $\approx 5 \mu \text{ in/in strain}$ .

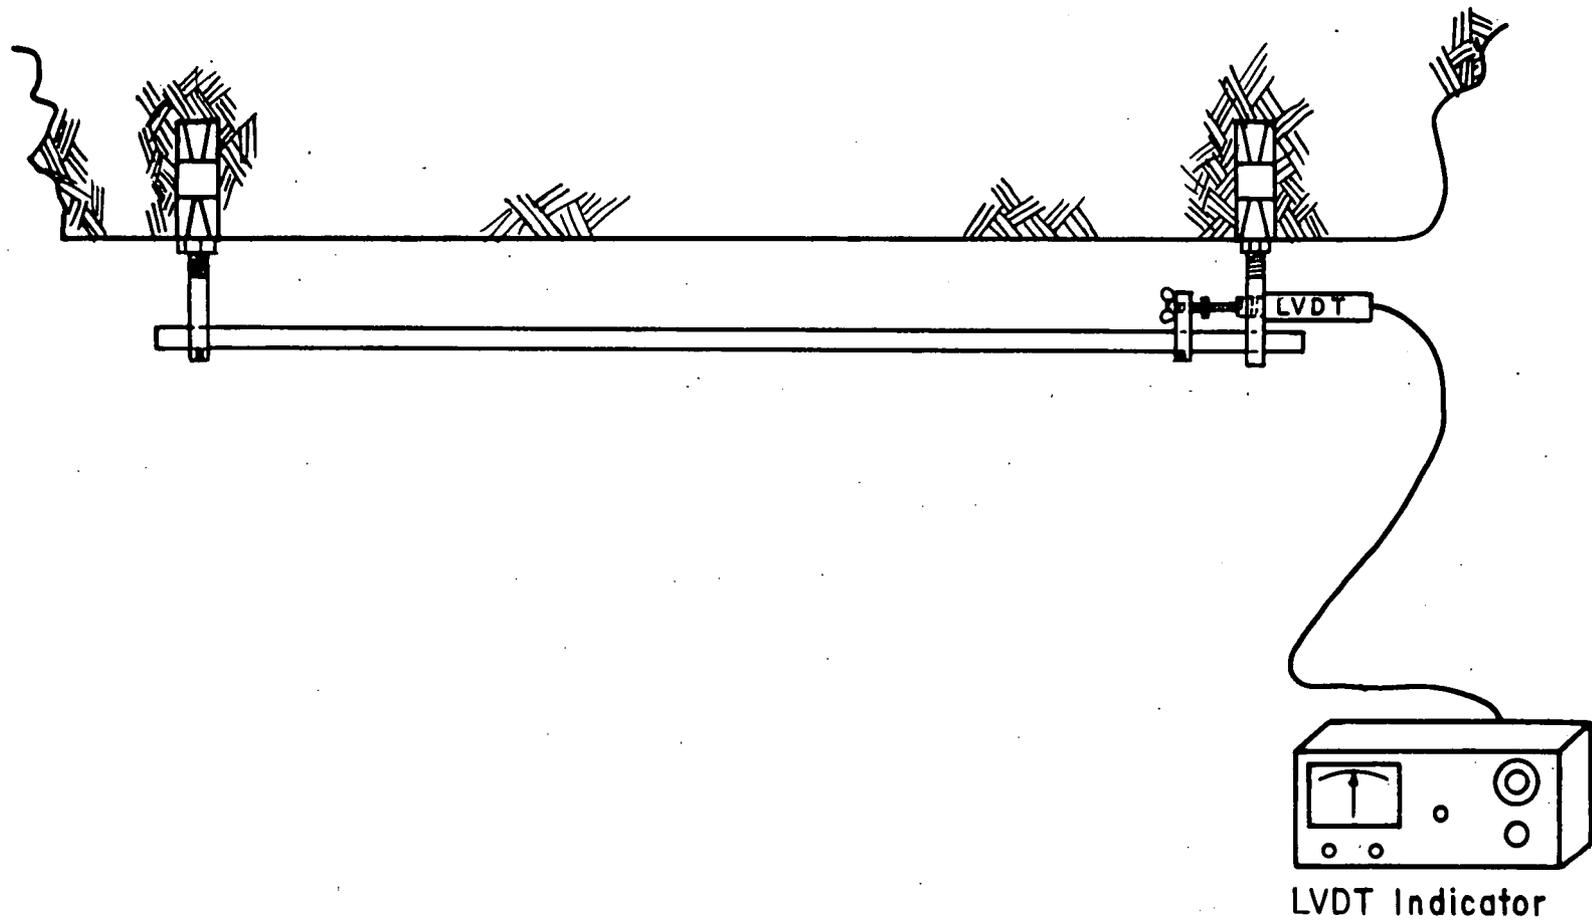
FIGURE 4.- Roof Strain Extensometer.

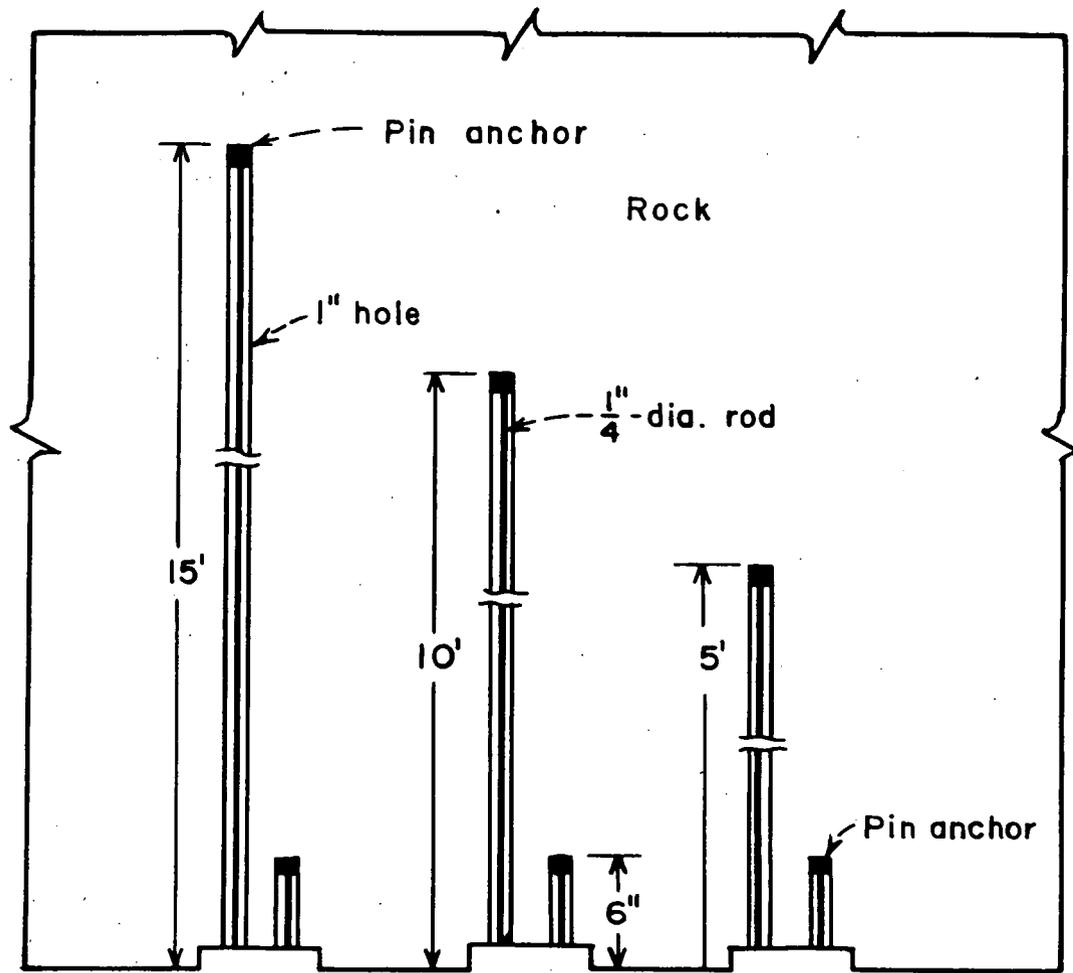
FIGURE 5.—Idealized Section of Typical Sag Pin Installation .

Changes in roof sag were made by measuring the distance between rods anchored at points 5, 10, and 15 feet in the roof, and a reference rod anchored about 6 inches in the roof. A typical sag pin installation is

illustrated in figure 5. Briefly, each instrument consists of two rods anchored in a borehole drilled normal to the back. The reference rod is about 1 to 1-1/2 inches from the adjacent rod anchored in the bottom of the other borehole. A group of one or more sag pins is called a sag station. The distance between the two rods was measured directly with a standard machinist's depth gage. Sag pins were anchored at roof depths of 5, 10, and 15 feet at stations 1, 2, 3, and 4 (see Fig. 6). Sag pins were anchored at depths of 15 feet at stations 1A, 2A, and 4A, and at a depth of 10 feet at station 3A. The distance between the end of the anchored rod and the end of the reference pin was measured three times and an average computed. The reproducibility of this measurement is largely dependent upon the operator; in this investigation the reproducibility was 0.010 inch, or less.

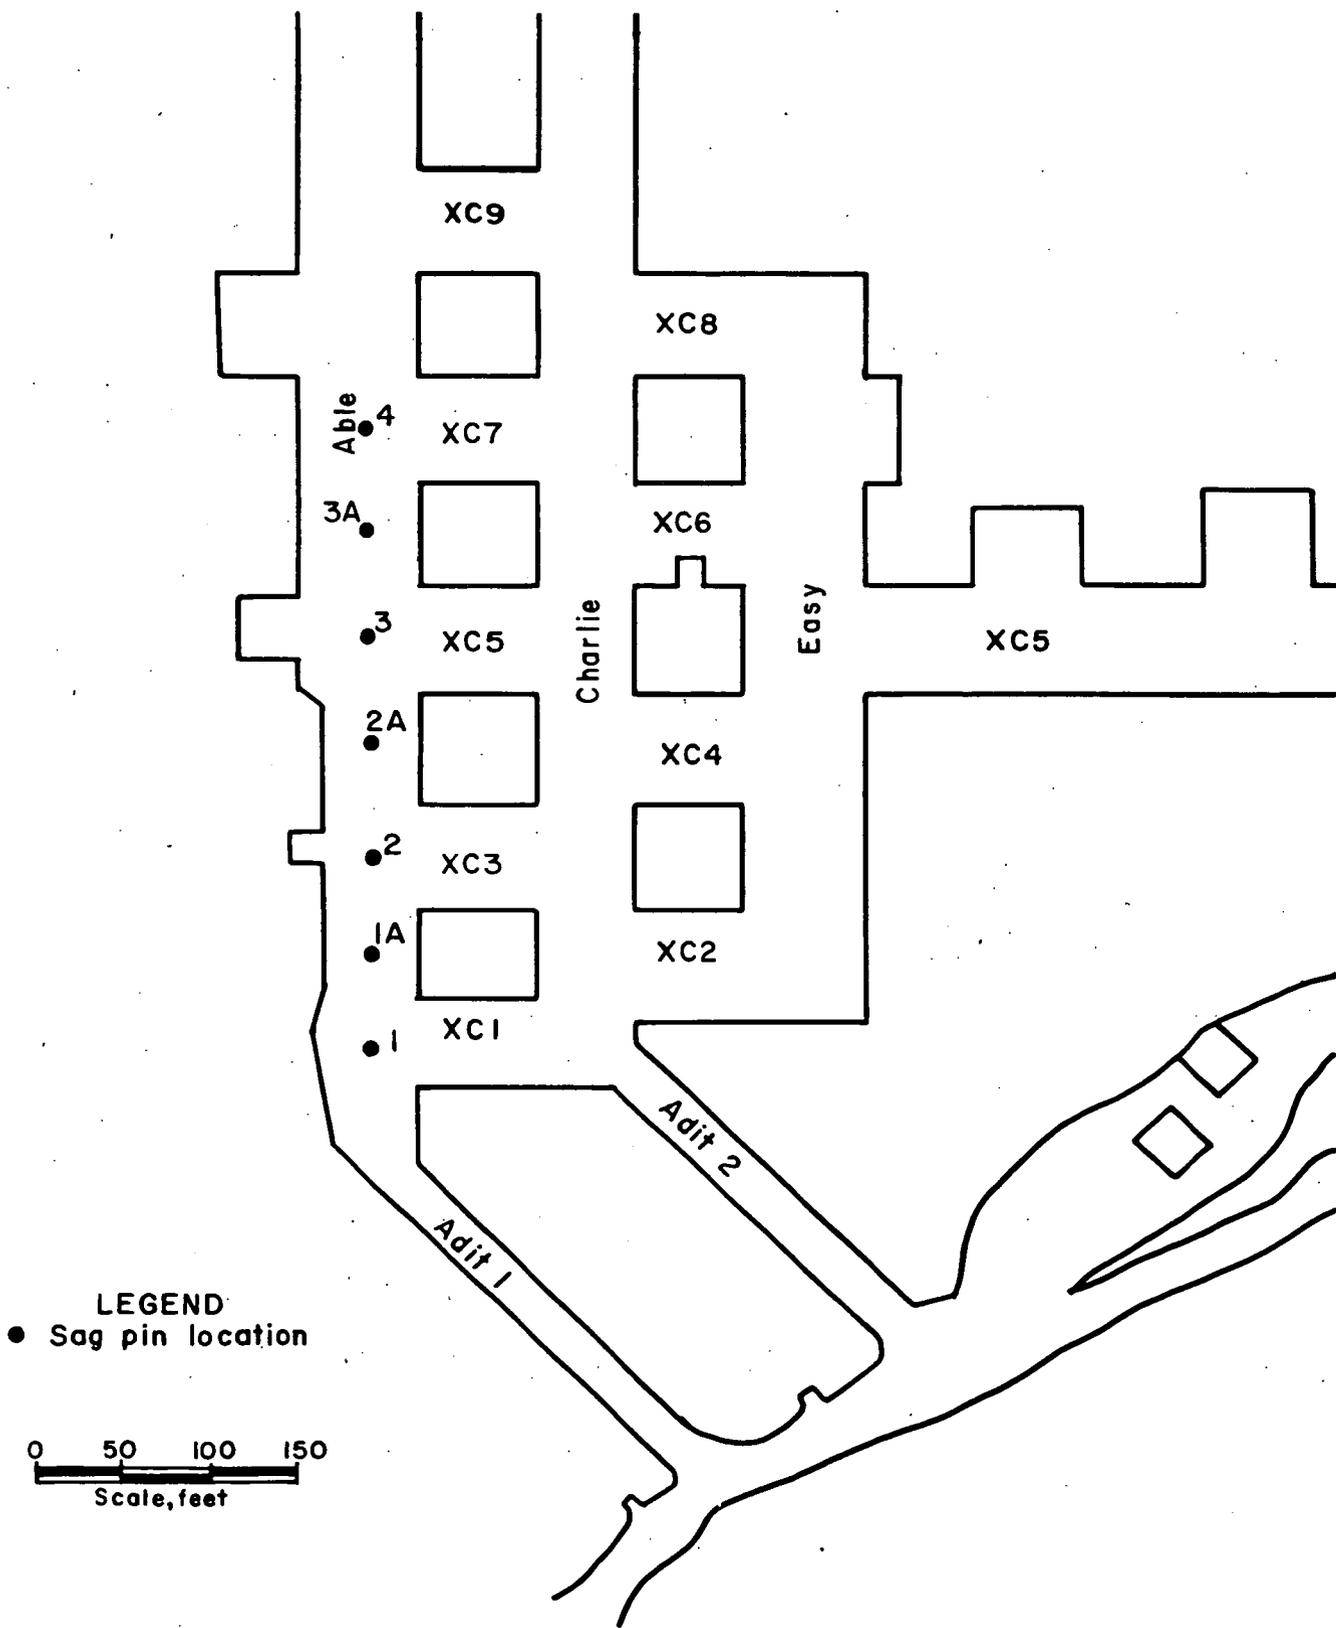
FIGURE 6.- Plan Map Showing Location of Sag Pins.

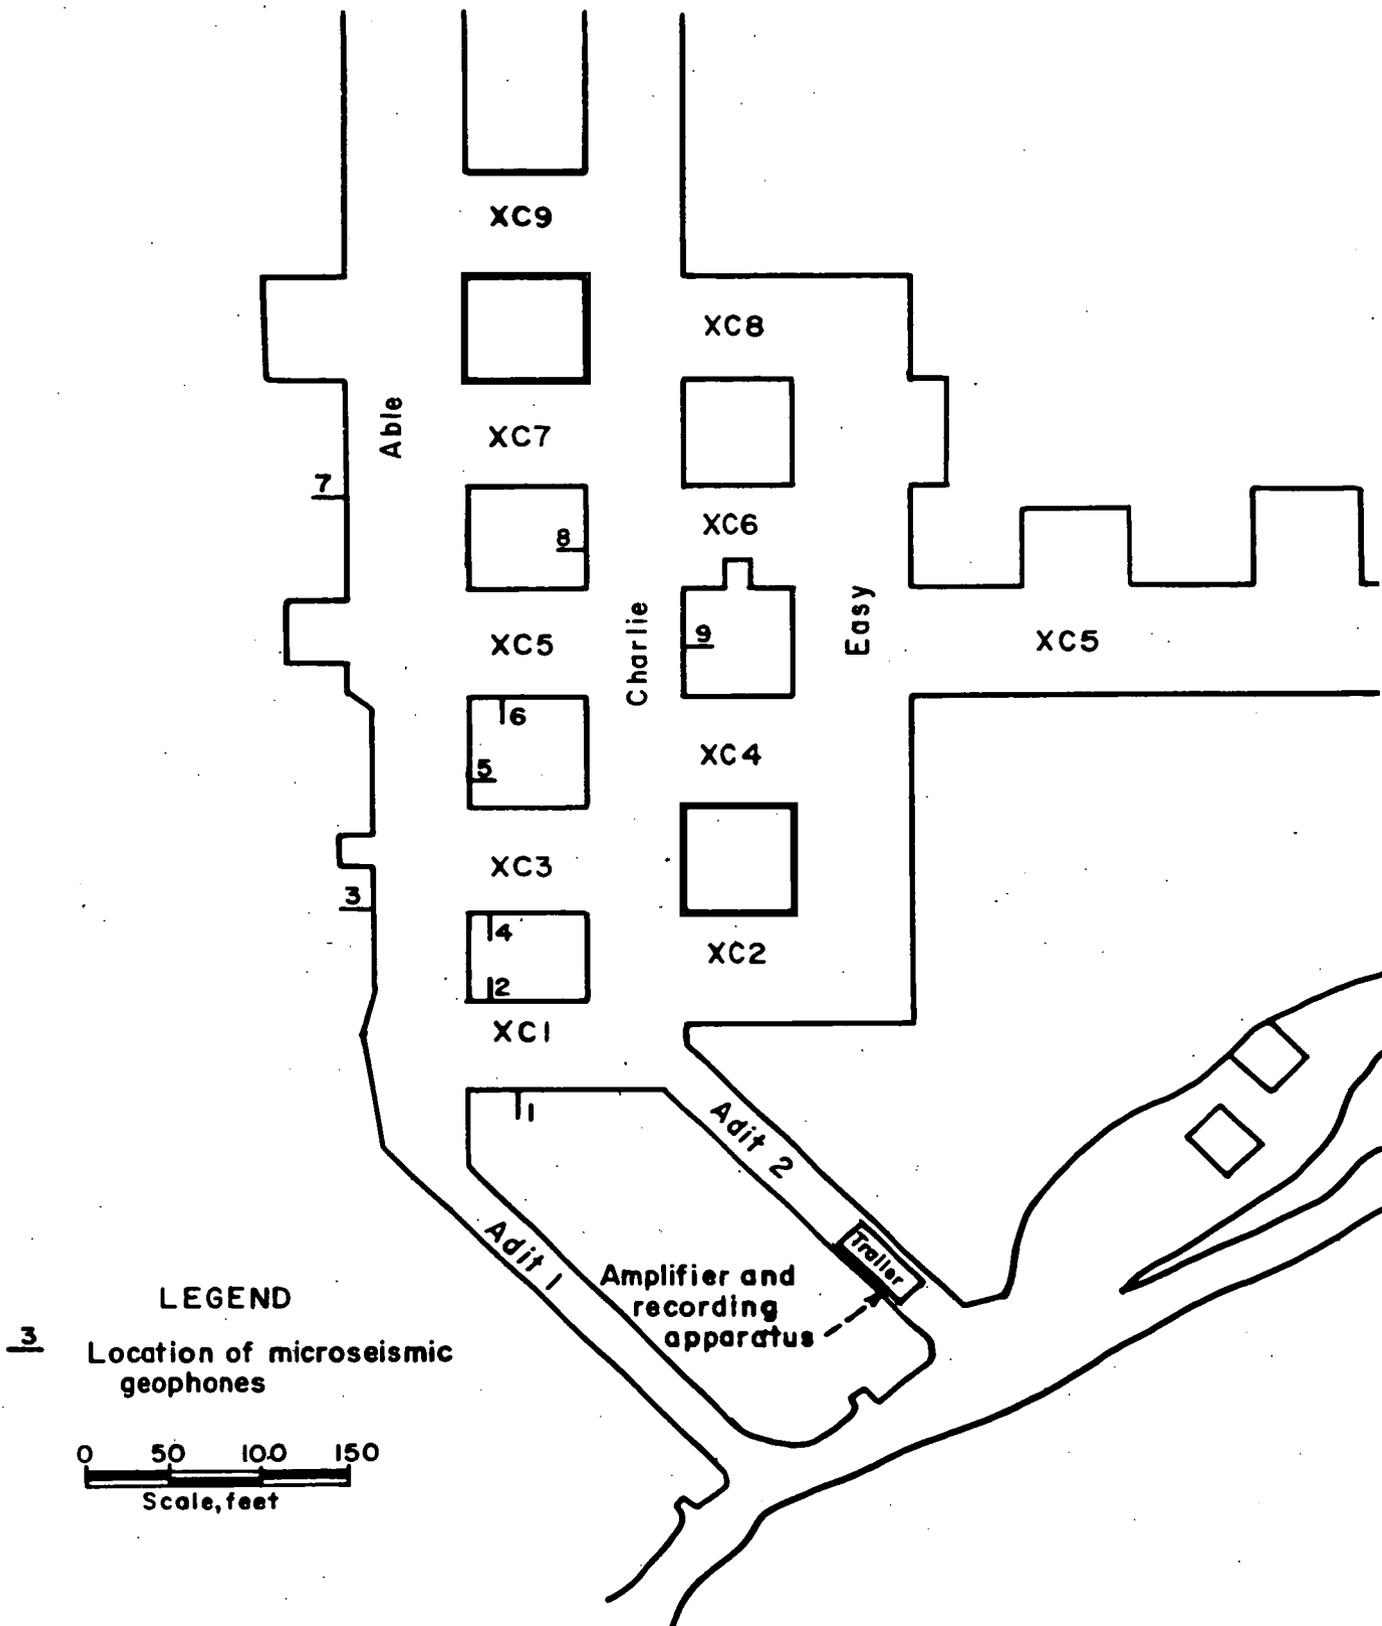
**FIGURE 7.- Plan Map Showing Location of Geophones and microseismic Recording Apparatus.**

Nine geophones were placed in boreholes at locations illustrated in figure 7 and their output cabled to amplifying and recording instruments housed in a trailer at the portal of adit 2. Recordings of microseismic noises were made before, during, and after the shot.

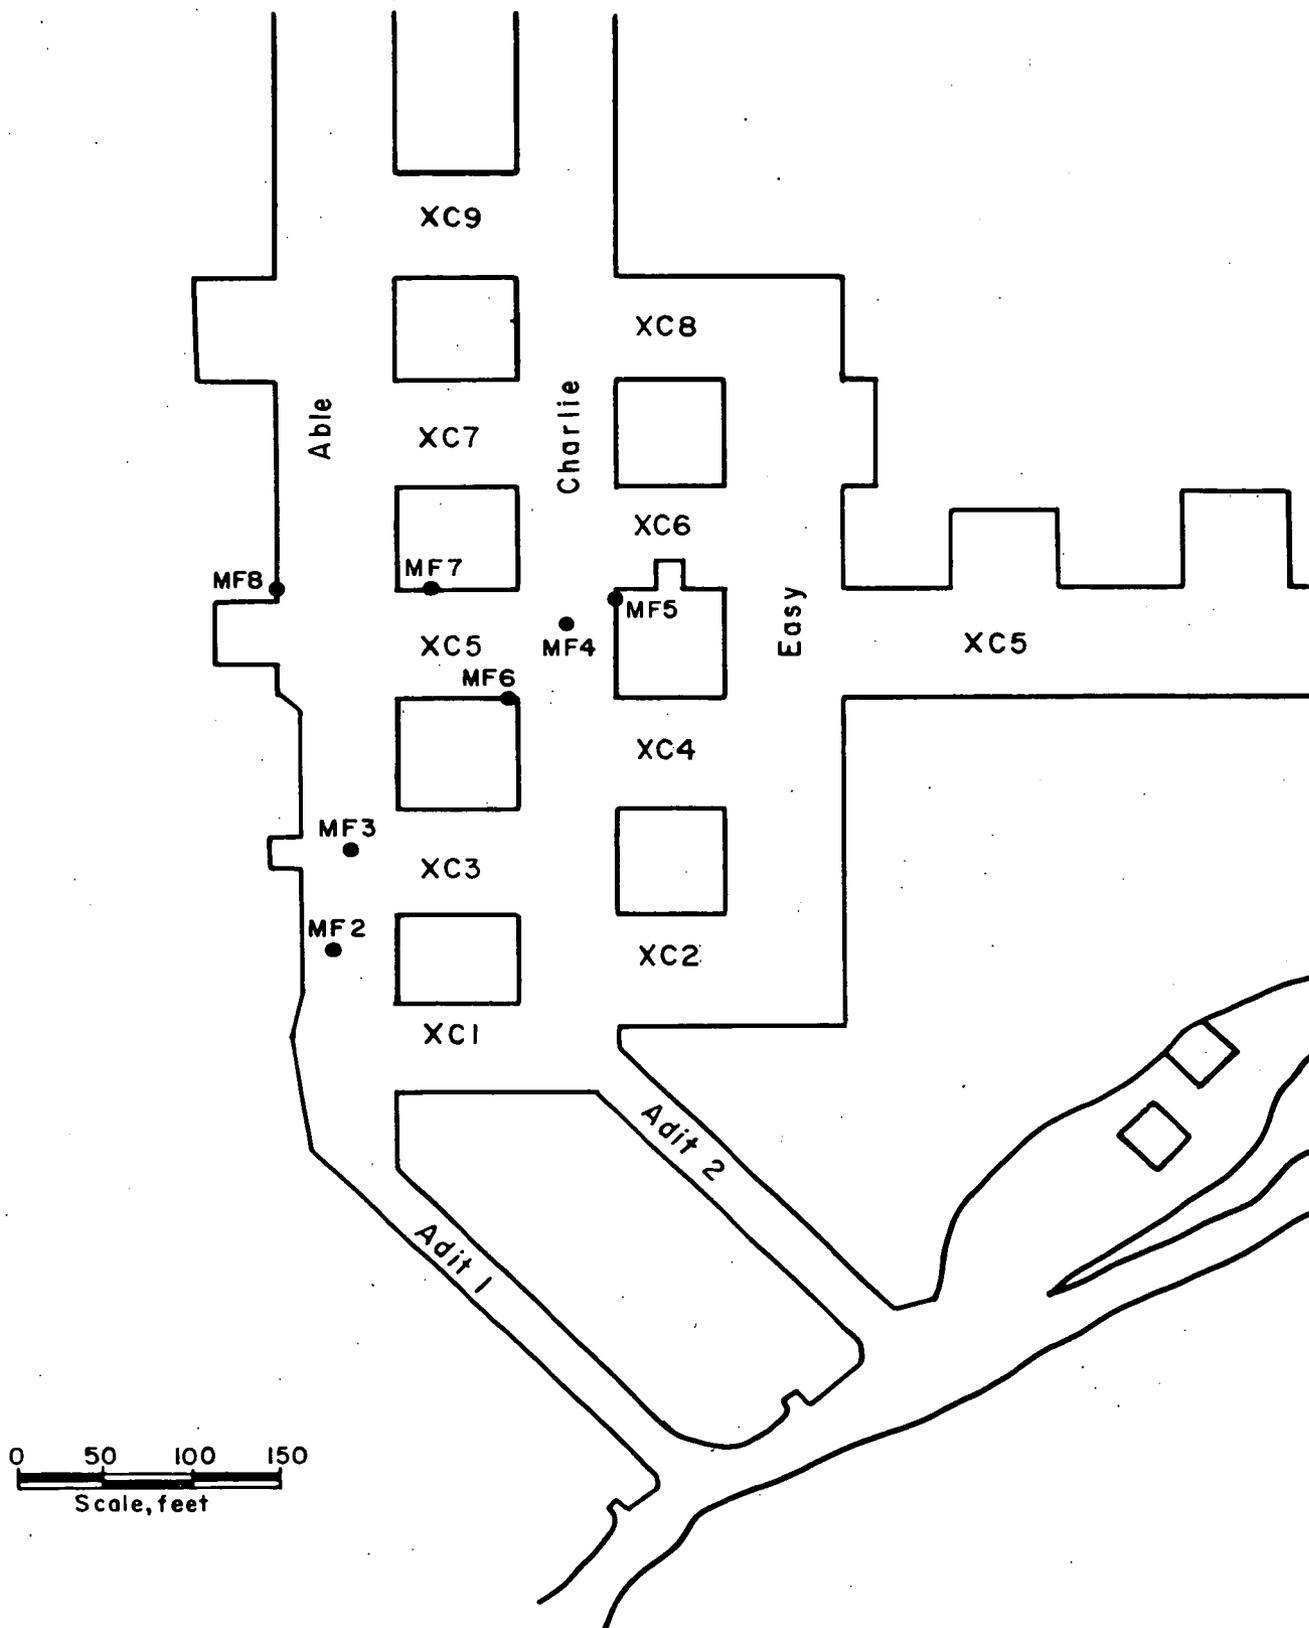
FIGURE 8.-Plan Map Showing the Location of the Accelerometers.

A seven-channel, broad-band microseismic system was used with seven accelerometer locations as shown on figure 8. Accelerometers MF 2, MF 3, and MF 4 were attached to the roof and the remaining geophones were attached to rock in the lower part of pillars.

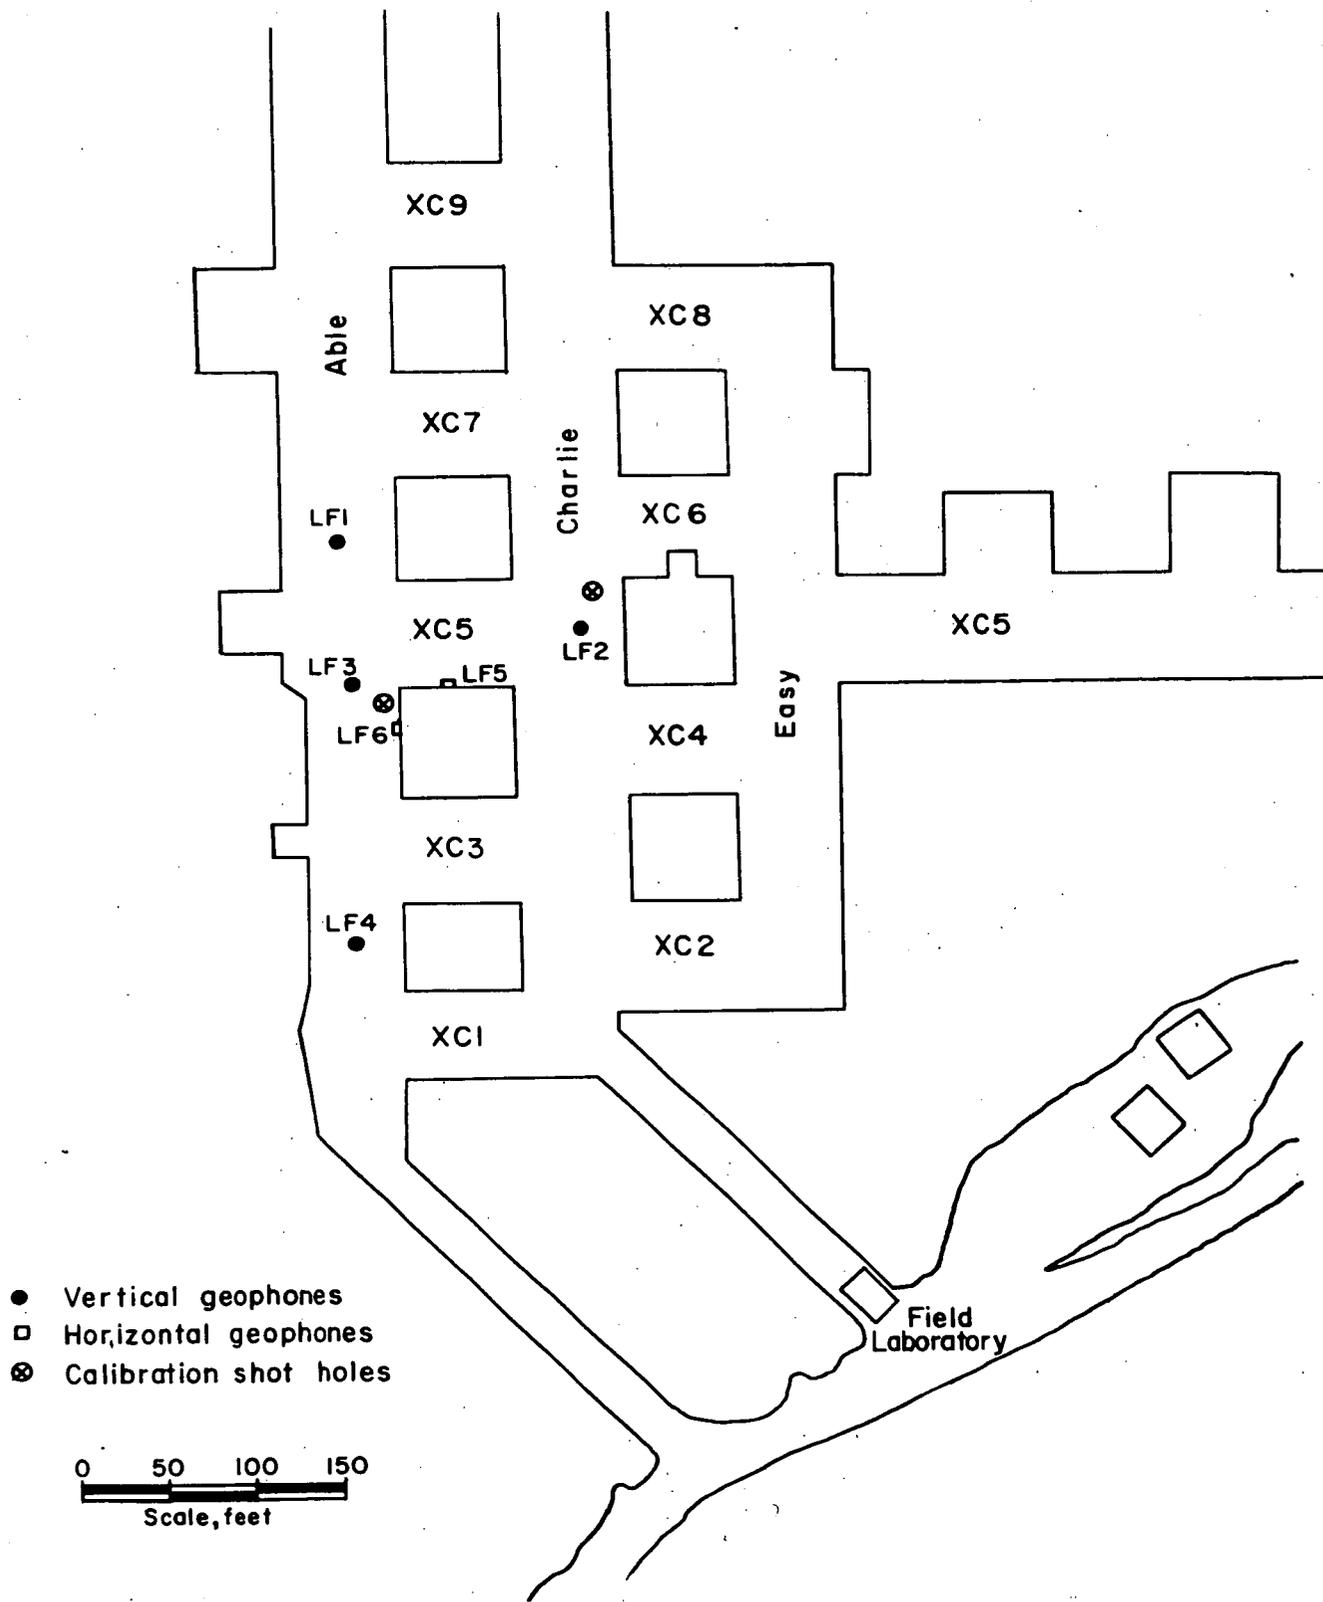
FIGURE 9.-Plan View of Low Frequency Geophone Locations.

Low frequency microseismic equipment was installed at locations shown in figure 9. Geophones LF 1, LF 2, and LF 4 were mounted on the roof. LF 3 was on the floor and LF 5 and LF 6 were mounted on a pillar halfway between the floor and roof. Figure 10 shows a typical geophone mount on the roof.

Several 150-gram calibration shots were detonated on September 10, in two drill holes (see Fig. 9) in the mine. These data were used to check geophone polarity, evaluate the geophone mountings and location, and to determine P and S velocities.

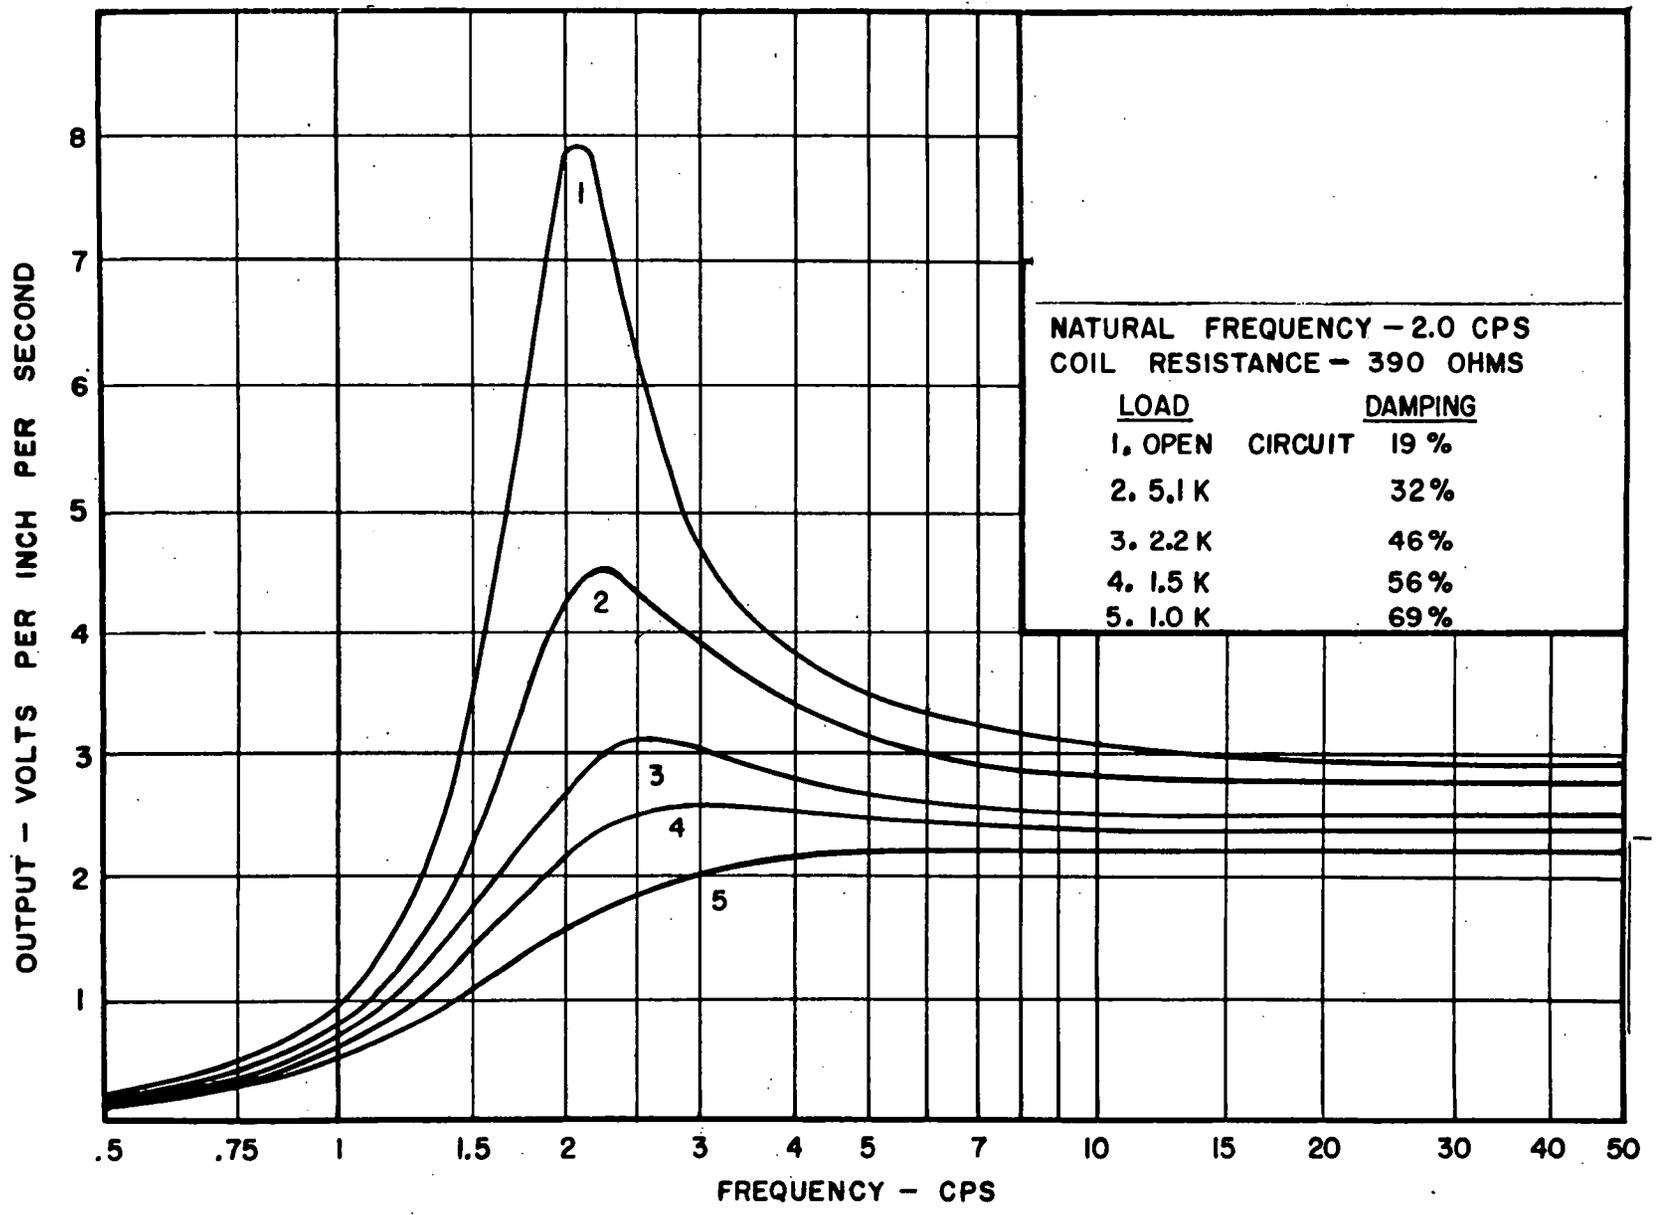
FIGURE 11.-Geophone Frequency Response Curve.

The geophones were standard velocity type, with a 2-cycle natural frequency. Each geophone output was shunted with 1500 ohms to flatten the response curve. A typical response curve is shown in figure 11. All data were recorded on magnetic tape, using a 14-channel FM magnetic tape recorder. A tape speed of 7-1/2 IPS was used to provide maximum running time while retaining good signal-to-noise ratio (48 db), and frequency response (dc to 5 k Hz). The data were dual-recorded with a separation of 14 db, with the high gain being unity.

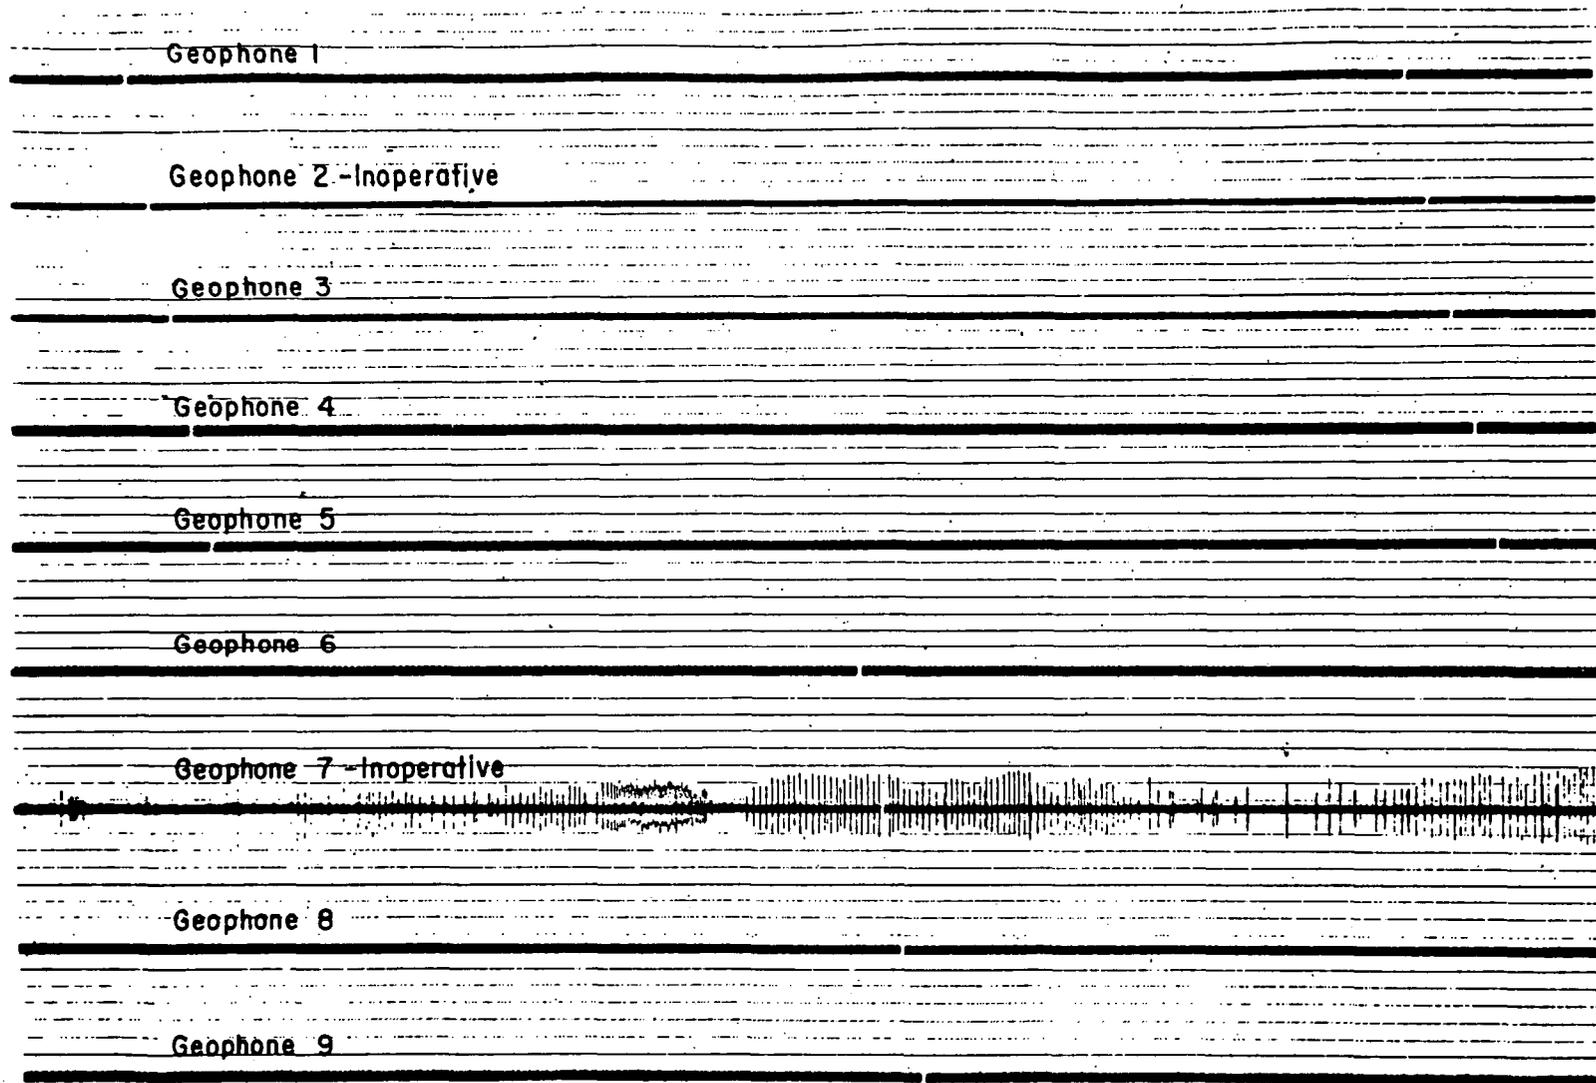
FIGURE 12.- Sample Record -Pre-Shot Microseismic Recording

Representative samples of microseismic recordings showing pre-shot, shock arrival, and post-shot periods are given in figures 12, 13, and 14, respectively. Recording times as shown in the figures are short compared with the longer periods of pre- and post-shot recording; however, these records are representative of the data obtained over the longer periods.

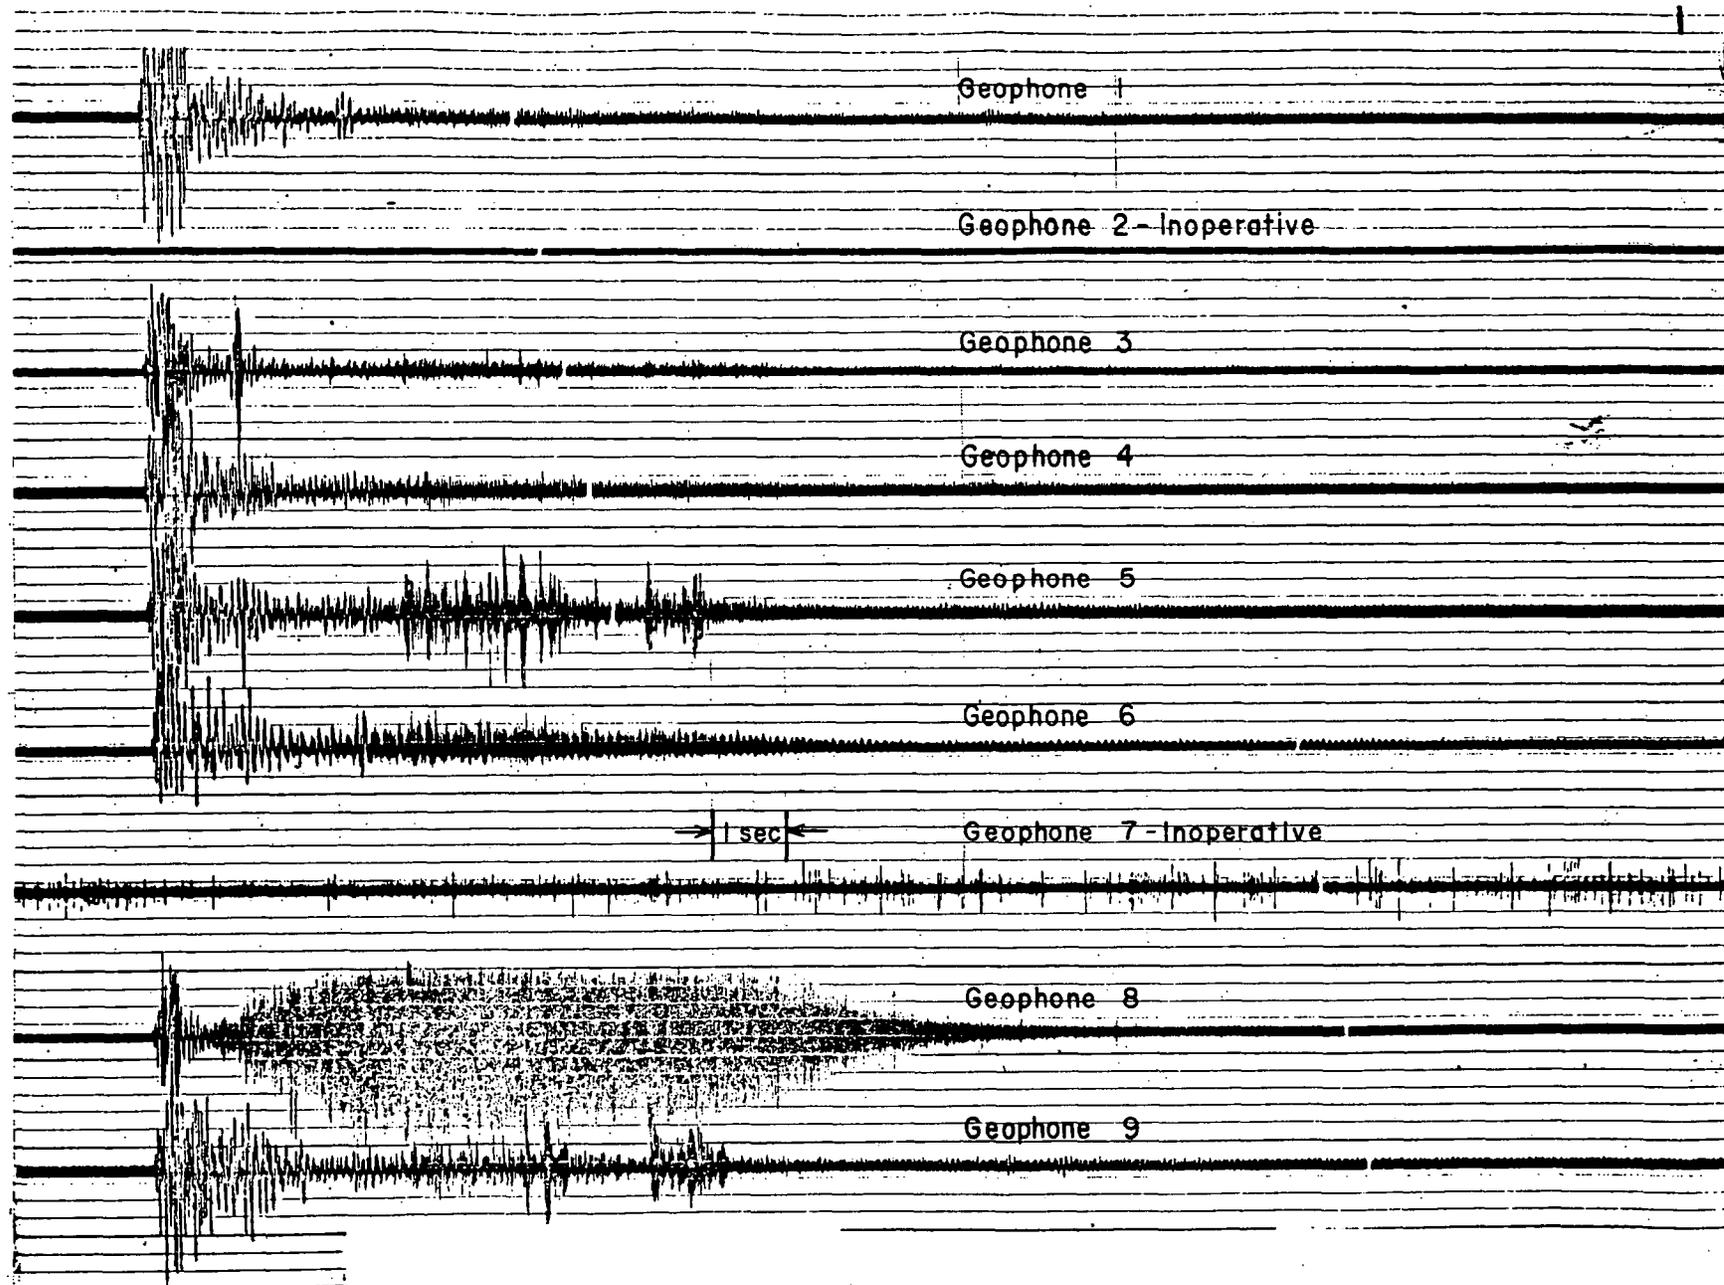
FIGURE 13.- Microseismic Recording - Rulison Event.

The wide-range microseismic equipment did not detect any appreciable rock noise 20 seconds after the shot (see Fig. 13). As in all of the other measurements of seismic response, the greatest amplitudes and largest number of noises appeared with the first arrival, and gradually lessened to almost zero response within 10 seconds.

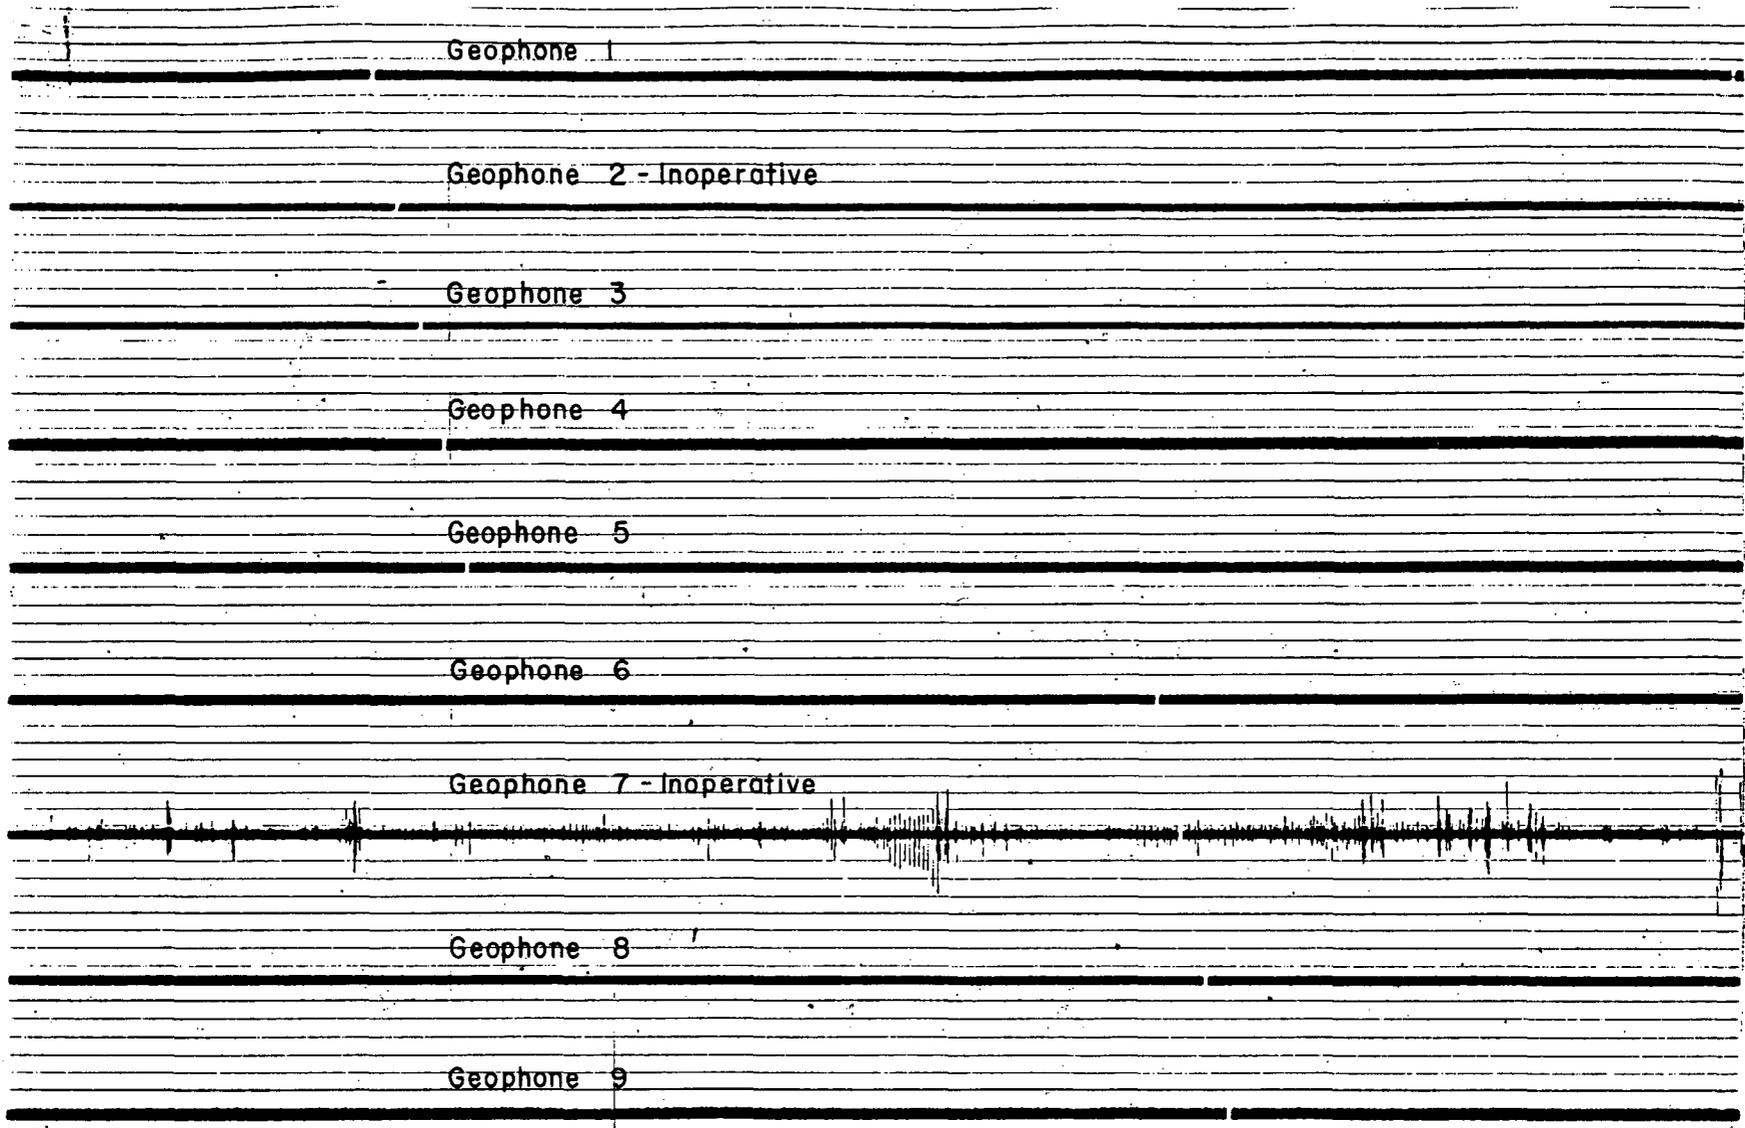
FIGURE 14.- Sample Record - Post Shot Microseismic Recording
