Dynamic and Static Response of  
the Government Oil Shale Mine at  
Rifle, Colorado, to the Rulison  
Event

UNITED STATES  
DEPARTMENT OF THE INTERIOR  
BUREAU OF MINES

February 2, 1970

DYNAMIC AND STATIC RESPONSE OF THE GOVERNMENT  
OIL SHALE MINE AT RIFLE, COLORADO,  
TO THE RULISON EVENT

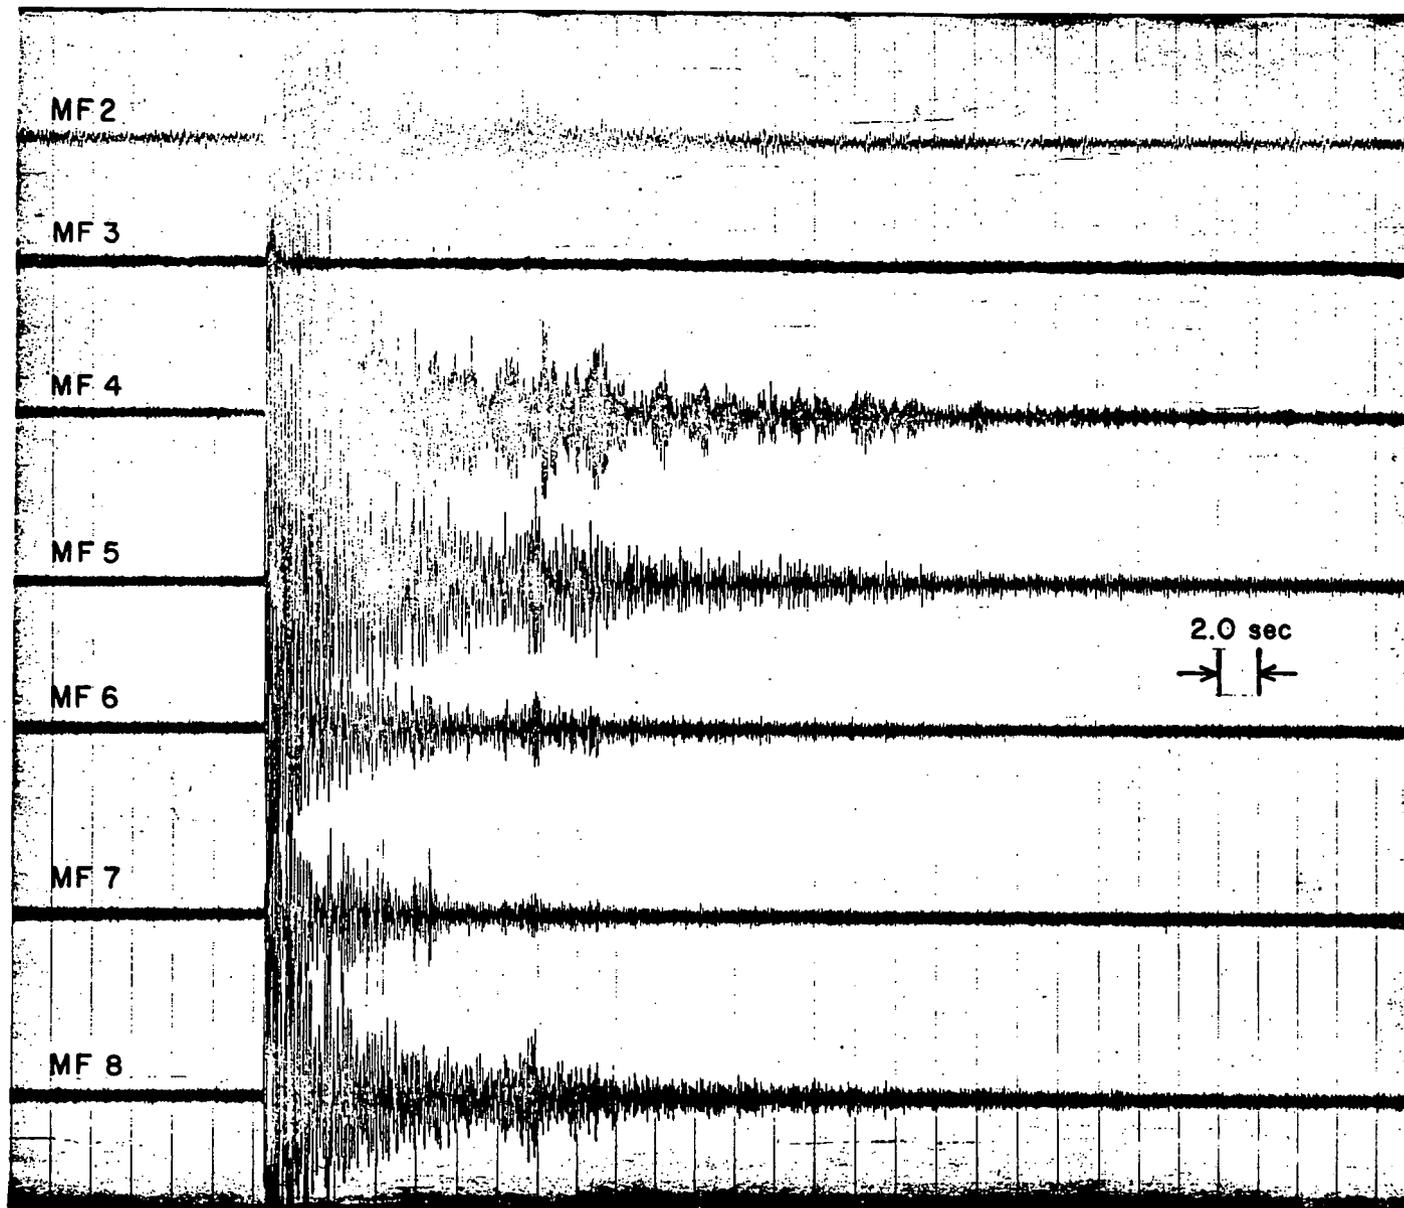
FIGURE 15.—Reproduced Record of Noises Recorded by the Source Location Microseismic Equipment.

A copy of the record taken by the source location microseismic equipment, for a period of about 18 seconds before and about 80 seconds after the detonation, is shown in figure 15. The response was high on all channels with the exception of MF 3, which was inoperative. There was an abundance of noise for about 8 to 10 seconds, and most of the noise following 10 seconds has been identified as dust particles striking the accelerometers. There was no identifiable source of sustained noise; rather, the noises were general and randomly located throughout the area of investigation.

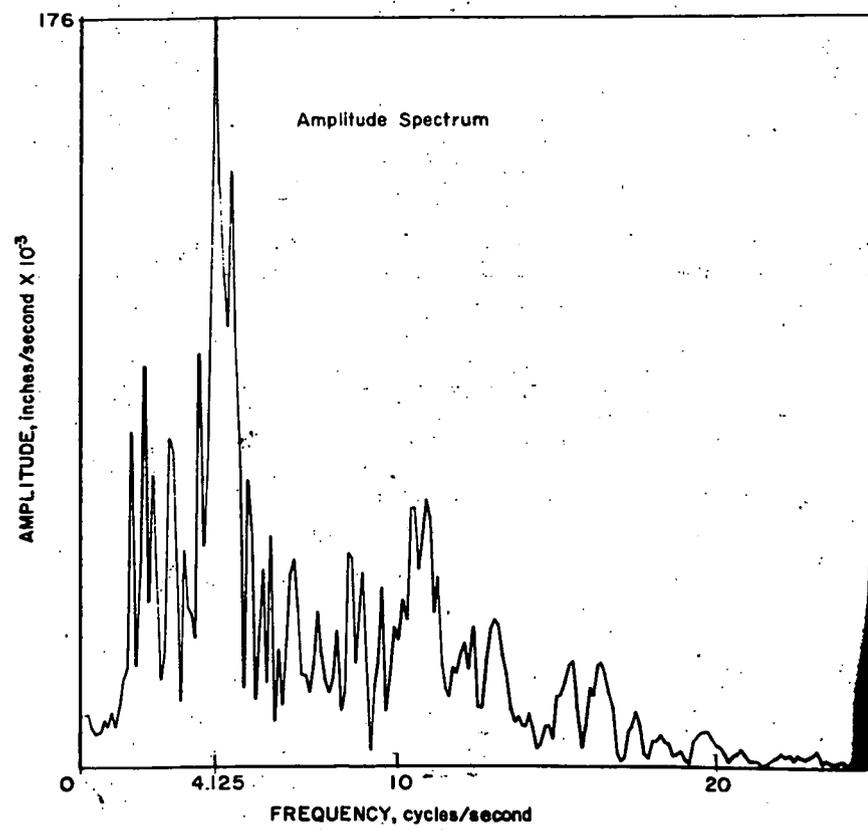
FIGURE 17.-Amplitude Versus Time and Frequency, LFI.

The analog data were digitized and computer processed to provide amplitude spectra, displacements, and accelerations. Figures 17 through 22 show these results as well as the original velocity data. One interesting

observation is, as the unsupported roof area around the geophone increases so does the particle velocity amplitude.

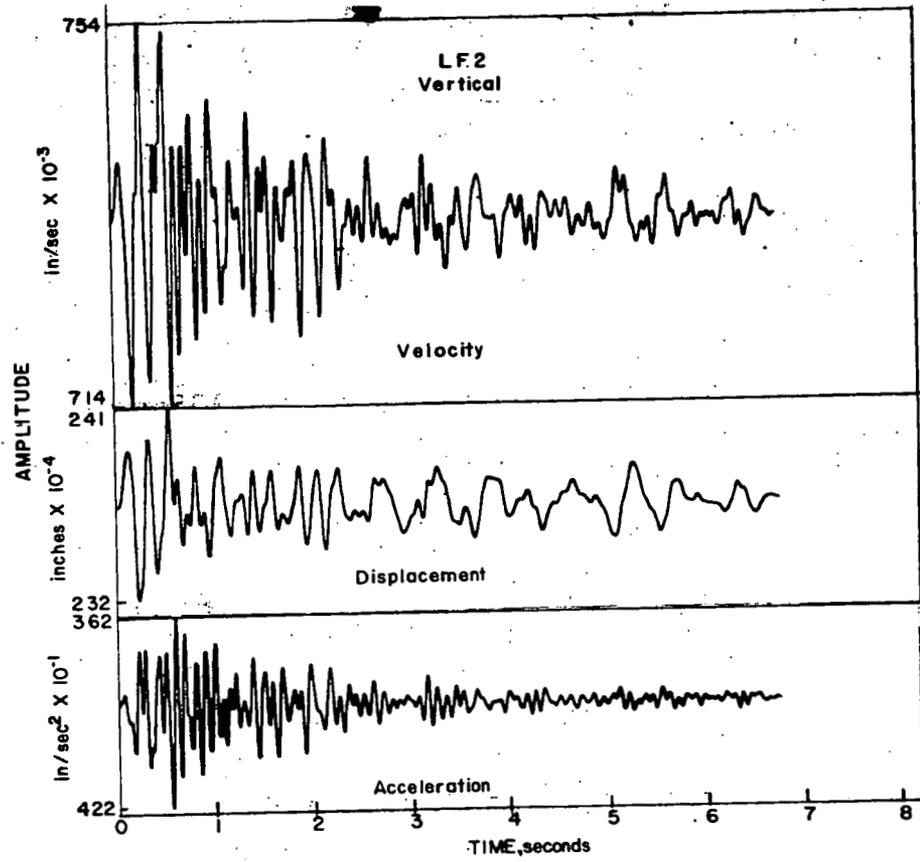
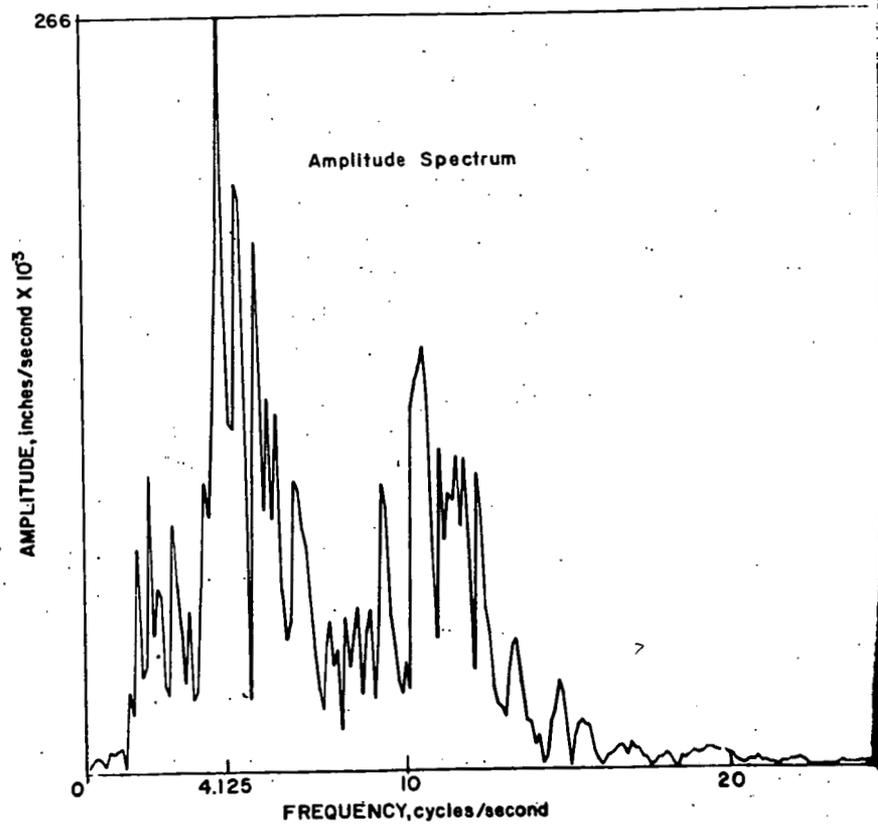
FIGURE 18.-Amplitude Versus Time and Frequency,LF2.

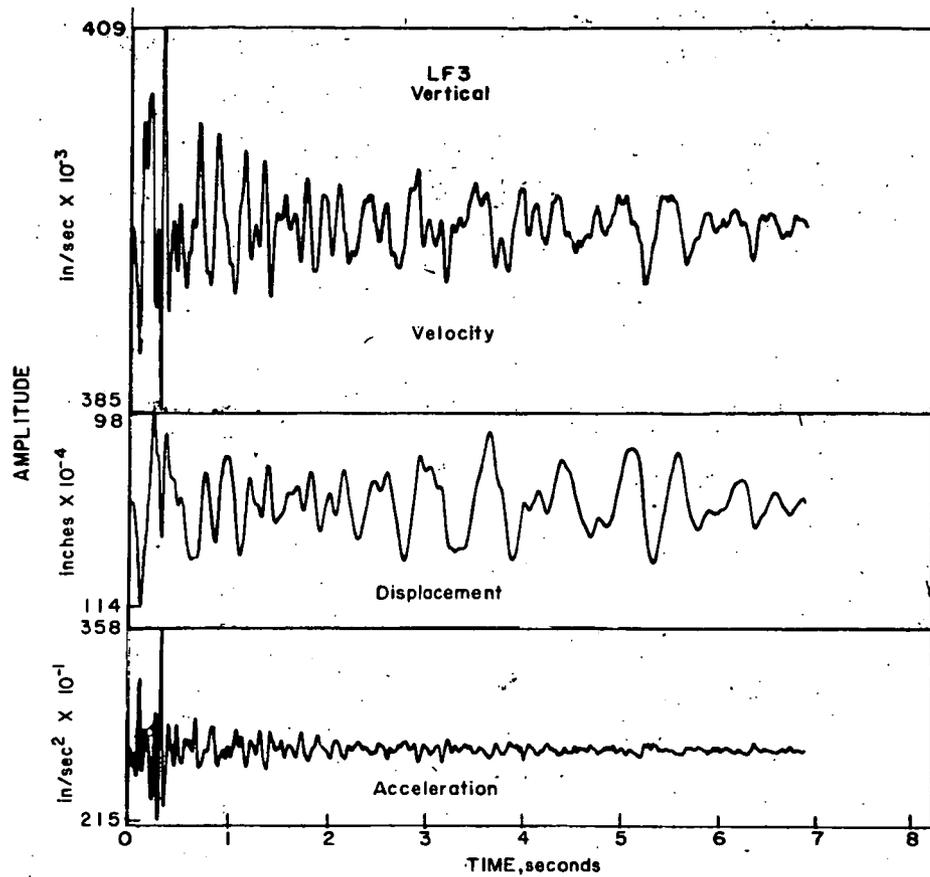
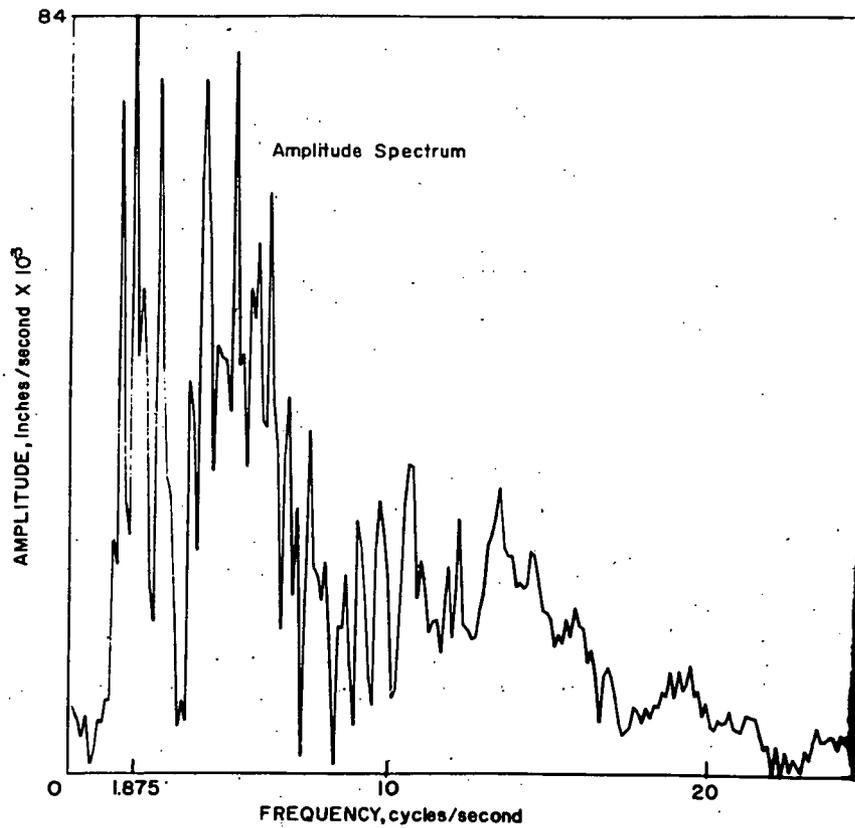
FIGURE 19.-Amplitude Versus Time and Frequency, LF3.

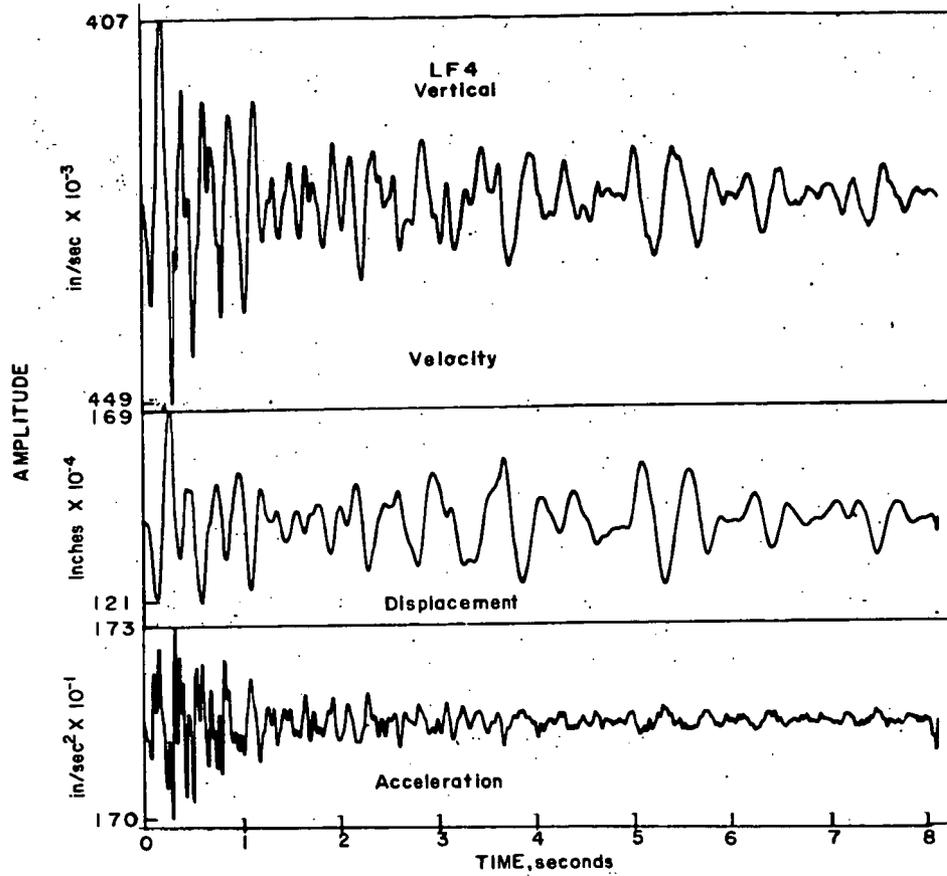
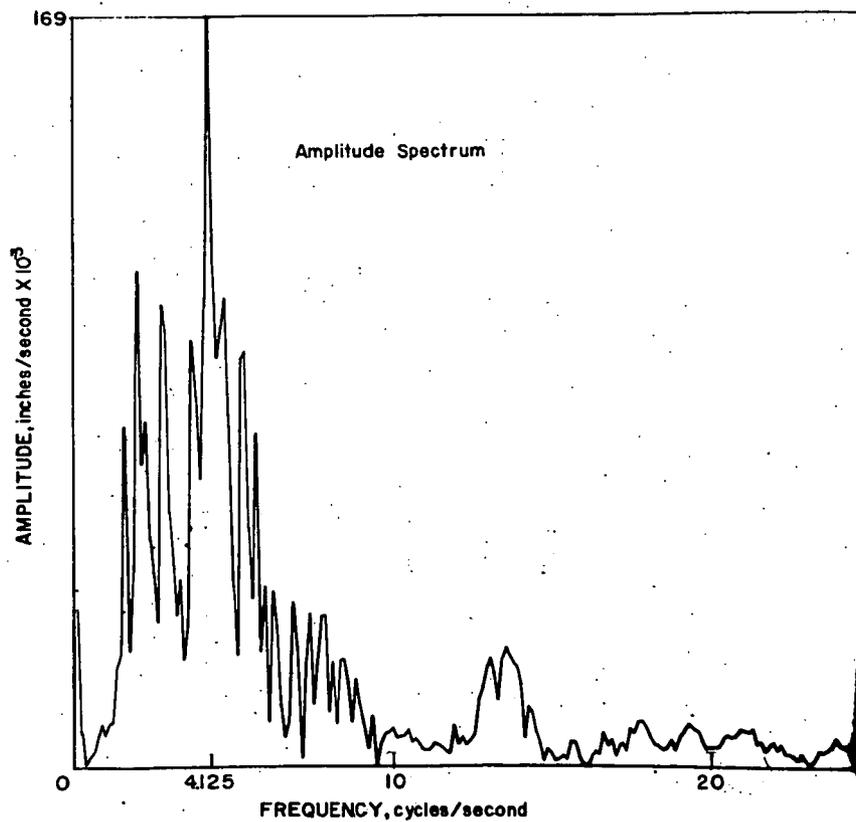
FIGURE 20.-Amplitude Versus Time and Frequency, LF4.

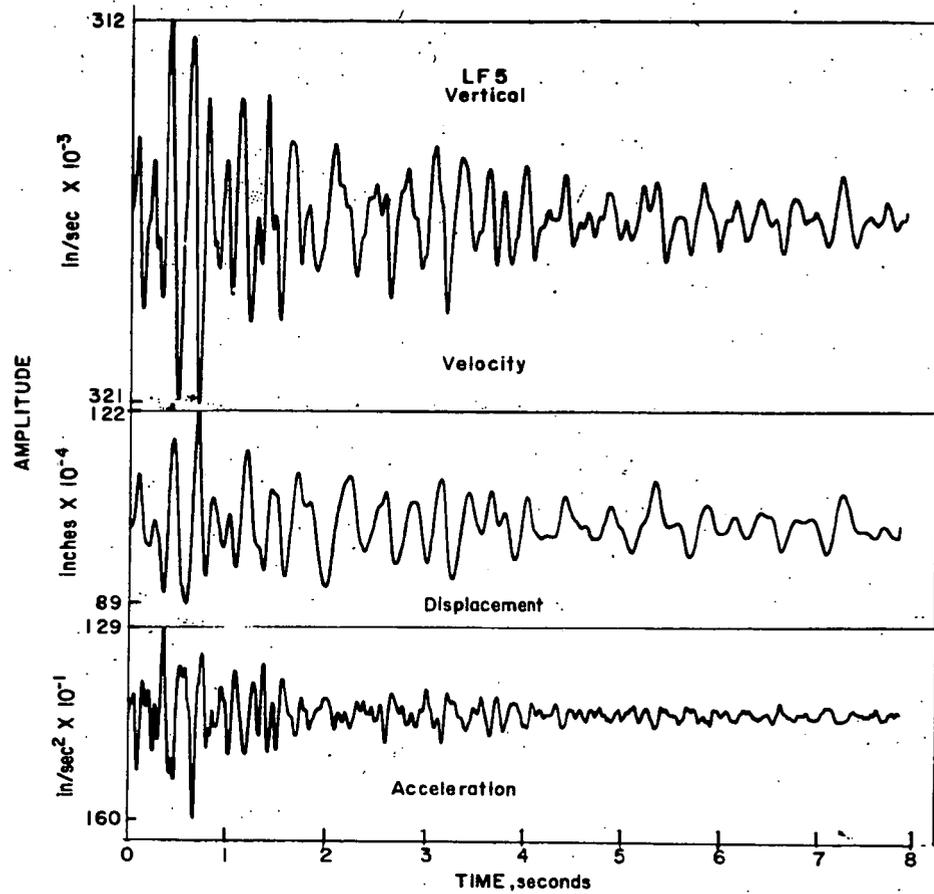
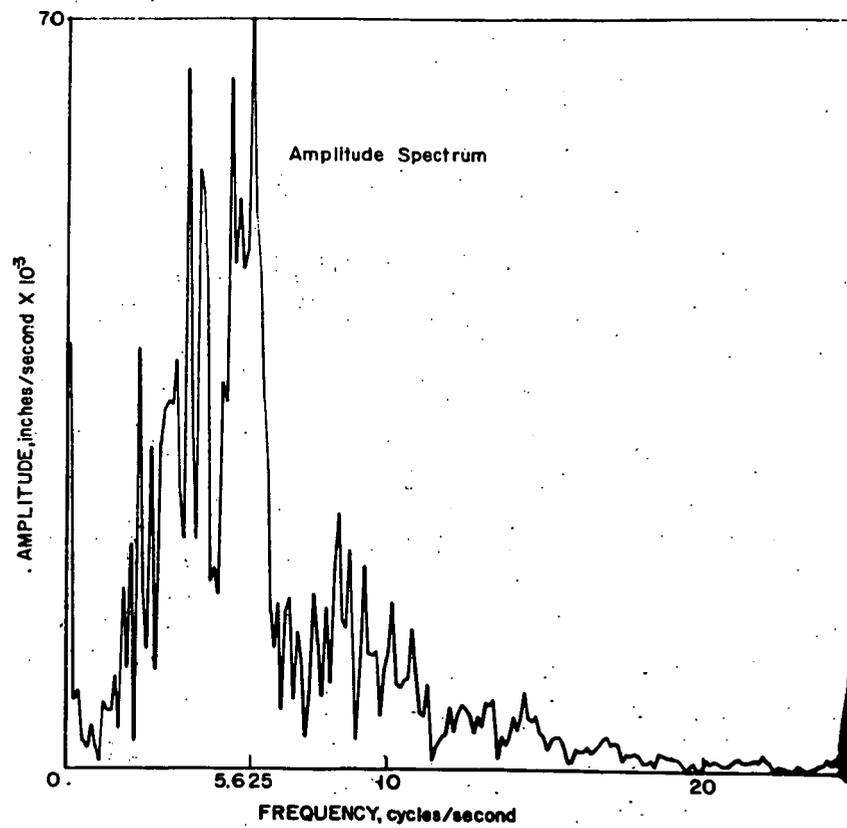
FIGURE 21.-Amplitude Versus Time and Frequency, LF5.

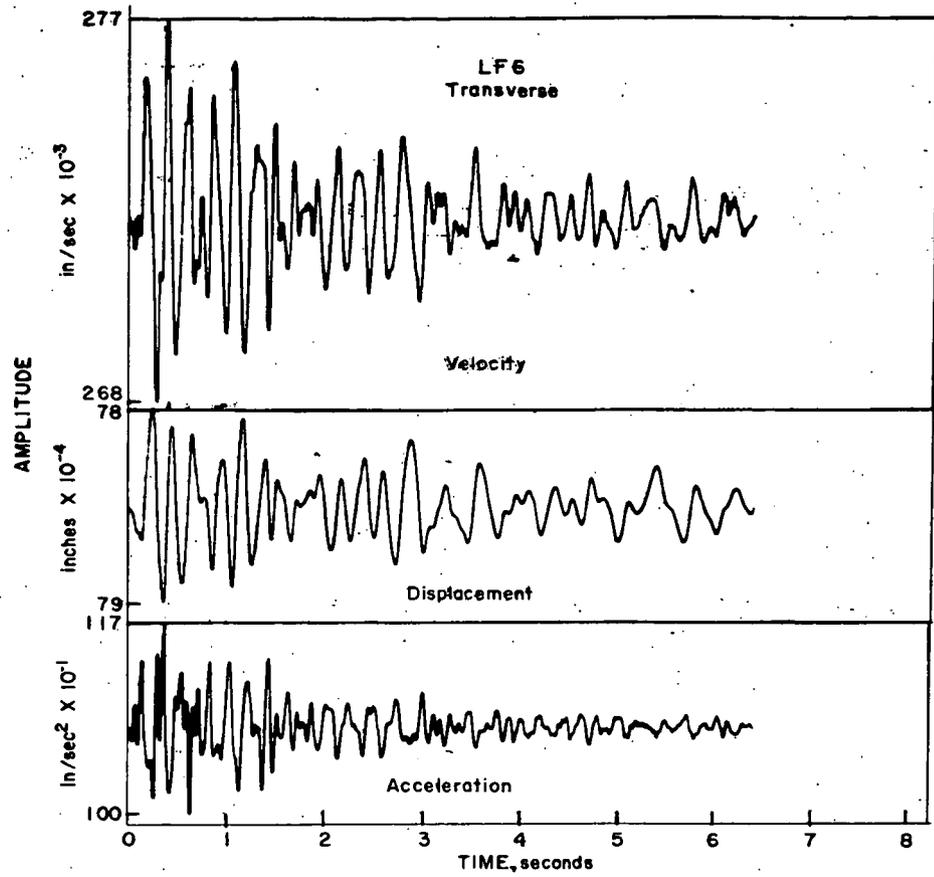
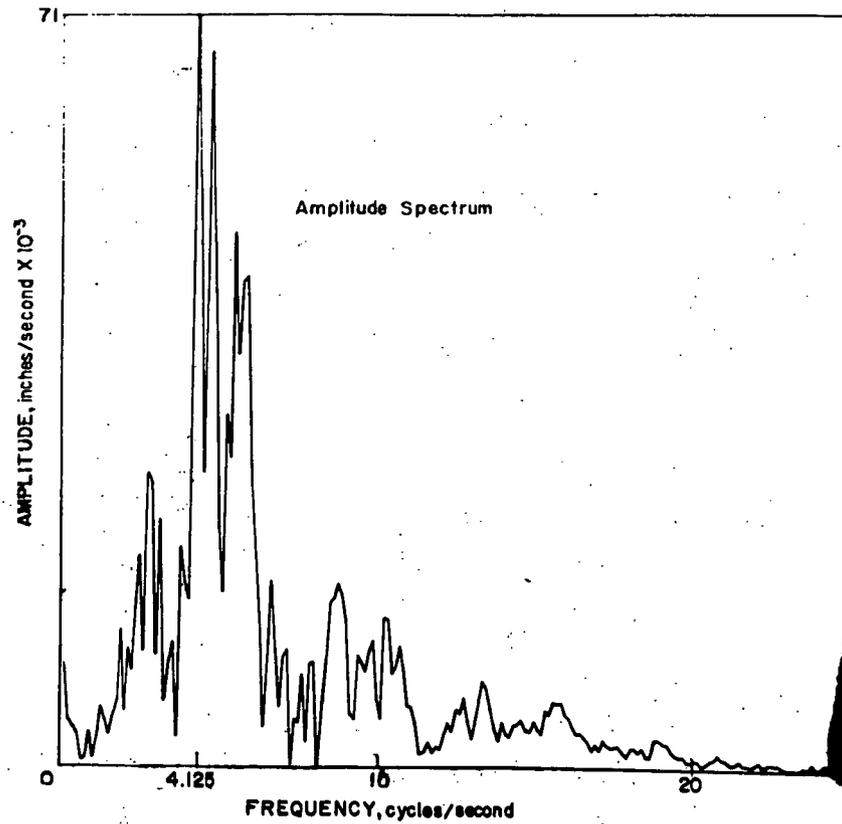
FIGURE 22.-Amplitude Versus Time and Frequency, LF6.
