NVO-1163-TM-23

**PHOTO INTERPRETATION  
OF CLOSE-IN PHYSICAL EFFECTS  
OF AN  
UNDERGROUND NUCLEAR DETONATION**

ENVIRONMENTAL RESEARCH CORPORATION  
a subsidiary of computer sciences corporation

SEPTEMBER 1970

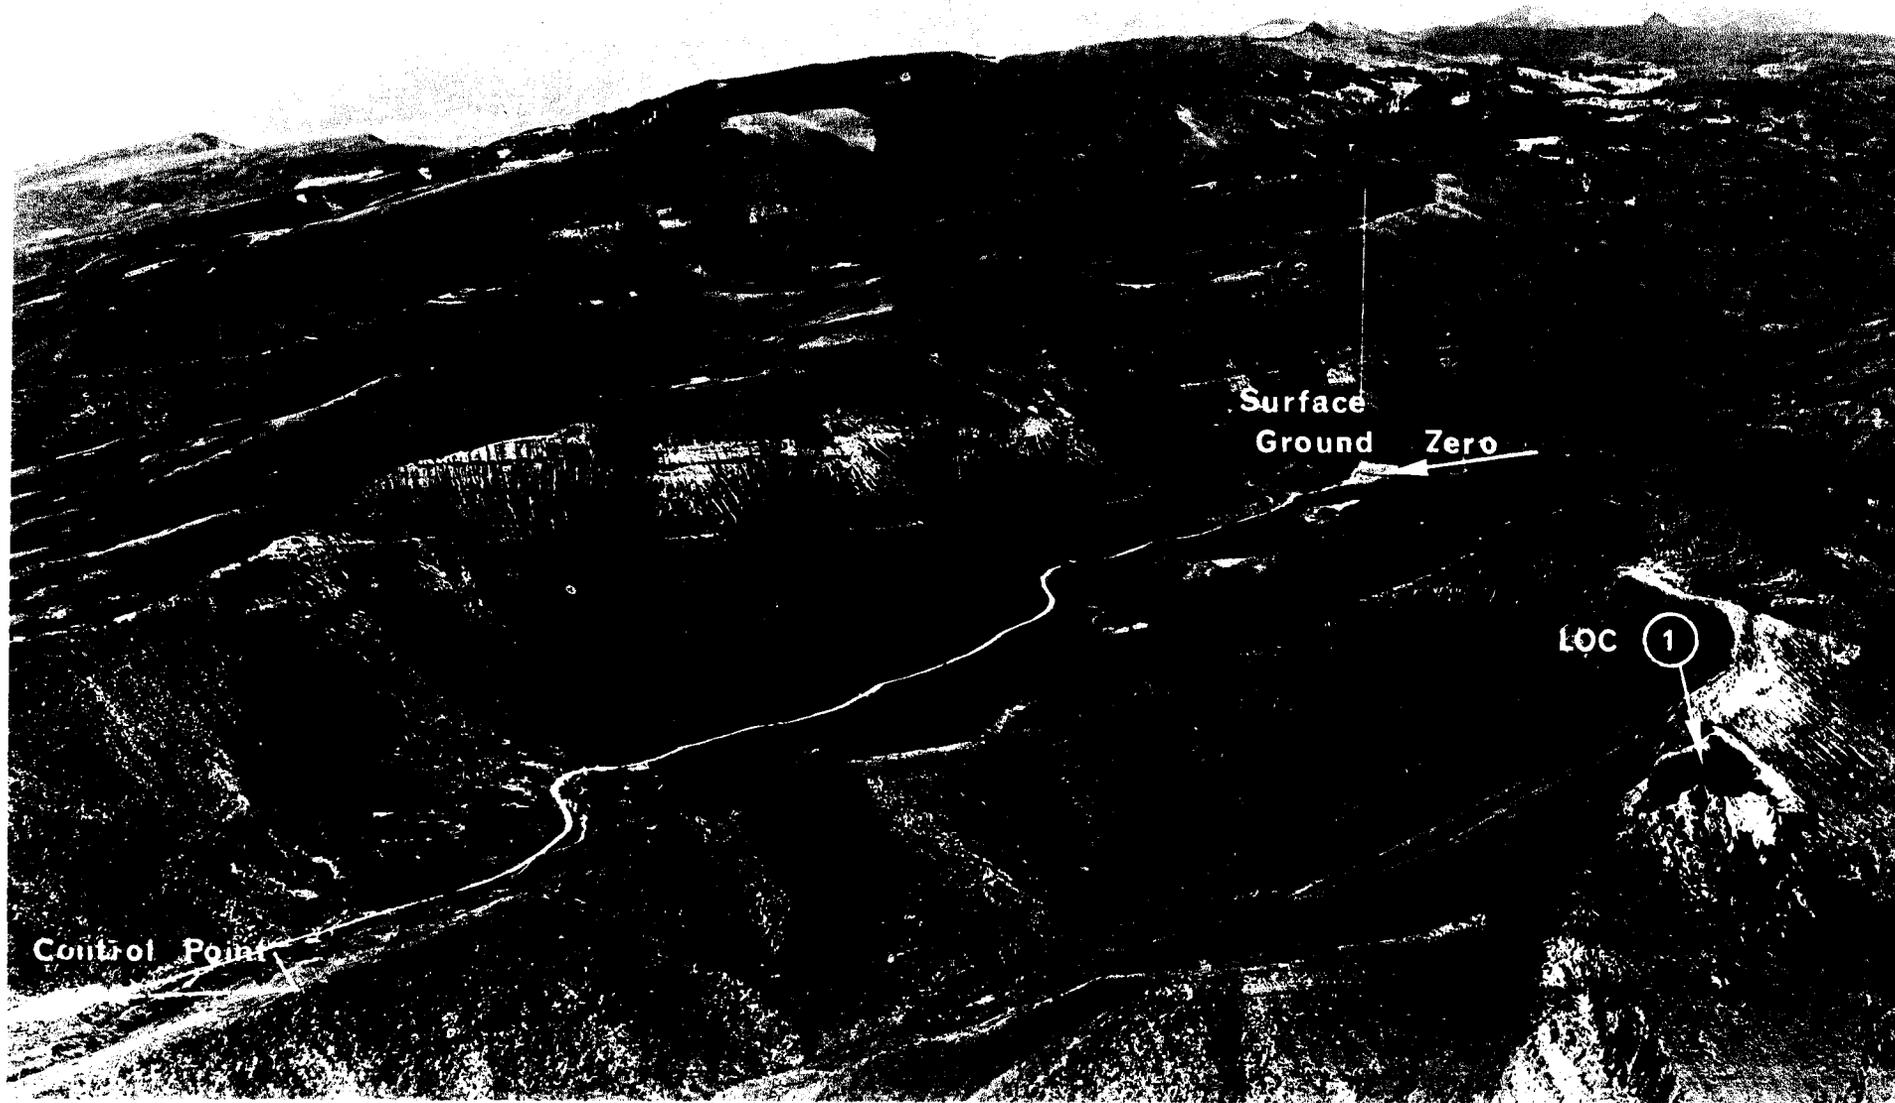
The location of the Rulison event is shown in an oblique aerial photograph in Figure 2-6.

Figure 2-6. Oblique Aerial Photo of Rulison Event Vicinity (including Location No. 1 Slide Area).
