2016 Inspection and Annual Site Status Report for the Site A/Plot M, Illinois, Decommissioned Reactor Site

July 2016

U.S. DEPARTMENT OF
ENERGY

Legacy
Management

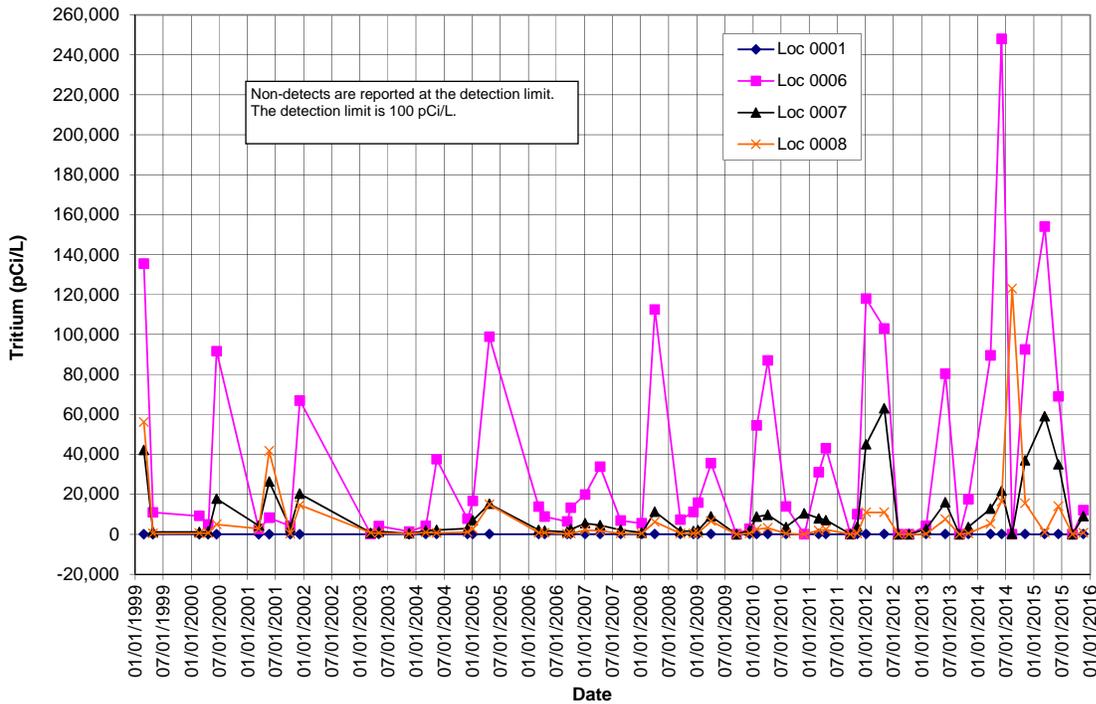
Figure 1. Tritium Activities in Surface Water at Plot M, Cook County, Illinois

For the intermittent stream that runs along the east side of Plot M, sample location 0001 is upgradient of Plot M and sample locations 0006 and 0007 are downgradient of Plot M. In 2015, tritium levels exceeded the State of Illinois standard of 20,000 picocuries per liter (pCi/L) at both downgradient locations (seep location 0006 and surface sampling location 0007).

Tritium levels at seep location 0006 ranged from 12,000 to 154,000 pCi/L (Figure 1) in 2015. The 154,000 pCi/L level is the second highest level observed at seep location 0006 since 1999. In 2014 the measured concentration was higher (248,000 pCi/L). The unusually high concentrations in 2014 and again in 2015 could be due to altering the sampling point in 2014. Prior to 2014, the sample was collected from a natural shallow depression in the intermittent stream bed. Since 2014 the samples have been collected from a shallow hole dug into the stream bank. The shallow hole, compared to the natural shallow impression, provides a sample that contains a higher fraction of seepage water and less rainwater runoff. It is also possible that the course of this intermittent stream could be changing a little. ANL plans to walk down this stream in 2016 to determine whether the course appears to be shifting and if any additional seeps can be located for sampling. Tritium activities at location 0007 ranged from 910 to 59,000 pCi/L in 2015. At surface sampling location 0007 the east side intermittent stream crosses over a hiking trail (PL-8). ANL is working with the forest preserve district to determine the best way to route water from the stream so that it runs beneath the hiking trail.

Action: ANL will walk down the intermittent stream to assess if the course is changing and if any additional seeps can be located.

Action: ANL is working with the forest preserve district to determine the best way to route water from the stream so that it runs beneath the hiking trail.

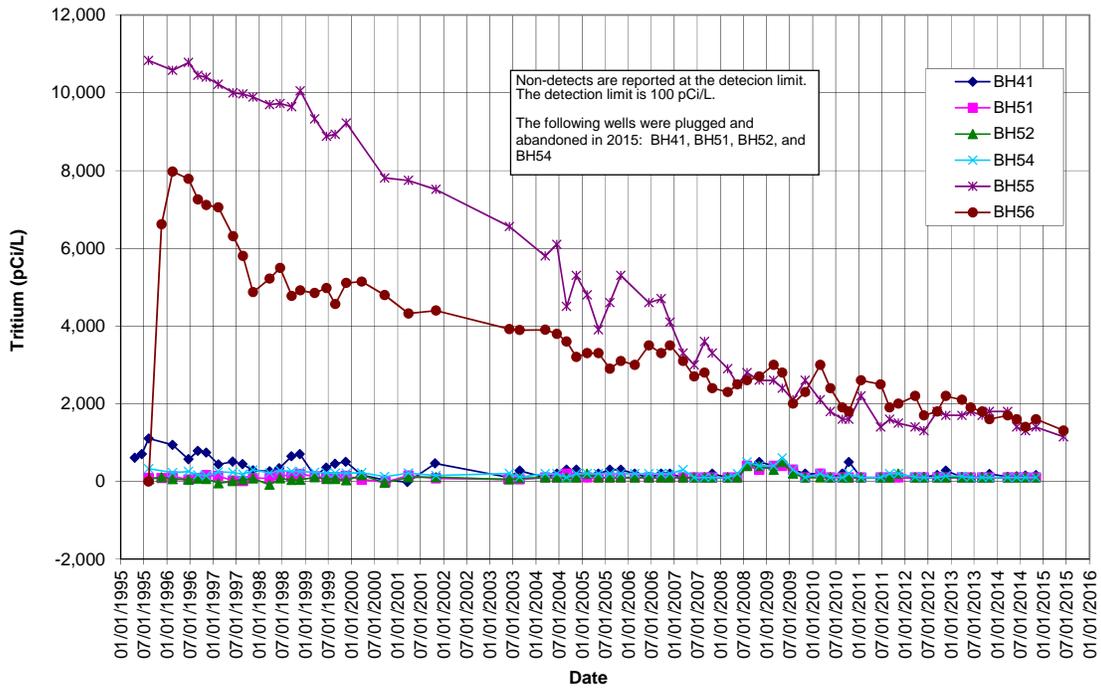
Figure 2. Tritium Activities in Groundwater in the Glacial Drift at Site A, Cook County, Illinois

In 2015, tritium was detected in the groundwater at Site A in two monitoring well locations completed in the glacial drift. No measured activities exceeded the standard of 20,000 pCi/L. Activities ranged from 1150 to 1310 pCi/L (Figure 2).

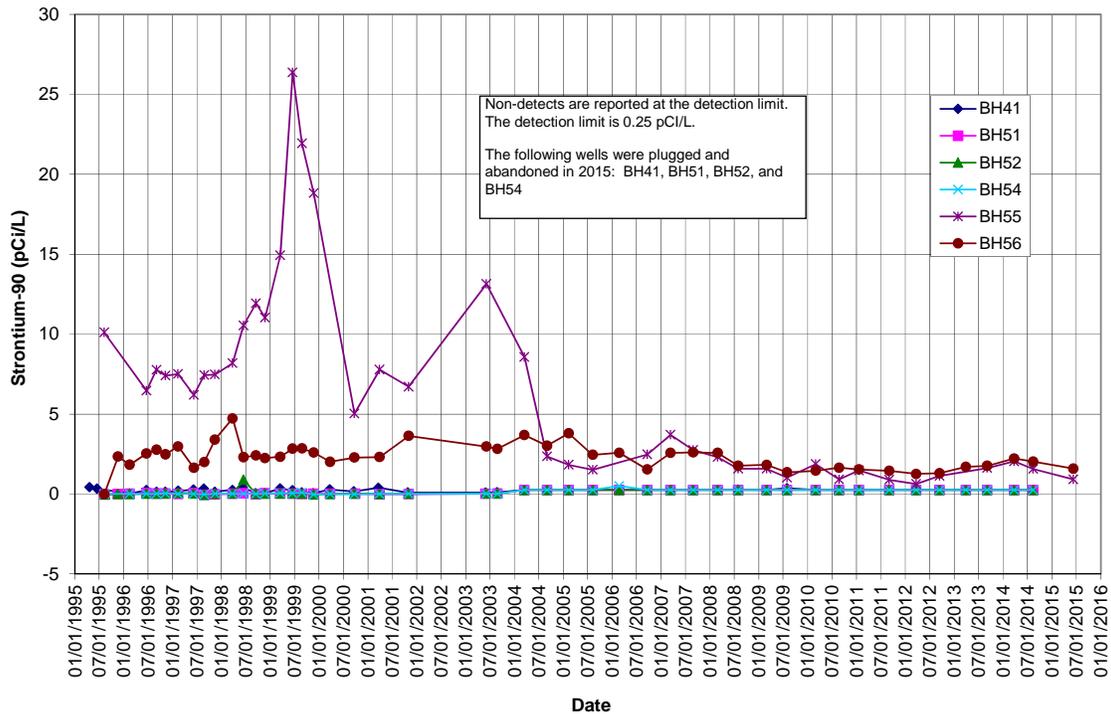
Figure 3. Strontium-90 Activities in Groundwater in the Glacial Drift at Site A, Cook County, Illinois

In 2015, strontium-90 was detected in the groundwater at Site A in two monitoring well locations completed in the glacial drift. Activities ranged from 0.85 to 1.59 pCi/L, but none exceeded the State of Illinois standard of 8 pCi/L (Figure 3).

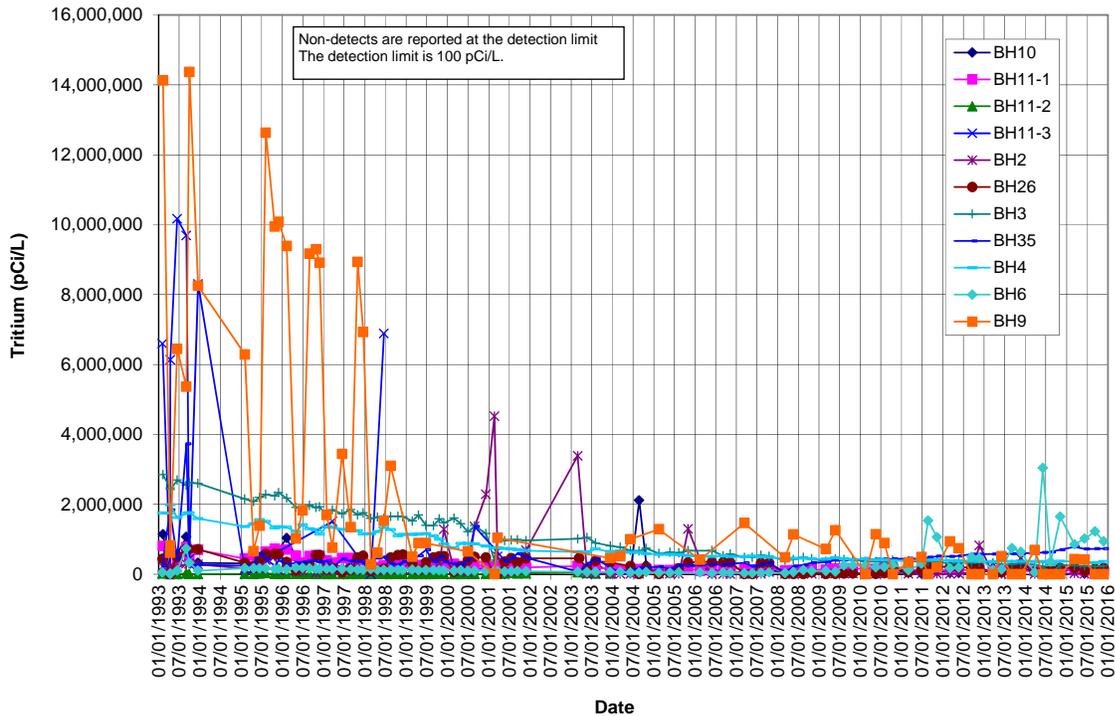
Figure 4. Tritium Activities in Groundwater in the Glacial Drift at Plot M, Cook County, Illinois

In 2015, tritium was detected in the groundwater beneath Plot M at all nine of the monitoring wells completed in the glacial drift. Tritium concentrations ranged from 11,100 pCi/L to 1,223,000 pCi/L (Figure 4).

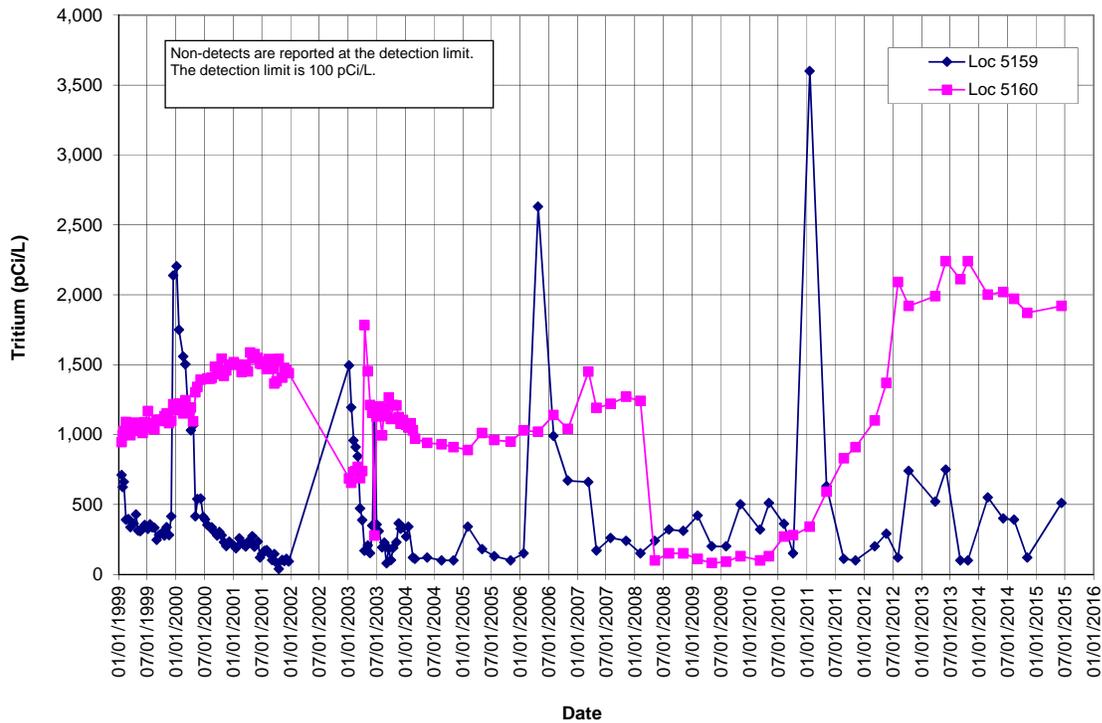
Figure 5. Tritium Activities in Groundwater in the Picnic Wells, Site A/Plot M, Cook County, Illinois

In 2015, tritium was detected in the groundwater at the picnic wells at the Red Gate Woods picnic area. Activities for the two picnic wells in 2015 ranged from 510 pCi/L to 1920 pCi/L (Figure 5). No activities measured in 2015 exceeded the State of Illinois standard of 20,000 pCi/L.

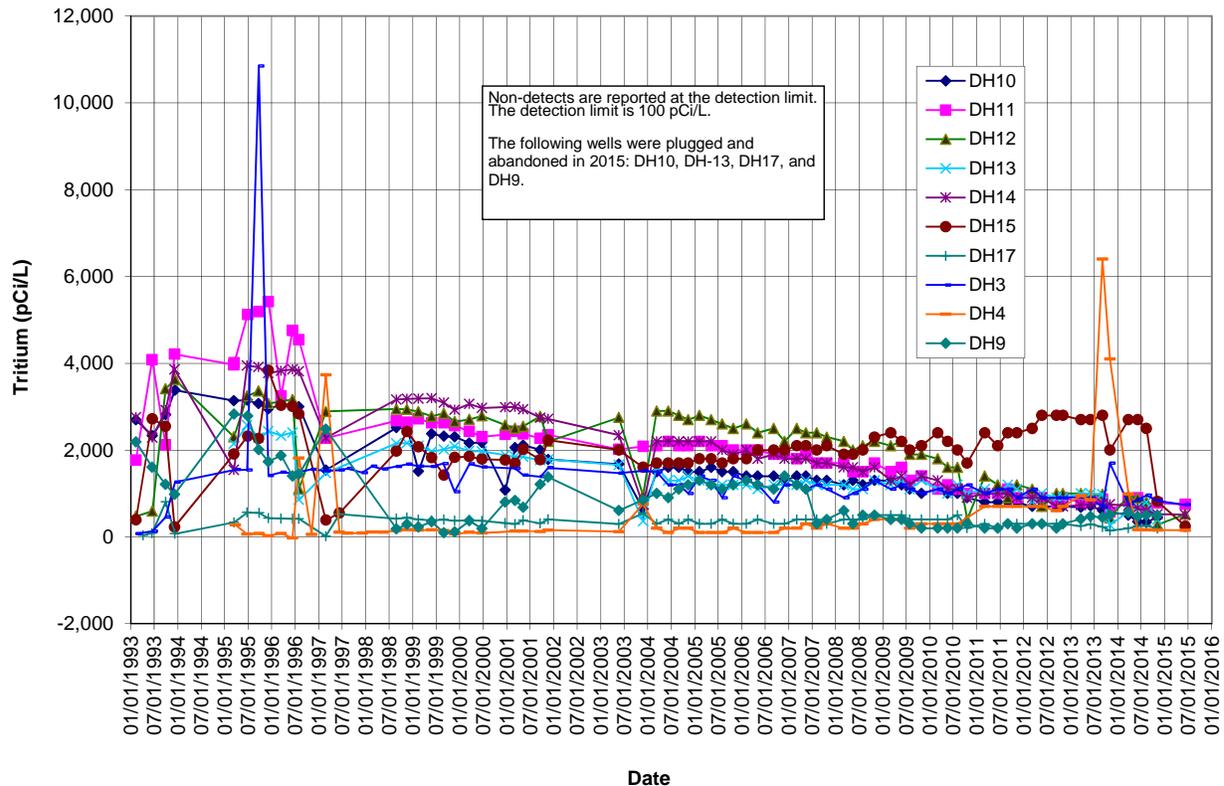
Figure 6. Tritium Activities in Groundwater in the Dolomite Bedrock, Site A/Plot M, Cook County, Illinois

In 2015, tritium was detected in the groundwater at all six monitoring wells completed in the dolomite bedrock north of Plot M. Activities ranged from 510 pCi/L to 2450 pCi/L (Figure 6). Tritium is no longer sampled for in the dolomite bedrock beneath Site A. Monitoring stopped in 2004 after approximately 30 years of sampling failed to detect tritium.

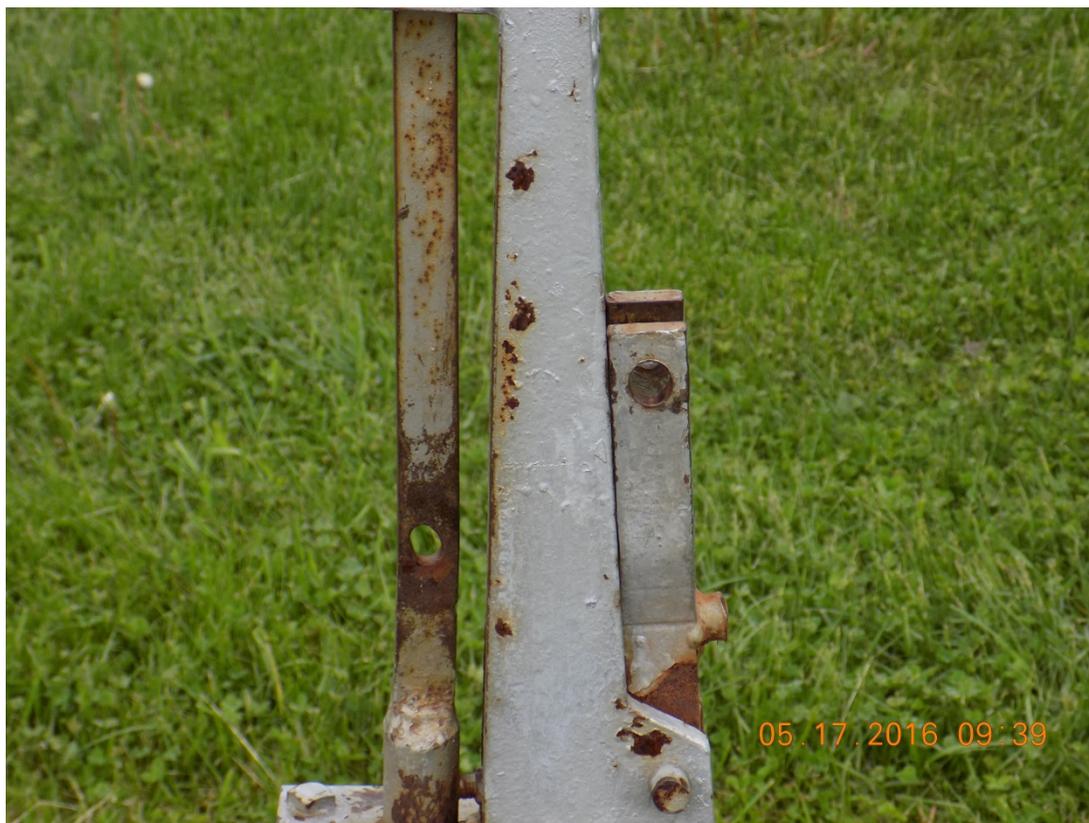
Inspectors met at the Red Gate Woods parking area and reviewed the Plan of the Day and the Job Safety Analysis. Inspectors noted that the pump handles remained off the picnic wells and that a portable restroom was no longer present in the area (PL-1). The handles were removed from the pumps years ago to prevent use of the well due to fecal coliform in the water. The fecal coliform originated from a nearby permanent restroom facility, which was removed.

SAM 5/2016. PL-1. Handle removed from picnic well 5160.

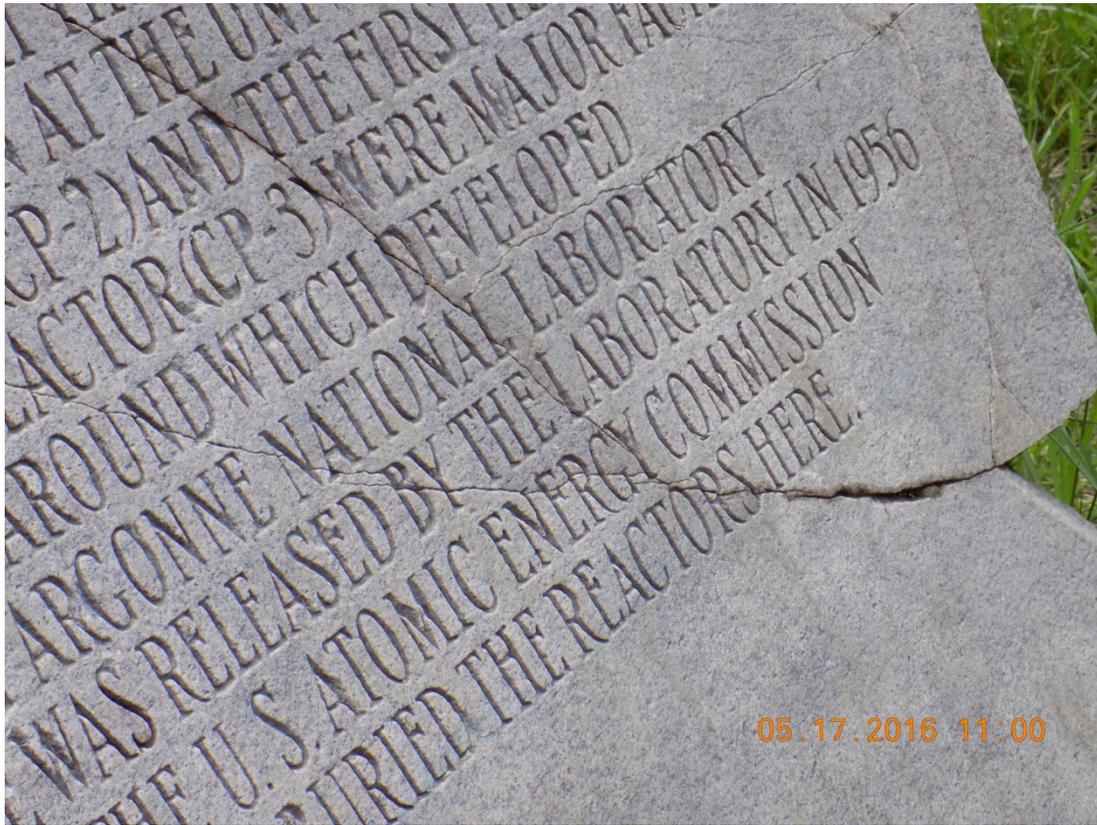
Inspectors were able to drive to Site A during this year's inspection. Site A and the Site A monument were in good condition. The crack in the Site A monument appears to be getting larger over time (PL-2). In 5–10 years the monument might need to be replaced, but for now the monument remains serviceable.

SAM 5/2016. PL-2. Crack in Site A monument.

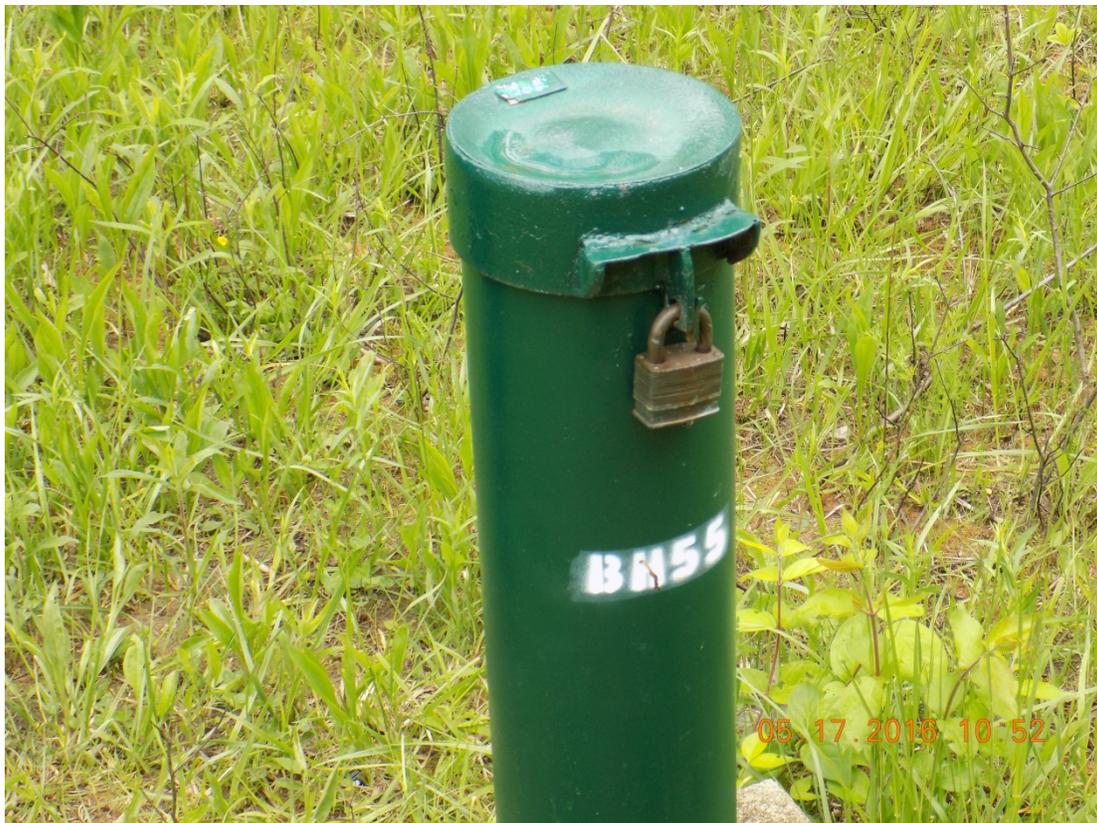
Two monitoring wells remain at Site A: BH55 and BH56. Both monitoring wells were secured with locks and identified with a well number on the outer casing (PL-3, PL-4). ANL personnel visited the wells one time in 2015 for sampling, to ensure well security, and to perform any required maintenance.

SAM 5/2016. PL-3. Monitoring well BH55.

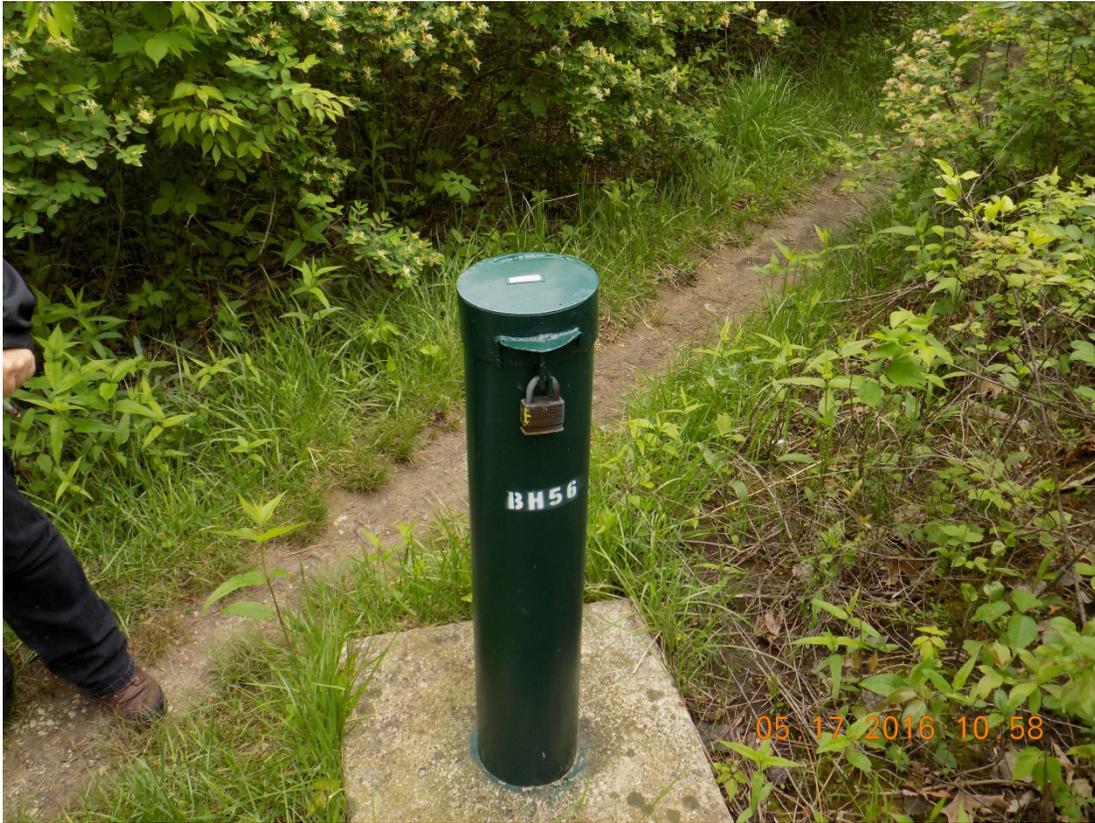
SAM 5/2016. PL-4. Monitoring well BH56.

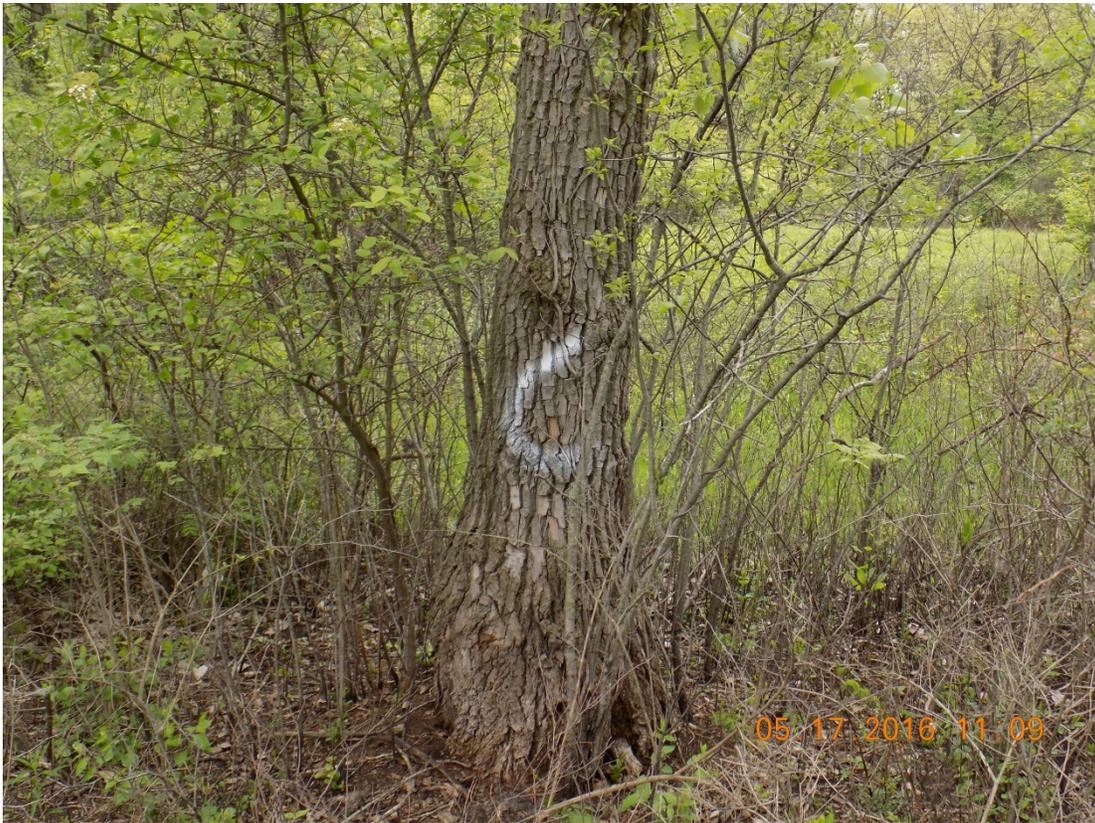
A brick was present on the ground surface of Site A, approximately 30 yards from the monument on a compass bearing of 136 degrees (PL-5). DOE requested that ANL personnel return to the site, scan the brick for potential radiation, and use the scan results to dispose of the brick appropriately.

SAM 5/2016. PL-5. Tree at location where a brick was found.

Action: ANL will scan the brick for radiation and use the scan results to dispose of the brick appropriately.

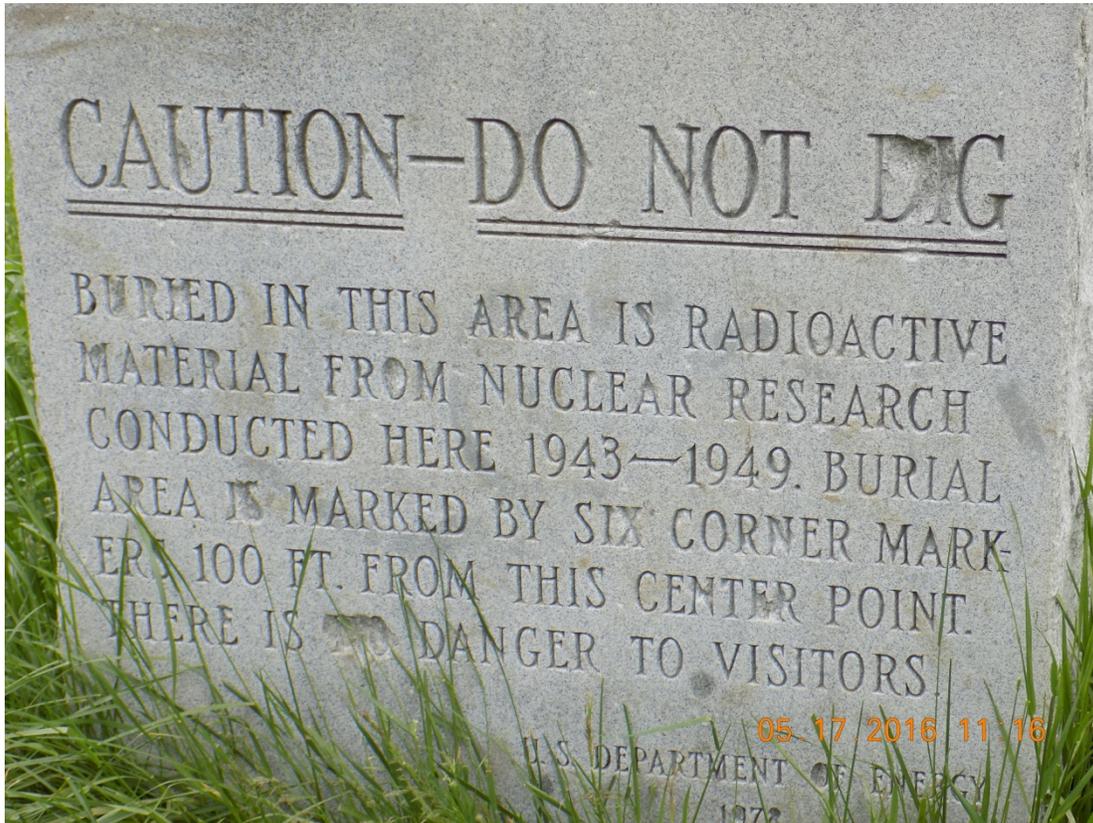
The Plot M site marker was unchanged from last year's inspection. It was in good condition, with the exception of some minor vandalism that occurred several years ago (i.e., some words on the marker are chiseled off) (PL-6). All Plot M corner markers were located and found to be in good condition. ANL is planning to clear vegetation from the west, northwest, and northeast sides of the Plot M mound to make the corner markers more visible, and to keep vegetation off the footprint of the buried inverted concrete box.

SAM 5/2016. PL-6. Plot M monument.

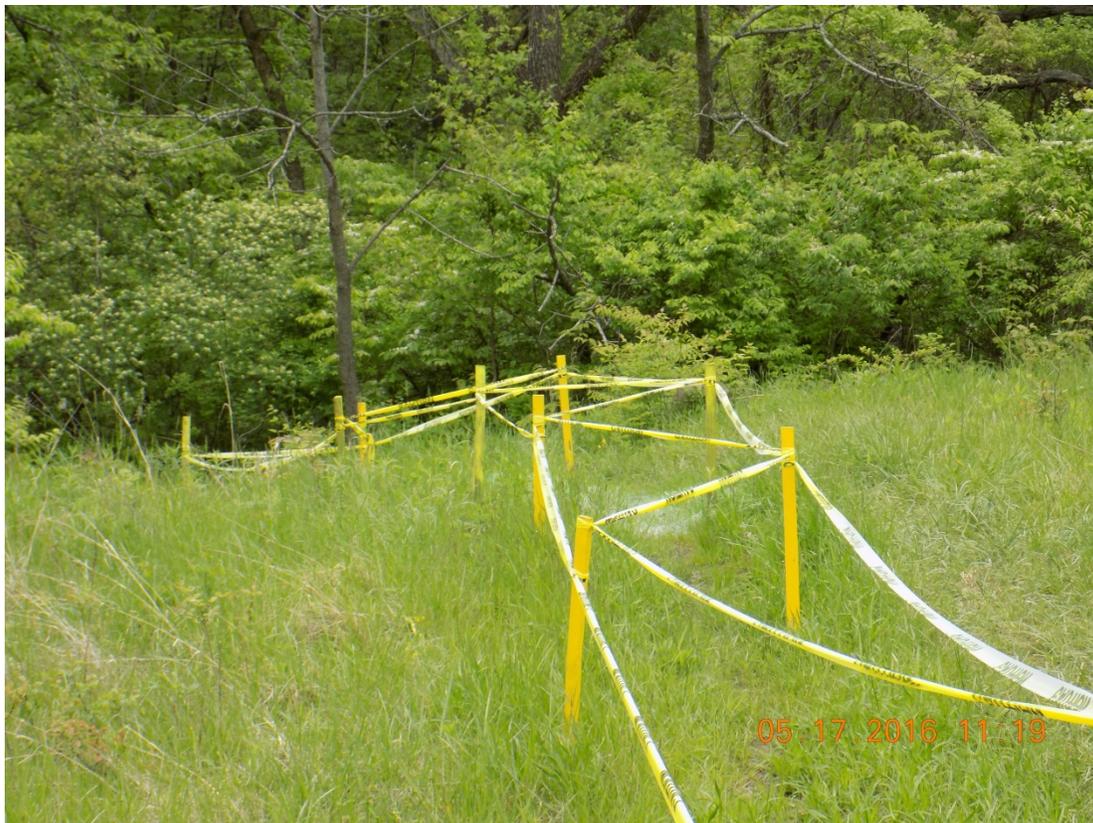
Erosion on top of the grass covered mound at Plot-M continues to be an issue. The erosion is caused by visitors riding their bicycles across the mound. ANL conducts annual maintenance reviews of the grass-covered mound and periodically adds topsoil to erosion ruts as needed to keep them from expanding. Rut repairs made in 2015 are progressing nicely in that the areas are becoming reestablished with new grass growth (PL-7 and PL-8). Additional repairs were not needed at the time of the inspection.

SAM 5/2016. PL-7. Grass growing in rut repair on top of Plot M.

Action: ANL will continue to routinely inspect the grass-covered mound and repair ruts periodically by filling them in with clean dirt and reseeding.

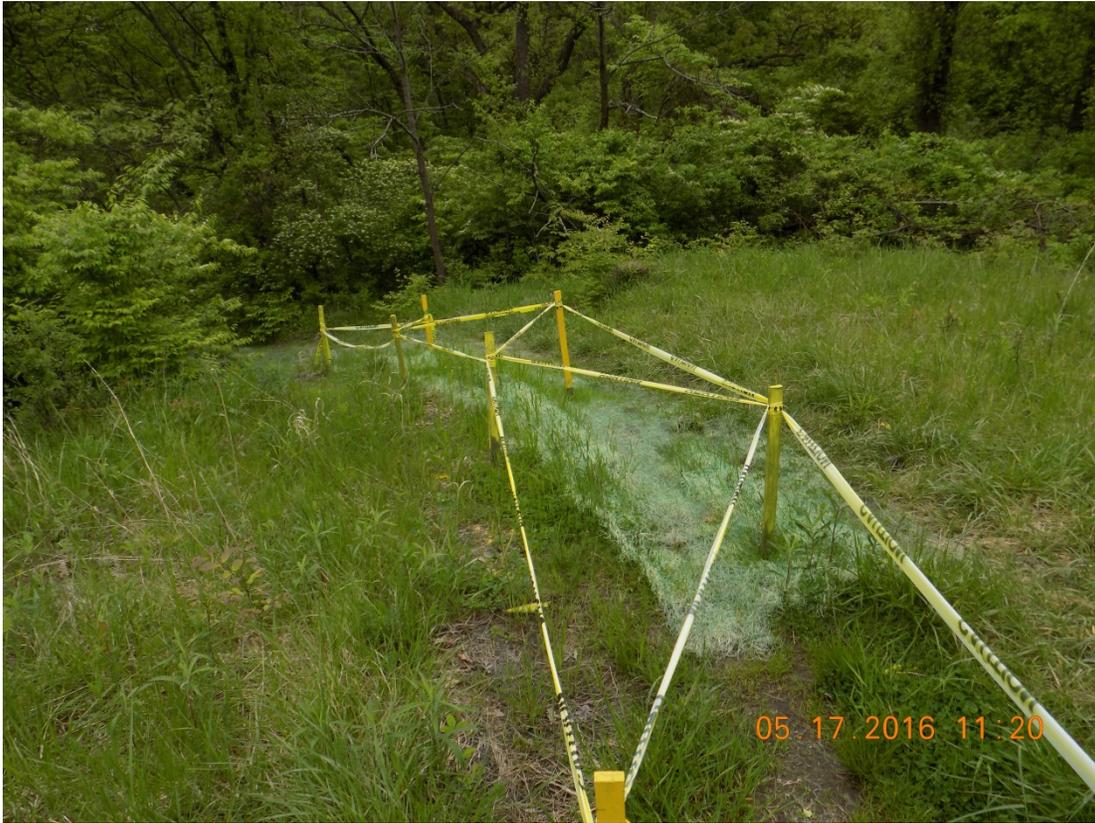
SAM 5/2016. PL-8. Grass growing in rut repair on top of Plot M.

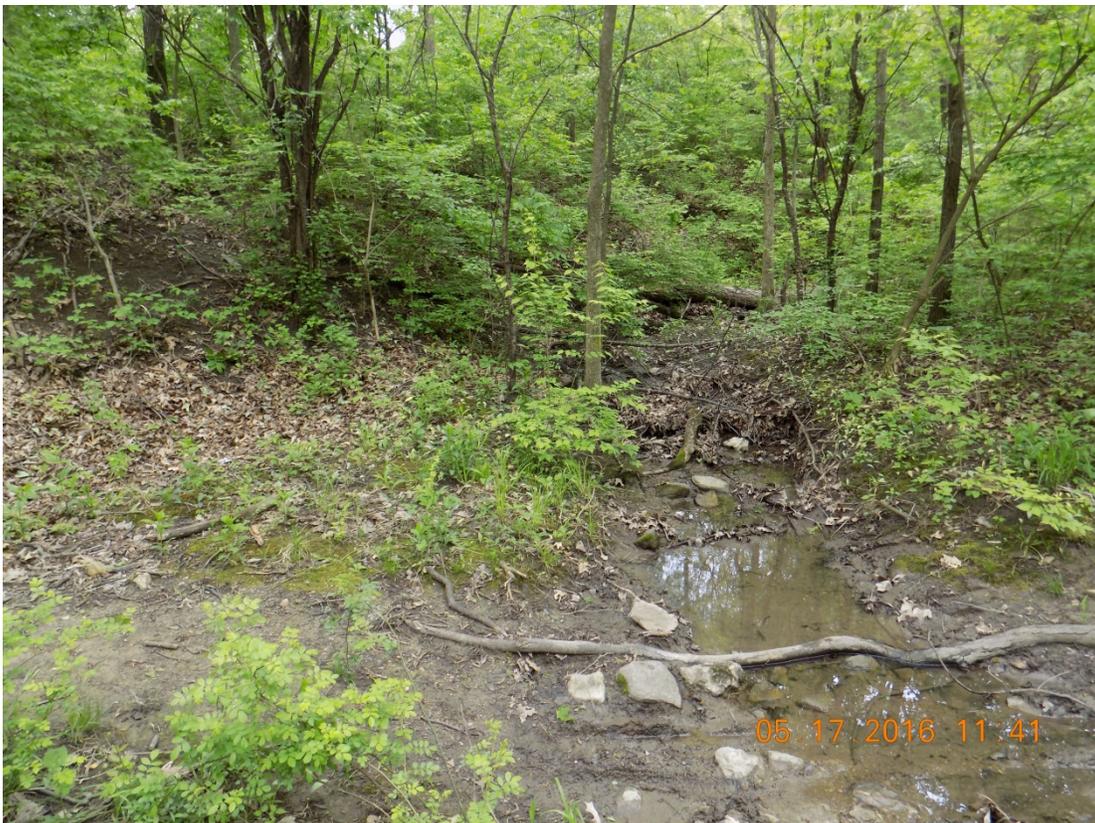
7. An intermittent stream near Plot M with elevated levels of tritium crosses over a hiking trail north of Plot M.

SAM 5/2016. PL-9. Intermittent stream crossing over hiking path north of Plot M.

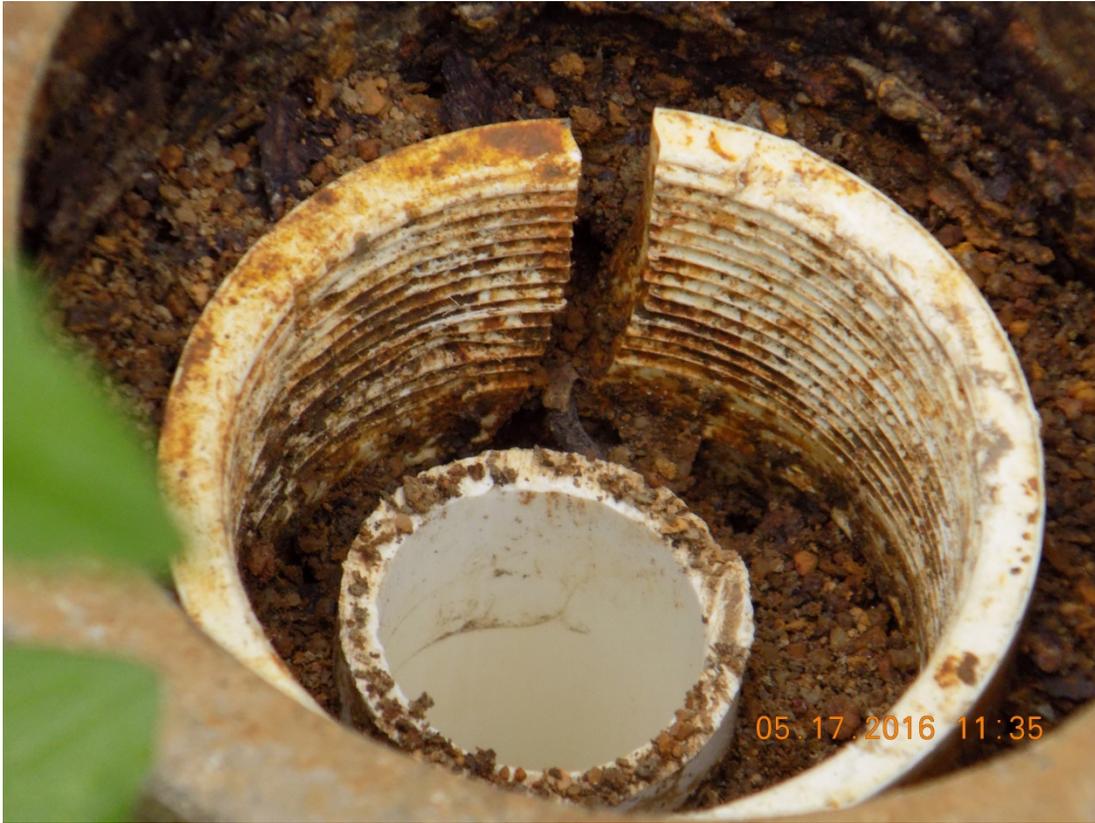
During the inspection, ANL personnel reported that monitoring well BH35 has a damaged casing (PL-10). Samples are being collected from a 1-inch sleeve that is installed inside the damaged casing. DOE requested that ANL plan on installing a replacement well for BH35 in the next year or so.

SAM 5/2016. PL-10. Cracked casing at monitoring well BH35.

Action: ANL will install a replacement well for BH35 in the next year or so.
