# **2009 Inspection and Annual Site Status Report for the Site A/Plot M, Cook County, Illinois Decontamination and Decommissioning Program Site**

## **Summary**

Site A/Plot M was inspected on April 28, 2009. The site, located within a county forest preserve with significant tree and grass cover, is in good condition. No cause for a follow-up inspection was identified.

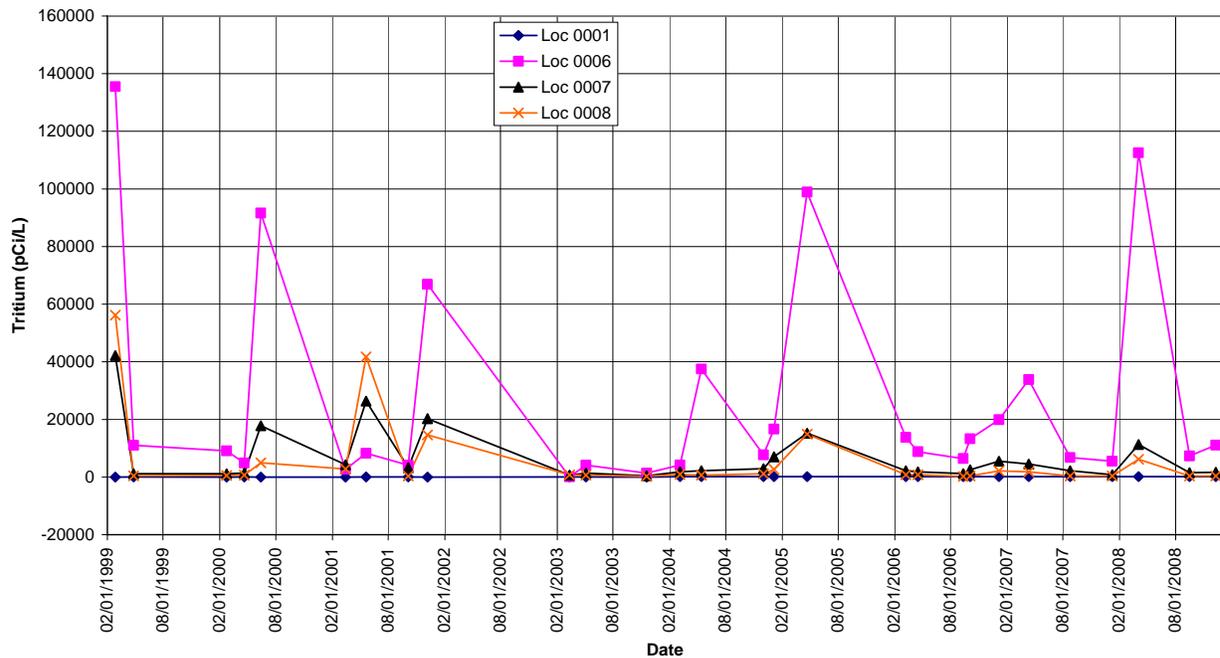
Figure 1. Tritium Activities in Surface Water at Site A/Plot M, Cook County, Illinois

Tritium levels exceeded the State of Illinois standard of 20 nanocuries per liter (nCi/L), or 20,000 picocuries per liter (pCi/L) at the seep (Location 0006) and decreased downstream. Seep activities ranged from 5.5 to 112.5 nCi/L (Figure 1).

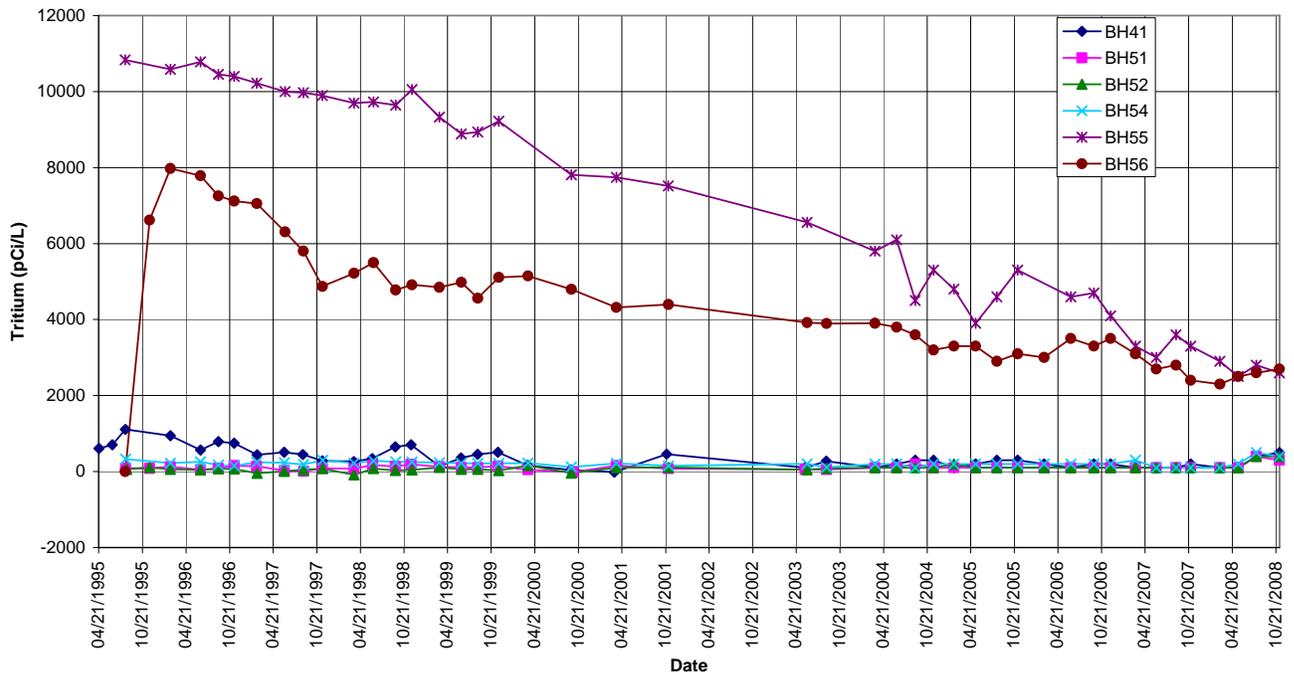
Figure 2. Tritium Activities in Groundwater in the Glacial Drift at Site A, Cook County, Illinois

In 2008, tritium was detected in the groundwater at all six Site A monitor well locations completed in the glacial drift. None exceeded the standard of 20 nCi/L. Activities continue to decrease and ranged from non-detect (less than 0.1 nCi/L) to 2.9 nCi/L (Figure 2).

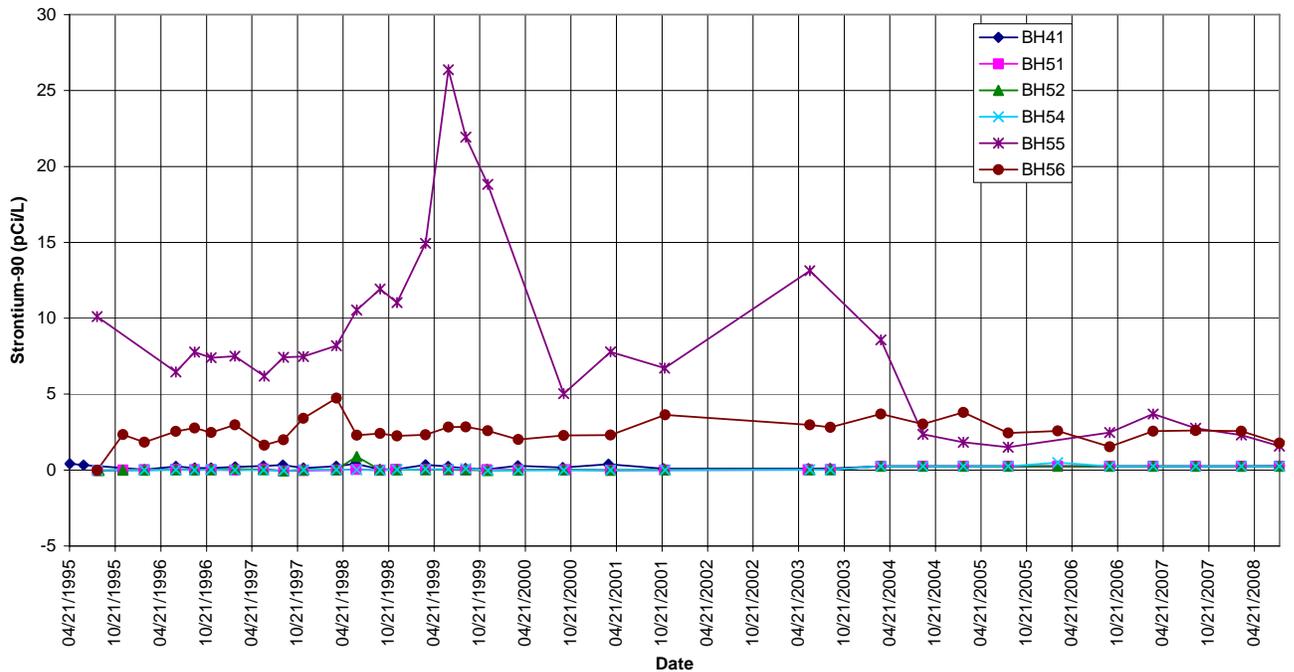
Figure 3. Strontium-90 Activities in Groundwater in the Glacial Drift at Site A, Cook County, Illinois

In 2008, strontium-90 was detected in groundwater at three of six Site A monitor well locations. Activities ranged from non-detect (less than 0.25 pCi/L) to 2.57 pCi/L, but none exceeded the State of Illinois standard of 8 pCi/L (Figure 3).

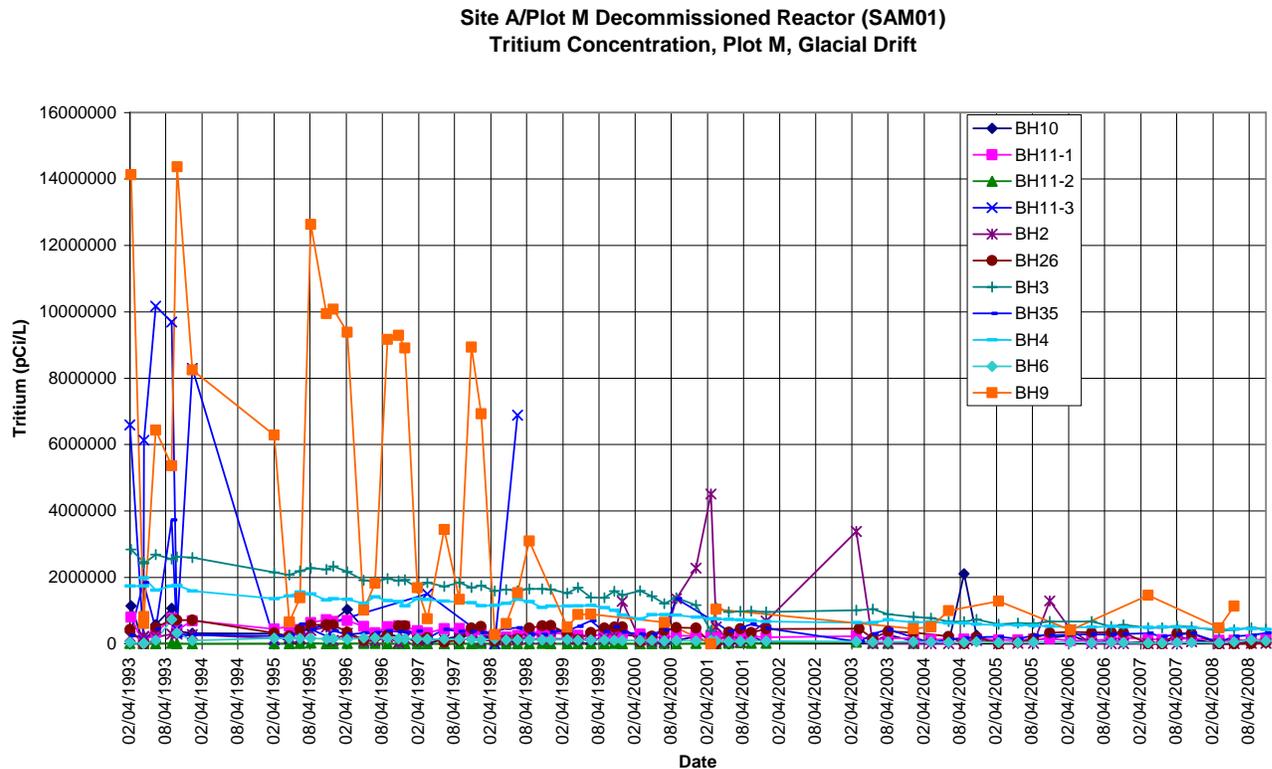
Figure 4. Tritium Activities in Groundwater in the Glacial Drift at Plot M, Cook County, Illinois

In 2008, at Plot M, tritium was detected in groundwater at all nine monitor wells completed in the glacial drift. Tritium concentrations ranged from 0.3 to 1,136 nCi/L (Figure 4). The highest reading was taken at BH9 on May 20, 2008; BH9 was dry for the remainder of 2008.

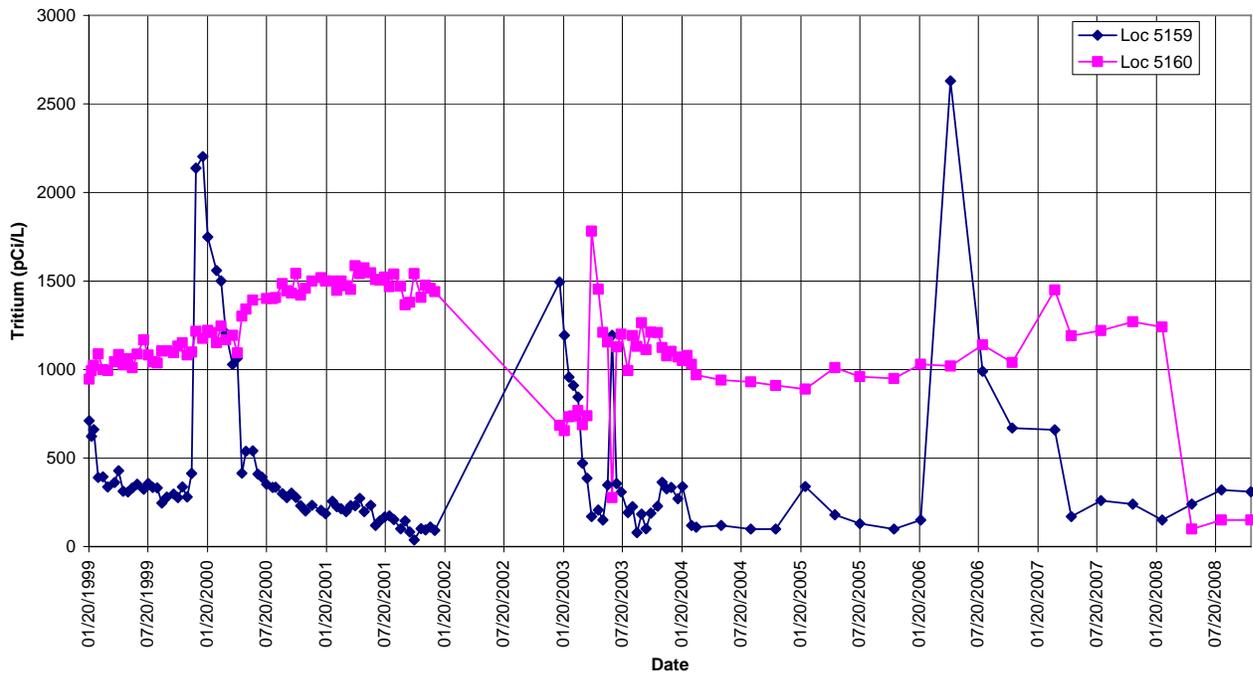
Figure 5. Tritium Activities in Groundwater in the Picnic Wells, Site A/Plot M, Cook County, Illinois

In 2008, tritium was detected in the groundwater at the picnic wells at the Red Gate Woods picnic area. Activities ranged from non-detect (less than 0.1 nCi/L) to 1.24 nCi/L (Figure 5). None exceeded the standard of 20 nCi/L.

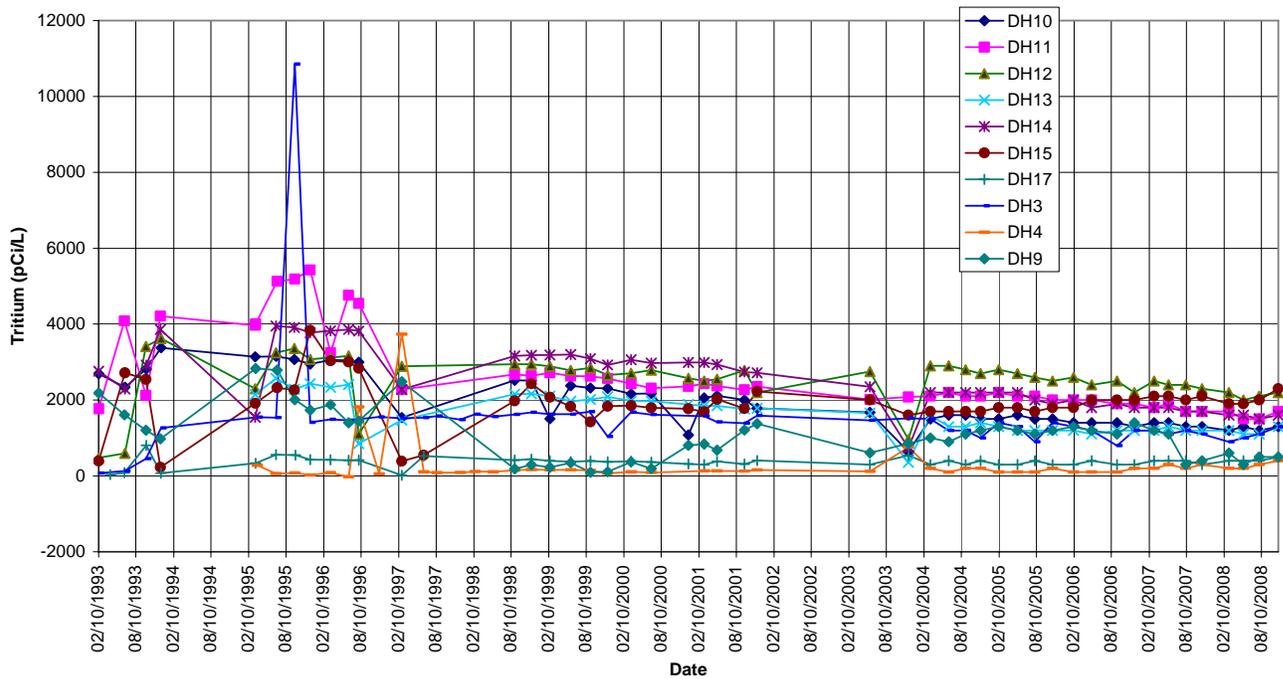
Figure 6. Tritium Activities in Groundwater in the Dolomite Bedrock, Site A/Plot M, Cook County, Illinois

In 2008, tritium activities were detected in groundwater at all ten sample locations intercepting the dolomite bedrock north of Plot M and ranged from 0.2 to 2.3 nCi/L (Figure 6). Tritium sampling is no longer conducted in the dolomite bedrock beneath Site A. Monitoring stopped in 2004 after approximately 30 years of sampling failed to detect tritium.

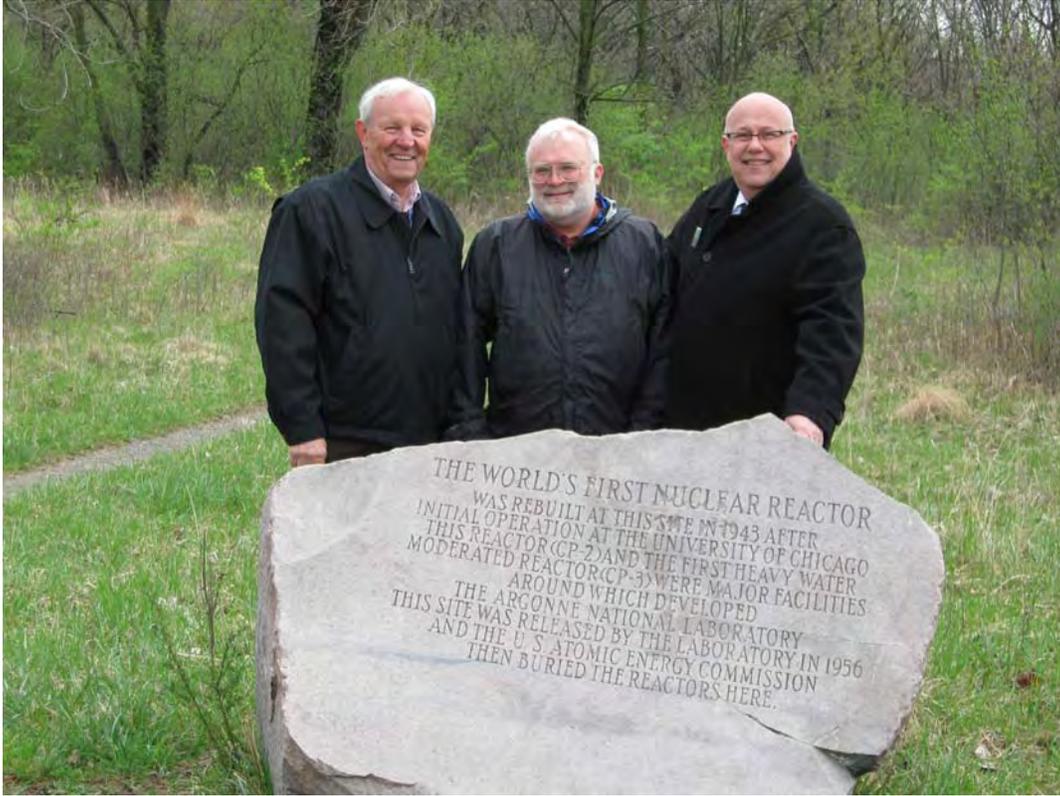
SAM 4/2009. PL-1. Historical Marker at Site A.

Inspectors drove to Site A, walked to the center of the area, and examined the historical monument (PL-1) and monitor wells. The Site A historical monument is in good shape.

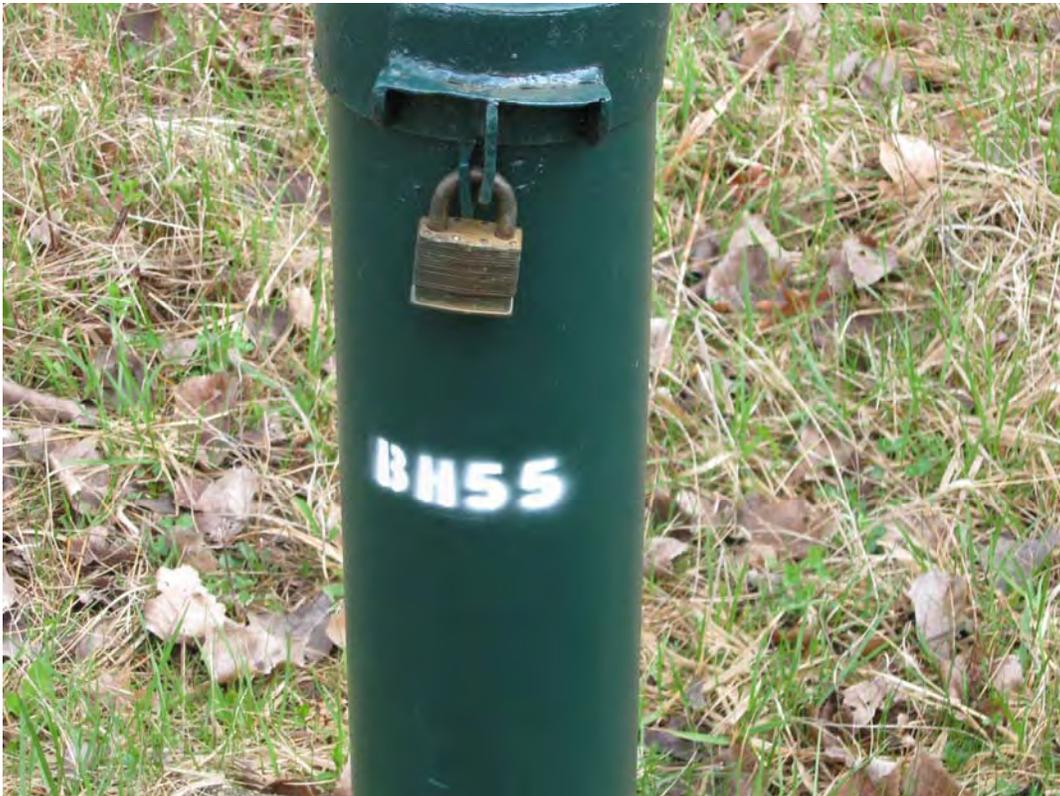
SAM 4/2009. PL-2. Monitor Well BH55, Site A.

Inspectors walked Site A, inspecting monitor wells and observing the general condition of the site. All monitor wells observed at Site A were secured with locks and identified with a well number on the outer casing (PL-2). No monitor wells were opened during the inspection. ANL personnel visit the wells quarterly for sampling, ensure well security, and perform required maintenance at that time.

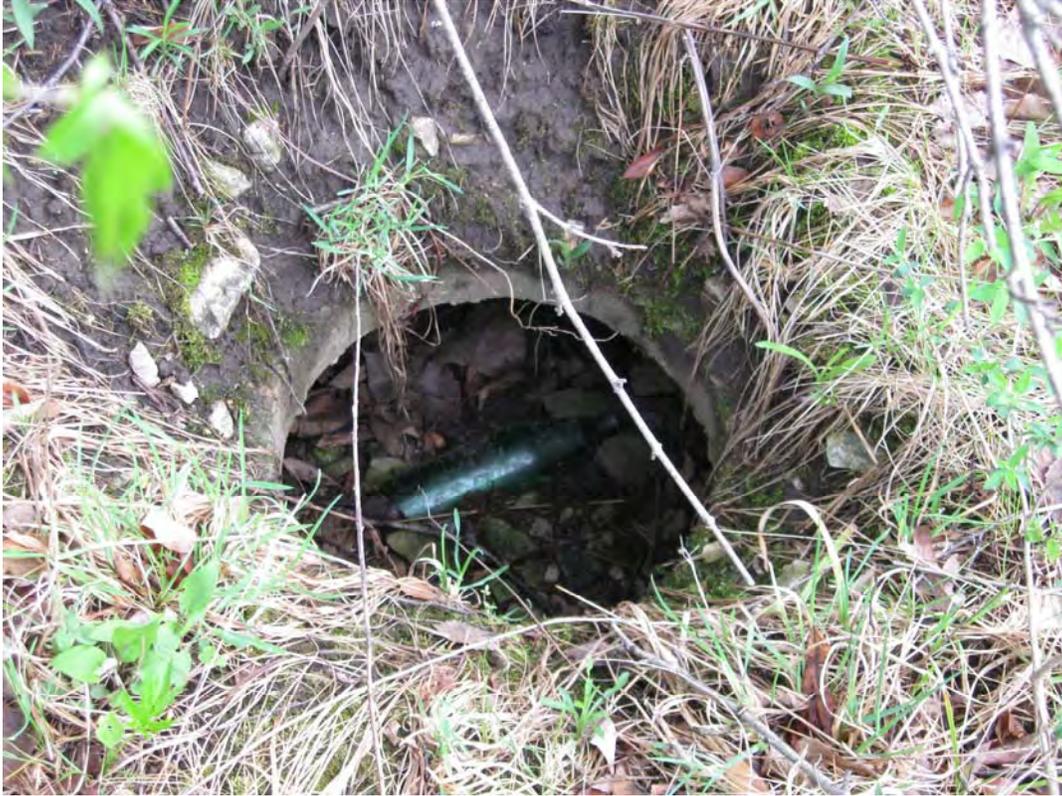
SAM 4/2009. PL-3. Hole in ground at Site A.

Inspectors identified two holes in the ground at Site A that appear to be associated with sanitary/sewer lines that were abandoned in place (PL-3 and PL-4). ***It is recommended that ANL fill in the holes with topsoil.***

2. Inspectors identified two holes in the ground at Site A that appear to be associated with sanitary/sewer lines that were abandoned in place (PL–3 and PL–4) (page 3).

**Recommendation:** It is recommended that ANL fill in the holes with topsoil.

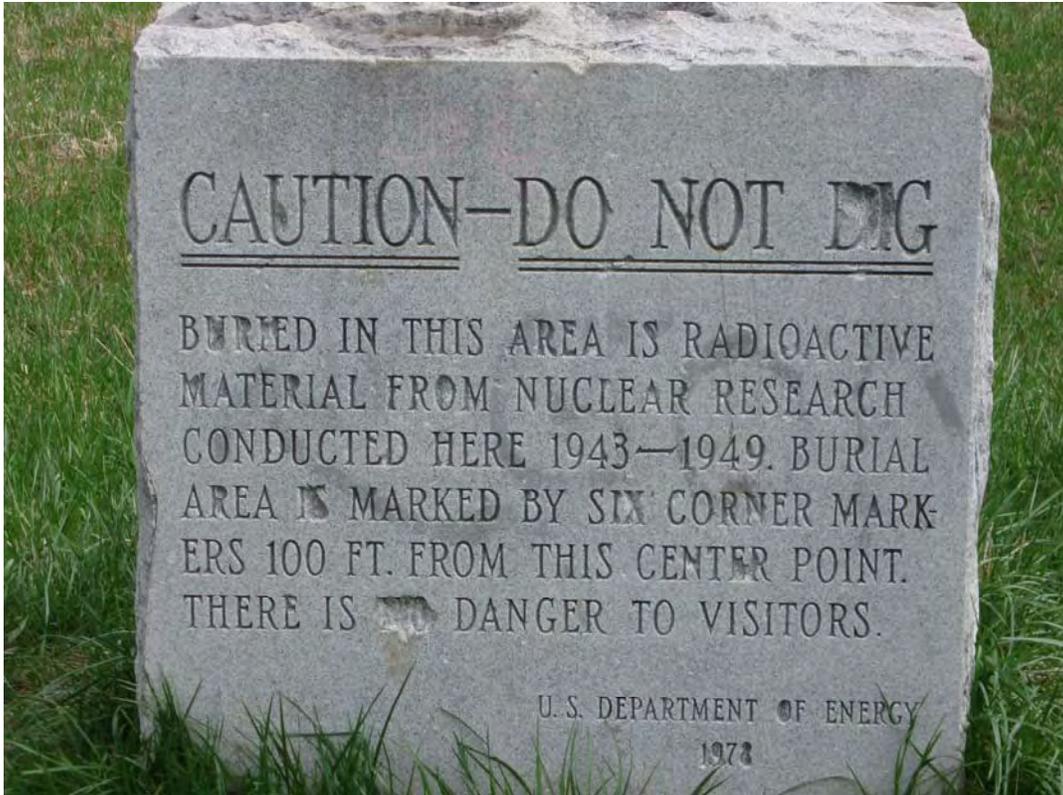
SAM 4/2009. PL-5. Site marker at Plot M.

Inspectors drove from Site A to an area leading back to Plot M, and then walked back to Plot M. The Plot-M historic marker was in good condition, with the exception of some minor vandalism that was reported in previous inspections. Some words on the marker are chiseled off (PL-5). All of the corner markers were located and found to be in good shape (PL-6).

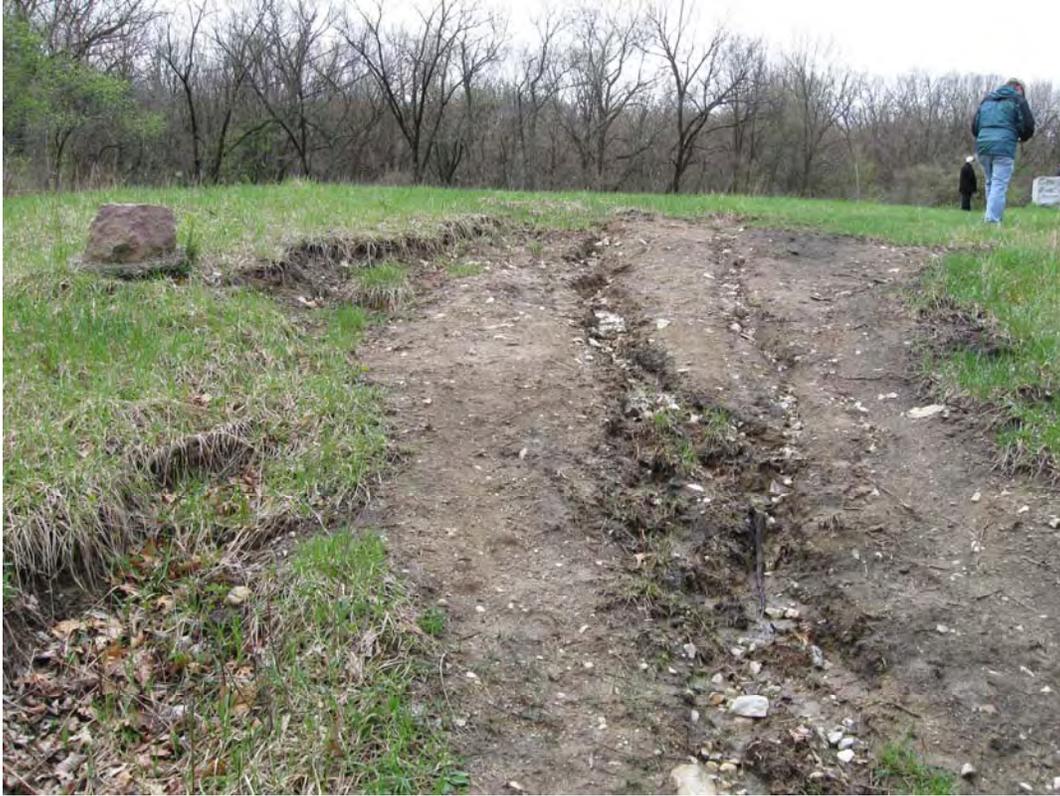
SAM 4/2009. PL-7. Erosion at Plot M.

Erosion along footpaths on top of Plot M remains in need of repair. ANL is in the process of obtaining a contractor to conduct the erosion repair work.

Erosion along the footpaths that cross over the top of Plot M (and identified in previous inspections) has not been repaired (PL-7). Efforts by ANL to secure a subcontractor to repair the erosion are underway now that all of the monitoring wells that needed to be abandoned at Plot M were taken care of in 2008.

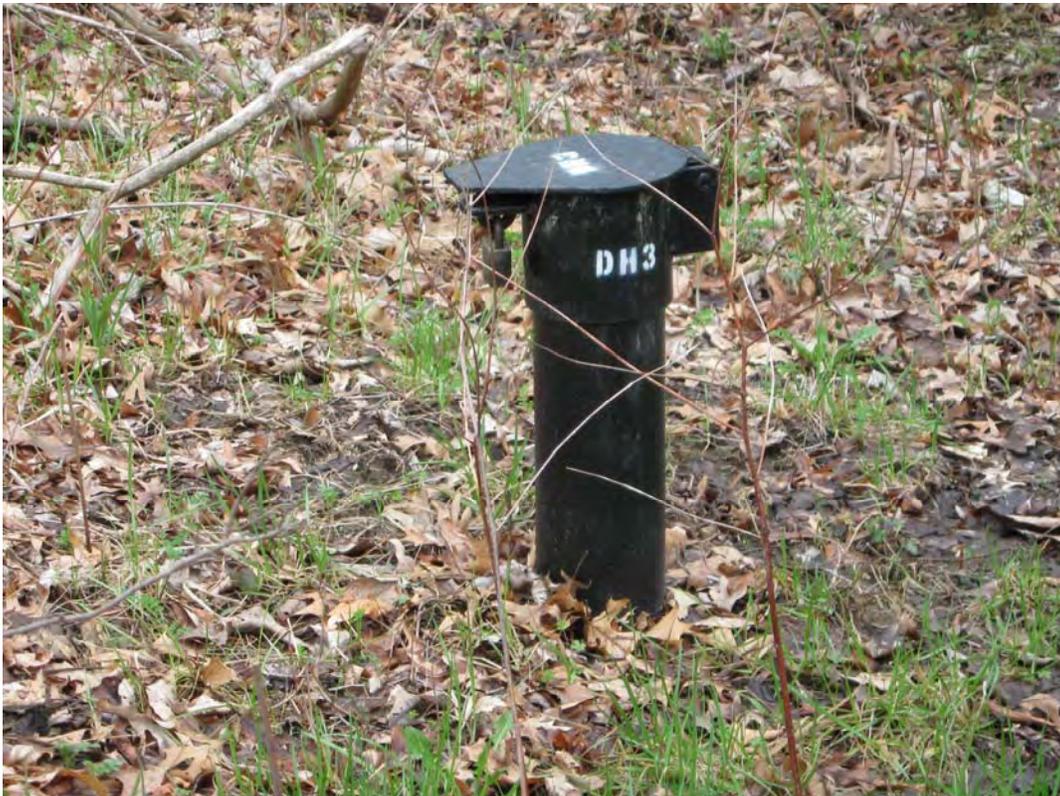
SAM 4/2009. PL-8. Monitor Well DH3, Plot M.

The protective casings of the monitor wells at Plot M were clearly identified with well numbers (PL-8 and PL-9). All monitor wells at Plot M, with the exception of Well 11-A (PL-10) were locked and secured. *It is recommended that ANL install a lock on Well 11-A as soon as possible.*

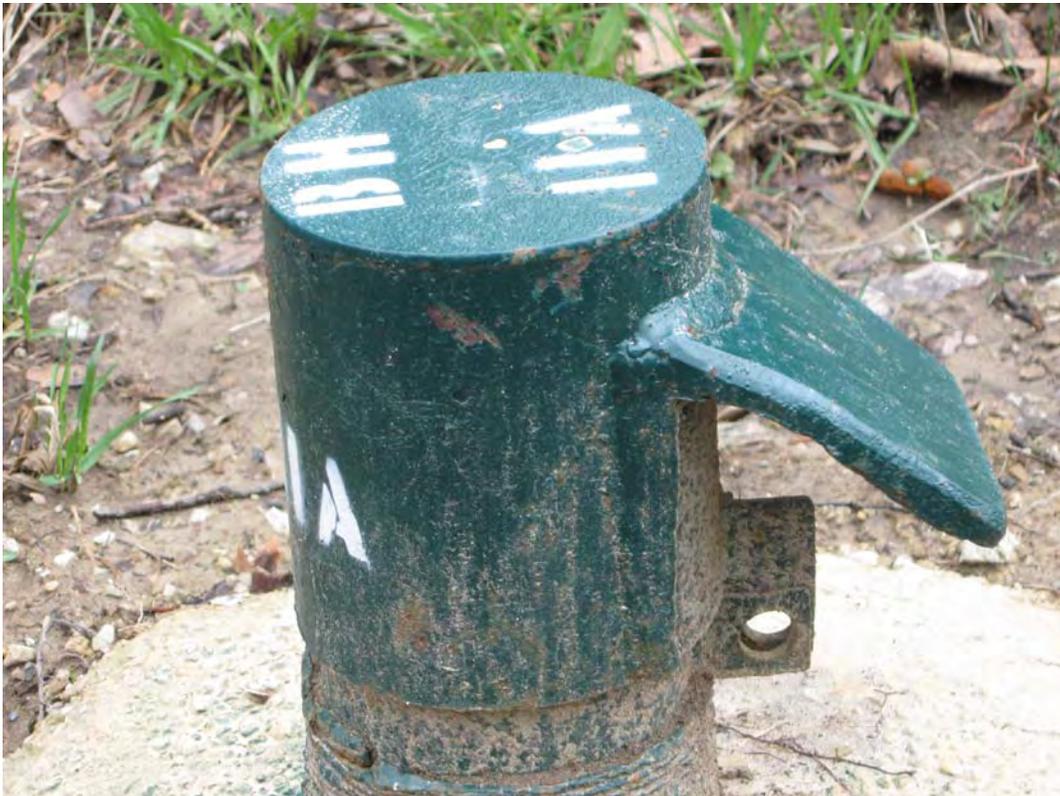
SAM 4/2009. PL-10. Monitor Well 11A, missing lock, Plot M.

5. All monitor wells at Plot–M, with the exception of well 11–A (PL–10) were locked and secured (page 4).

**Recommendation:** It is recommended that ANL install a lock on Well 11–A as soon as possible.
