2004 Annual Inspection Report for the Weldon Spring, Missouri, Site

Summary

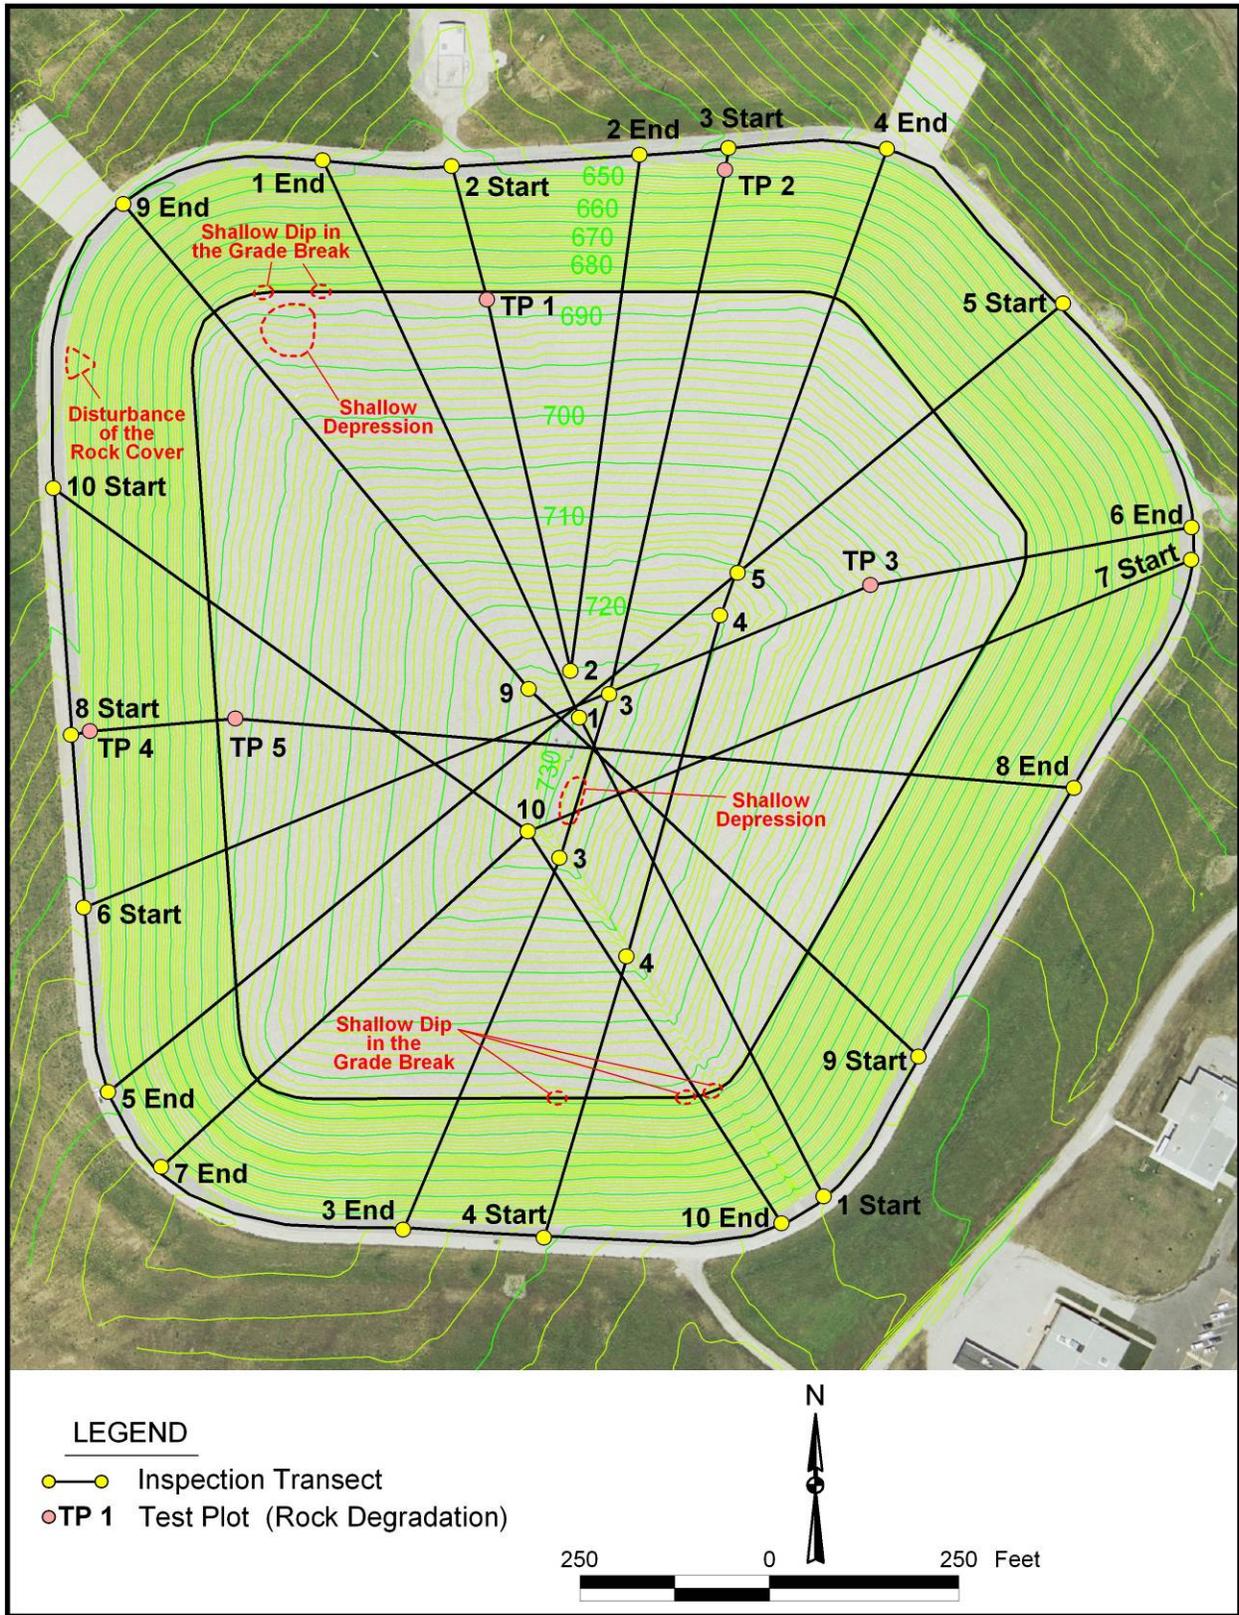
Figure 7. Disposal Cell Inspection Transects and Rock Test Plot Locations at the Weldon Spring, Missouri, Site

A few small shallow depressions on the cell cover and along the grade break were noted during the inspection. It appeared that the depressions ranged up to approximately 2 or 3 inches deep. Also, a small area of surface disturbance was noted at the base of the side slope near the northwest corner of the cell. This area of disturbance was initially identified by the presence of different-colored side slope rocks present on top of the toe apron (Photo 18). Upon further inspection, it was apparent that a small area of the side slope had slipped just enough to rotate the rocks and dislodge some of them. The depressions and area of side slope disturbance are shown in Figure 7.

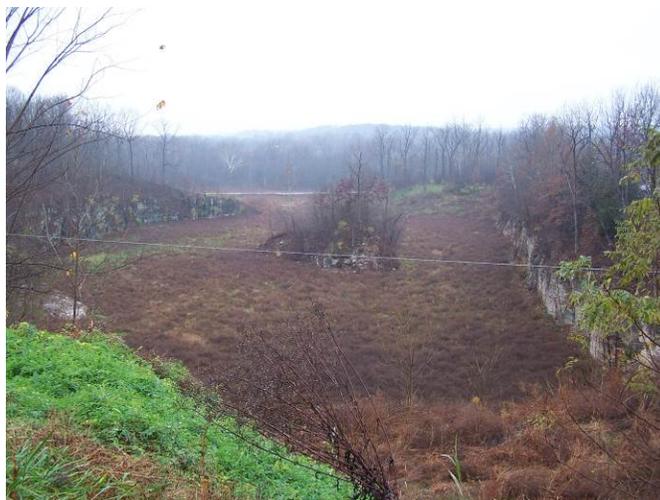
Inspection Results: The Quarry Property was inspected and no indications of excavation into soil or bedrock or groundwater withdrawal or use were observed. Also, no party has been granted use of portions of the Quarry area. Quarry backfill continues to provide positive drainage from the quarry to the Little Femme Osage Creek and vegetative cover remains well established (Photo 3). Current land use remains consistent with planned institutional controls.

Photo 3. View of dense vegetation establishing in the Quarry.

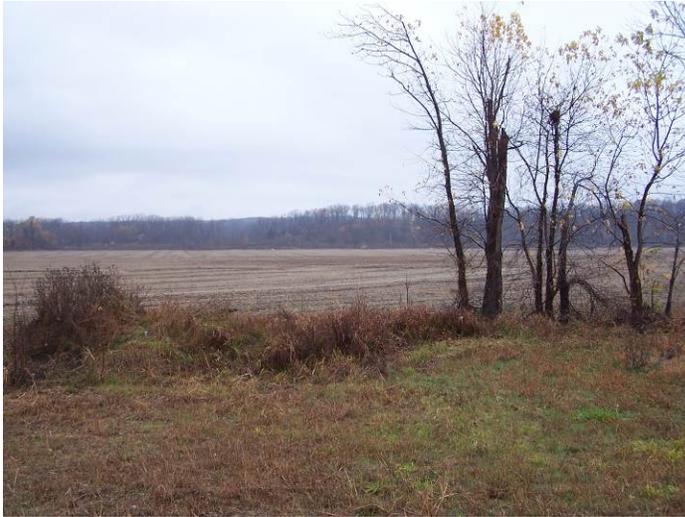
Inspection Results: The groundwater restricted area was inspected and no evidence of groundwater withdrawal or use in the area was observed (Photo 4). The county test wells, which had been noted in last year's inspection as not properly secured, were decommissioned by a DOE subcontractor in April 2004, with the permission of St. Charles County. The subcontractor was under contract to decommission four DOE wells in the quarry area at the same time. Current land use remains consistent with planned institutional controls. The quarry groundwater restriction area boundary survey monuments are shown in Figure 5.

Photo 4. View northwest from county well PW09 of the institutional control area south of the Quarry.

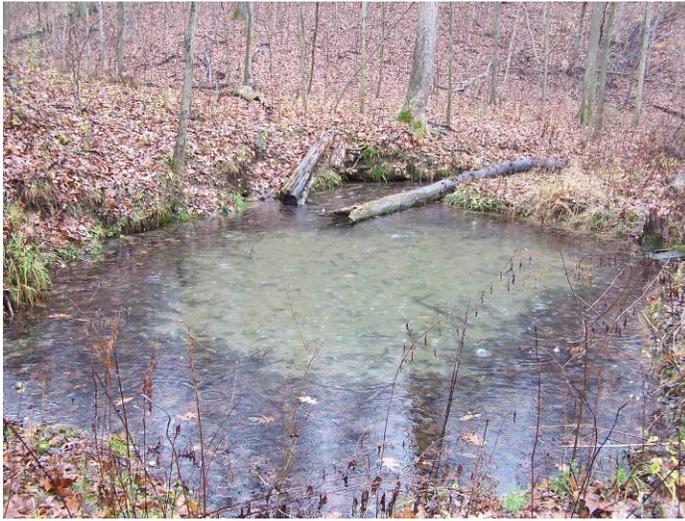
recreational use of the area were observed. The springs also were inspected and no indications of residential, commercial, or agricultural use of the springs were observed (Photo 5). Current land use remains consistent with planned institutional controls.

Photo 5. Spring SP-5304 in the Southeast Drainage.

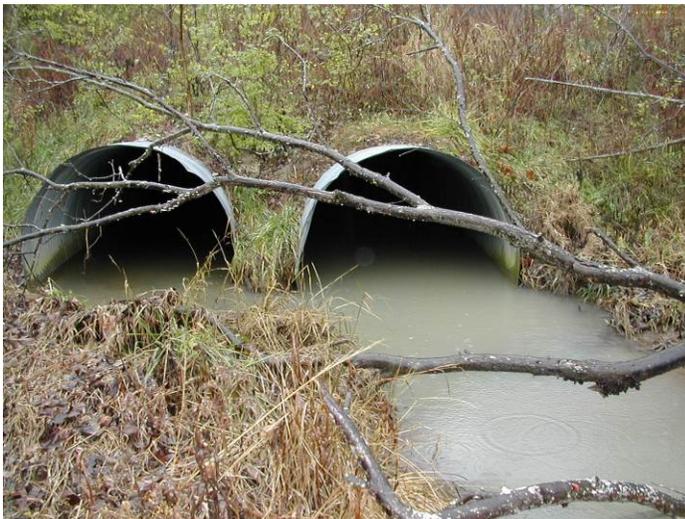
Inspection Results: The Highway D culvert was inspected (Photo 6). The area where the culvert passes beneath the ditch between Highway D and the north end of the culvert was eroded on top, exposing the culverts (Photo 7). As noted in last year's report, this observation had been brought to DOE's attention, prior to the 2003 inspection, by MDC, who later notified the Missouri Department of Transportation (MoDOT). The MoDOT stated at that time that it was not a priority for them as long as the culverts are not compromised. The inspectors concluded during last year's inspection that the drainage in the ditch was entering the culverts at the joint between the two lengths of culvert and therefore was not eroding soil or sediment beneath the culverts. This conclusion was also supported by a lack of erosion at the outlet ends of the culverts. The area seemed to have more erosion on top of the culverts but the outlets appeared unchanged.

Photo 6. View of Highway D culverts from outlet side.

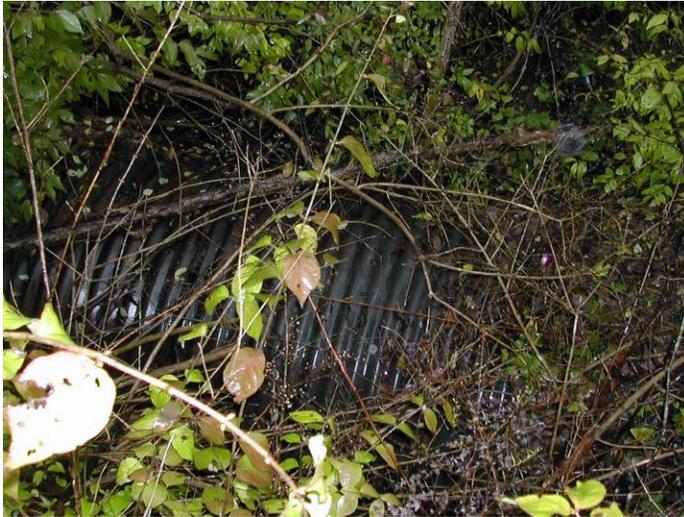
Photo 7. Eroded area of ditch between the exposed Highway D culverts and the highway.

Note any observations: As observed during 2003 inspection, the ditch between the Hwy and culverts has eroded, exposing the top of the culverts.

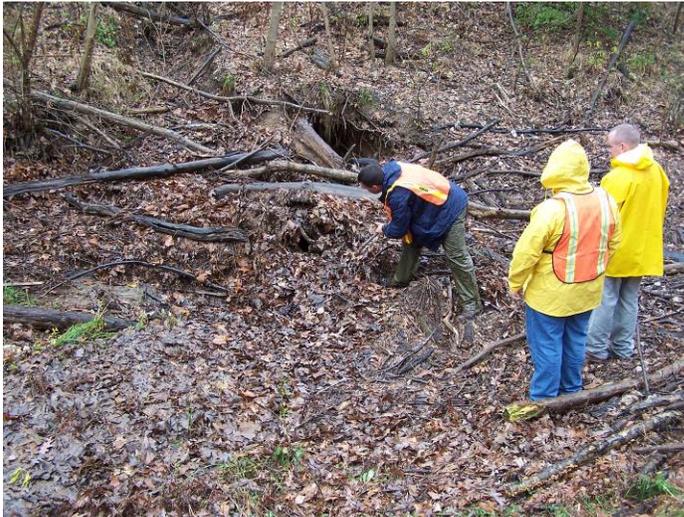
Inspection Results: The State Route 94 culvert was inspected and found to be essentially unchanged since the 2003 inspection. The upstream end was substantially blocked with debris and erosion had occurred on the embankment (Photo 8). The downstream end of the culvert is corroded on the bottom and the last section of pipe is partially separated from the rest of the culvert, causing runoff to leak through and erode beneath the final segment of culvert (Photo 9).

Photo 8. Highway 94 culvert inlet in the Southeast Drainage.

Note any observations: Essentially unchanged from 2003 inspection. The upstream end was substantially blocked with debris and erosion had occurred on the embankment. The downstream end was corroded and the last section of pipe was partially separated from the rest of the culvert.

8. **Recommendation:** The State Route 94 Culvert remains corroded and the inlet side had become almost completely blocked with debris and by partial collapse. The condition of the culvert is not a remedy issue. The only concern is that the inside of the culvert contains some fixed contamination and the DOE wants to ensure that if the culvert is ever removed that it is disposed of properly. The recommendation is to notify MoDOT of the condition of the culvert as a courtesy, since it was observed during the inspection.

Corrective Action: Notify MoDOT of the condition of the culvert.

Note: Don Wichern of MoDOT was notified of the condition of the culvert and supplied pictures by email. Since MoDOT indicated it would take corrective action to clear the inlet area and spread the debris, DOE requested advance notice in order to be present in the event MoDOT decided in the field to remove any portion of the damaged culvert (see Interview Record form in Appendix D).

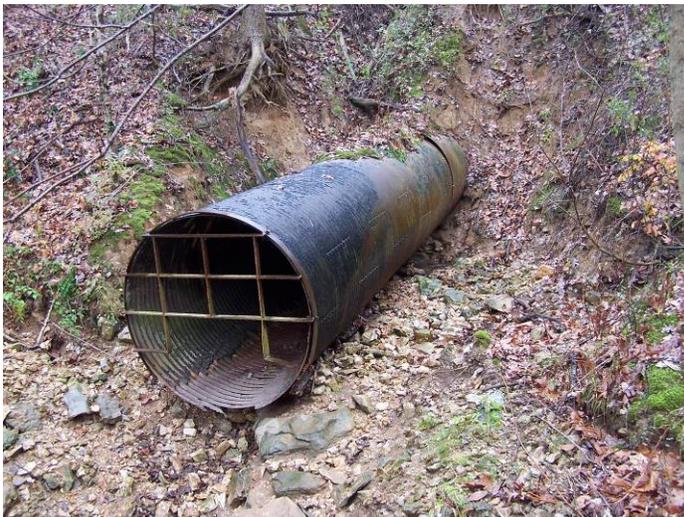
Photo 9. Highway 94 culvert outlet in the Southeast Drainage.

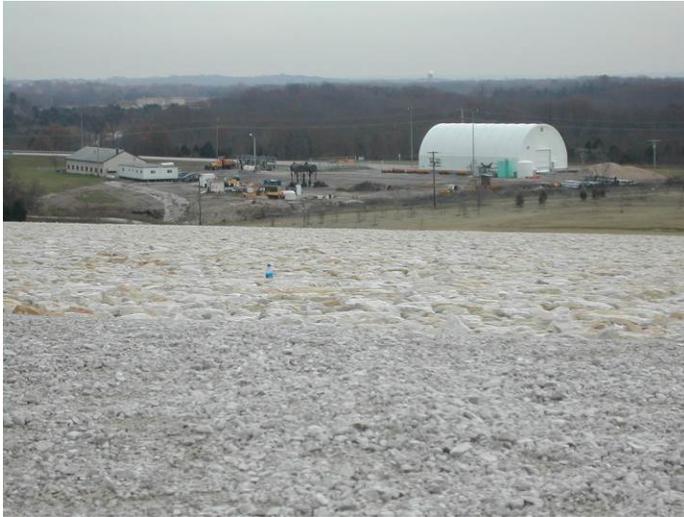
Photo 10. Small depression on top of cell facing northeast from the ramp.

4. **Finding:** A few small depressions and a minor surface disturbance were observed on the disposal cell.

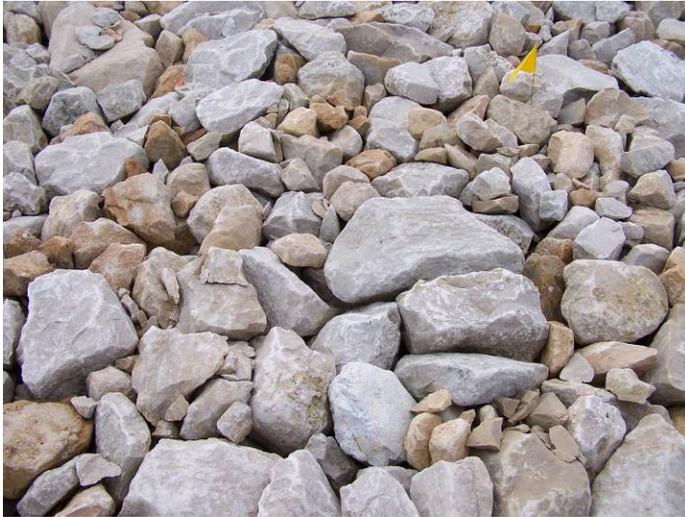
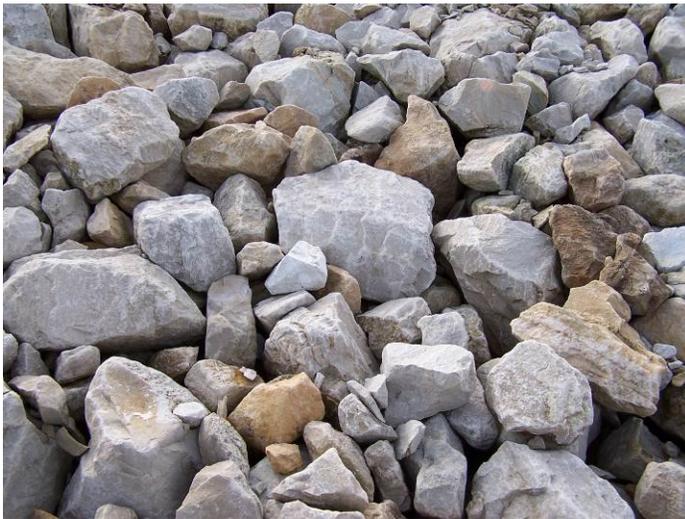
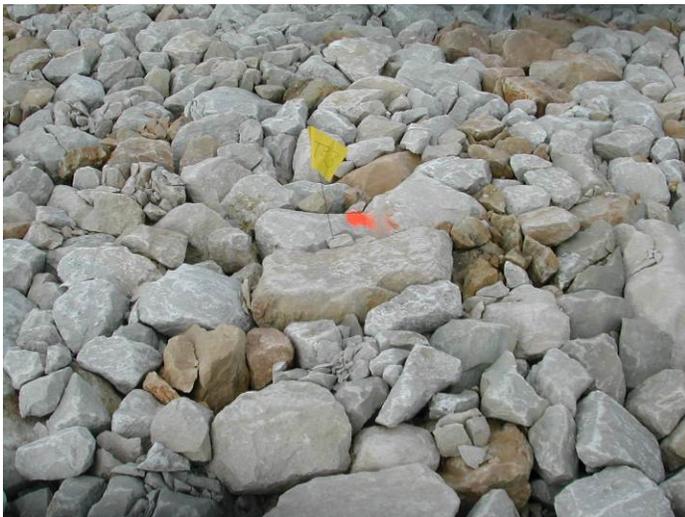
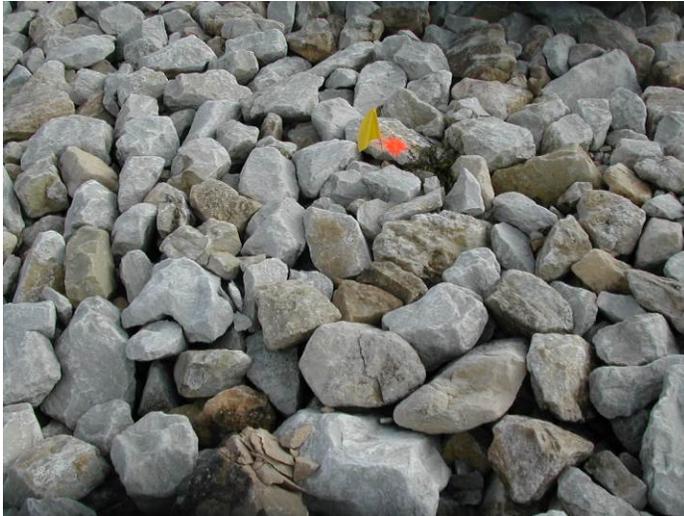
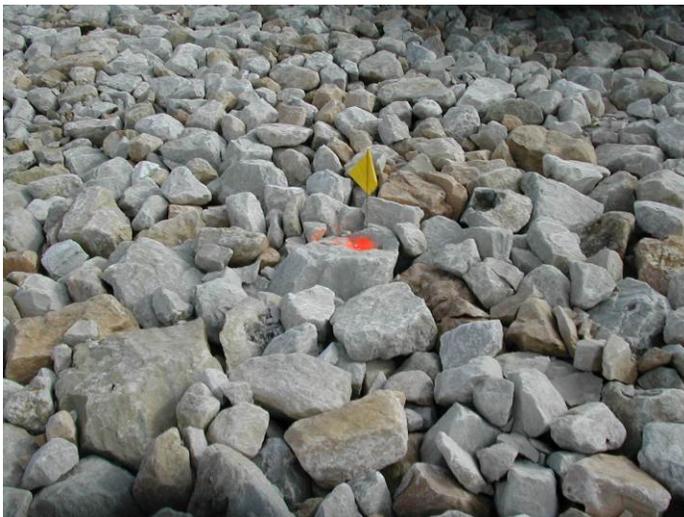
inspection were vegetation, wet areas, apron drains, guard rail, and the stairs. A GPS unit was used during the 2003 inspection to map five areas chosen for rock degradation review (Figure 7). The inspectors inspected these areas and observed no rock degradation. These areas are shown in Photos 13 through 17.

Photo 13. Cell cover rock test plot TP1; north edge of north facet.

Photo 14. Cell side slope rock test plot TP2; bottom of north side slope.

Photo 15. Cell cover rock test plot TP3; northeast ridgeline.

Photo 16. Cell cover rock test plot TP4; lower west side slope.

Photo 17. Cell cover rock test plot TP5; west edge of west facet.

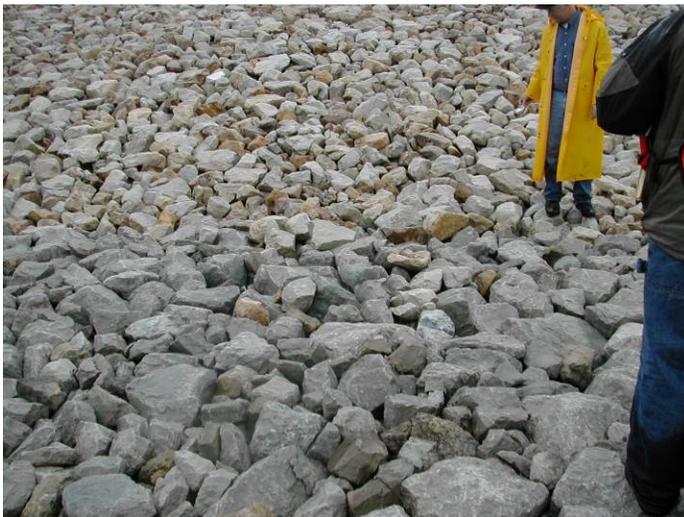
During the 2003 inspection, erosion areas were identified on the north and northwest sides of the disposal cell. These areas had been recently repaired with soil and mulch at the time of the 2003 inspection. During the spring of 2004, these areas were greatly affected by one or more heavy rainfalls and the repairs were washed out resulting in very large erosion gullies. Also during the 2003 inspection, an area of erosion was identified at the outfall NP-0050 on the southwest side of the property. Runoff from the chemical plant property had flowed under the fence onto the Army property and had eroded out a gravel road used to travel around the Army property. Both of the areas were repaired during July 2004 and were stable at the time of the inspection (Photo 18, 25 and 26). A discussion of the repairs was held during the inspection.

Photo 18. Side slope rocks on the apron.

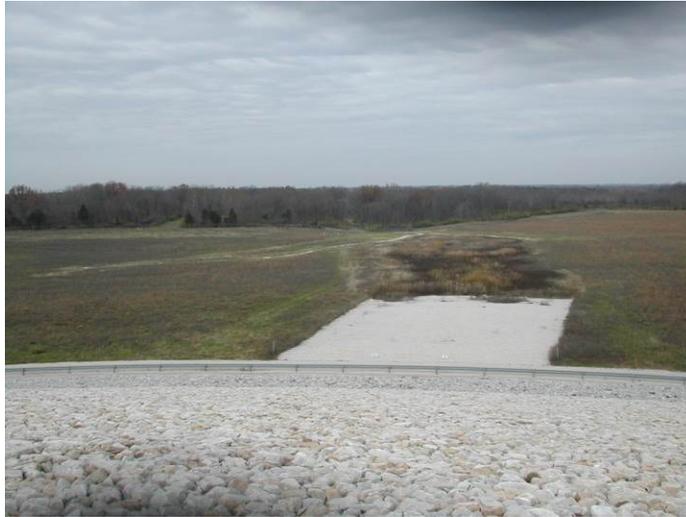
In accordance with the checklist the inspectors also checked for wet areas or water drainage and observed that none were present. The toe and apron drains were inspected and found to be functioning as designed (Photo 19). A small willow tree was growing on the northwest drainage fin (Photo 20). The guardrail and stairs were in good condition (Photos 21 and 22). Five plants were found on the disposal cell and consisted of a perennial wildflower and some small weeds. The flower was pulled during the inspection and herbicide was applied to the weeds the week after the inspection. The condition of the 300-foot buffer zone was found to be good with vegetation established and the survey monuments were verified to be in place. The areas of erosion which had been repaired during the summer were inspected and found to be stable. Some additional erosion was noted north of the disposal cell and is described in Section 2.4.1. The condition of the prairie was good at this time. A section on prairie maintenance is included in Section 2.11.

Photo 19. View of fin and erosion repairs on northwest side of disposal cell.

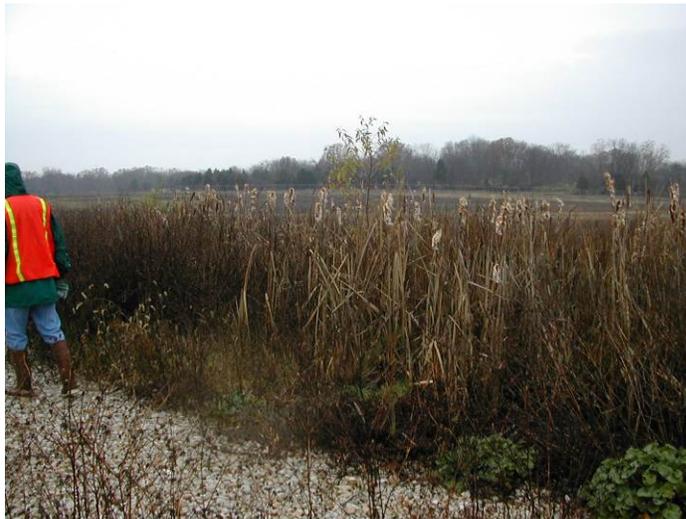
Photo 20. Location of small willow tree in the northwest fin.

9.	Condition of Prairie <input checked="" type="checkbox"/> Evidence of erosion (shown on map) <input checked="" type="checkbox"/> Vegetative growth of woody species (show location) Remarks <i>Erosion on north side. Willow tree noted at end of NW fin.</i> _____ _____	
IX. GROUNDWATER MONITORING

5. **Finding:** A small willow tree was observed in the drainage fin on the northwest side of the disposal cell.

Corrective Action: Remove the willow tree and any other trees found.

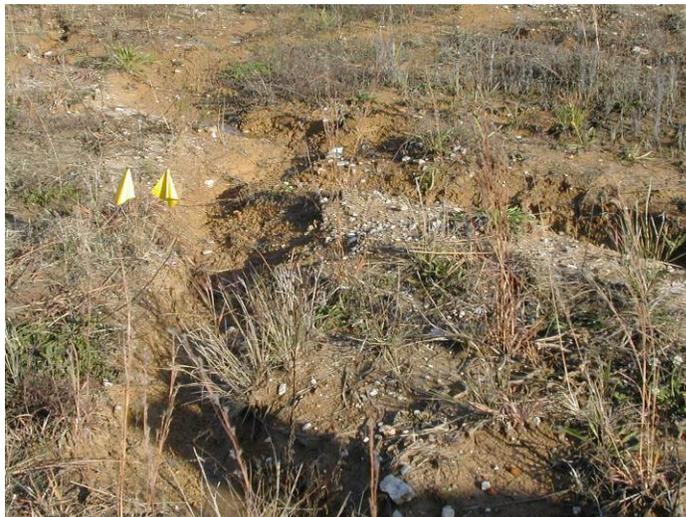
Photo 24. Erosion on north side of chemical plant inside buffer zone; buffer zone pin location indicated by flags.

1. **Chemical Plant Areas** Location shown on site map Erosion not evident
 Areal extent _____ Depth _____
 Remarks Erosion was noted on the north side of the
chemical plant property. Small area of erosion was
inside the buffer zone, next to a survey pin
Erosion areas noted during 2003 inspection were repaired

8.	Condition of 300 Ft. Buffer Zone <input checked="" type="checkbox"/> Evidence of erosion (shown on map) <i>small area</i> <input type="checkbox"/> Vegetative growth of woody species (show location) Remarks <i>Small area of erosion inside buffer zone. Survey pin WS34P is threatened to be washed out.</i> _____ _____

Corrective Action: Survey and map erosion areas outside the buffer zone and monitor the areas. Repair the erosion inside the buffer zone.

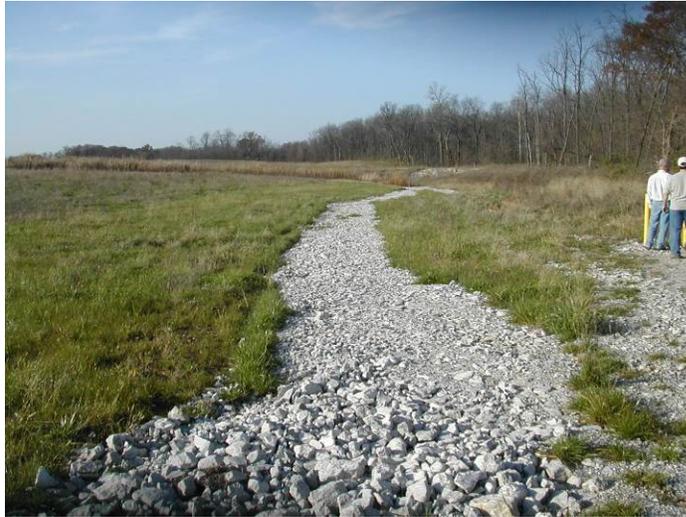
Photo 25. Erosion repair on north side of chemical plant property.

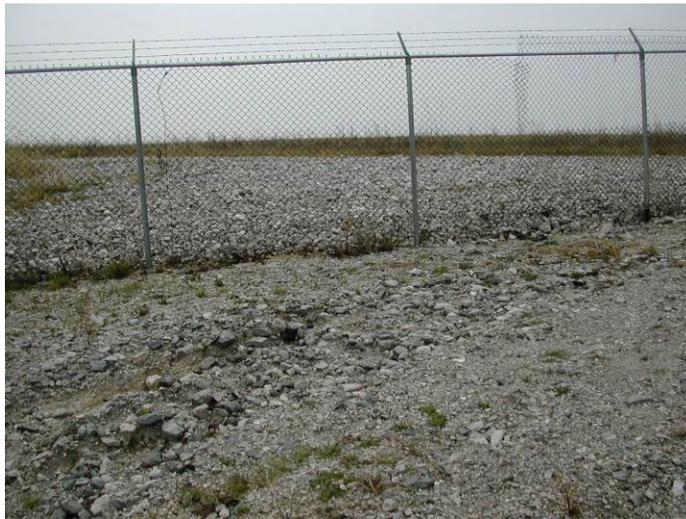
Photo 26. Repairs of Army road erosion.

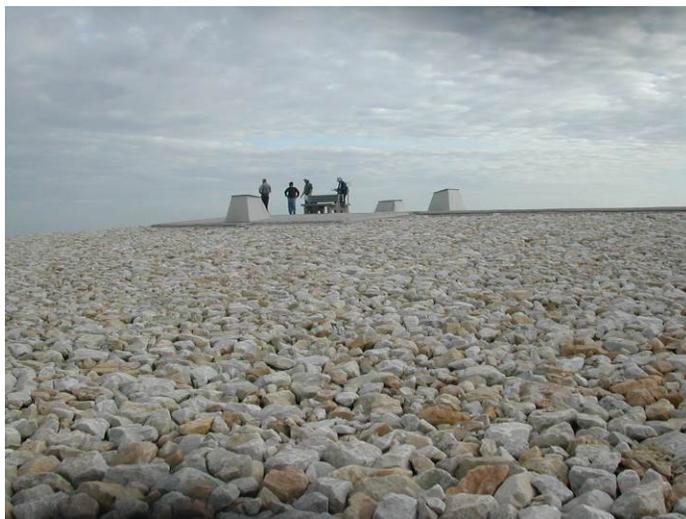
The four information plaques on top of the cell were in good condition (Photo 27). The historical markers were also in good condition.

Photo 27. The platform and markers on the disposal cell.

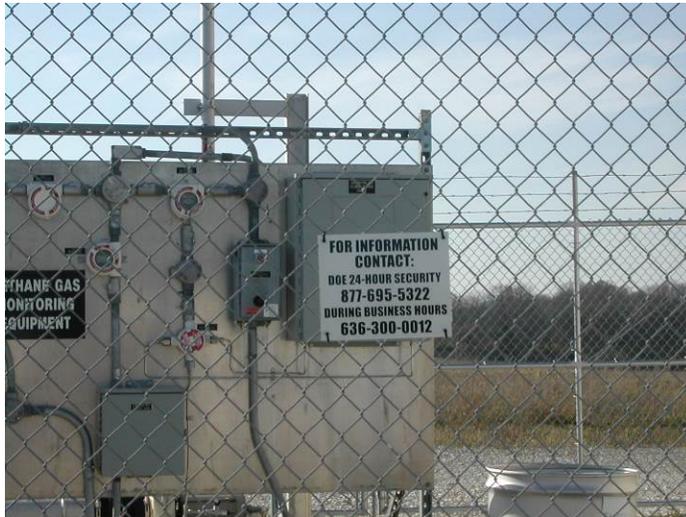
The plan also states that signs are posted on the LCRS fence to inform the public that trespassing is forbidden and that persons may call the DOE 24-hour security telephone number (970-248-6070 or 877-695-5322) for information. During the 2003 inspection, it was noted that signs were posted on the LCRS fence on all three sides that stated "U.S. Property, No Trespassing." There were no phone numbers posted at the LCRS. This was corrected after the inspection and signs with the local and 24-hour number were posted on three sides of the LCRS fence (Photo 28).

Photo 28. Contact information sign on LCRS fence.

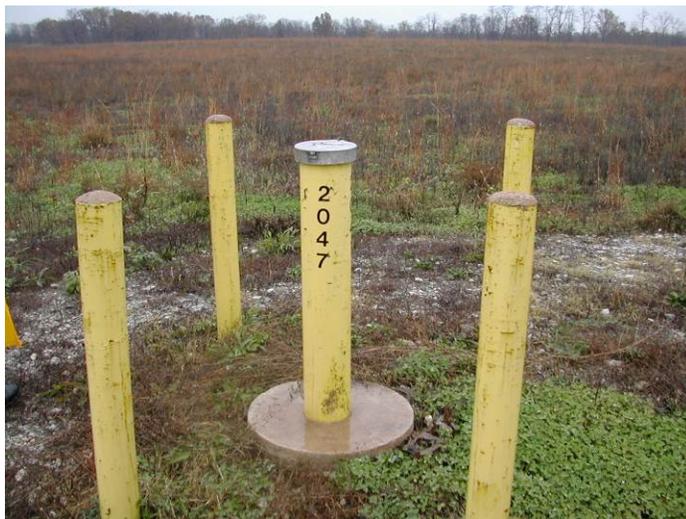
Monitoring wells in the Disposal Cell Monitoring Well Network, Chemical Plant Monitoring Well Network, and Quarry Monitoring Well Network were inspected (Photo 29). The inspection checklist required all the disposal cell wells to be inspected and greater than 10 percent of the chemical plant and quarry wells to be inspected. The checklist required the wells to be inspected to ensure they are properly secured and locked, in good condition, and to check if they need maintenance and have the proper ID number on the well.

Photo 29. Monitoring well MW-2047 on Chemical Plant Property.

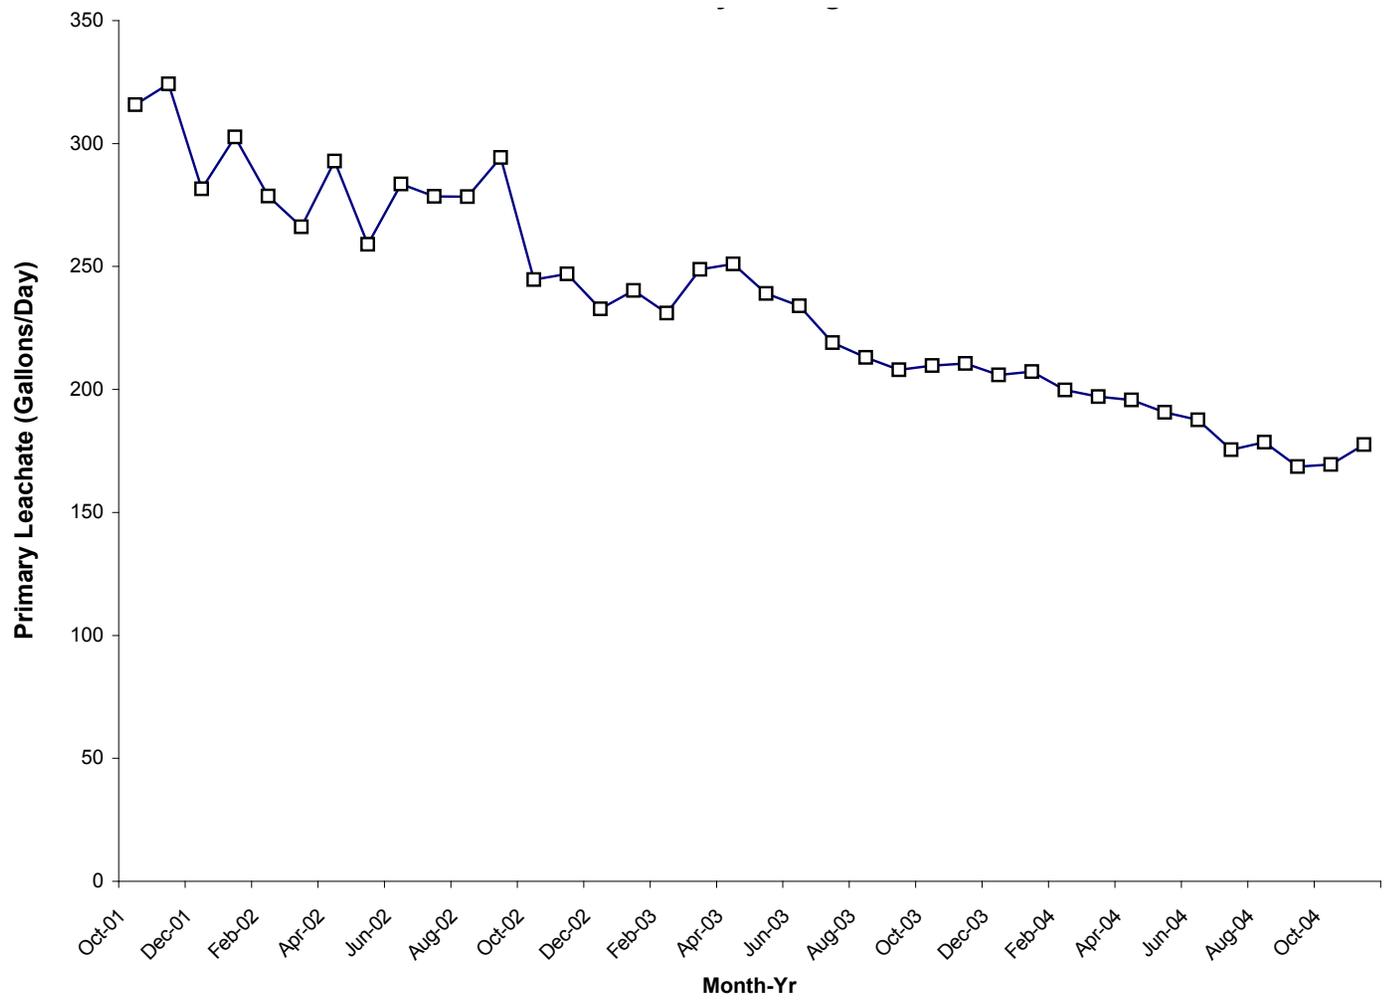
Figure C-1. Average Daily Rate of Primary Leachate Flow

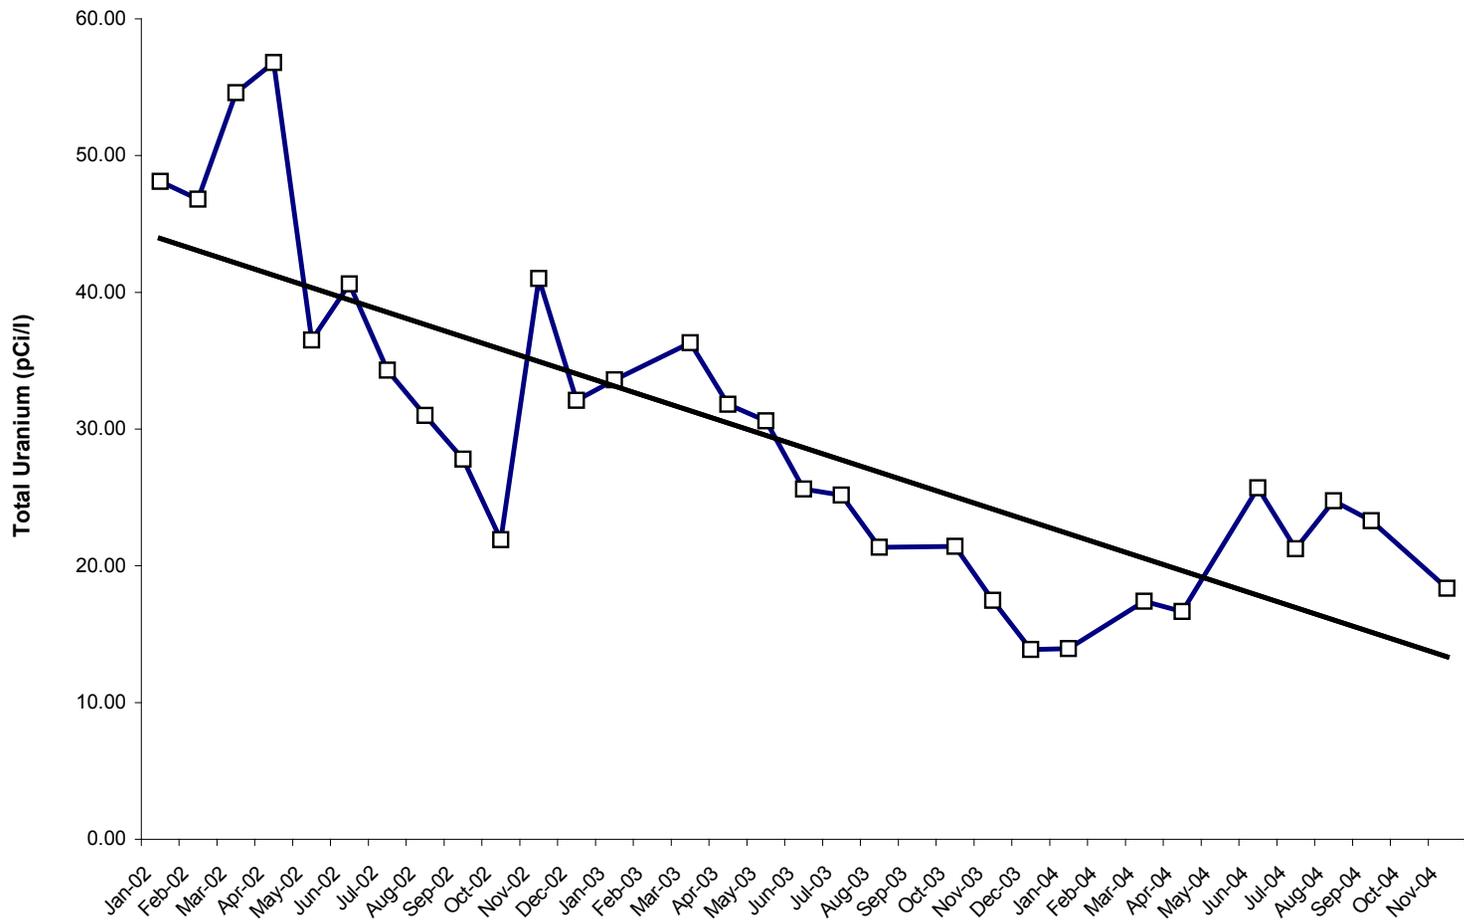
Figure C-2. Total Uranium Concentration in the Primary Leachate
