2012 Annual Inspection Report for the Weldon Spring, Missouri, Site

January 2013

The Weldon Spring Site, located in St. Charles, Missouri, was inspected October 23 through 25, 2012. The inspection was conducted in accordance with the *Long-Term Surveillance and Maintenance Plan for the Weldon Spring, Missouri, Site* (LTS&M Plan) (December 2008), and associated inspection checklist. Representatives from the U.S. Department of Energy (DOE), the DOE contractor S.M. Stoller Corporation (Stoller), U.S. Environmental Protection Agency (EPA), and Missouri Department of Natural Resources (MDNR) participated in the inspection. Representatives from the Missouri Department of Transportation (MoDOT), and St. Charles County, Division of Environmental Health and Protection participated in portions of the inspection. The Weldon Spring Site is a Comprehensive Environmental Response, Compensation, and Liability Act (CERCLA) site.

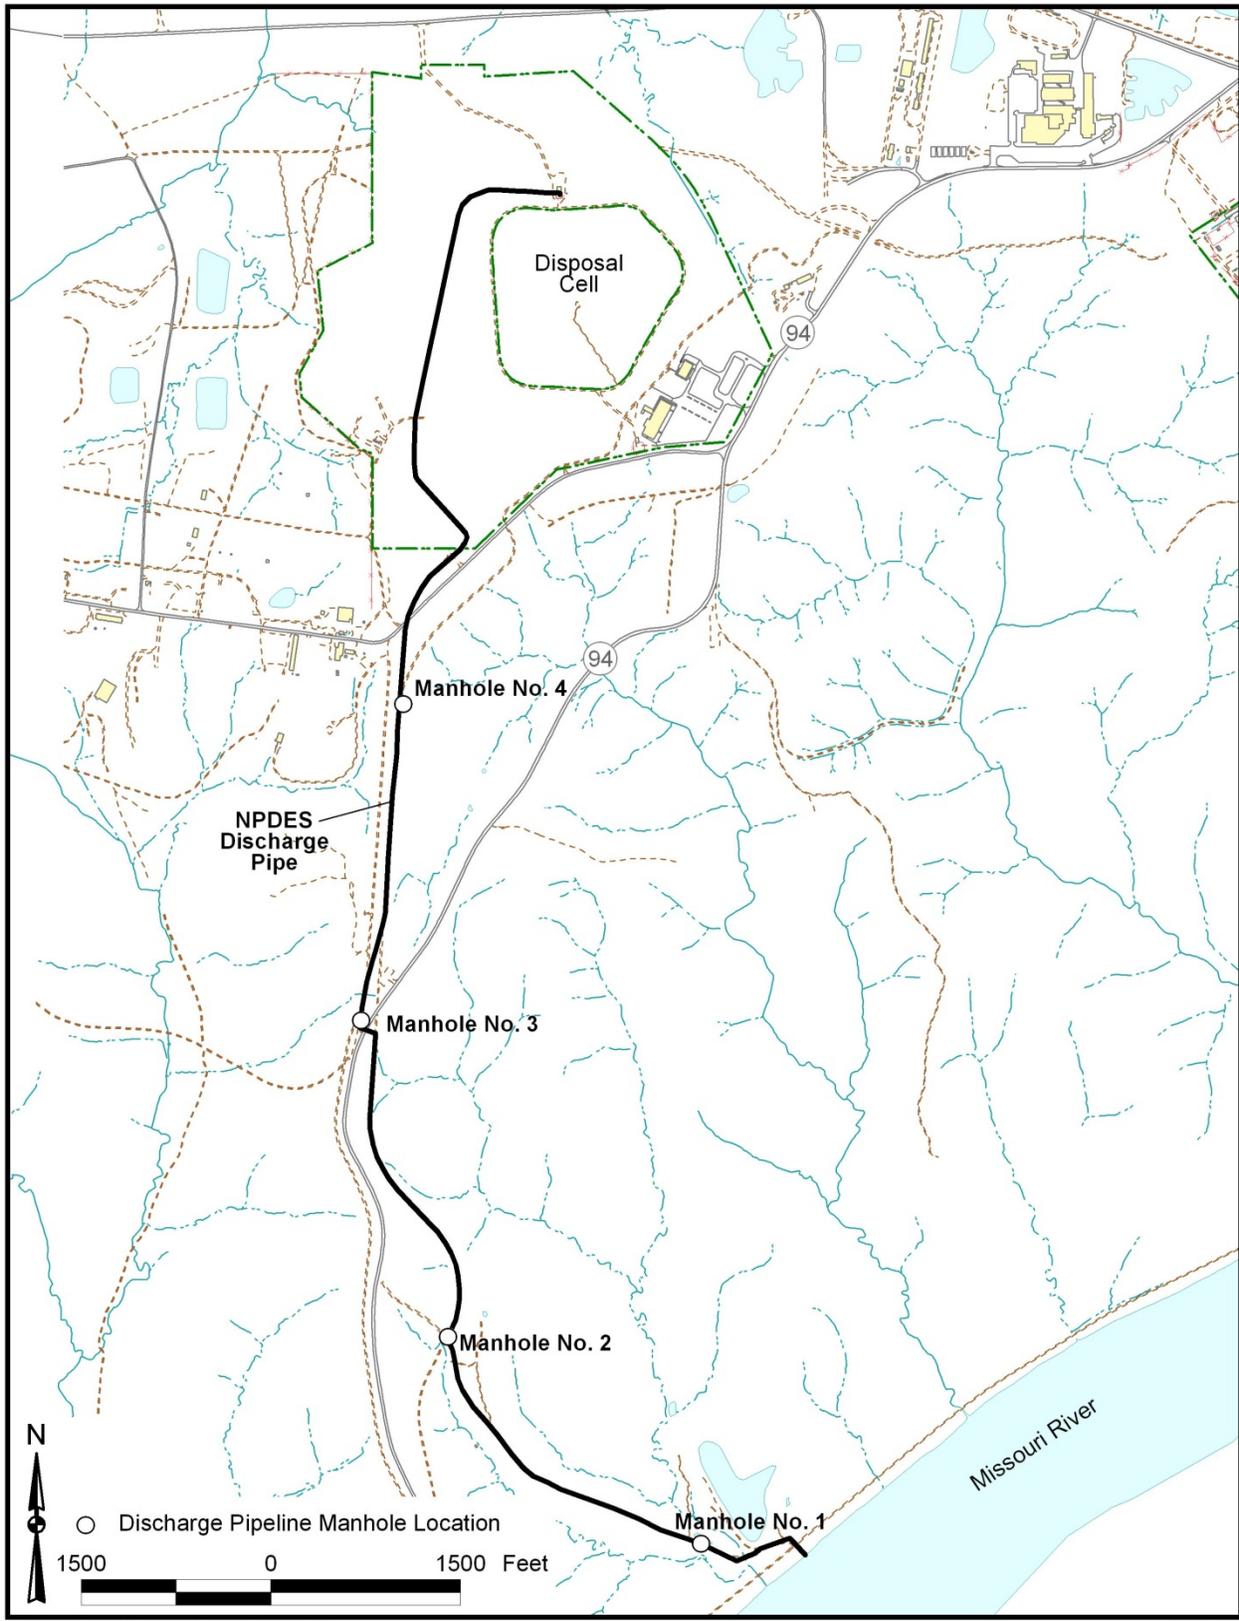
Figure 6. NPDES Discharge Pipeline Between the LCRS Support Building at the Missouri River, Weldon Spring, Missouri, Site

Inspection Results: The area of the pipeline was inspected. A map of the pipeline, indicating the manhole locations, is shown in Figure 6. It was noted that there were no on-site disturbances of the pipeline and there were no apparent disturbances in the area of the pipeline or manholes in the off-site areas. It was observed that there is some minor debris in the opening of the discharge pipe at the Missouri River. This pipeline serves as a contingency for discharge of disposal cell leachate. The pipeline has not been used for that purpose to date.

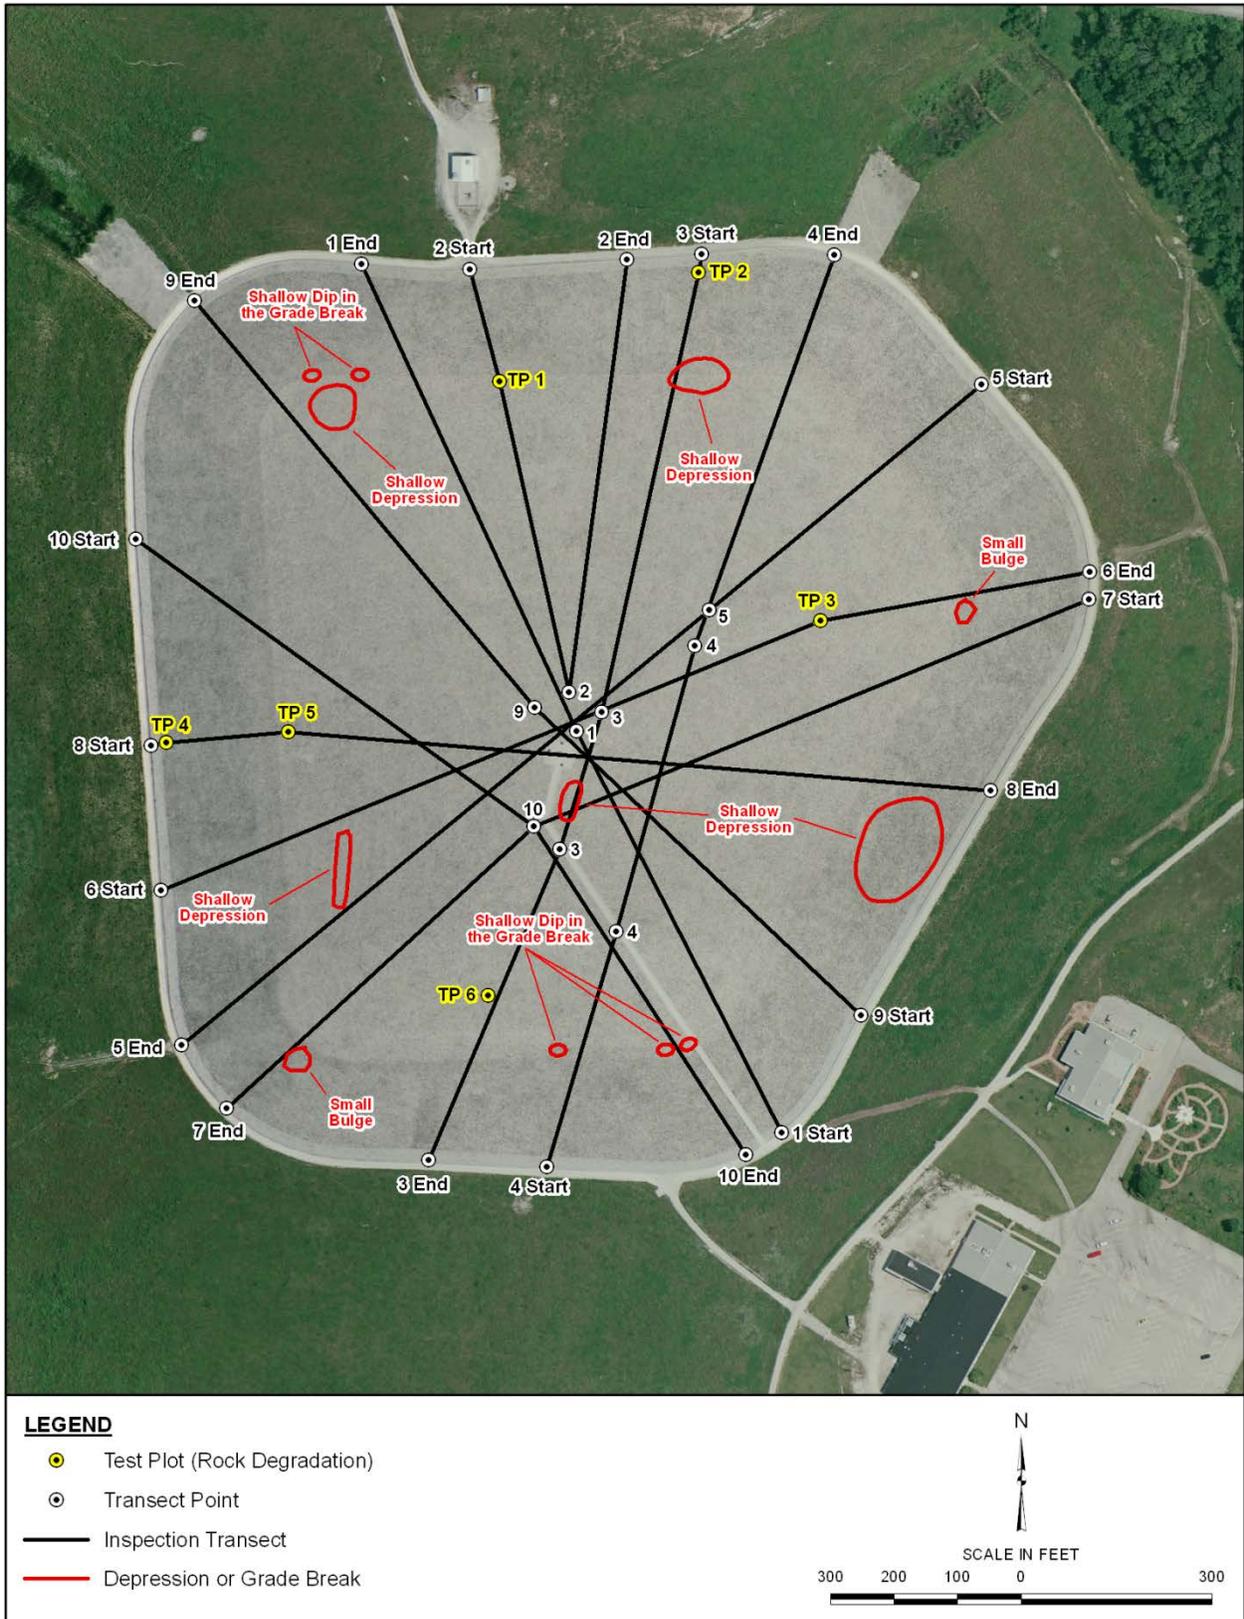
Figure 7. Disposal Cell Inspection Transects and Rock Test Plot Locations at the Weldon Spring, Missouri, Site

The disposal cell was inspected by walking ten transects over the cell and around the cell perimeter. Hand-held global positioning system (GPS) equipment was used to navigate the ten transects. Six areas of the cell which had been marked were located and observed for any signs of rock degradation. The LCRS was also inspected and observed to be in good condition. Forty-eight of the 107 groundwater-monitoring wells were inspected and were in good condition. Other site features including the prairie, site markers, and roads also were inspected.

Remarks The inspectors walked the 10 transects. A few
minor depression areas were noted.

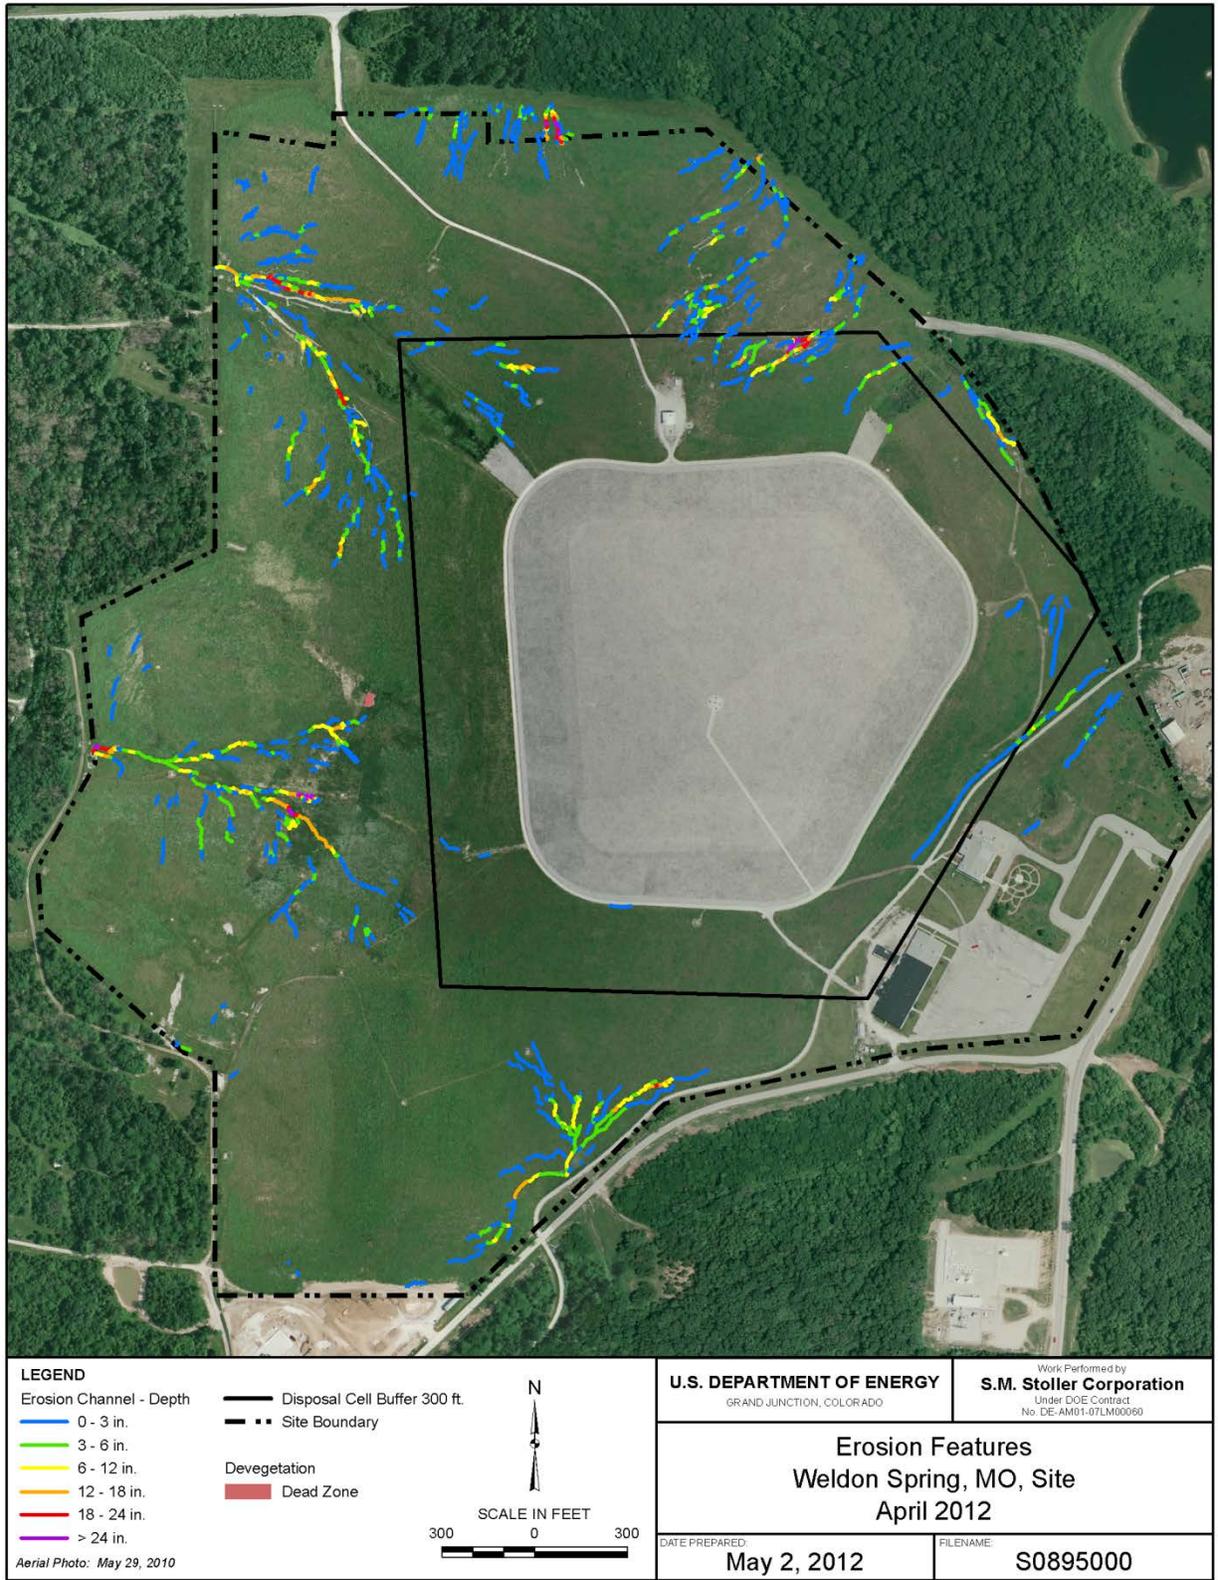
Figure 8. Erosion Channels within the Prairie

The erosion areas were observed during the inspection. Erosion channels within the entire prairie have been mapped with GPS annually since 2007 (Figure 8). The resulting information will be used to track the nature and extent of erosion and to determine possible action if deemed necessary.

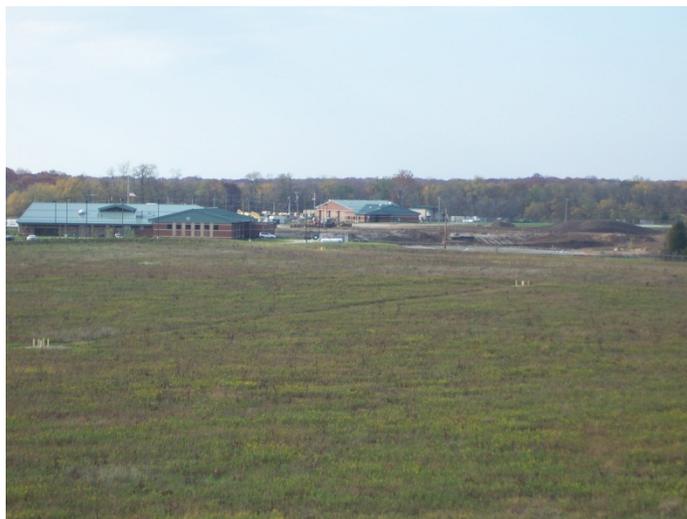
Photo 3. View from the disposal cell of the clearing on the Army Property.

Inspection Results: The surrounding area where groundwater use is restricted was inspected. This included property owned by the MDC and the Army. No evidence of groundwater use was observed and current land use remains consistent with institutional controls on both properties. Burgermeister Spring 6301 (Photo 2) and Spring 6303 on MDC property were inspected and there were no indications of spring water use. Spring 6303 was not flowing. All the monitoring wells inspected were appropriately secured. The maintenance on the monitoring wells was also sufficient. The Army has started clearing land for a new large reserve center (Photo 3).

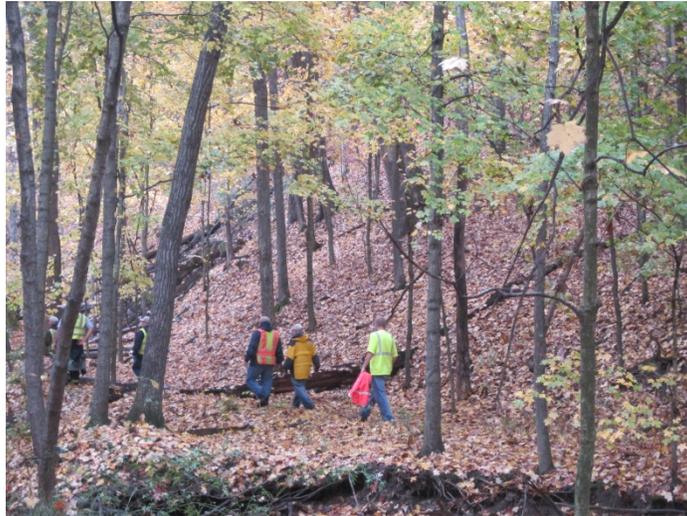
Photo 4. Southeast drainage.

Inspection Results: The inspectors walked down the entire Southeast Drainage (Photo 4) and no indications of residential use, construction, or any other activity that would indicate non-recreational use of the area were observed. The springs also were inspected and no indications of residential, commercial, or agricultural use of the springs were observed. Both of the springs were observed to be flowing. Current land use remains consistent with planned institutional controls. It was recommended during the 2011 inspection that monitoring well MW-4026 be repainted and it was noted during this inspection that the well had been repainted. (Photo 5). It was observed during the 2011 inspection that erosion is occurring under the culvert which crossed under the Hamburg Trail (Photo 6). John Vogel of MDC had noted this issue during the 2011 inspection as they are responsible for maintenance of the Hamburg Trail under a formal agreement between DOE and MDC. The erosion was again observed during the 2012 inspection and an email was sent on November 2, 2012, to John Vogel informing him of the observation.

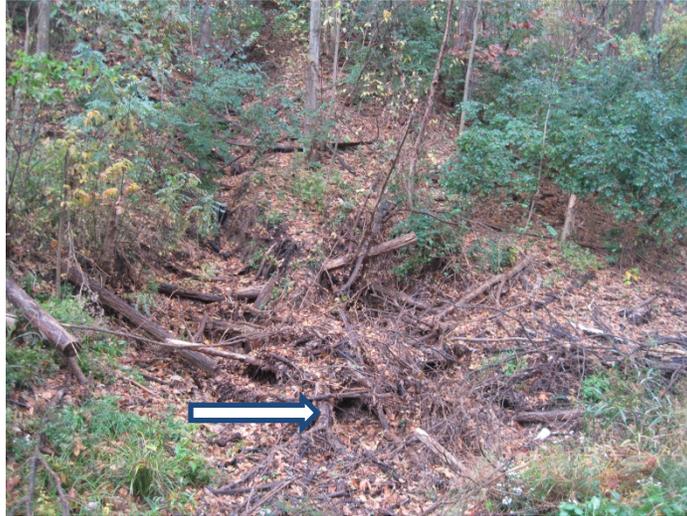
Photo 7. Culvert inlet under Highway 94..

Inspection Results: The State Route 94 culvert was inspected. It was noted during the inspection that the culvert inlet was filled with tree debris (Photo 7). The MoDOT representative, Kevin Wideman, stated that he would inform the local MoDOT representatives.

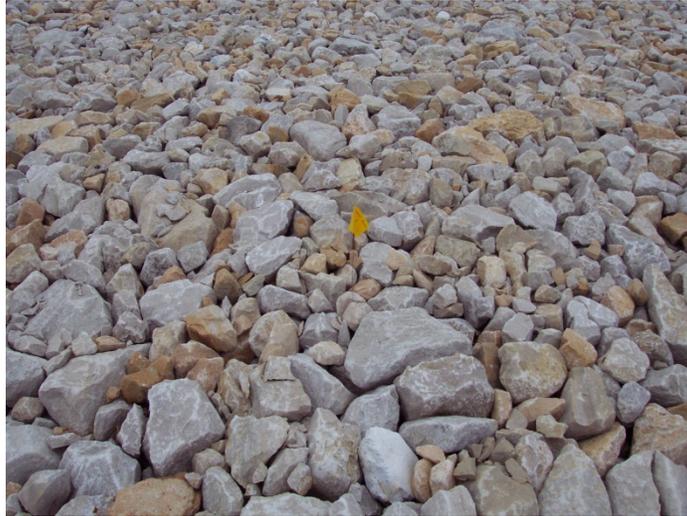
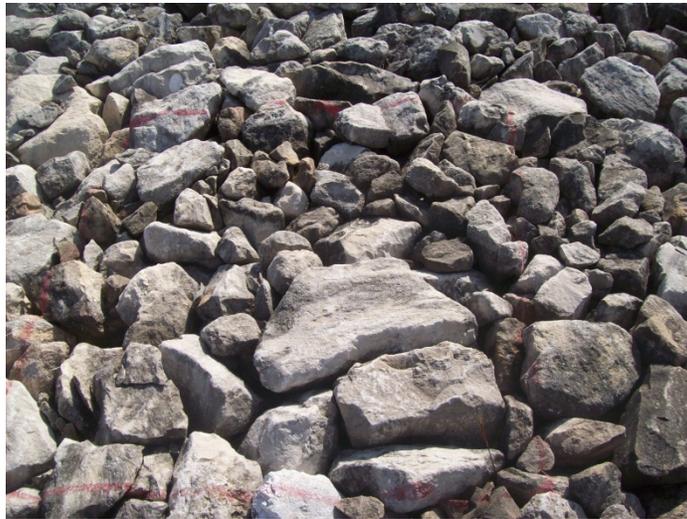
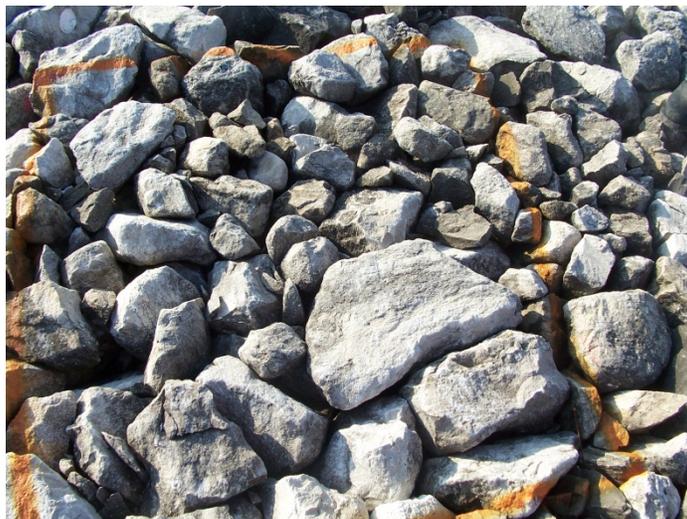
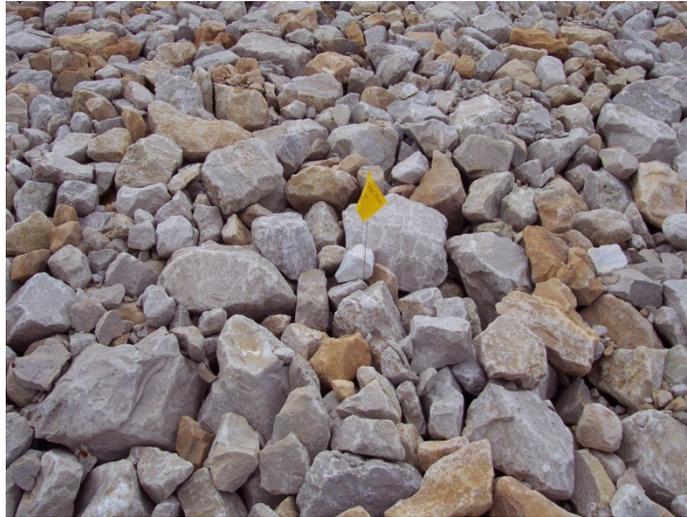
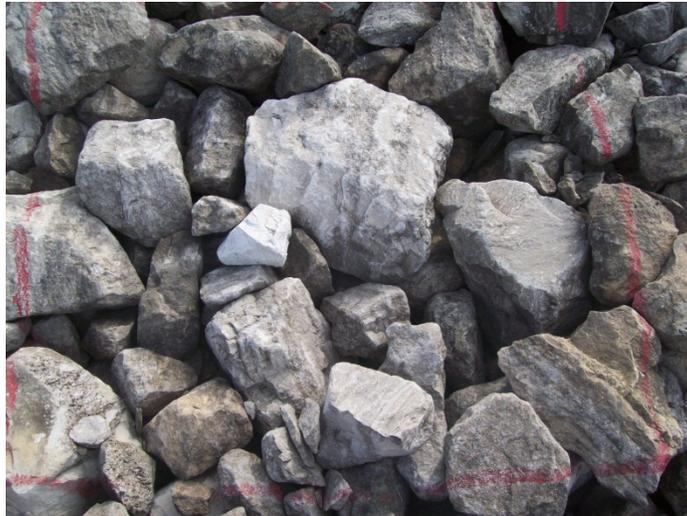
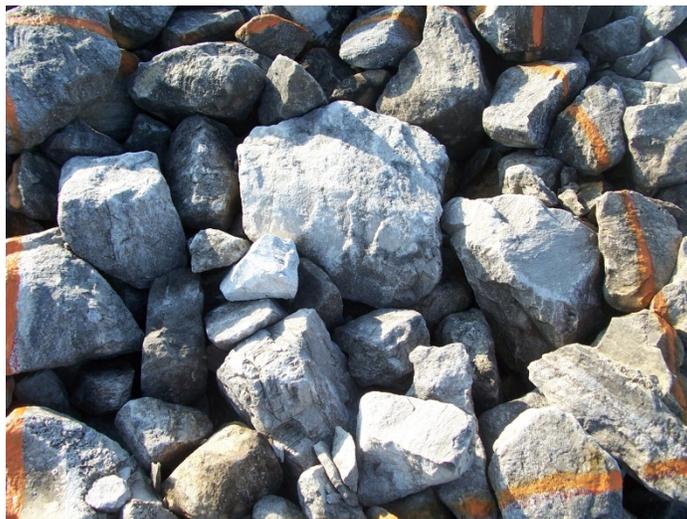
Photo 10. 2003-Cell cover test plot TP1; north edge of north facet.

Photo 11. 2011-Cell cover test plot TP1; north edge of north facet.

Photo 12. 2012-Cell cover test plot TP1; north edge of north facet.

Photo 13. 2003-TP2; foot of north side slope of disposal cell.

Photo 14. 2011-Cell cover test plot TP2; bottom of north side slope.

Photo 15. 2012-Cell cover test plot TP2; bottom of north side slope.

Remarks The 6 rock degradation test plots were compared
to previous years photos. The rocks had not changed or
degraded. The rock plots had been repainted.

2. Recommendation: Repaint Rock Degradation Test Plots

Action: Repainted Rock Degradation Test Plots

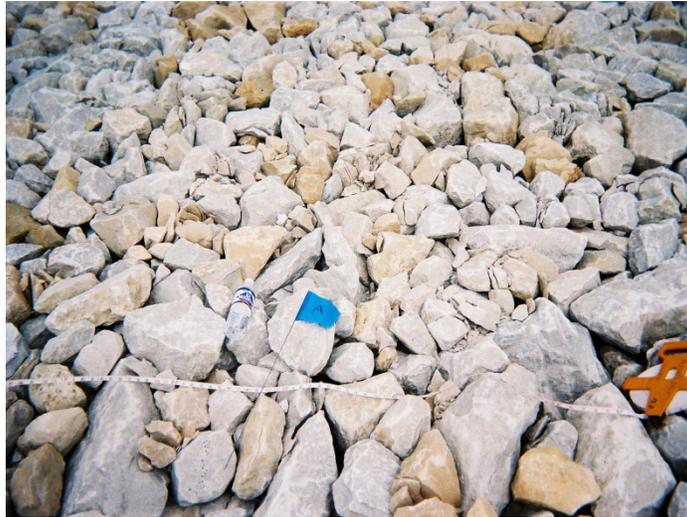
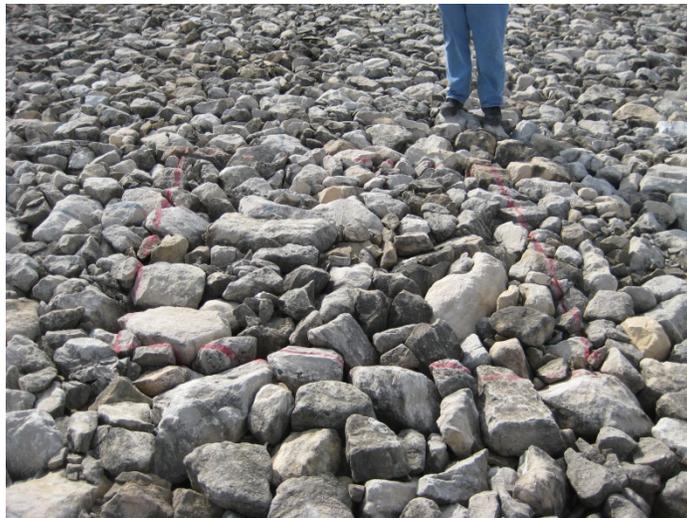
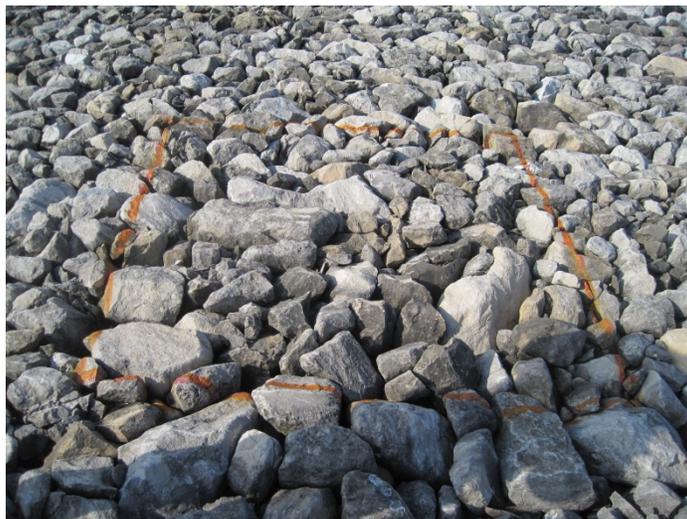
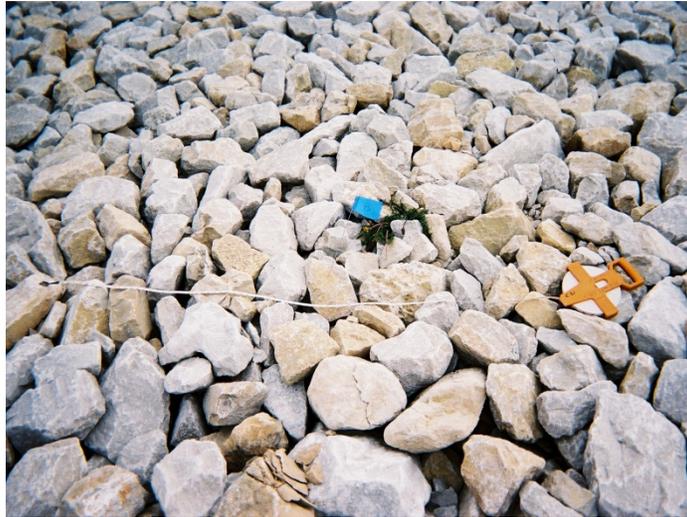
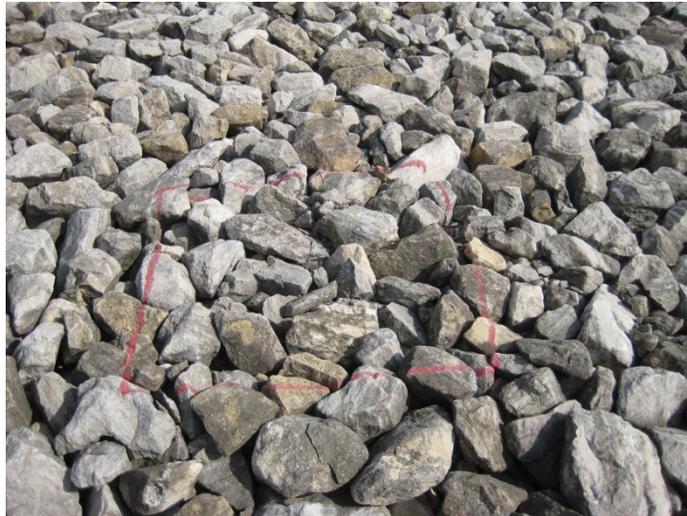
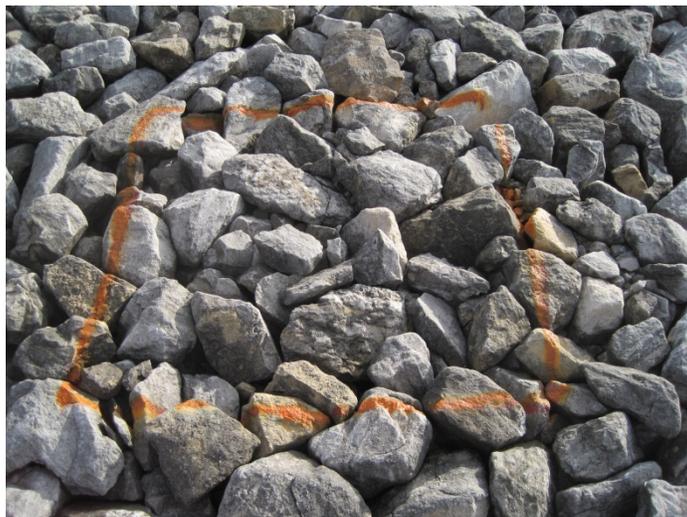
Photo 16. 2003-Cell cover test plot TP3; northeast ridgeline.

Photo 17. 2011-Cell cover test plot TP3; northeast ridgeline.

Photo 18. 2012-Cell cover test plot TP3; northeast ridgeline.

Photo 19. 2003-Cell cover test plot TP4; located on upper west side.

Photo 20. 2011-Cell cover test plot TP4; located on upper west side.

Photo 21. 2012-Cell cover test plot TP4; located on upper west side.

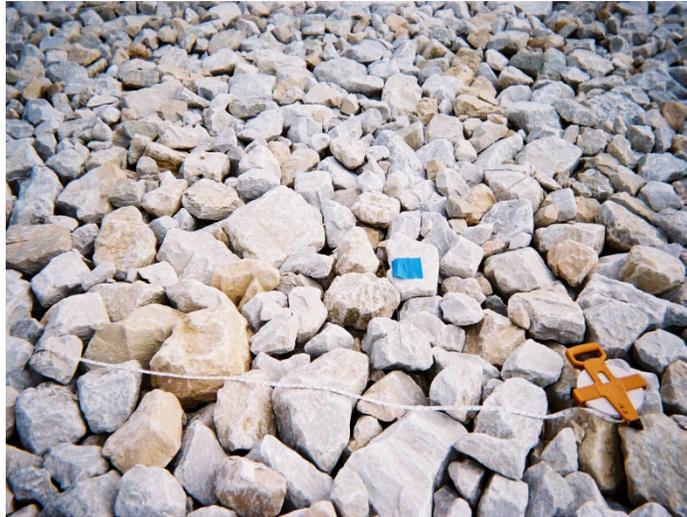
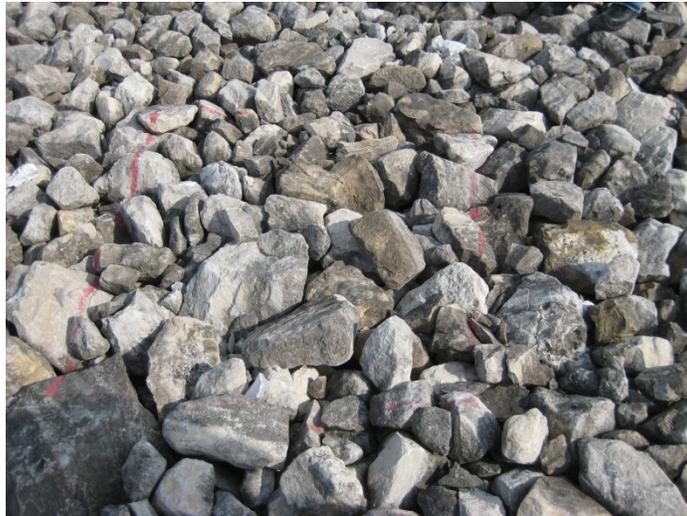
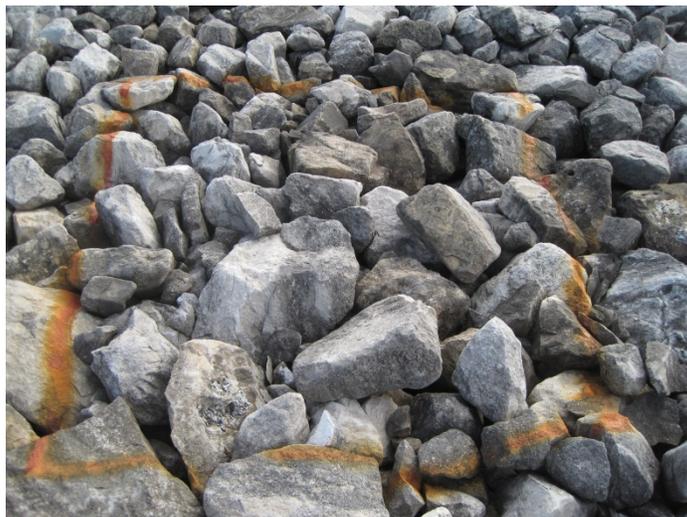
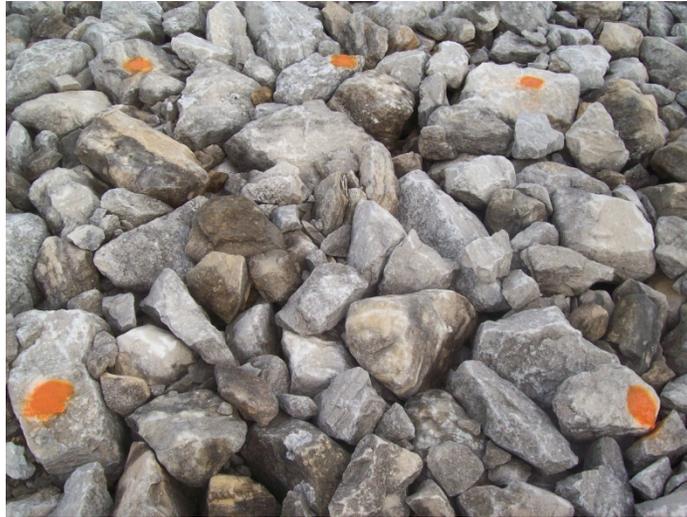
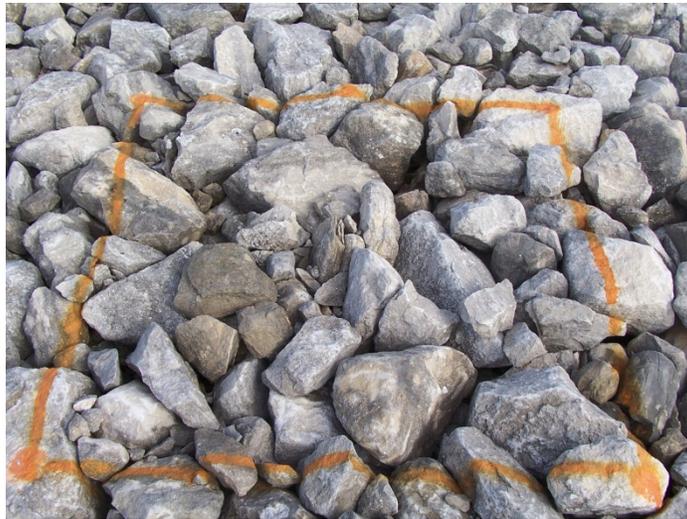
Photo 22. 2003-Cell cover test plot TP5; located on lower west side.

Photo 23. 2011-Cell cover test plot TP5; located on lower west side.

Photo 24. 2012-Cell cover test plot TP5; located on lower west side.

Photo 25. 2011-Cell cover test plot TP6; located on upper south side.

Photo 26. 2012-Cell cover test plot TP6; located on upper south side.

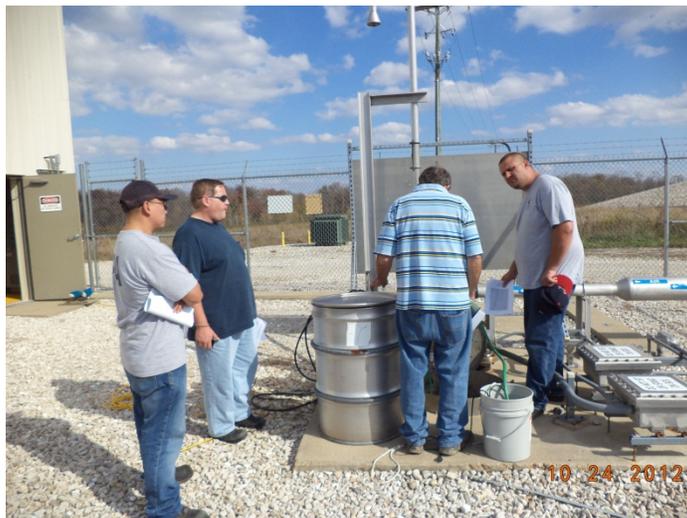
Photo 27. Sump outside LCRS Building.

Operations of the LCRS were discussed with the inspection participants, the LCRS data and the SOARS system was presented, and the system was inspected (Photo 27). The fences and doors were locked and were in good condition. The system was functioning as designed. The leachate production rates, uranium levels, and flow rates are provided in Appendix D.

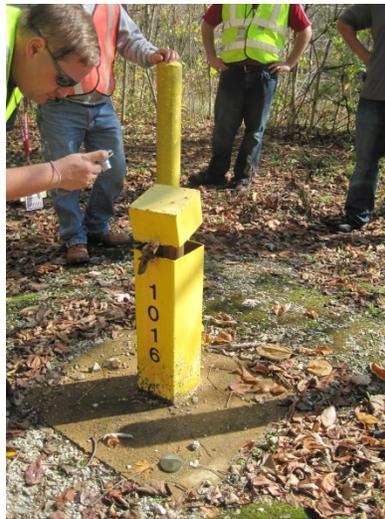
Photo 29. Monitoring well MW-1016; one of wells damaged from the drought due to ground subsidence.

Monitoring wells in the Disposal Cell Monitoring Well Network, Chemical Plant Monitoring Well Network, and Quarry Monitoring Well Network were inspected. The inspection checklist required all the disposal cell wells to be inspected, and greater than 10 percent of the Chemical Plant and Quarry wells to be inspected. The checklist required the wells to be inspected to ensure they are properly secured and locked, in good condition, and to check if they need maintenance and have the proper ID number on the well. The maintenance on the wells looked good, with many wells having been freshly painted. Prior to the inspection during regular sampling and inspection of the wells it was noted that several of the wells and/or well casings had settled and caused damage to the wells or the concrete pads (Photo 29). It is assumed that the extreme drought over the summer caused the settling. The following wells from the Chemical Plant were affected: MW-2033, 2034, 4001. The wells affected at the Quarry were MW-1013, 1015, 1016, 1018, and 1046. It is planned to hire a subcontractor to repair the affected wells.

1. Recommendation: Repair wells which have been observed to be damaged by ground subsidence. These include MW-1013, 1015, 1016, 1018, 1046, 2033, 2034, and 4001.

Action: Repair wells which have been observed to be damaged by settling. These include MW-1013, 1015, 1016, 1018, 1046, 2033, 2034, and 4001.
