**SITE ANALYSIS FEED MATERIALS PRODUCTION
CENTER FERNALD OHIO INTERIM REPORT
SEPTEMBER 1988**

TS-PIC-88088
September 1988

Site Analysis
Feed Materials Production Center
Fernald, Ohio

Interim Report

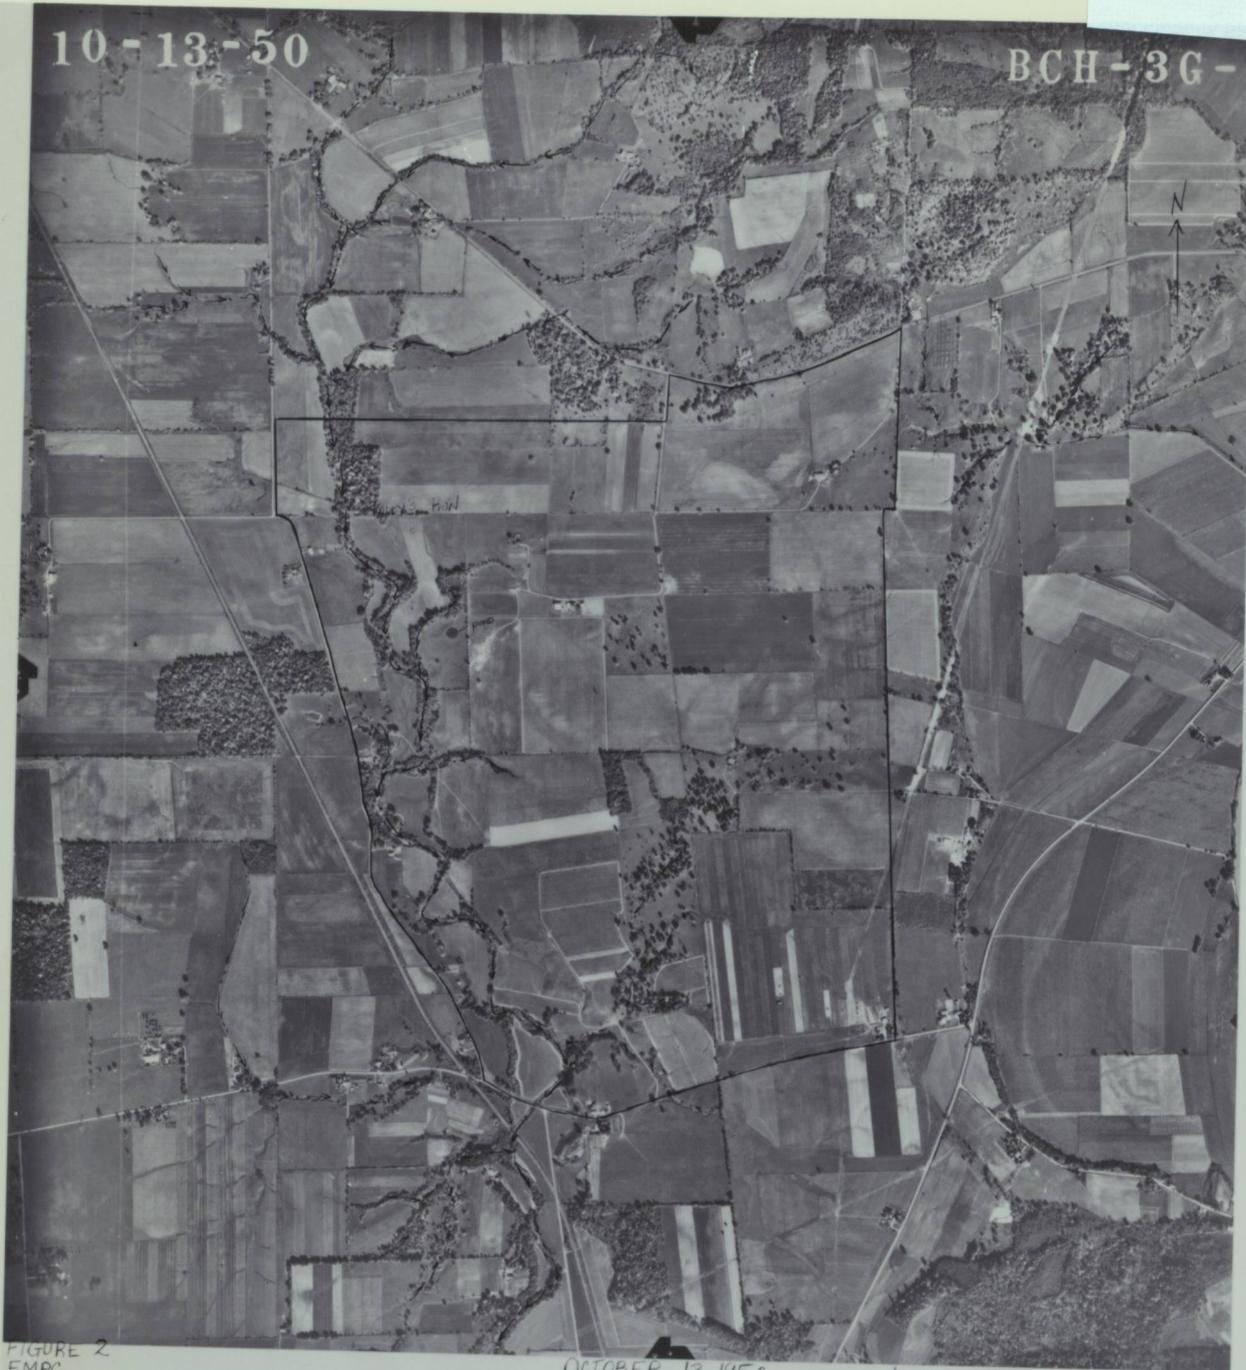
FIGURE 2
FMPC

The 1950 photography illustrates the site area before the construction of the FMPC. The majority of the site area is agricultural fields. Paddy's Creek flows through the western portion of the site and leads to the Great Miami River approximately 2.4 kilometers (1.5 miles) to the south (not shown in photo). A smaller tributary leads from near the southwest corner of the site.

An unnamed stream located outside the northeast boundary of the FMPC leads east to the Great Miami River.

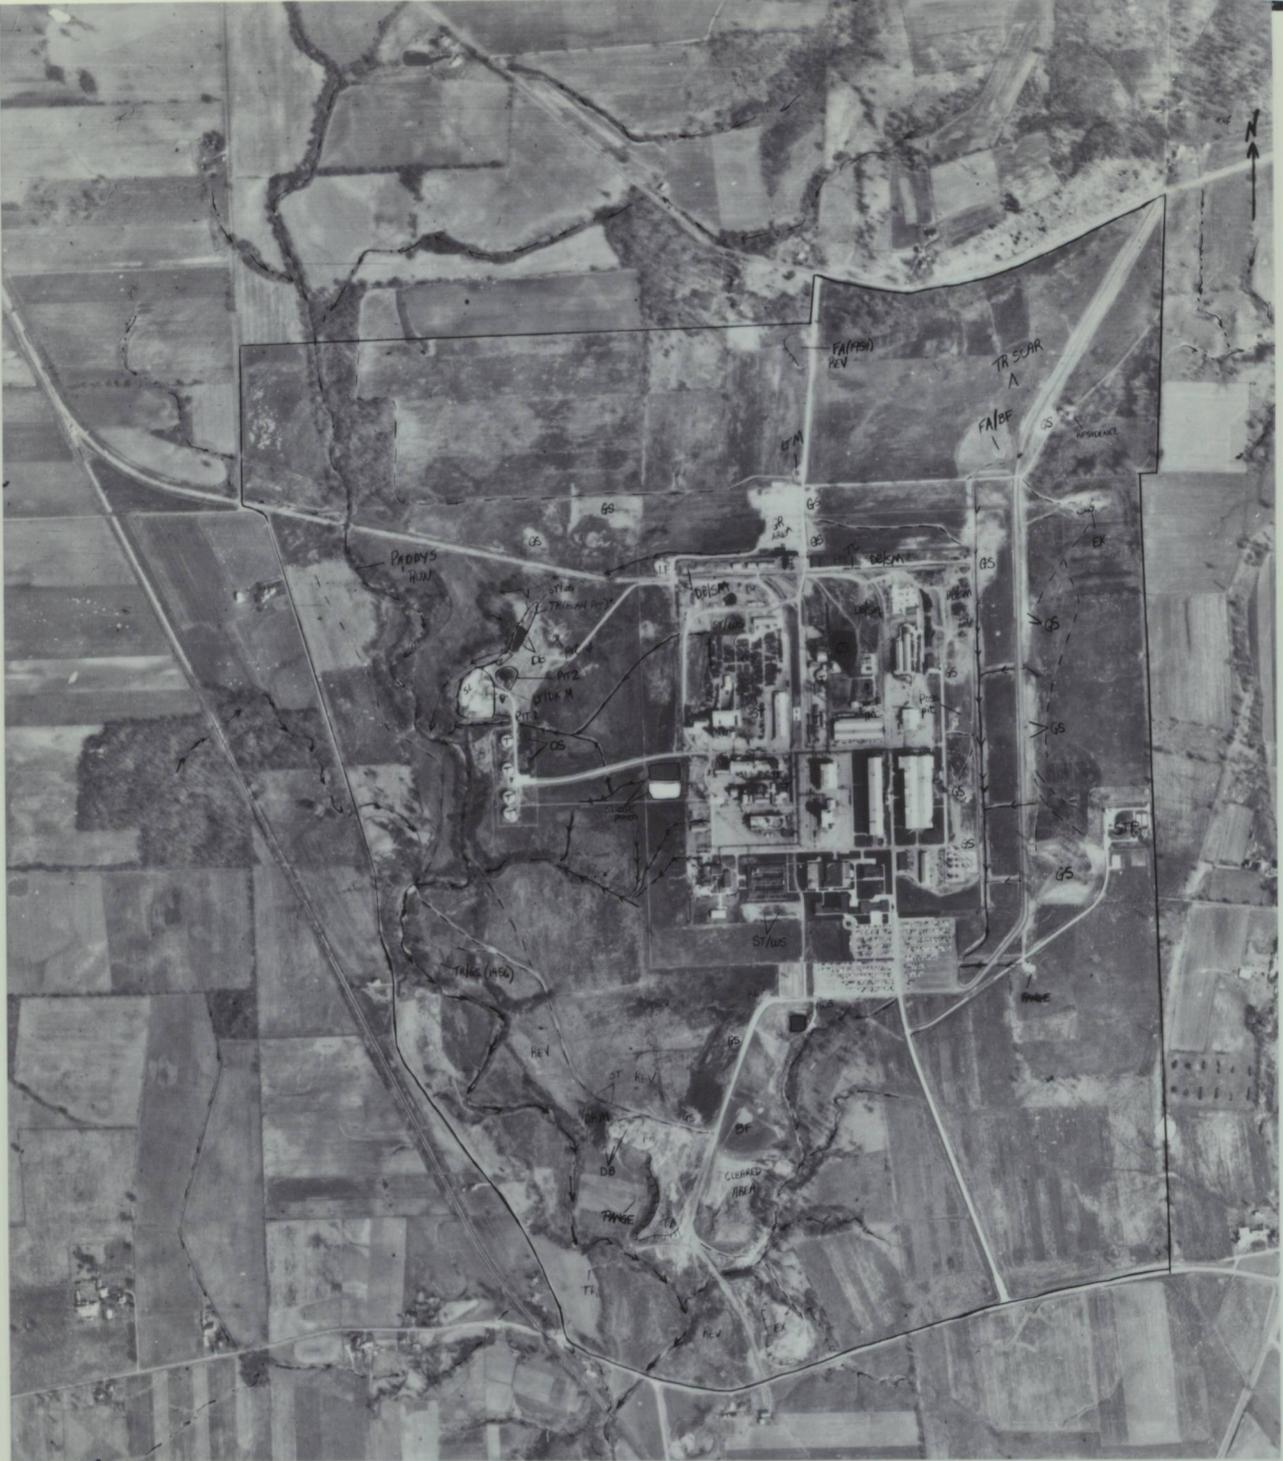
FIGURE 4
DOE FEED MATERIALS

Pit 1 contains more waste material than noted in 1954. Standing liquid is visible in the western portion of the pit. Medium-toned possible waste material and standing liquid (not annotated) appear within Pit 2, which has been constructed from the former pond noted in 1950 and 1954. Pit 4¹ is a smaller excavated area containing standing liquid and does not appear to be used for waste disposal at this time.

The trench/burn pit* appears to have increased in size since 1954 and is segmented into three parts. The southern end contains medium-toned standing liquid (not annotated); the central segment contains dark or deep standing liquid (not annotated); and the northern end contains a stained or wet area of soil (WS) possibly emanating from a nearby vehicle. Debris is visible on the east side of the trench.

The landfill at the northeast portion of WSA1 appears relatively unchanged.

Dark-toned (DK) waste material and a stained access road remain at the center of WSA 2. A significant amount of debris is visible east and southeast of the dark-toned material, and filling activity has expanded in this direction since 1954. Areas north, northwest, and northeast of the waste pile have revegetated (REV) since 1954. The excavated areas were likely filled and graded.

The three excavated pits noted in 1954 in the southern portion of WSA 2 are no longer visible. An extraction area remains in the far southern end of this area. The disturbed area noted in the western portion of WSA 2 in 1954 is no longer visible. An access road still leads to the edge of Paddy's Run, past a trench and ground scarred area that were noted on 1956 photography.

The majority of the light- and medium-toned material noted at the north end of the site is no longer present. The cleared area now contains fill material for the construction of a ball field. A trench scar remains north of the fill area where the possible trench was noted in 1954. The fill area in the far northern end of the PA is revegetating.

Several areas of staining or wet soil are visible in the western half of the PA. Ground scarred areas appear in the eastern portion of the site. The two disturbed areas noted here in 1954 have been graded smooth and now appear as scarred areas. A possible pit is located between two scarred areas. Access roads lead to the excavated area, which has expanded, in the northeast portion of the PA.

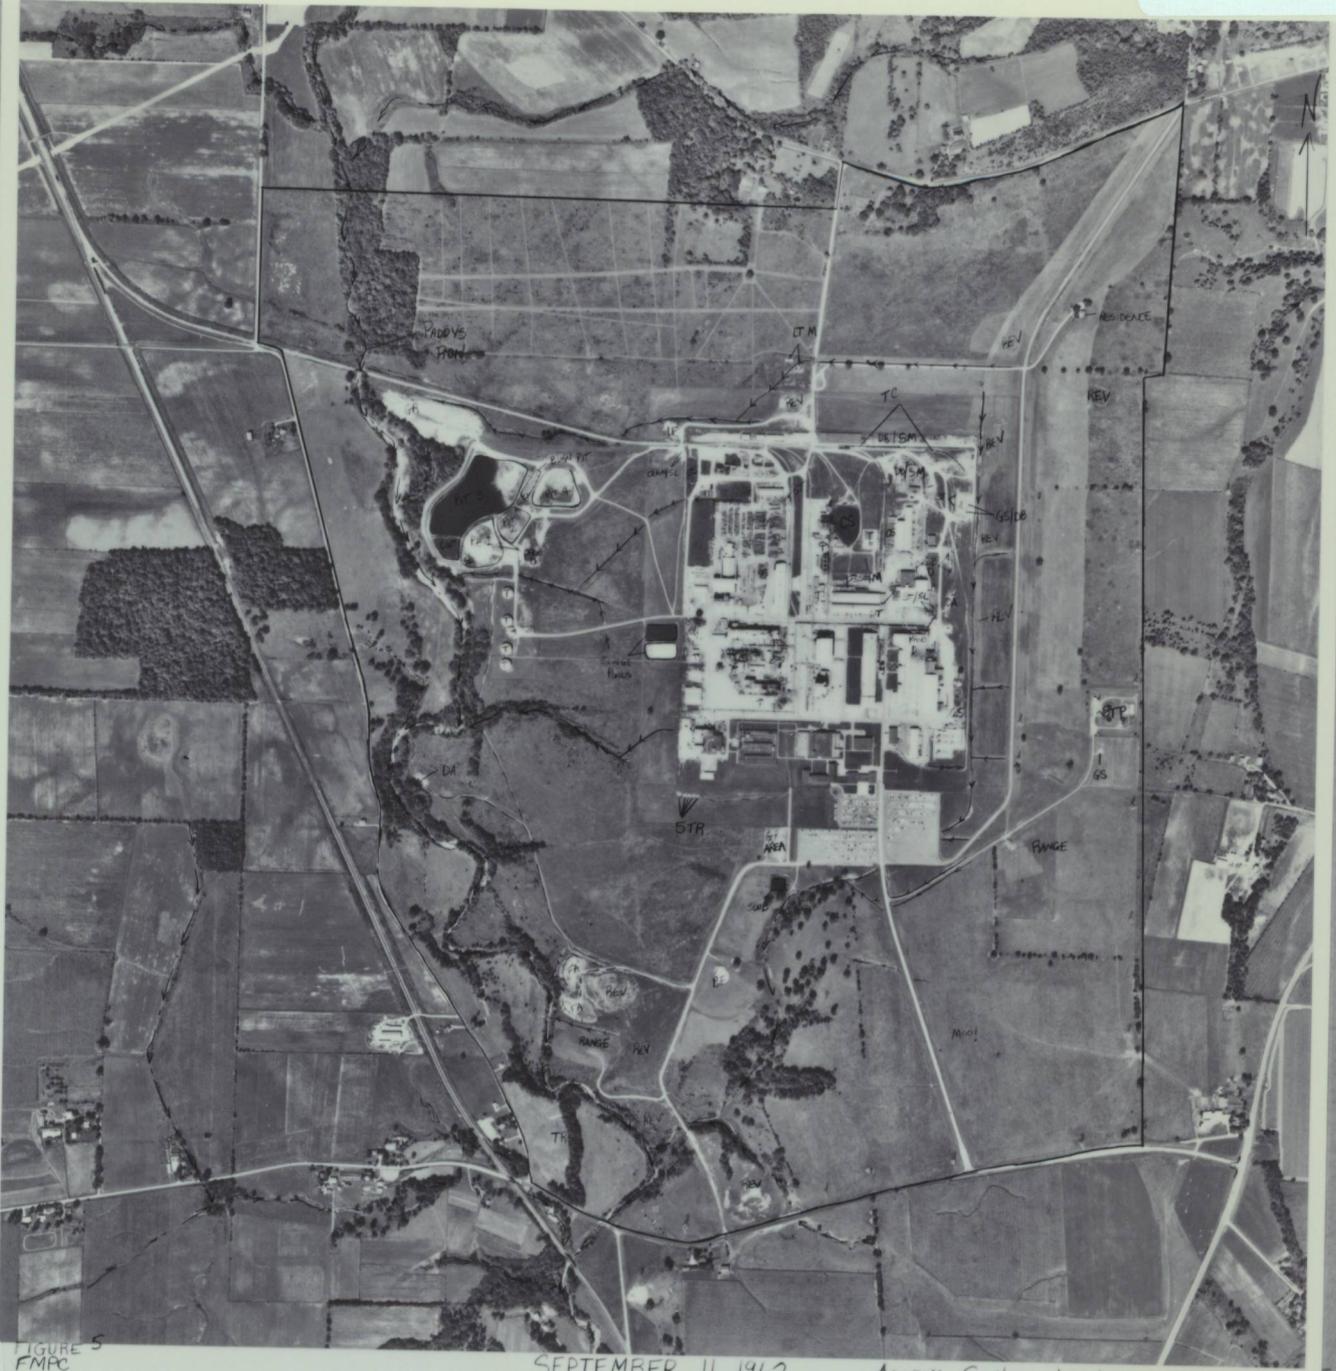
FIGURE 5
FMPC

Pit 1 has been filled and covered since 1957, although a small amount of standing liquid is visible in its southern end. Pit 2 contains a slurry of solid and liquid material. Pit 3, reportedly used as a settling basin, contains mostly liquid, although its northeast end contains solid material. A clear well (CW)* appears south of Pit 3 and remains throughout the study period. Pit 4 contains liquid and solid material. The burn pit is smaller in size than noted in 1957 and now consists of two segments. The southern segment contains standing liquid, while the northern end contains scattered debris (neither is annotated). Probable drums (D) are visible between Pits 1 and 2. A large graded area is located northwest of the pits and is likely related to the construction of the new Pit 3 and the enlarged Pit 4. A channelized drainage ditch is under construction in the north end of the site to divert drainage around the waste pit area. Pit 3 is situated over a former natural drainage channel.

A bermed area containing standing liquid is located south of the landfill in the northeast corner of WSA 1.

Two fill areas containing medium-toned, fine-textured material and light-toned material possibly mixed with debris are present at the center of WSA 2. The active fill area noted east of here in 1957 is revegetating. Channelized ditches have been constructed around the fill areas, probably to keep natural precipitation off and away from the fill area. The fill area to the southeast and the extraction area in the southern end of WSA 2 are revegetating.

Access roads still lead to the edge of Paddy's Run. A disturbed area is visible near one access road north of WSA 2.

Light-toned material is visible in the northern end of the PA. The ball field has revegetated and no longer appears in use. Staining is evident in two places in the western half of the PA and in several places in the eastern portion.

A ground scarred area containing debris is located in the northeast corner of the PA. Three groups of probable drums are visible farther south. Staining and/or standing liquid is visible near the southernmost group and may be the result of a leak or spill. A disturbed area is located east of this group of probable drums where a possible pit was noted in 1957.

Several scarred areas have revegetated since 1957. The extraction area has also been filled and is revegetating.

A series of five open trenches are present at the southwest corner of the PA. Reportedly, the trenches were used to dispose of laboratory equipment and materials containing perchloric acid.* A small amount of liquid is visible within the trenches; however, no debris is visible.

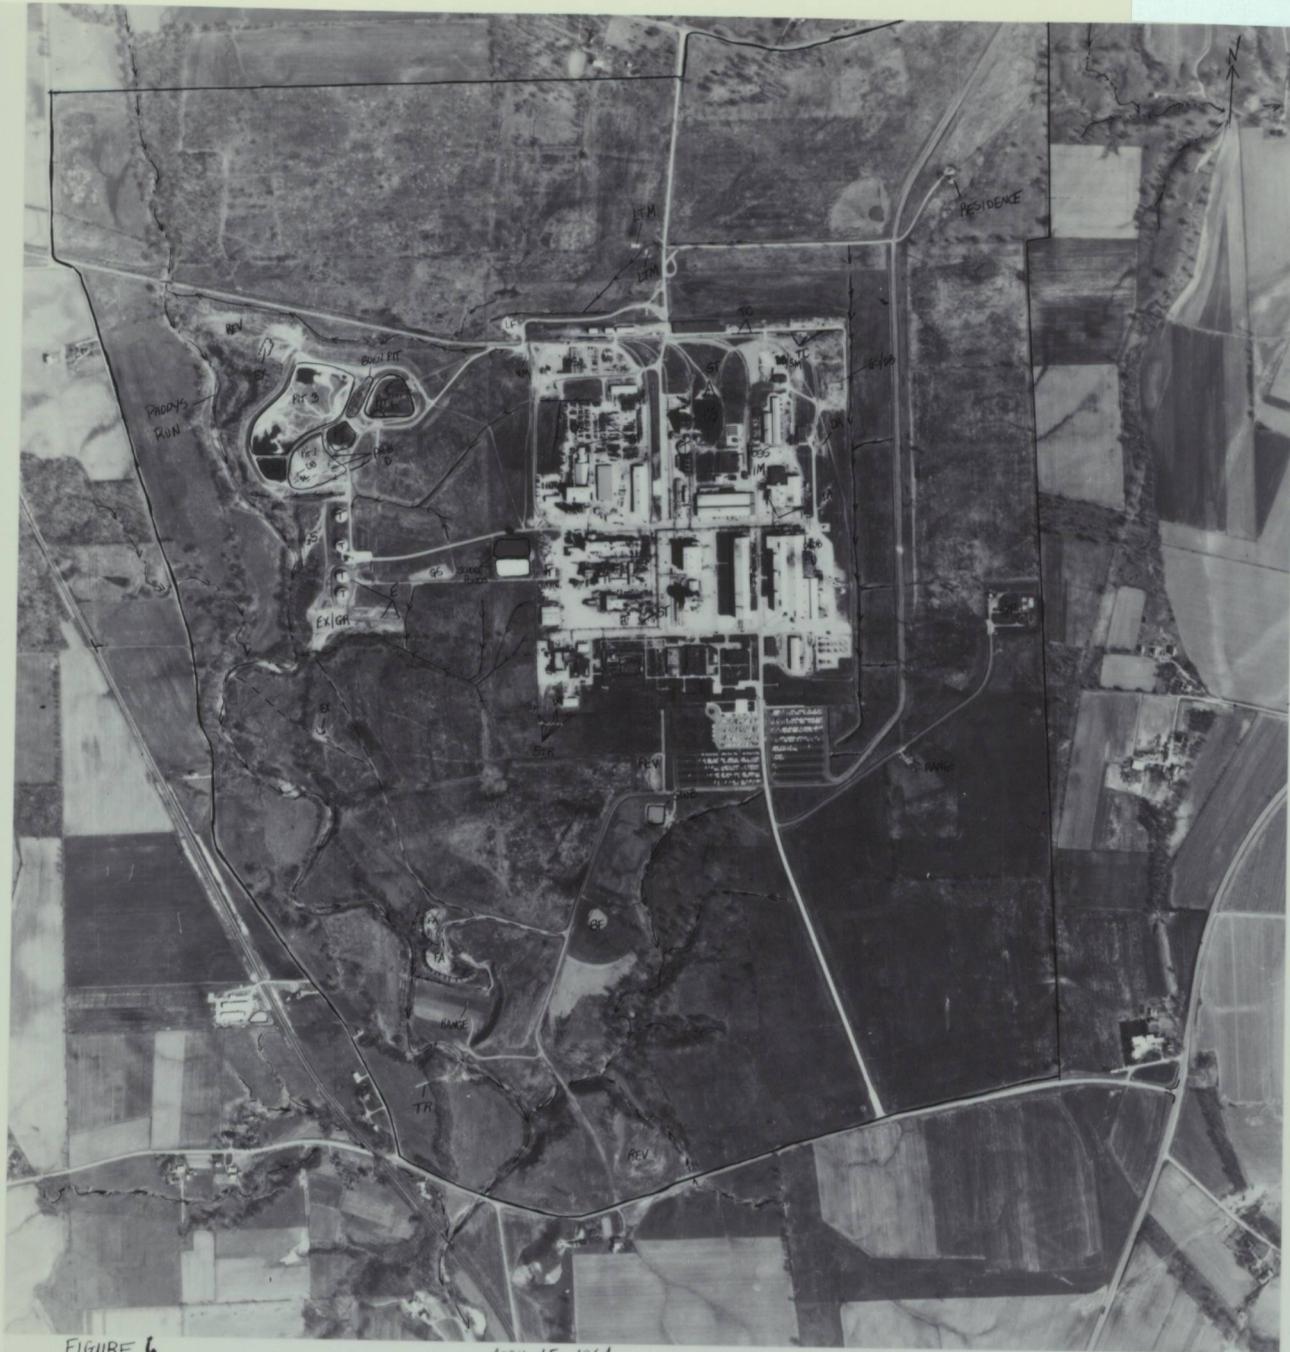
FIGURE 6
DOE FEED MATERIALS

An access road leads across Pit 1 to an area of debris and standing liquid. Pit 2 contains mostly liquid with some solid material along its southern end. Pit 3 contains a slurry of solid and liquid material. Pit 4 contains solid and liquid material. The burn pit contains a significant amount of solid, dark debris, some of which could be containers. Probable drums are visible between Pits 1 and 2. A portion of the former graded area noted in 1962 northwest of the pits is revegetating, while the eastern end is now being used for extraction. The channelized ditch north of the pits now joins Paddy's Run. The bermed area noted south of the landfill now contains mounded material, suggesting filling activity. A new berm has been constructed west of the mounded material.

A significant amount of grading and extraction activity is visible south of the four tanks within WSA 1. Equipment (E) is actively working in the area.

Two fill areas remain at the center of WSA 2, although the southern fill area has expanded since 1962. Material similar to that noted in 1962 appears in the fill areas.

An extraction area is visible near one of the access roads that lead to the edge of Paddy's Run northwest of the fill area. The disturbed area noted near here in 1962 is no longer visible.

Light-toned material remains at the northern end of the site. Staining is evident in several places within the PA and may be the result of leaks or spills. The heavy staining noted north of the coal storage area appears in an

area reportedly containing an oil burner used to burn waste motor oil, solvents, tributyl phosphate and kerosene.*

The ground scarred area containing debris remains in the northeast portion of the PA. This debris appears to consist of drums or containers. Only one group of probable drums remains farther south. Heavy staining is associated with this group of probable drums. Two disturbed areas appear farther east.

The five trenches at the southwest corner of the site remain open. Three of the trenches appear to contain standing liquid, while two others contain debris.

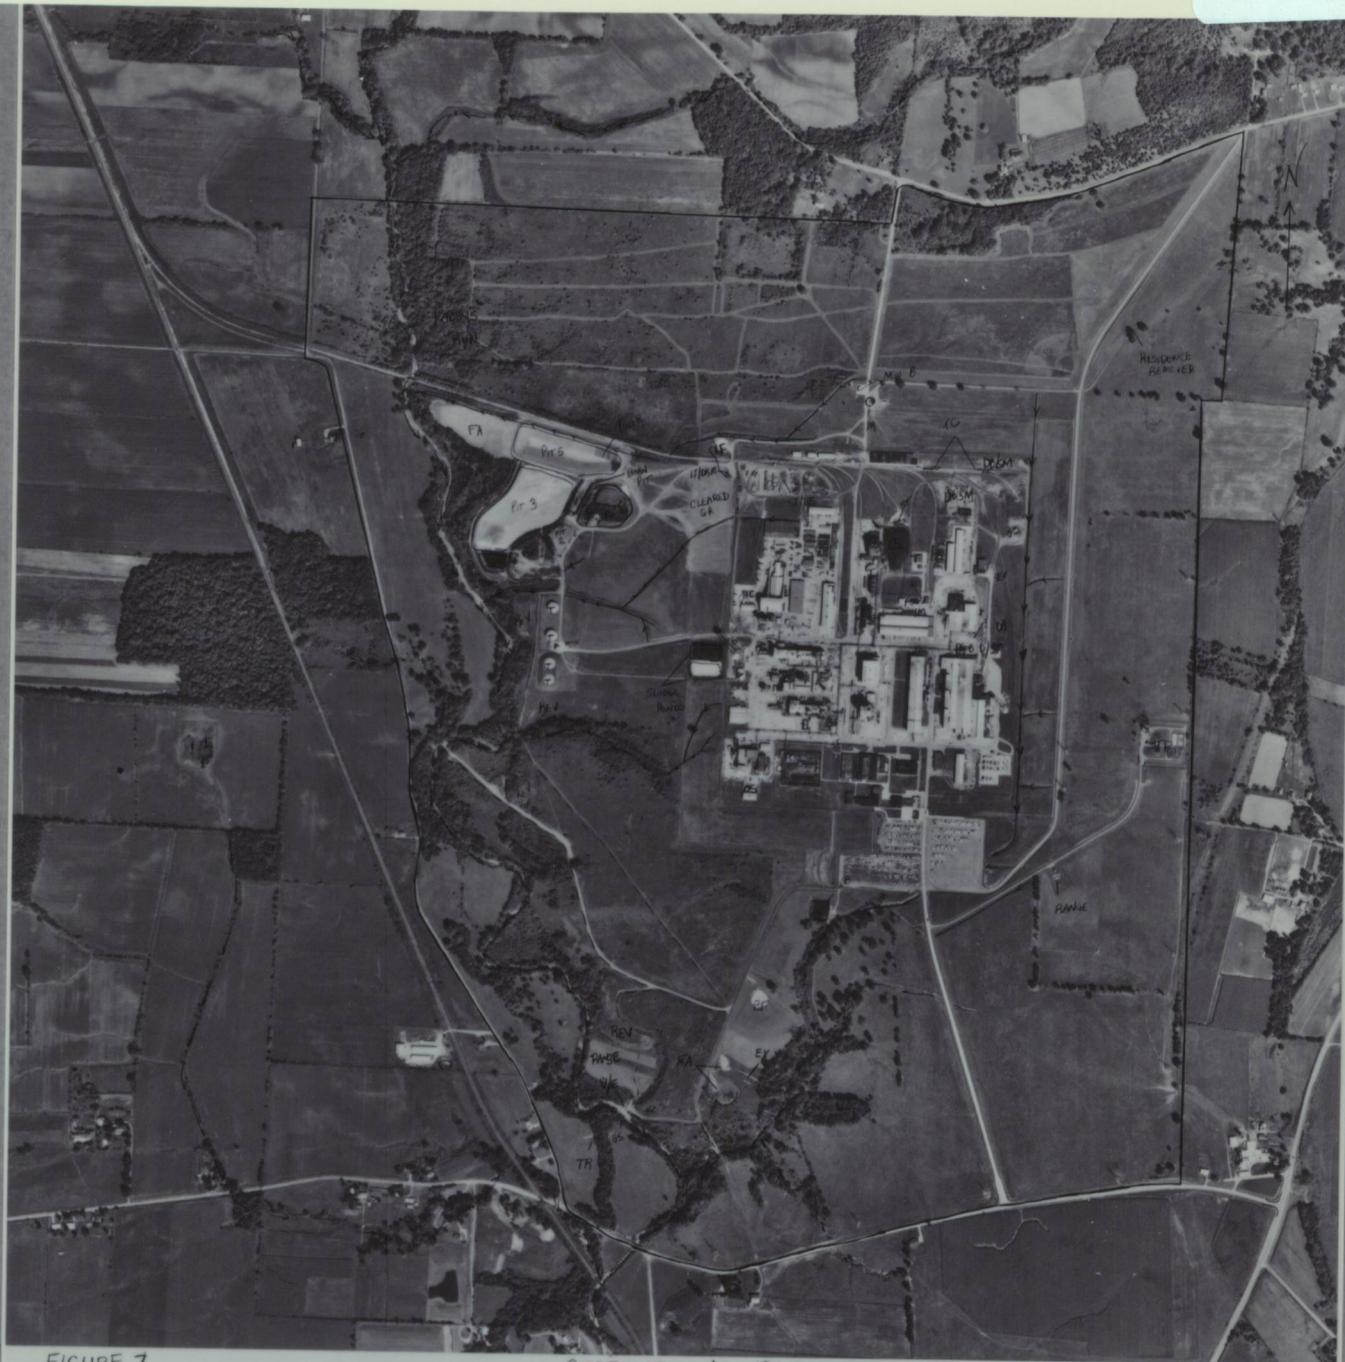
FIGURE 7
FMPC

Pit 1 appears to be revegetating; however, an access road still leads across the former pit to an area of debris. Standing liquid is no longer present here. Pit 2 has been filled, covered and is now revegetating with low grass. Pit 3 contains a slurry of light-toned liquid and semi-solid material. Pit 4 contains solid and liquid material. The burn pit appears empty at this time except for a single vehicle. Pit 5 appears to be under construction. A portion of a liner can be seen in the eastern end of Pit 5. The area northwest of the pits now appears as a fill area, probably containing the material extracted to construct Pit 5. The landfill contains light- and dark-toned material similar to that seen south of the landfill. The bermed area noted near the landfill in 1962 is no longer visible. A large cleared, graded area is located here and farther south.

The areas south and west of the four large tanks within WSA 1 have revegetated.

The fill areas noted in WSA 2 in 1964 have revegetated and a new fill area is present farther east. Similar material to that noted in 1962 is present in the fill area. A linear excavated area or channelized ditch is visible east of the new fill area.

Vehicles and equipment appear in a scarred area southwest of the new fill area. The excavated area noted near access roads northwest of the fill area is revegetating.

Light-toned material is no longer visible in the northern end of the site. A new building and an impoundment have been constructed at the northern end of the site. The impoundment contains a tank in its center and may be used as a sump. A raised, rectangular trough (not annotated) is located east of the impoundment and looks much like a watering trough for animals.

Staining appears within the PA; however, it does not appear as heavy as that noted in 1964. One of the disturbed areas noted in the eastern end of the PA is revegetating.

The trenches visible in the southwest end of the PA in 1962 and 1964 have been filled and covered.

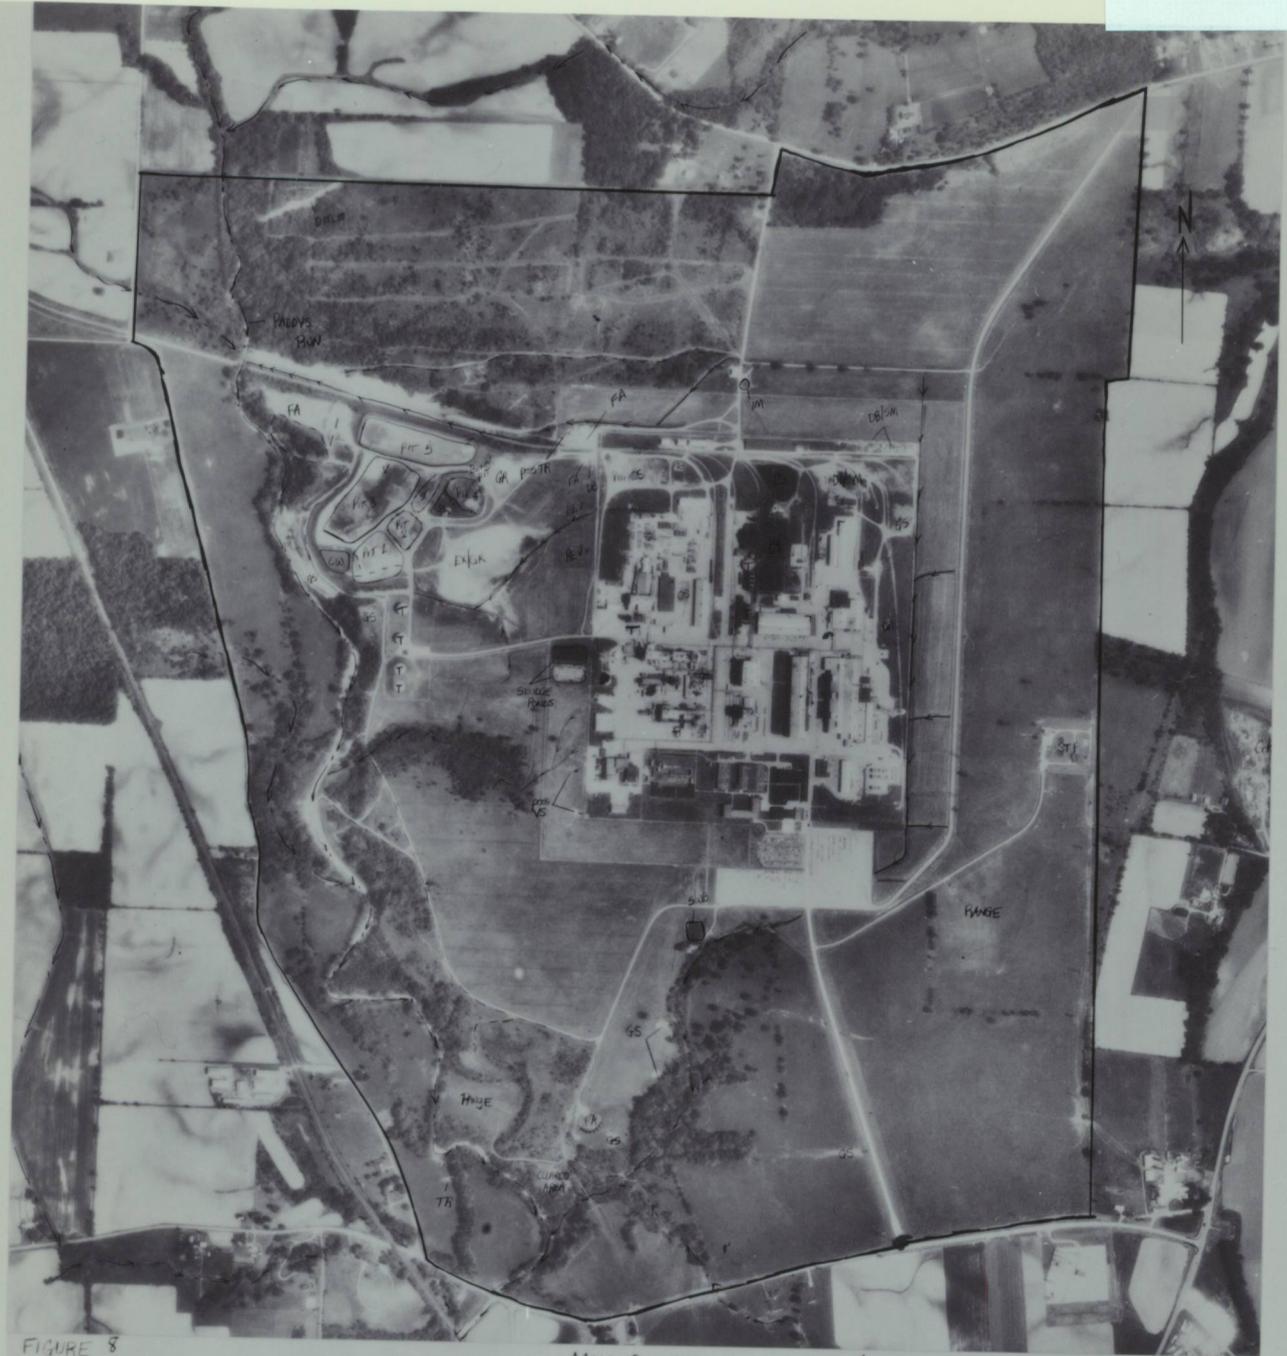
FIGURE 8
FMPC

Access roads still lead across Pit 1, although no debris is noted here. The surface of Pit 2 is scarred; however, no additional waste disposal is evident. The northern end of Pit 3 appears filled and graded, while the southern end contains solid waste material. Pit 4 contains liquid and solid material. Pit 5 contains a slurry of light-toned liquid. The burn pit area appears stained. Access roads lead into the fill area northwest of the pits and to a ground scarred area to the west, although no waste material was noted.

Large graded areas are visible east of the pits. The landfill to the northeast has expanded since 1968 and filling and debris are present farther south. Two possible trenches are visible at the landfill. The cleared areas noted south of the landfill have revegetated.

A large ditch is visible north of WSA 1; however, this may be related to agricultural activity.

The fill area at WSA 2 appears similar to that noted in 1968. The excavation or channelized ditch is no longer visible.

The drums and staining noted in the eastern end of the PA are no longer visible. Drainage rills lead away from a group of buildings at the southwest corner of the PA. The ground surface near two of these rills appears scarred and may indicate possible vegetation stress.

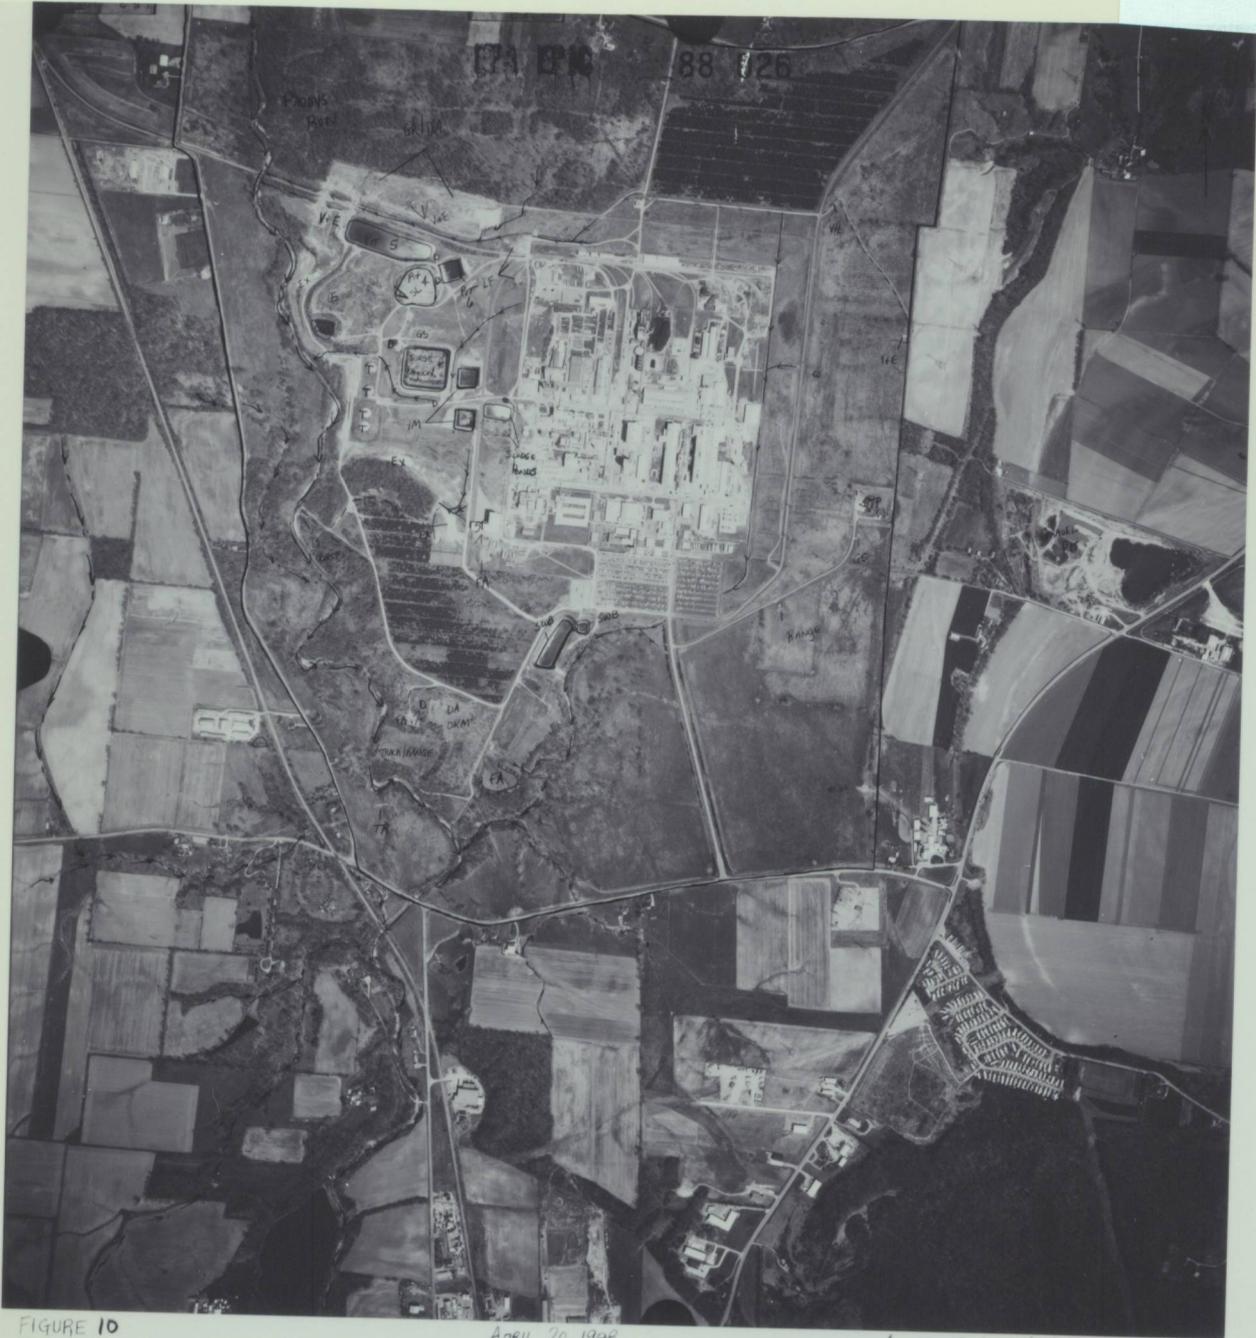
FIGURE 10
DOE FEED MATERIALS

Significant change has occurred within WSA 1 since 1983. Pit 4 is covered, although no vegetation is visible on its surface. Pit 5 contains a greenish liquid and some solid material. Pit 6 contains debris on its western end, and the remainder is filled with liquid.

The area north and northwest of the pits appears graded and disturbed and contains numerous vehicles and equipment. The landfill has expanded since 1983 (see Figure 11).

A large biodenitrification surge lagoon* and two raised impoundments have been constructed since 1983. All of these have liners; however, they do not contain solid or liquid waste at this time.

The eastern fill area at WSA 2 has expanded since 1983 and appears to contain a uniform, grey fine-textured material (fly ash*). Another fill area is developing in the area formerly used for waste disposal west of the fly ash. Light-toned and dark-toned mounded material and drums are present here. The area east of the drums appears disturbed. Light-toned objects appear near access roads that lead to Paddy's Run northwest of WSA 2. A larger stormwater retention basin has been constructed in the north end of WSA 2.
