## PROJECT COMPLETION REPORT

### SEWAGE TREATMENT PLANT COMPLEX DECONTAMINATION AND DISMANTLEMENT PROJECT

FERNALD ENVIRONMENTAL MANAGEMENT PROJECT  
FERNALD, OHIO

DOCUMENT CONTROL NO. 55210-PR-0002 (REV. 0)

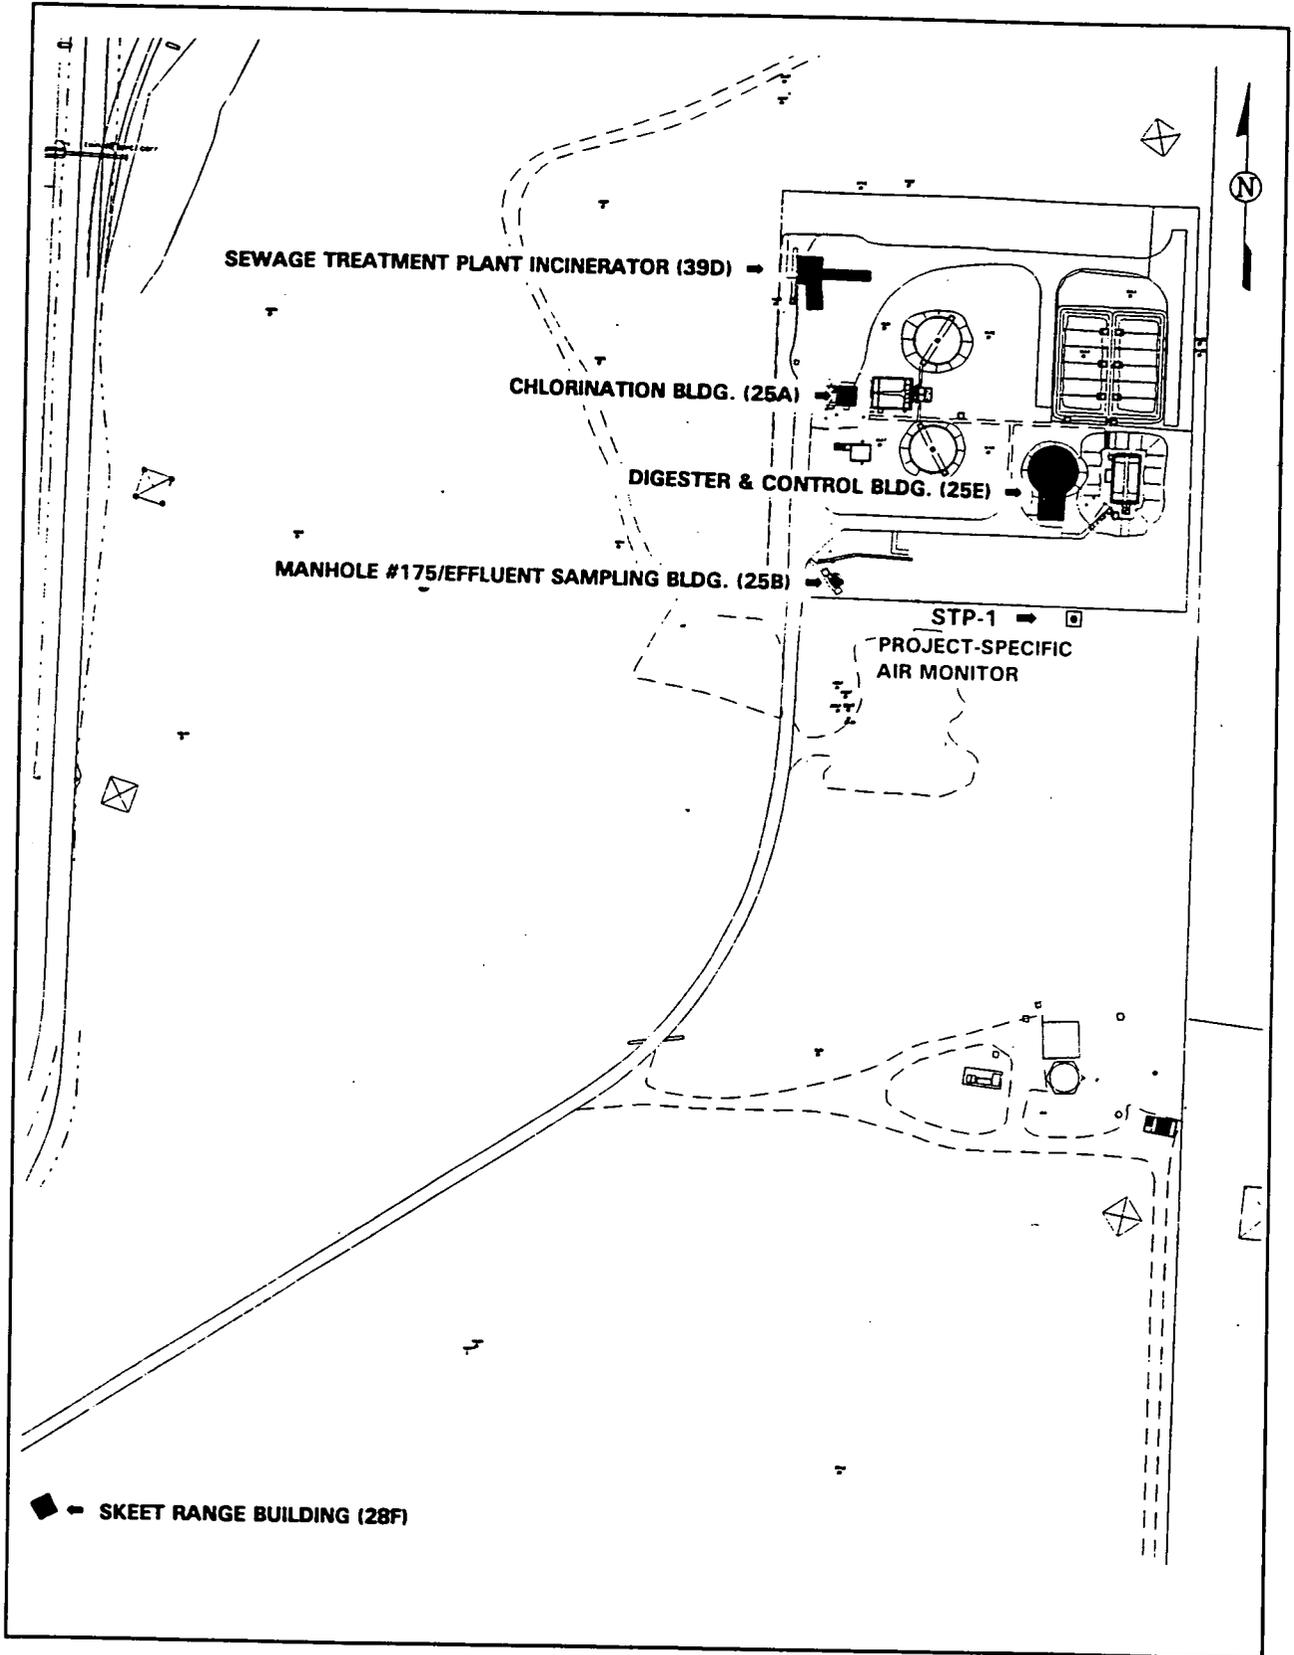
FIGURE 1-1 Sewage Treatment Plant Complex Project Area

The STP Complex project area is illustrated in Figure 1-1. As stated in the project implementation plan, Component 25D - U.V. Disinfection Building was not included in the above-grade D&D scope due to it being located 75 percent below-grade. The D&D of Component 25D has been included in the scope of the Area 1 - Phase II excavation project. The details regarding remediation of at- and below-grade components are described in the Area 1 - Phase II remedial design documentation.

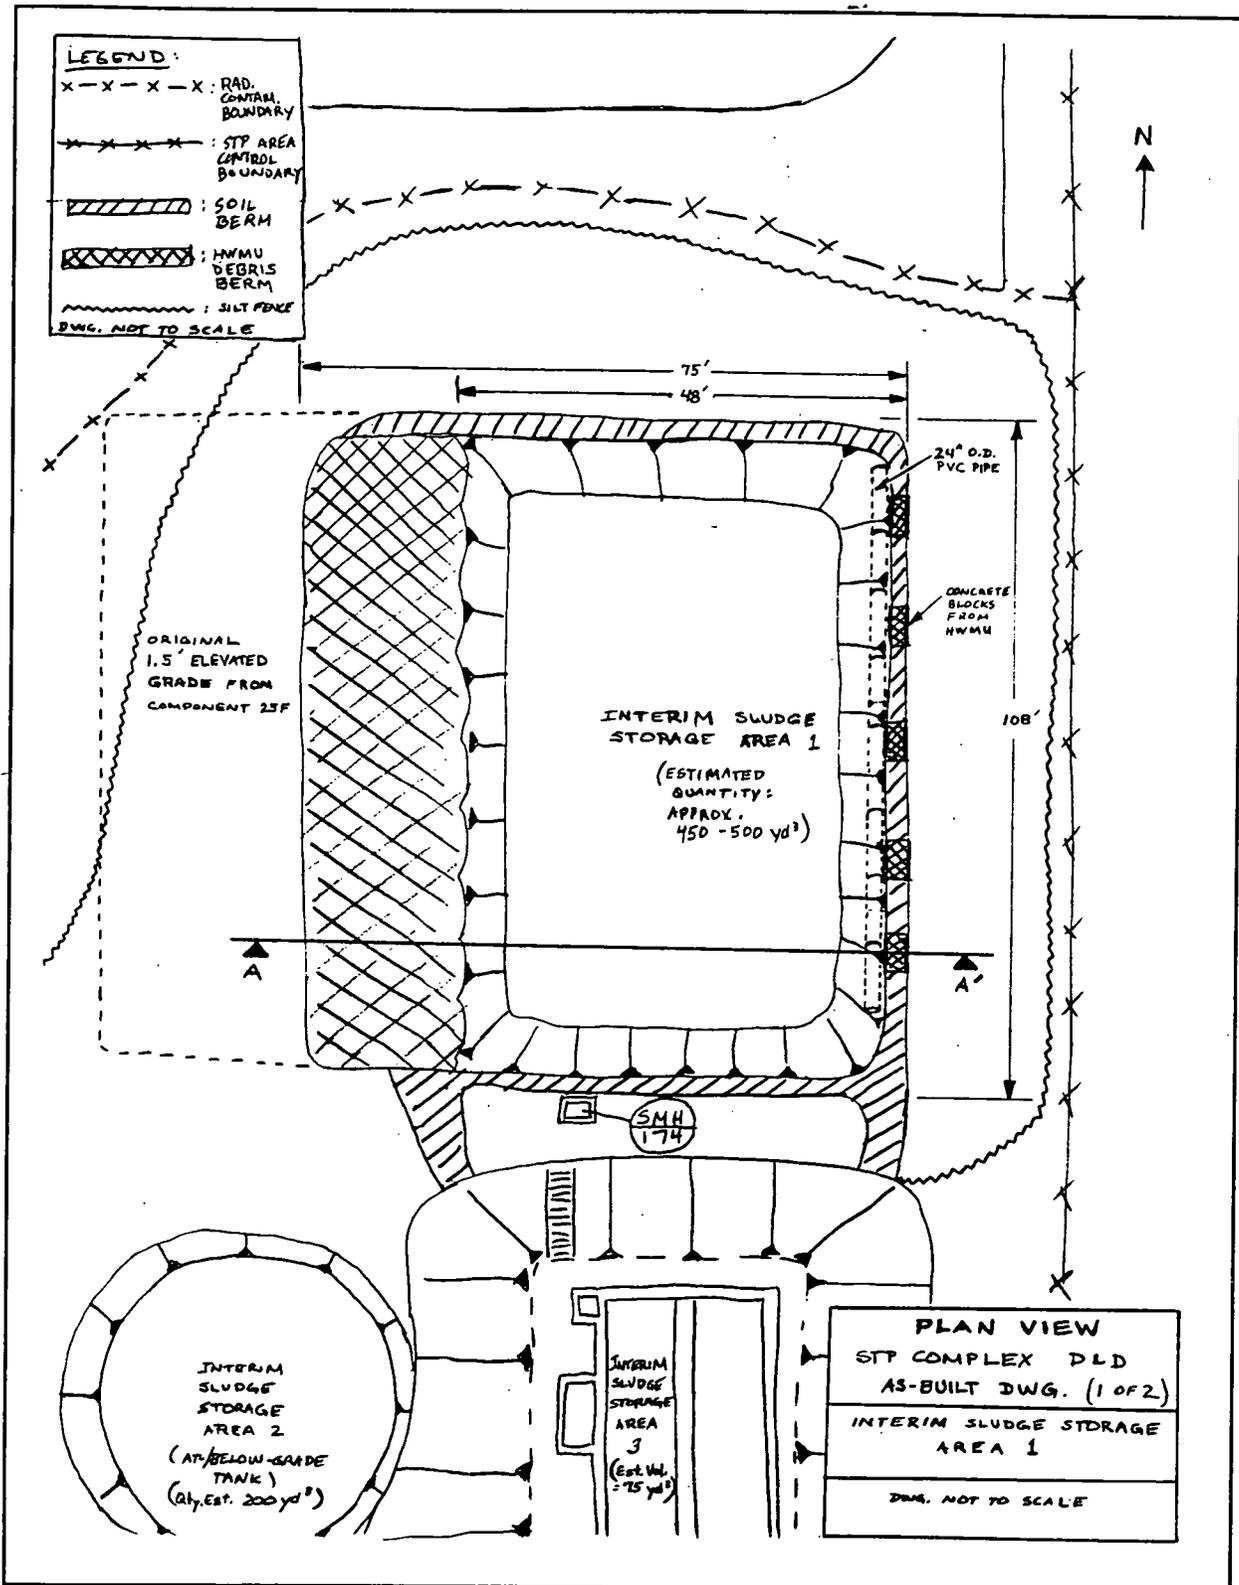
FIGURE 2-1 Interim Sludge Storage Area 1 Plan View

"Supersucker" — a sludge removal tank truck which pumps sludge through a hose — proved ineffective due to the high viscosity of the sludge. Sludge removal was then performed by use of a trackhoe with bucket attachment, which transferred sludge into a front end loader for placement into the former sludge drying beds (Component 25F - Hazardous Waste Management Unit No. 41) — an area approved by the regulatory agencies for interim storage of sludge. This interim sludge storage area was cleared of vegetation and debris and lined with geotextile material to prevent contact of the sludge with the underlying material. The vegetation and debris were removed and stockpiled to the western boundary of the Hazardous Waste Management Unit (HWMU) and covered with geotextile material. This storage area was improved by creating four foot berms around the perimeter. Two sheets of polyethylene sheeting were securely placed over the storage area followed by additional berm and silt fencing enhancements. Figures 2-1 and 2-2 illustrate features and as-built construction details of this interim storage area. Since the sludge volume from the tank would have exceeded the capacity of the former sludge drying bed, additional EPA approval was obtained to divert the remaining sludge from the Digester Tank to the two Primary Settling Tanks (25G). Sufficient sludge was removed from the tank (using the trackhoe bucket transfer method to the west Primary Settling Tank) to reduce the Digester Tank sludge level to approximately six inches below-grade. The west Primary Settling Tank was almost completely filled; the eastern tank did not receive any sludge. The remaining sludge in the Digester Tank now rests at approximately six inches below grade and approximately 10 -12 inches below the pier footer of the former tank. Sludge sampling was performed by SCEP A1P2 as sludge was removed from the Digester Tank (one sample per foot in depth removed) to determine future disposition options by the A1P2 Project. Analytical results obtained during STP D&D are provided in Table 2-1. Following sludge removal operations, the remainder of the tank walls above the sludge level was washed free of sludge residues using high pressure water spray. The washwater remained in the remnant tank mixed with sludge.

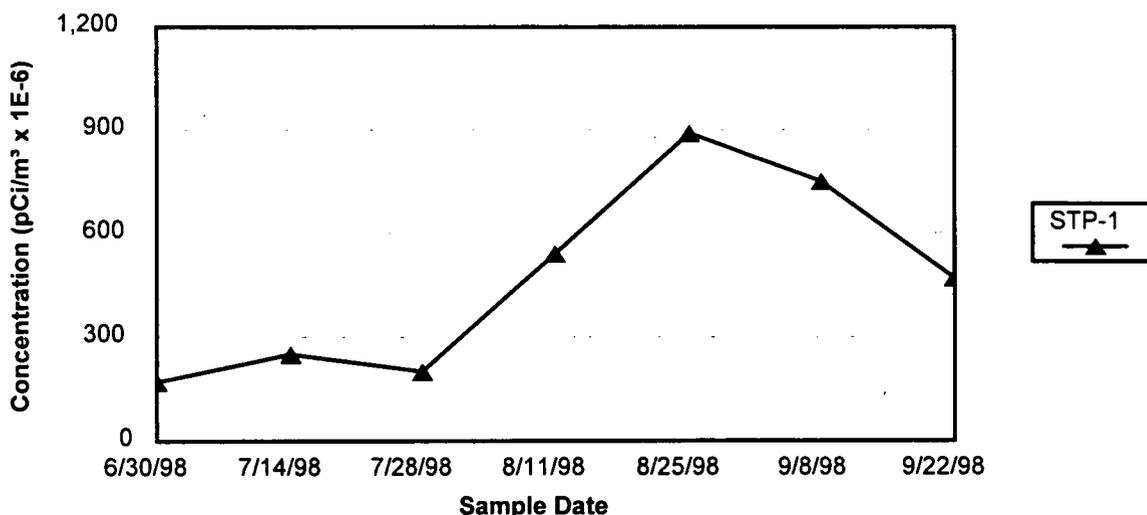
**FIGURE 4-1 STP-1 Air Monitoring Data**

Environmental radiological air monitoring of the STP Complex D&D project began in June and continued for several weeks after the completion of the project. Air monitors, which provide data on fugitive emissions from the project, include AMS-3 (located 500 feet northeast along the FEMP fence line), AMS-29 (located 1,400 feet to the south along the fence line), and project-specific air monitor, STP-1, which was installed just south of the Building 25E during the last week of June. The STP-1 monitor was installed immediately following an Ohio EPA request for supplemental monitoring during the review/comment process for the Implementation Plan. The location of these monitors is shown in the Implementation Plan. The results shown in Table 4-1 and Figures 4-1, 4-2, and 4-3 present the results of weekly monitoring for total uranium. It should be noted that the monitoring results of the STP Complex D&D activities did not exceed the DOE guideline of 0.1 pCi/m<sup>3</sup> (1.0E-01) of uranium in air and confirm that the STP Complex D&D project did not impact public health and the environment.

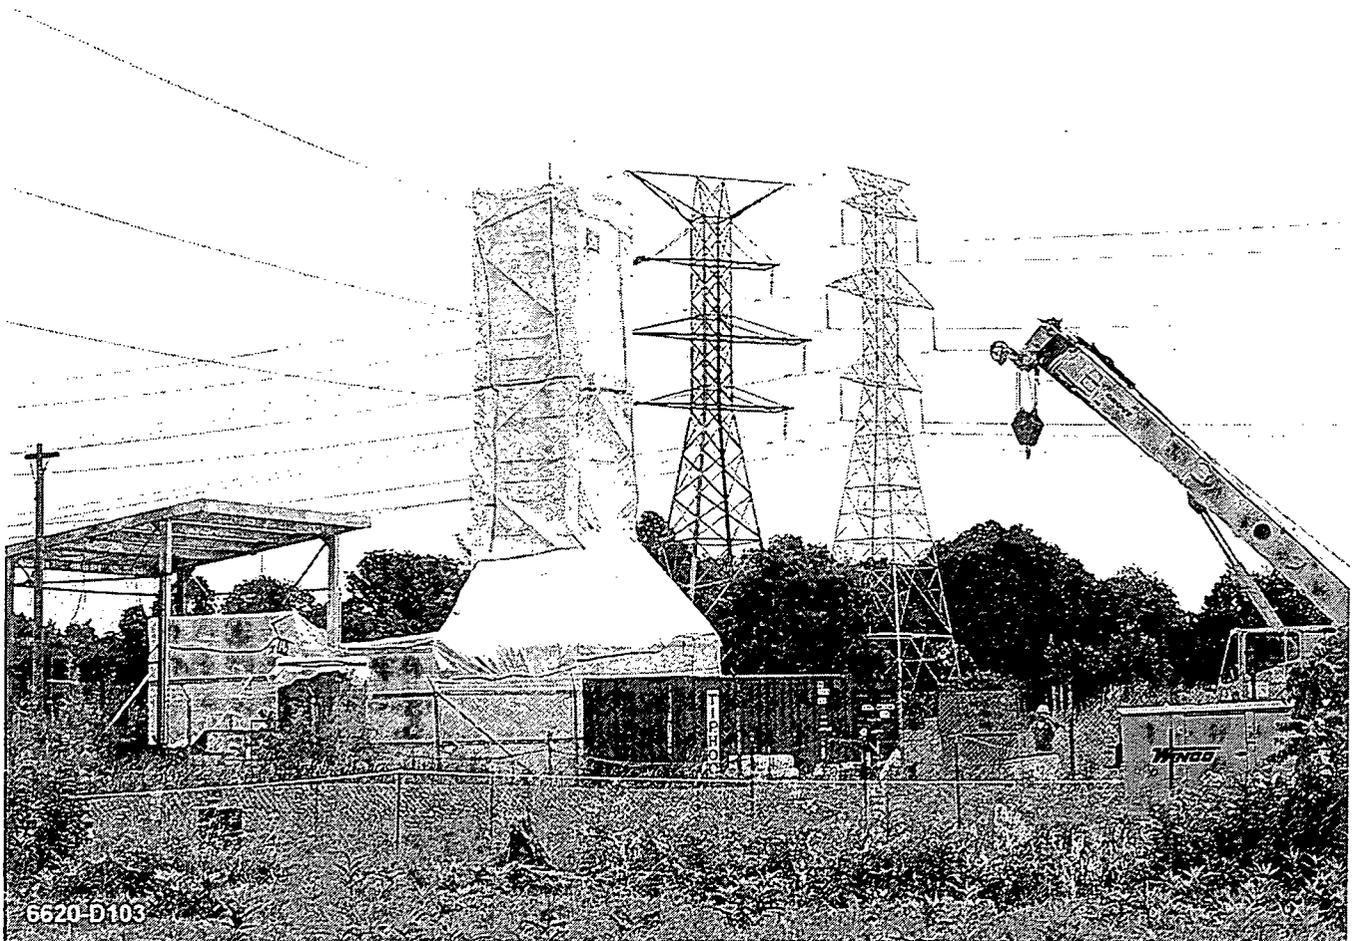
Due to the friable condition of the internal (non-asbestos) refractory lining of the incinerator, surface decontamination measures were not practical. Therefore, the STP Incinerator was enveloped in a HEPA-ventilated reinforced polyethylene enclosure for dismantling (Attachment 1, Photo No. 1). To minimize the generation of airborne radioactivity within the enclosure, all internal surfaces of the incinerator were sprayed thoroughly with an encapsulant (Chil-Lock) before dismantlement occurred. Additional encapsulant was applied as necessary during dismantlement.

**PHOTO 1: STP Incinerator (39D) - Enclosure during stack removal**

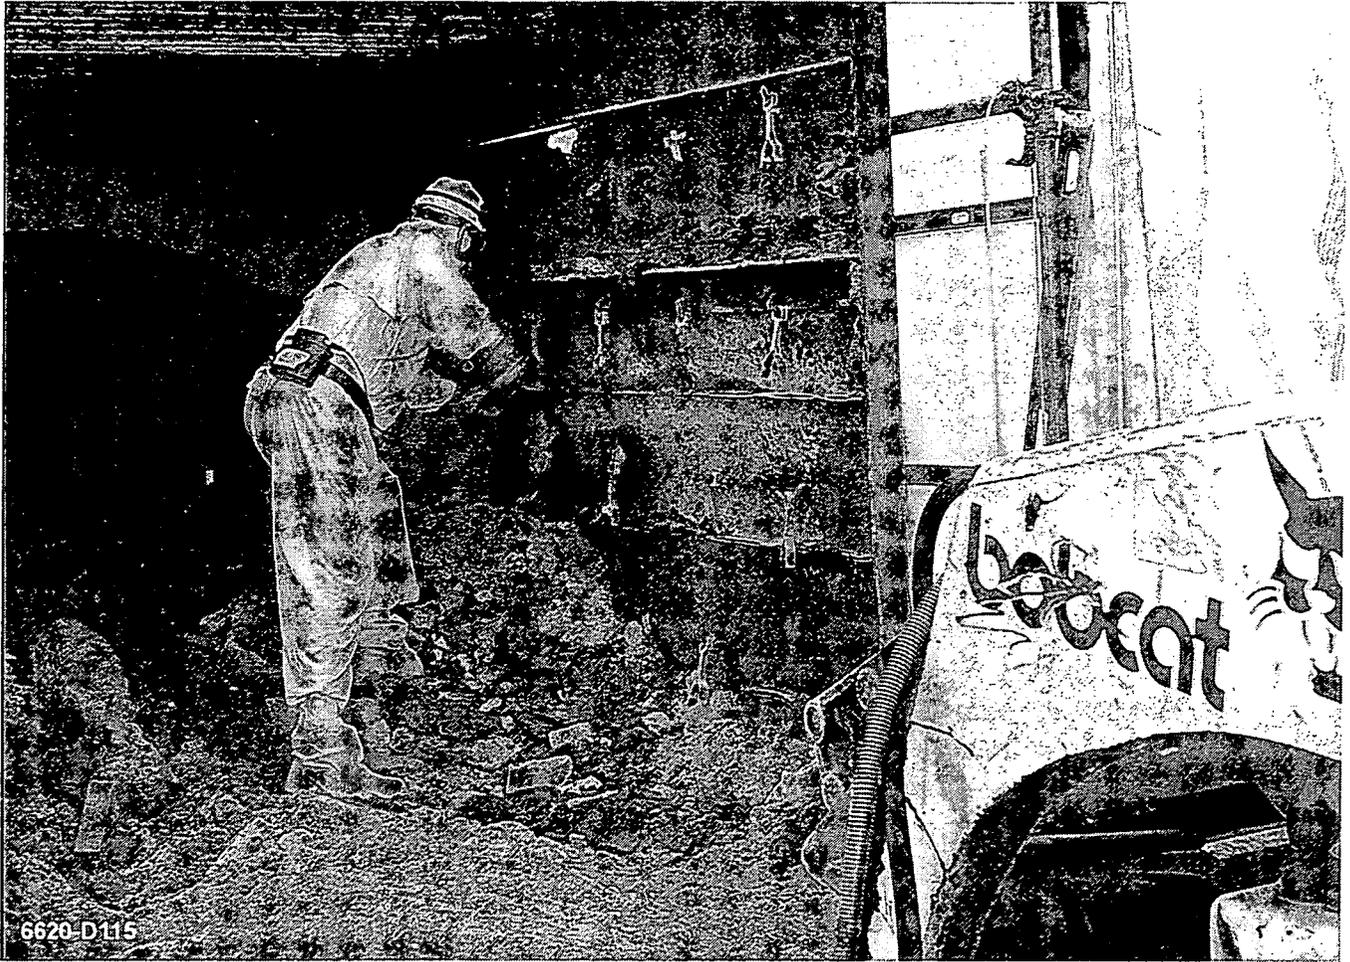
For structural dismantlement of the incinerator itself, the polyethylene enclosure was made big enough for a skid steer (Bobcat type), crew and waste containers to fit inside during interior dismantlement. An airlock compartment in the enclosure was used for cleaning equipment and containers, and for movement of containers in and out of the enclosure. A skid steer using a ram-hoe was used inside the enclosure to dismantle the refractory lining. The interior debris was loaded into waste containers inside the containment. Following interior dismantlement, interior surfaces were encapsulated and passed release cleaning criteria. The enclosure was removed and the incinerator and loading dock structure was dismantled using the trackhoe mounted shear. The slab was thoroughly encapsulated with Chil-Lock. Photo Nos. 2 through 5 in Attachment 1 show interior debris removal and encapsulation of surfaces.

PHOTO 2: STP Incinerator (39D) - Removal of refractory lining

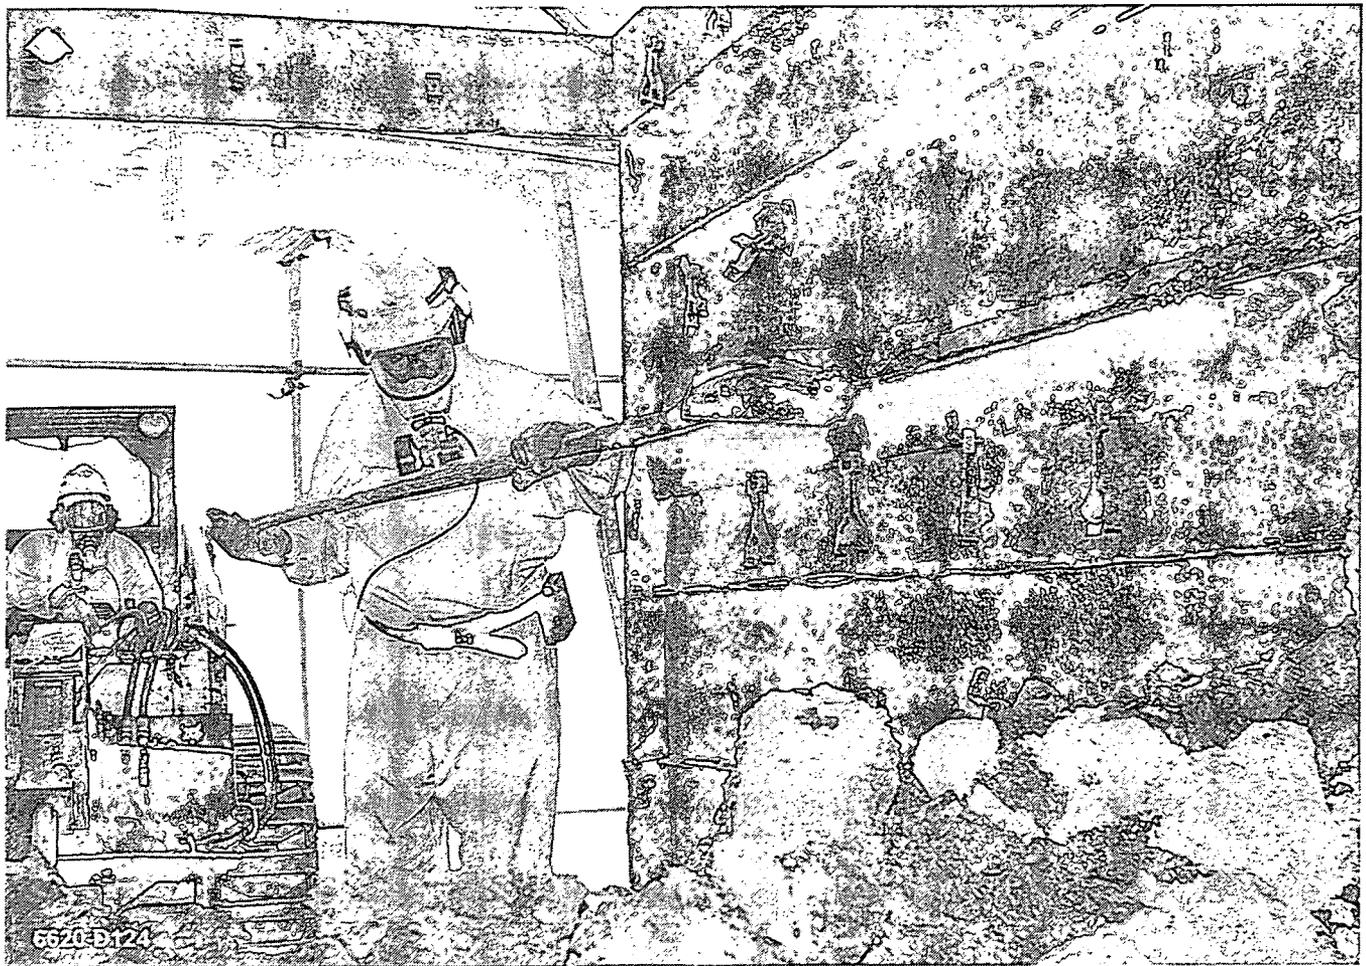
**PHOTO 3: STP Incinerator (39D) - Removal of refractory lining**

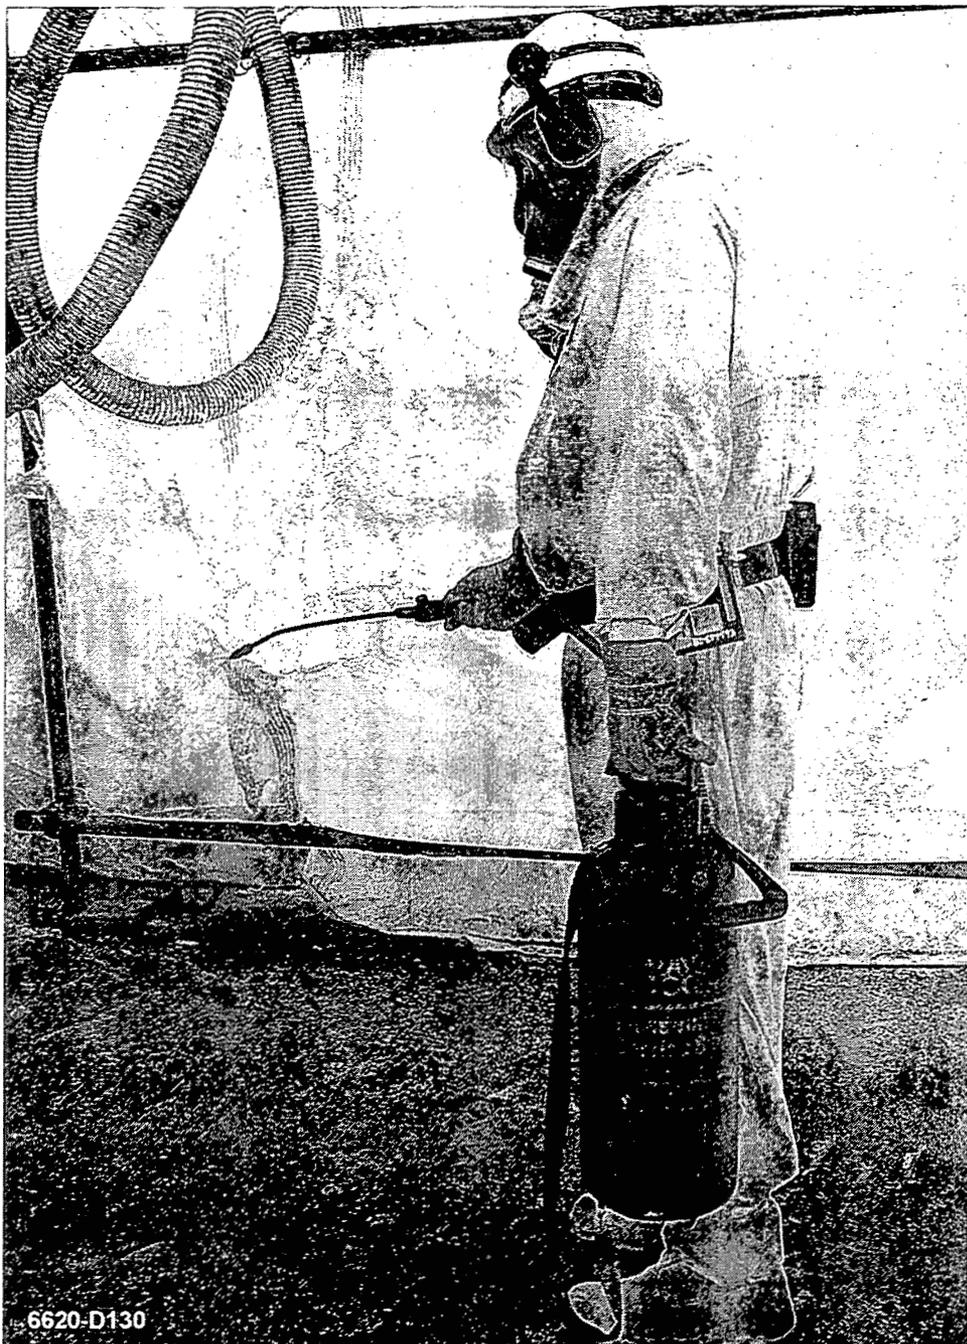
6620-D130

**PHOTO 4: STP Incinerator (39D) - Encapsulation of surfaces within enclosure**

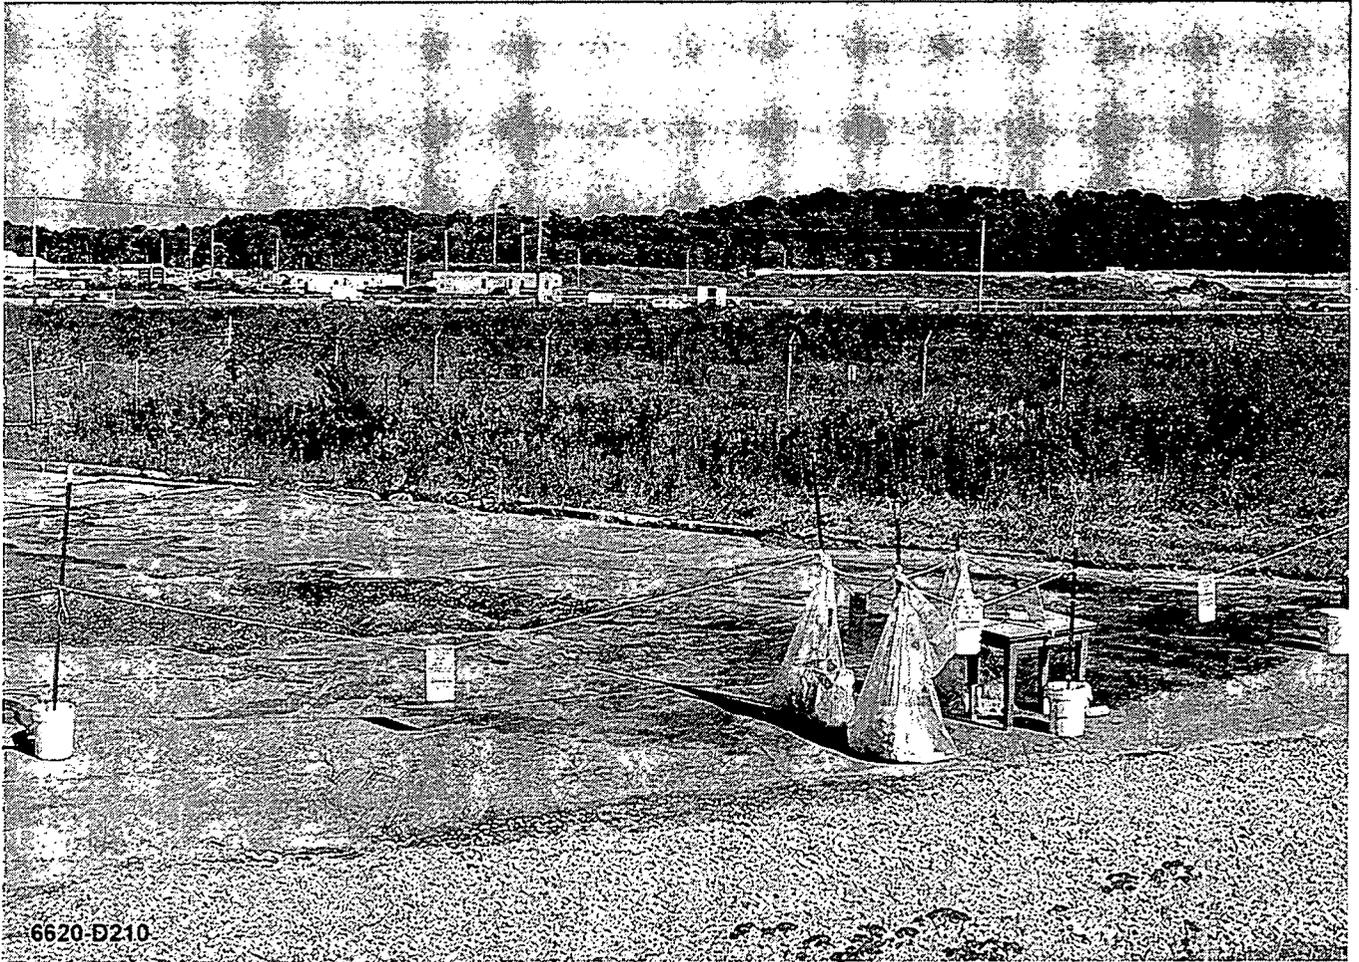
PHOTO 5: STP Incinerator (39D) - Completion of Structural Dismantlement

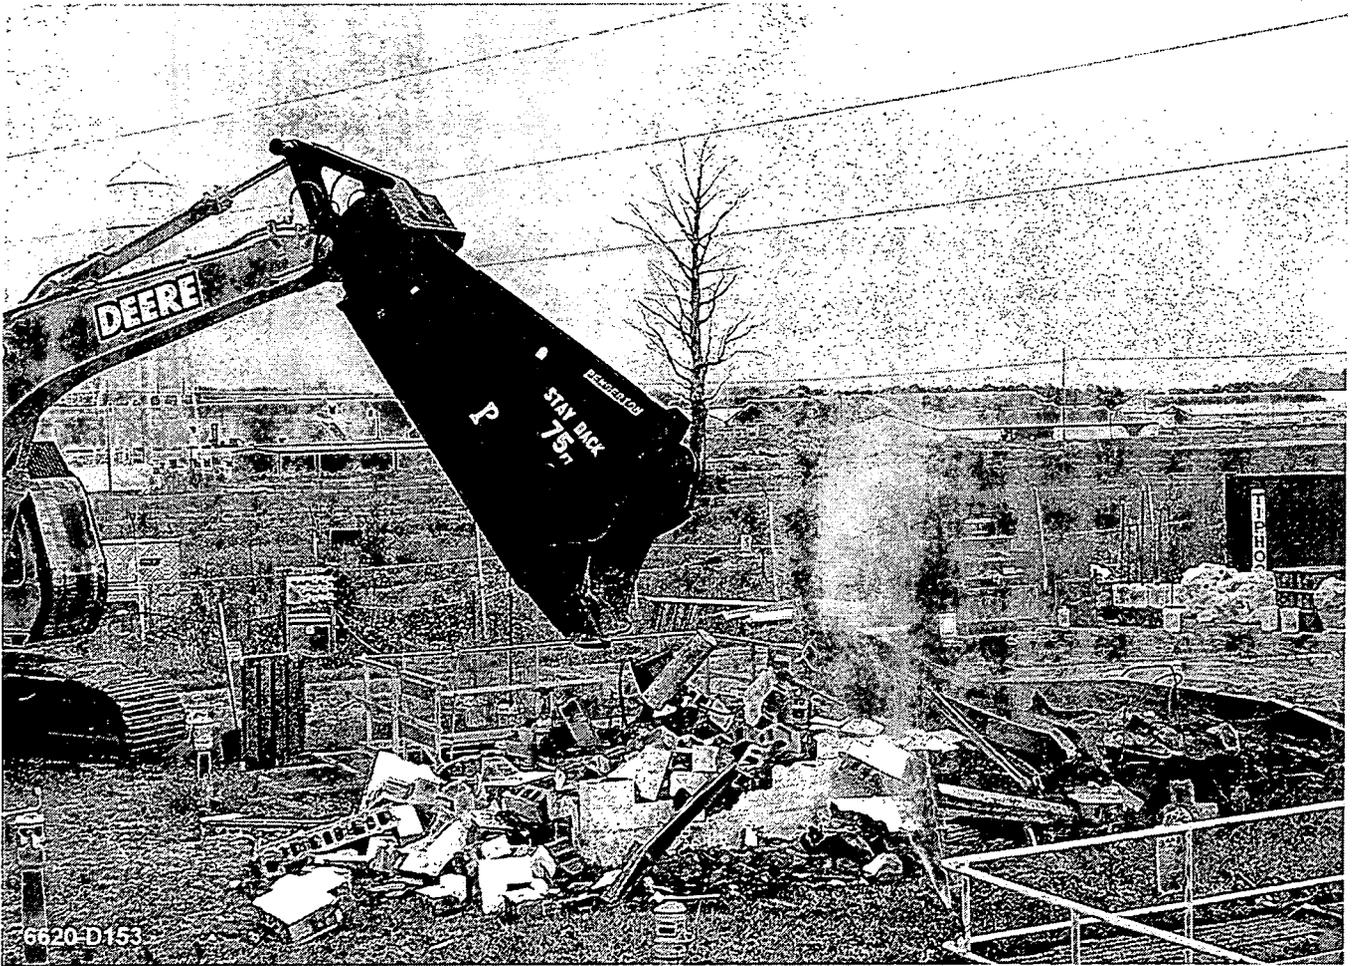
The structure was dismantled using the trackhoe-mounted shear. All debris was containerized in Roll-off Boxes (ROBs) for disposal in the On-Site Disposal Facility (OSDF). Photo No. 6 in Attachment 1 shows structural dismantlement and use of water spray for dust suppression. A wooden guardrail was placed in the position previously occupied by the west wall of the structure to maintain area safety around the below-grade tanks located on the west side of the slab. Penetrations in the slab were sealed with concrete/grout except for a large central pit where a pump had been situated. That pit was covered with plywood, secured in place by cement abutments and weights, and marked identifying the pit located beneath. The slab was sprayed with Chil-Lock fixative (blue in color) to encapsulate any residual contaminants that may have existed on the slab.

PHOTO 6: Structural Dismantlement of Chlorination Building (25A)

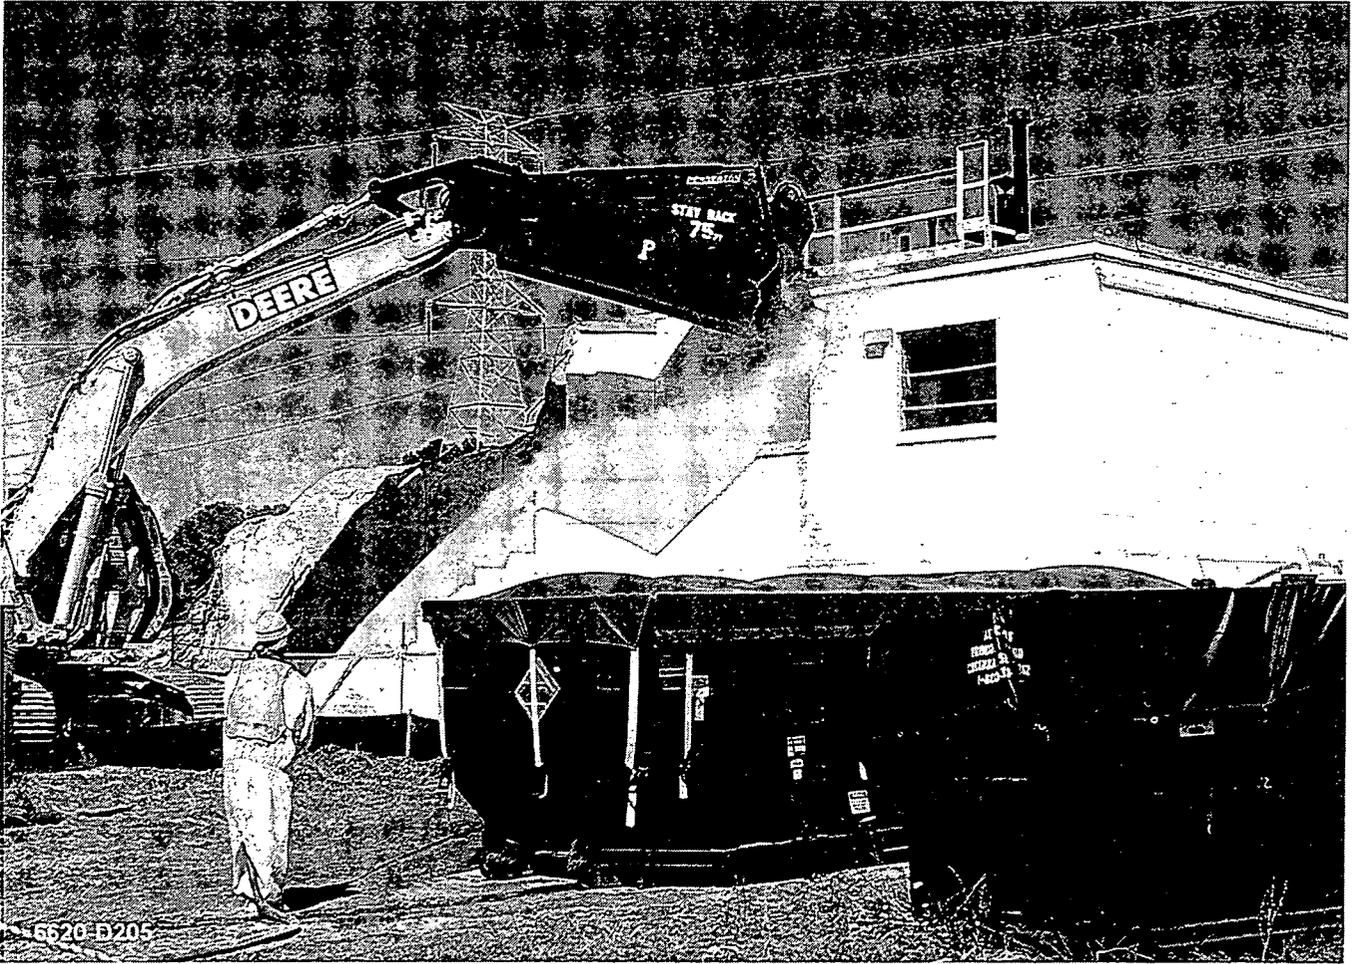
Dust control measures throughout the D&D of 25E included frequent use of water spray during shearing. Photo No. 7 in Attachment 1 shows dismantlement and use of water spray. The slab of 25E was thoroughly encapsulated with Chil-Lock fixative following debris removal.

PHOTO 7: Structural Dismantlement of Digester Control House (25E)

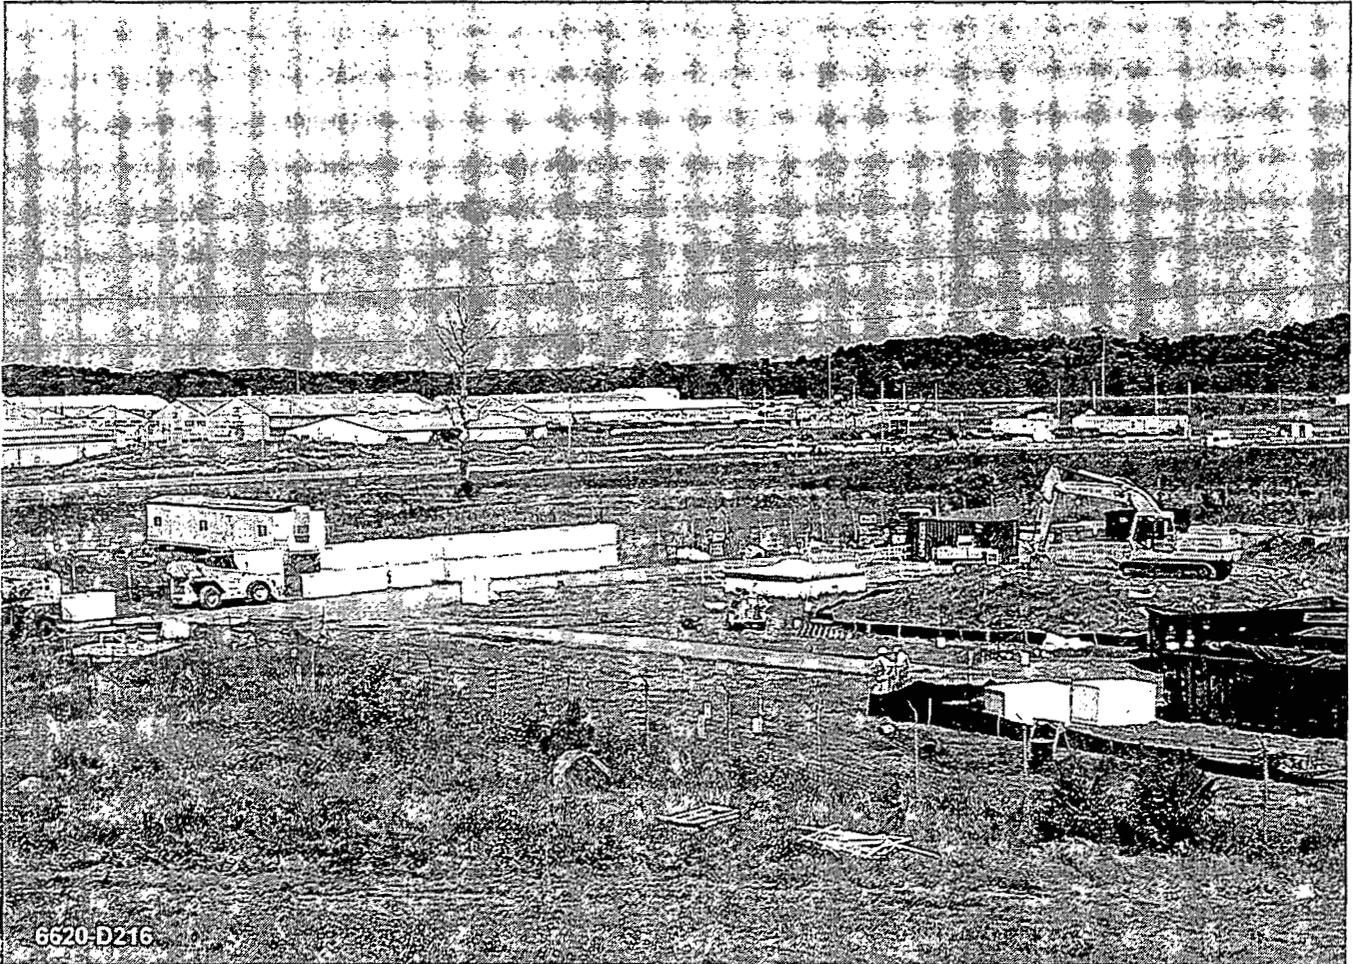
**PHOTO 8: Northwest view of west half of STP Area - follows dismantlement of all above-grade STP Complex components.  
(Match right of Photo 8 with left of Photo 9).**

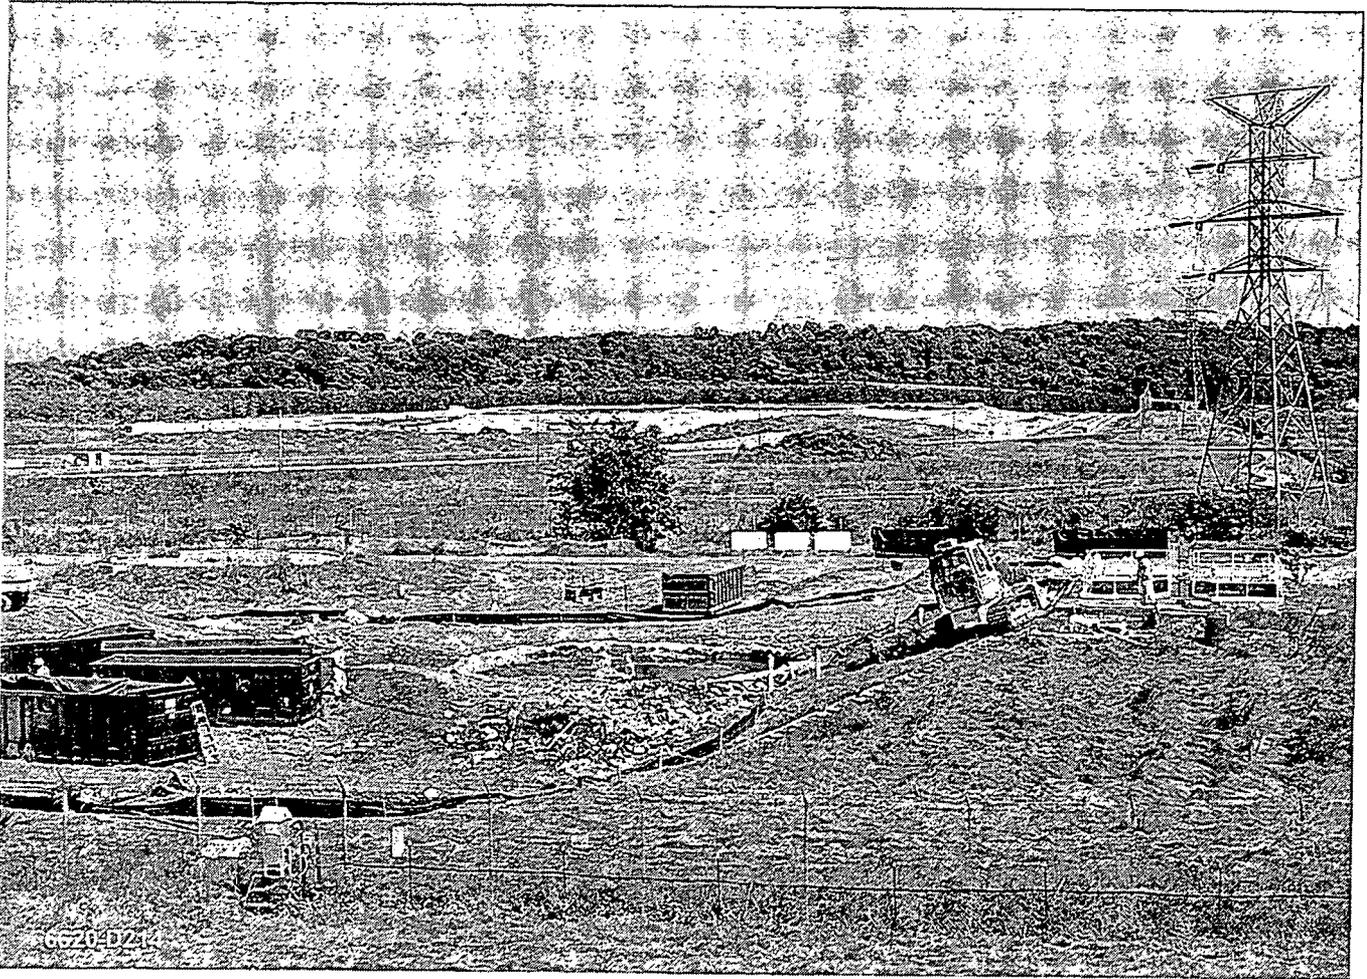
**PHOTO 9: North view of east half of STP Area - follows dismantlement of all above-grade STP Complex components; Digester Control House being containerized. STP-1 Air Monitor in foreground. (Match left of Photo 9 with left of Photo 8)**
