# Fernald Preserve

## Legacy Management Mission

# Fernald Preserve Annual Community Meeting

September 16, 2014

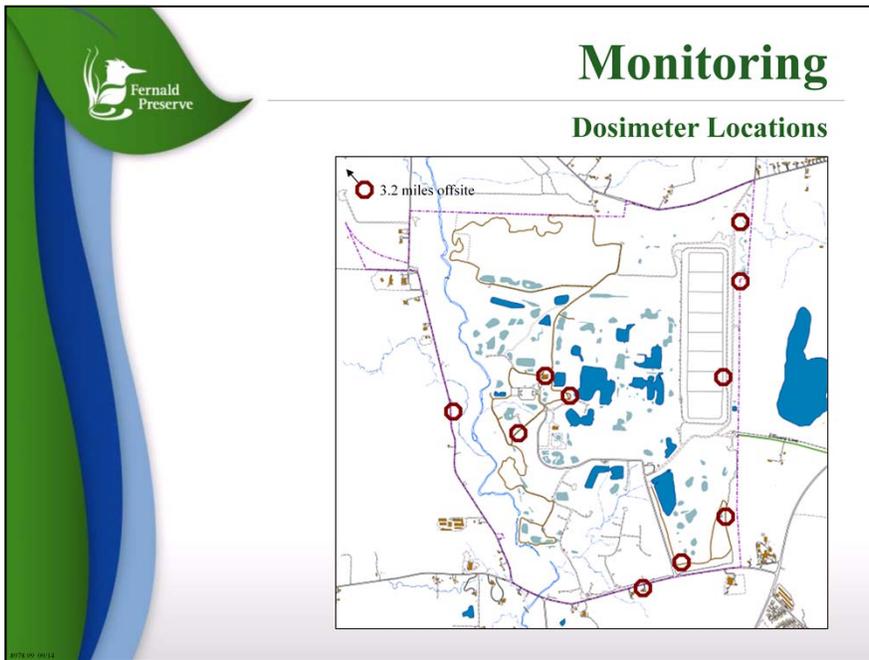
- The dosimeters are located along some of the trails, in the Visitors Center, and at the site boundary.
- Direct radiation levels continue to be at or near background levels.
- Point out VC and trails.

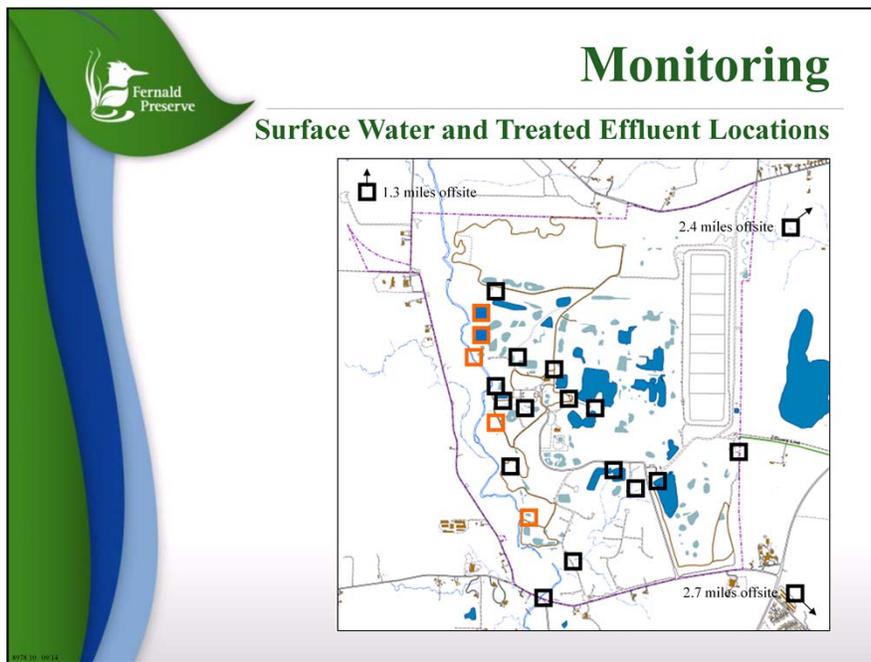
- Paddys Run is on the left and the other areas are surface water (i.e., ponds, wetlands, etc.)
- Several locations onsite are monitored to determine the potential impact of surface water on the groundwater.

- Five locations (orange) exceeded the groundwater final remediation level of 30 parts-per-billion in 2013.
- Two locations (blue) east of the Waste Storage Area were the only areas to exceed the surface water uranium concentration final remediation level of 530 parts-per-billion in 2013.

- These two locations are in an area where the public is not allowed and are dry much of the year.
- One location (SWD-05) exceeded the groundwater final remediation level for Thorium-232 (1.2 picocuries/liter) for a second straight year.

- All locations are within the capture zone of the extraction wells and will continue to be monitored.
- The concentrations, although above the surface water final remediation level, are statistically trending downward or no trend.

- During a site inspection in early 2014, erosion of the Paddys Run bank was noted in this area (i.e., two locations that are higher than surface water FRL). Plans were made to stabilize the bank, which John Homer will discuss later.

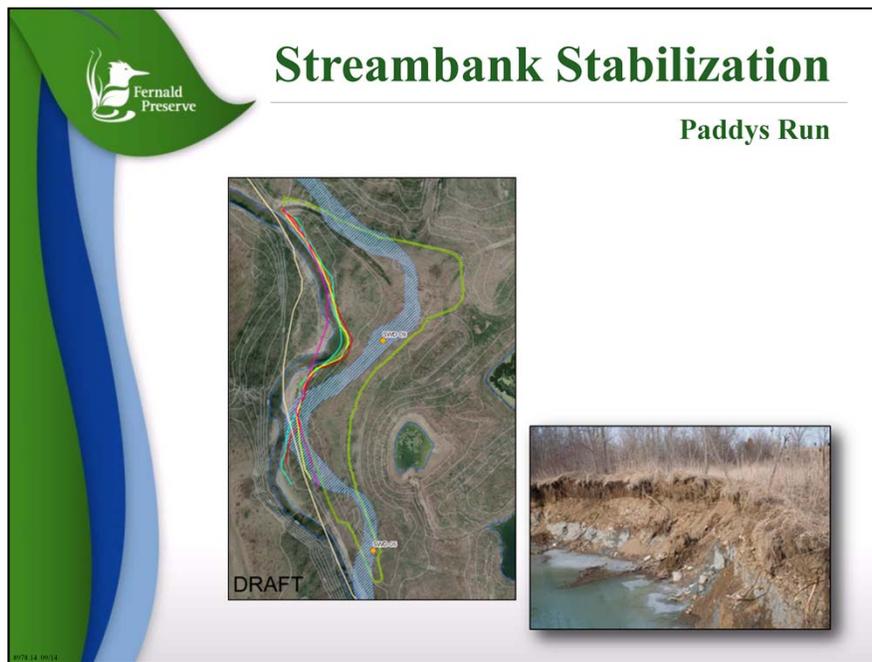
- The Paddys Run stream has been migrating into the former Pit 3 Swale area. It has moved approximately 13 feet eastward since 2012.
- This swale area is the location of the puddles with elevated uranium concentrations that were just discussed.
- These puddles are not an immediate concern because they are isolated. They do not drain into Paddys run and are located with the “capture zone” of aquifer restoration.
- These puddles do not normally drain into Paddys Run, but this may change if Paddys Run continues to migrate east.
- DOE has decided to stabilize the streambank to prevent further migration of Paddys Run into the swale area.
- Ken Broberg will discuss the On-Site Disposal Facility and aquifer restoration.

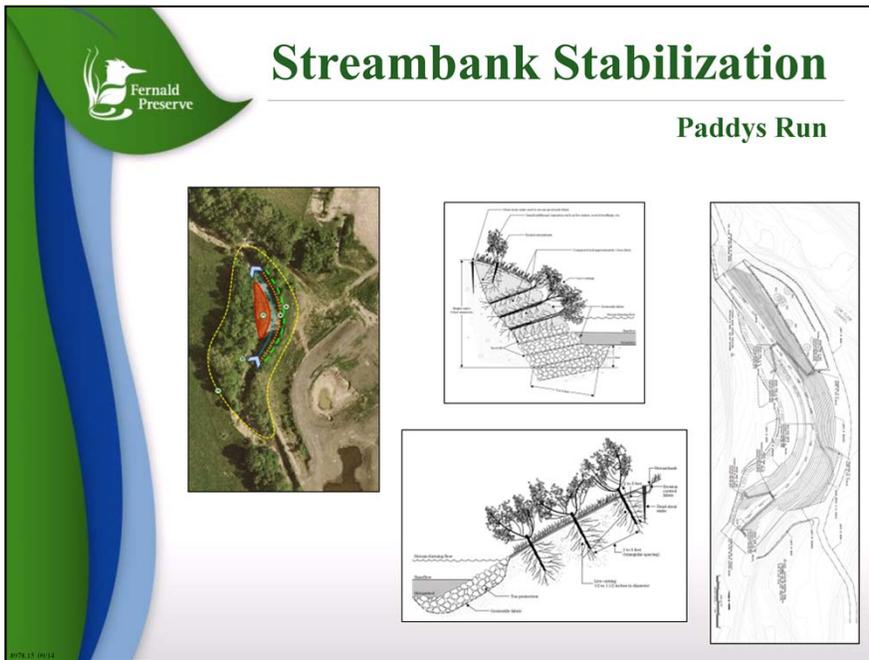
- Work includes relocating the streambed and softening the curve
- Bank stabilization will be accomplished with soil encapsulated lifts and regrade/fabric/reseed
- Two “crossvanes” will be installed in the streambed to stabilize the streambed elevation
- Work will take place for the next several months

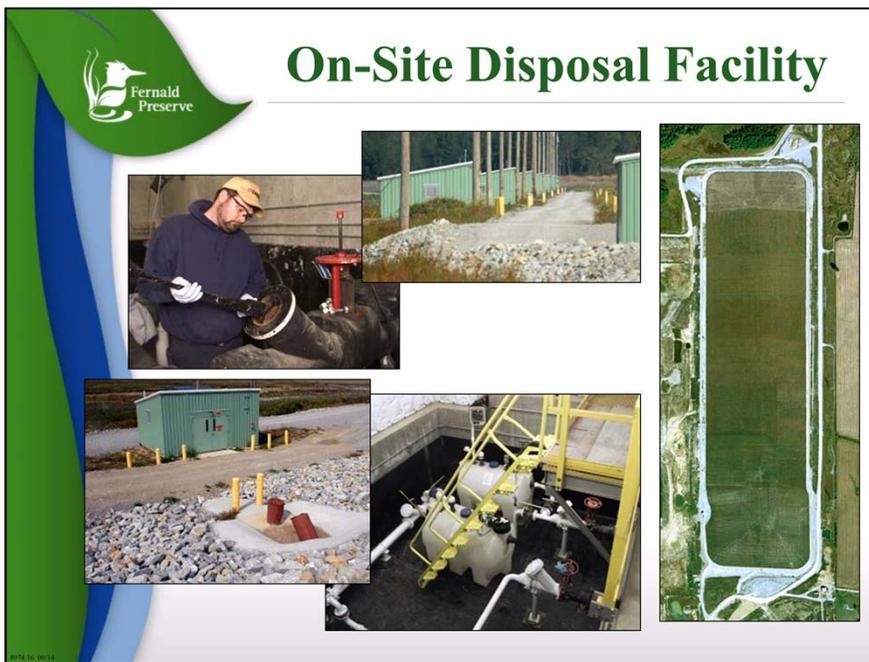
- Counterclockwise –
  - Typical aerial shot of entire On-Site Disposal Facility after capping in 2006.
  - View from south to north of the valve houses where Leachate Collection System and Leak Detection System flows are collected and monitored.
  - Worker preparing to camera survey one of the pipes.
  - Individual valve houses.
  - Valve house tanks where the drainage from the Leachate Collection System and the Leak Detection System is collected and monitored.

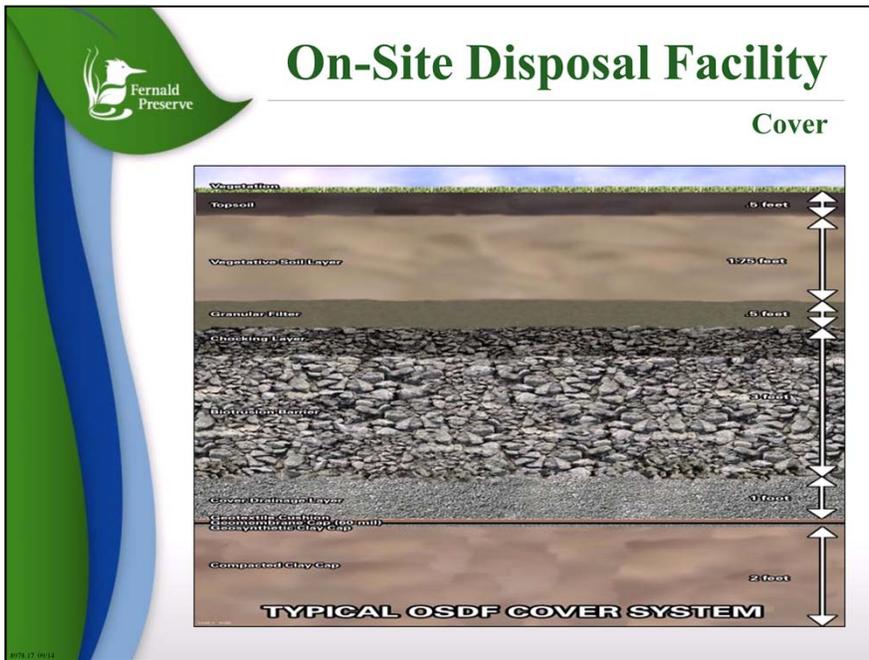
- Cap is nearly 9 feet thick
- Designed to keep water, roots, and animals out.

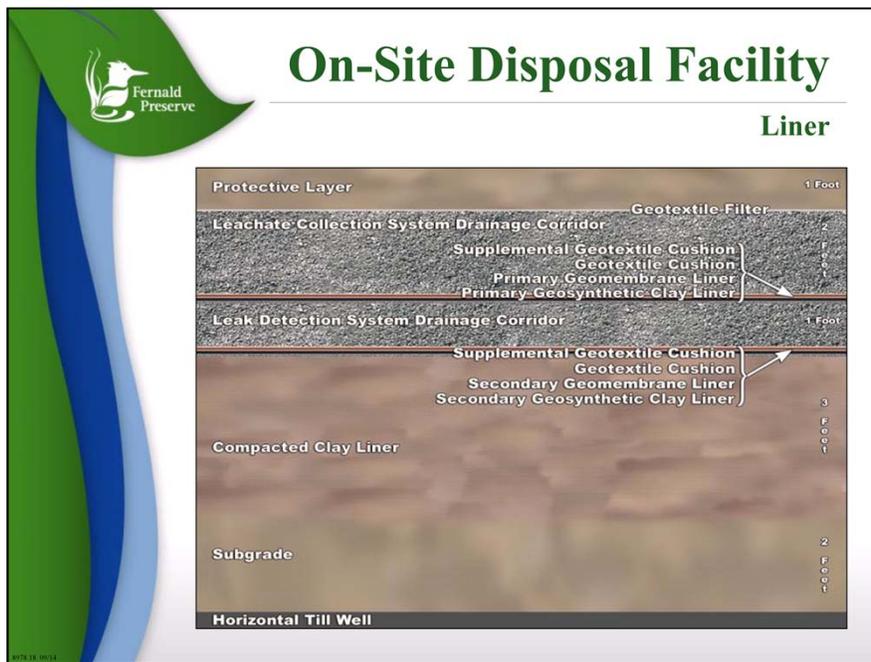
- 6-foot-thick liner system.
- Two high-density polyethylene liners (primary and secondary).
- Leachate Collection System and Leak Detection System layers that slope to the center, then west.
- Drainage from these layers collects in the valve houses for each cell.
- The drainage collects in tanks where flow volume is closely monitored, and samples are collected for analysis two times per year.
- Visual display provided in column in the atrium.

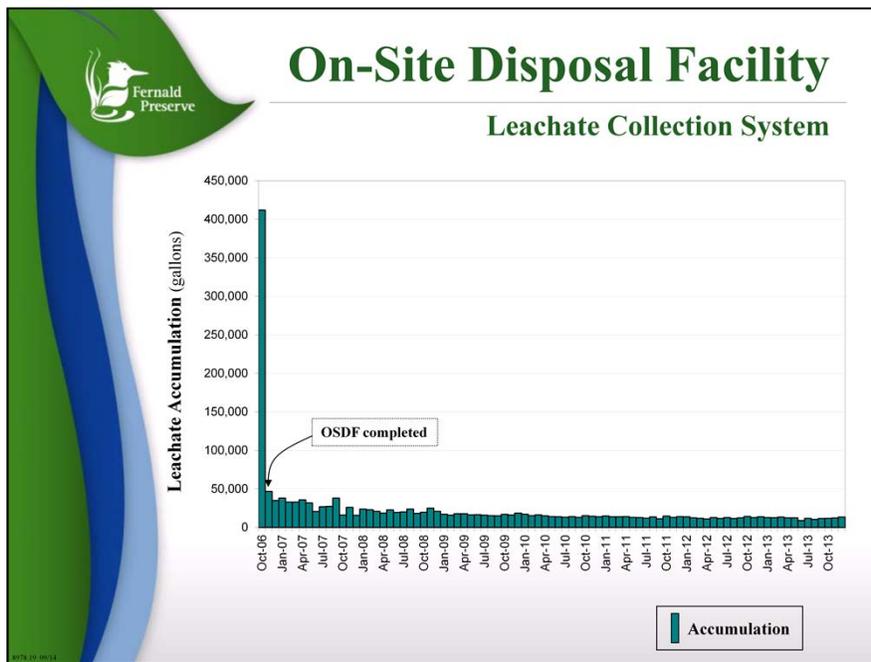
- Graph shows Leachate Collection System flow from the entire facility by month, from just before the final capping (in September 2006) through December 2013.
- Note the large flows prior to cap completion; flow was greater than 800,000 gallons in September 2006, and greater than 400,000 gallons in October 2006. Flows have been much lower since capping was completed in October 2006.

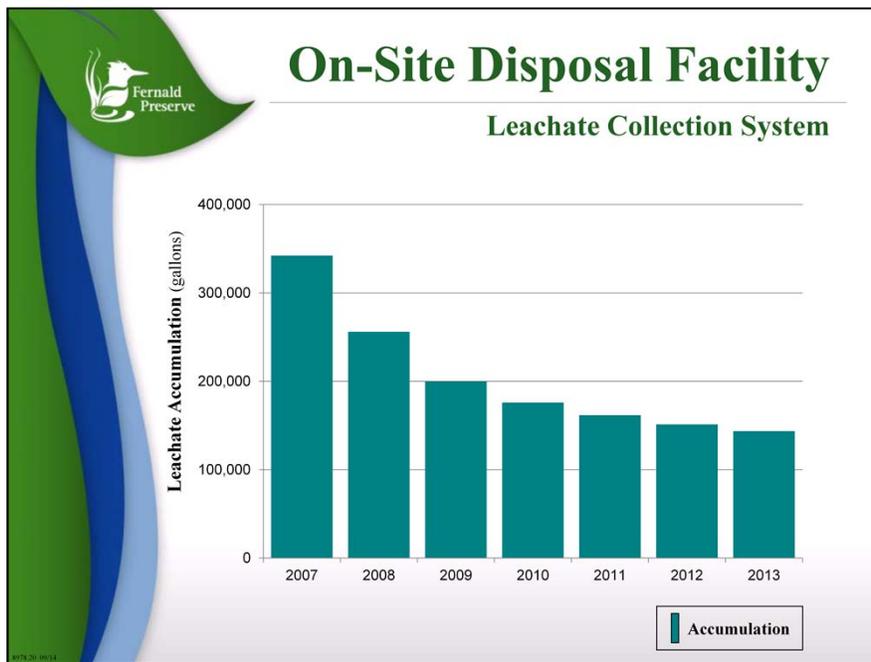
- Graph shows Leachate Collection System flow from the entire facility by year after final capping (in September 2006) through December 2013.
- The annual flow amount continues to decline. Total annual flow as measured at 151,343 gallons in 2012 and at 143,733 gallons in 2013.

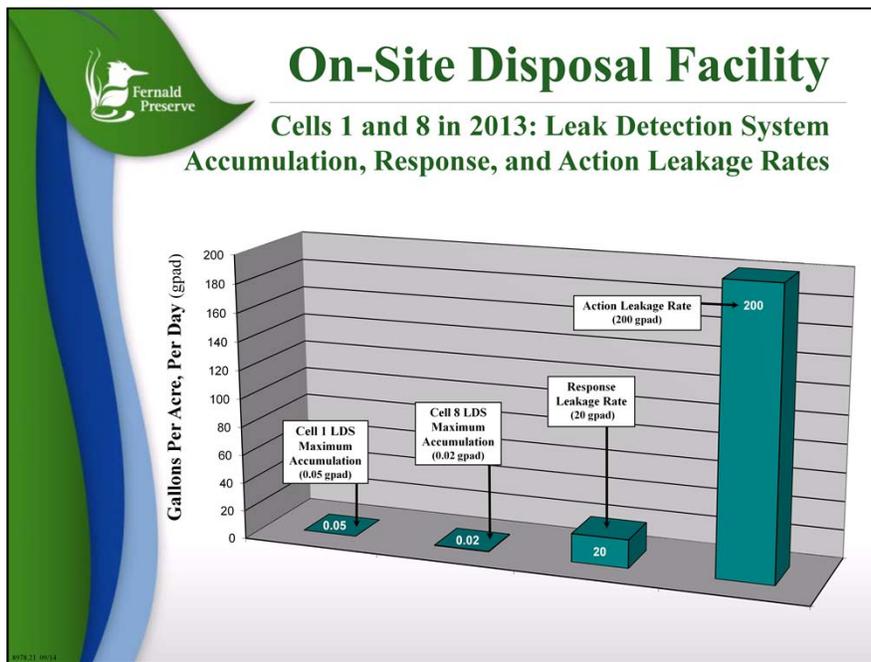
- Cell 1 was the first cell completed.
- Cell 8 was the last cell completed.
- Leak Detection System accumulation rates in Cells 1 and 8 were very small compared to the Response Leakage Rate which is 20 gallons per acre per day, while the Action Leakage Rate was 200 gallons per day.

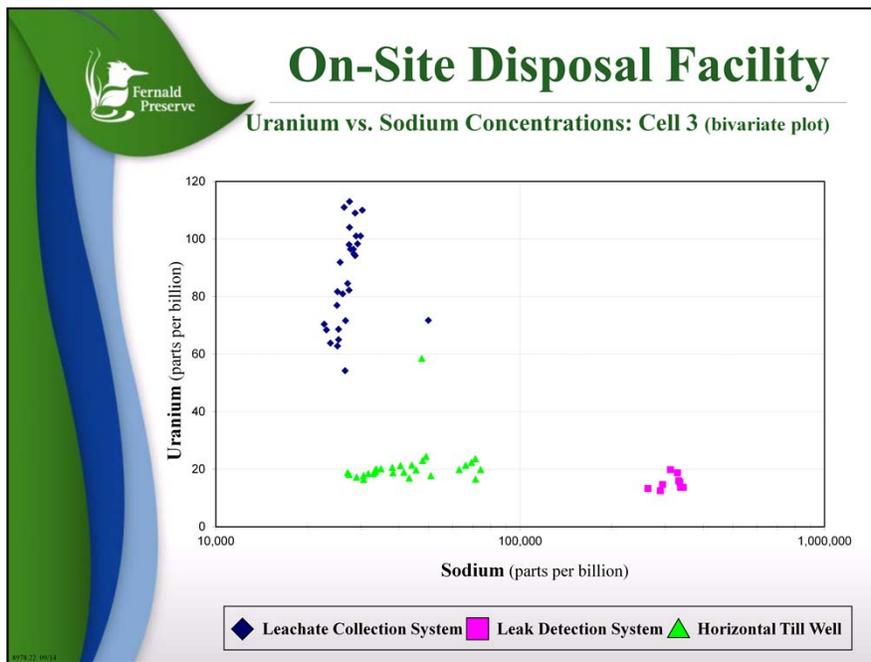
- Note that each monitoring horizon plots out on a different area on the graph.
- If all horizons plotted out in the same area, that would indicate similar chemical characteristics and possible mixing of the water from the different horizons.
- This graph can be used to look for potential mixing over time.

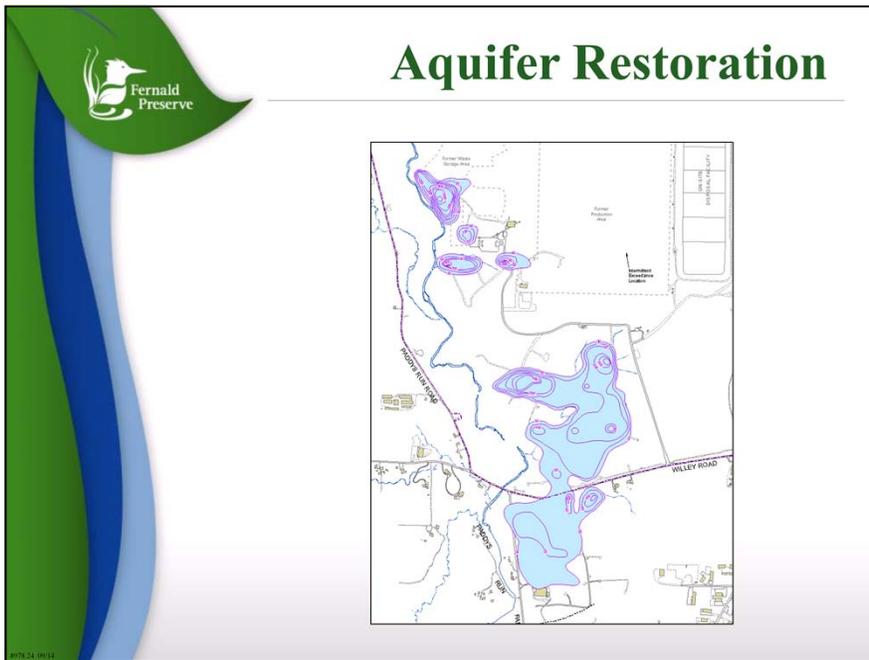
- Aquifer restoration data as of December 31, 2013:
  - 4,775 average gallons per minute target pumping rate
  - 23 extraction wells
  - 140 monitoring wells
  - 34.9 billion gallons extracted 1993
  - 9.86 billion gallons treated since 1993
  - 11,784 pounds of uranium removed

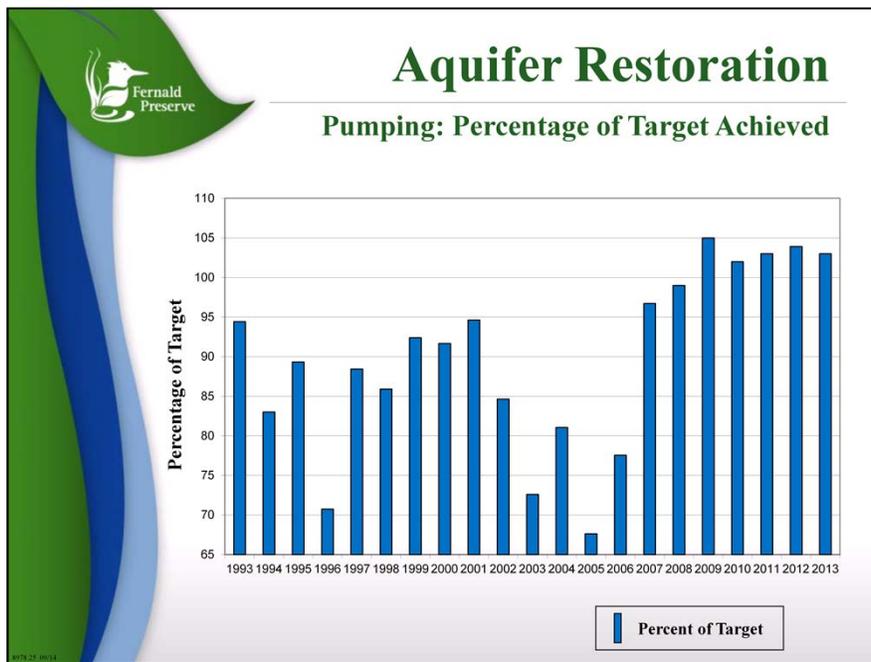
- Left axis shows percent of target pumping rate (4,775 gallons per minute).
- Blue bars show how we've done with respect to the target.
- Note the improvements in percent of target achieved since 2006.
- Improvements directly reflect the improvements (e.g., insitu well treatment to clean pumps, performance testing, etc.) we've made to our well field operation and maintenance program.

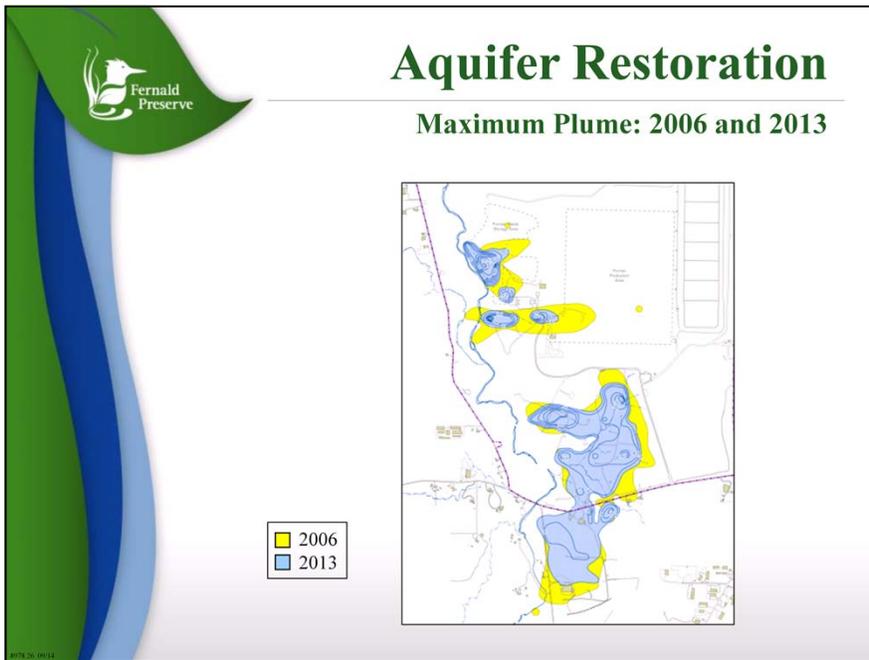
- Concentrations from all depths projected onto one surface.
- Represents worst-case interpretation.

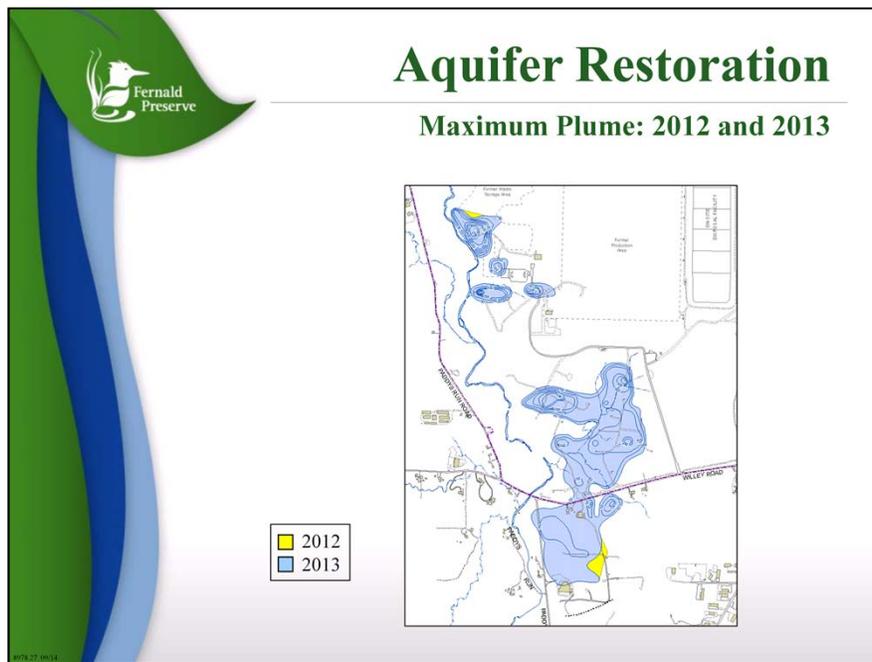
- Overall size of the uranium plume footprint did not decrease much between 2012 and 2013.
- At the end of 2013, the footprint (area above 30 ppb) was approximately 127.3 acres. This was a reduction of 3 acres (2.3 percent) from the 2012 interpretation.
- However, we did see significant concentration reductions within the more concentrated areas of the plume.
- The area within the plume above a concentration of 50 ppb decreased in size by 21.1 acres (21.7 percent).
- The area within the plume above a concentration of 100 ppb decreased in size by 13.4 acres (26.5 percent).
- The difference in concentration between the two years does not necessarily mean that the concentrations decreased in one year. It means only that we were able to sample and document the decrease in 2013.

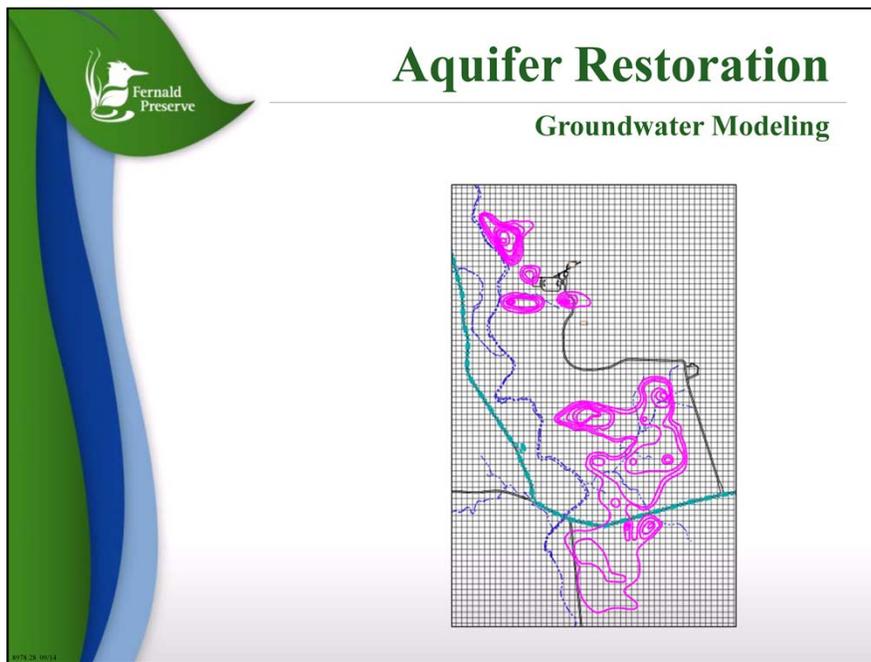
- New groundwater modeling was completed in 2013.
- Groundwater samples collected in 2011 indicated that an area of the uranium plume just south of Willey Road was higher in concentration and larger than previously characterized.
- 2012 uranium concentrations were loaded into the groundwater model site-wide and the model was rerun.
- The result was longer predicted cleanup times. The revised cleanup prediction was: South Plume 2028, SF 2028, WSA 2032. Based on a 2012 start.
- Additional groundwater modeling using a variety of pumping scenarios was conducted to try to shorten the cleanup time predictions.

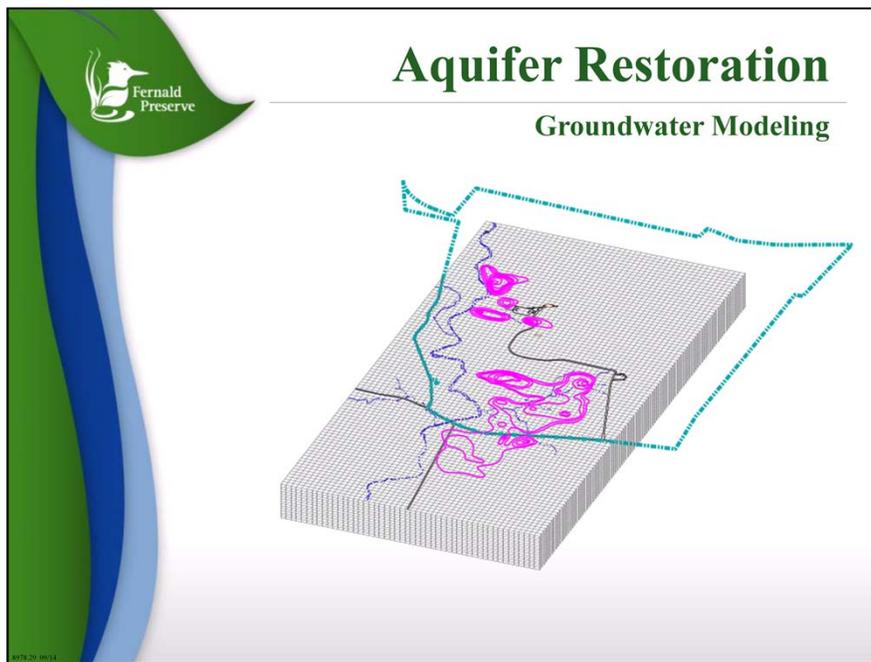
- Each point in the aquifer fits into a unique cell of the groundwater model.
- The model has 72,114 cells (101 x 51 x 14 layers).
- In 2013 we had 23 extraction wells pumping at design rates ranging from 100 to 300 gallons per minute.
- The groundwater modeling has two components: (1) flow and (2) transport.

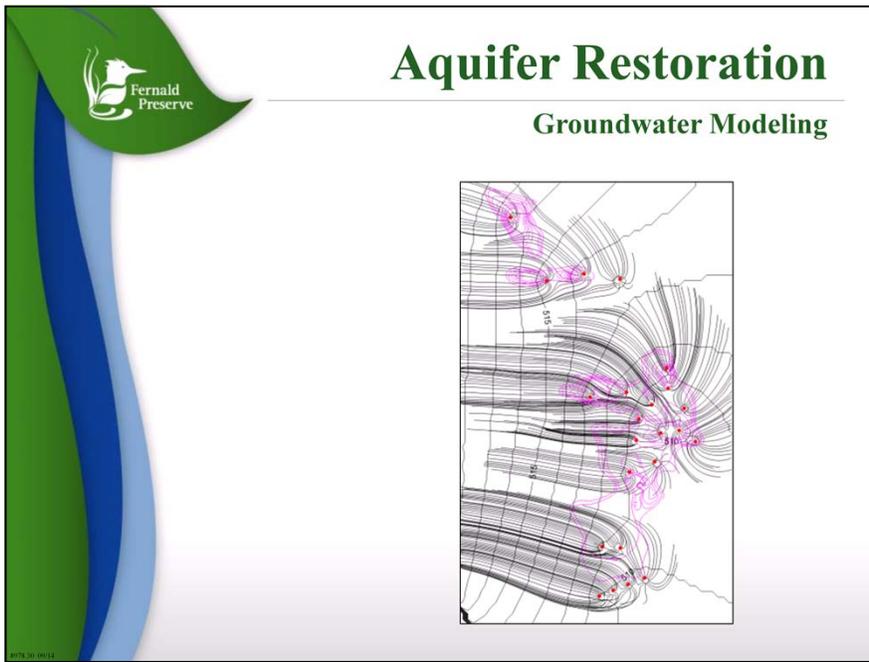
- This figure shows the flow pattern of operations in 2013.
- Water is moving toward each pumping well. The water moves along what is referred to as “particle tracks.”
- Note that some of the particle tracks no longer pull from the plume area, because the plume is no longer there.

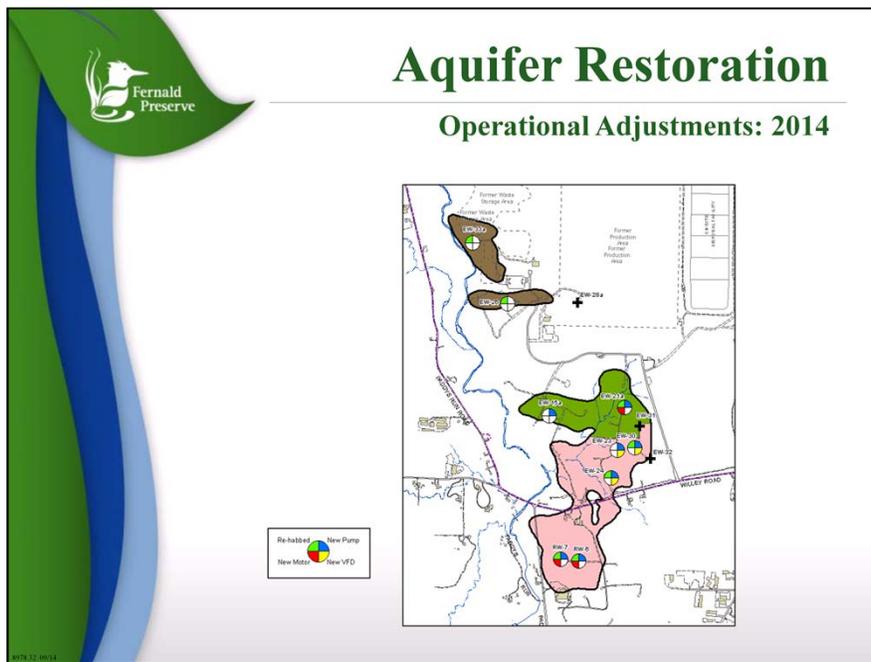
- Turned off extraction wells EW-28A, EW-31, and EW-32.
- Rehabilitated seven extraction wells.
- Installed new larger pumps in seven extractions wells.
- Installed new motors in three wells.
- Installed larger variable frequency drives in three extraction wells.
- Implemented new pumping targets in July 2014.

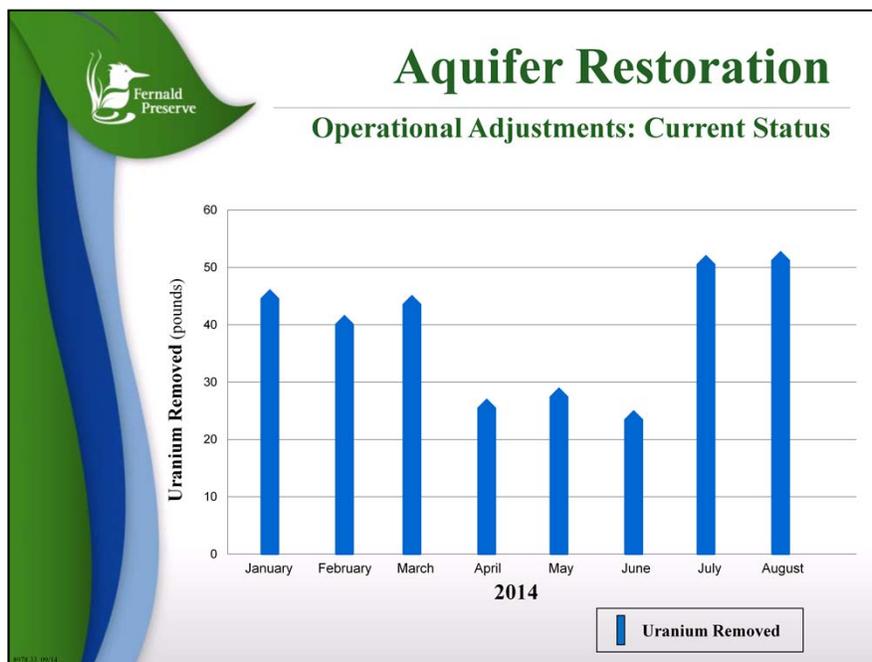
- As the groundwater model predicted, with the new pumping rates, more uranium is being pulled out of the aquifer. This means that some of the groundwater pumped from the aquifer now needs to be treated in order to meet discharge limits at the Great Miami River.
- A few wells have not achieved their target set points.
- In the next few months DOE will adjust operations as needed in an effort bring all wells up to their new target design set points.
- DOE will determine the cause for any well not meeting its set point and take appropriate action to either mitigate the problem or to assess the impact that not meeting design set point will have on model-predicted cleanup times.
- Data will be in next year's SER.

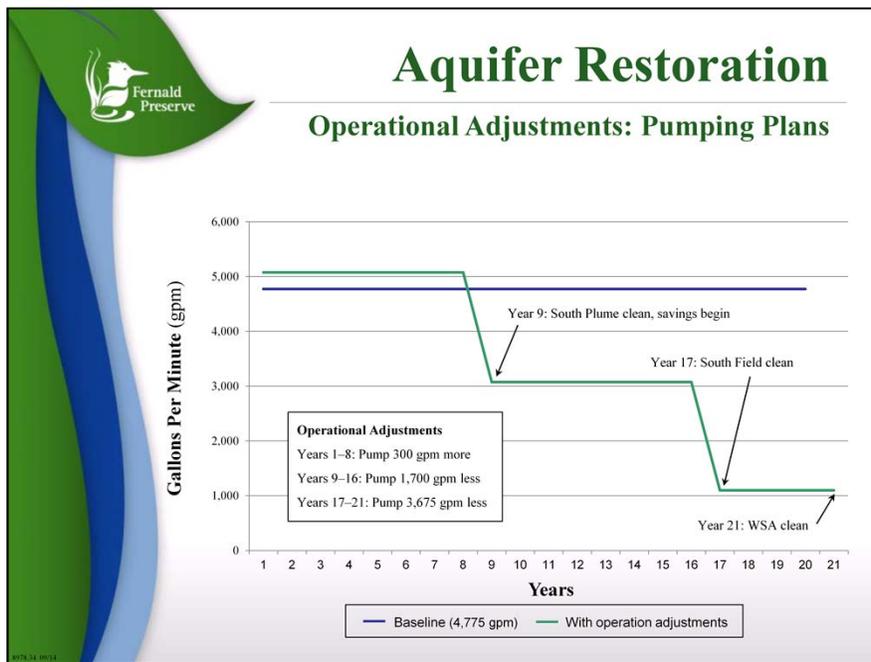
- Extraction wells will pump at slightly higher rates for the first 8 years after implementing the changes.
- The model predicts that pumping can be decreased in year 9, then again in year 17.

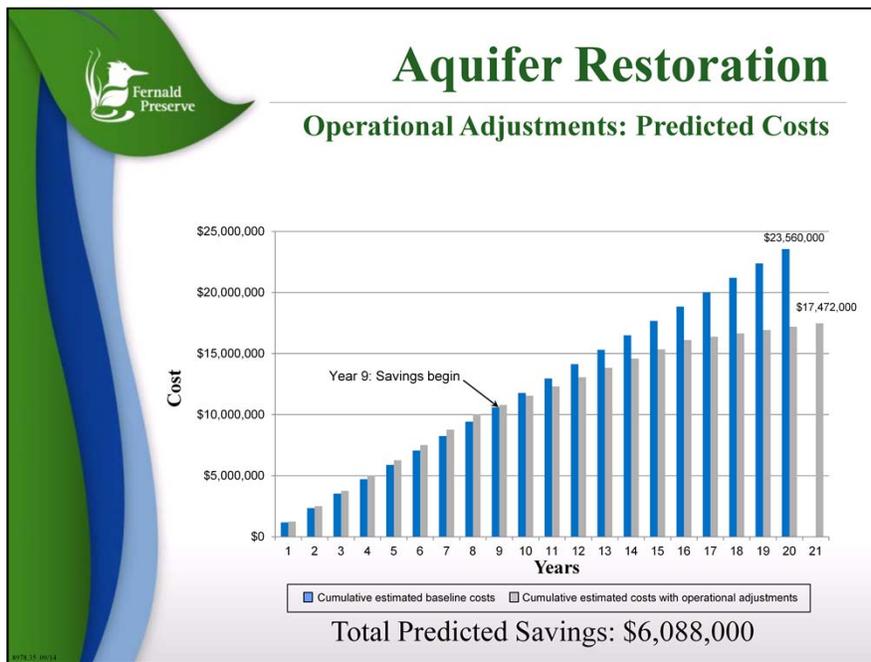
- The revised pumping scenarios indicate higher operating costs for the first 8 years.
- Savings will begin if pumping rates are reduced in year 9, as the model predicts.
- The potential savings are estimated at \$6 million.
- Introduce Penny Borgman, Public Affairs.

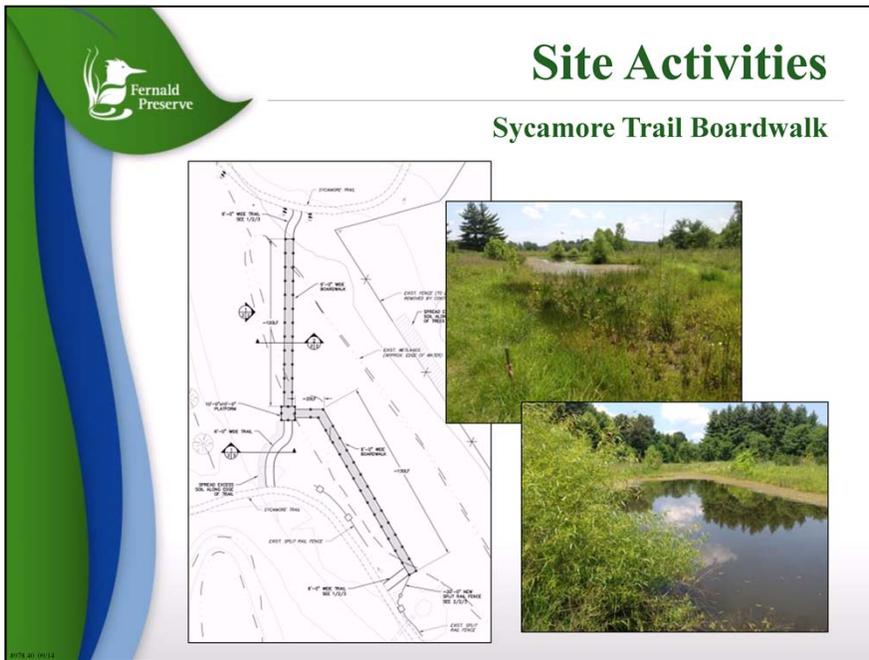
- A boardwalk is being built along the Sycamore Trail to enhance outreach programs that involve wetlands.
- The project is being designed and constructed to ensure minimal damage to the wetland.
- Helical piers are being used, along with special equipment (i.e., rubber tracks, relatively lightweight equipment, and smaller footprint) that will limit entry points into the wetland.

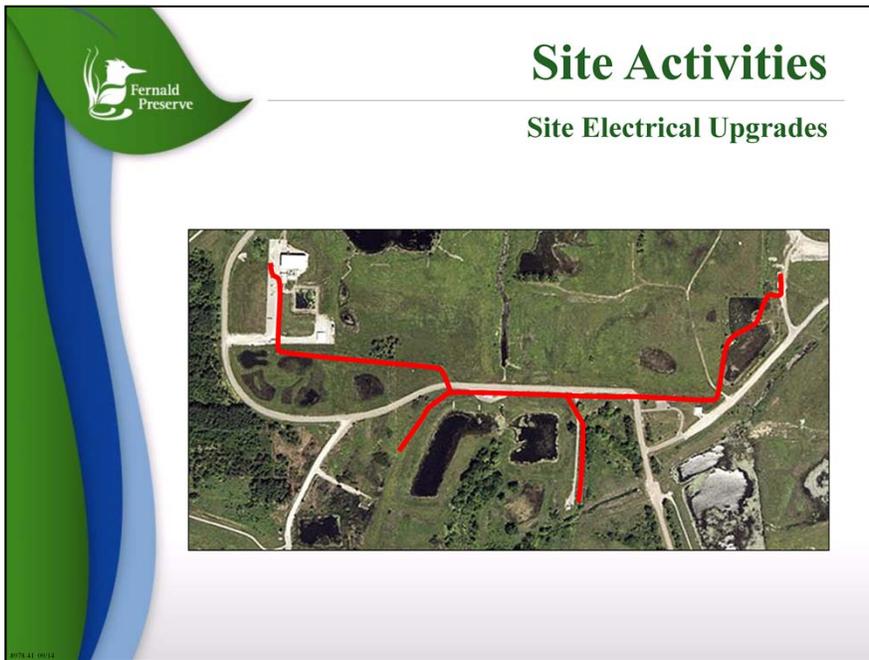
- This project is a follow-on to a project we completed in 2010.
- The area of focus for this project is from the southwest corner of the On-Site Disposal Facility to the site access road, and then over to the wastewater treatment facility.
- Drawing shows above ground lines to be removed.
- Project Scope includes:
  - Install new power lines and conduit for communication lines underground, and then remove overhead electrical power lines, communication lines, and poles.
  - Install new more efficient pad-mounted transformers and then remove the old oversized transformers located on the power poles.
- Reintroduce Gwen.
