**Annual Assessment of the  
Effectiveness of  
Site-Wide Institutional Controls  
Applied to the Former  
DOE Mound Site Property**

**June 2010**

LMS/MND/S06401

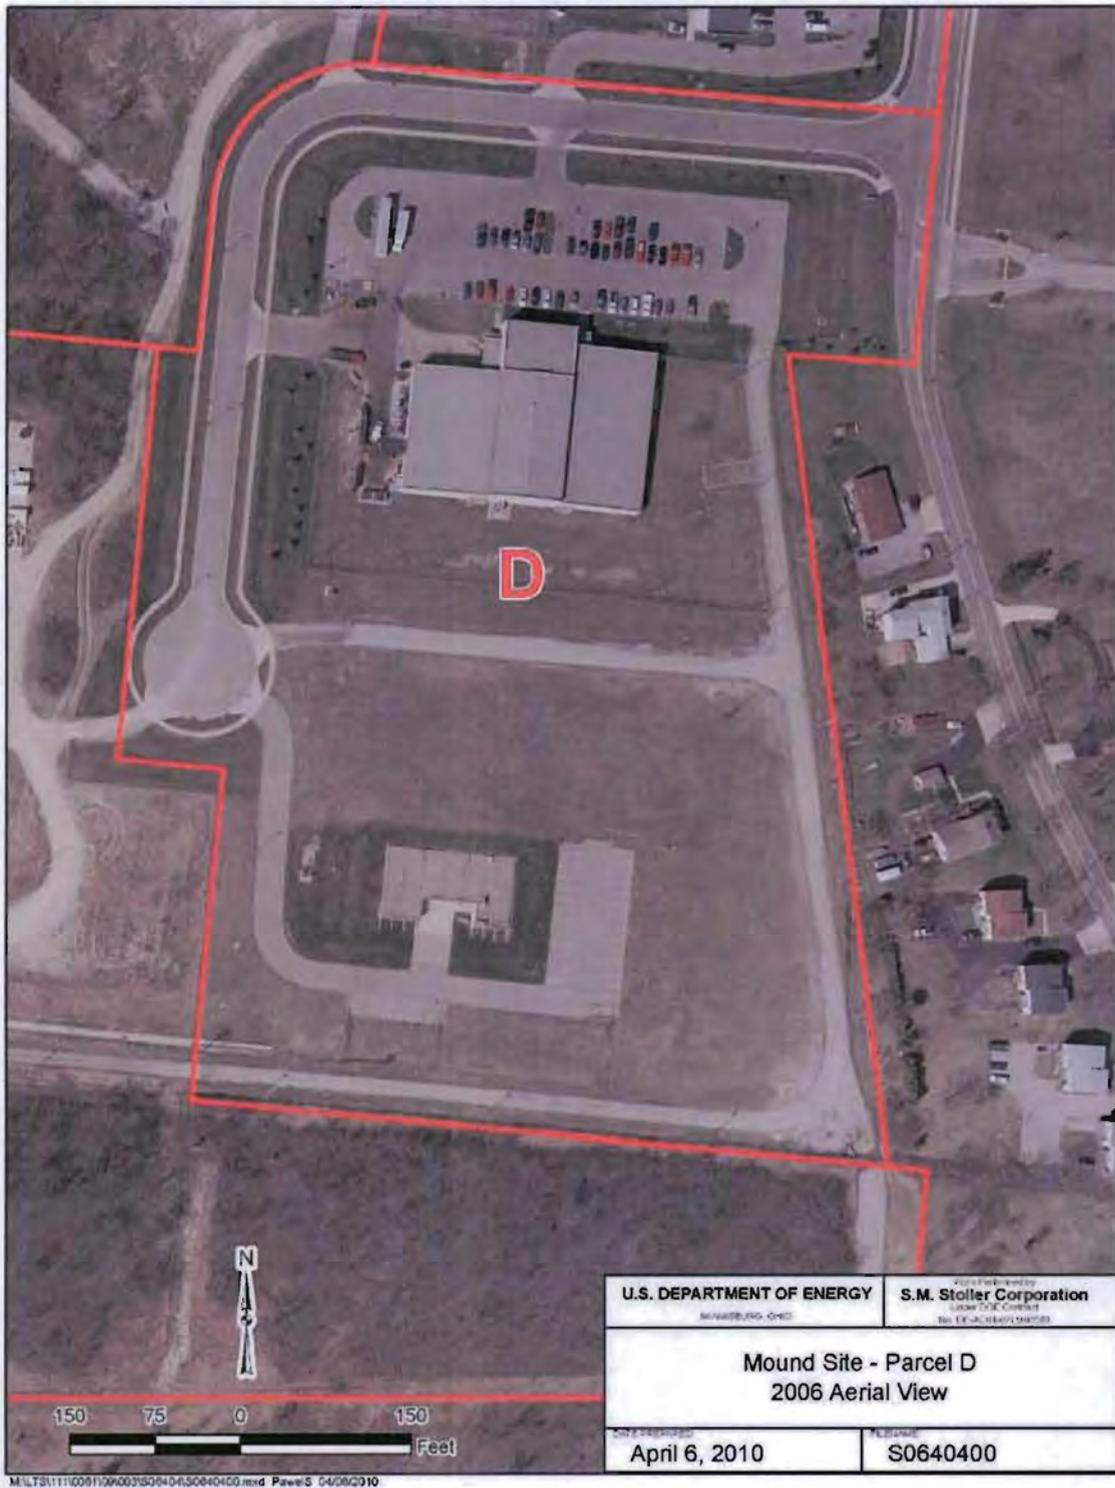
Figure 3. Parcel D 2006 Aerial View

In Parcel D (Figure 3), there were no observations of noncompliance with the ICs. In particular, there was no evidence of unauthorized well installation or soil removal from the original boundaries of the DOE Mound Site Property.

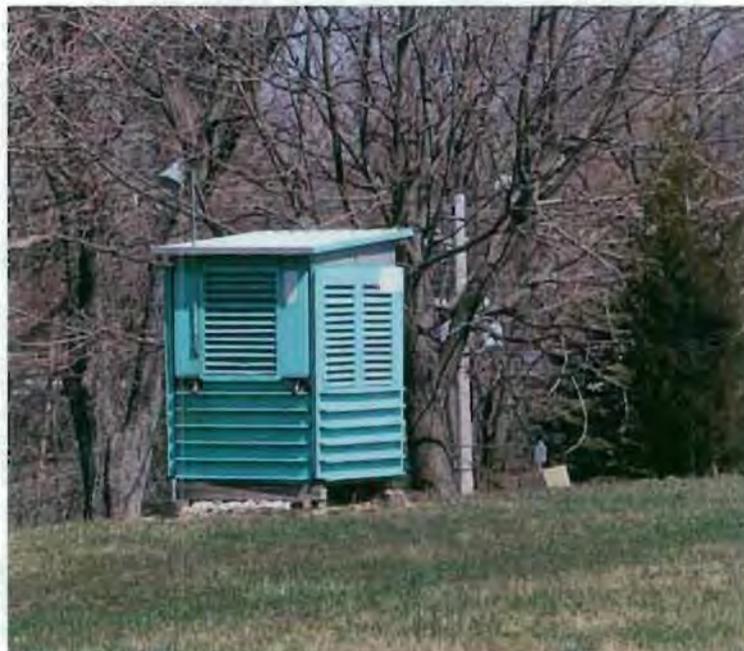
Although air monitoring is not part of the CERCLA remedy for any parcel covered by this assessment, DOE continues to use site air monitoring stations. One station is on the northeast corner of Parcel H (Figure 4). DOE will continue to operate its Mound Site air monitoring stations until the National Emission Standards for Hazardous Air Pollutants (NESHAPs) requirements are met after Operable Unit (OU)-1 work is completed.

*Figure 4. Parcel H DOE Air Monitor*

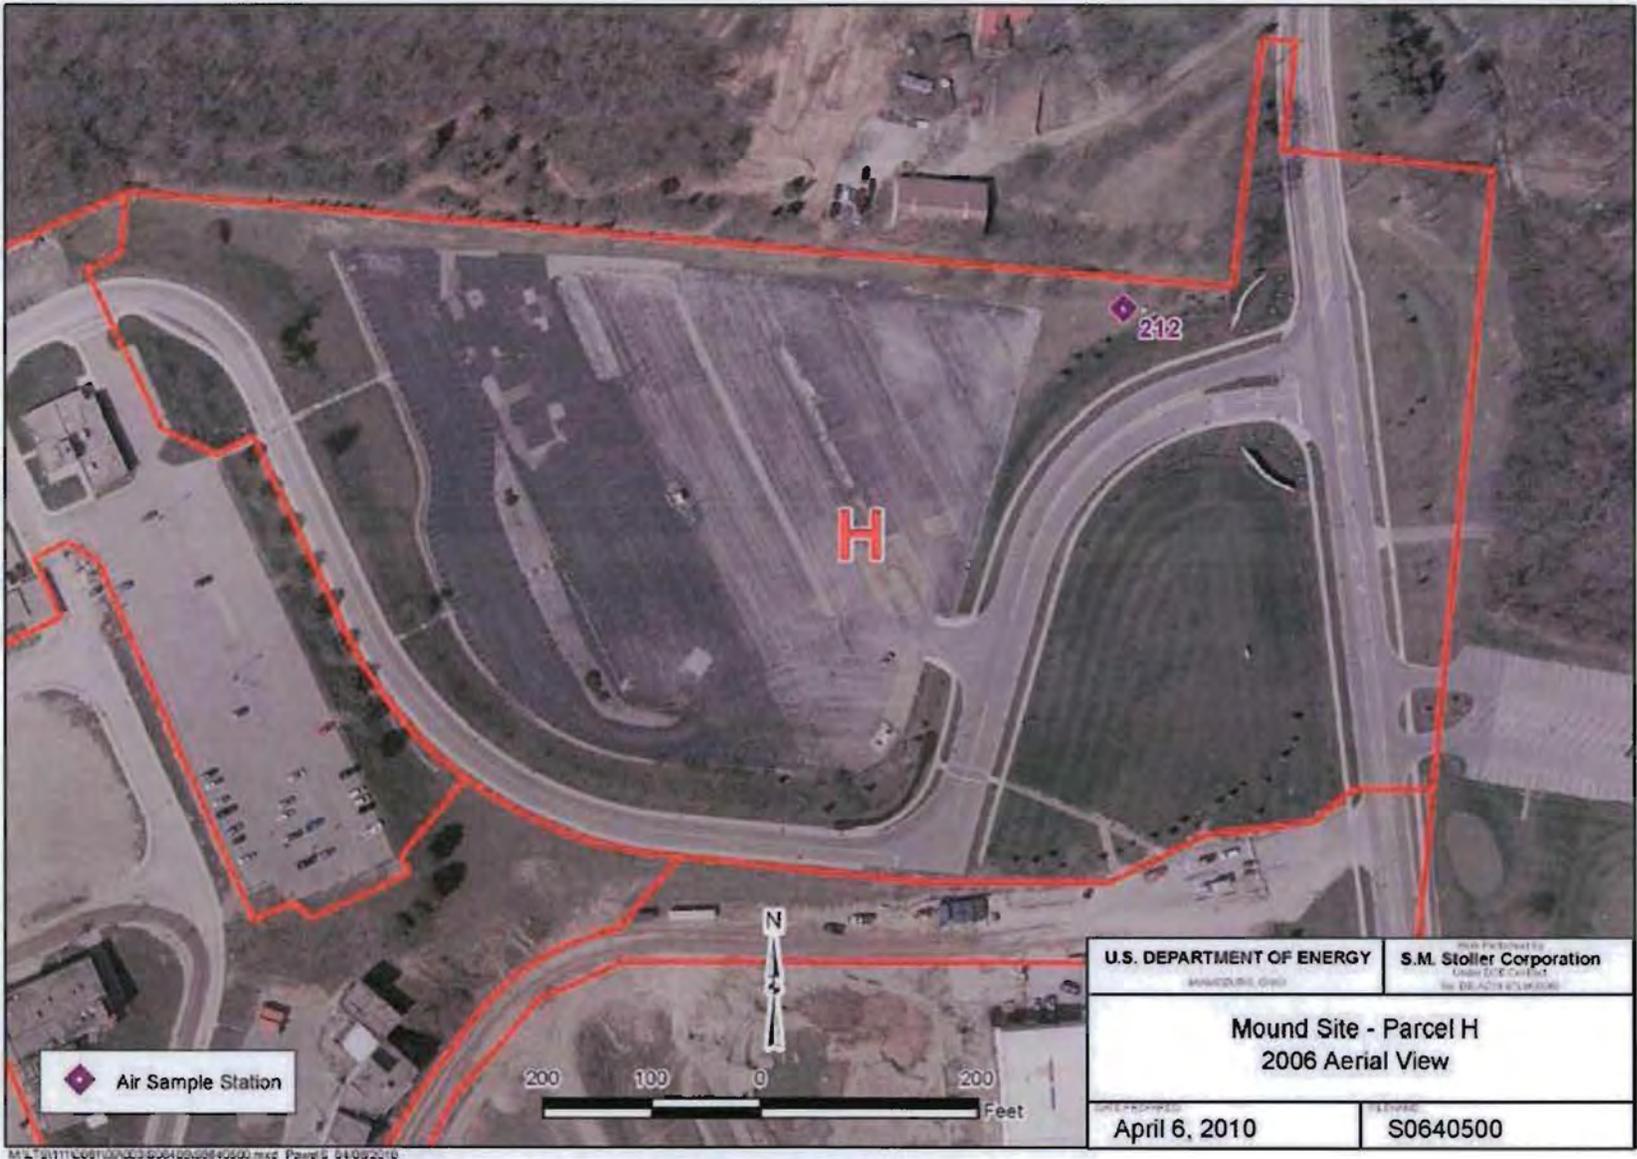
Figure 5. Parcel H 2006 Aerial View

Figure 5 was formerly called Release Block H. There were no observations of noncompliance with the ICs. In particular, there was no evidence of unauthorized well installation or soil removal within the original boundaries of the DOE Mound Site Property.

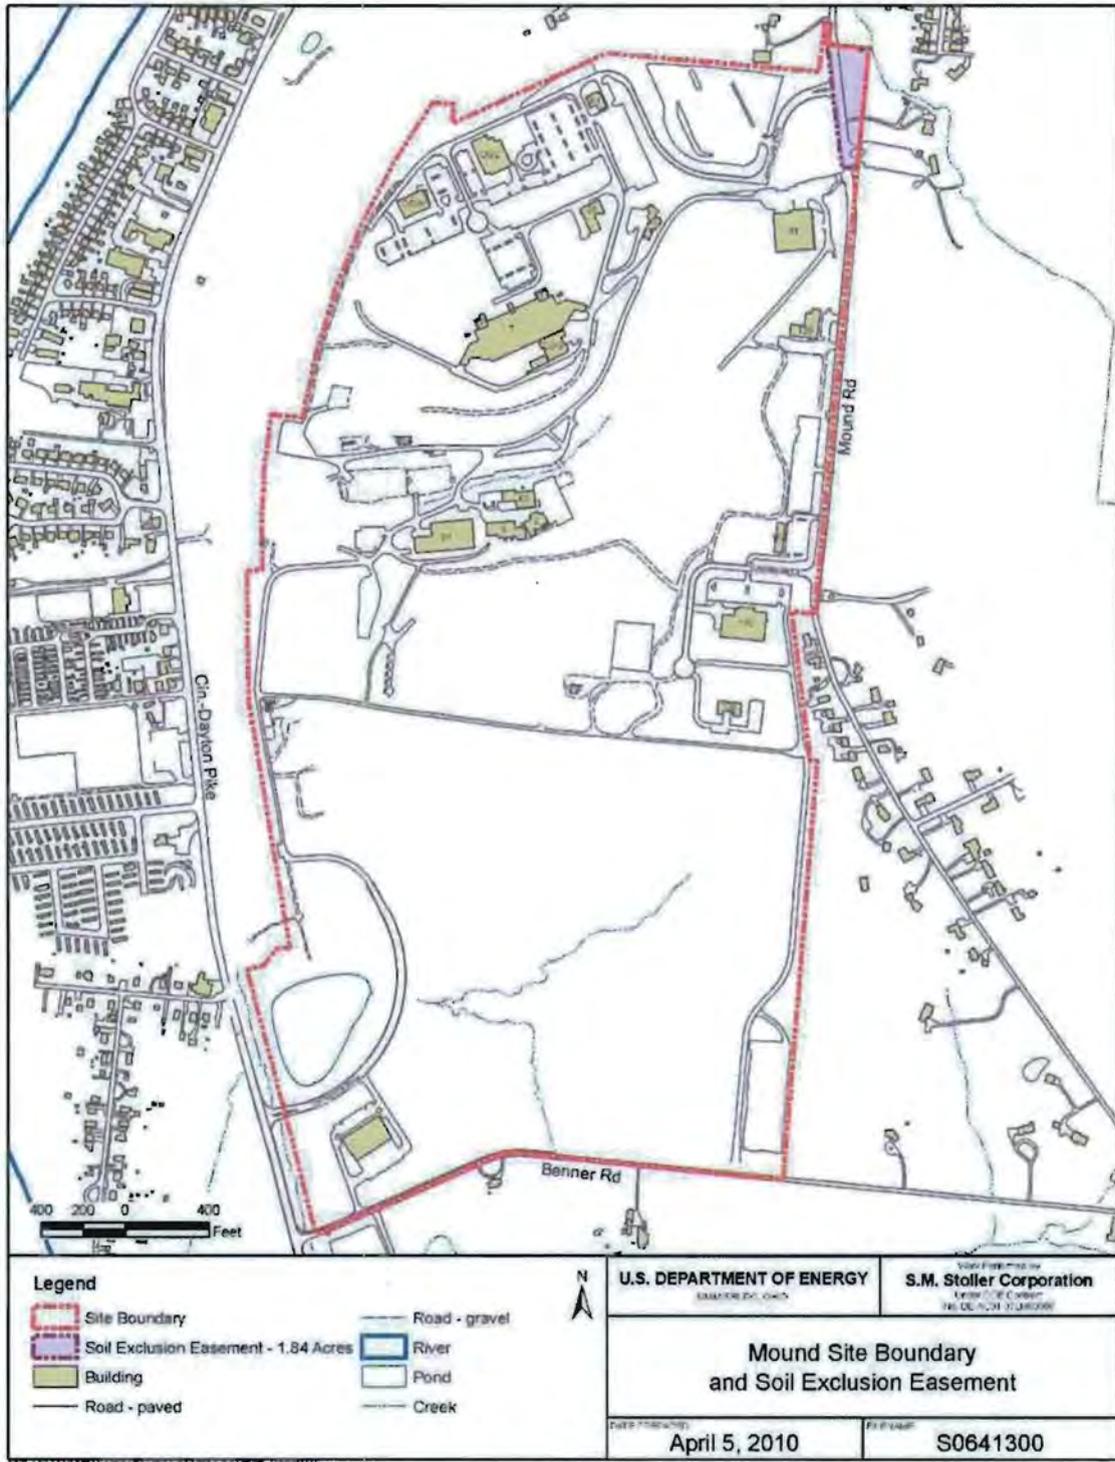
Figure 6. Parcel H Soil Removal Exclusion Area

One area of Parcel H is exempt from the soil removal restriction (Figure 6). Modifications to the entry and the rerouting of Mound Road isolated this area from the original Mound property.

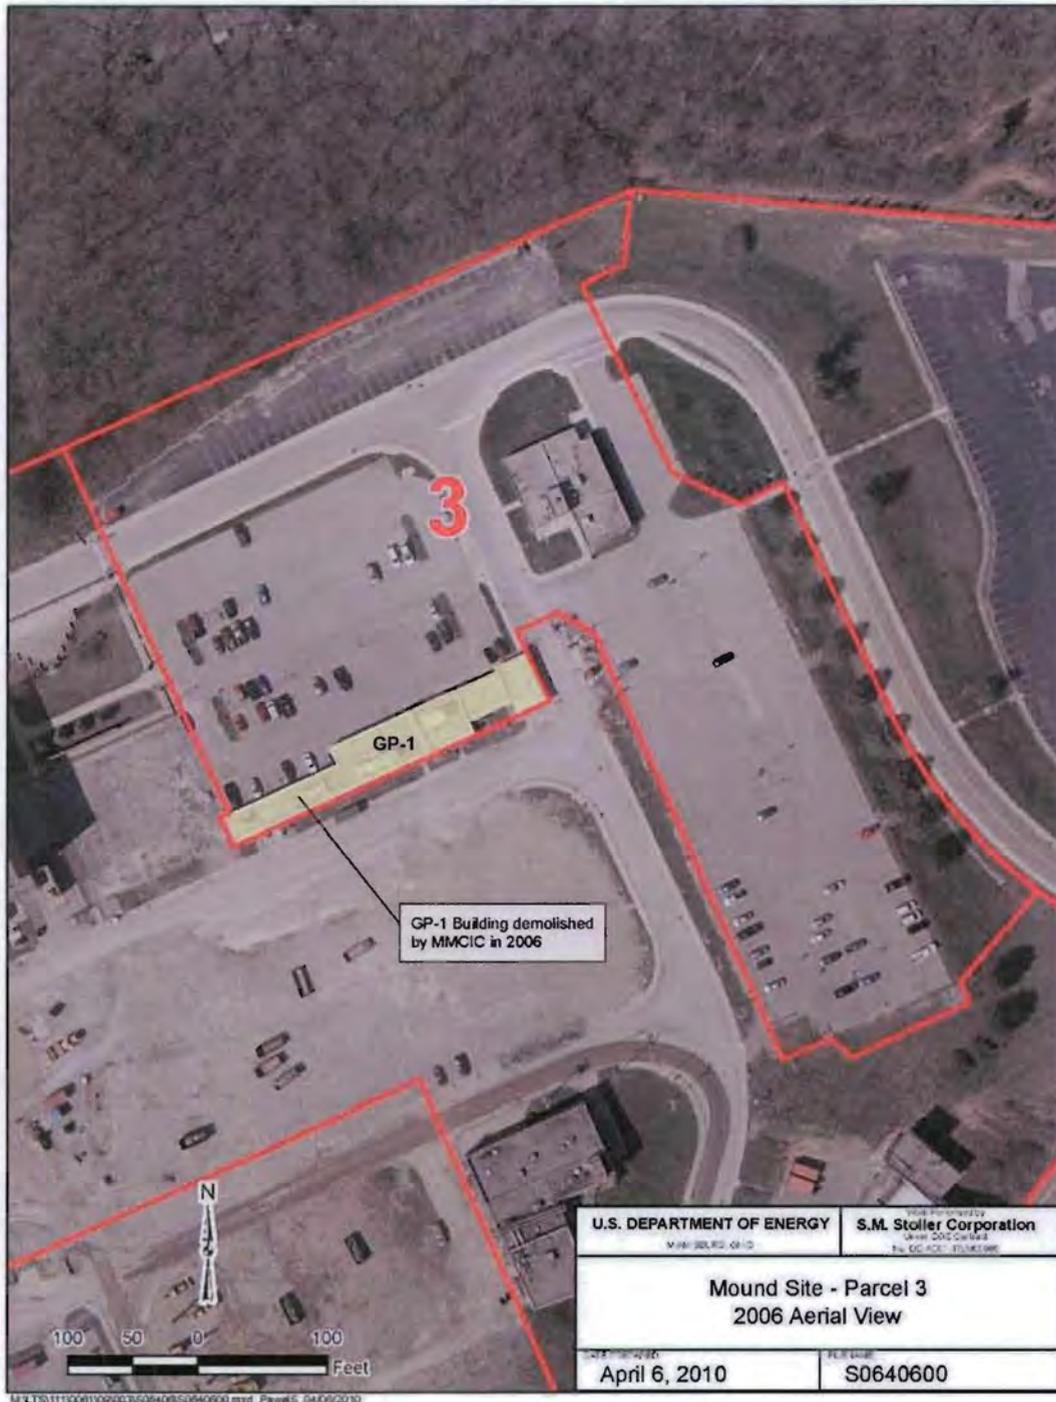
Figure 7. Parcel 3 2006 Aerial View

In Parcel 3 (Figure 7), there were no observations of noncompliance with the ICs. In particular, there was no evidence of unauthorized well installation or soil removal within the original boundaries of the DOE Mound Site Property. There are no groundwater monitoring wells in Parcel 3.

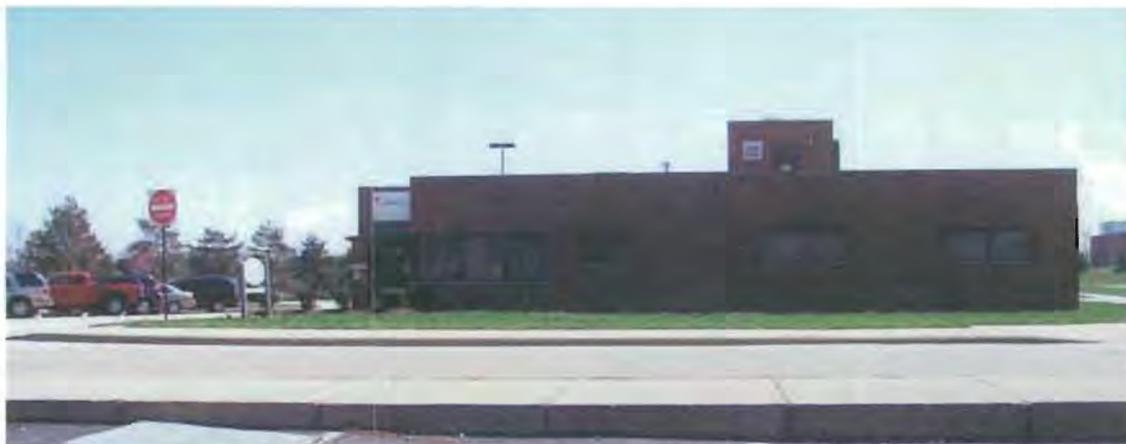
Figure 8 shows the Mound Museum Association building in Parcel 3. The building, formerly known as GH Building, is at 500 Vantage Point.

*Figure 8. Parcel 3 View from Parking Lot South toward Mound Museum Building*

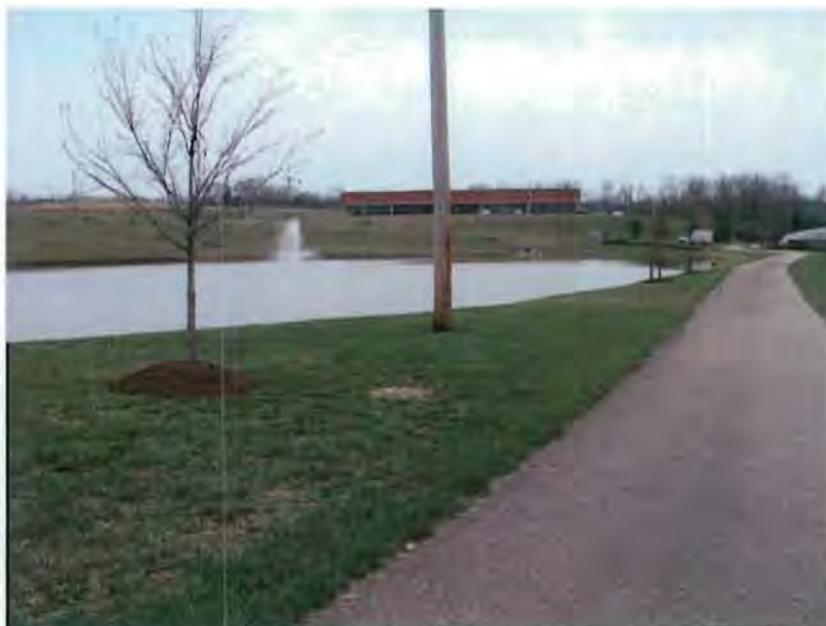
*Figure 11. Parcel 4 Retention Pond and Flex Building with Bike Path at Right*

There is a pond for retaining and detaining storm-water runoff in the southwest part of Parcel 4 (Figure 11). One sign, which states, "Recreational Use Prohibited," was observed. These signs were damaged and replaced before each of the 2008, 2009, and 2010 annual inspections.

Two of the three signs around pond in Parcel 4 were broken during preliminary inspections. MMCIC was notified. One sign was observed during the April 13, 2010, physical inspection.

Several signs near the pond were missing and were replaced before each of the IC walkdowns in 2008, 2009, and 2010.

Number	Issue/Recommendation	Responsible
1	Improve marking labels at seeps.	Stoller
2	Paint Well 0124 in old canal area.	Stoller
3	Remove water sampling station and fencing over Seep 0607, and return area to its original condition.	Stoller
4	Insure that that signs by pond in Parcel 4 are present at all times.	MMCIC

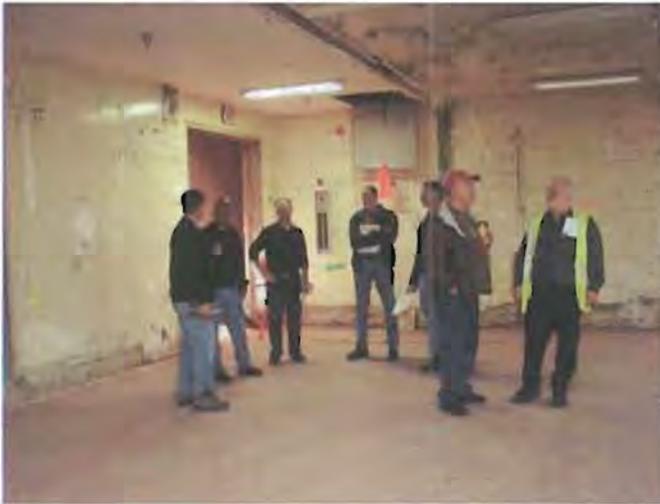
The physical inspection included property and buildings and the areas within T Building with special ICs (Figure 15, Figure 16, and Figure 17). These ICs prohibit penetration in some areas, and removal of concrete flooring in others, without prior approval by the regulators. Figure 18 indicates these areas. Photos of each room are included in Appendix D.

*Figure 15. Bob Ransbottom, Paul Lucas, Tim Fischer, Jeff Smith, Brian Nickel, Joe Crombie, and Art Kleinrath Inspecting T Building Red Concrete Area*

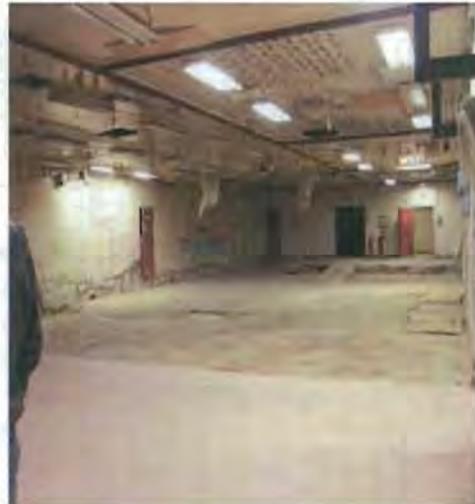
*Figure 16. Looking West Toward One of the T Building Areas Where Removal of Concrete Floor is Prohibited without Prior Approval*

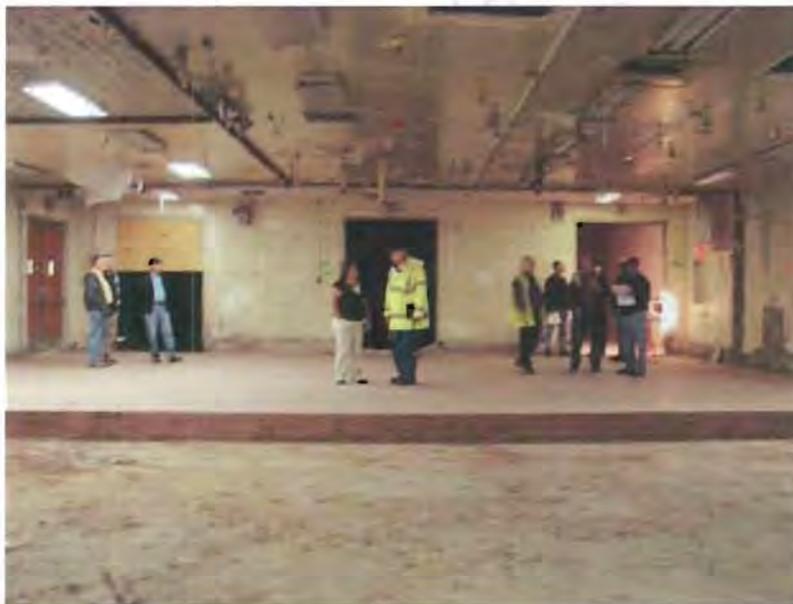
*Figure 17. Looking East Toward Inspection Participants Standing on T Building Red Concrete Where Penetration is Prohibited without Prior Approval*

The red concrete cap over one of the two areas in T Building was cracked in several places in the large bay area, former Room 44.

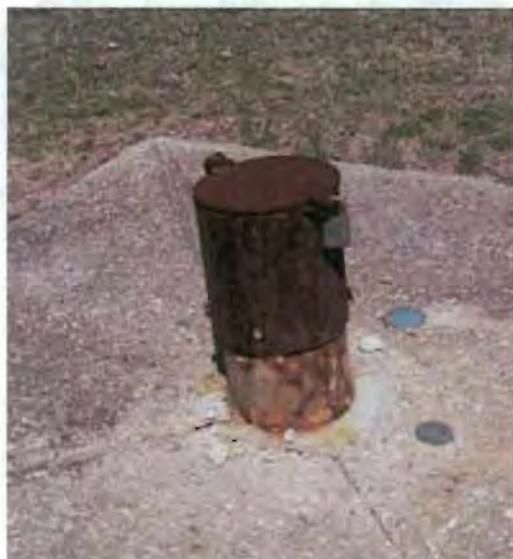
*Figure 20. Well 0124.*

Several things were observed during the physical inspection of Parcel 6, 7, and 8 wells and seeps. First, Well 0124 was rusty and needed painting (Figure 20). Second, the seeps were marked with unsubstantial pink plastic flags with faded numbers (Figure 21). It is recommended that a sturdier marker be used.

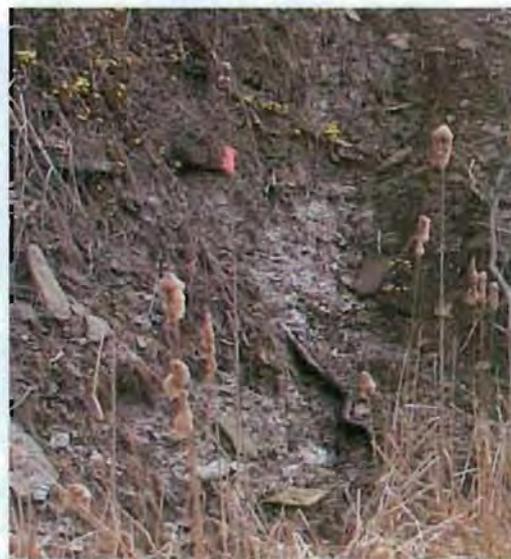
*Figure 21. Pink Plastic Marker at Seep 0608*

Seeps were marked with plastic flags, and some markings were illegible. Seep 0606 had no flag and was located with GPS. The GPS coordinates for Seep 0607 were found to be incorrect in the DOE well database.

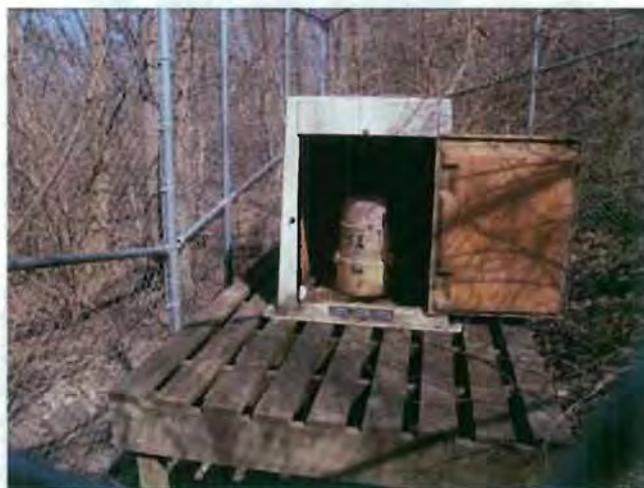
*Figure 22. Old Sampler over Seep 0607 (No Longer in Use)*

Third, the old sampler over Seep 0607 was no longer functional (Figure 22). It is recommended that the sampler and the surrounding fencing be removed and the area be returned to its original state.

Remove water sampling station and fencing over Seep 0607 and return area to its original condition.

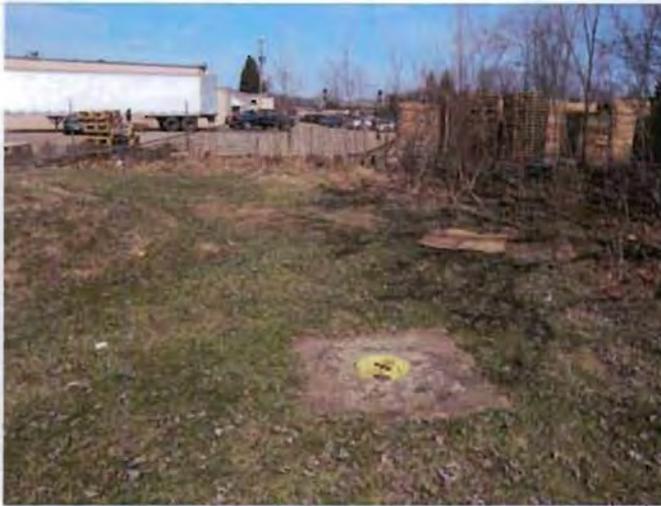
*Figure 23. Well 0118, Off Site*

Photos of wells and seeps are shown in Figure 23 to Figure 40. All were locked and in good condition.

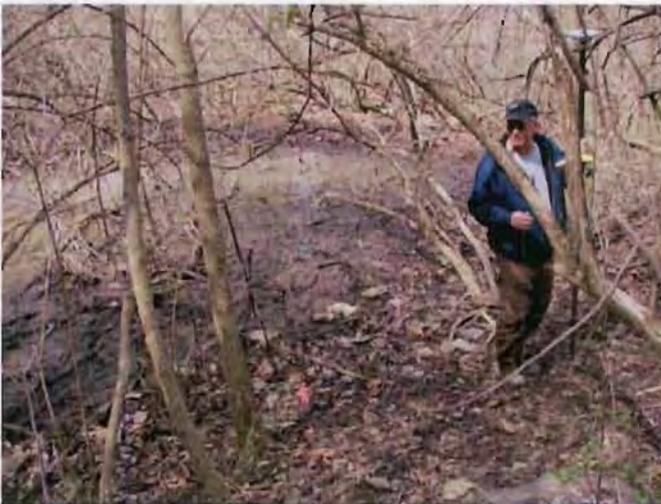
*Figure 37. Roy Mowen Verifying GPS Location at Off-Site Seep 0605*

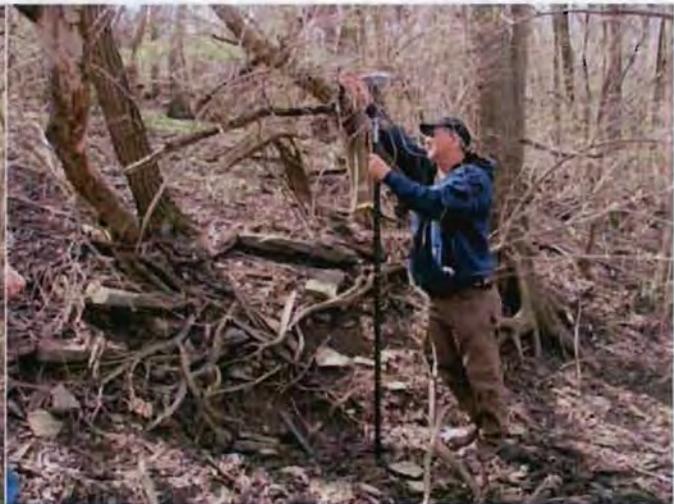
*Figure 38. Roy Mowen Verifying GPS Location at Off-Site Seep 0606*

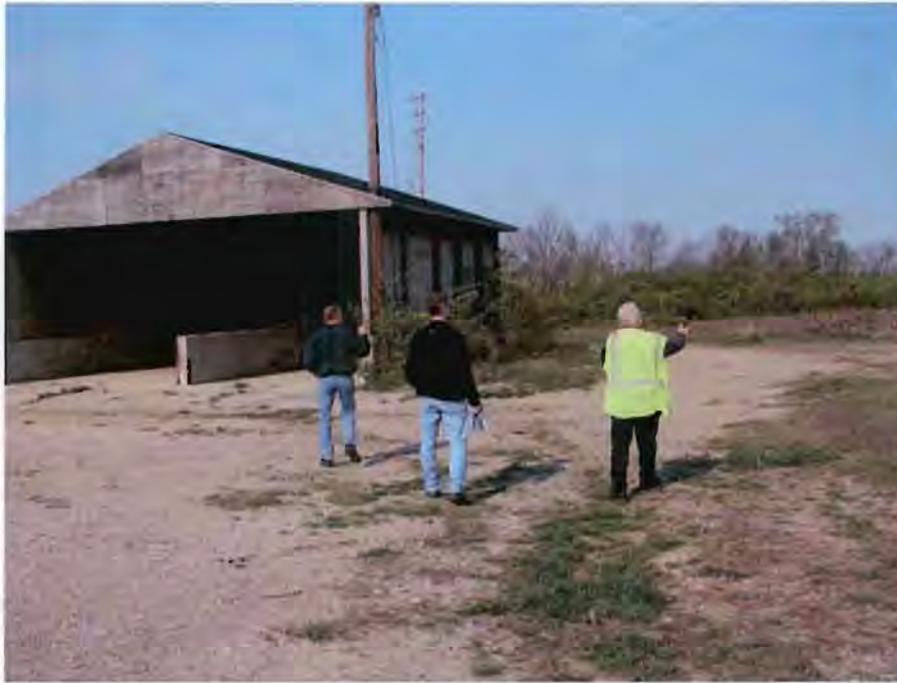
The salt storage shed shown in Figure 55 and the concrete pad in Parcel IB remain empty.

Figure 55. Jeff Smith and Brian Nickel, OEPA, and Art Kleinrath, LM, at the Phase IB Empty Salt Storage Shed

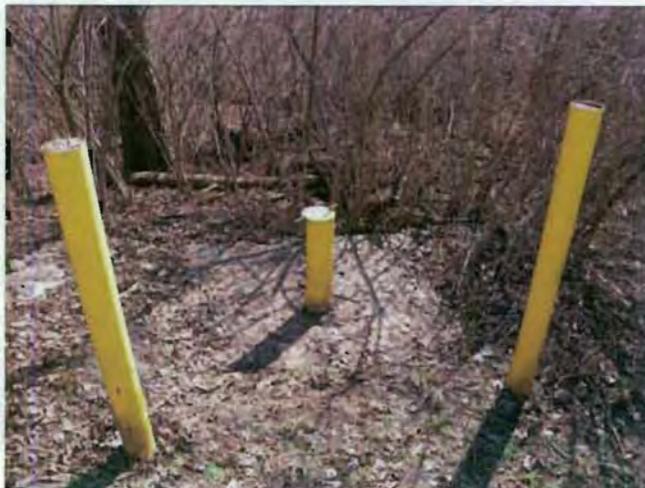
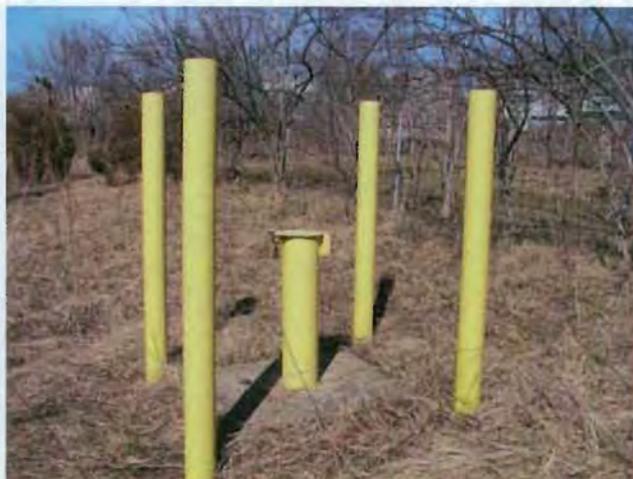
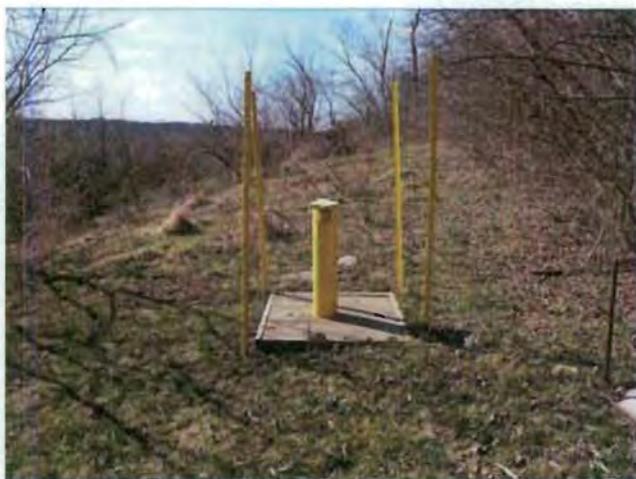
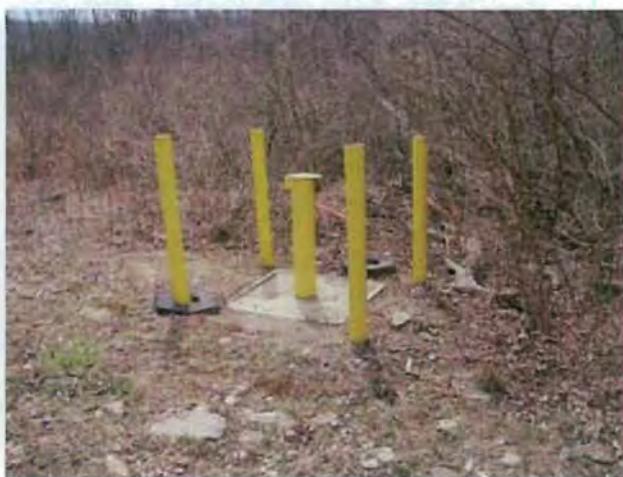
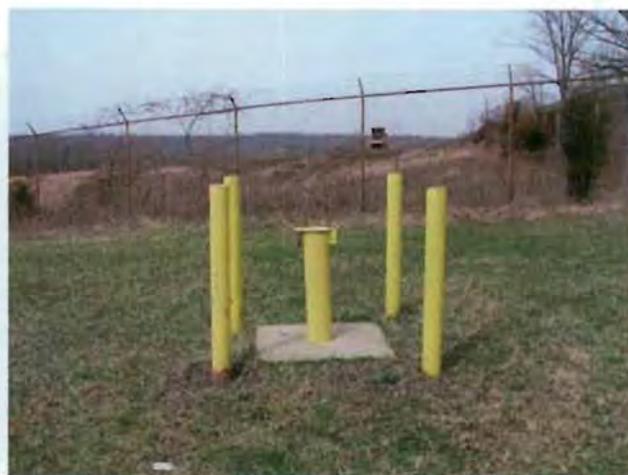
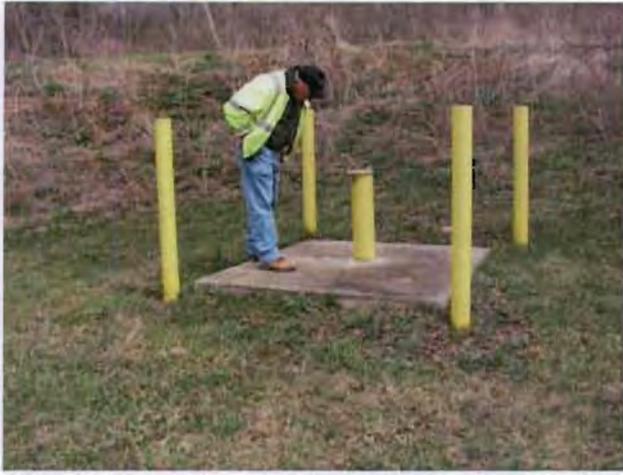
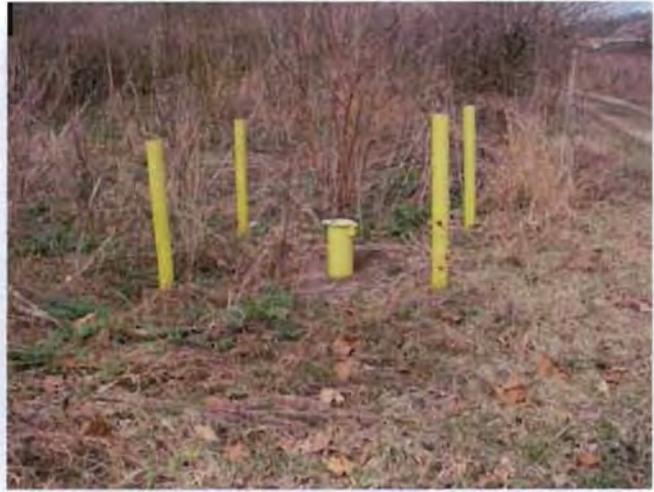
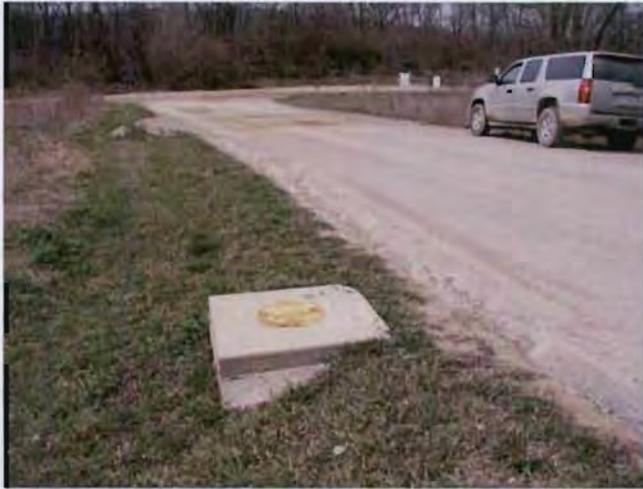
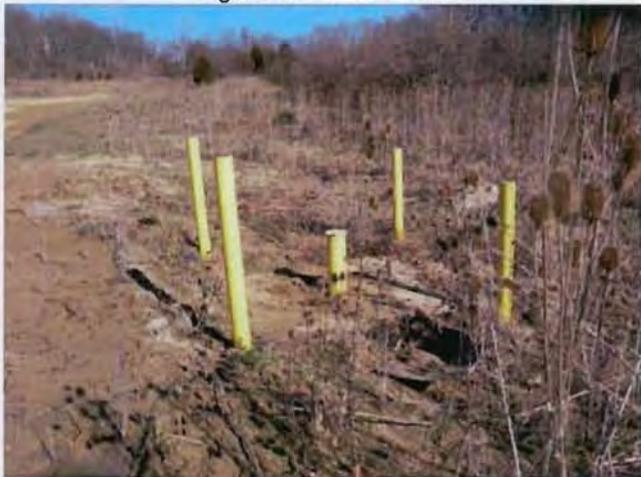
Figure 57 through Figure 67 are photos of the wells and seep. All wells were locked, had permanent markers, and were in good condition.

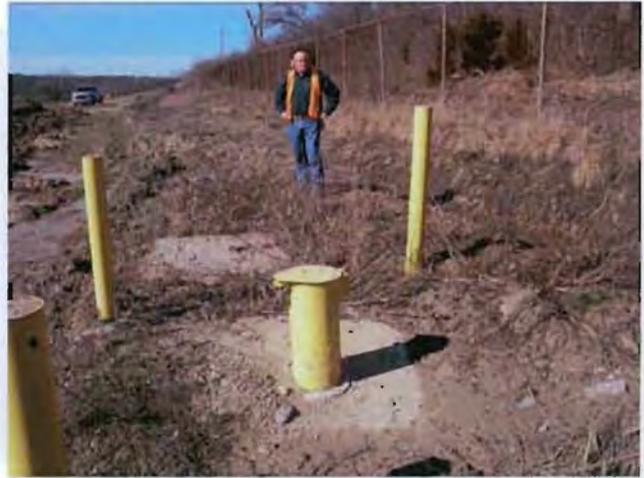
Figure 66. Well 0353, Which Still Has Drainage Problems
