U.S. Department of Energy
Office of Legacy Management
ATTN: Arthur W. Kleinrath
2597 Legacy Way
Grand Junction, CO 81503SUBJECT: Contract No. DE-AM01-07LM00060, S. M. Stoller Corporation (Stoller)
Annual Assessment of the Effectiveness of Site-Wide Institutional Controls
Applied to the Former DOE Mound Site Property, June 2011

Enclosed are fifteen copies of the final report, "Annual Assessment of the Effectiveness of Site-Wide Institutional Controls Applied to the Former Mound Site Property, June 2011."

Subject: Annual Assessment of the Effectiveness of Site Wide Institutional Controls Applied to the Former DOE Mound Site Property, June 2010

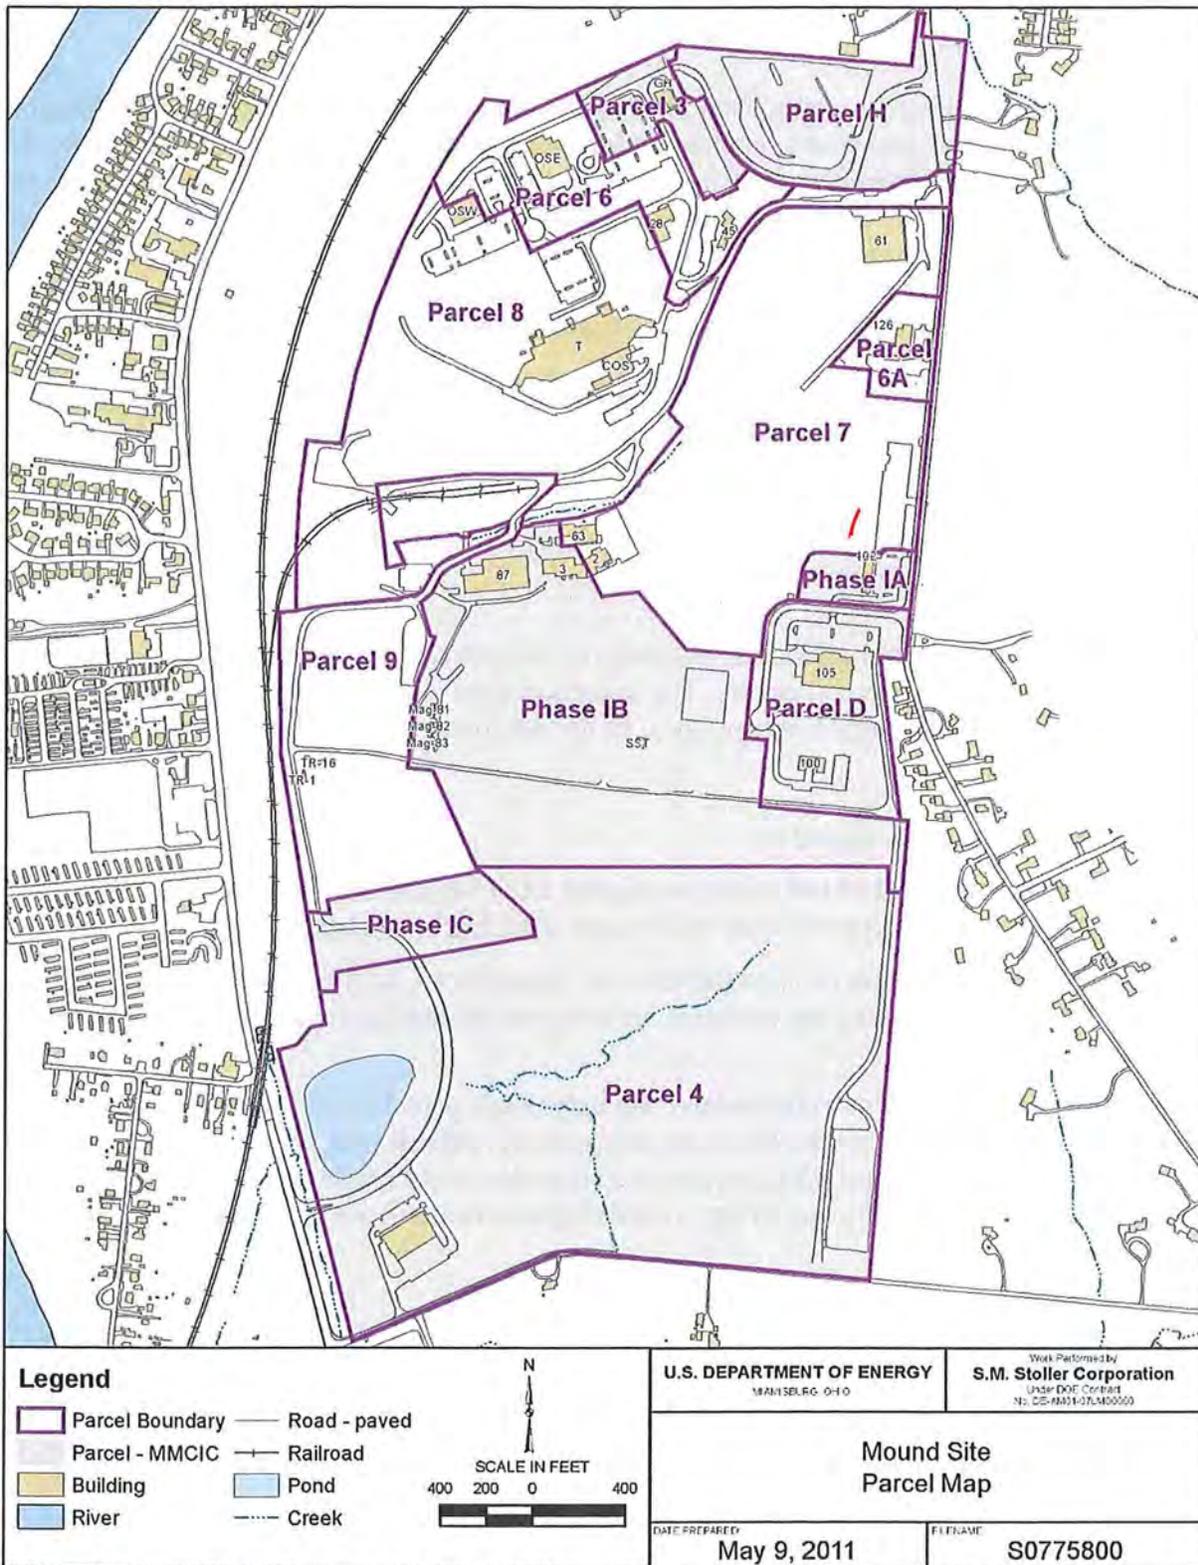
Figure 1. Parcel Map of the Former DOE Mound Site Property, Miamisburg, Ohio

Figure 1 shows the original boundaries of the former DOE Mound Site Property divided into parcels. The shaded areas show the parcels that have been transferred to MDC.

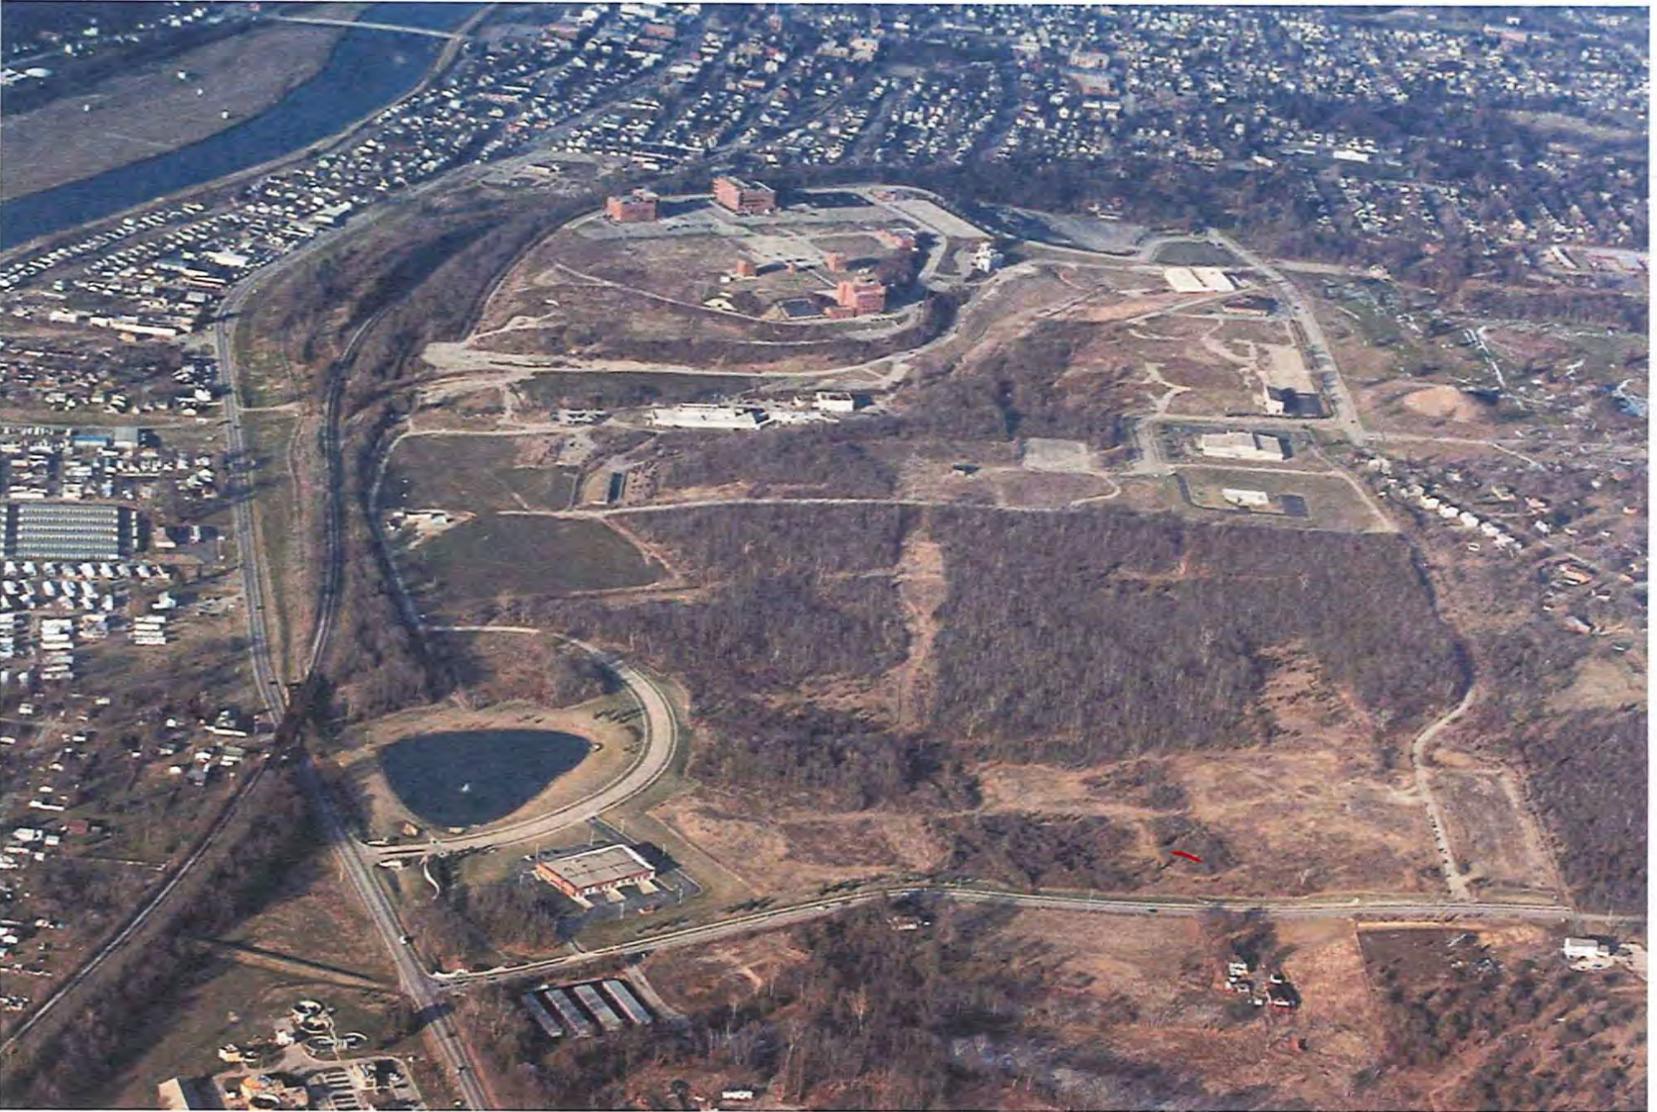
Figure 2. March 2011 photo of Mound Site from the south

Figure 2 is a photo taken in March 2011 that shows the entire site from the south.

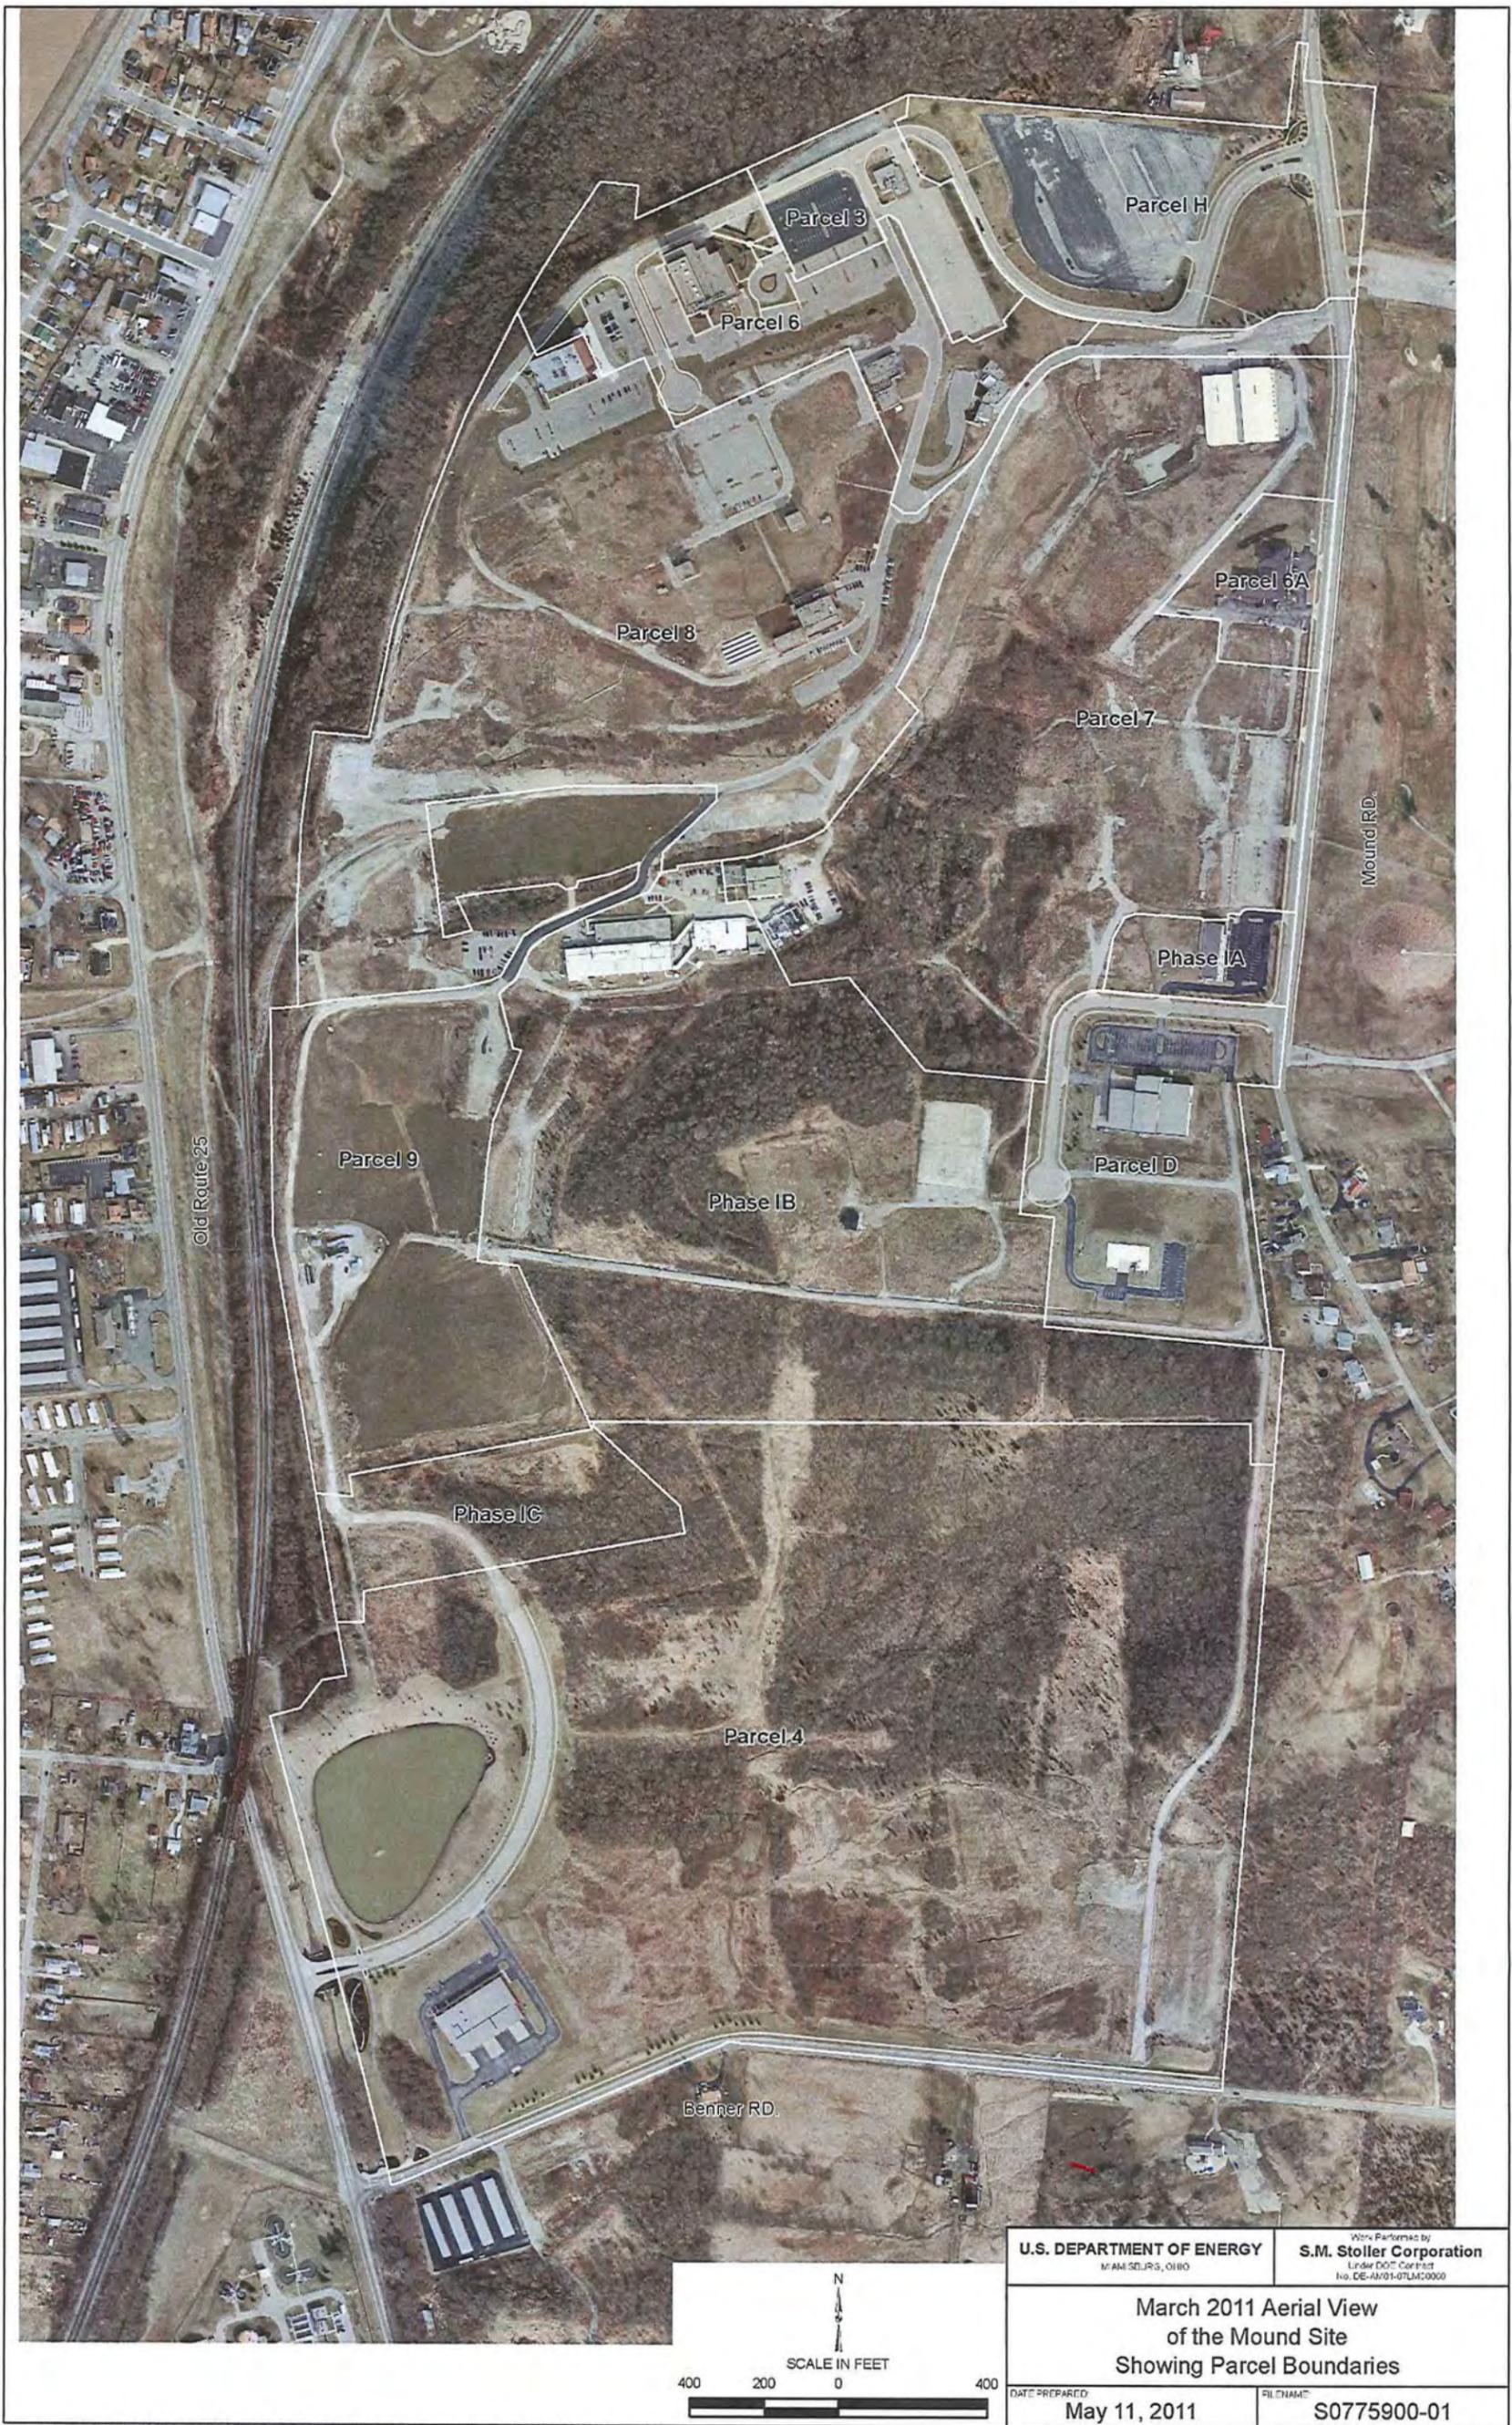
Figure 3. March 2011 Aerial View of Mound Plant Showing Parcel Boundaries

Figure 3 shows the parcel boundaries laid over a March 2011 aerial photograph of the Mound Site. The actual photographs were taken at a low altitude, using a nominal negative scale of 1:4800, and were developed using 1"=100' scale planimetric mapping (the scale sizes of figures in this assessment vary). Photographic-controls points were Horizontal Datum: NAD83, Vertical Datum: NAVD88, U.S. Survey Feet, and State Plane – Ohio South Zone.

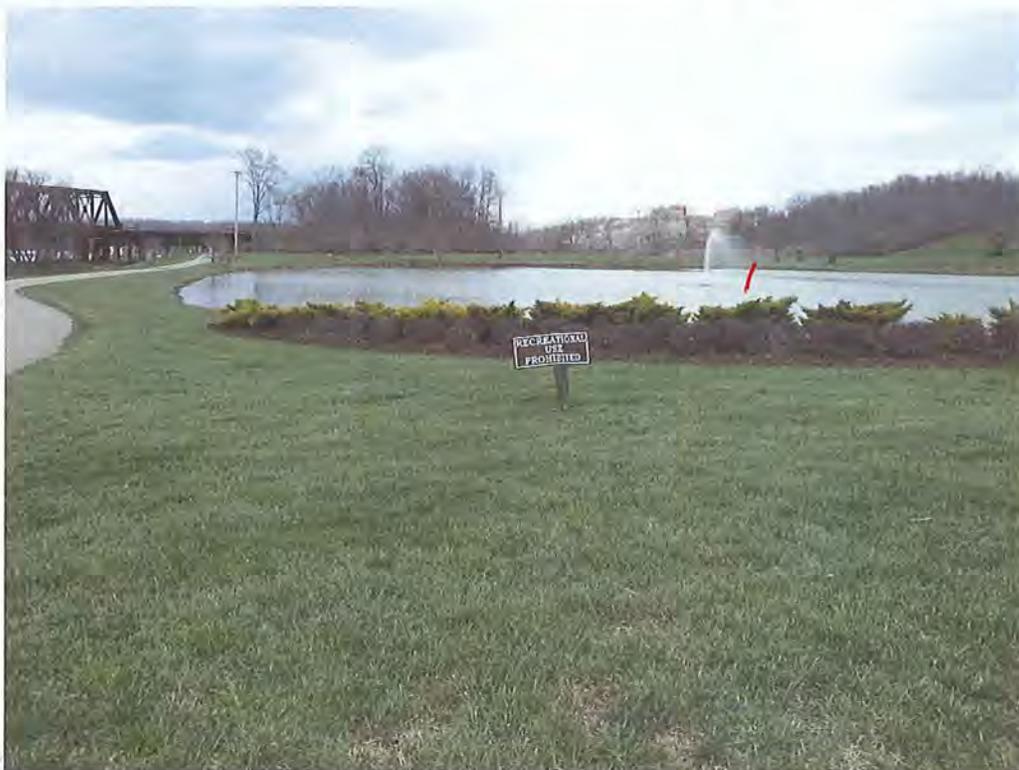
Figure 6. Parcel 4 sign at retention pond, with bike path at left

One sign, which states, "Recreational Use Prohibited," was observed at the pond used for retaining and detaining storm-water runoff in the southwest part of Parcel 4 (Figure 6).

The second five-year review for the DOE Mound site recommended that the issue of adequate signage around the Parcel 4 retention basin be addressed by DOE, EPA, and OEPA. Signs placed around the basin to inform area visitors that recreational use around the basin is prohibited have been damaged and removed on several occasions by members of the public.

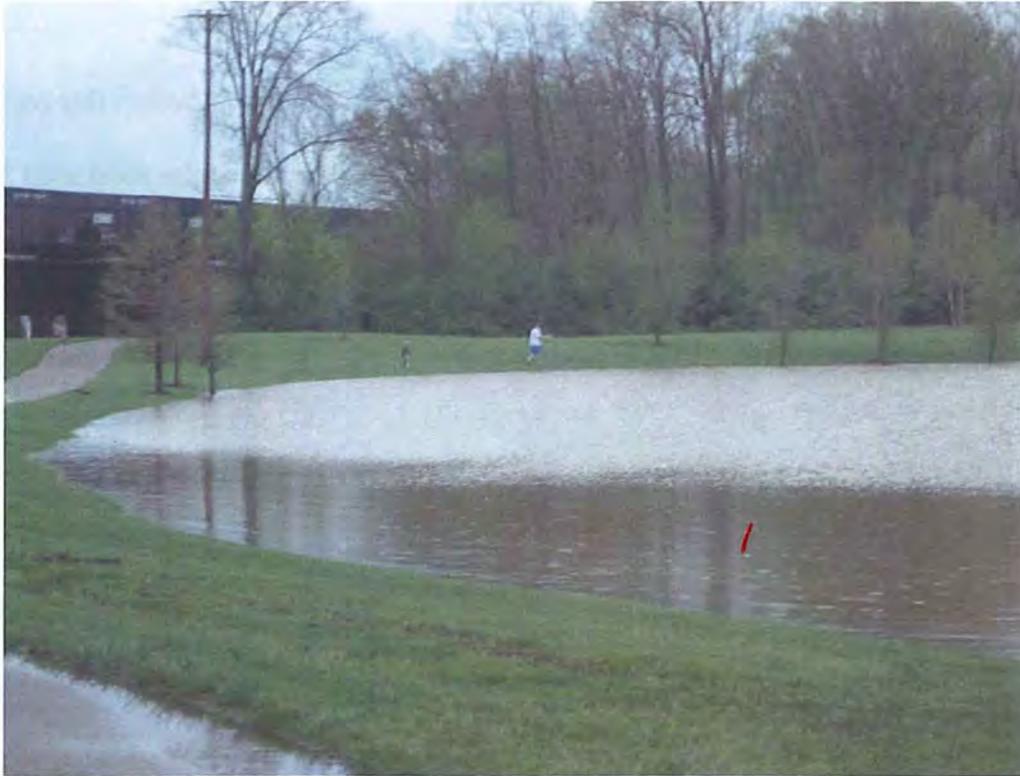
Figure 7. Fishermen observed at pond in Parcel 4 on April 25, 2011

On April 25, 2011, Stoller personnel observed two individuals fishing at the pond and reported that information to EM. Paul Lucas of EMCBC and Bob Ransbottom of Stoller approached the fishermen and advised them that fishing was not permitted. They also advised them that the site is cleared for industrial reuse, but not for recreational use.

After reconsidering the exposure assumptions that were used to develop the industrial/commercial cleanup standards for the Mound site, DOE, EPA, and OEPA have reached the conclusion that occasional visits to the retention pond by area residents will not result in an unacceptable risk to the visitors. Even so, DOE and the Mound Development Corporation will continue to monitor and discourage these unauthorized uses of the Parcel 4 retention basin area. No further action is required to assure protectiveness of human health or the environment.

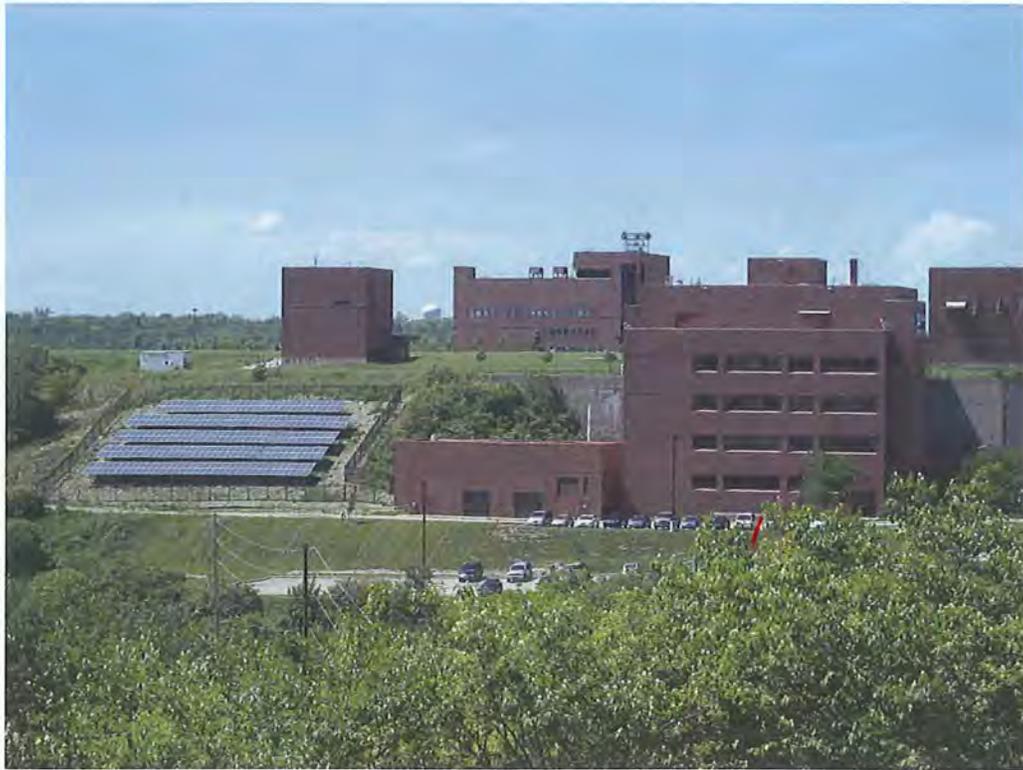
Figure 8. Solar array west of COS Building

The solar array shown in Figure 8 was installed west of COS Building. This work was covered by City of Miamisburg permits and was overseen by MDC.

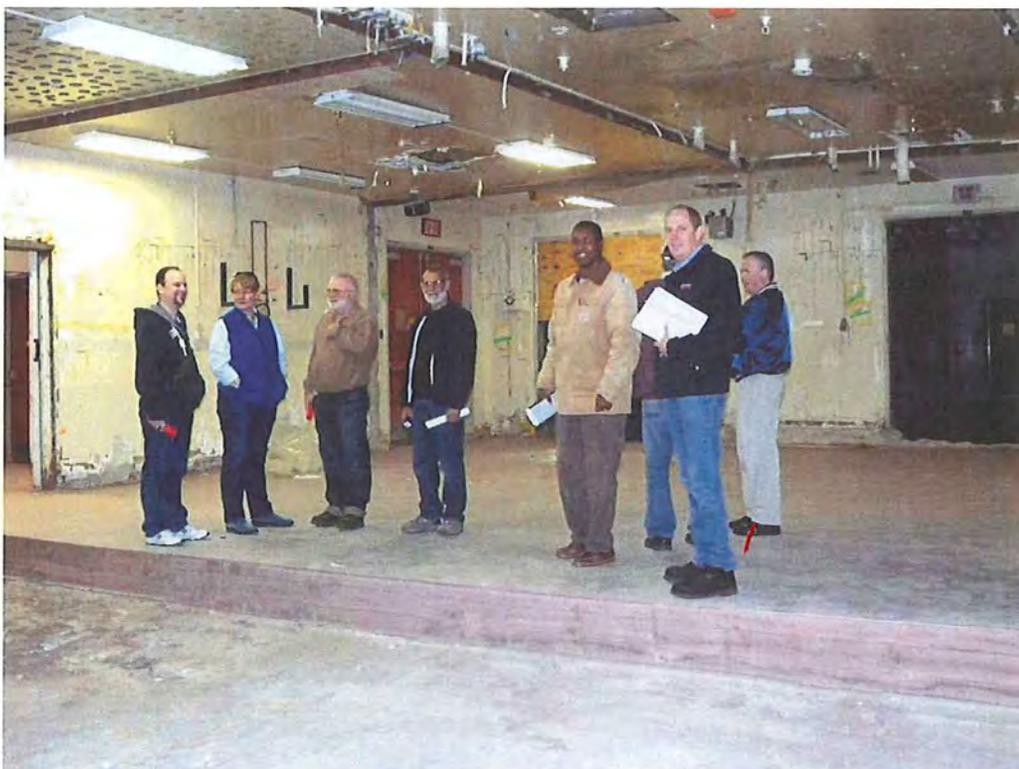
Figure 9 and Figure 10 are photos taken during the April 12 physical inspection of the building. There are cracks across the red concrete, but these are not of concern to the Core Team at this time. The Figure 11 drawing of the 1st floor of T Building identifies the special IC areas with crosshatching.

Figure 9. Tim Fischer, Jane Powell, Art Kleinrath, Ken Karp, Anthony Campbell, Jeff Smith, and Frank Bullock inspecting T Building Red Concrete Area where penetration is prohibited without prior approval

The red concrete cap over one of the two areas in T Building was cracked in several places.

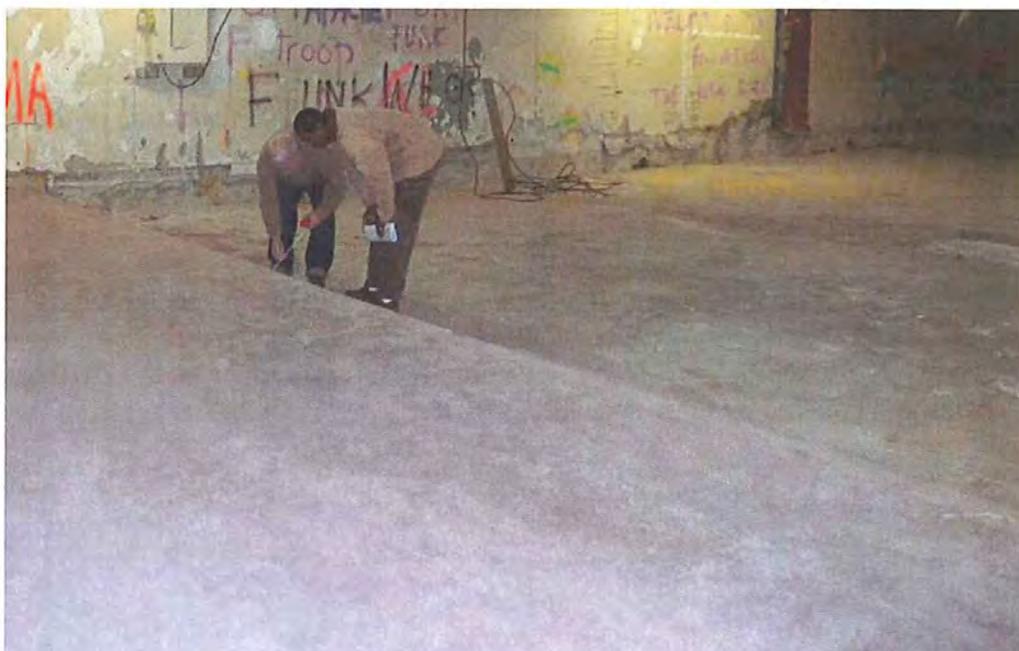
Figure 10. Art Kleinrath and Anthony Campbell examine edge of red concrete slab in T Building areas where penetration of concrete floor is prohibited without prior approval

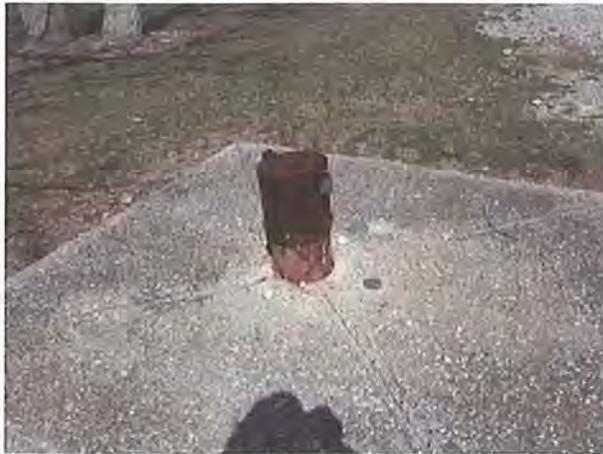
All of the Parcel 6, 7, and 8 wells were locked and in good condition. Well 0124, which was rusty and needed painting last year (Figure 12), was painted and locked in 2011 (Figure 13).

Figure 12. Well 0124 offsite condition during 2010 IC assessment

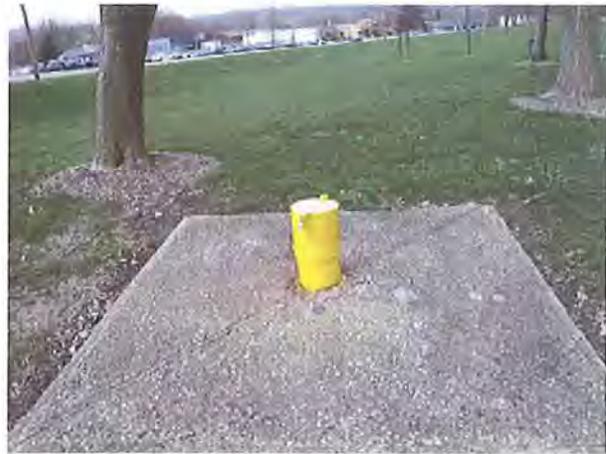
Figure 13. Well 0124 offsite condition during 2011 IC assessment

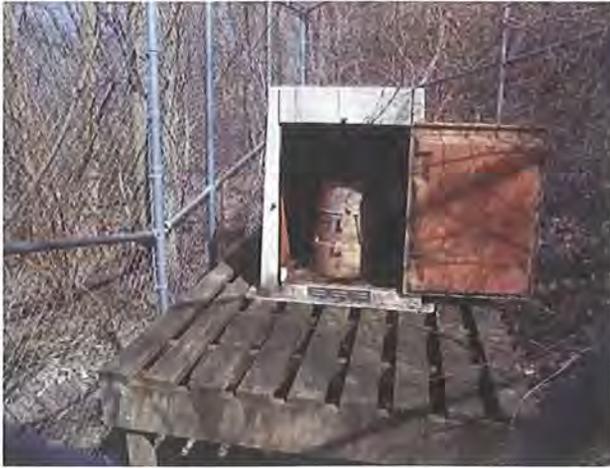
It was observed in 2010 that the old tritium sampler over Seep 0607 was no longer required or functional (Figure 14). This sampler and the surrounding fence were removed, and the area was returned to its original state (Figure 15).

Figure 14. Unused tritium sampler and fencing at Seep 0607 in 2010

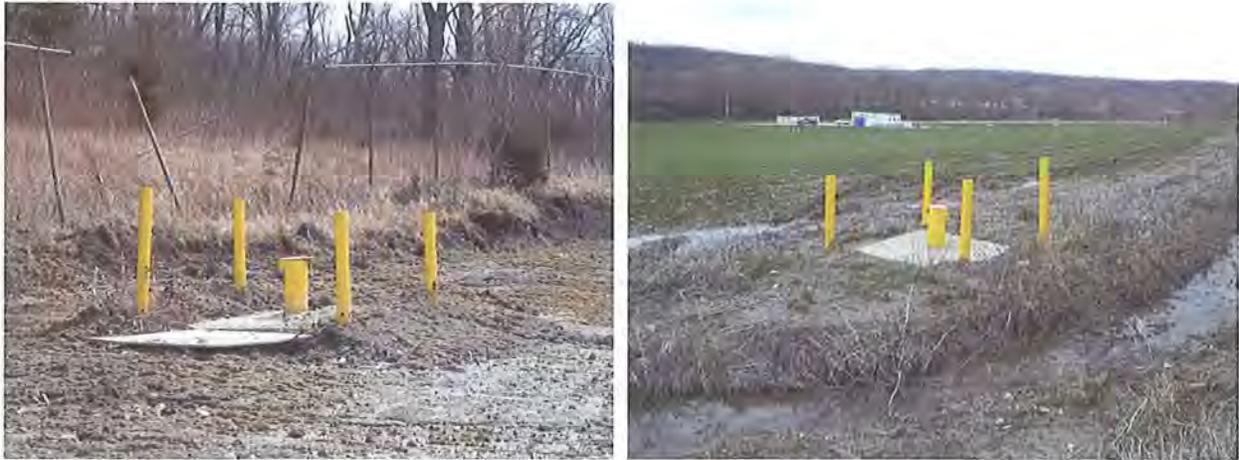
One outstanding recommendation from the 2009 annual assessment was to improve the drainage around well 0353. This was completed after the excavation at OU-1, as shown in Figure 16.

Figure 16. Well 0353 in 2009, with drainage problems, and in 2011, with water diverted away from well

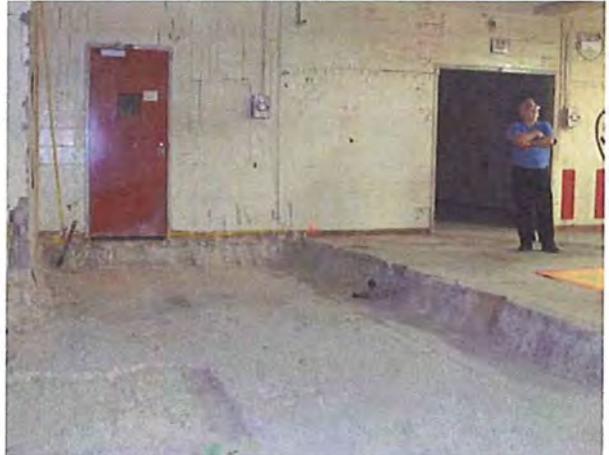
T Bldg. Rooms 39-44, 48-50 View F

The photos in this appendix show the baseline conditions of the rooms in April 2010. No changes have occurred since those photos were taken last year.

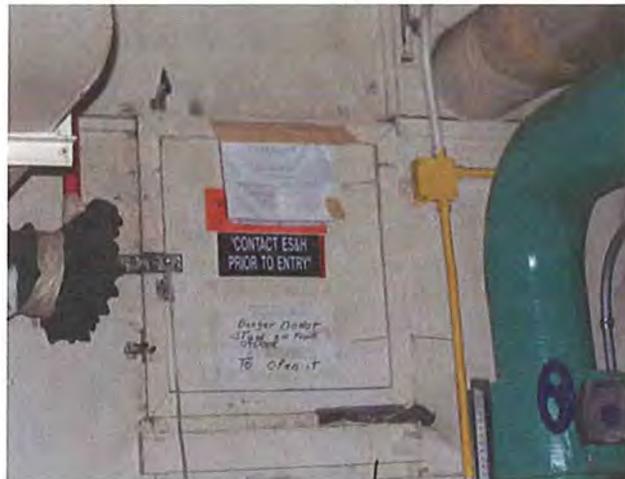
T Bldg. Room 99 - Access door to airshaft with special ICs leading to west head house

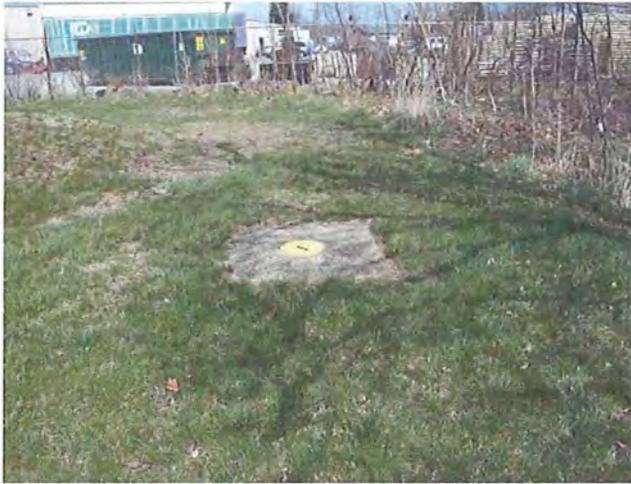
Well 0118, Off Site

Table 1 and Figure 1 show the Parcel 6, 7, and 8 groundwater monitoring wells and seep locations. Table 2 contains photos of all wells and seeps. All of the Parcel 6, 7, and 8 wells were locked and in good condition.

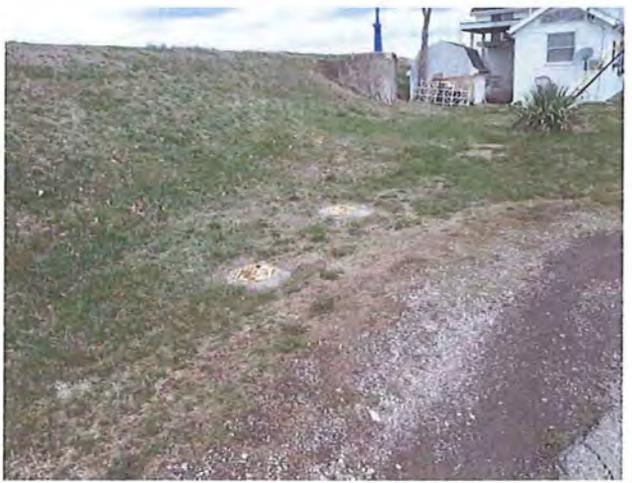
Wells 0333 and 0334, Off Site (removed from active monitoring program in 2009)

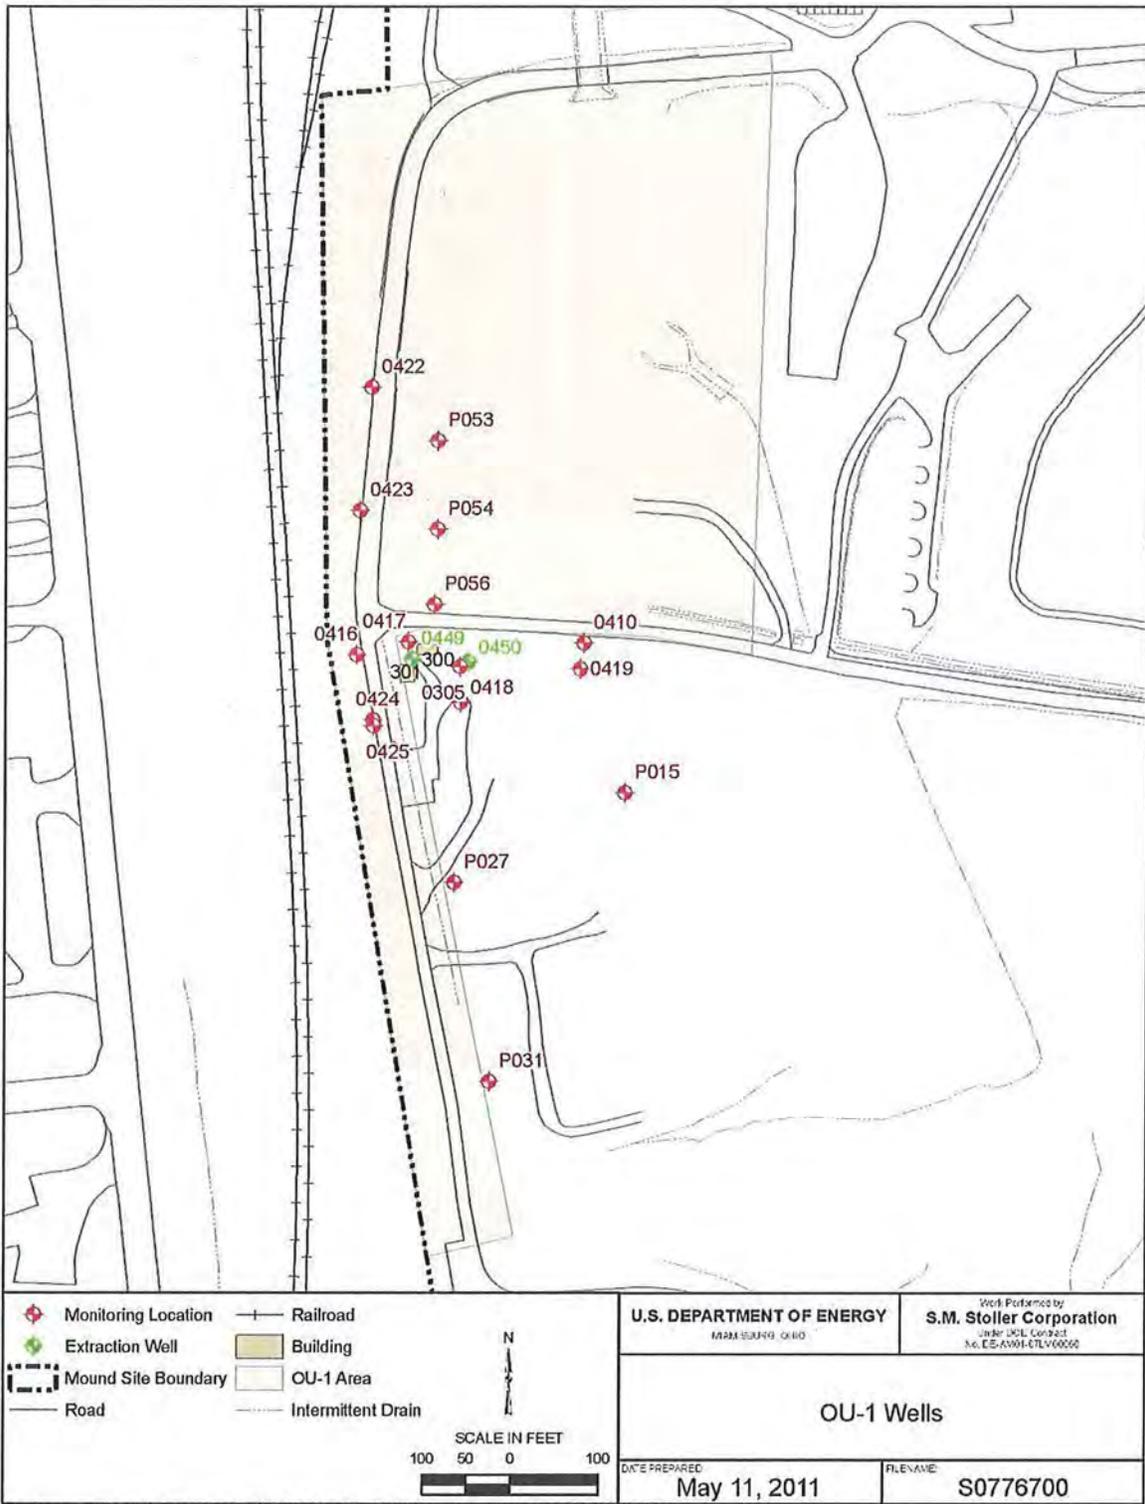
Figure 2. OU-1 wells

Table 3 and Figure 2 list and show the locations of the OU-1 monitoring wells. Table 4 contains photos of all wells. All wells were locked and in good condition.

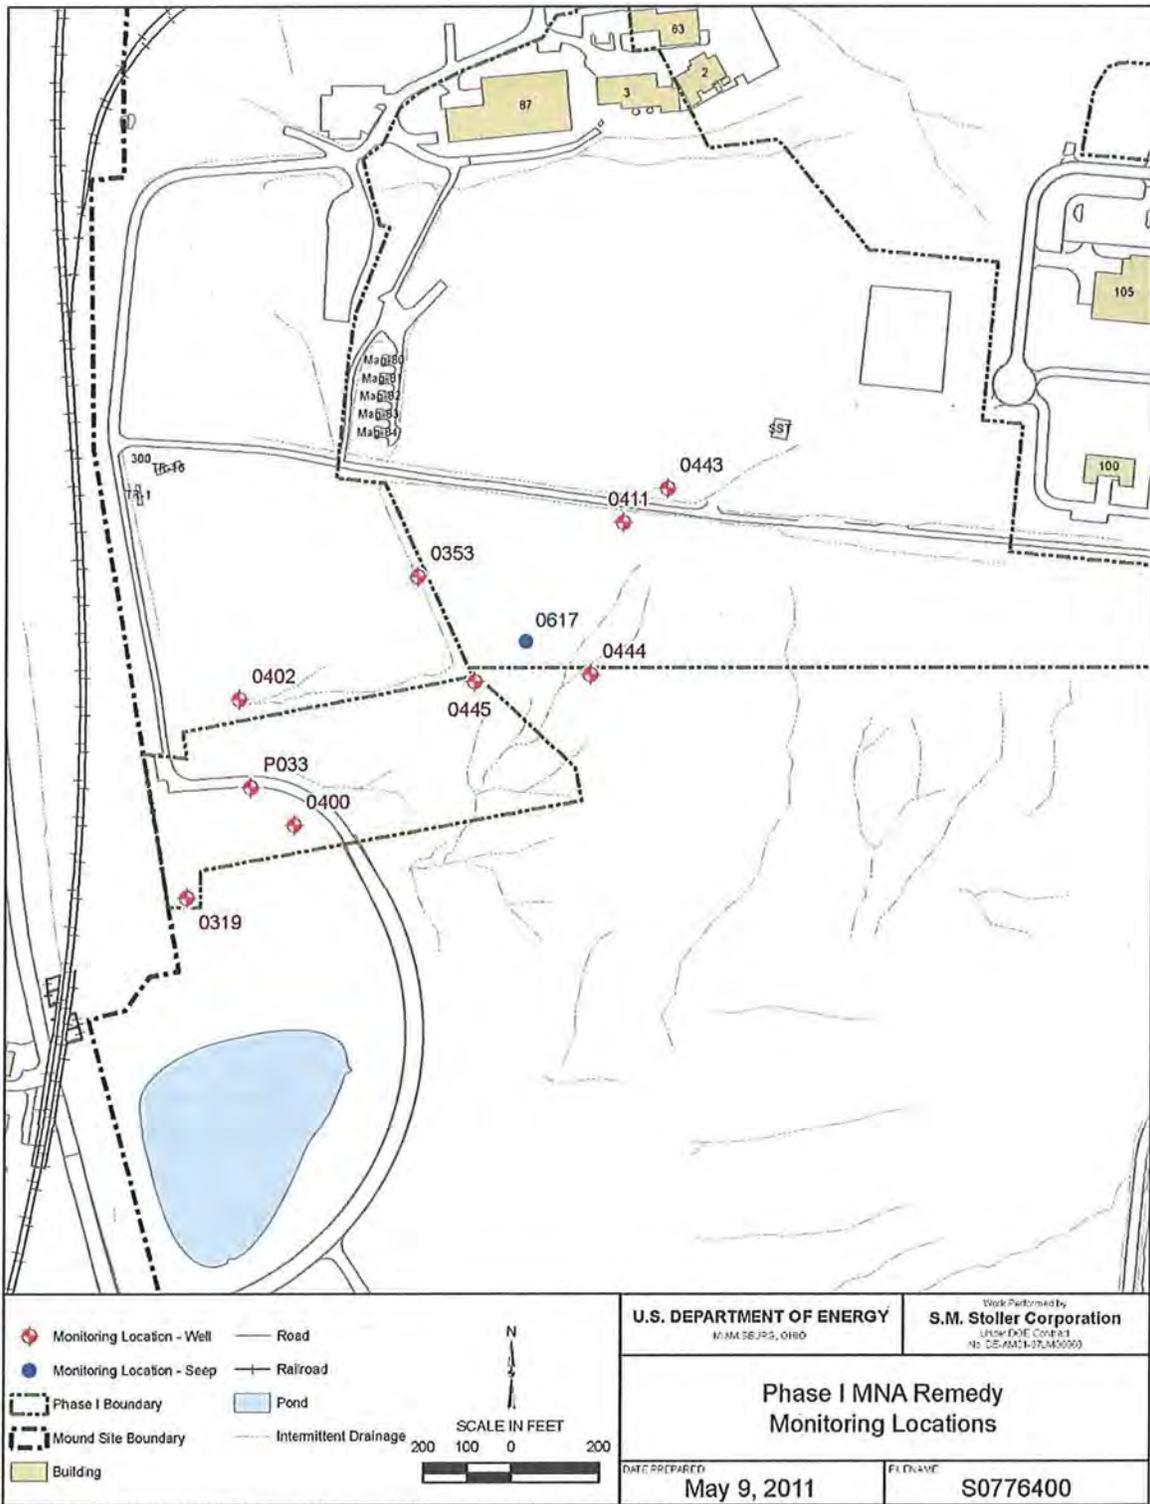
Figure 3. Phase I MNA Remedy Monitoring Well Location

All wells were locked, had permanent markers, and were in good condition.

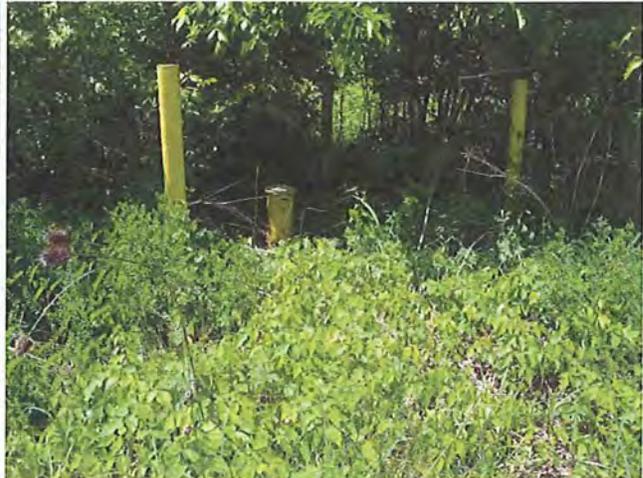
Well 0319 (inactive)
