Miamisburg Closure Project Potential Release Site Package

PRS 269

PRS 269: Building 36 Historic Gasoline Tanks

**Miamisburg Closure Project
Potential Release Site Package
PRS 269
Addendum 1**

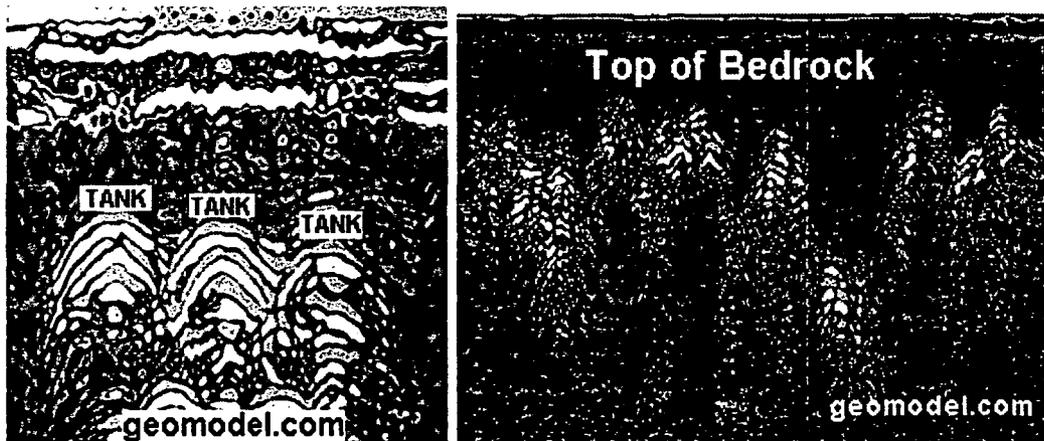
Three Buried Tanks and Irregular Bedrock Topography

When the transmitted signal enters the ground, it contacts objects or subsurface strata with different electrical conductivities and dielectric constants. Part of the ground penetrating radar waves reflect off of the object or interface; while the rest of the waves pass through to the next interface.

The reflected signals return to the antenna, pass through the antenna, and are received by the digital control unit. The control unit registers the reflections against two-way travel time in nanoseconds and then amplifies the signals. The output signal voltage peaks are plotted on the ground penetrating radar profile as different color bands by the digital control unit.

For each reflected wave, the radar signal changes polarity twice. These polarity changes produce three bands on the radar profile for each interface contacted by the radar wave.

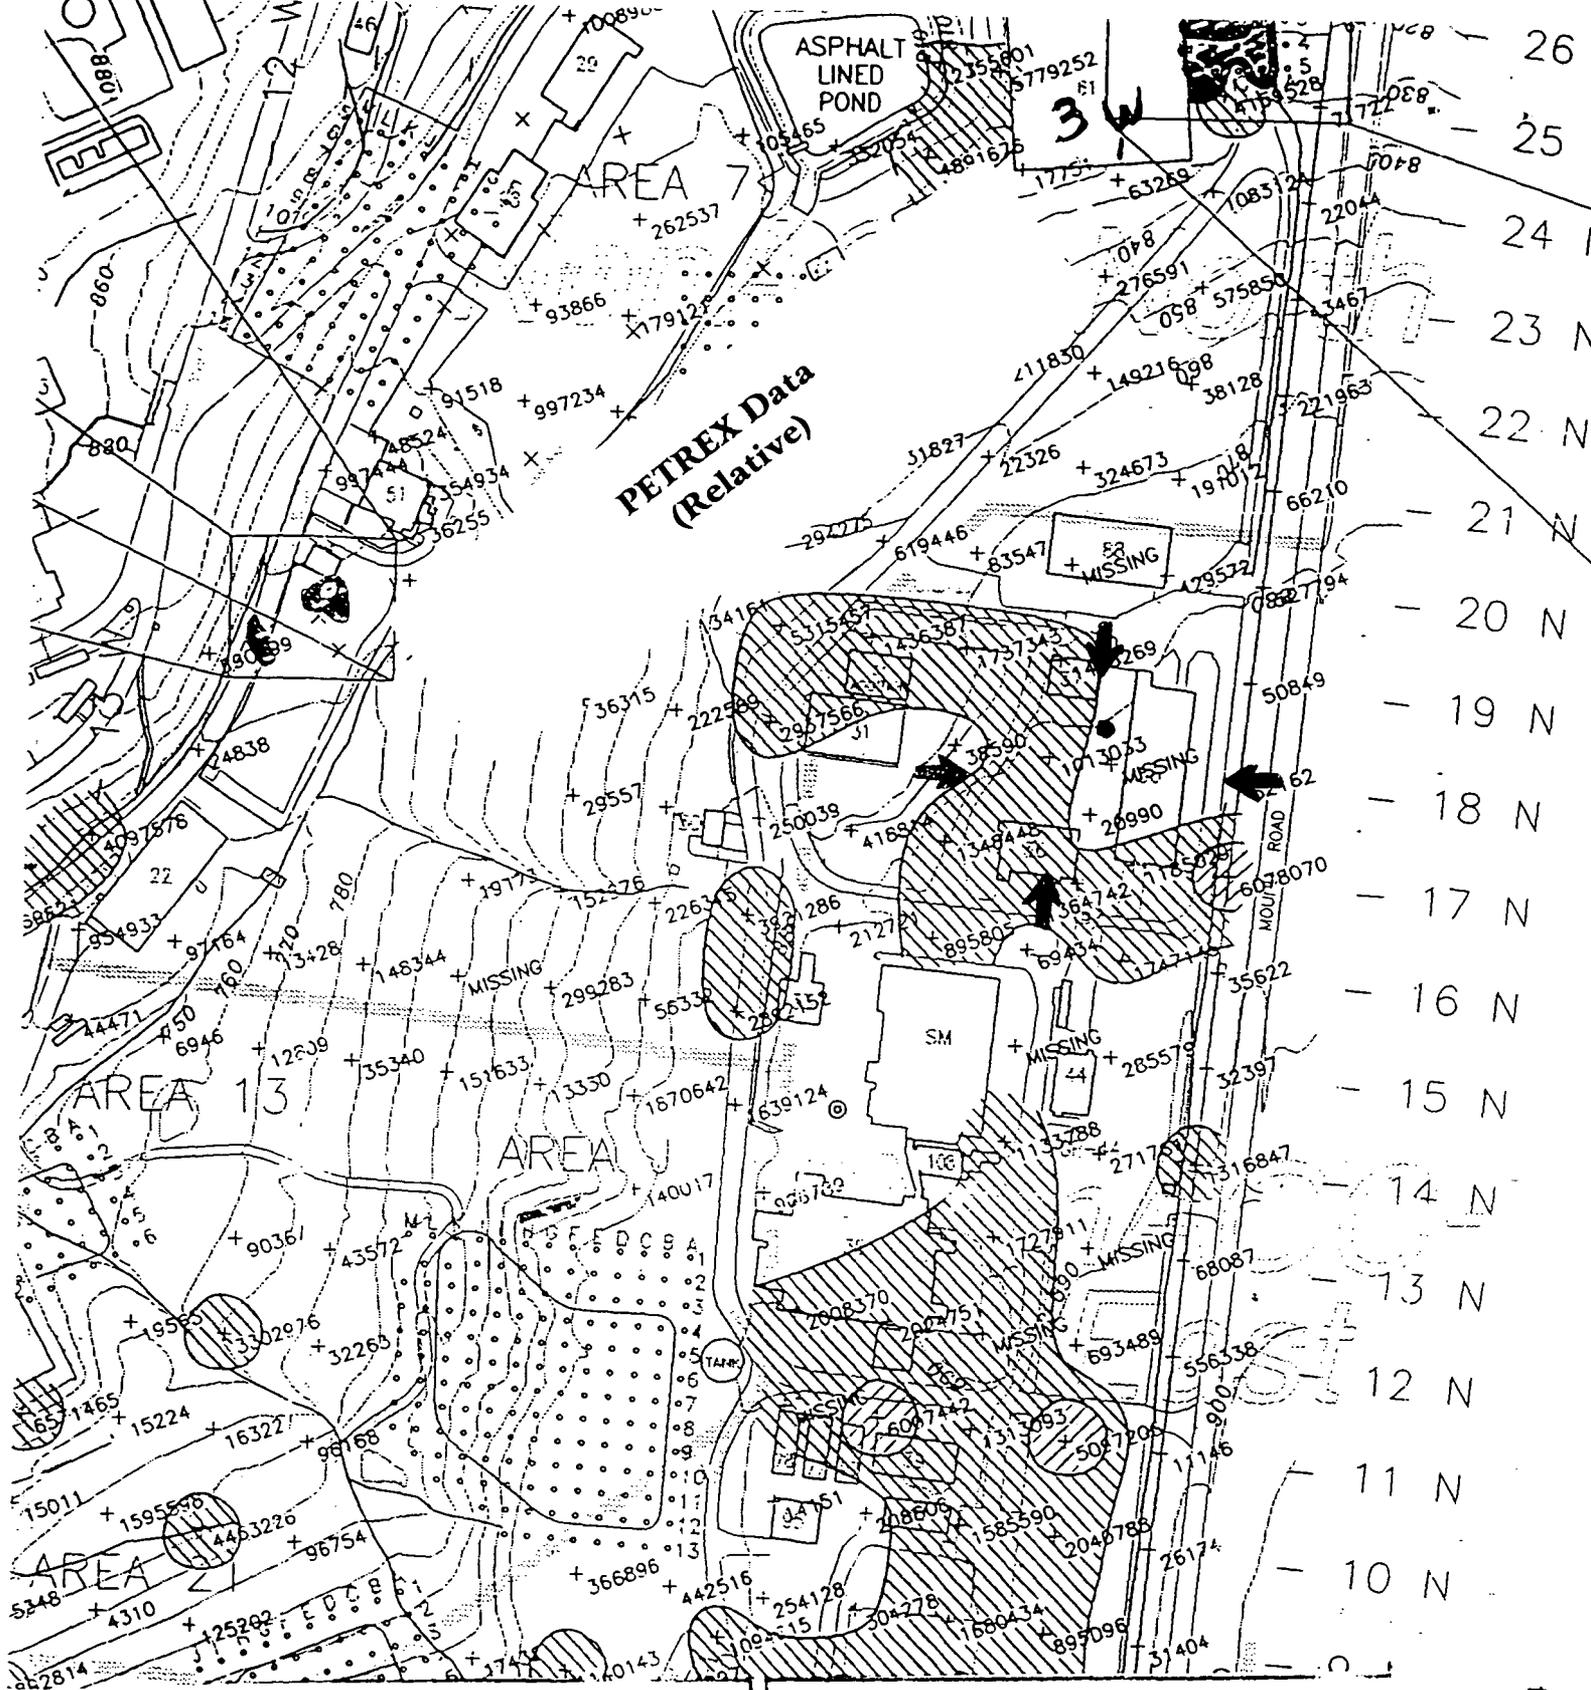
Plate 2

A passive soil gas survey, in 1994, indicated that PRS 269 is on the margin of an area that exhibits relatively high total aromatic hydrocarbons (1,013,033 ion counts) and total petroleum hydrocarbons (2,927,024 ion counts); low semivolatile hydrocarbons (3942 ion counts). No halogenated hydrocarbons were detected.³

- + PETREX Sample Location
- ND Not Detected
- T Denotes interference by terpenes; see text.

Total Aromatic Hydrocarbons

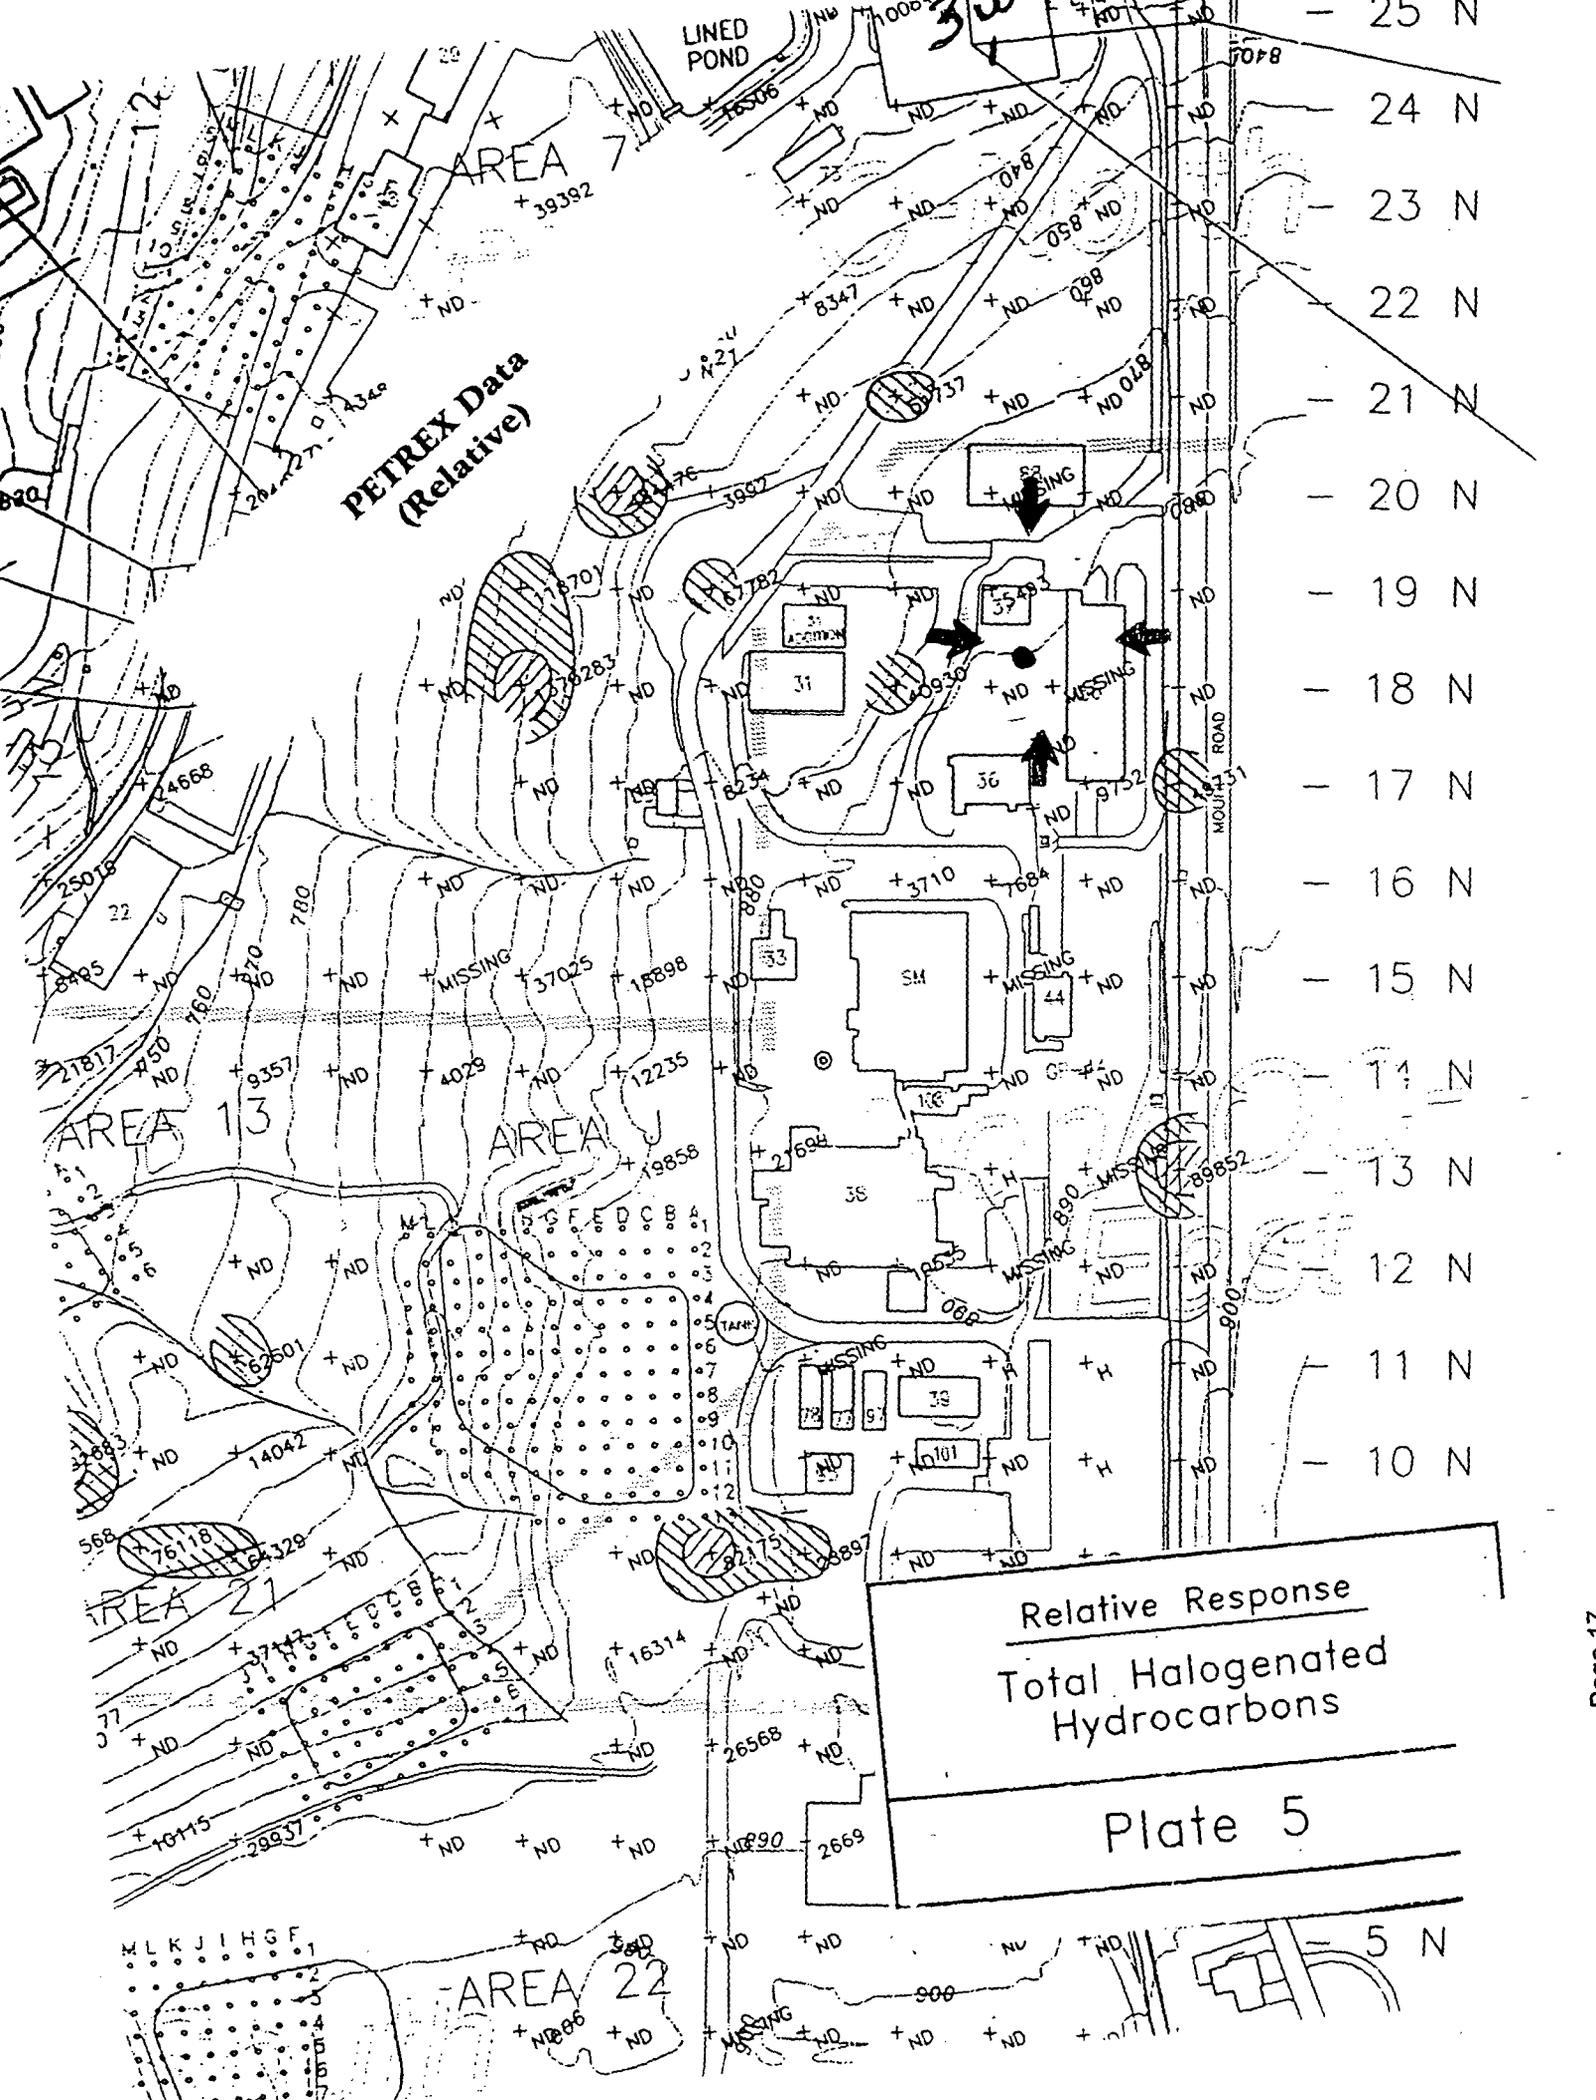
Plate 5

Relative Response
Total Halogenated
Hydrocarbons

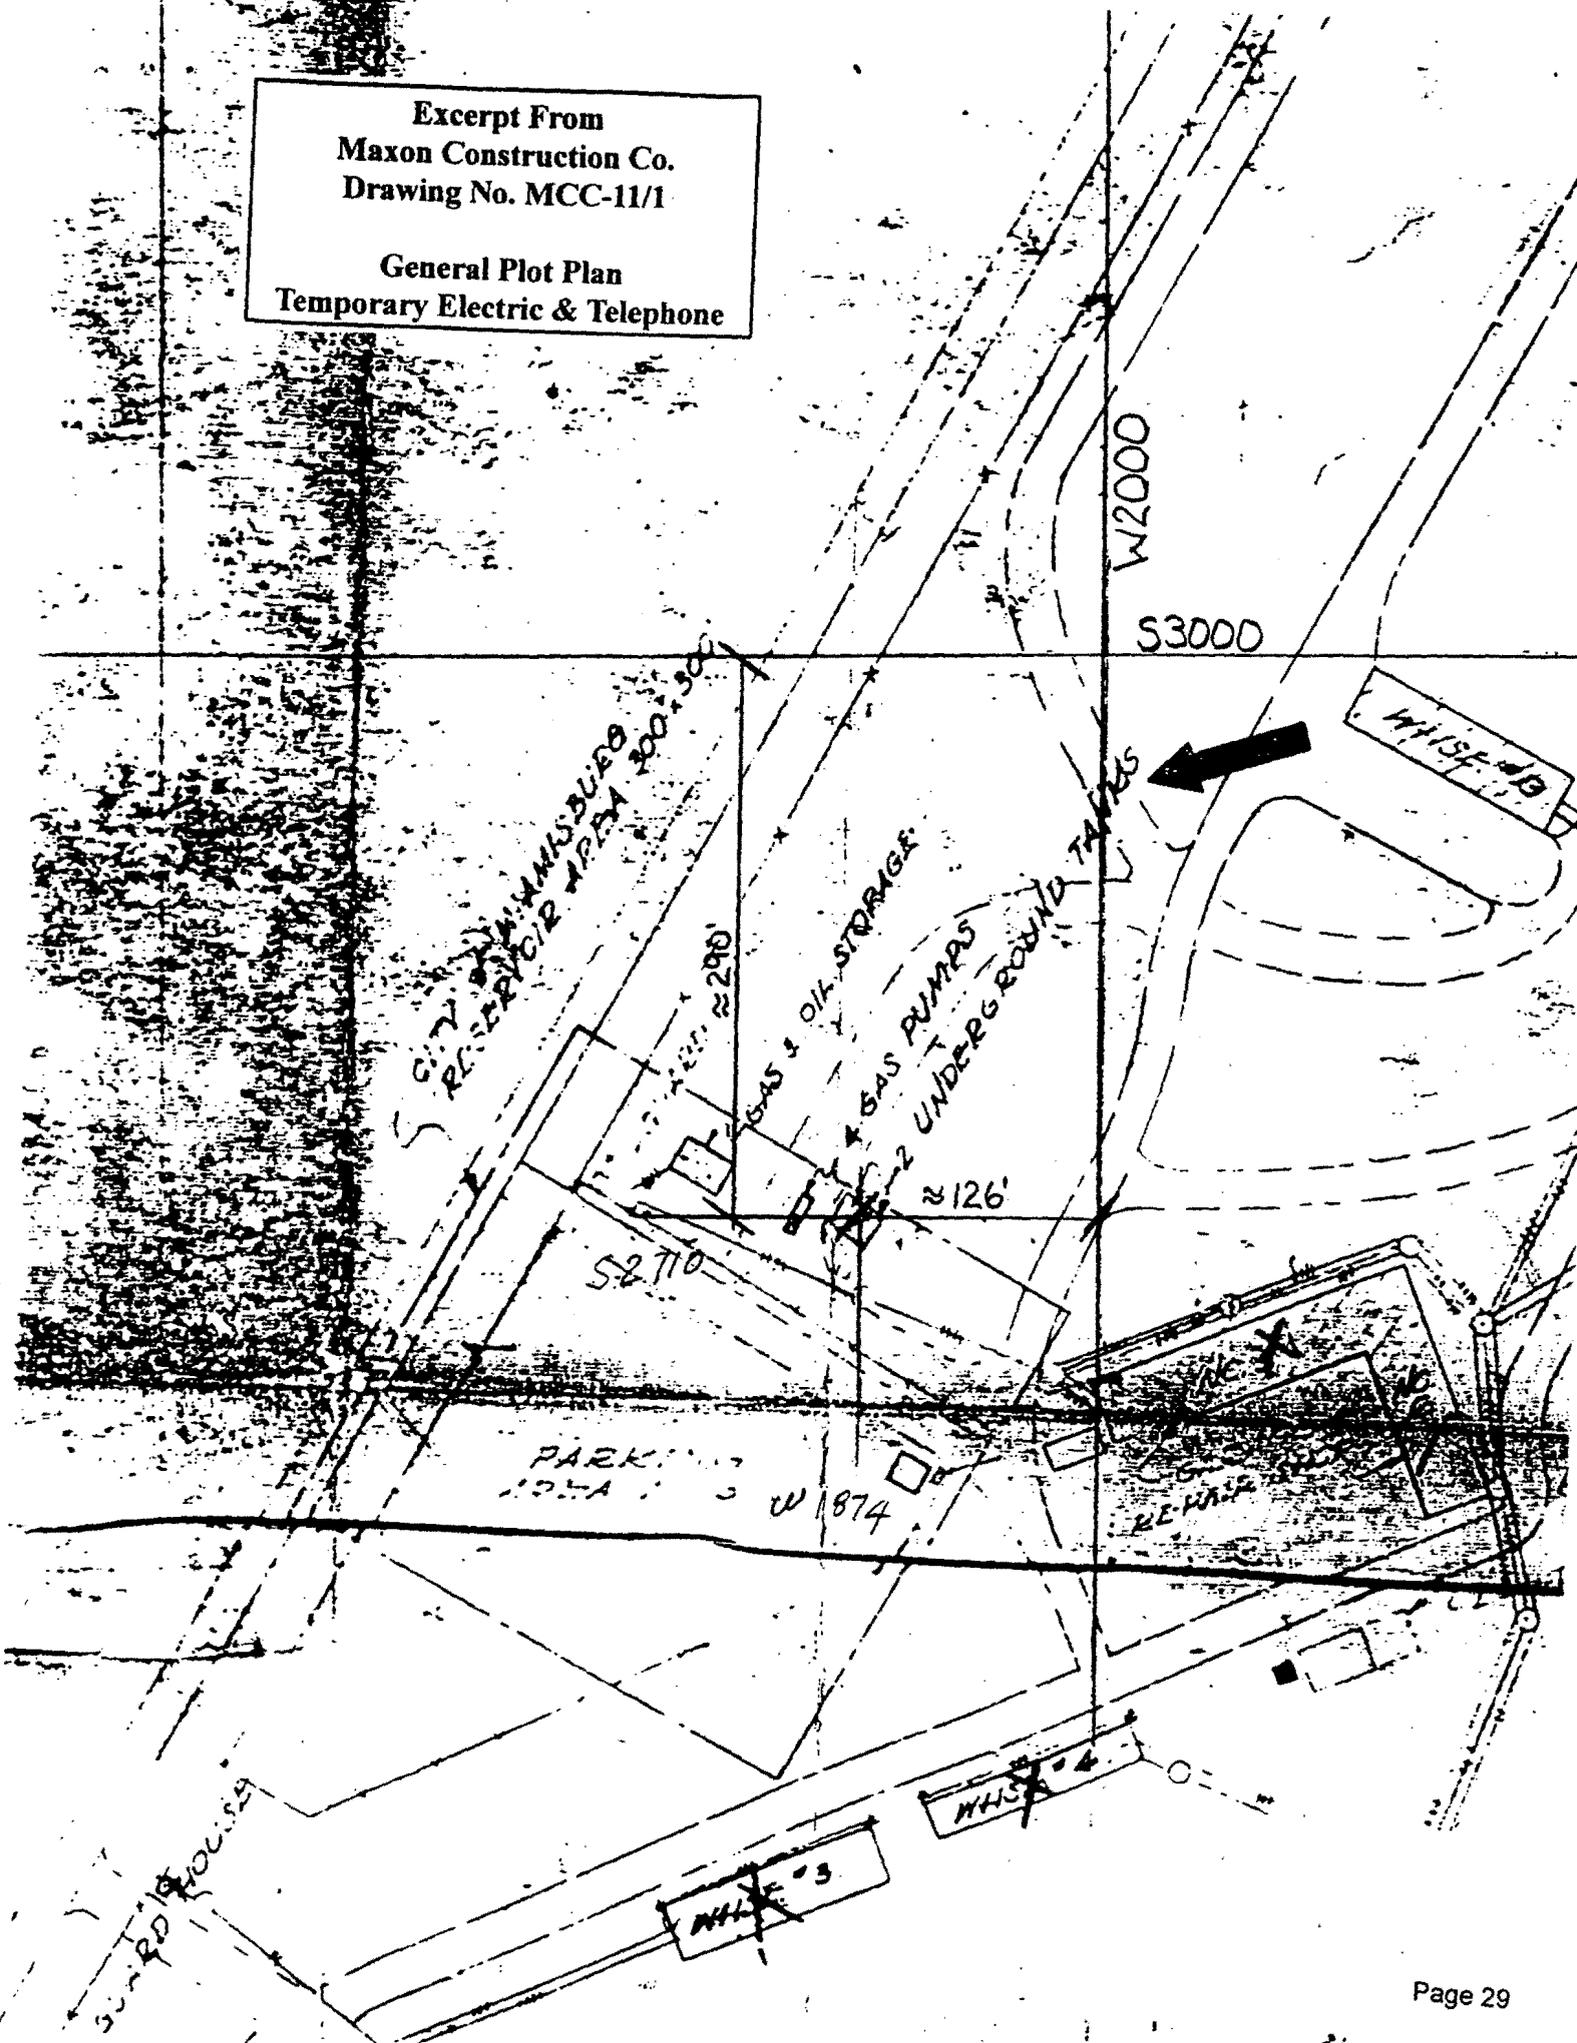
Excerpt From
Maxon Construction Co.
Drawing No. MCC-11/1

General Plot Plan
Temporary Electric & Telephone

Potential Release Site (PRS) 269 is an area of land where two underground fuel tanks were shown to be located to support the original plant construction.^{1,2} A 1948 construction drawing⁵ indicates that a fueling facility existed at a location near the northwest corner of Building 50.^{5,6} The drawing shows four pumps supplied by two underground storage tanks.⁵ The volume and construction of these tanks have not been determined, nor has documentation concerning closure of the tanks been found, although it is believed that the tanks were probably removed as part of construction demobilization. The site of these tanks is near the northwest corner of Building 50.^{5,6} This site was identified during the Mound Plant Underground Storage Tank Program and Regulatory Status Review as a result of a review of historic construction drawings.

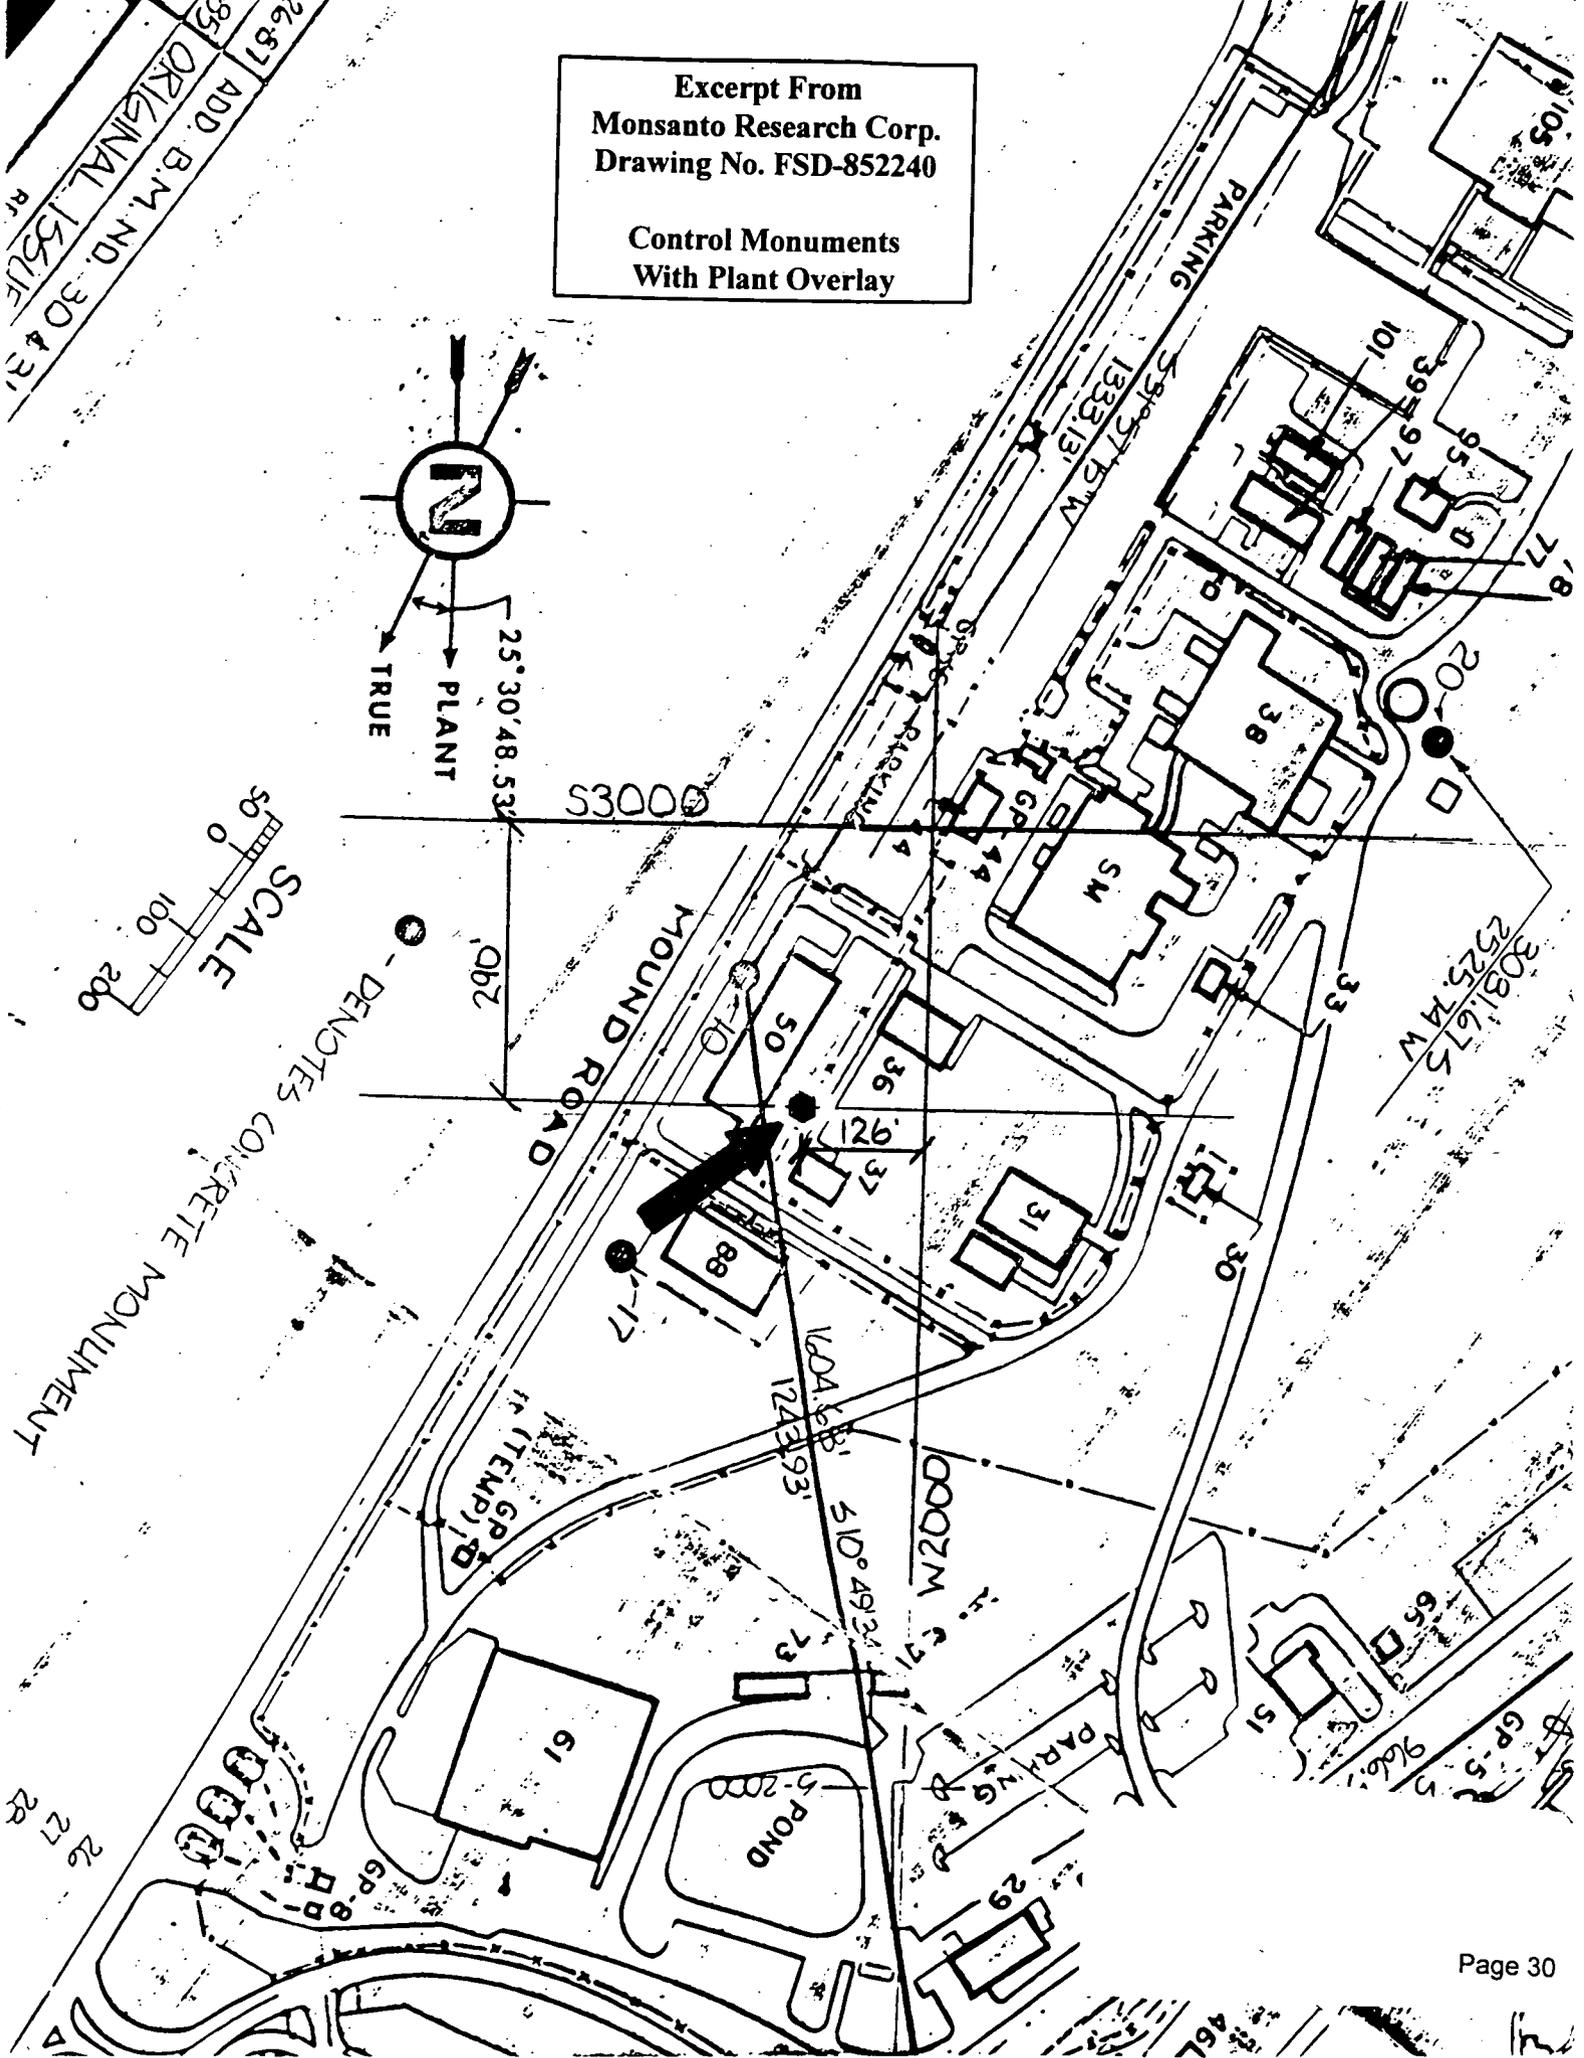
Excerpt From
Monsanto Research Corp.
Drawing No. FSD-852240

Control Monuments
With Plant Overlay

DENOTES CONCRETE MONUMENT
