MOUND PLANT

Potential Release Site Package

PRS # 58

**MOUND PLANT
PRS 58
SEDIMENT DRYING BEDS**

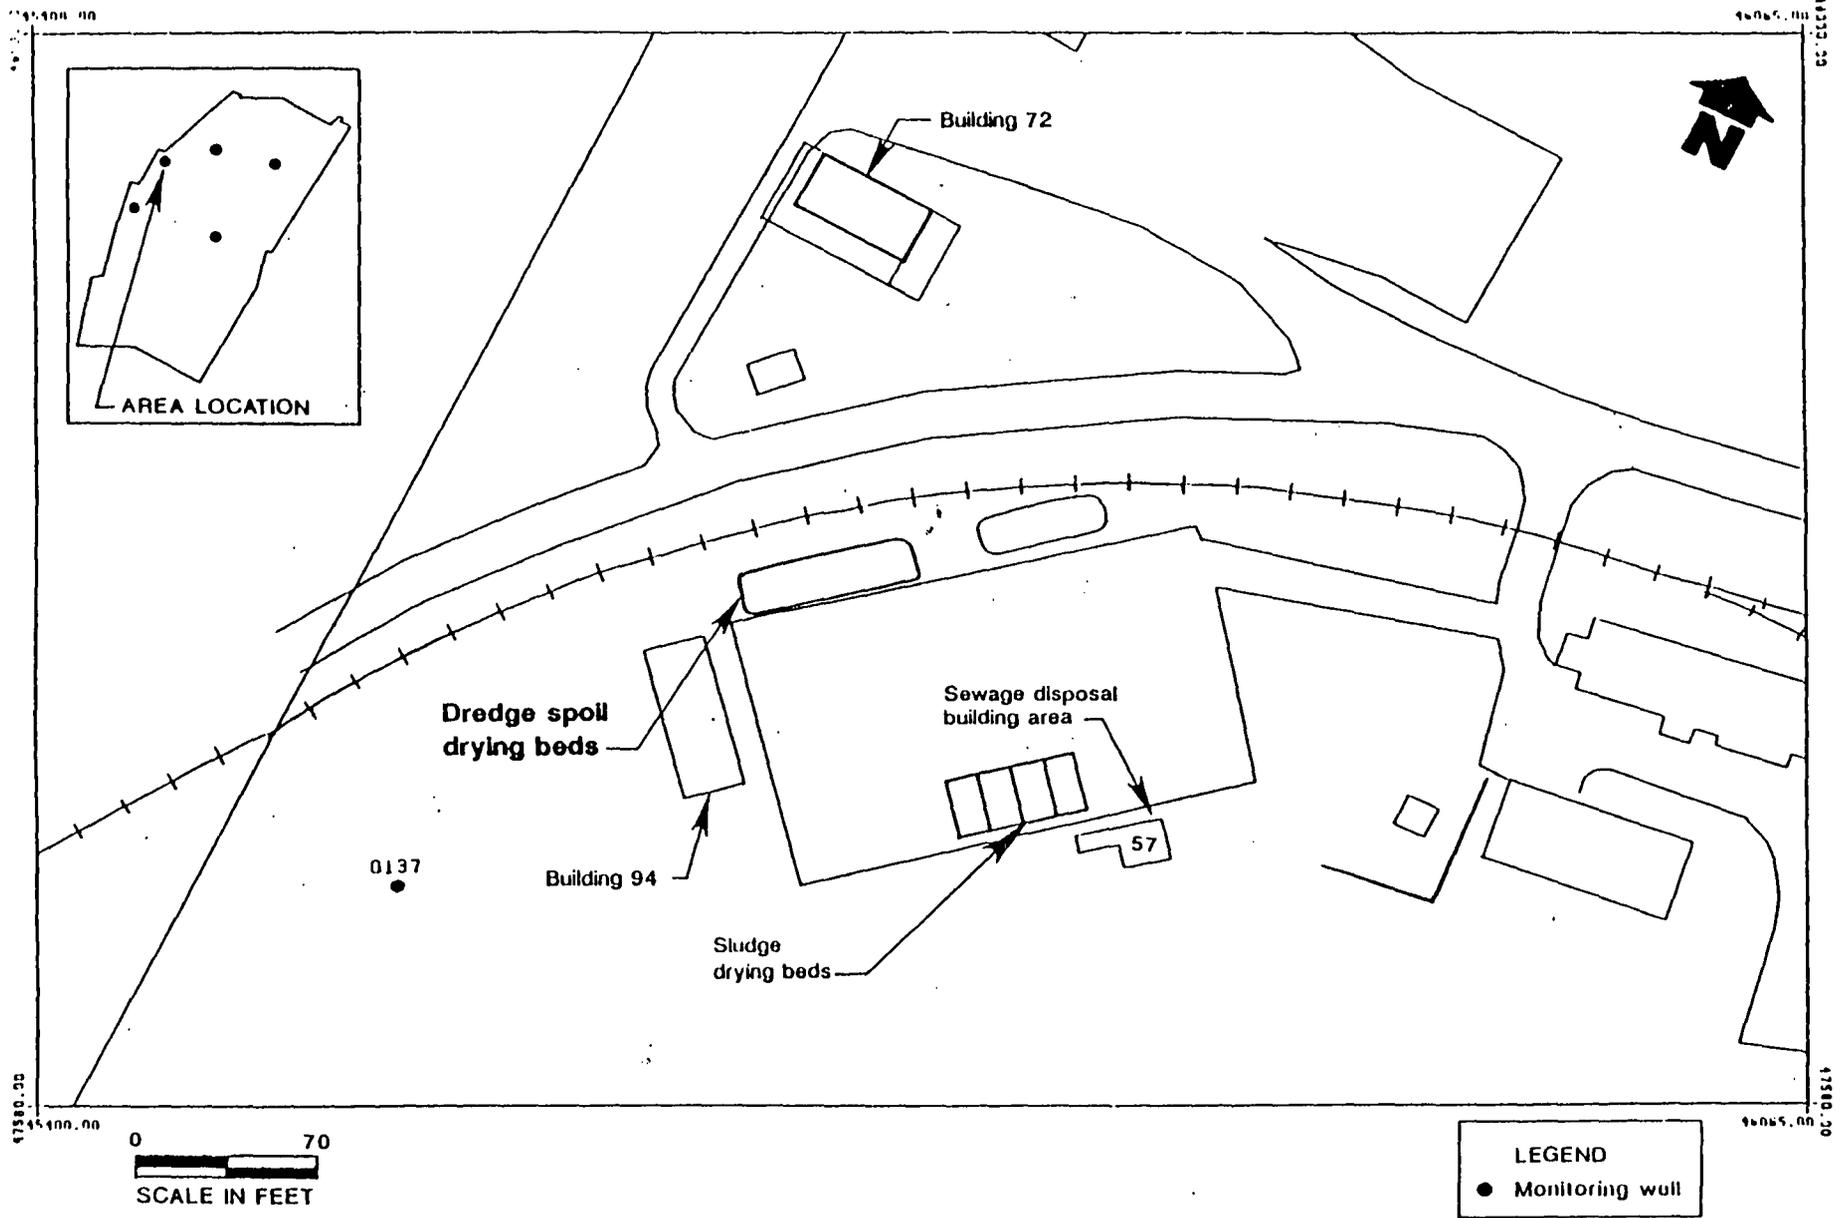
Figure 5.1. Dredge spoil drying beds.

The dredge spoil drying beds are located east of Building 94, near the sludge drying beds and the Sewage Disposal Building area (section 3; Figures 1.3 and 5.1). The beds are located near the west end of the sanitary wastewater treatment system. Dredge spoil from the asphalt-lined pond (section 6) was stored and dried in the beds before it was packaged for offsite disposal, and the remaining capacity of the beds was filled with material from the sludge drying beds (section 4). The dredge spoil drying beds now in use receive sludge from the sanitary wastewater treatment system (see section 3). Monitoring well 0137 is located downgradient of the beds (Figure 5.1).

The dredge spoil drying beds are open-topped, wooden structures approximately 6 to 8 ft wide and 3 ft deep. The beds in use are lined with plastic and are positioned on asphalt. Three units are currently in use at the location shown on Figure 5.1. An additional 56 beds are stacked in the adjacent parking lot and are full and closed.

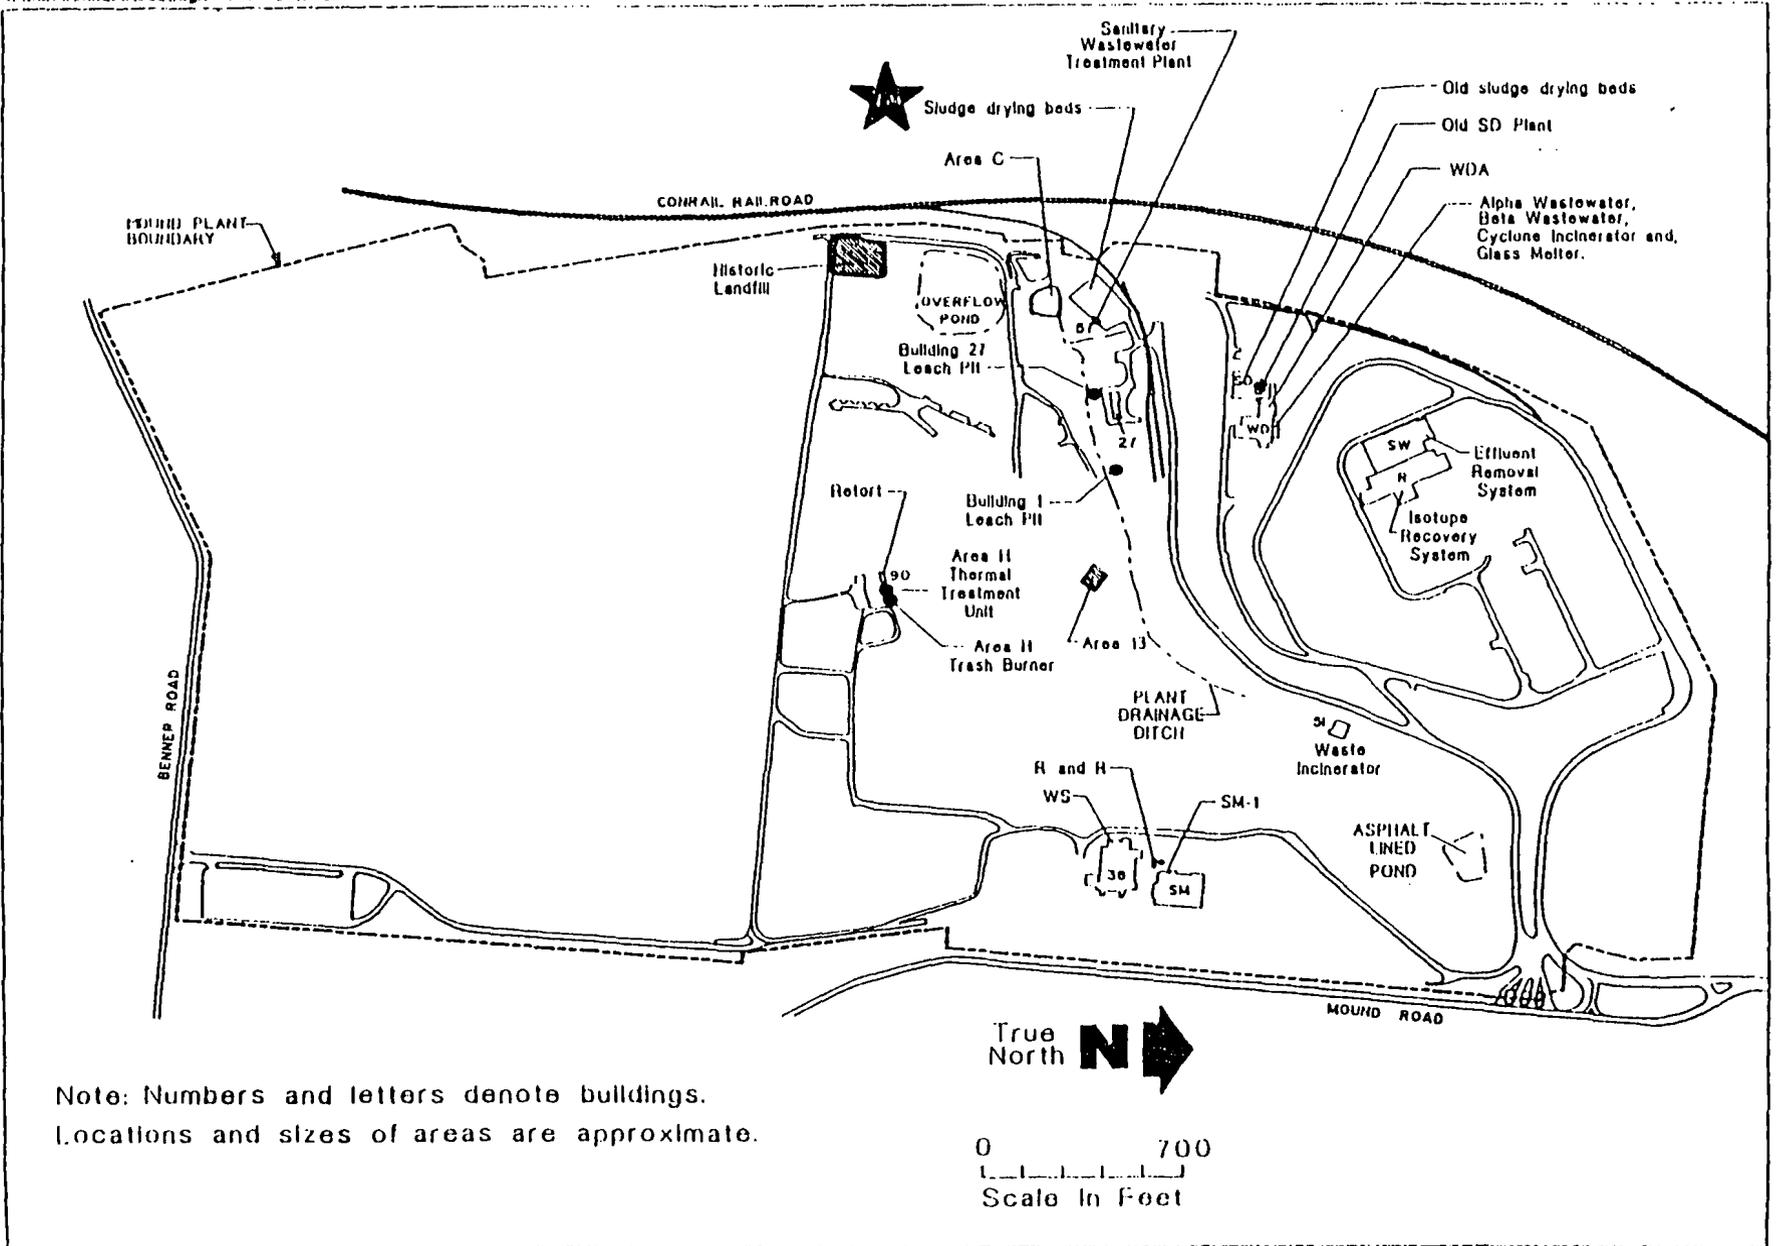
Figure 4.1 Waste treatment facilities.

The dredge spoil drying beds were originally placed around the edge of the asphalt-lined pond. The dredge spoil drying beds are open-topped wooden structures, approximately 6 to 8 ft wide and 3 ft deep. The wooden beds consisted of an upper bed lined with plastic canvas that drained to a lower bed of sheet metal. Wet sediments dredged from the asphalt-lined pond were placed in the upper bed, and excess water that drained to the lower pan was allowed to drain back to the pond. The dredge spoil material contained low levels of radioactivity. Dredge spoil was packaged for offsite disposal. The beds were moved for storage to the southeast of the Main Hill in the parking lot of Building 57, next to the sludge drying beds (Figure 4.1). The beds have also been used to dry sanitary material from the sludge drying beds. The dredge spoil drying beds were first used in the mid-1980s and are not now in use.

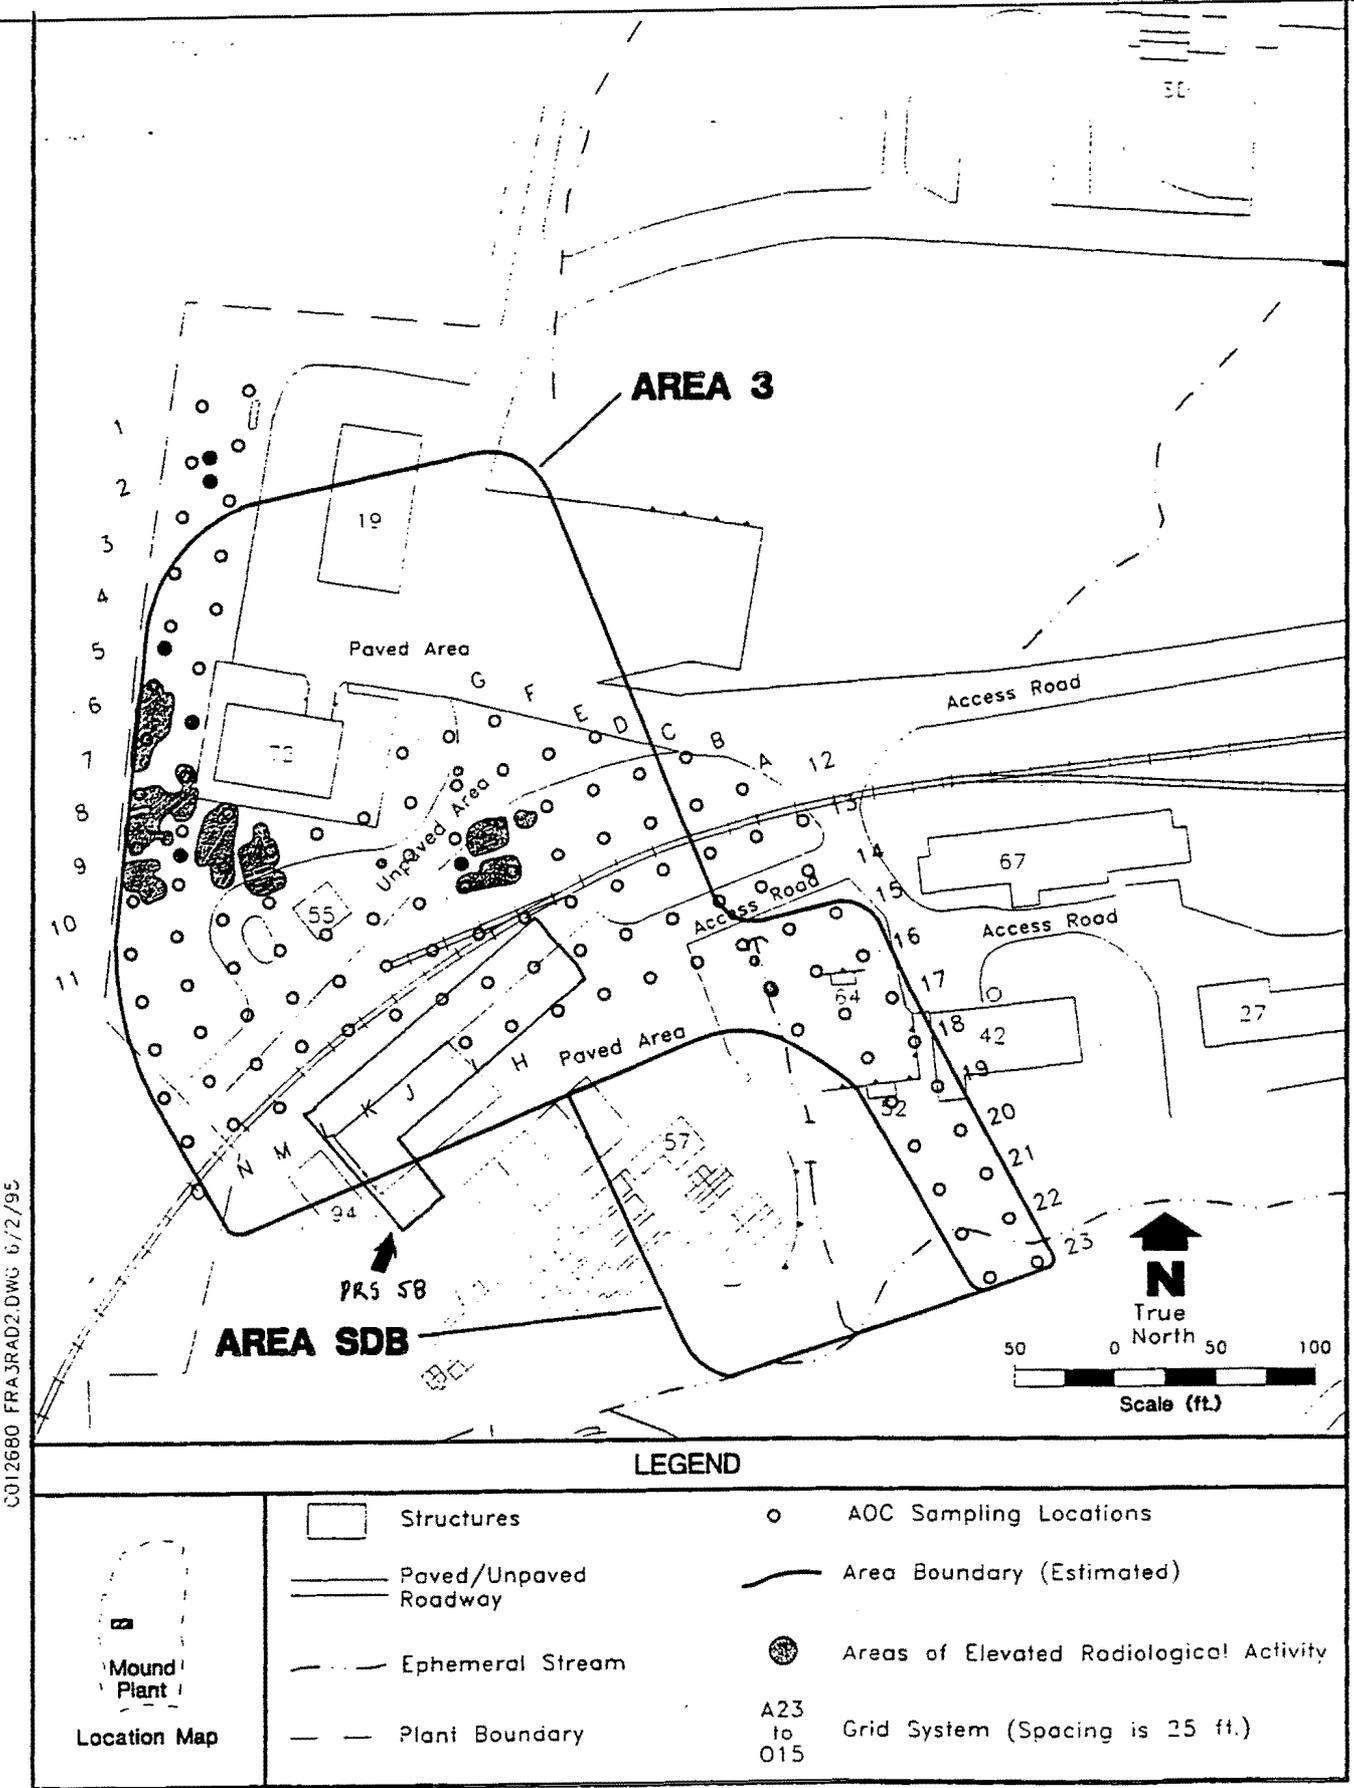
Figure 2.2. Areas of Elevated Surface Radiological Activity (FIDLER Survey)

The OU5, Operational Area Phase I investigation⁶ recently (1994) included part of PRS 58 in a systematic investigation of Area 3. This investigation included a field instrument for the detection of low energy radiation (FIDLER) survey; surface soil sampling and analysis using the Mound Plant screening facility. The survey was conducted over a 25-foot grid system that partially covered the area on and near the parking lot used to store the historic drying beds.

The radiological results, of the OU5 investigation, indicated that no plutonium-238 or thorium-232 contamination is present above the ALARA guidelines in the area of PRS 58 covered by the survey.⁶
