SUBJECT: **Contract No. DE-AC24-03OH20152: Deliverable #36 Building Data Package; Section C.2.1.1 Facility Demolition; T East, T West, and B Stack Structures OSC Report, Final**

# T EAST, T WEST, AND B STACK STRUCTURES REMOVAL ACTION

# OSC REPORT

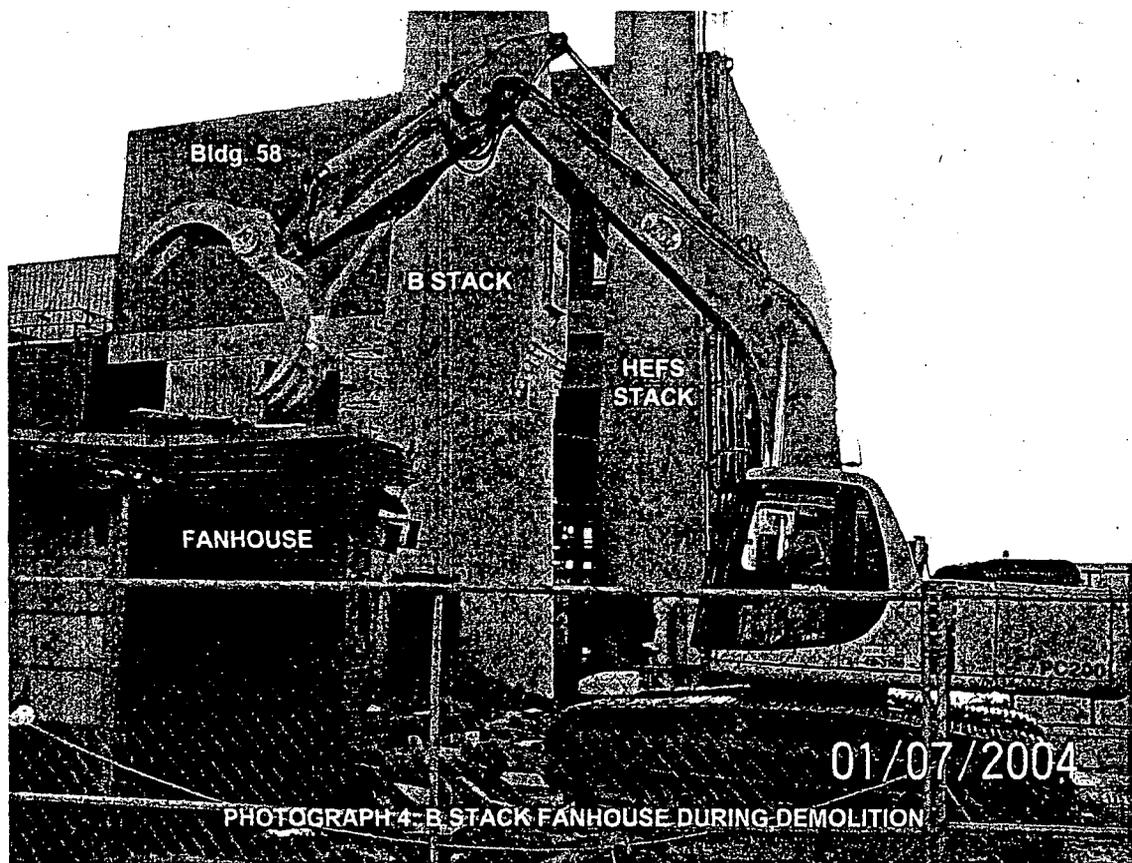
PHOTOGRAPH 4: B STACK FANHOUSE DURING DEMOLITION

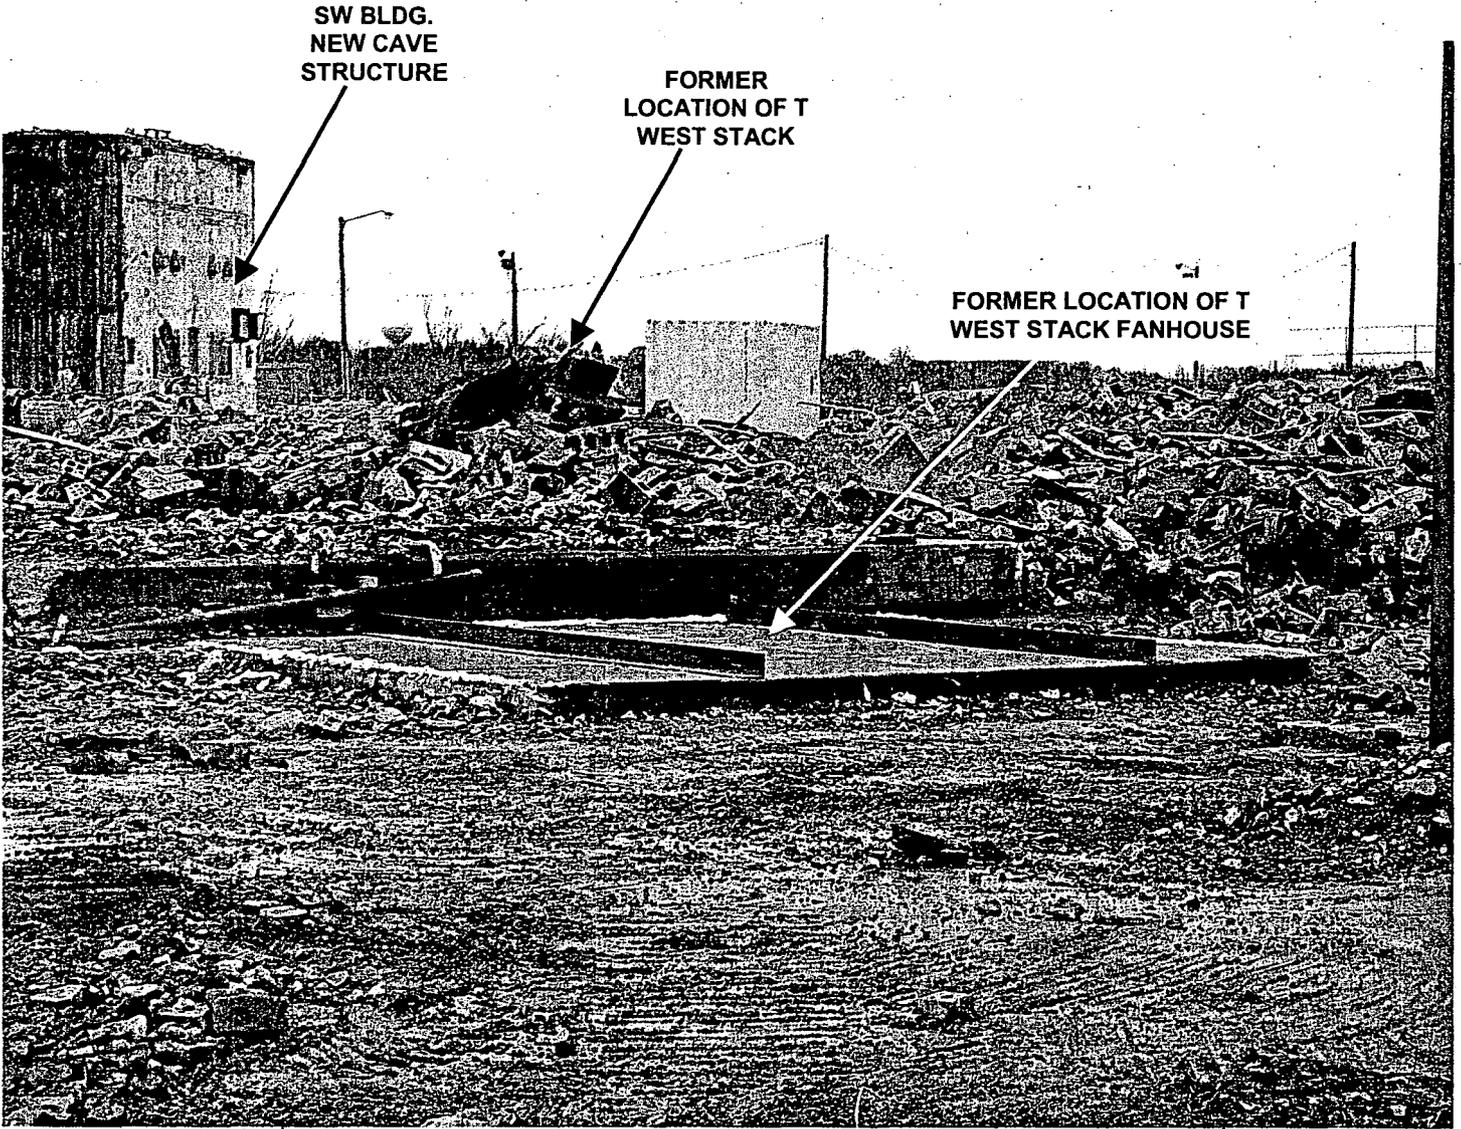
T West stack and fanhouse above ground structures were removed; photograph documentation is contained in Appendix D.

**PHOTOGRAPH 11: AFTER DEMOLITION OF T WEST STACK AND FANHOUSE**
