MOUND PLANT

Potential Release Site Package

PRS #429, 430, 431, 432, 433

**Potential Release Site 429, 430, 431, 432, 433: Main Hill Underground Lines
(North Side of Bldg. T to Manhole 8)**
**Potential Release Site 434, 435, 436: Main Hill Underground Lines
(South Side of Bldg. T to Manhole 8)**

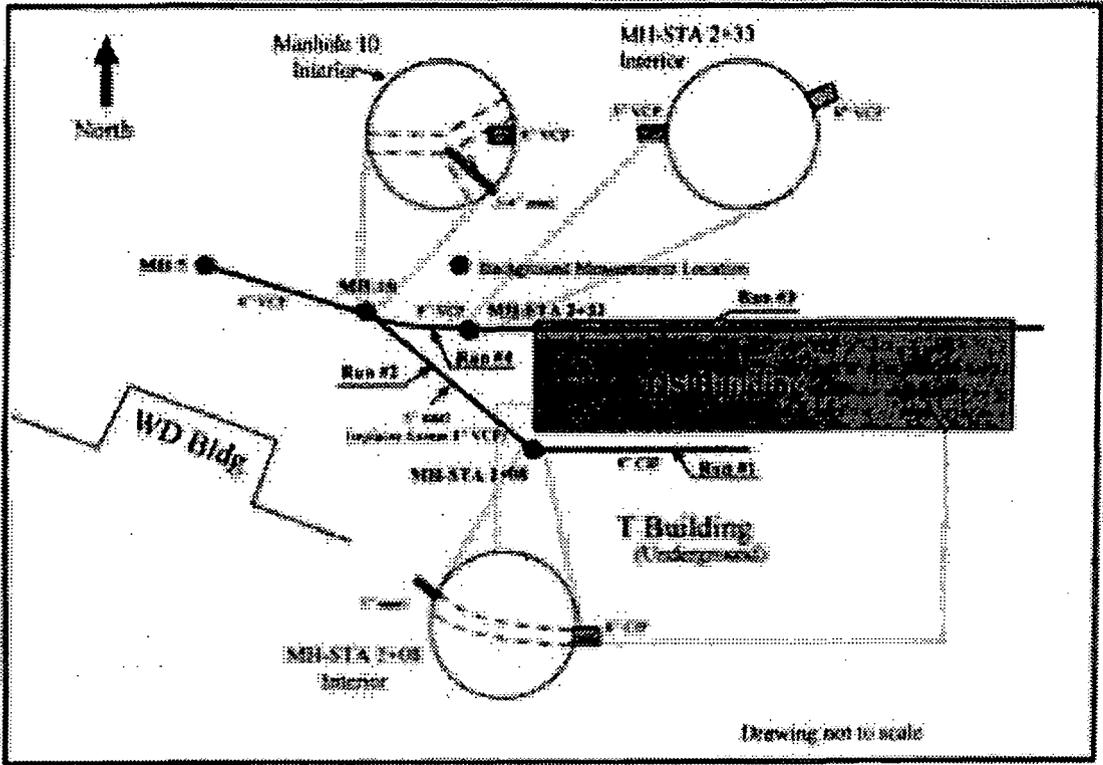
Figure B. Sketch of the pipe segments surveyed showing the access manholes and run numbers.

In late 1996, a robotics survey was conducted within areas of PRSs 429 through 433. The intent of the survey was to note physical and radiological conditions in the underground lines. See Reference E, *Results of Radiological and Video Surveys of Drain Lines at the US DOE Mound Facility With the Pipe Explorer™ System*, January 1997 (excerpt). Figure 1 of Reference E (the survey) indicates that survey Run #3 and Run #4 approximate the PRSs of concern. This figure is also presented below as Figure B. Reference Cobalt 60, results from the survey are presented below in Figures C and D.

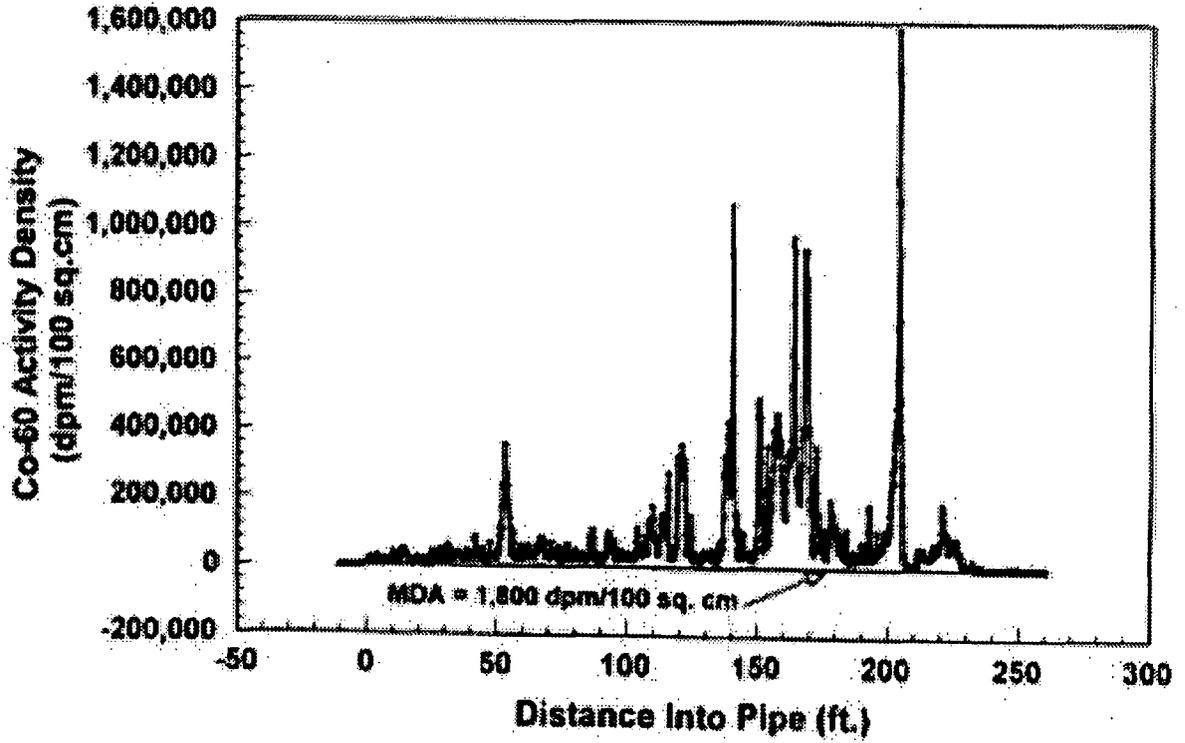
Figure C. Pipe Explorer Data Summary Graph
Run #3 (A-1)

**Pipe Explorer Data Summary Graph
U.S. DOE Mound Facility
Run #3 (A-1)
8-Inch Vitrified Clay Pipe
Data Taken 12/12/96 & 12/13/96**

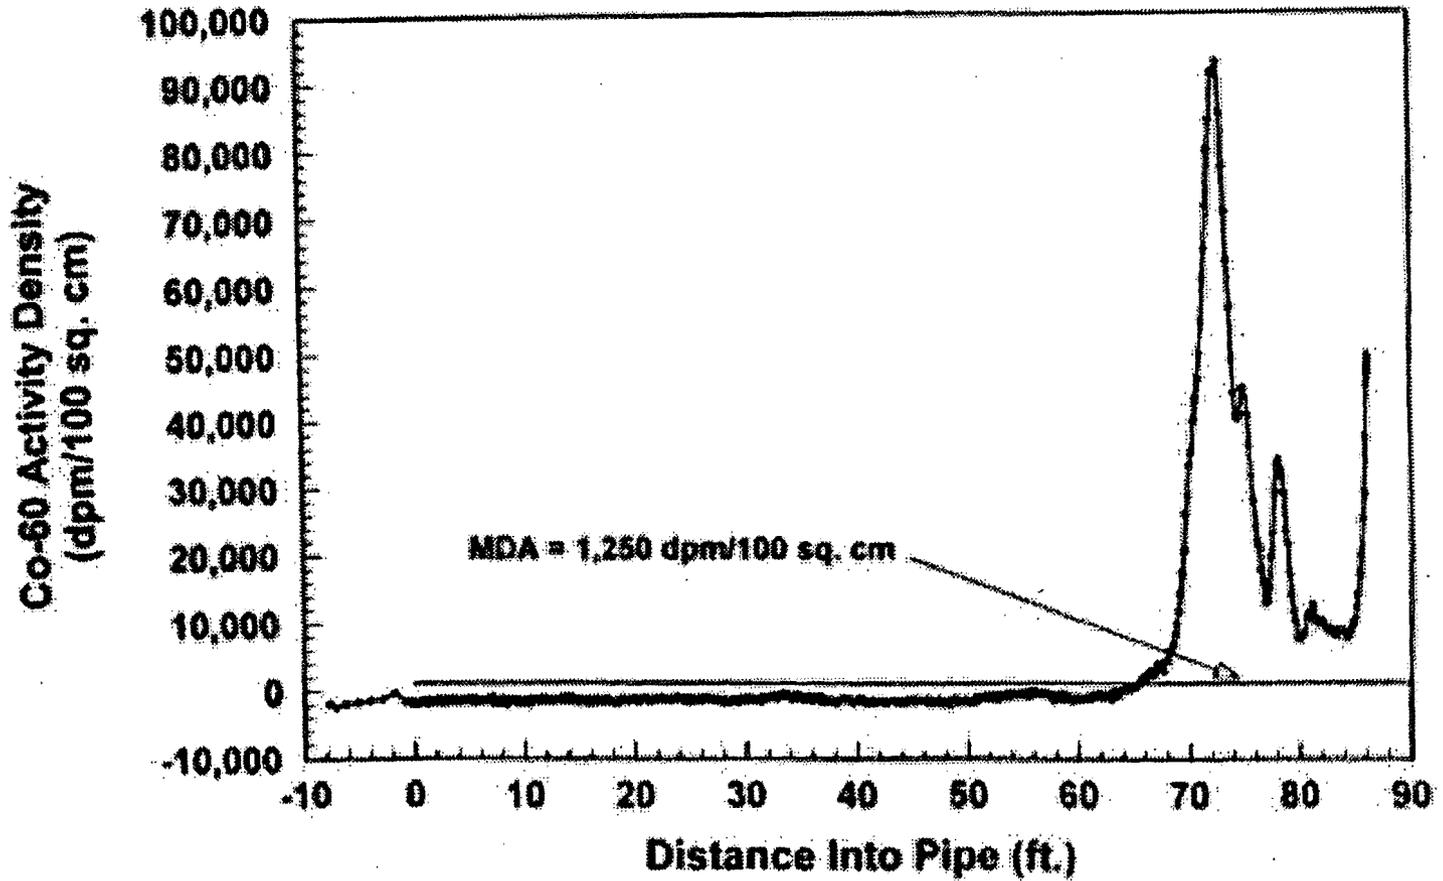
Figure D. Pipe Explorer Data Summary Graph
Run #4 (A-1)

**Pipe Explorer Data Summary Graph
U.S. DOE Mound Facility
Run #4 (A-1)
8-Inch Vitrified Clay Pipe
Data Taken 12/10/86**

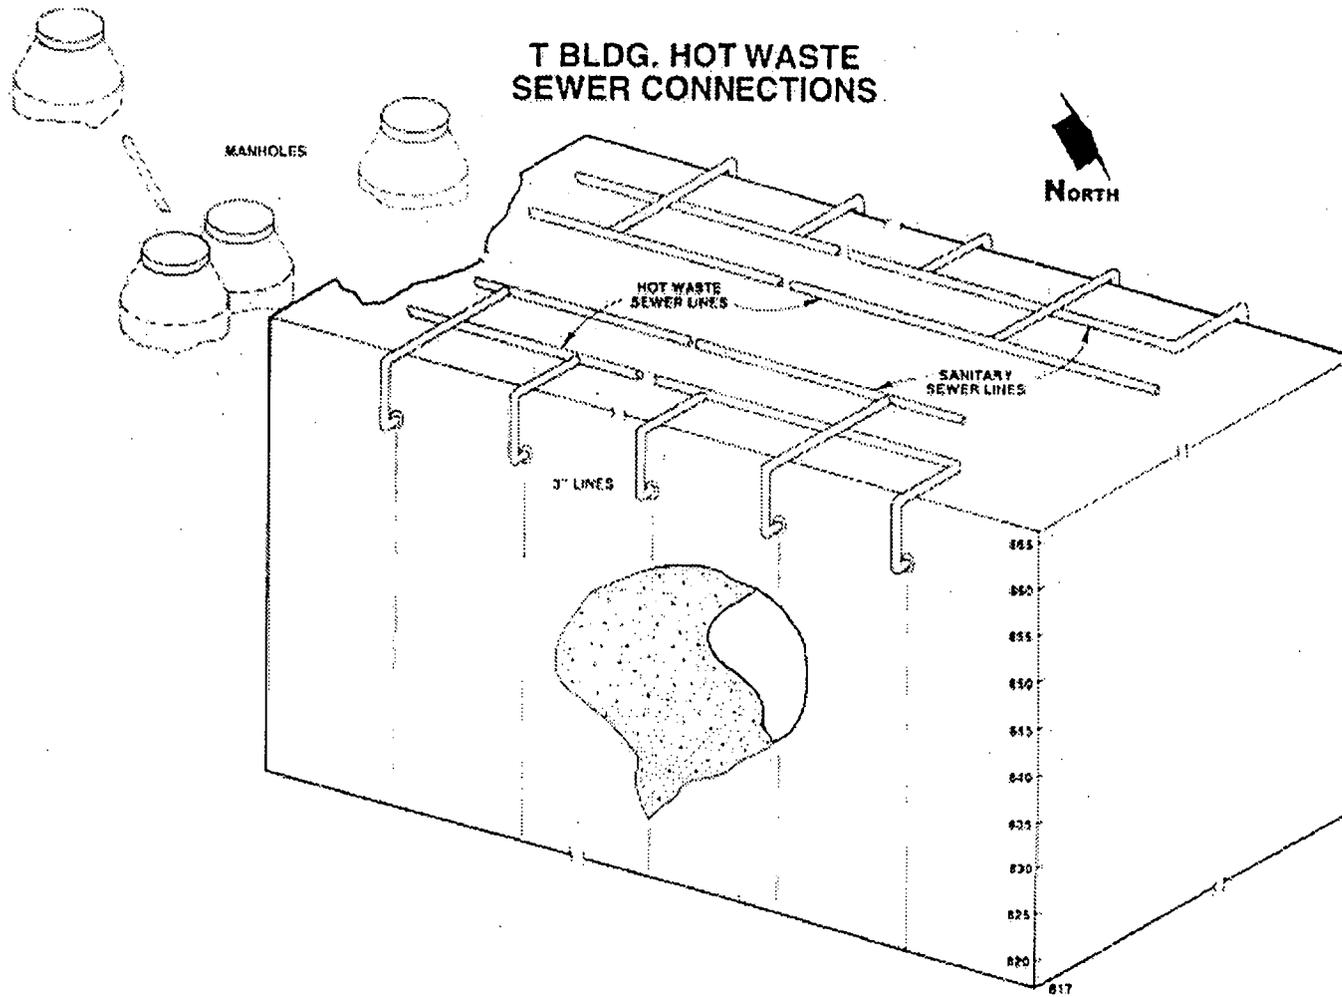
DS BLDG.
(PLAN VIEW)

- T Building Engineering Design (cont.)
 - Complicating T Building Design
 - DS Building built on top of T Building (finish floor elevation ~ 6 ft. above the T Building roof)
 - built in three segments: 1971, 1976, and 1978
 - no hot wastes originated in DS Building and no connections to the hot waste sewer
 - The north side hot waste and sanitary sewer lines are sandwiched between the DS Building Floor and T Building Roof.

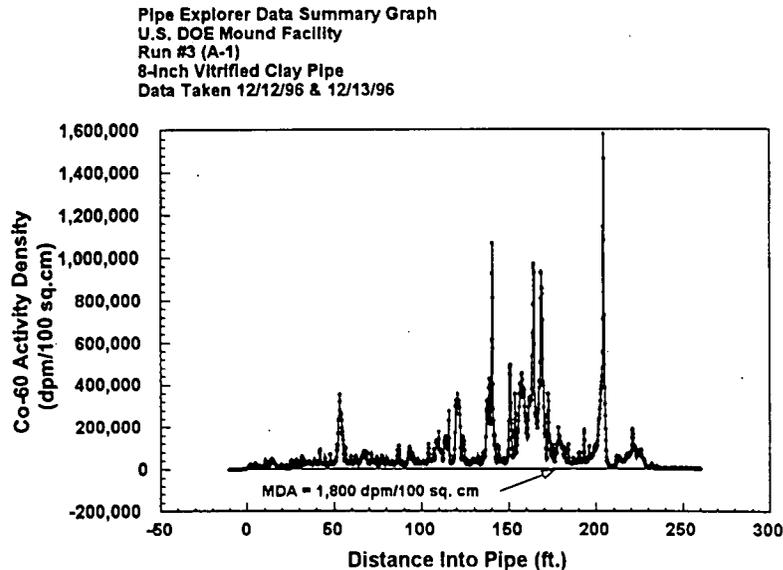
3 Co⁶⁰ Activity Density Profile

- General range of contamination source activity densities 7,000 to 14,000 pCi Co⁶⁰/100 cm²
- 30 contamination sources with > 45,000 pCi Co⁶⁰/100 cm²,
 - average source 2.6 ft. wide
- maximum contamination source 712,000 pCi Co⁶⁰/100 cm²
 - contamination source located at 204 ft. (near HR sump # 10 riser)
 - contamination source 8.2 ft. wide

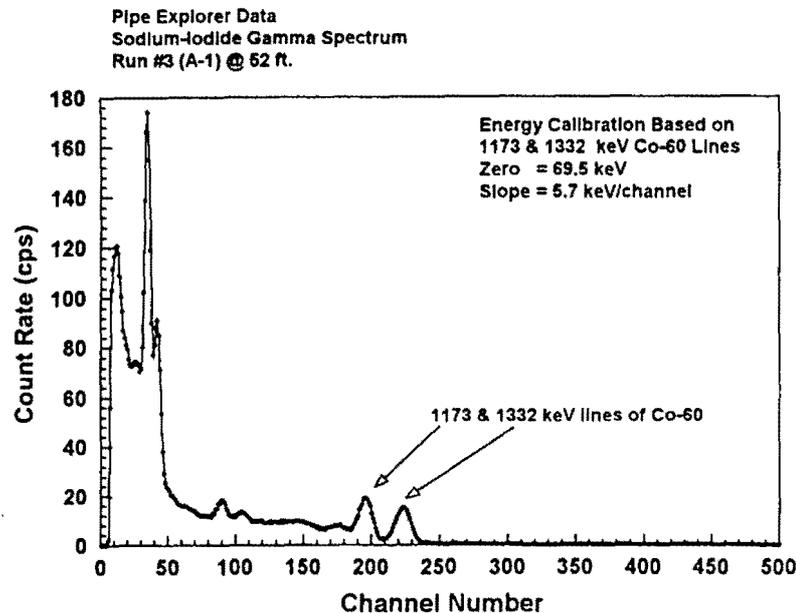
- Gamma Energy Analysis
@ 52 ft.

- Peak count rate 174 cps @
~ 269 keV
- Bi^{210m} @ channels 35, 40,
and 104 (i.e. ~269 keV, 309
keV, and 662 keV.)
- other gamma peaks (i.e. 138
keV and 577 keV) are
unidentified

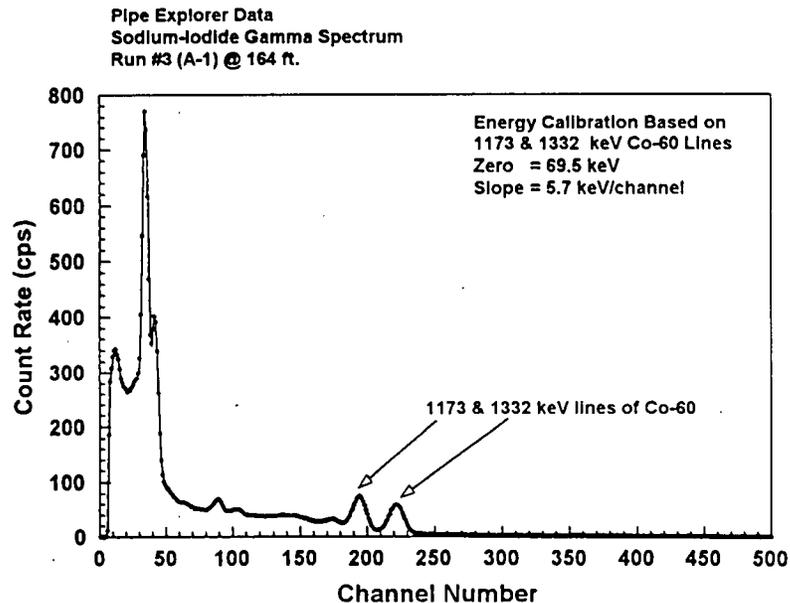
- Gamma Energy Analysis
@ 164 ft.

- Peak count rate 770 cps @
~ 263 keV
- Bi^{210m} @ channels 34, 40,
and 104 (i.e. ~263 keV, 303
keV, and 657 keV.)
- other gamma peaks (i.e. 138
keV and 577 keV) are
unidentified

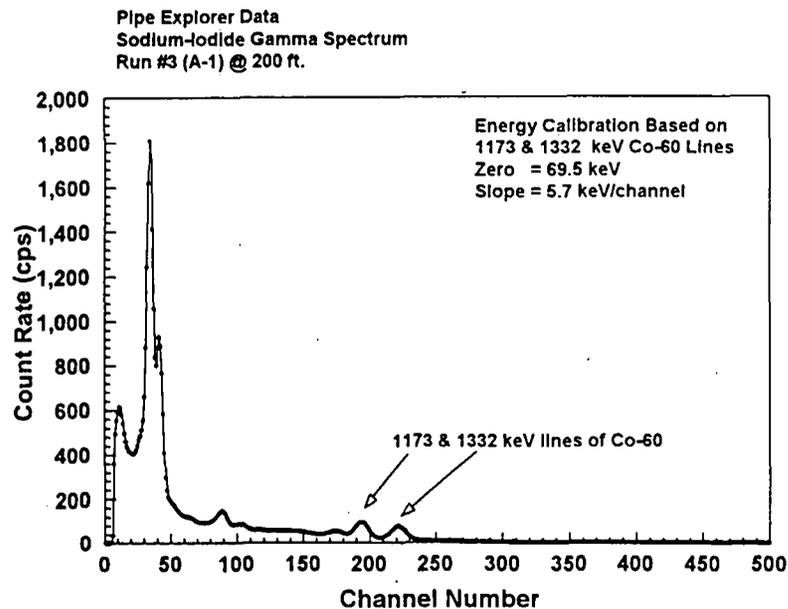
- Gamma Energy Analysis
@ 200 ft.

- Peak count rate 1810 cps @
~ 263 keV
- Bi^{210m} @ channels 34 and
41 (i.e. ~263 keV and 303
keV.)
- other gamma peaks (i.e. 138
keV and 571 keV) are
unidentified

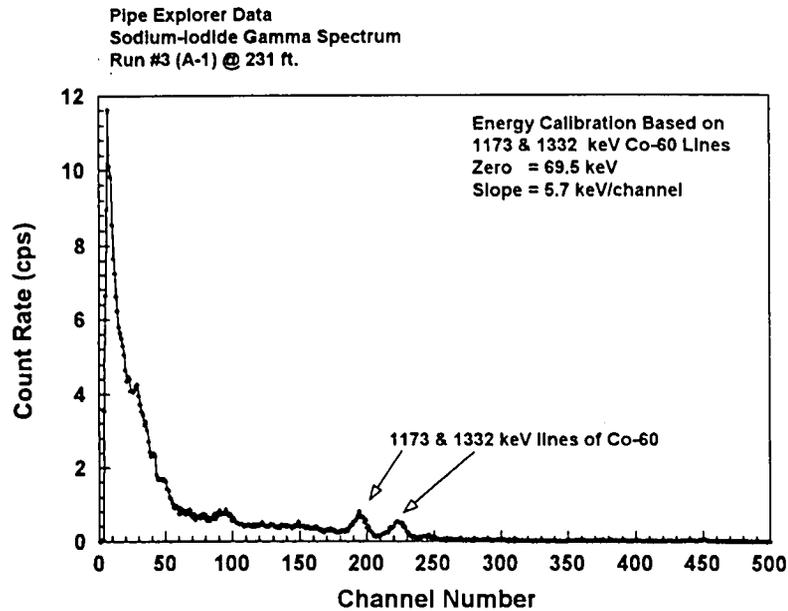
- Gamma Energy Analysis
@ 231 ft.

- Peak count rate 11 cps @ ~
109 keV

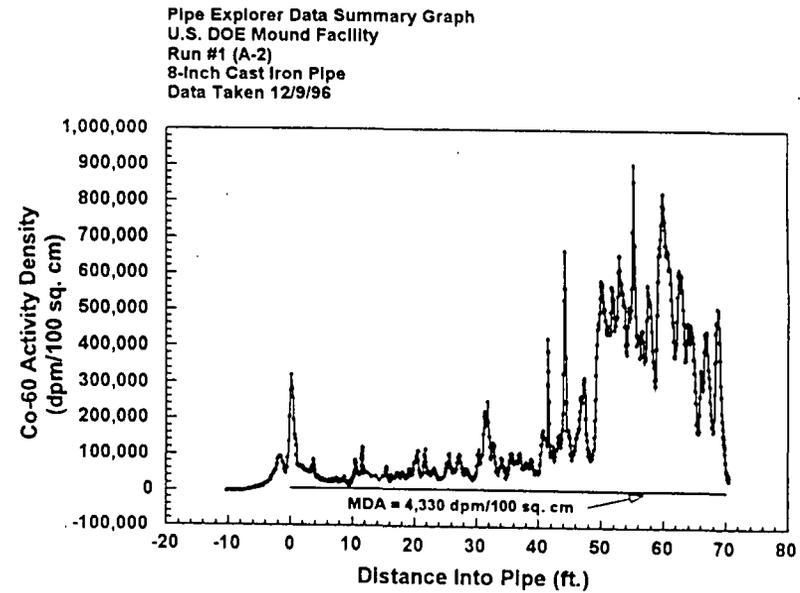
Radiological Surveillance Run # 1 Co⁶⁰ Activity Density Profile

- 29 contamination sources with activity densities varying between 38,000 and 409,000 pCi Co⁶⁰/100 cm²,
- ~17 ft. long band of contamination between 48 and 65 ft.
- maximum contamination source 409,000 pCi Co⁶⁰/100 cm²
 - contamination source located at 55 ft.

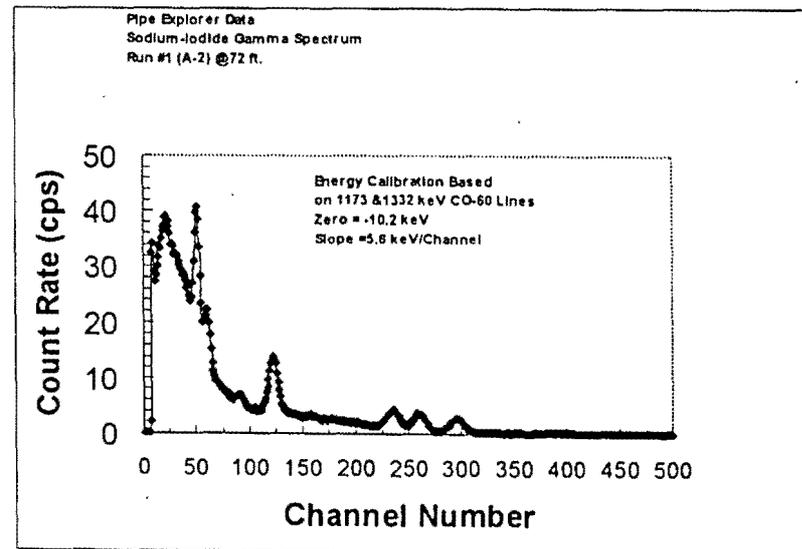
- Gamma Energy Analysis
@ 71 ft.
 - Bi^{210m} @ channels 59, 68, and 130 (i.e. ~264 keV, 315 keV, and 673 keV.)
 - other gamma peaks (i.e. 102 keV, 483 keV, and 1,295 keV) are unidentified

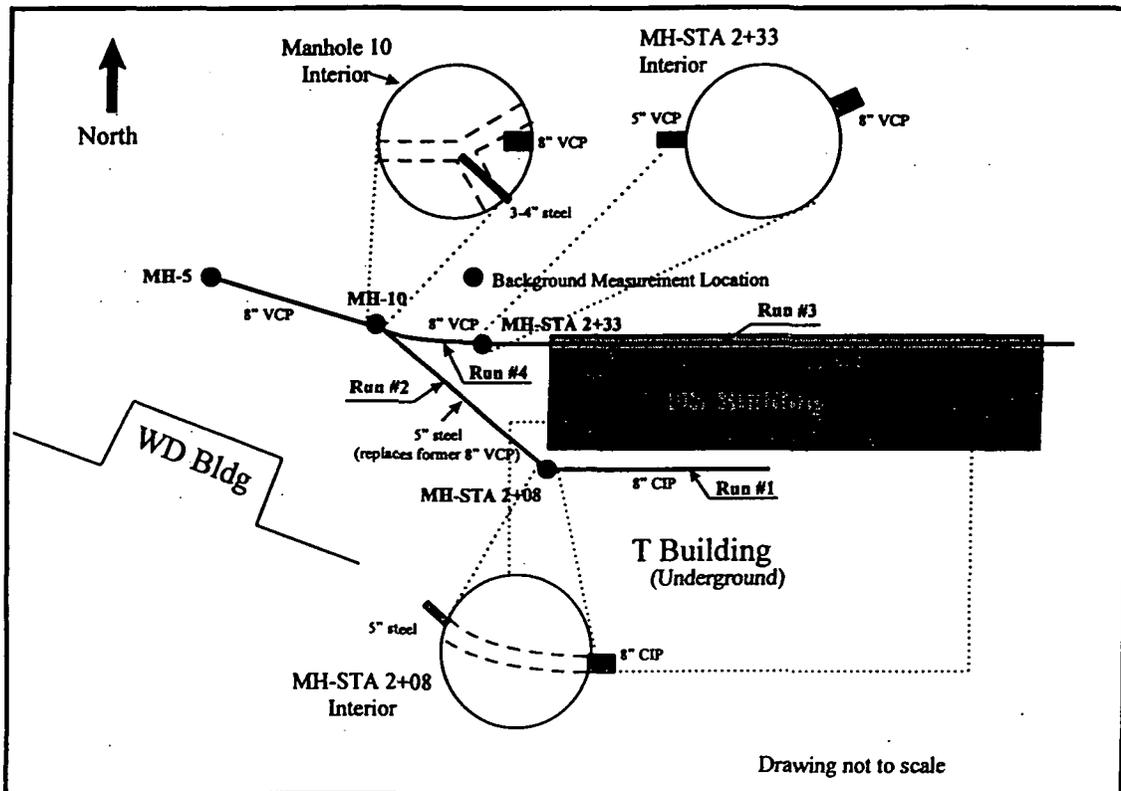
Figure 1. Sketch of the pipe segments surveyed showing the access manholes and Run #'s.

Run ID	Access ID manhole	Deployment direction	Pipe diameter (in.)	Segment length (ft.)	Video survey Length (ft.)	Radiological survey length (ft.)
Run # 1 (A-2)	MH STA 2+08	West->East	8	202	121	71
Run # 2 (A-2)	MH STA 2+08	SE->NW	5	210	29	28
Run # 3 (A-1)	MH STA 2+33	West->East	8	500	259	260
Run # 4 (A-2)	MH STA 2+33	East->West	8	90	83	86

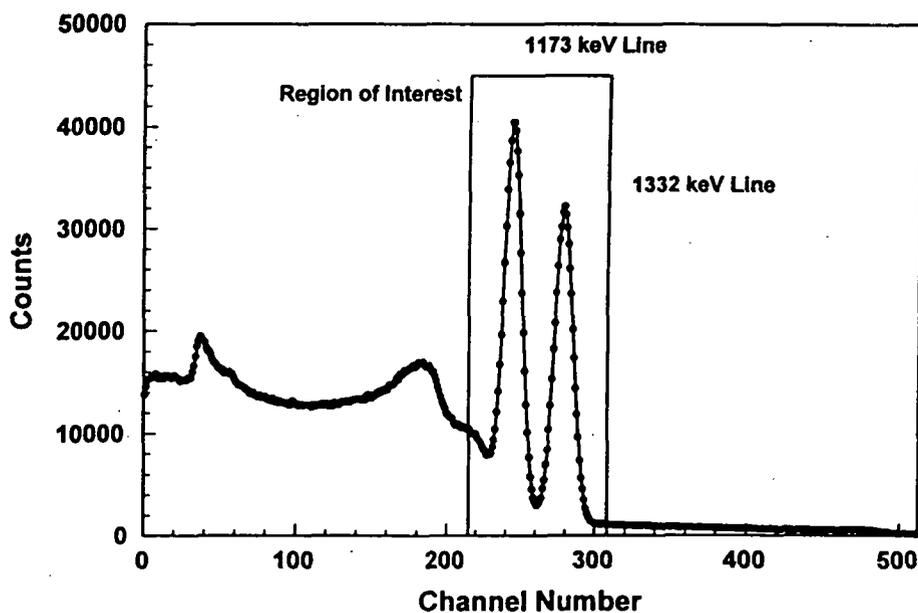
Radiological characterizations of the drain lines were conducted using a Canberra model 802 gamma detector (2x2-inch NaI(Tl)) set-up specifically to detect the 1173.2 & 1332.5 keV gamma emissions of Co-60. The detector package included a Canberra model 2007B preamplifier. This detector package was operated with NIM standard electronics consisting of an Ortec model 478 high voltage bias supply, a Canberra model 2022 spectroscopy amplifier, a Canberra model 2030 single channel analyzer (SCA), and an Ortec model 996 counter/timer. The SCA was used to establish an energy window encompassing the two principal gamma ray energies from Co-60. Figure 2 shows a gamma spectrum obtained with the NaI(Tl) detector and a Co-60 source with the energy window indicated by the box labeled Region of Interest. Any pulse occurring within the energy window results in the generation of an output pulse from the SCA to the counter/timer, which increments its count register. Pulses occurring outside of the energy window do not result in recorded counts. The energy window is somewhat wider than might appear optimum to accommodate small temperature driven gain shifts in the counting system that may have occurred during the course of a survey.

Figure 2. Shows a gamma ray spectrum from the detector employed in these measurements. The region of interest used is indicated by the box surrounding the two principal photopeaks of Co-60.
