MOUND PLANT
Building Data Package
GIS Building
Located within Release Block H

BUILDING DATA PACKAGE (BDP)

GIS BUILDING

DOE MOUND PLANT

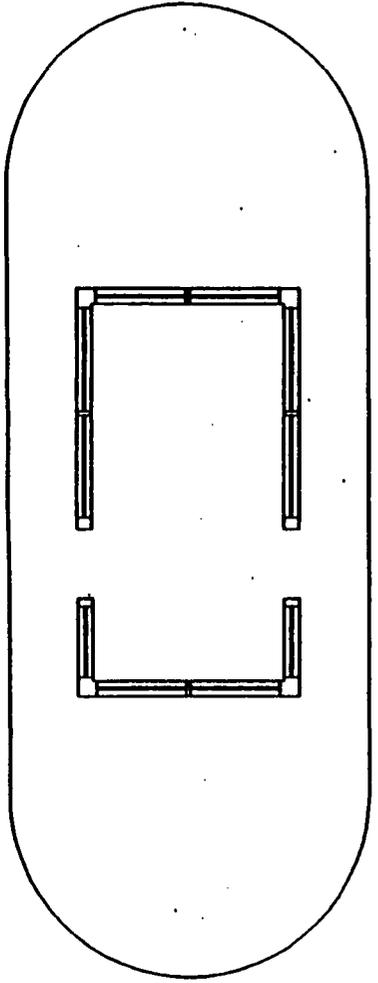
**GIS BLDG
FIRST FLOOR
BLDG CODE:3532**

DESIGN NO.	PROJ. NO.	ISSUE	1	2	3	4	5	6	TITLE	(U) TITLE CLASSIFICATION
		B							GIS (GUARD ISLAND SHELTER) FLOOR PLANS	
SPCS	ISS. REV.	PART CLASSIFICATION								
LP & EC	PLUM. REV.	GRADE CLASSIFICATION								
CONTR.		UNCLASSIFIED		C		FSC911308		JOB NUMBER 12335		
SP-0	DATE	Dwg. TYPE		SFP		FROM GIS BLDG		CASE 14865		SCALE AS NOTED
		STATUS		MO-REL-12/12/91		ORIGIN		MO-BR3-V3.0		SHEET 1 OF 1

Building print, 350700-02003, prepared in 1947 was reviewed. It does not include details of any soil disturbances, cut-and-fill site work, or soil boring logs and profile. There are no indications on this drawing of any major soil disturbances beyond that necessary to build the road or building foundation. There are no sewer lines, fire lines, etc., buried by the building. See Appendix 7.2.
