MOUND PLANT
Building Data Package
Building GP-5
Located within Release Block L

BDP GP-5

MOUND PLANT BUILDING DATA PACKAGE

BUILDING GP-5

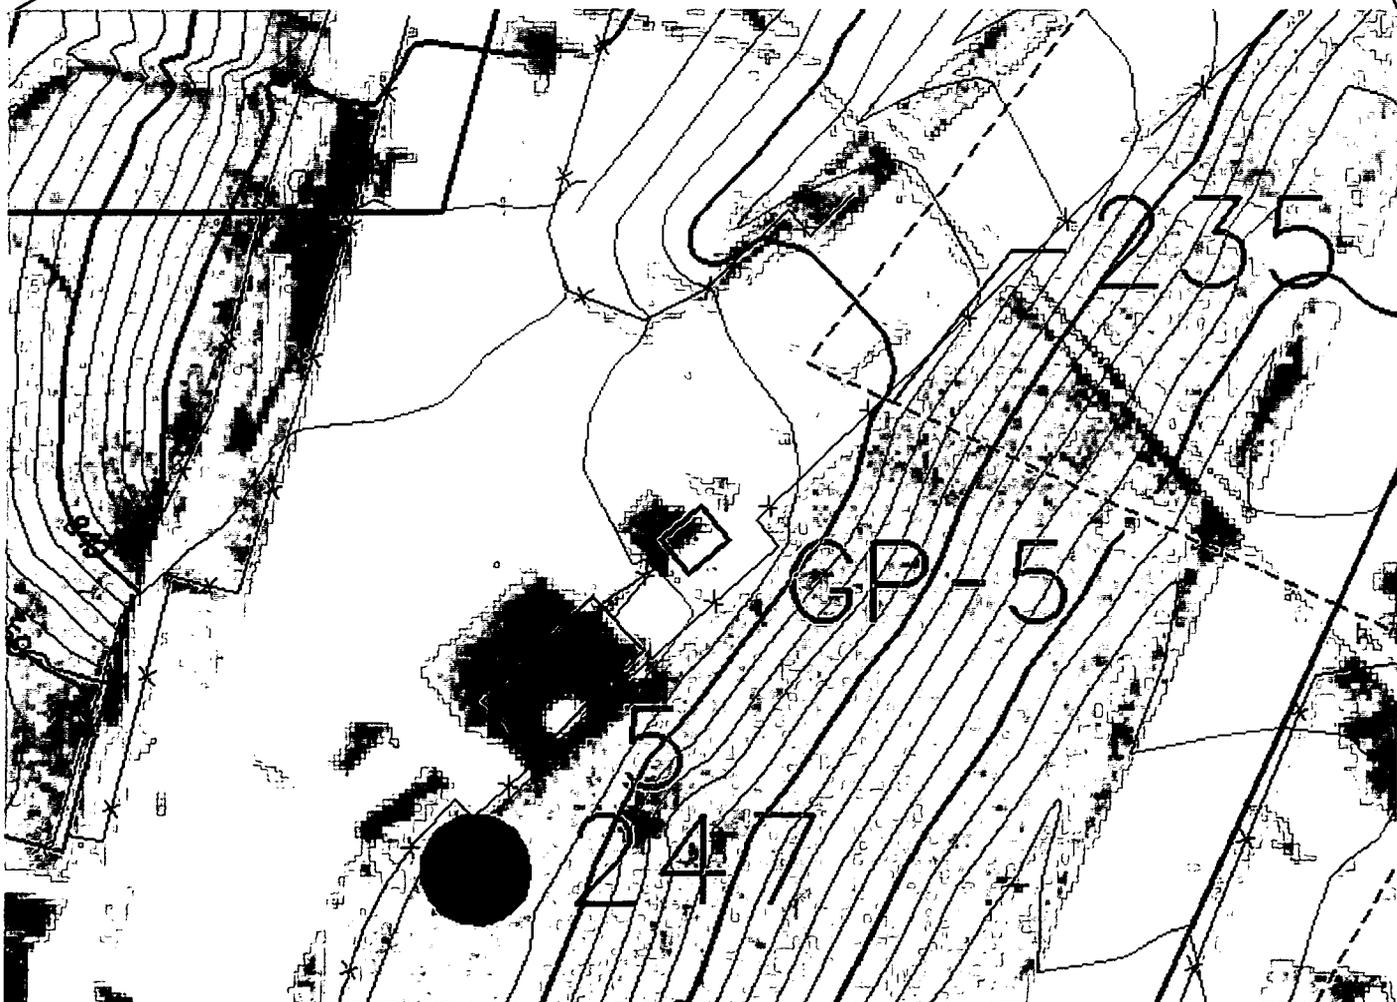
On the map below:

- Building number and location shown in black
- PRS locations and numbers shown in blue
- Surrounding buildings shown in green
- Fencing shown in red
- Elevation contours shown in brown
