SUBJECT: Contract No. DE-AC24-03OH20152  
Statement of Work Requirement 055 - Regulator Reports  
**BUILDINGS 36, 37 AND 50 CLOSEOUT REPORT, FINAL**

# Miamisburg Closure Project CLOSEOUT REPORT

## Buildings 36, 37 and 50 (Demolition)

Final  
February 2005

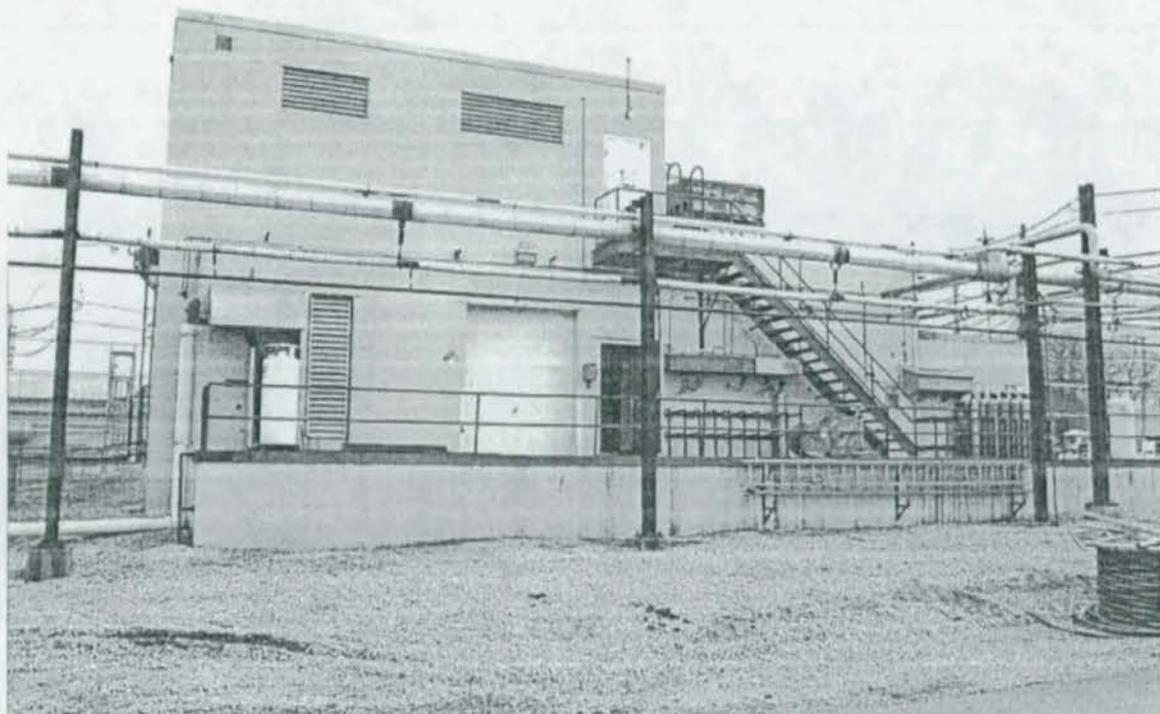
Building 36 Prior To Demolition

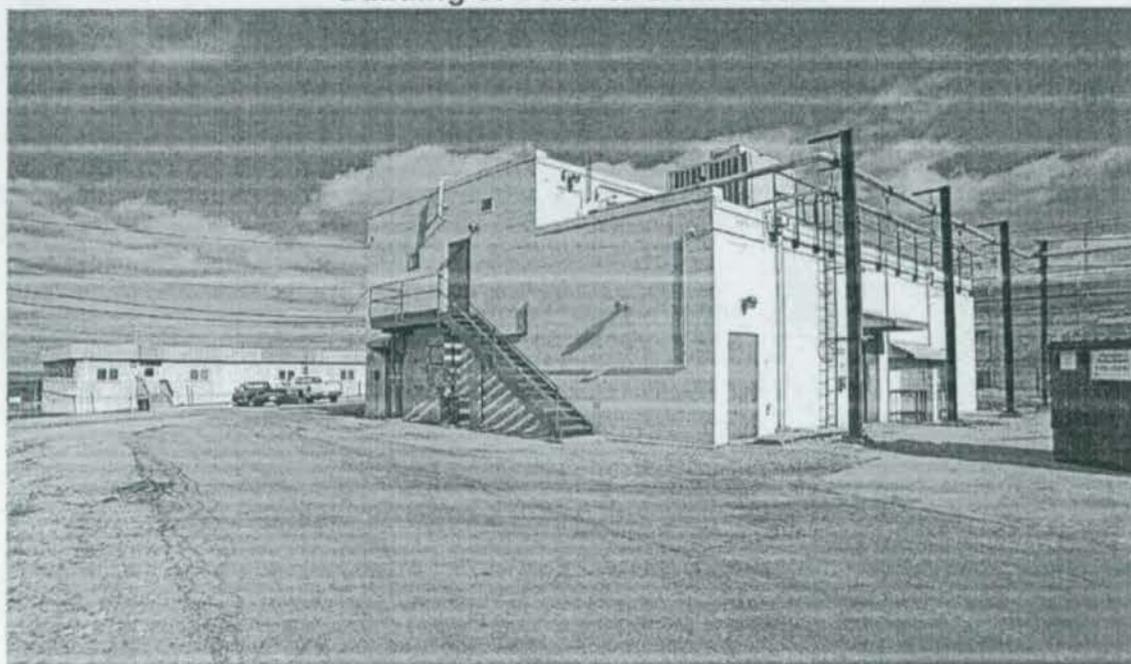
Building 37 Prior to Demolition

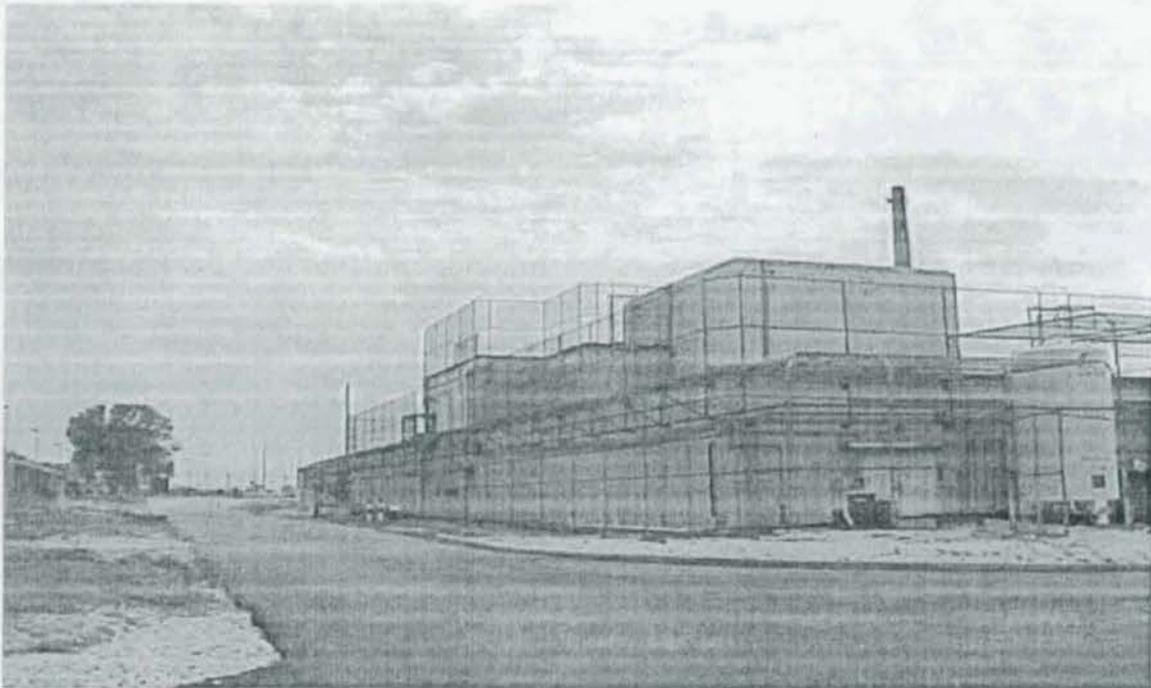
**Building 50 Prior to Demolition**

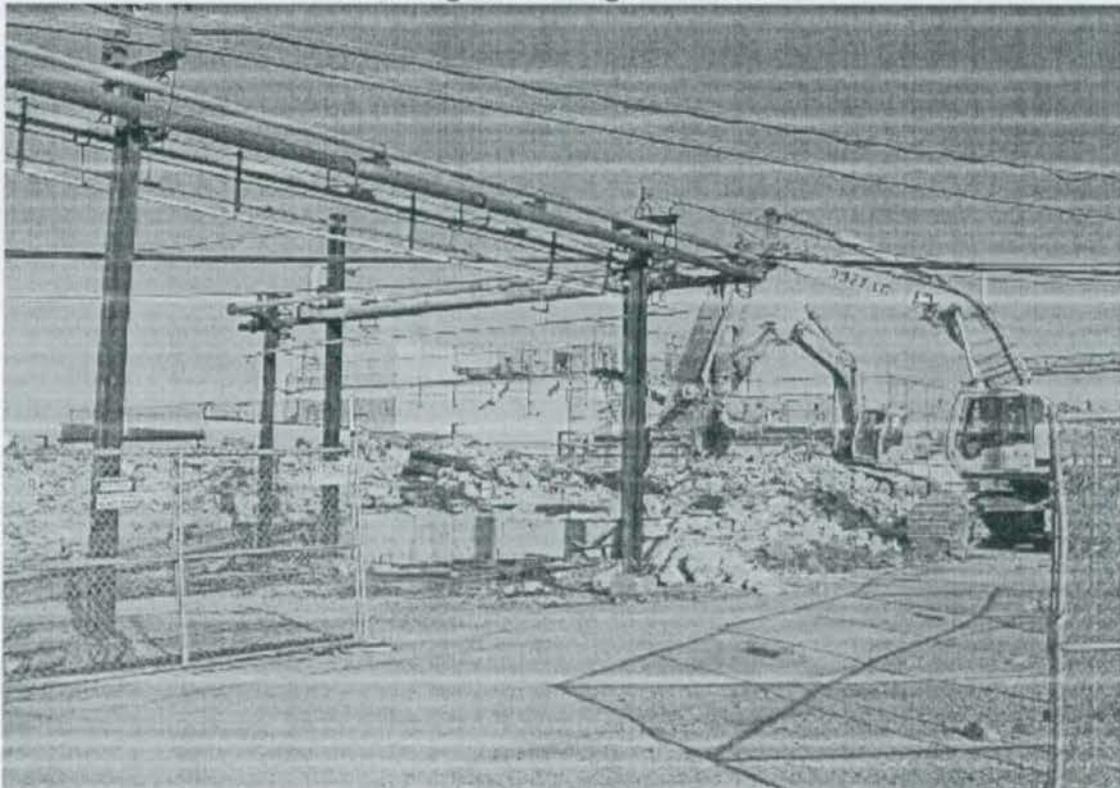
**Building 36 During Demolition**

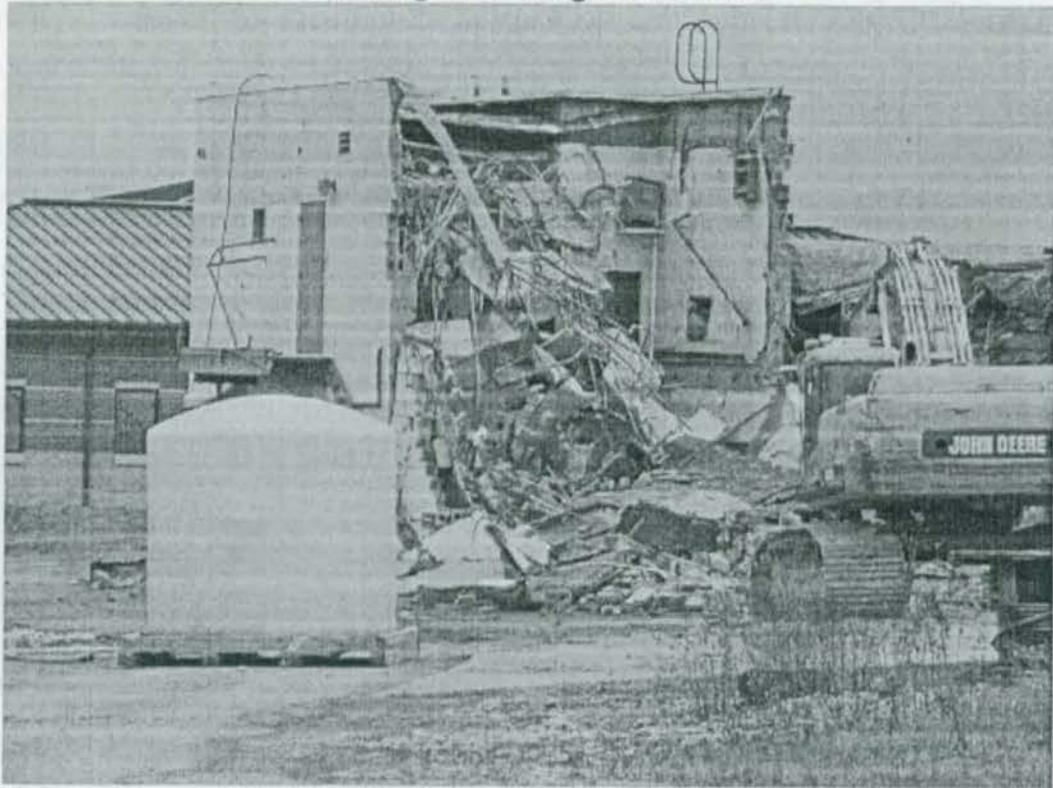
Building 37 During Demolition

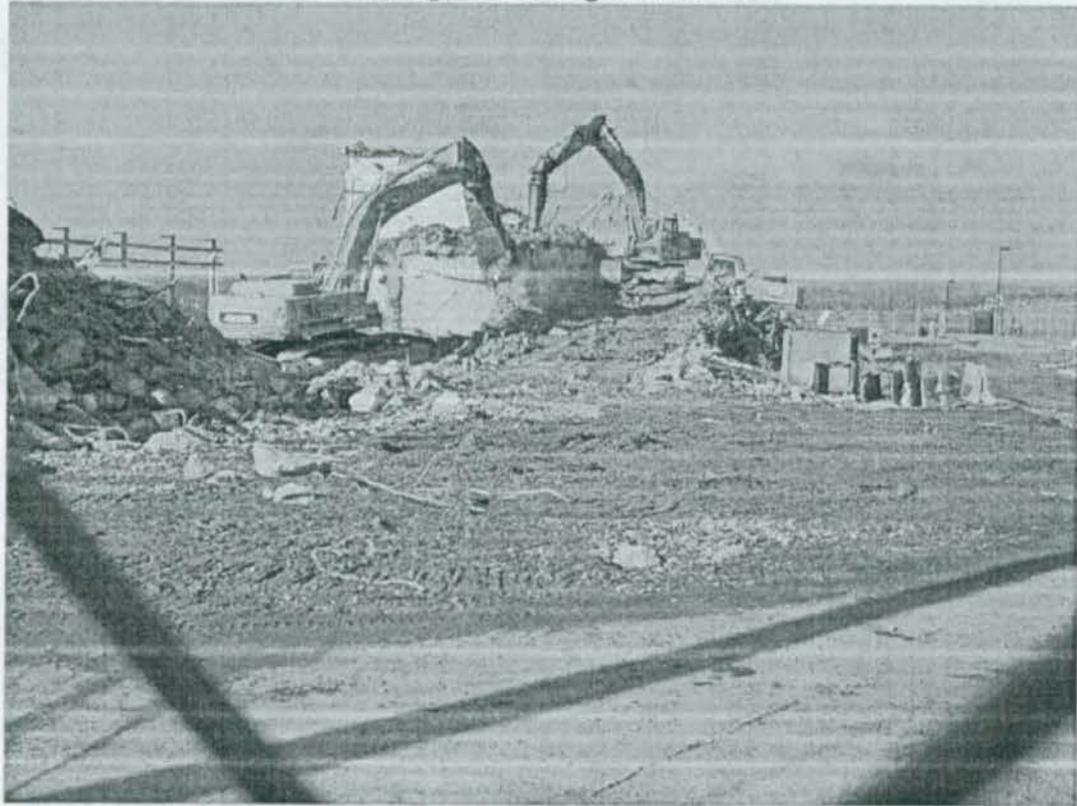
Building 50 During Demolition

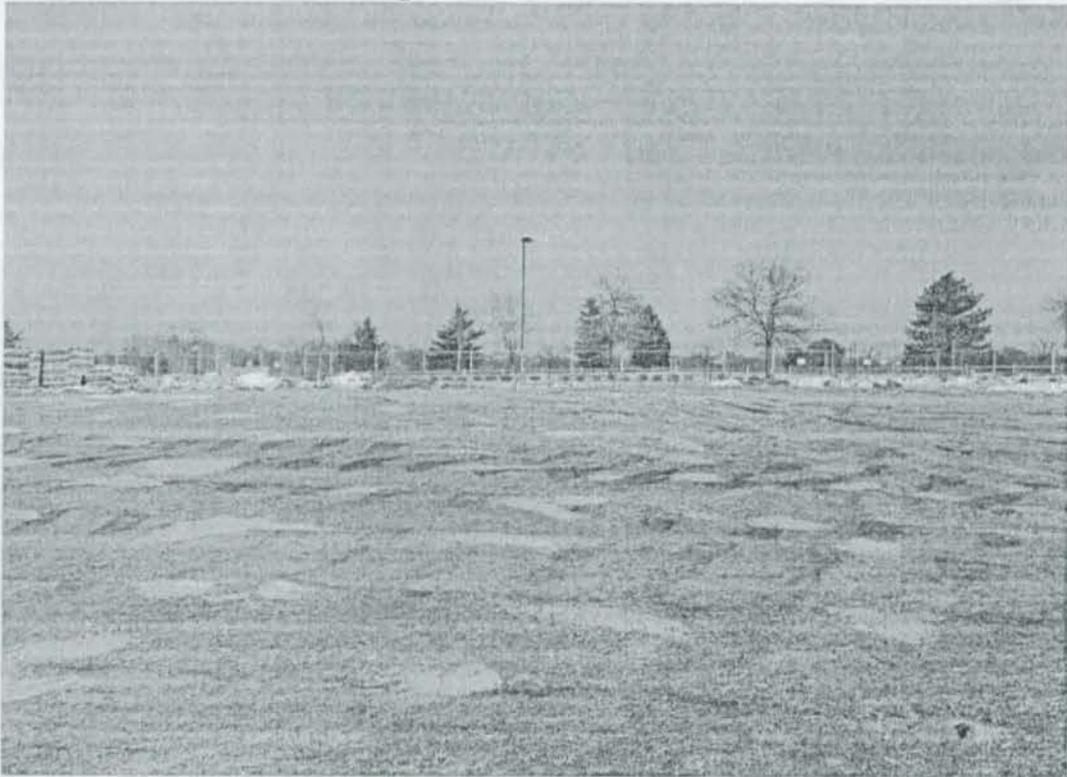
**Building 36 Area Post Demolition**

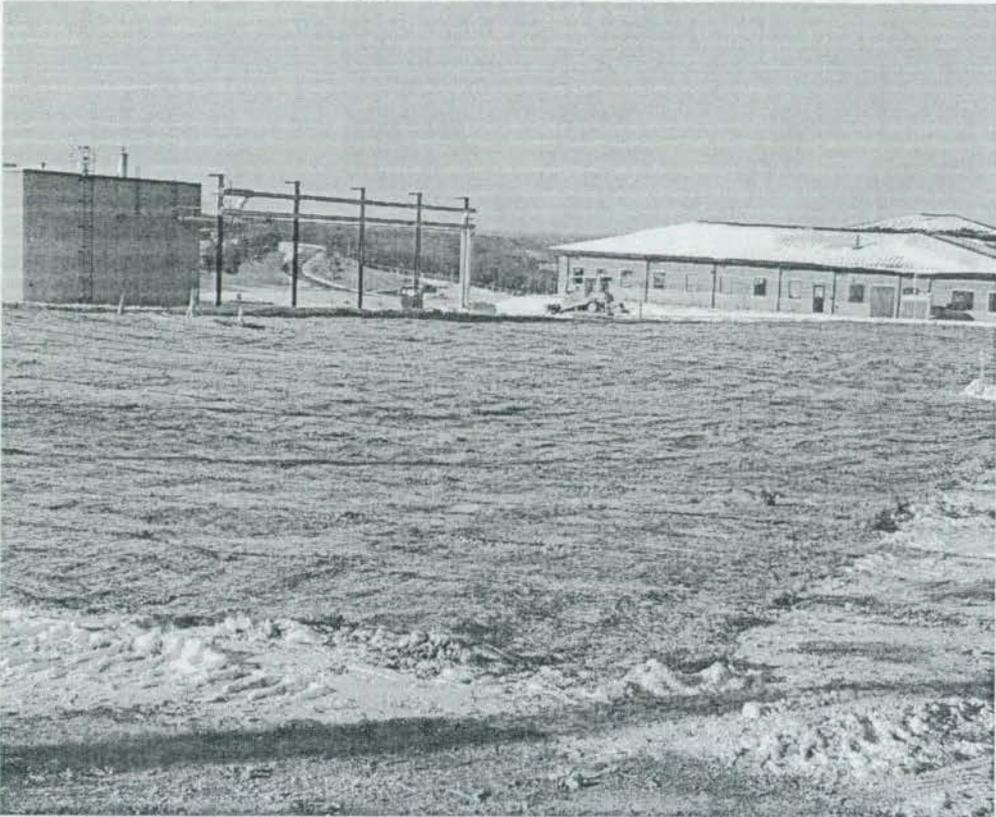
Buildings 36, 37 and 50 were successfully demolished per the Work Packages. After demolition of the buildings, the site was used to stage clean foundation demolition rubble from various buildings. The concrete rubble was size reduced and then used onsite as backfill. The area was graded and seeded. The area after final seeding is shown in Appendix B.

Building 50 Area Post Demolition

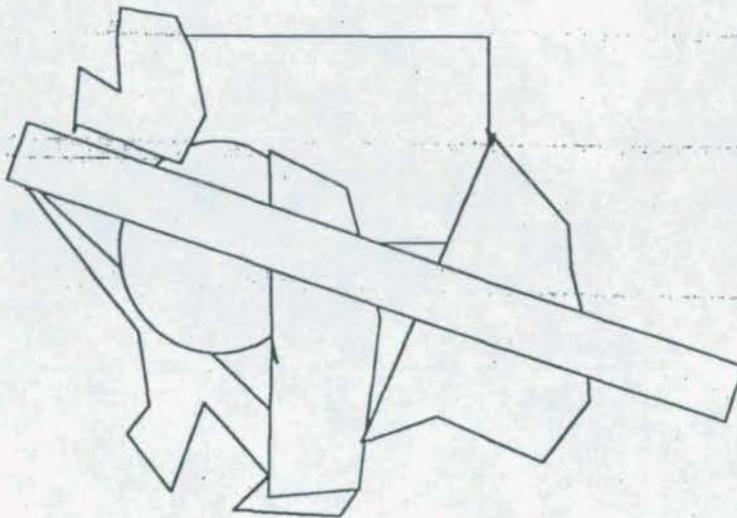
20 SMEARS TAKEN ON CONCRETE

Fidler used for indication only. Results were NON-detectable.

Integrated count taken IF audible detected. NO audible detected.

ALL direct readings <100dpm/100cm<sup>2</sup> Alpha and <5000dpm/100cm<sup>2</sup> Beta

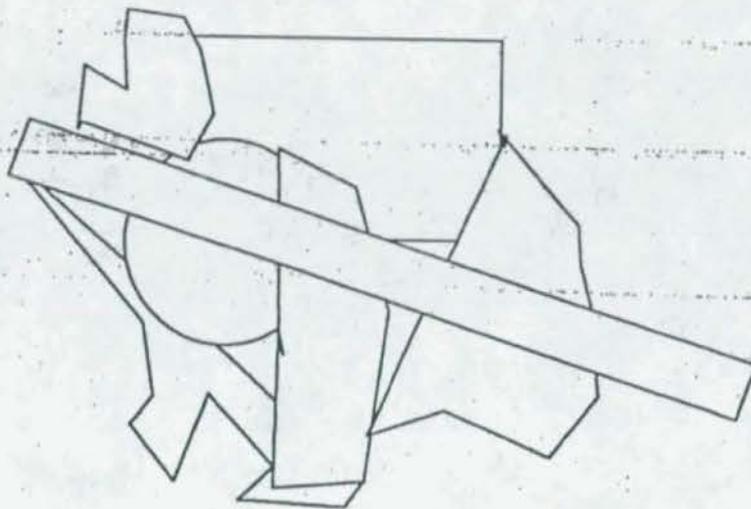
Fidler used for indication only. Results were NON-detectable.

Integrated count taken IF audible detected. NO audible detected.

ALL direct readings <100dpm/100cm<sup>2</sup> Alpha and <5000dpm/100cm<sup>2</sup> Beta

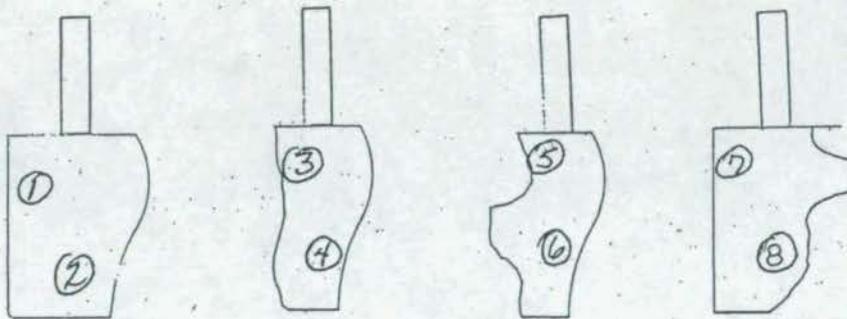
PIPING WITH CONCRETE BASE

INTEGRATED COUNT TAKEN IF AUDIBLE DETECTED. *NONE DETECTED.*

INDICATES DIRECT ALPHA  $< 100 \text{ dpm}/100\text{cm}^2$ , BETA  $< 5000 \text{ dpm}/100\text{cm}^2$

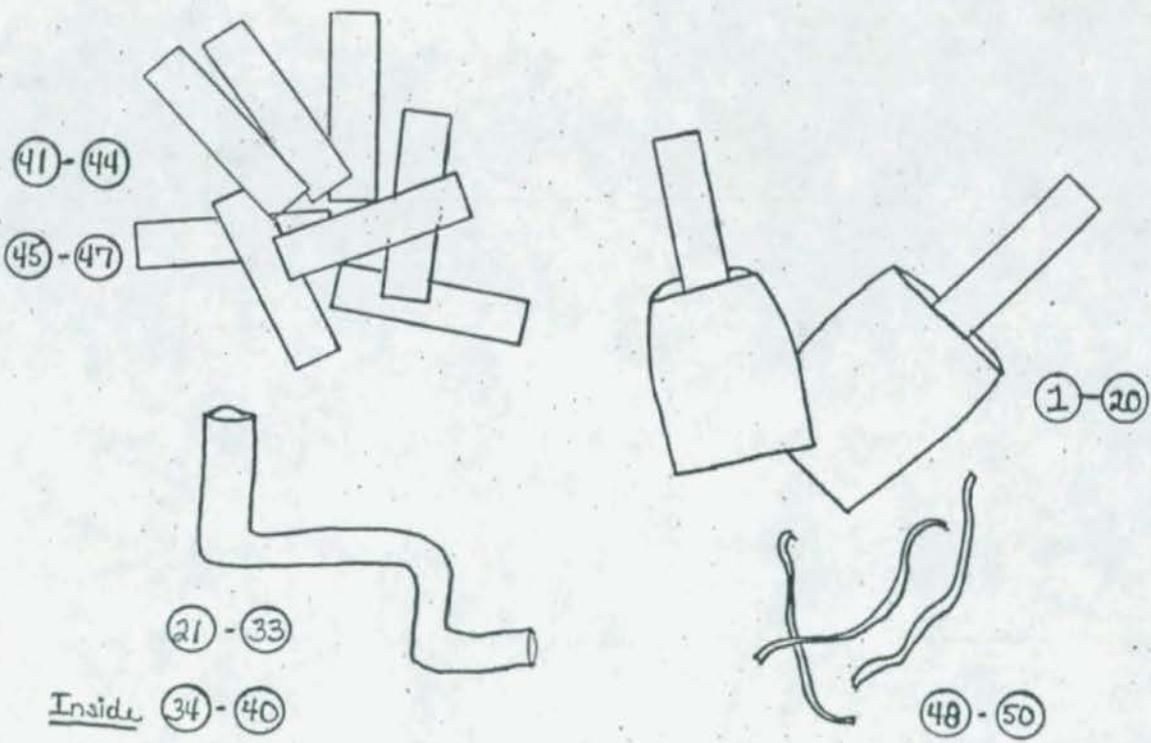
FIDLER used for indication purposes only. No increase above bkg detected.

Direct scan & pause survey conducted. See attached for required integrated counts, background and D.L.
