# Miamisburg Closure Project CLOSEOUT REPORT

## Building 56

(Demolition)

Final  
January 2005

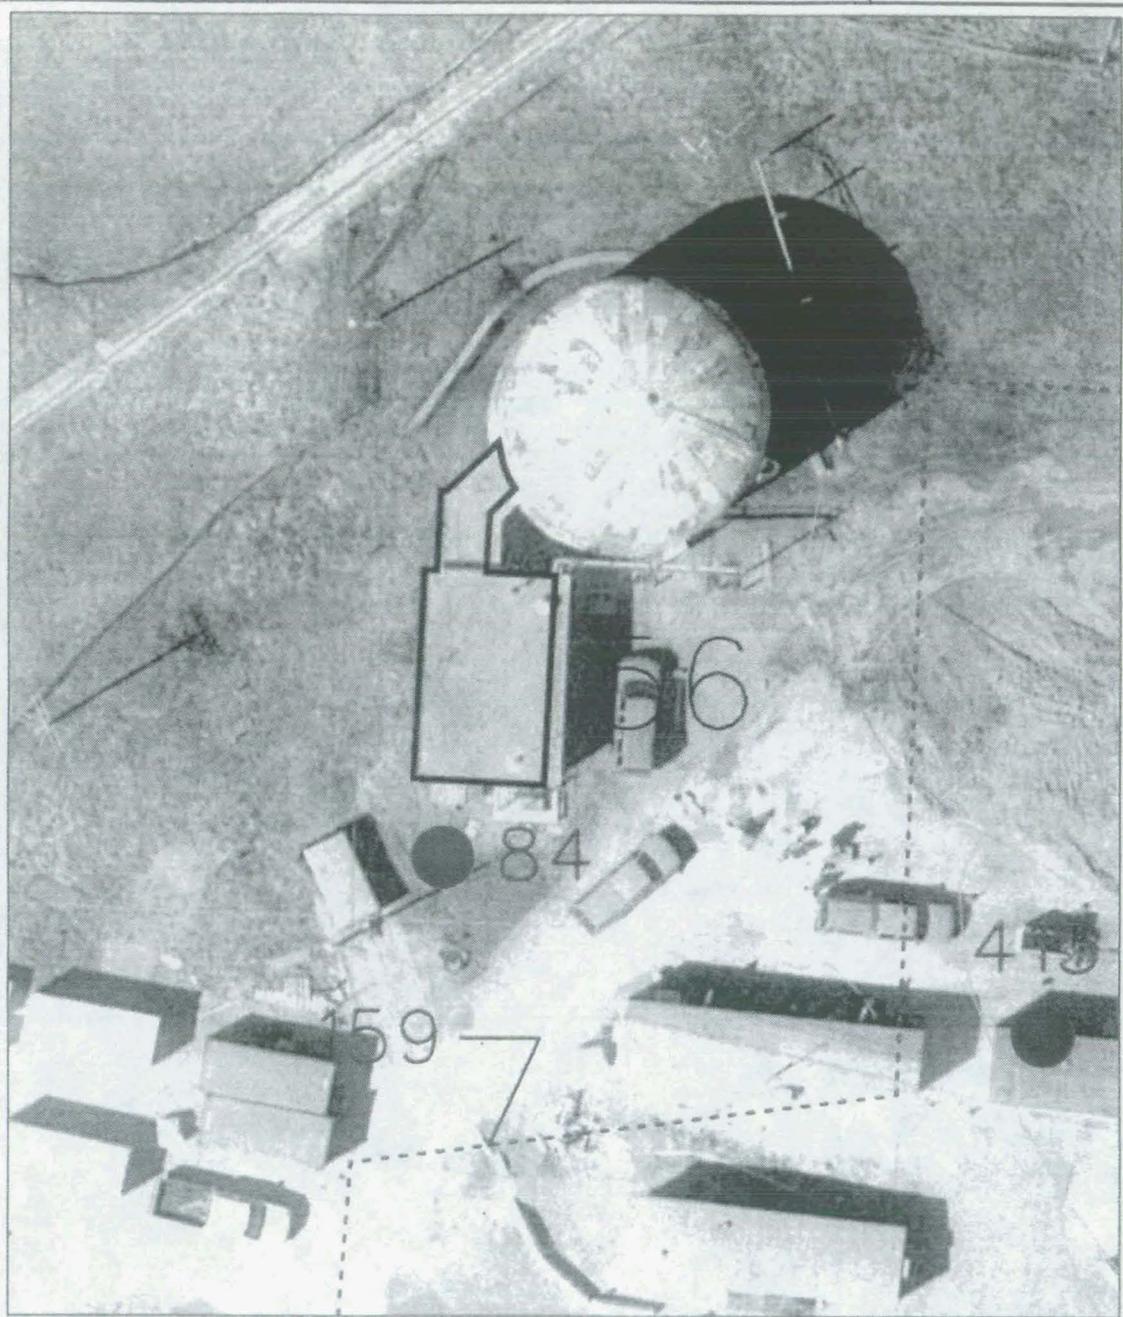
As a result of the investigations and documentation accomplished to comply with the CERCLA cleanup process via the Federal Facilities Agreement (FFA)/DOE Environmental Restoration (ER) Program, DOE and the site contractor tabulated all the PRSs identified under the various regulatory programs in effect at the site. Three PRSs are at or near Building 56, as identified in Table 1. The PRS locations are shown on Figure 2, and recommendation sheets are provided in Appendix C.

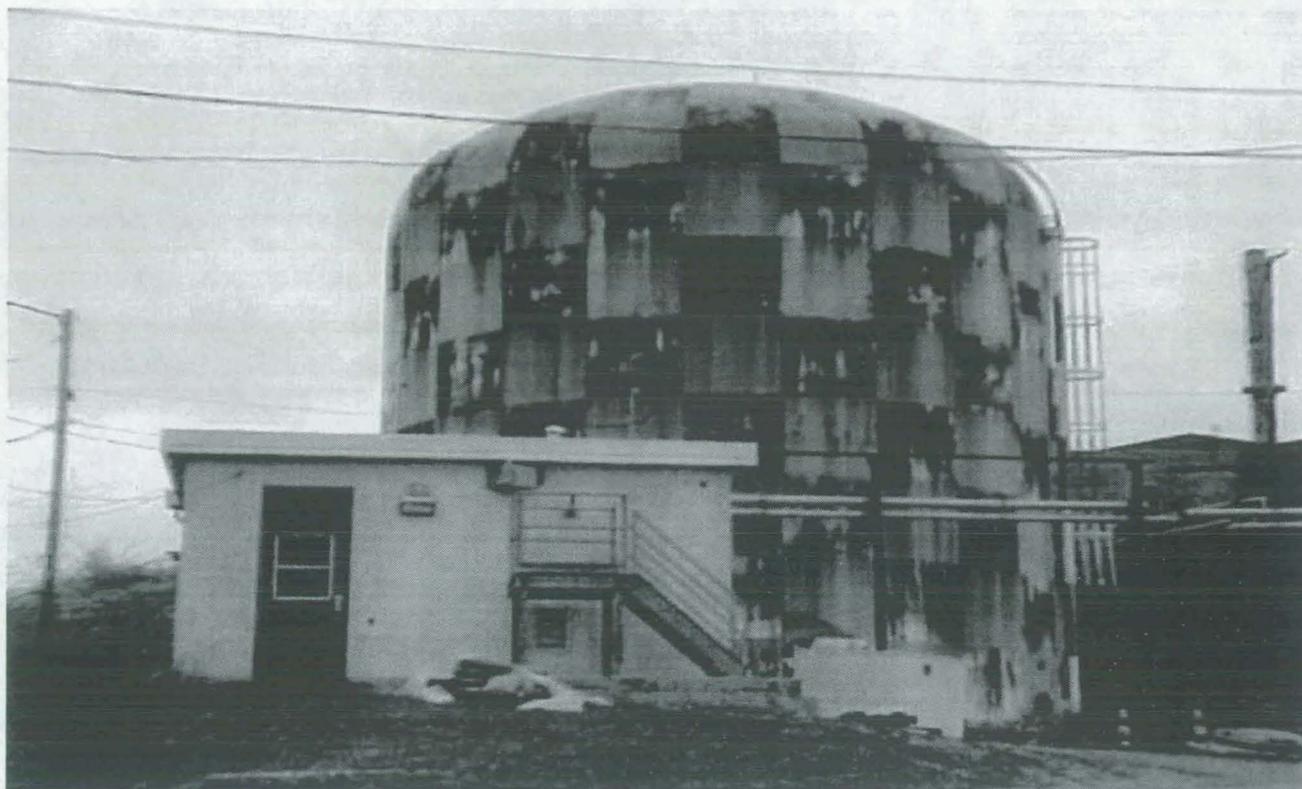
**Building 56  
and water tank**

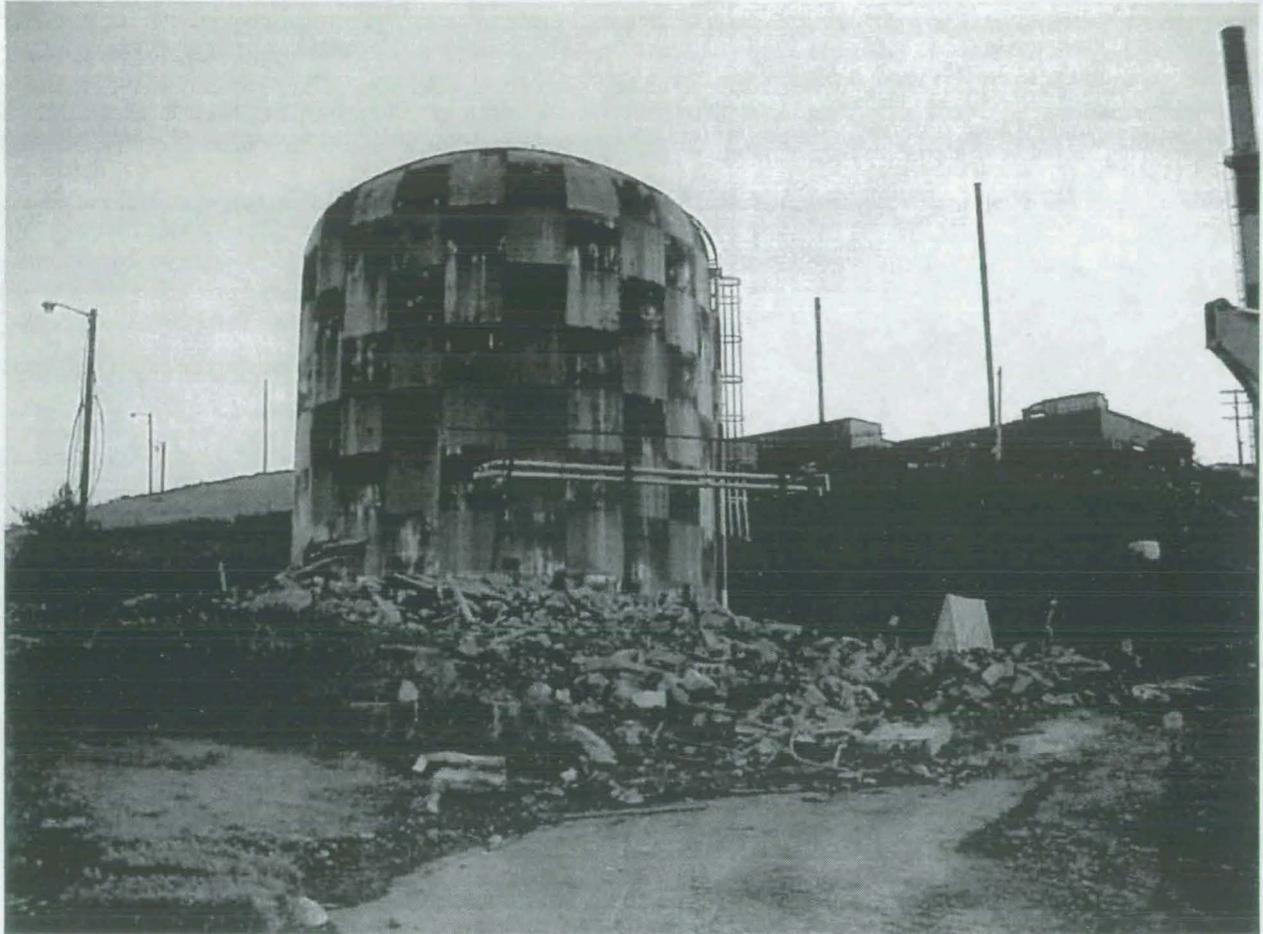
**Building 56  
Demolished**

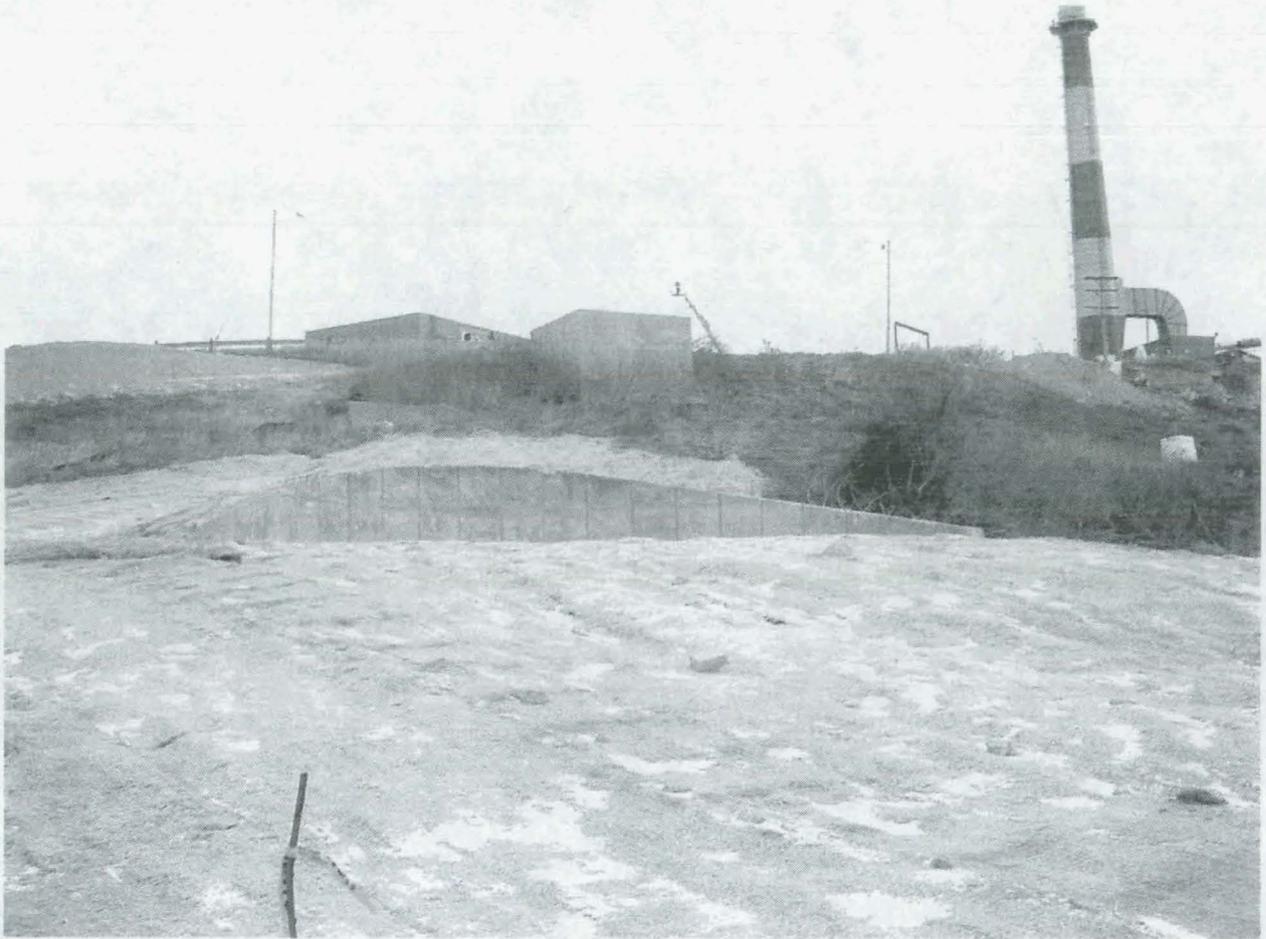
**Building 56 final restoration,  
grass mats rolled over area**

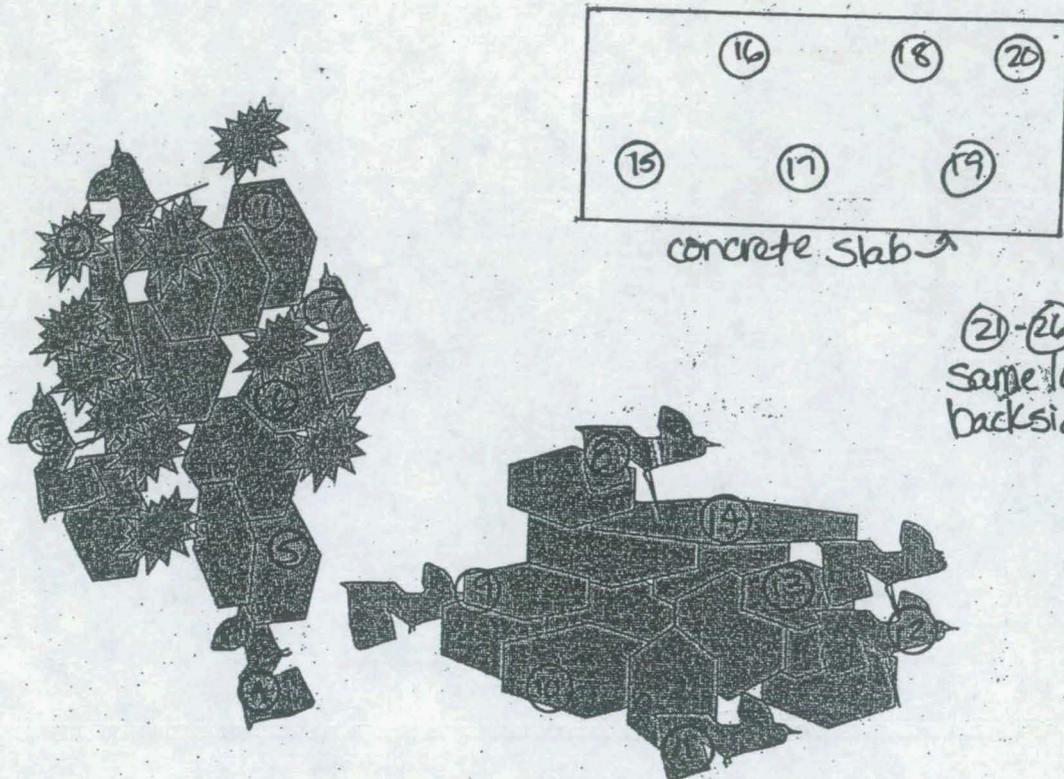
LOCATION: (BLDG./AREA/ROOM)	56 Lot	SURVEY NO.	04TF-0370
PURPOSE:	Survey of concrete rubble prior to going to crusher	RWP NO.	N/A
		DATE:	11.3.04
		TIME:	1500

(21)-(26) taken in same location on backside of slab

Scan: Pause survey conducted at various locations on rubble: slab  
 No audible clicks detected in required time therefore no integrated survey was required.

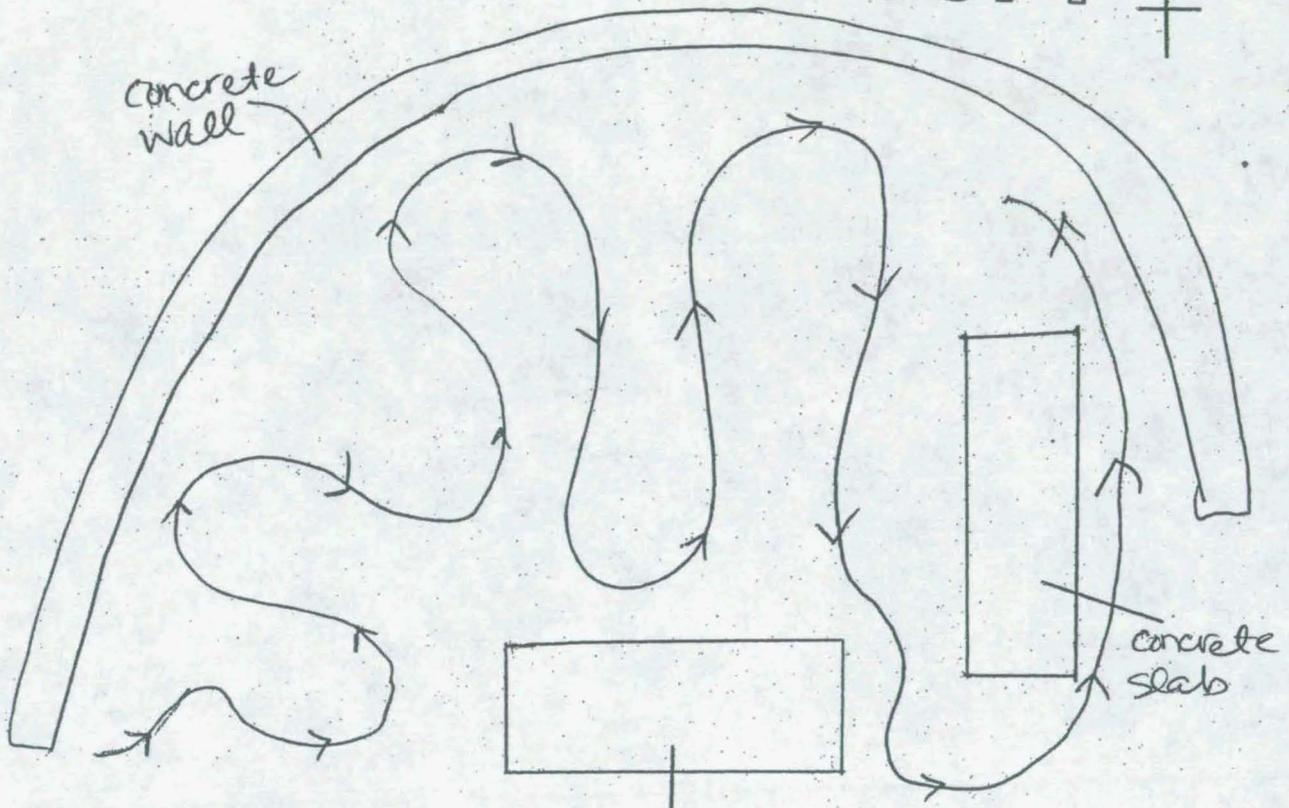
LOCATION: (BLDG./AREA/ROOM)	360 spot	SURVEY NO.	04-TF-0371
PURPOSE: Survey of soil prior to excavation *for indication purposes only*		RWP NO.	N/A
		DATE:	11.3.04
		TIME:	1400

Fidler Bkg. 360 cpm or  
All readings taken were  
background.

→ → → = Survey path w/ fidler
