Miamisburg Closure Project CLOSEOUT REPORT

Building 128

(Demolition)

Final, Rev. 1
July 2006

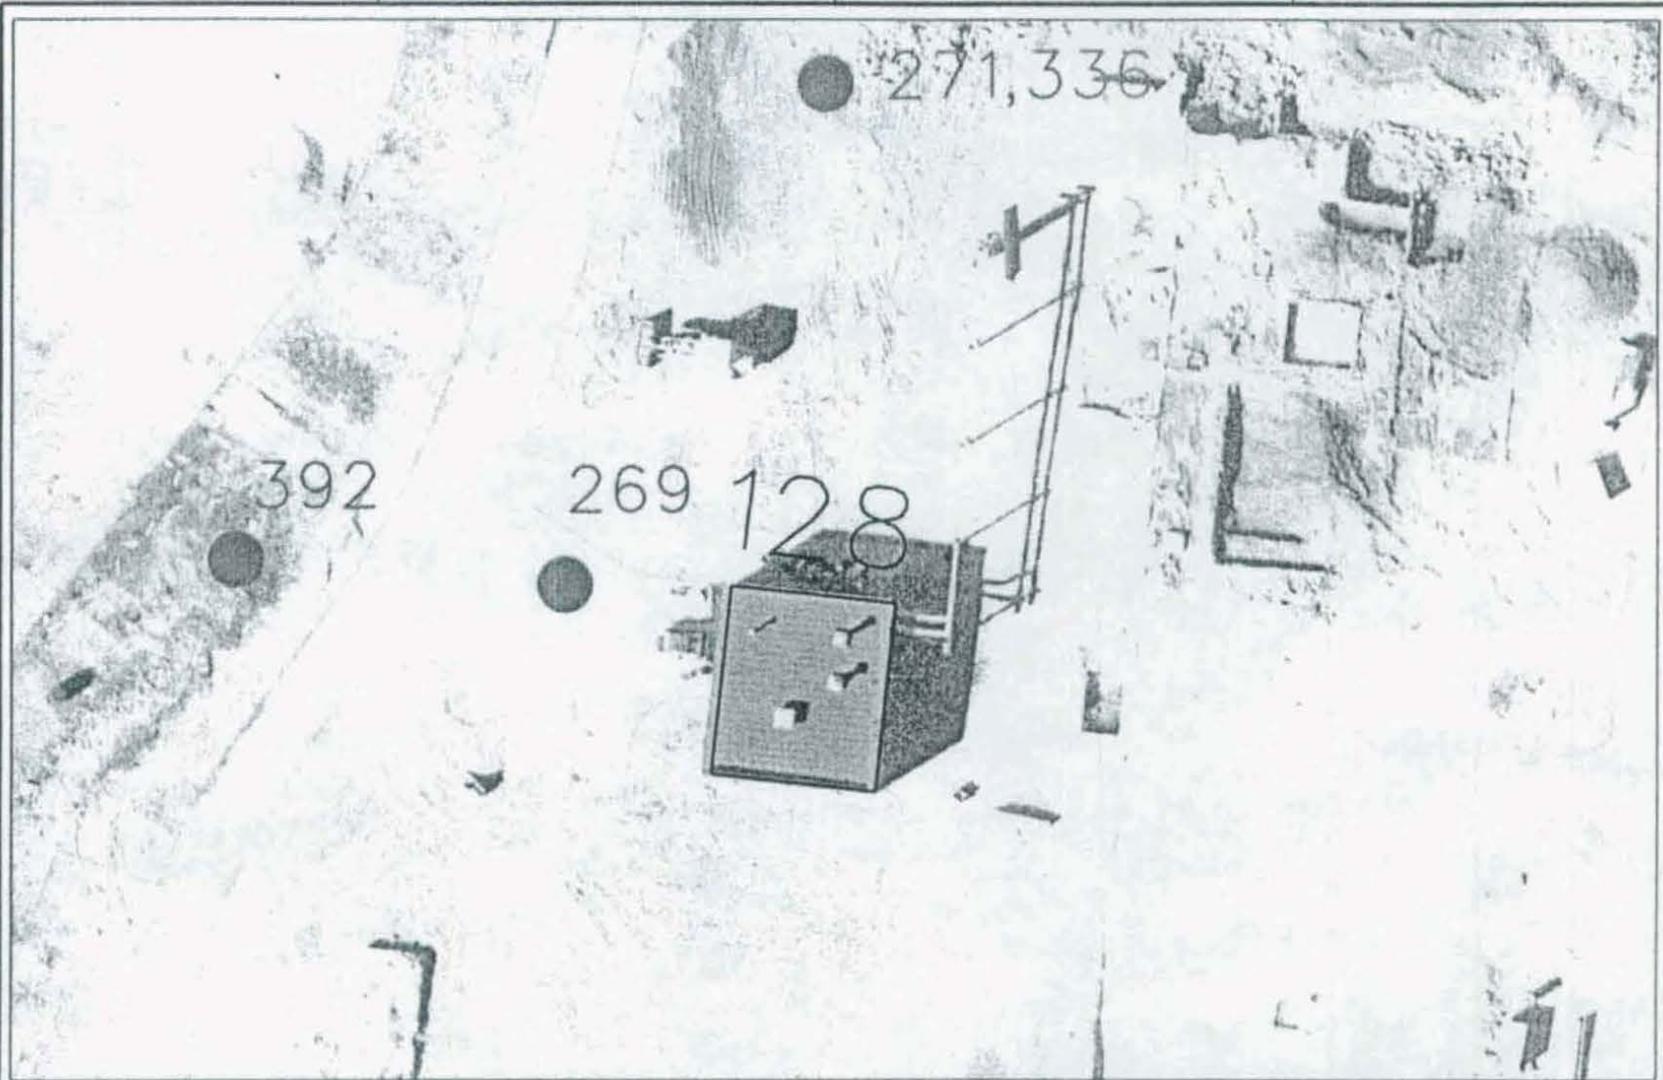
Figure 2: Building 128 and Vicinity

As a result of the investigations and documentation accomplished to comply with the CERCLA cleanup process via the Federal Facilities Agreement (FFA)/DOE Environmental Restoration (ER) Program, DOE and the site contractor tabulated all the PRSs identified under the various regulatory programs in effect at the site. Of these PRSs, four are at or near Building 128, as identified in Table 1. The PRS locations are shown in Appendix A, Figure 2 and PRS recommendation sheets are provided in Appendix C.

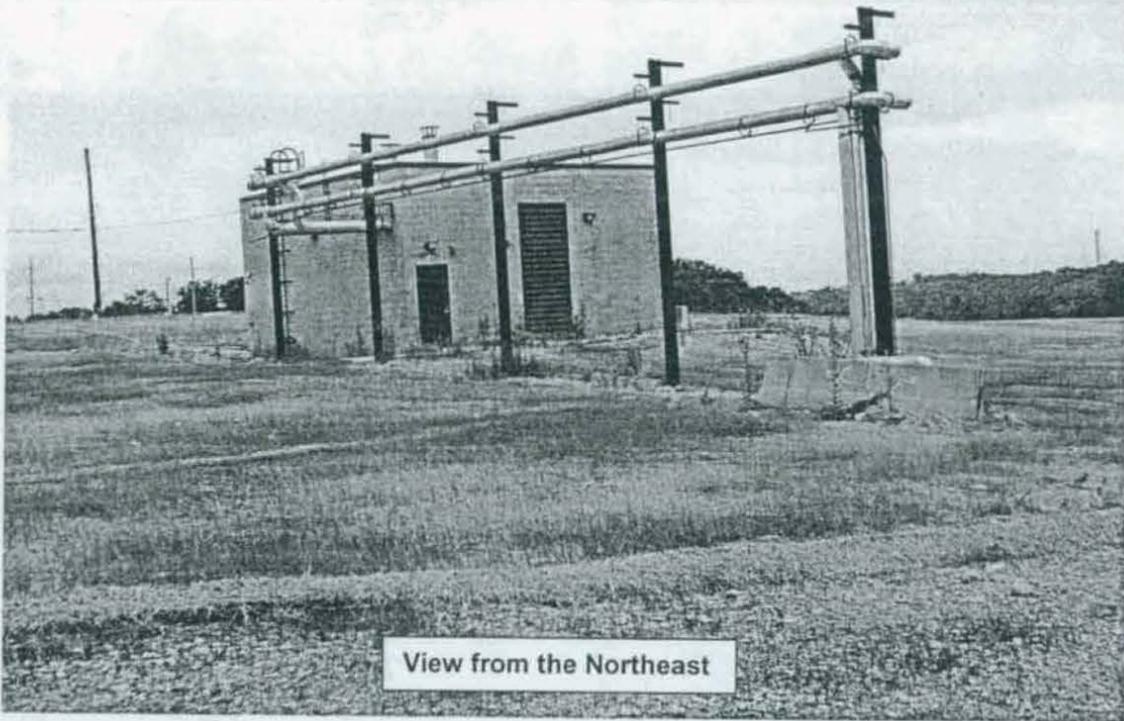
View from the Northeast

Building 128 – Prior to Demolition

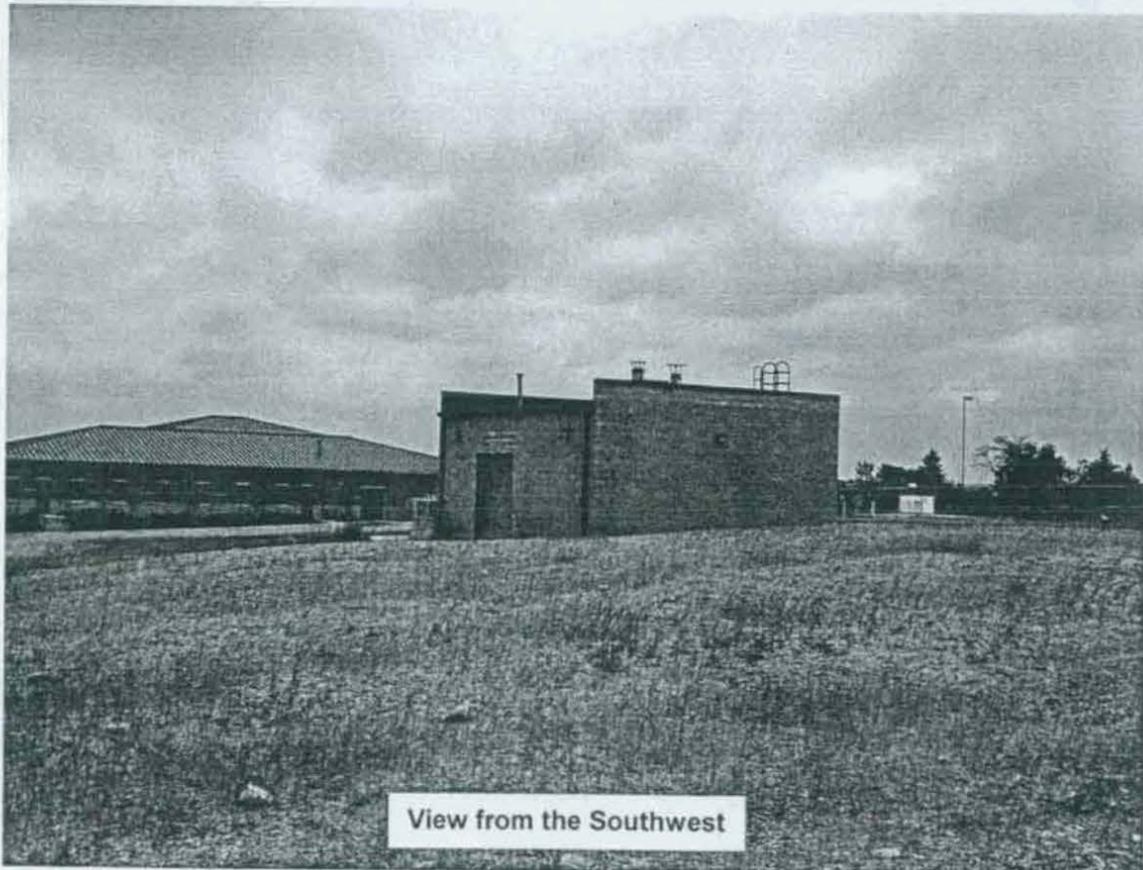
View from the Southwest

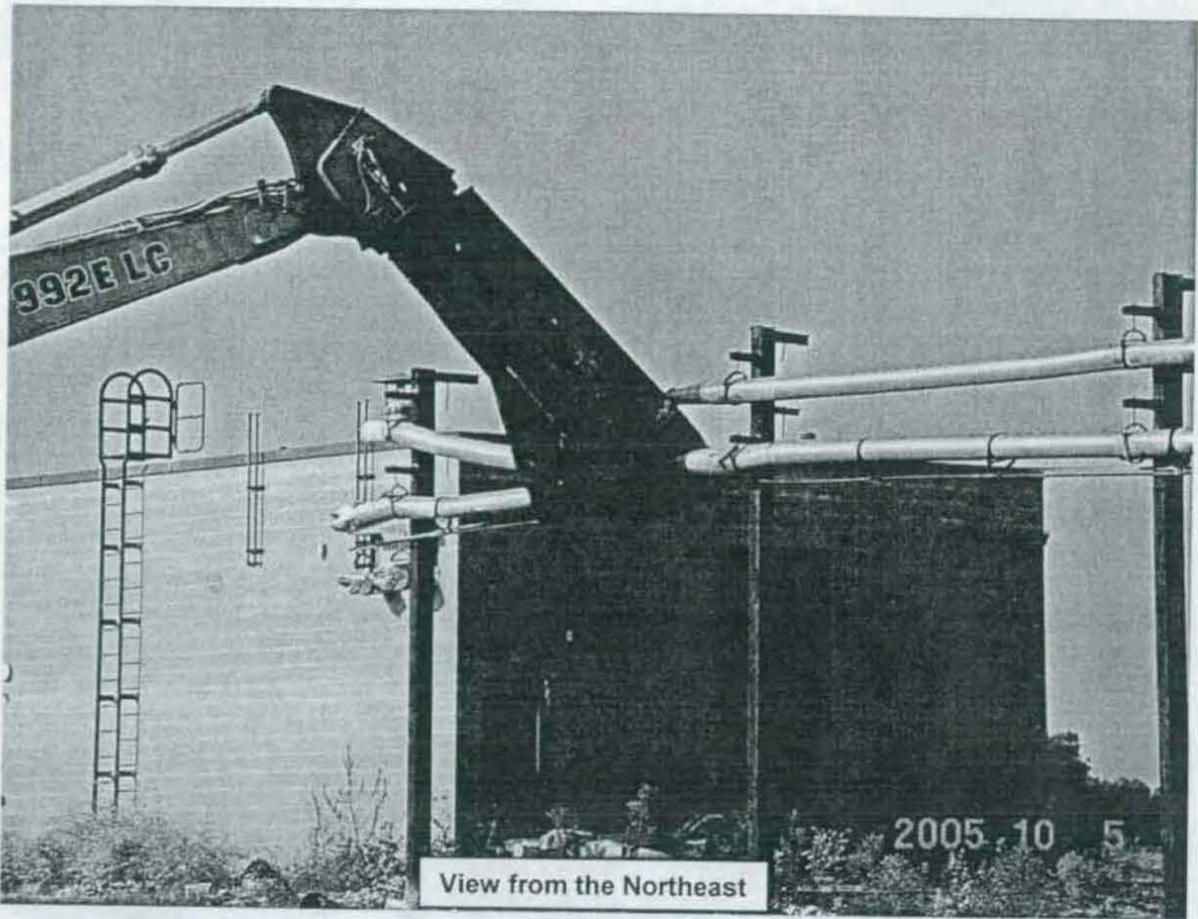
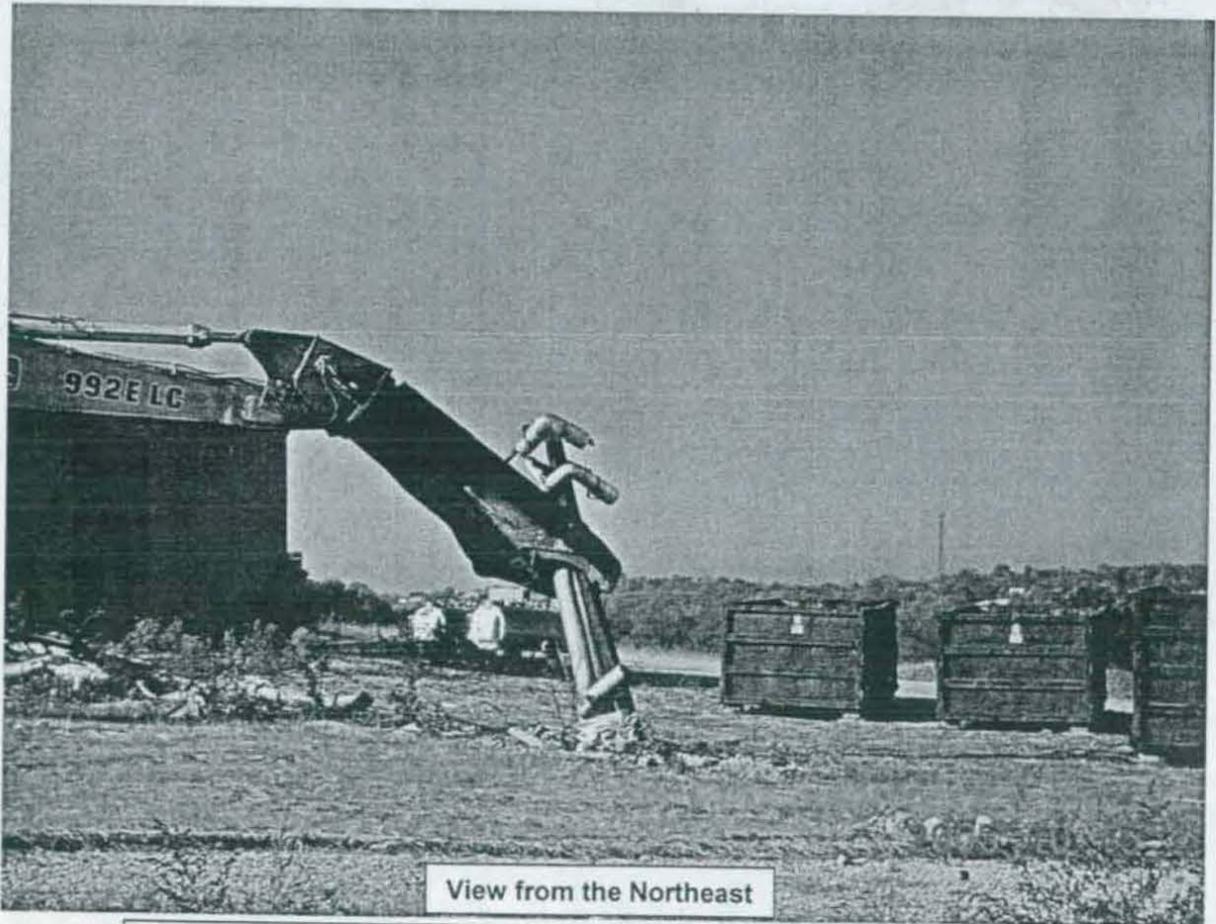
Building 128 – During Demolition Of Utility Stanchion Line

Demolition of Building 128 commenced on 05 October 2005. Demolition activities (including slab, concrete access pad, foundation/footers, sidewalks, and utility stanchion line), except for final site restoration and capping of underground hot water system and natural gas lines were completed on 19 October 2005. No post-demolition radiological surveys were performed on the Building 128 superstructure debris.

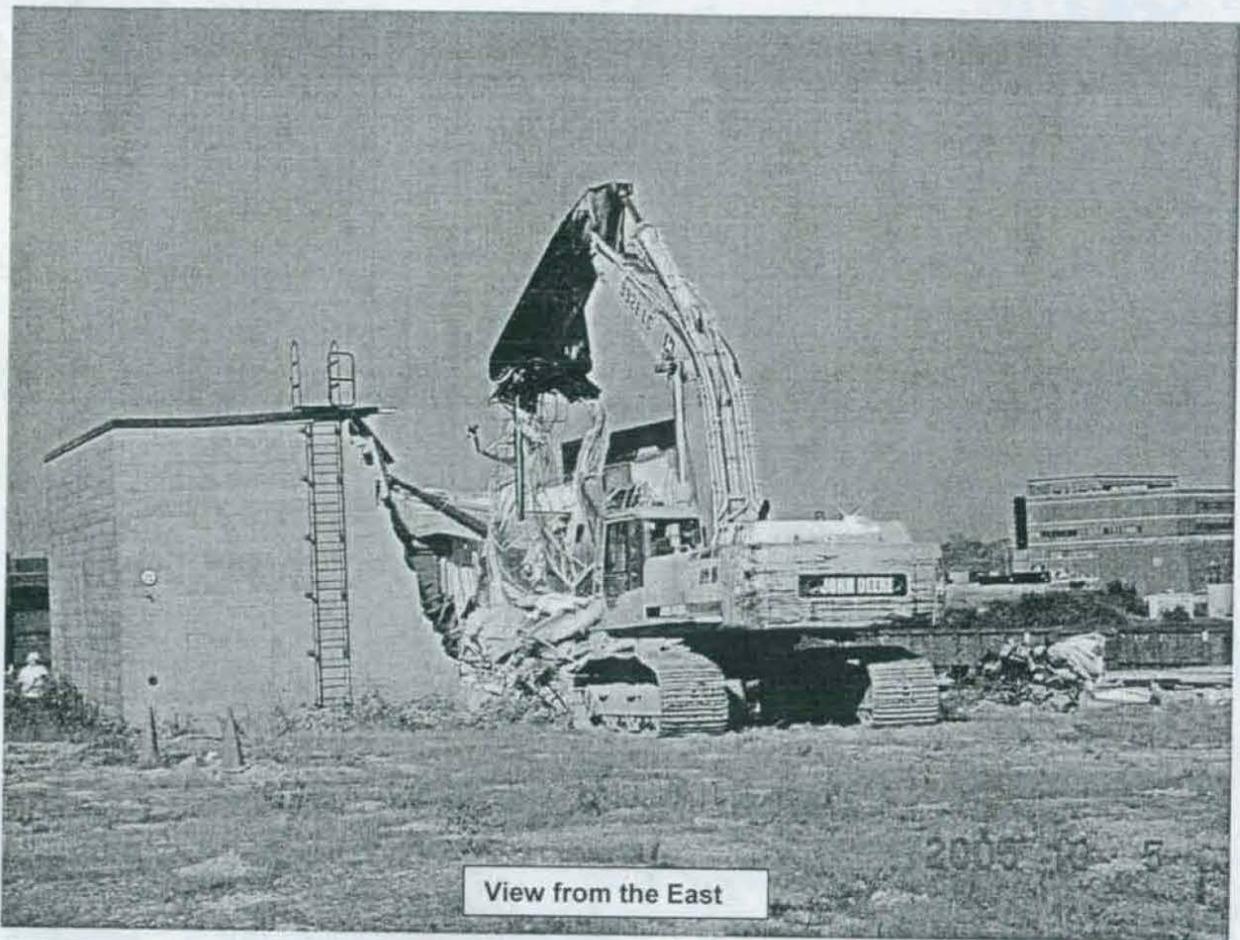
View from the East

Building 128 – During Demolition of Building Superstructure

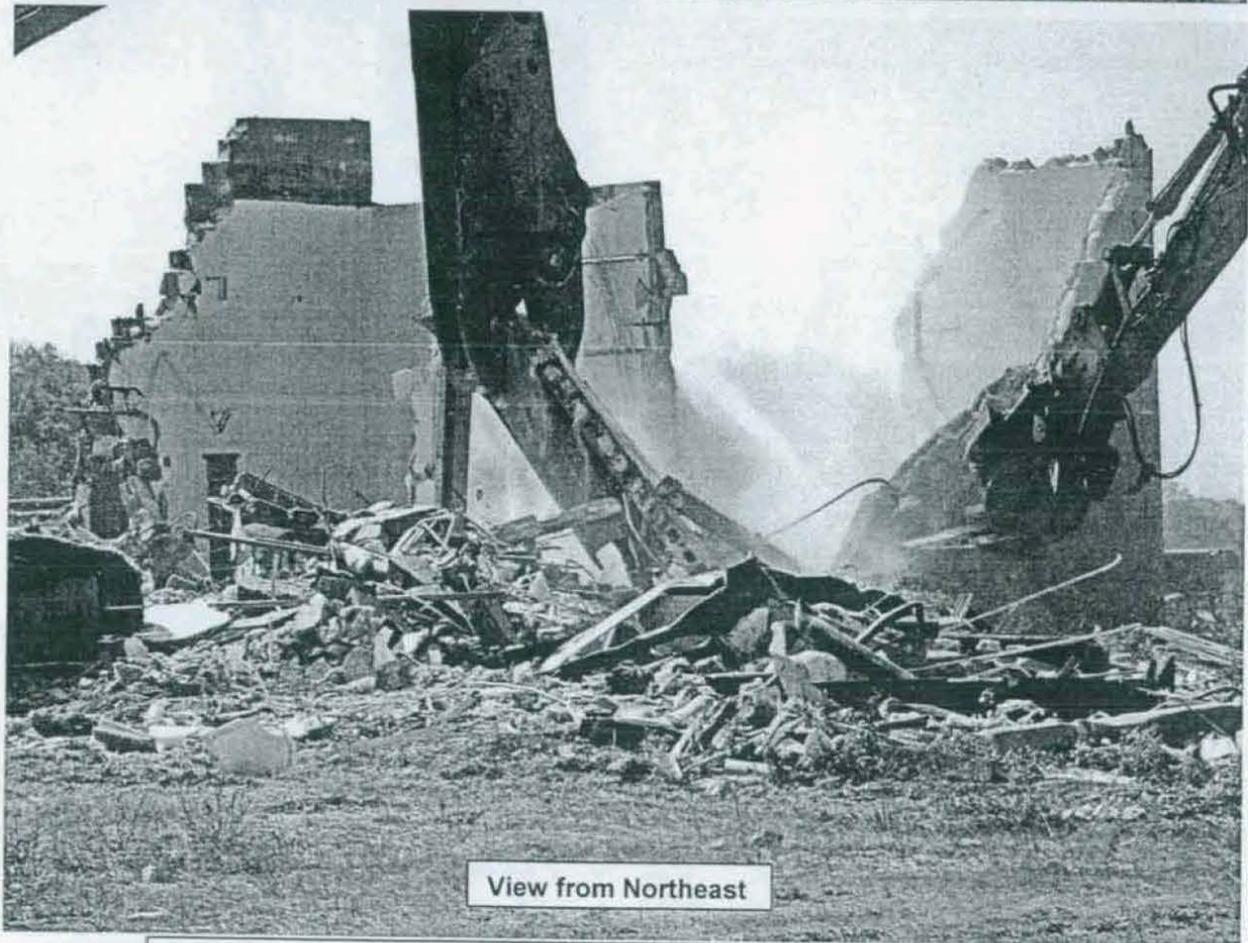
View from Northeast

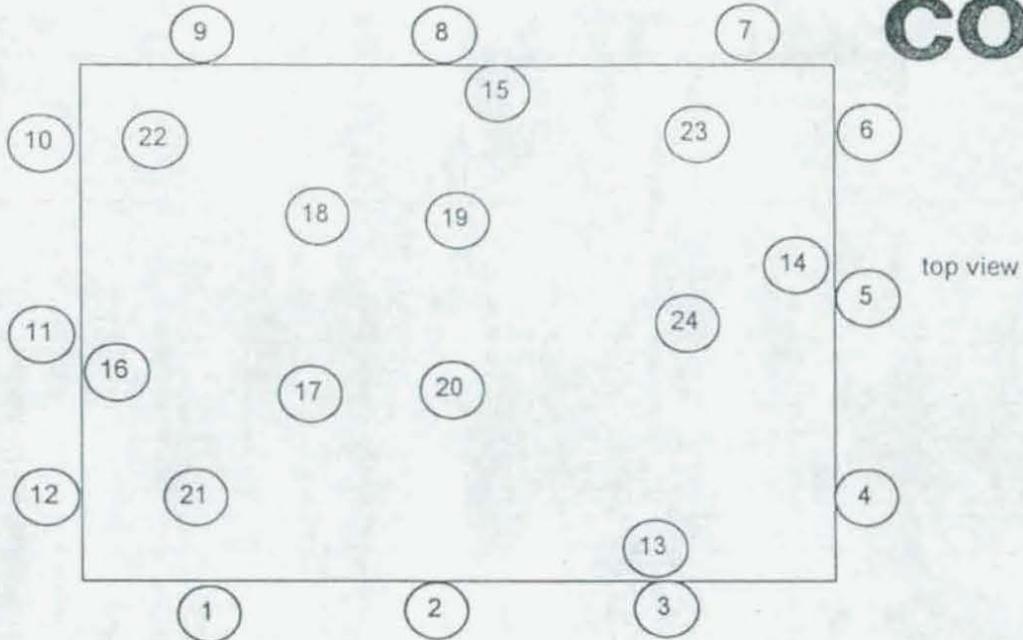
LOCATION (BLDG./AREA/ROOM)	Bldg 128	SURVEY NO.	05-TF-0309
PURPOSE	Verification survey prior to demo	RWT# (No)	N/A
		DATE	9/28/05
		TIME	10:00

Bkgd. = 1.8 cpm alpha
 142 cpm beta
 DL = 1.8 cpm alpha
 20 cpm beta

scan and pause survey performed at random and smear locations. no audible detected, therefore no intergrates taken *except at smear locations denoted on pages 5 and 6.*

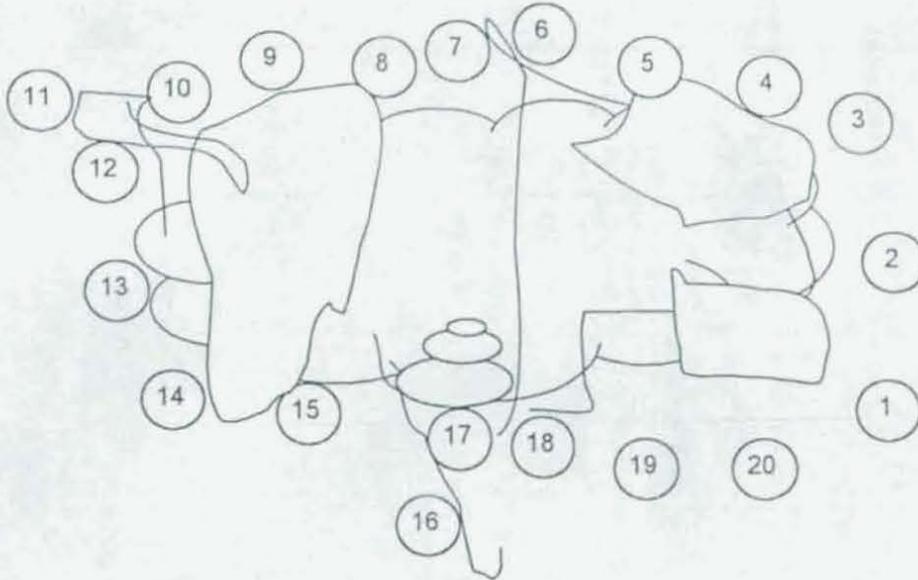
LOCATION (BLDG/AREA/ROOM)	Bldg. 128	SURVEY NO	05-TF-0313
PURPOSE	Characterization survey of concrete slab	RVP NO	N/A
		DATE	10/6/05
		TIME	16:00

Bkgd. 1.8 cpm alpha
 185 cpm beta
 D.L. 1.8 cpm alpha
 20 cpm beta

Direct scan and pause survey conducted at each smear location and other various locations
 No audible clicks in required time, therefore no integrated counts required.

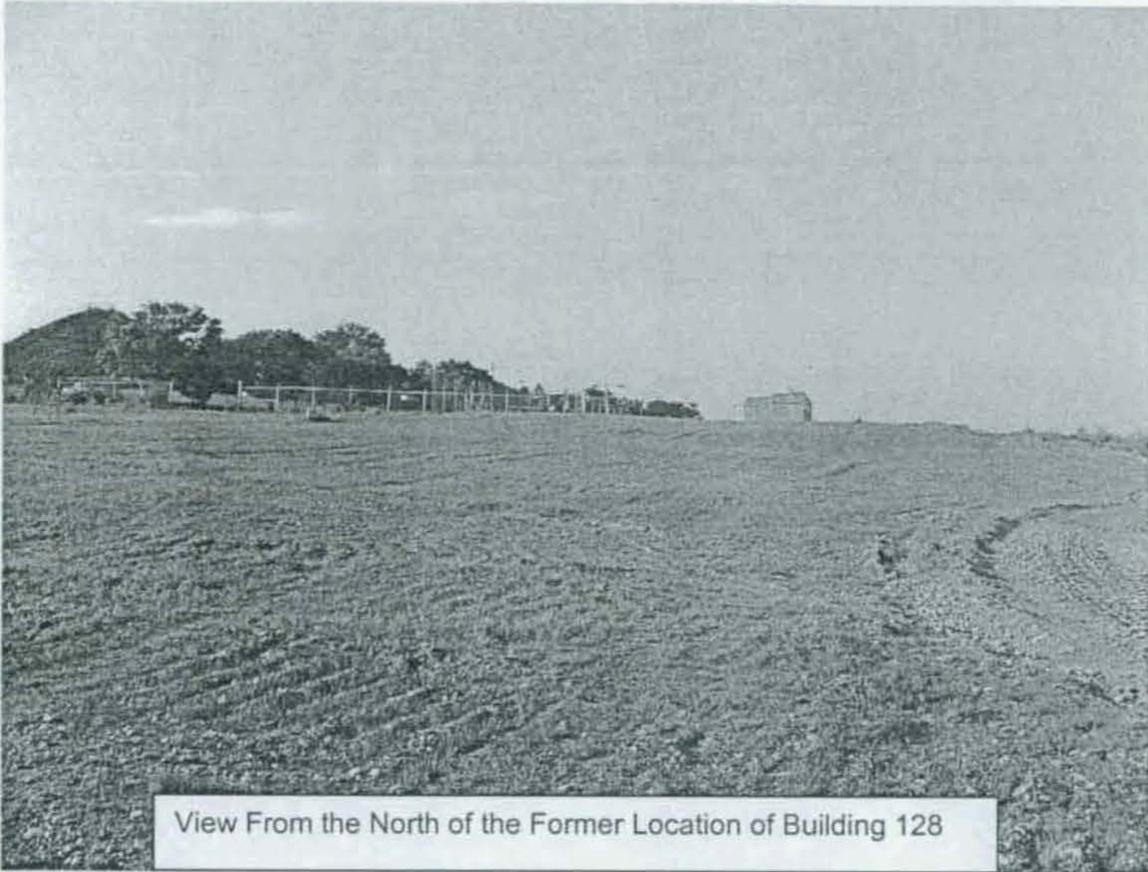
Building 128 Area After Final Site Restoration

View From the North of the Former Location of Building 128

The underground hot water system and natural gas lines to Building 128 were cut-off and capped approximately three-foot below grade. Soil from the site "spoils" area was applied over the demolition area and then graded and seeded.

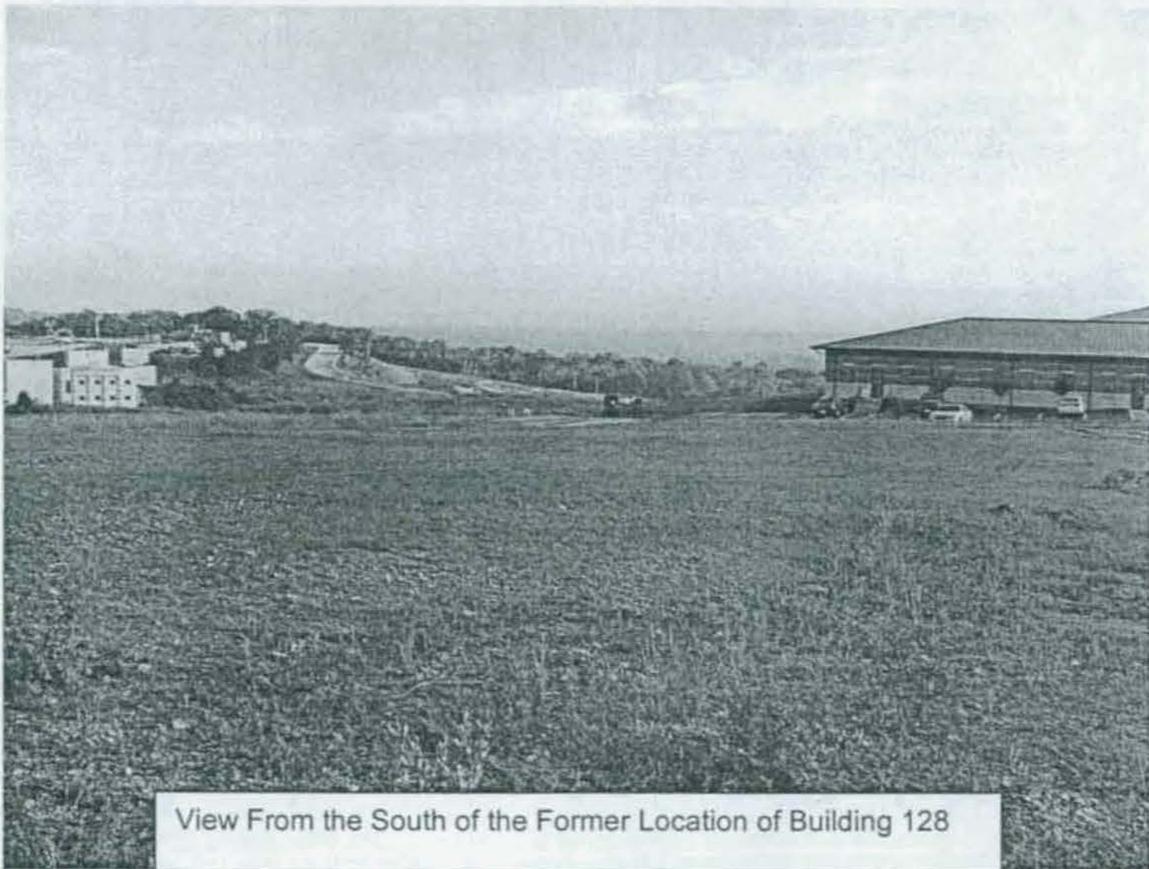
View From the South of the Former Location of Building 128
