Parcel 6, 7, and 8

Ecological Scoping Report

Final
June 2005

Miamisburg Closure Project

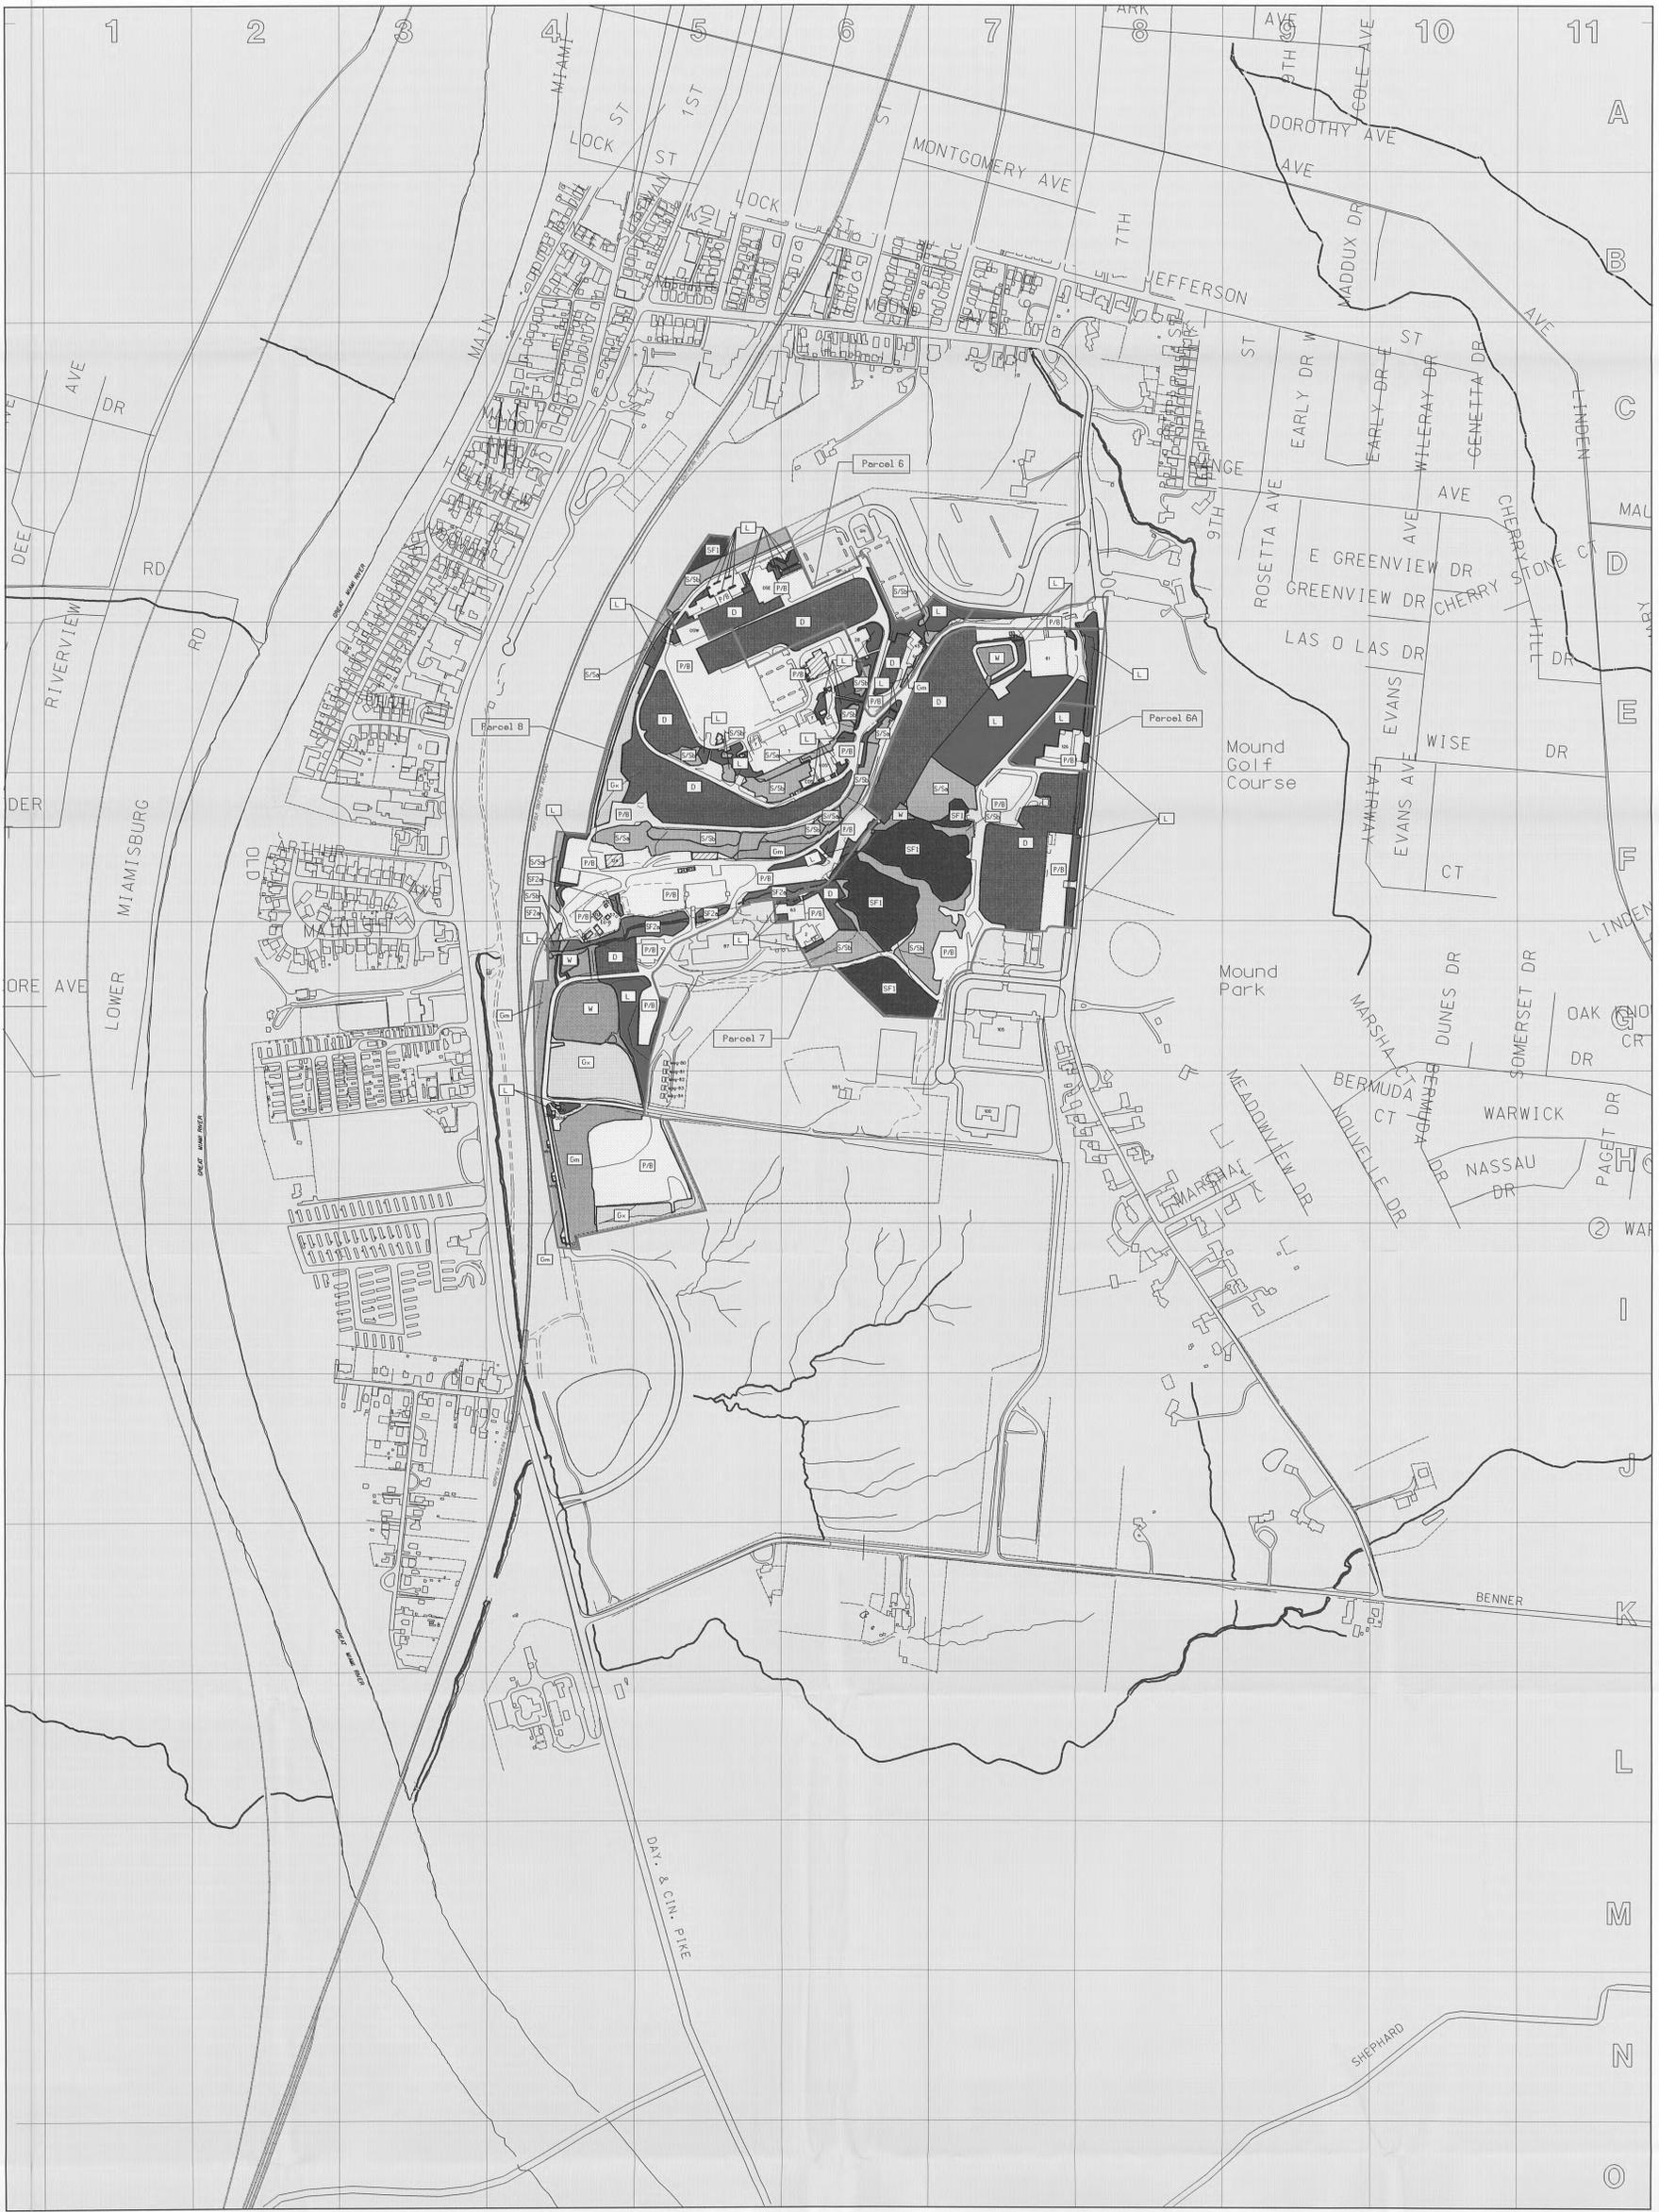
**Parcel 6, 7 and 8
Ecological Scoping Report
06/2005**

Legend	Parcel Boundary
Gn-Grassland	Parcel Boundary
Gs-Substrate grassland	Creek
S/S-Late successional scrub/shrub	Building to be removed
SF-High gradient upland forest dominated by North and West aspects	
SF-Low gradient upland forest at 10' level or nearby level topography	
L-Maintained lawn	
B-Disturbed	
P/B-Paved lot or building	
W-Wetlands / Perennial Waterways	
S/S-Early successional scrub/shrub
