RECONNAISSANCE LEVEL CHARACTERIZATION REPORT (RLCR)

444 CLUSTER CLOSURE PROJECT

Buildings 444, 445, 447, 448, 450, 451 & 455

REVISION 0

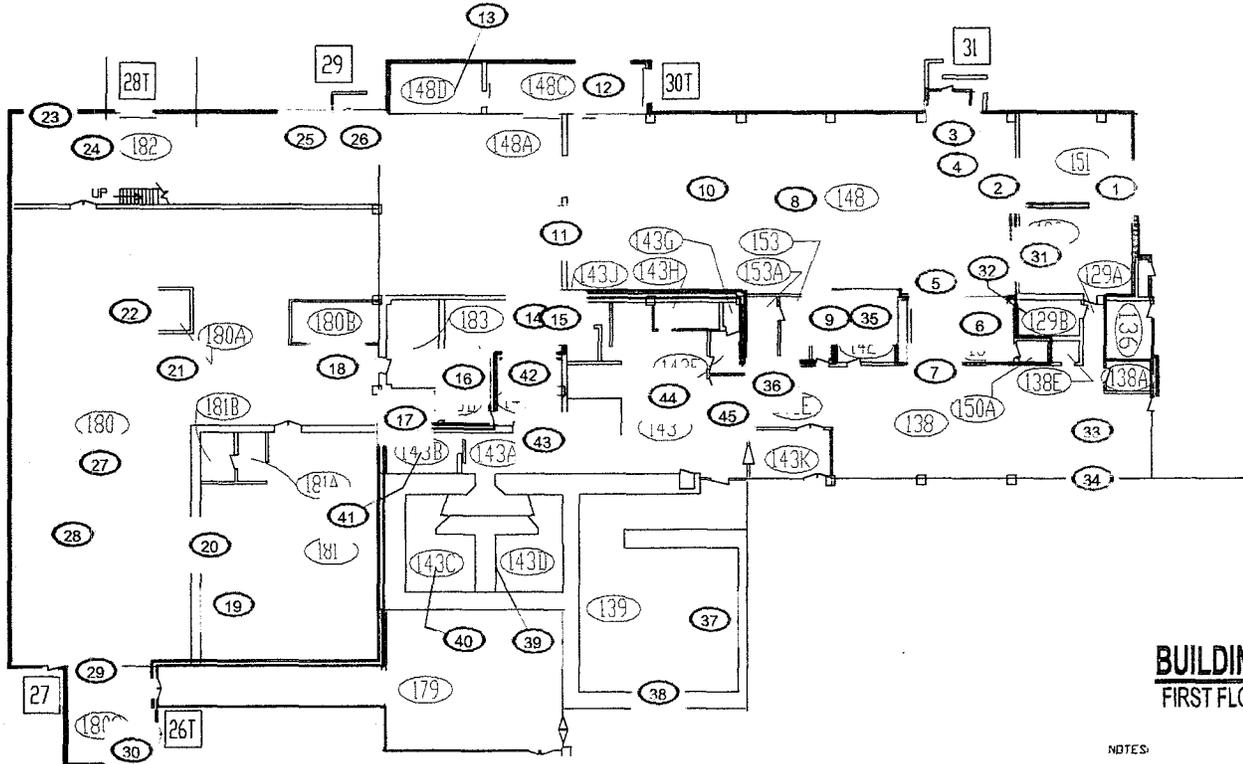
BUILDING 444
FIRST FLOOR PLAN

Survey Area: A Survey Unit: N/A Classification: N/A
 Building: 444 First Floor
 Survey Unit Description: <2m Floor & Walls
 Total Area: N/A sq. m. Total Floor Area: 1500 sq. m.

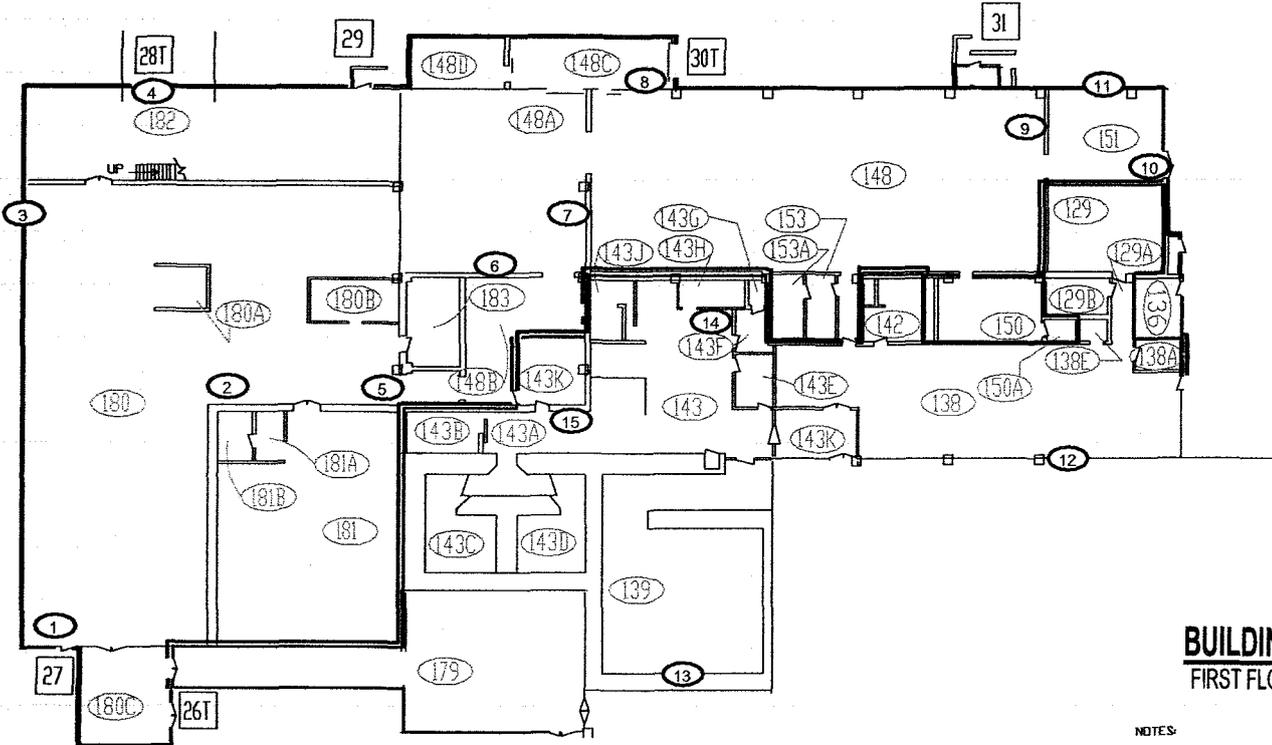
BUILDING 444
FIRST FLOOR PLAN

Survey Area: A Survey Unit: N/A Classification: N/A
 Building: 444 First Floor
 Survey Unit Description: >2m Ceiling & Walls
 Total Area: N/A sq. m. Total Floor Area: 1500 sq. m.

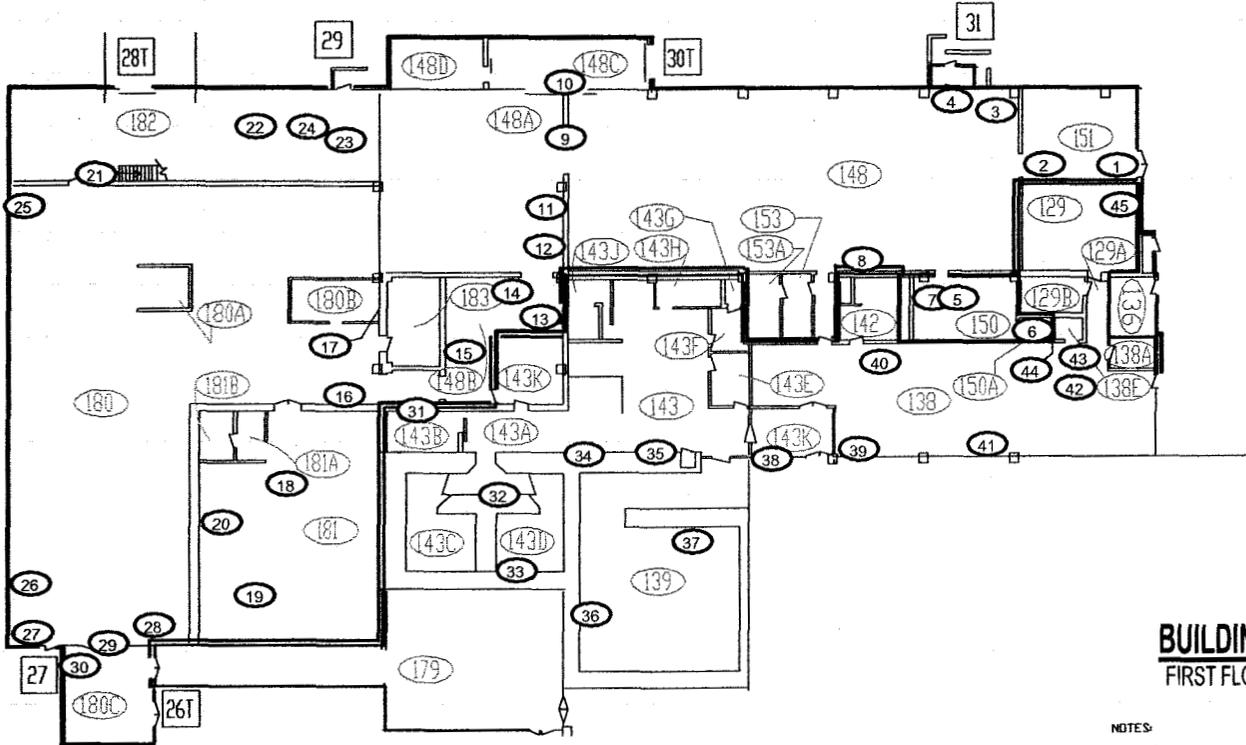
BUILDING 444
FIRST FLOOR PLAN

Survey Area: A Survey Unit: N/A Classification: N/A
 Building: 444 First Floor
 Survey Unit Description: Equipment Location
 Total Area: N/A sq. m. Total Floor Area: 1500 sq. m.

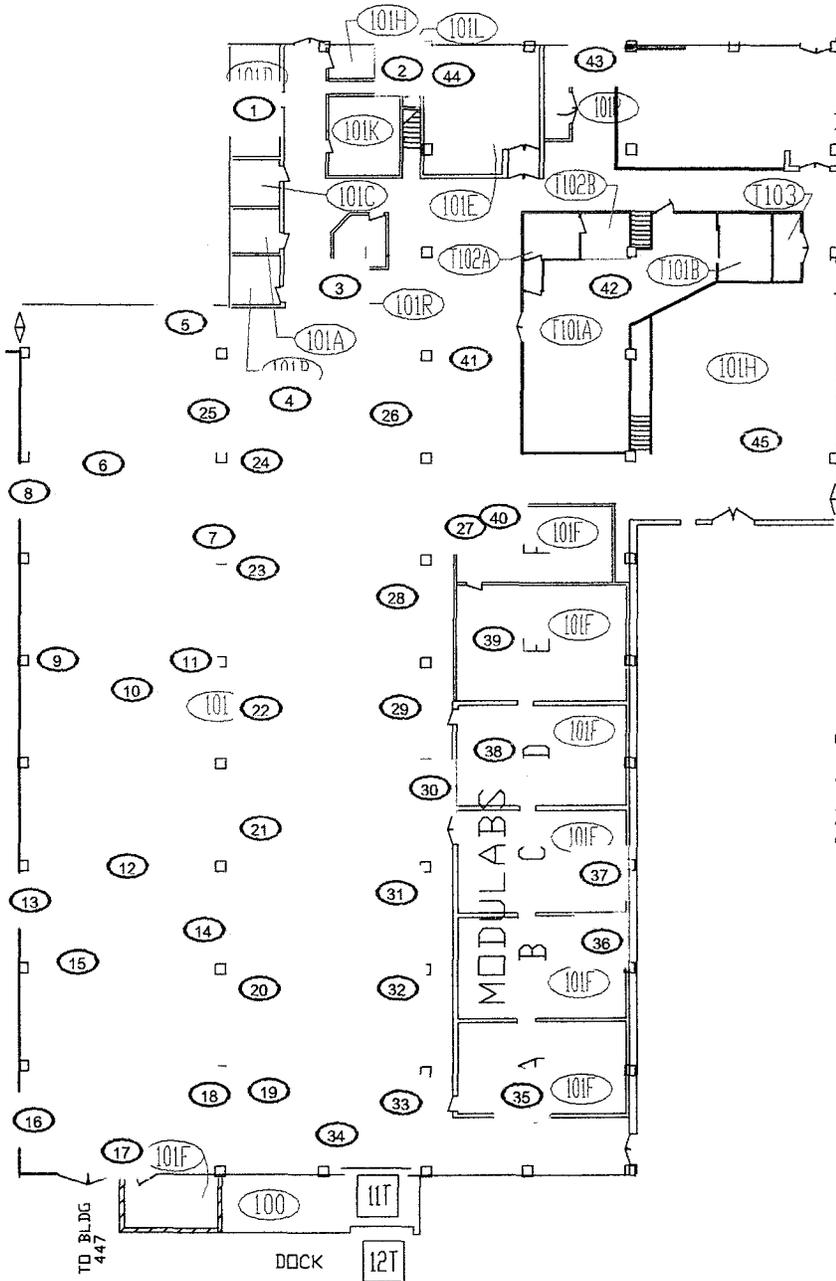
**BUILDING 444
FIRST FLOOR PLAN**

Survey Area: B Survey Unit: N/A Classification: N/A
 Building: 444 First Floor
 Survey Unit Description: <2m Floor & Walls
 Total Area: N/A sq. m. Total Floor Area: 1400 sq. m.

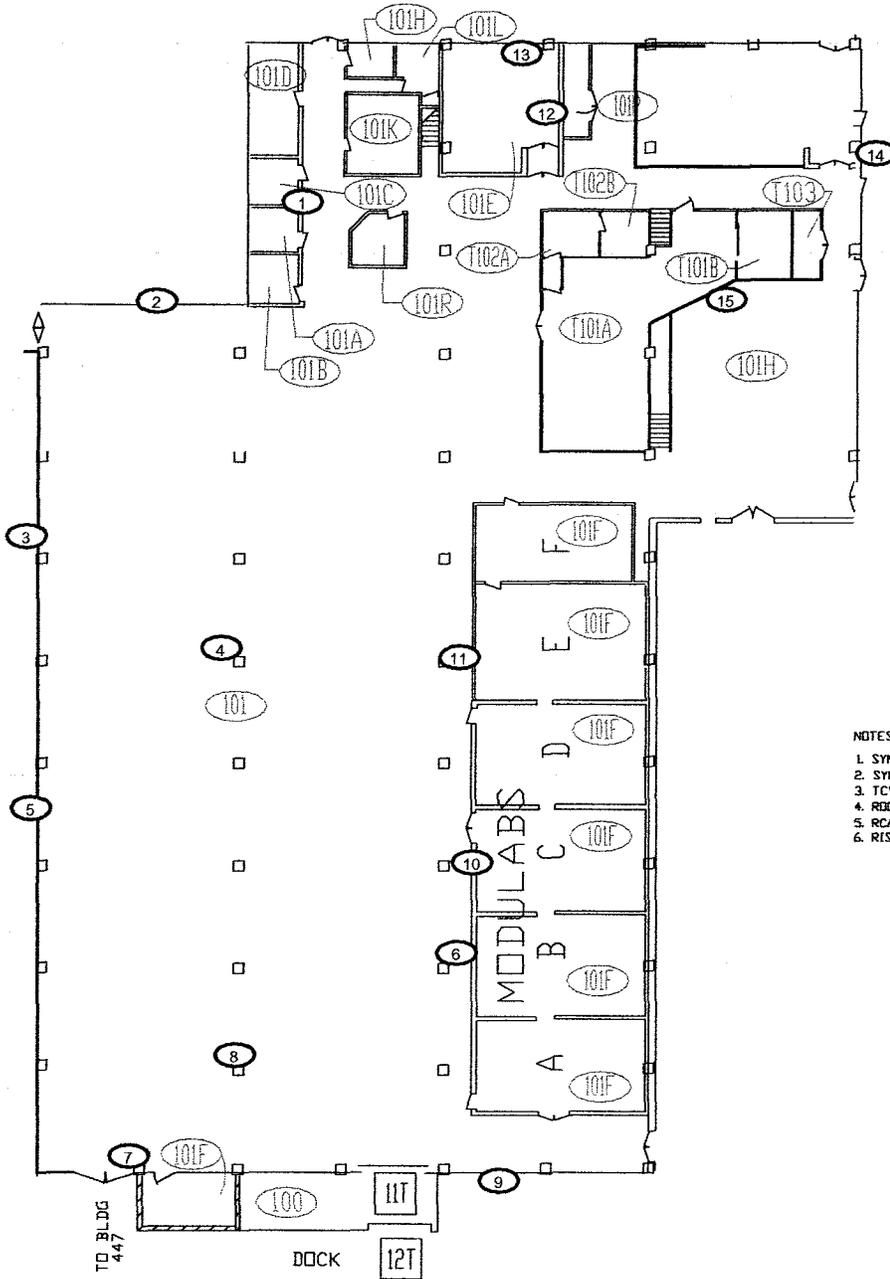
BUILDING 444
FIRST FLOOR PLAN

Survey Area: B Survey Unit: N/A Classification: N/A
 Building: 444 First Floor
 Survey Unit Description: >2m Ceiling & Walls
 Total Area: N/A sq. m. Total Floor Area: 1400 sq. m.

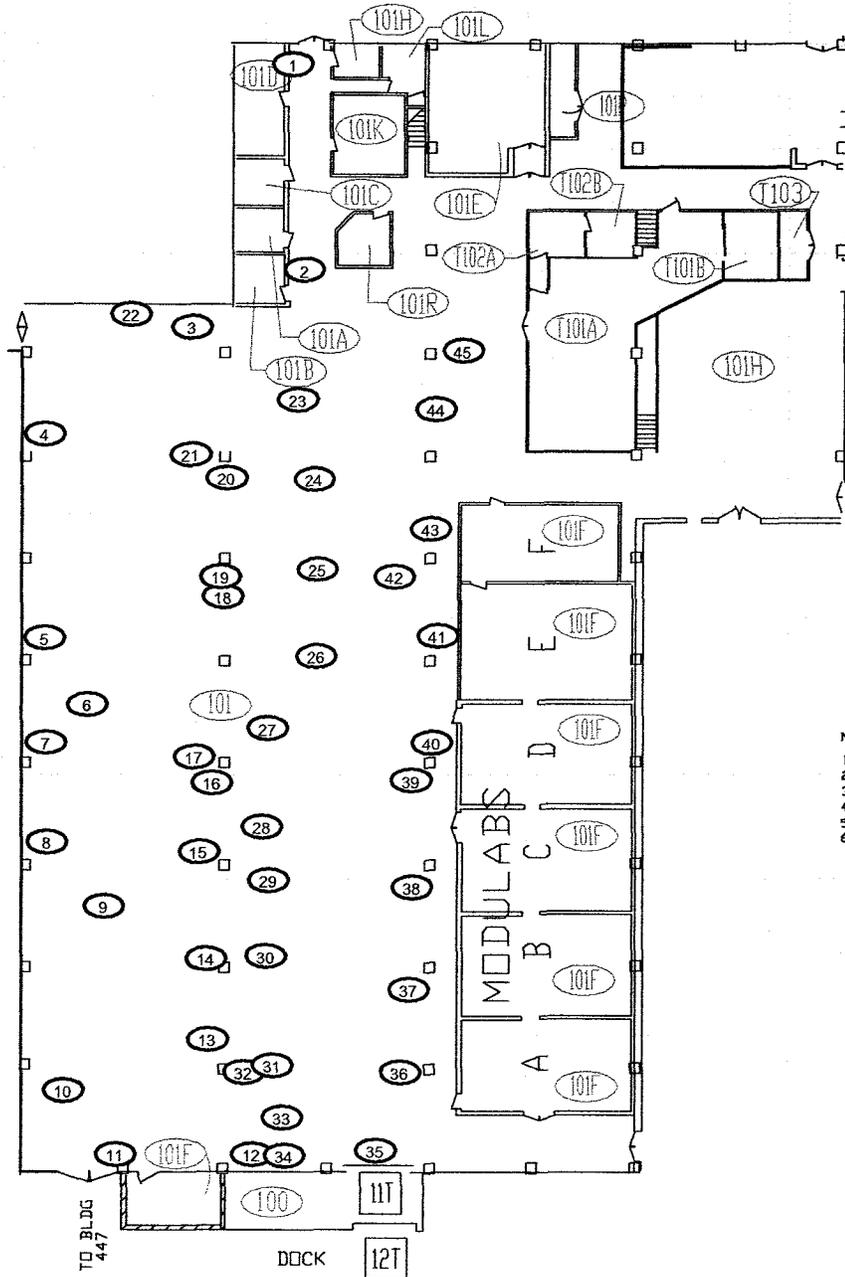
BUILDING 444
FIRST FLOOR PLAN

Survey Area: B Survey Unit: N/A Classification: N/A
 Building: 444 First Floor
 Survey Unit Description: Equipment Location
 Total Area: N/A sq. m. Total Floor Area: 1400 sq. m.

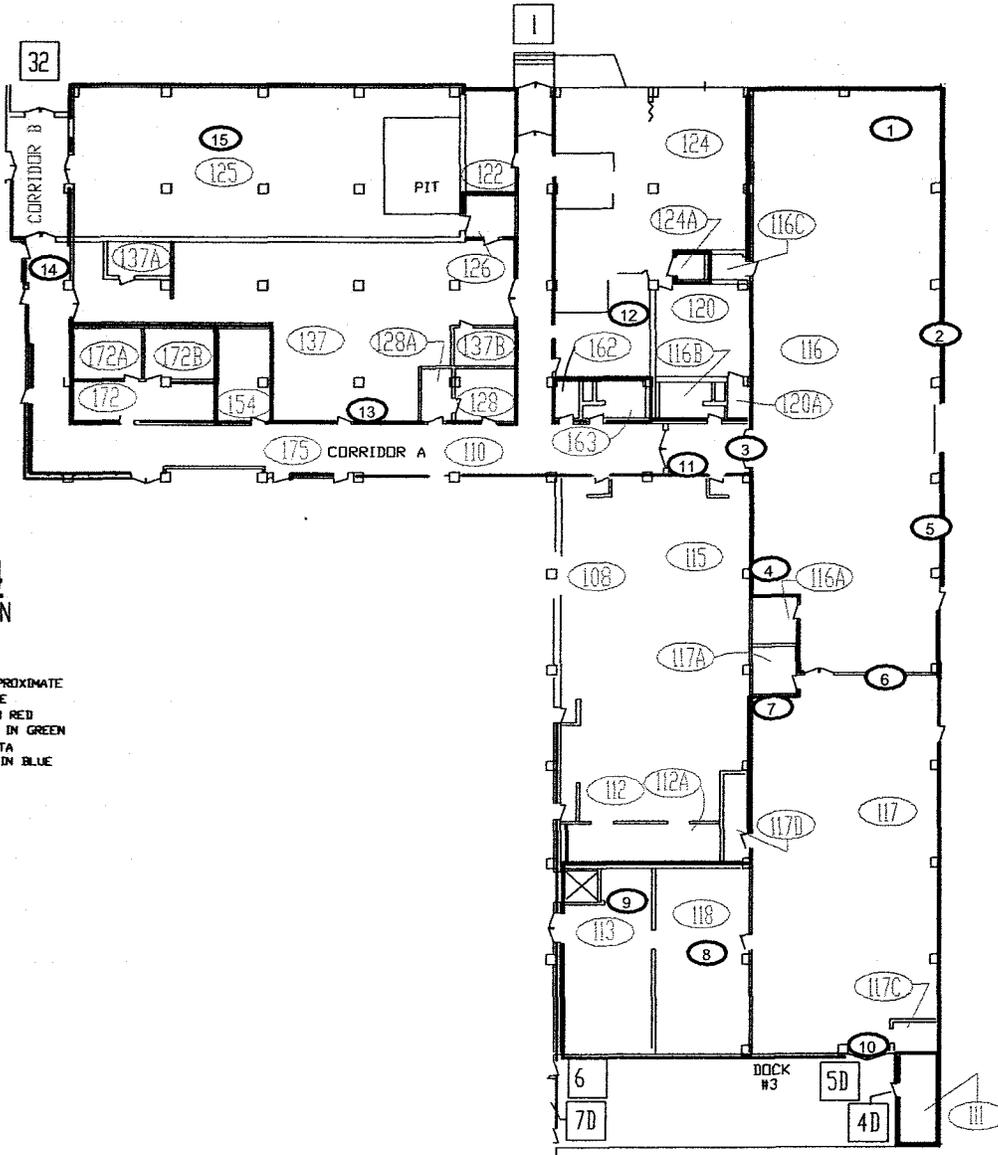
BUILDING 444
FIRST FLOOR PLAN

Survey Area: D Survey Unit: N/A Classification: N/A
 Building: 444 First Floor
 Survey Unit Description: >2m Ceiling & Walls
 Total Area: N/A sq. m. Total Floor Area: 1400 sq. m.

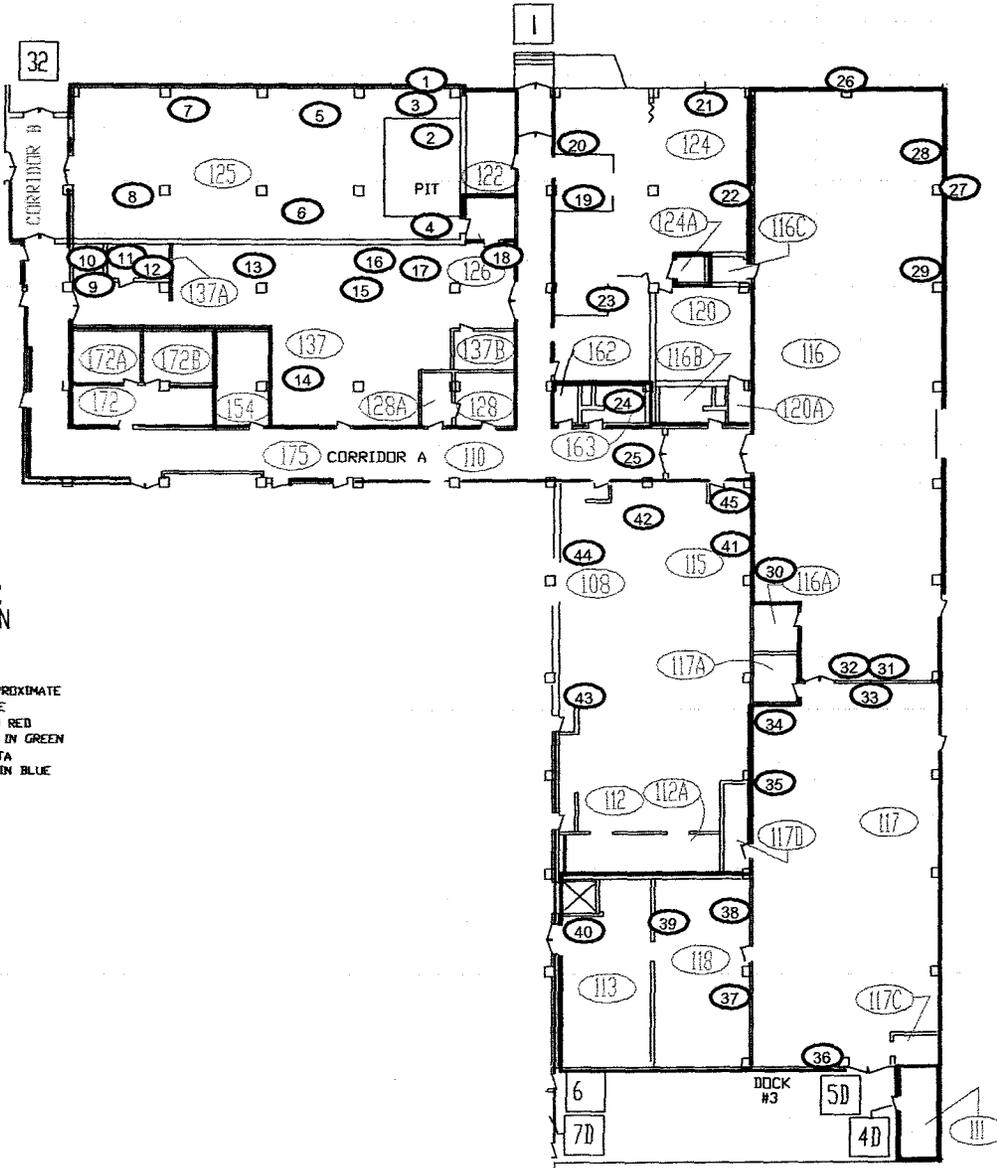
BUILDING 444
FIRST FLOOR PLAN

Survey Area: D Survey Unit: N/A Classification: N/A
 Building: 444 First Floor
 Survey Unit Description: Equipment Location
 Total Area: N/A sq. m. Total Floor Area: 1400 sq. m.

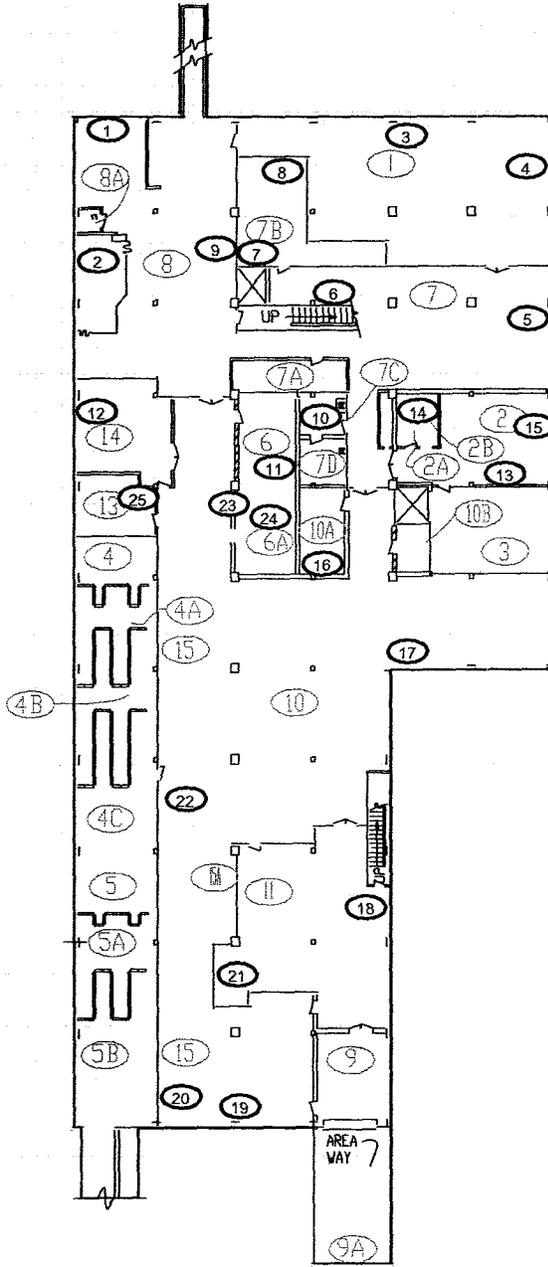
BUILDING 444
BASEMENT
FLOOR PLAN

Survey Area: E Survey Unit: N/A Classification: N/A
 Building: 444 Basement
 Survey Unit Description: >2m Ceiling & Walls
 Total Area: N/A sq. m. Total Floor Area: 2200 sq. m.

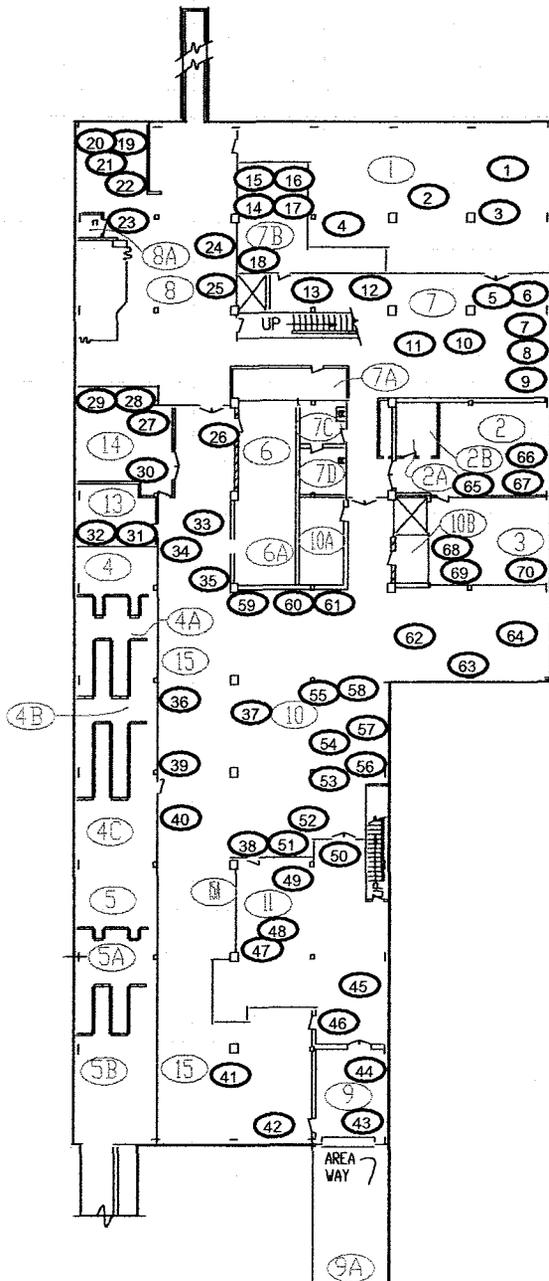
BUILDING 444
BASEMENT
FLOOR PLAN

Survey Area: E Survey Unit: N/A Classification: N/A
 Building: 444 Basement
 Survey Unit Description: Equipment Location
 Total Area: N/A sq. m. Total Floor Area: 2200 sq. m.

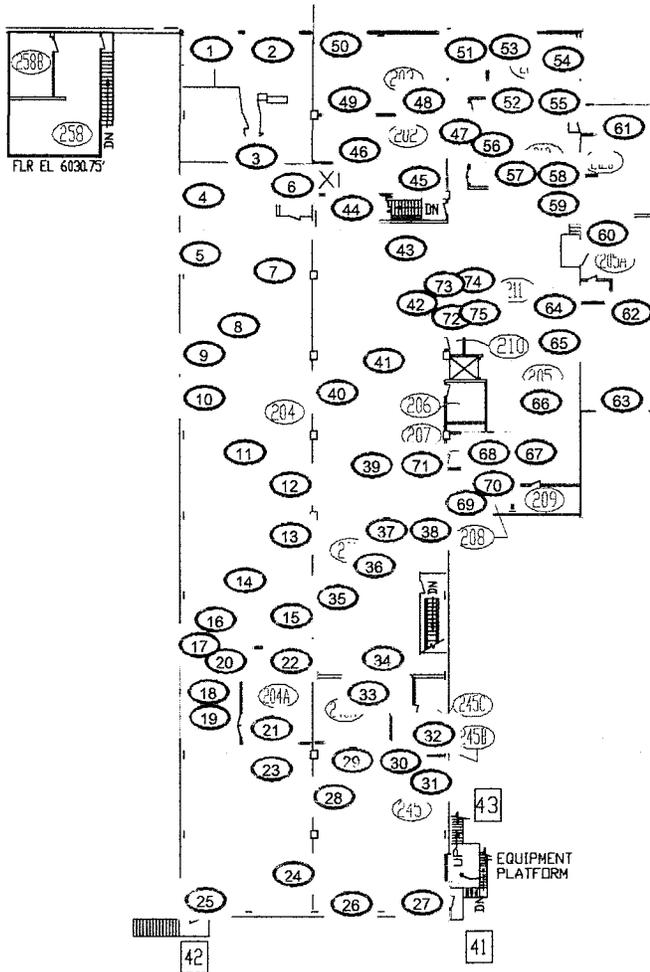
MEZZANINE FLOOR PLAN

Survey Area: F Survey Unit: N/A Classification: N/A
 Building: 444 Second Floor
 Survey Unit Description: <2m Floor & Walls
 Total Area: N/A sq. m. Total Floor Area: 2400 sq. m.

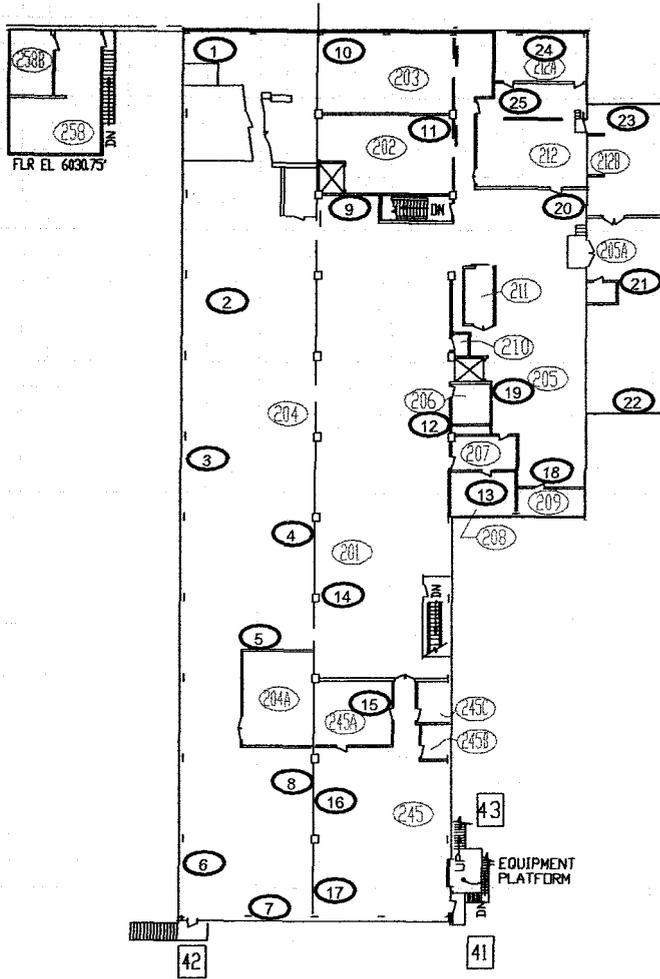
BUILDING 444
SECOND
FLOOR PLAN

Survey Area: F Survey Unit: N/A Classification: N/A
 Building: 444 Second Floor
 Survey Unit Description: >2m Ceiling & Walls
 Total Area: N/A sq. m. Total Floor Area: 2400 sq. m.

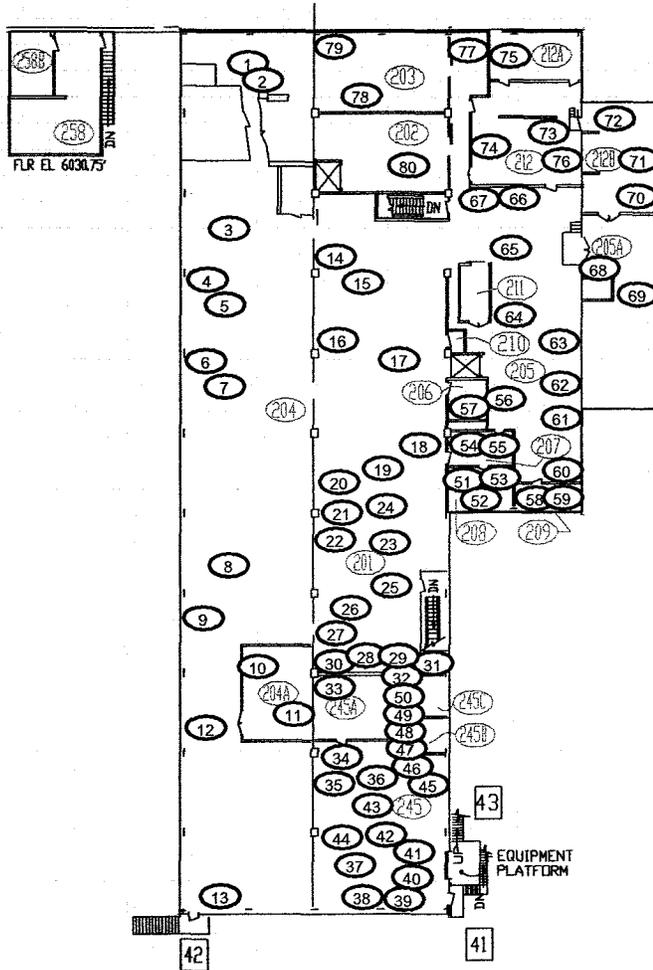
MEZZANINE FLOOR PLAN

Survey Area: F Survey Unit: N/A Classification: N/A
 Building: 444 Second Floor
 Survey Unit Description: Equipment Location
 Total Area: N/A sq. m. Total Floor Area: 2400 sq. m.

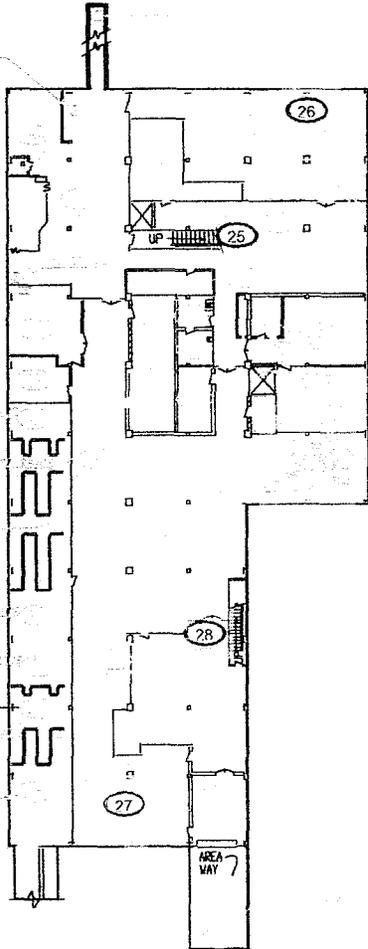
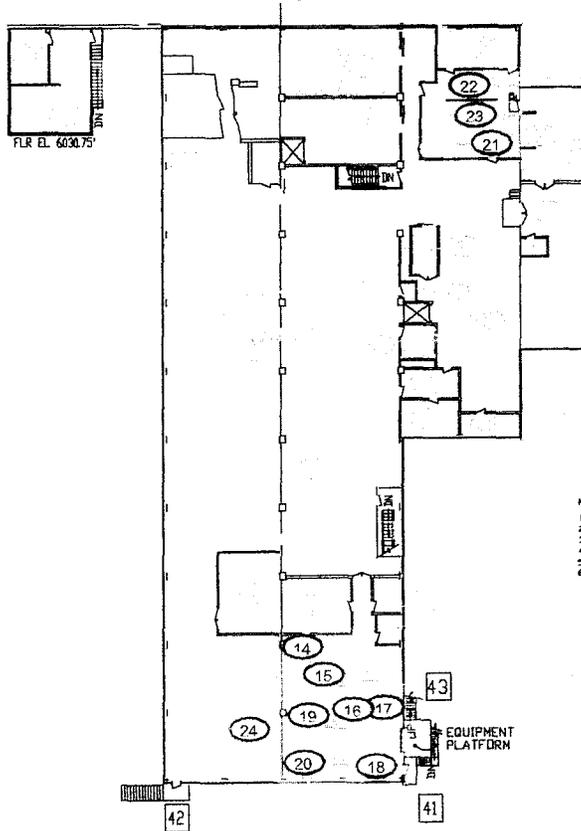
BASEMENT FLOOR PLAN
 FLOOR ELEVATION 6011'-0"

Survey Area: K Survey Unit: N/A Classification: N/A
 Building: 444 Second Floor & Basement
 Survey Unit Description: Sumps, Pit, & Trenches
 Total Area: N/A sq. m. Total Floor Area: N/A sq. m.

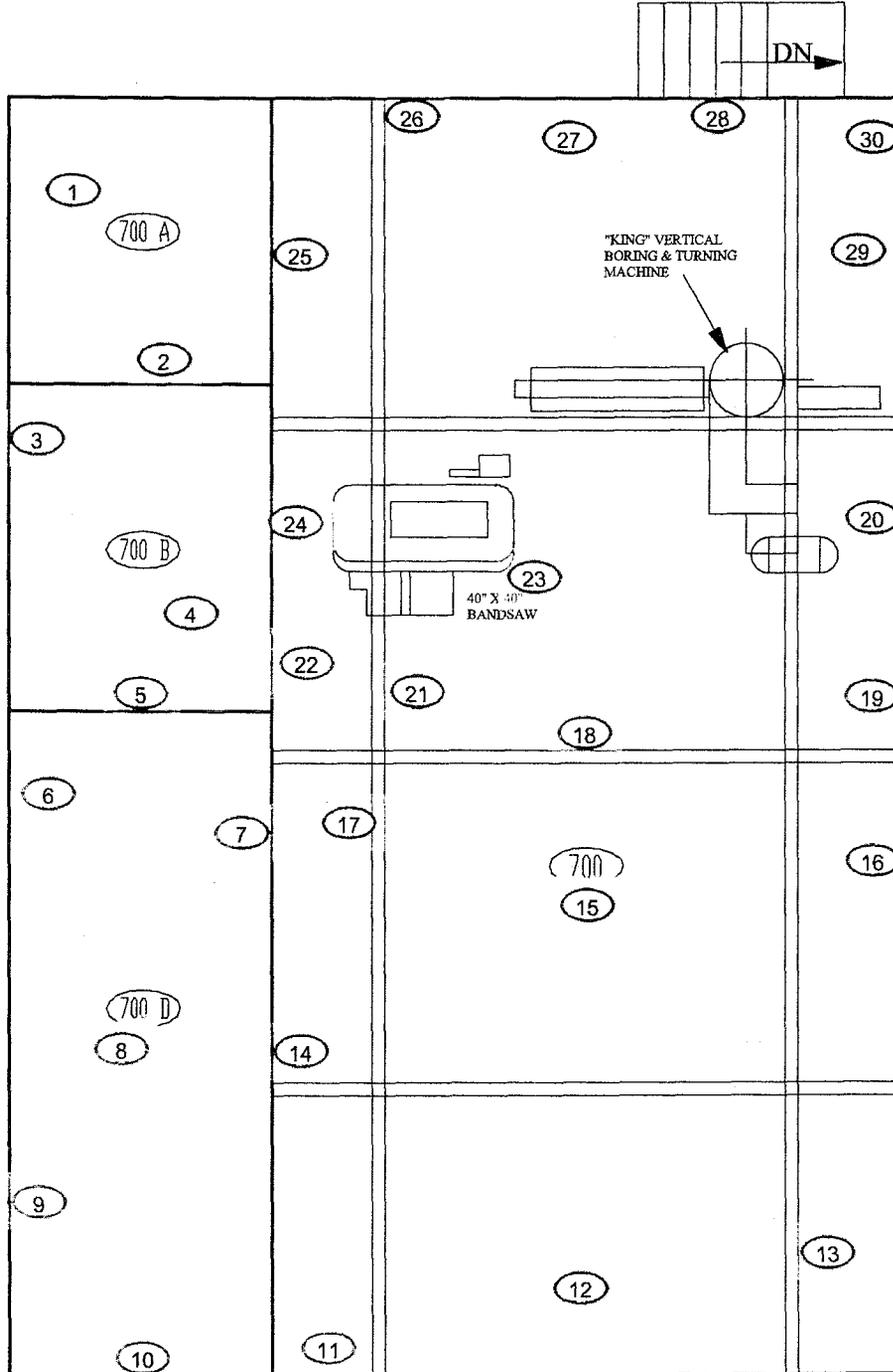
Survey Area: L Survey Unit: N/A Classification: N/A
 Building: 445
 Survey Unit Description: <2m Floor & Walls Total Floor Area: 428 sq. m.
 Total Area: N/A sq. m.

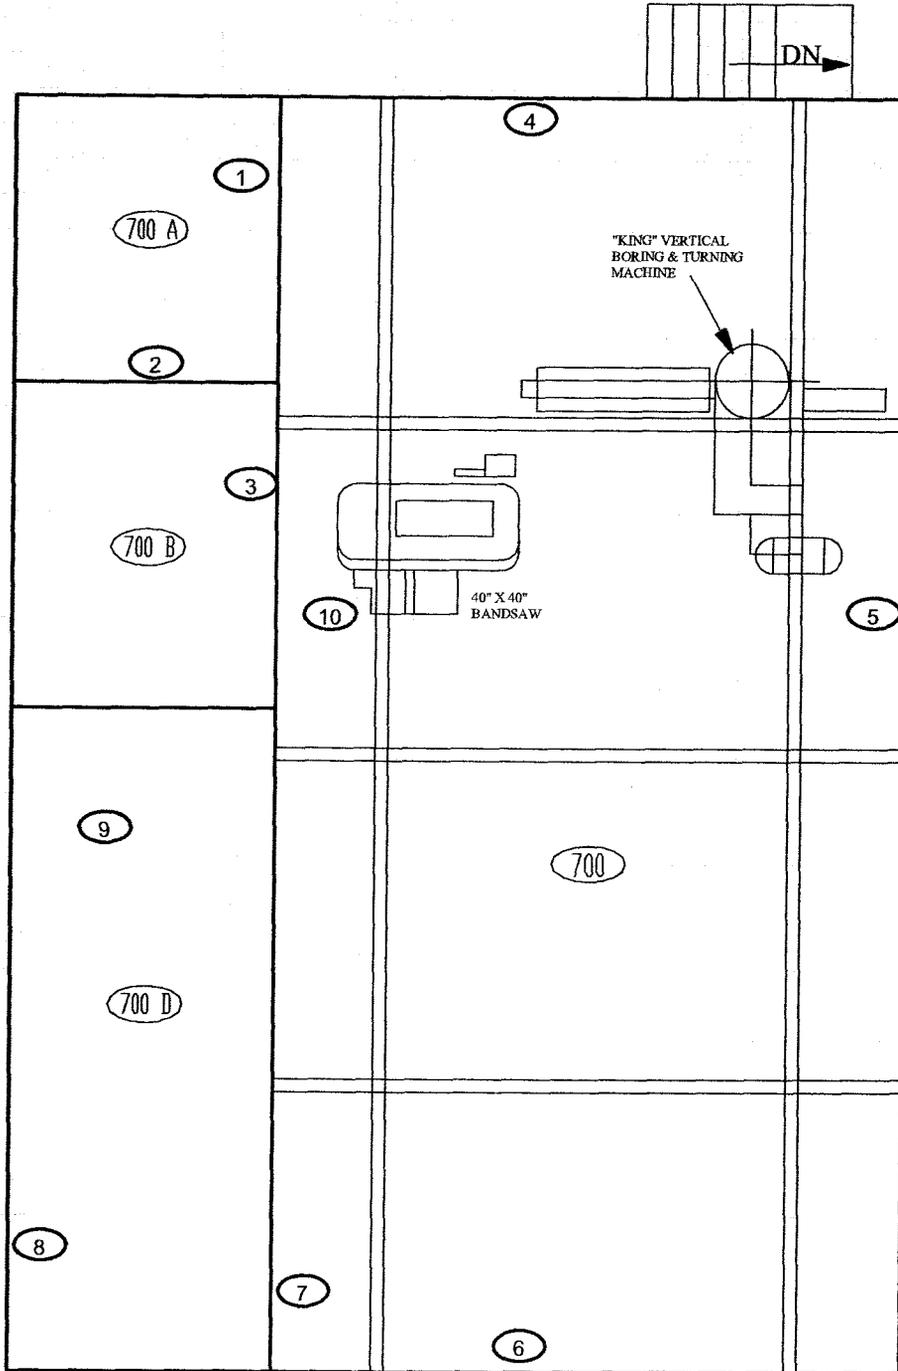
Survey Area: L Survey Unit: N/A Classification: N/A
 Building: 445
 Survey Unit Description: >2m Ceiling & Walls
 Total Area: N/A sq. m. Total Floor Area: 428 sq. m.

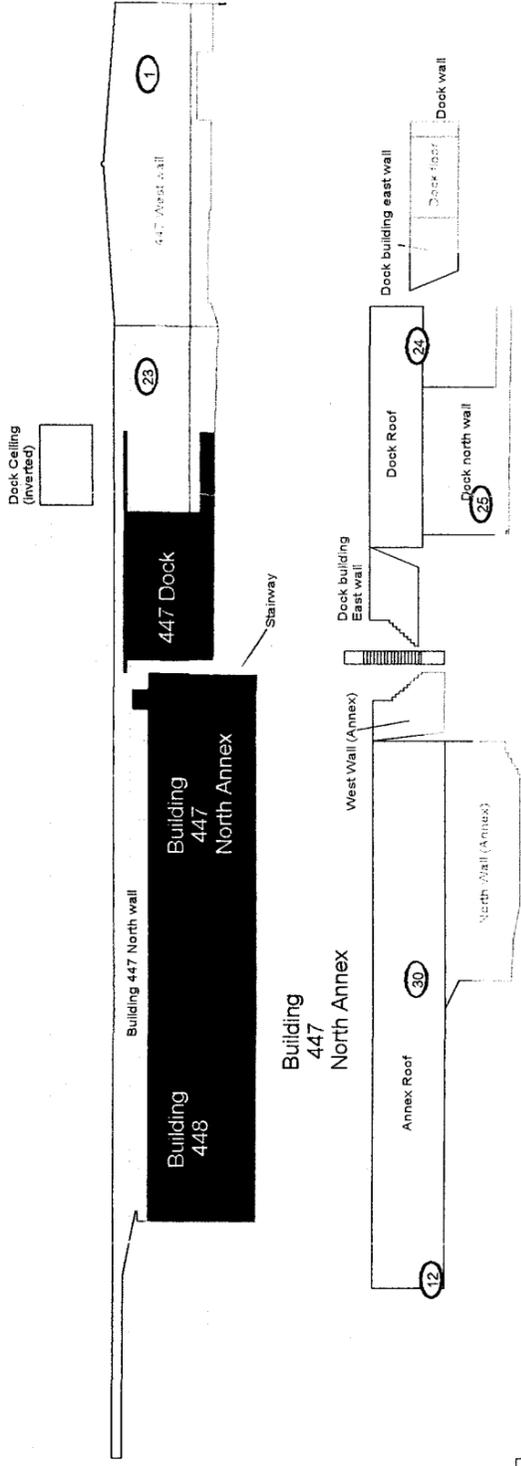
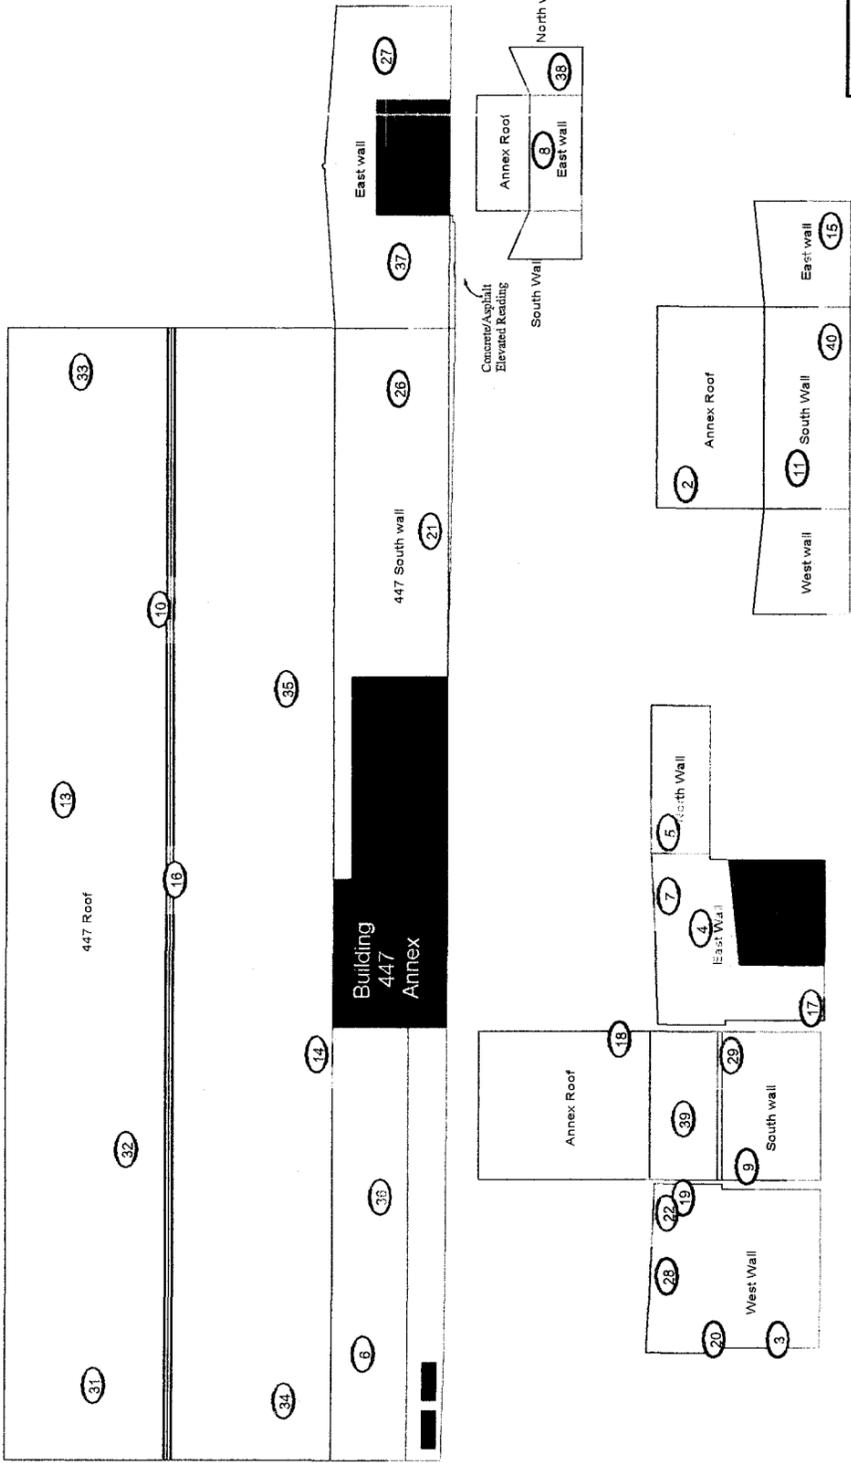
PRE-DEMOLITION SURVEY FOR B444 CLUSTER

Survey Area: B *DA 9/4/02*
 Survey Unit: 444-B-010 Classification: ~~HA~~ 3
 Building: 447
 Survey Unit Description: Exterior
 Total Area: 3,384 sq. m. Total Floor Area: 1,889 sq. m.

The Radiological RLC Survey of areas A through L confirmed depleted uranium contamination as expected for this Type 2 facility. The PDS surveys of exterior surfaces found contamination levels above the uranium DCGLs on and around loading docks. Future PDS surveys will be performed in and around the loading dock areas and building interiors after decontamination efforts are complete. All other exterior facility surfaces meet the PDSP radiological release criteria. No additional PDS radiological surveys are required except if a contamination event were to occur during decommissioning activities. Follow up action to a contamination event will require a verification survey prior to building demolition to ensure that PDSP release limits are met. Additionally, a confirmation smear survey shall be performed of the exterior surfaces prior to demolition.
