Facility Assessment for the Industrial Area Reuse Study

Rocky Flats
Environmental Technology Site

December 8, 1997

BUILDING 125 Facility Assessment and Summary

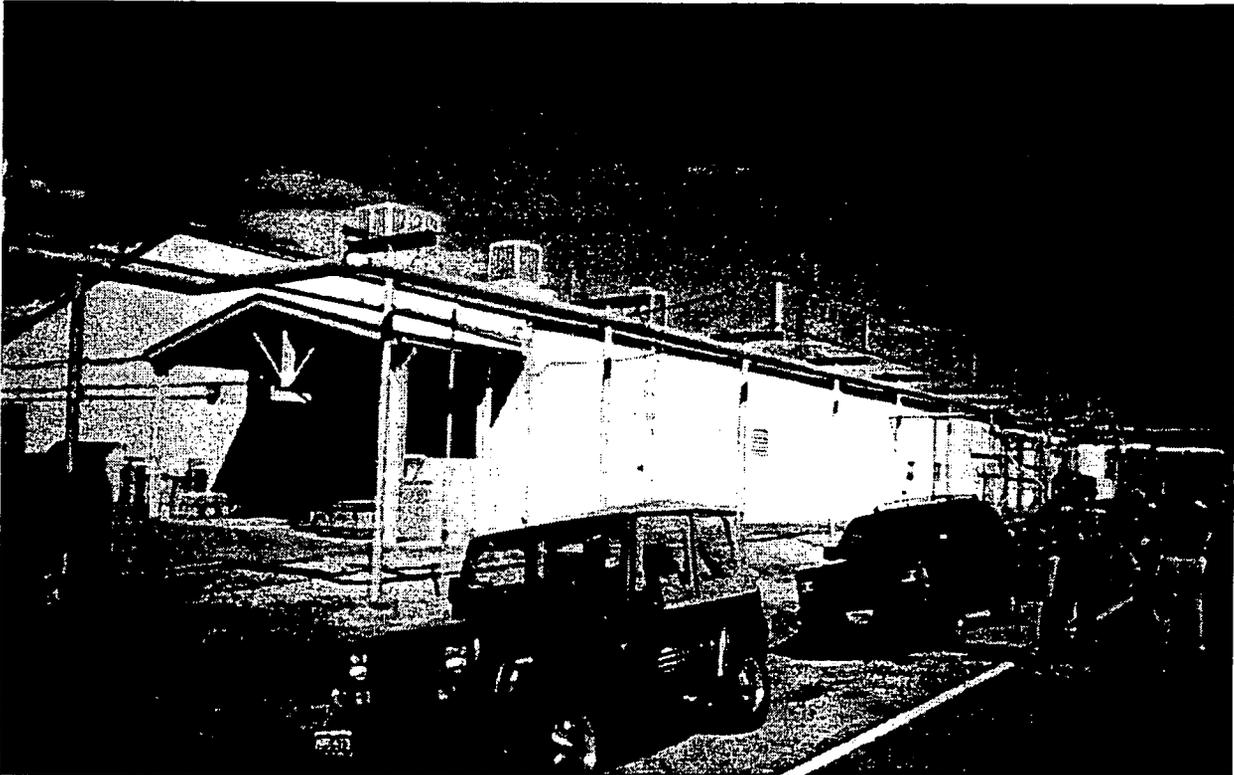
Building 125 - View from Southeast

1. Location: Building 125 is located just east of Parking Area 12 and west of the intersection of Third Street and Cottonwood.
2. Description: It is the Standards Metrology Laboratory, where measuring and timing instruments are calibrated. The facility is a single-story, metal frame building with metal siding and sloped metal roof with overlay. It was built in 1965 (with two subsequent additions) and contains 12,900 SF. It is presently occupied by 15 personnel but has a capacity of approximately 50. It contains several stainless steel, prefabricated laboratory modules that are climate controlled, one of which is also seismically isolated.
3. Future Usability:
 - Assumed Reuse: Standards or calibration lab.
 - Assets: Modular lab areas.
 - Liabilities: Age, energy inefficiency, lack of independent heat source.

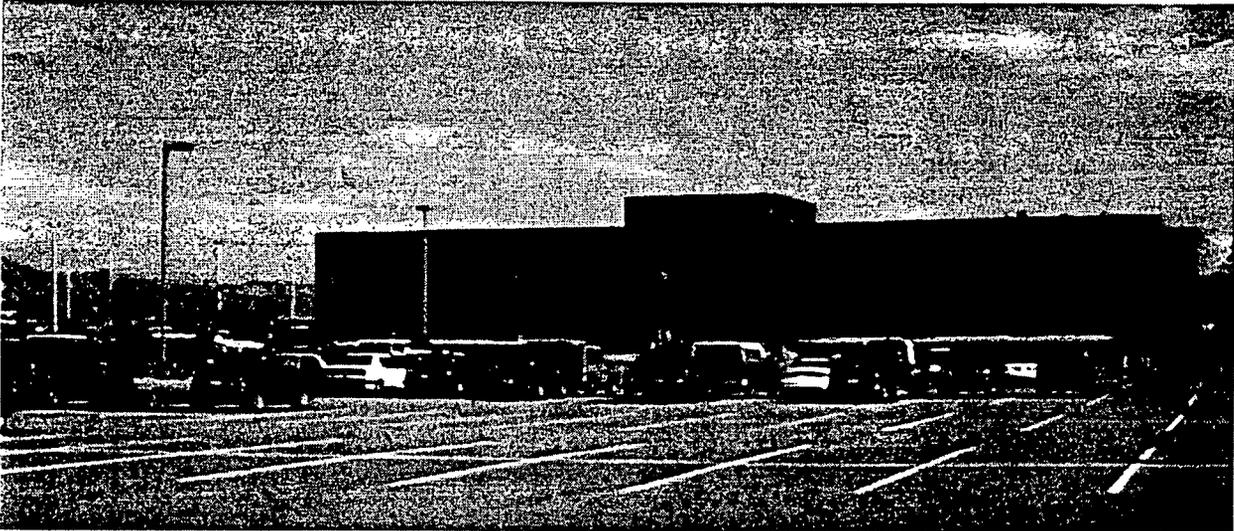
Building 130 - View of South Elevation

2. **Description:** It is a general office building holding a number of different organizations, mostly dealing with engineering support. The facility is a two-story, steel frame structure with a dark grey anodized aluminum skin and a "flat", modified bitumen roof. It was constructed in 1985 and comprises approximately a total of 50,000 SF. It is presently near full occupancy with 138 personnel. Its connection to Building 130W contains a cafeteria and kitchen with a seating capacity of approximately 100 persons.

- **Assets:** Relatively young age, flexible floor plan (central core with "racetrack" corridor and large open office areas), stand-alone HVAC system (although in poor condition - see below - not dependent on steam system).

- **Liabilities:** Inefficient and marginally functional HVAC system (series of small boilers tied to non-functional solar panels and evaporative cooling).

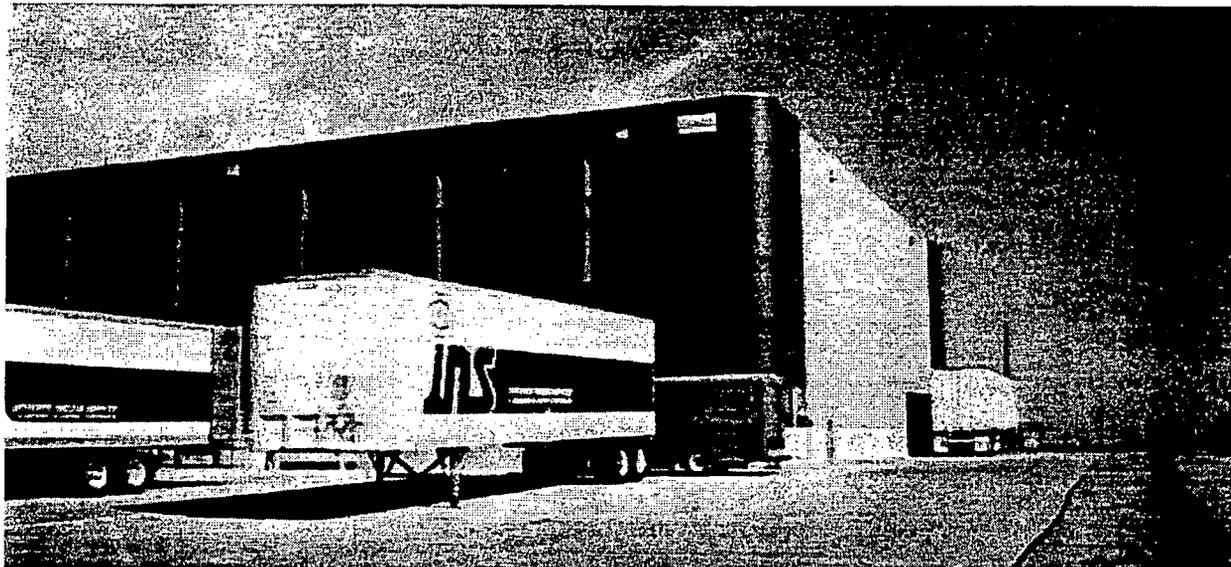
Building 130W - View from Southeast

1. Location: Building 130W is connected by a cafeteria and kitchen to Building 130, just north of the main entrance road to Rocky Flats
2. Description: Building 130W is warehouse constructed in 1985 and has approximately 30,000 SF. It is a partial two story, anodized aluminum panel and concrete masonry unit (with brick overlay), steel framed building with a tapered, modified built-up bitumen roof. It has a warehouse storage space height of approximately 22.5 feet.

3. Future Usability: Except for deterioration of its aluminum panel seals, poor roof skylights, and roof leaks, it is in generally fair condition.
 - Assumed Reuse: Warehouse or manufacturing.

- Liabilities: Inefficient and marginally functional HVAC system (series of small boilers tied to non-functional solar panels and evaporative cooling).

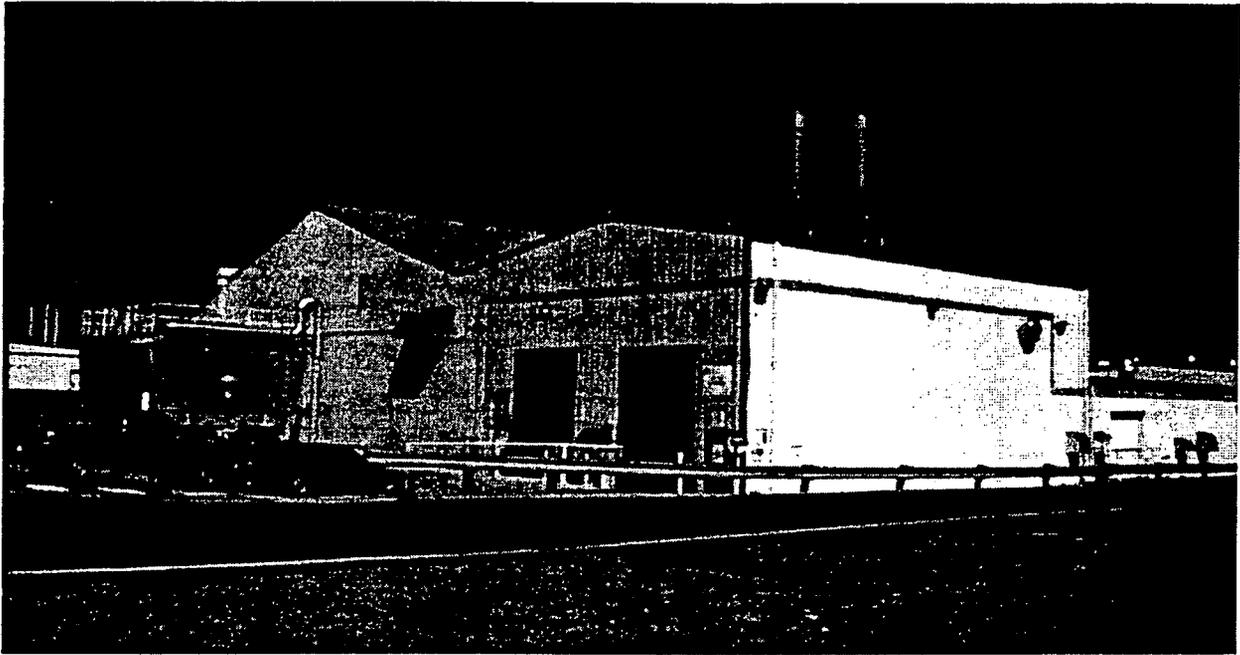
Building 440 - View from Southwest

1. Location: Building 440 is located just northeast of the intersection of Fourth Street and Cactus Avenue in the south-central portion of the Industrial Area.
2. Description: It is a railcar and truck modification facility constructed in 1971. This facility, containing 34,320 SF, is a single story steel framed, metal-sided and roofed building with an elevated center rail bay. It has a small amount of interior office space.
3. Future Usability:
 - Assumed Reuse: Warehouse or manufacturing.
 - Assets: Rail siding, high bay with traveling crane.
 - Liabilities: Age, energy inefficiency, lack of independent heat source.
