# Rocky Flats Environmental Technology Site

## RECONNAISSANCE LEVEL CHARACTERIZATION REPORT (RLCR)

### Group 9 CLOSURE PROJECT (Trailers T891G, O, R and V)

October 10, 2001

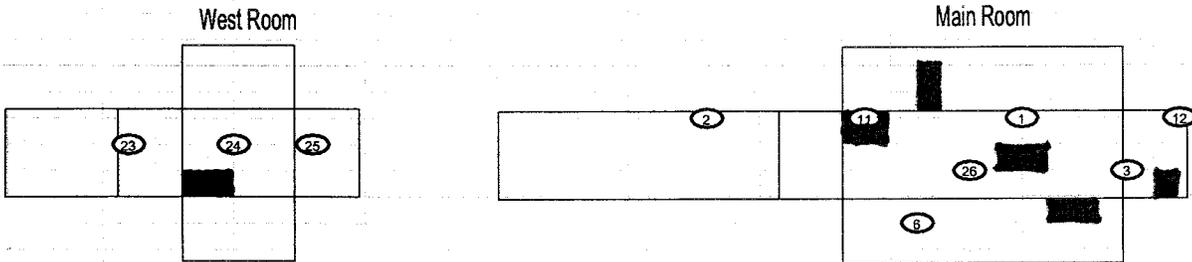
**T891G**

Survey Area: A      Survey Unit: GR9-A-001      Classification: 3  
 Building: T891G  
 Survey Unit Description: Interior & Exterior of T891G  
 Total Area: 509.1 sq. m.      Total Floor Area: 68.9 sq. m.

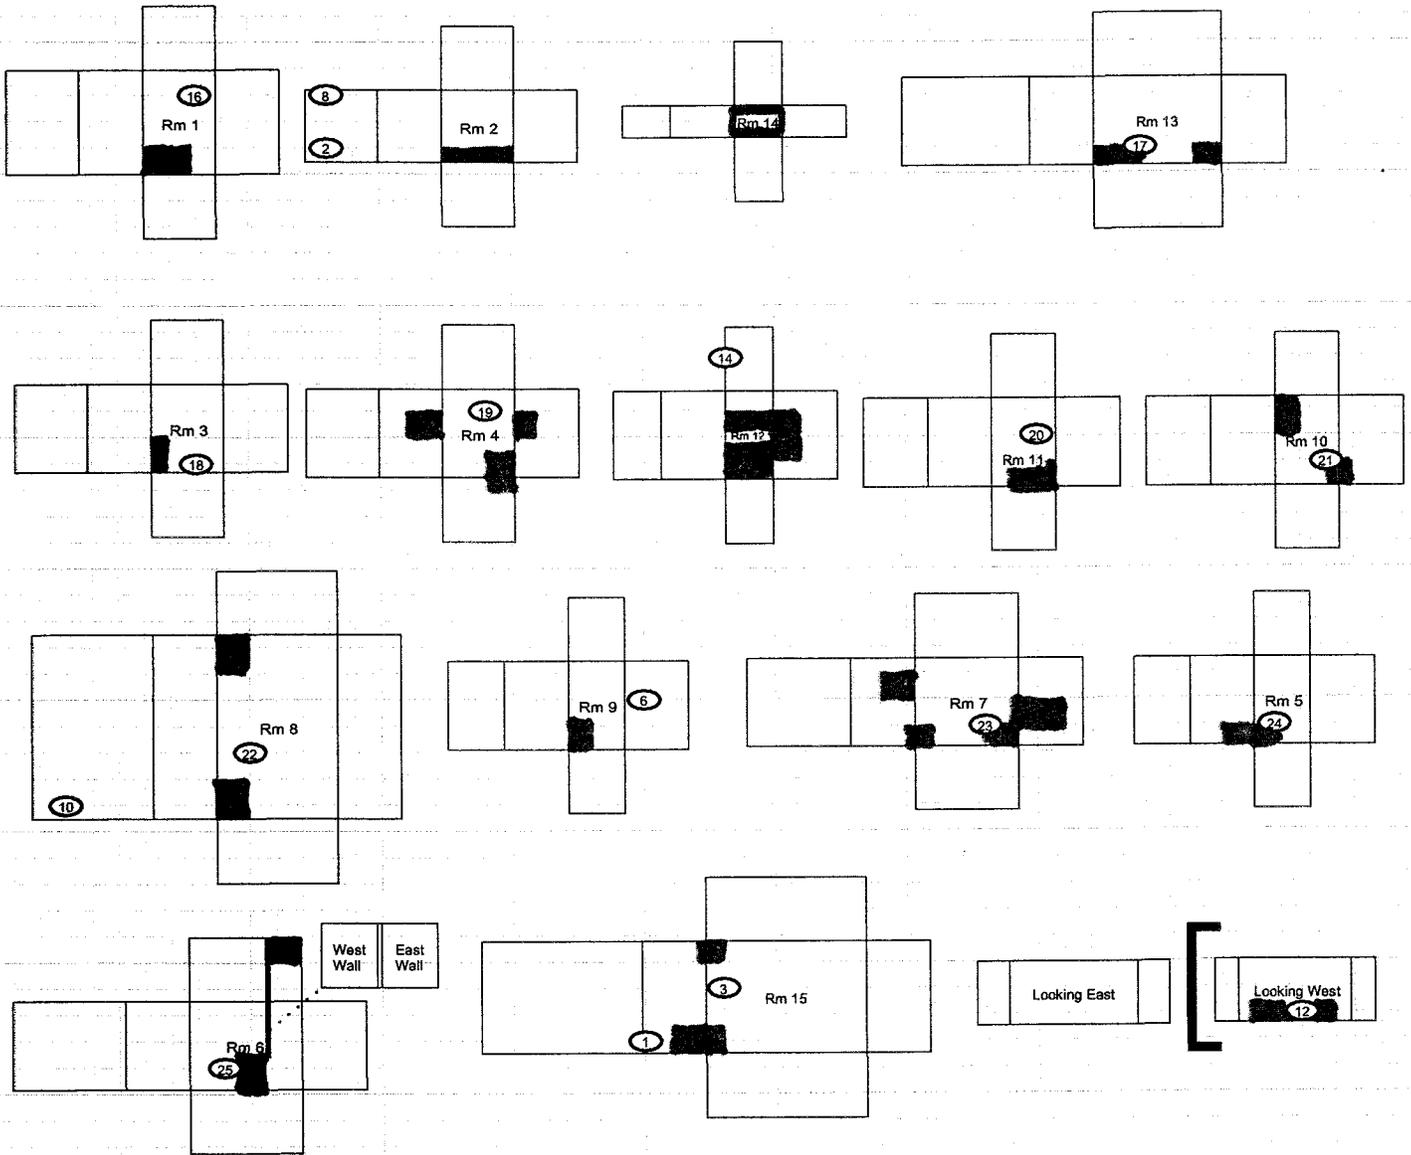
Survey Area: A      Survey Unit: GR9-A-002      Classification: 3  
 Building: T8910  
 Survey Unit Description: Interior & Exterior of T8910  
 Total Area: 963 sq. m.      Total Floor Area: 259 sq. m.

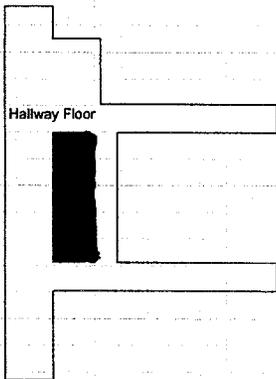
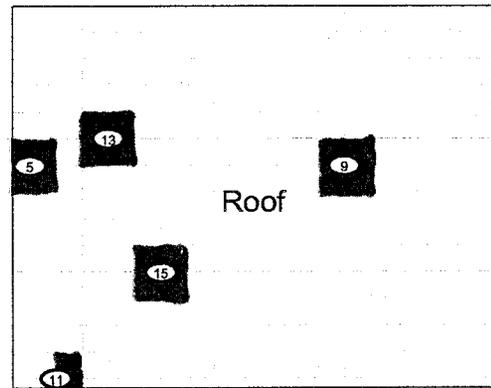
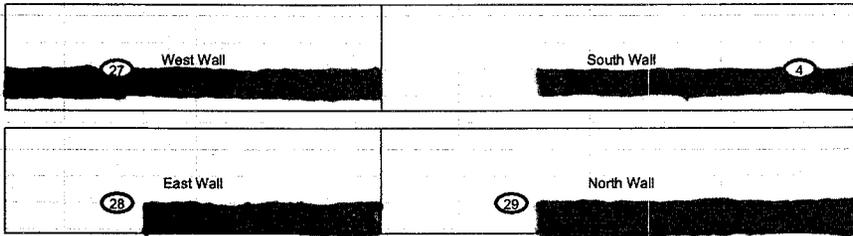
Survey Area: A      Survey Unit: GR9-A-002      Classification: 3  
 Building: T8910  
 Survey Unit Description: Interior & Exterior of T8910  
 Total Area: 963 sq. m.      Total Floor Area: 259 sq. m.

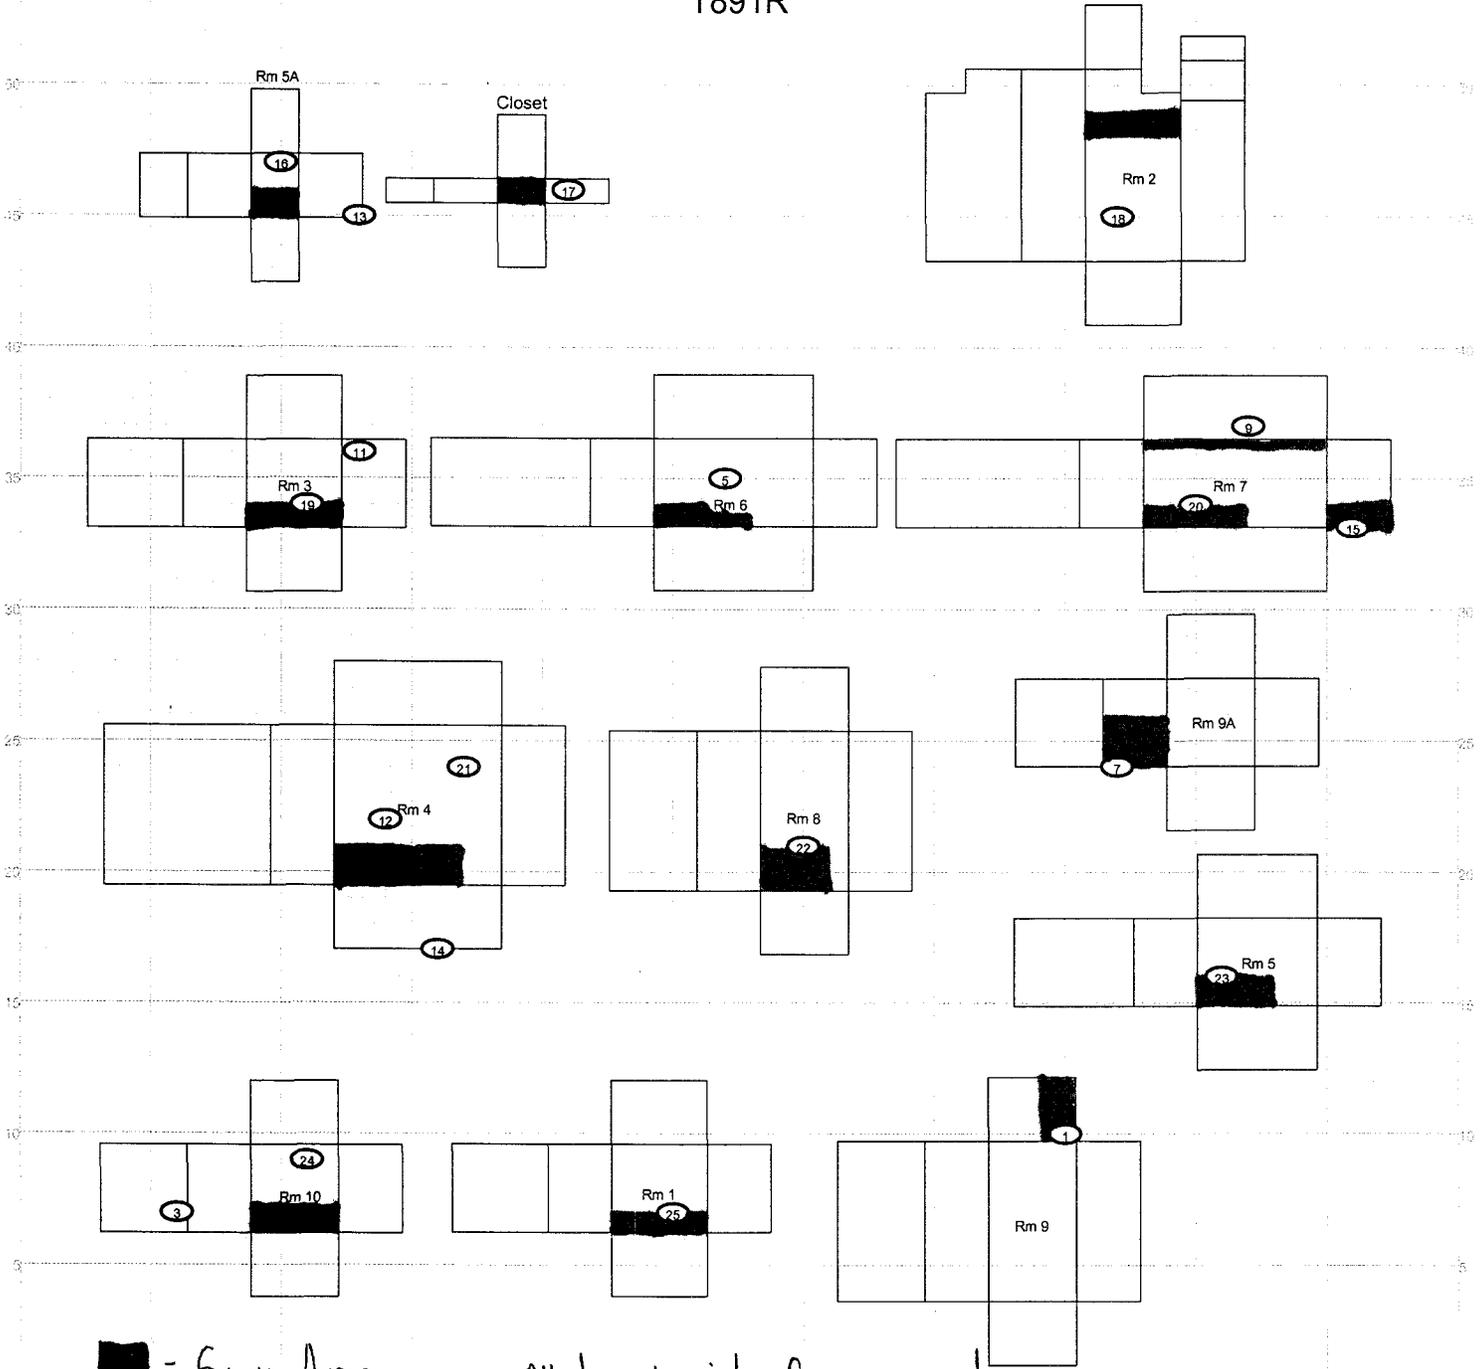
Survey Area: A      Survey Unit: GR9-A-003      Classification: 3  
 Building: T891R  
 Survey Unit Description: Interior & Exterior of T891R  
 Total Area: 1396 sq. m.      Total Floor Area: 256 sq. m.

*All doors & window frames scanned.*

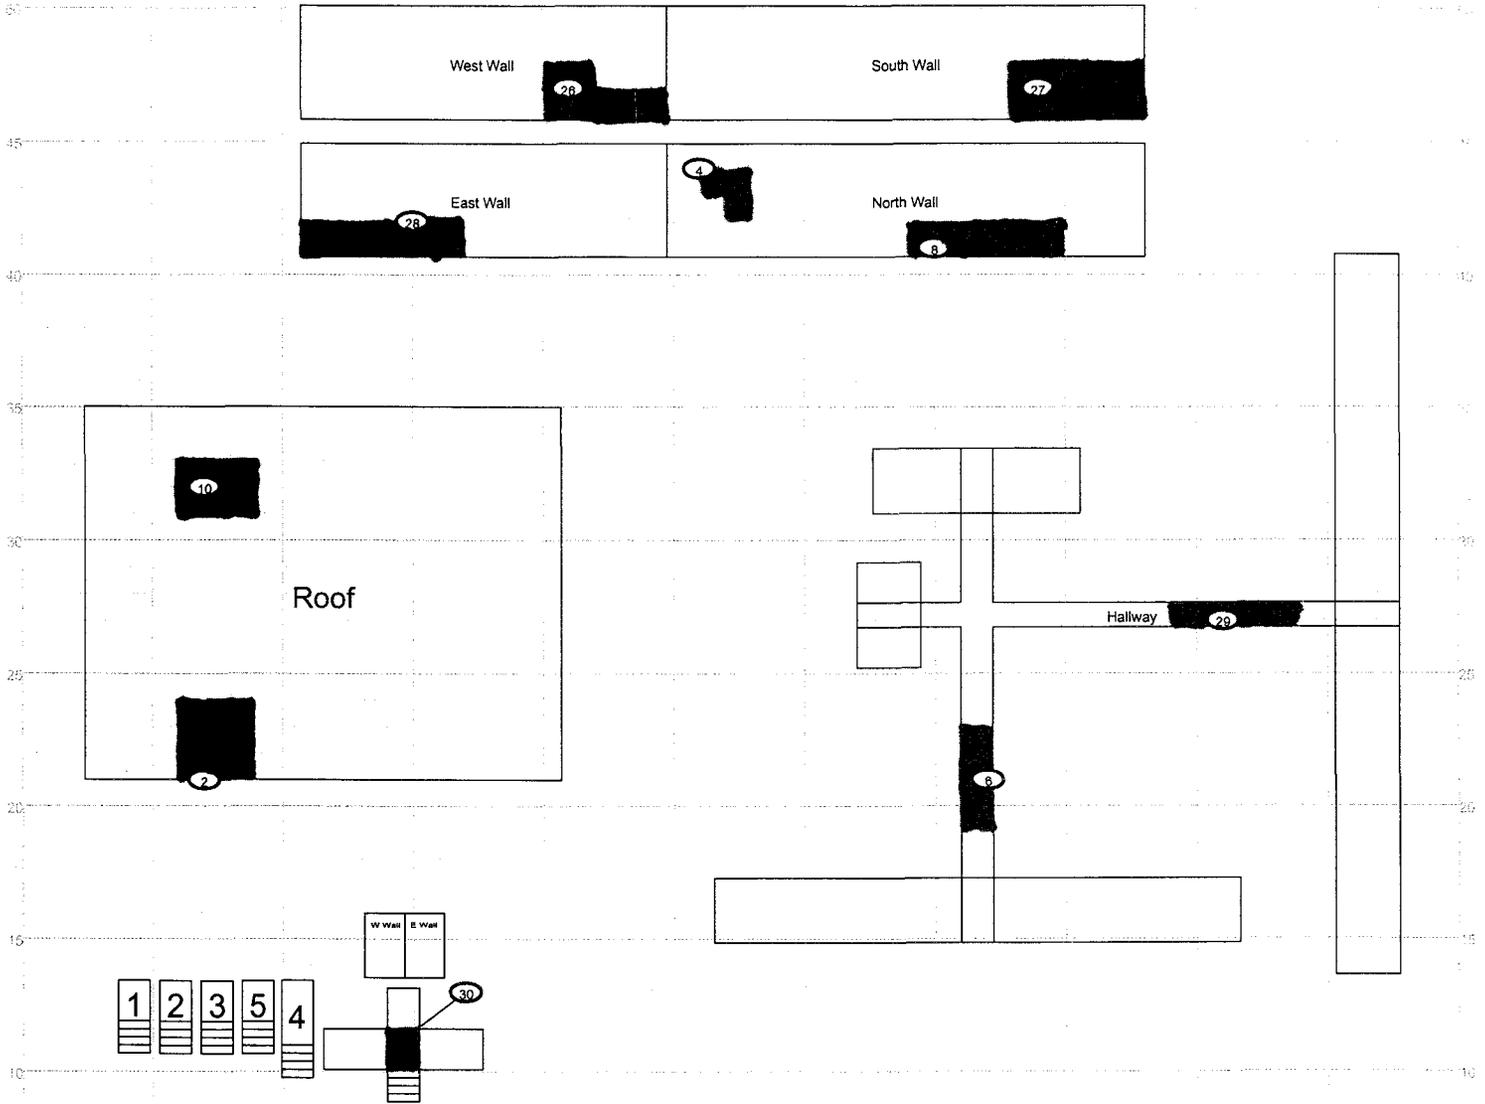
**T891R**

Survey Area: A      Survey Unit: GR9-A-003      Classification: 3  
 Building: T891R  
 Survey Unit Description: Interior & Exterior of T891R  
 Total Area: 1396 sq. m.      Total Floor Area: 256 sq. m.

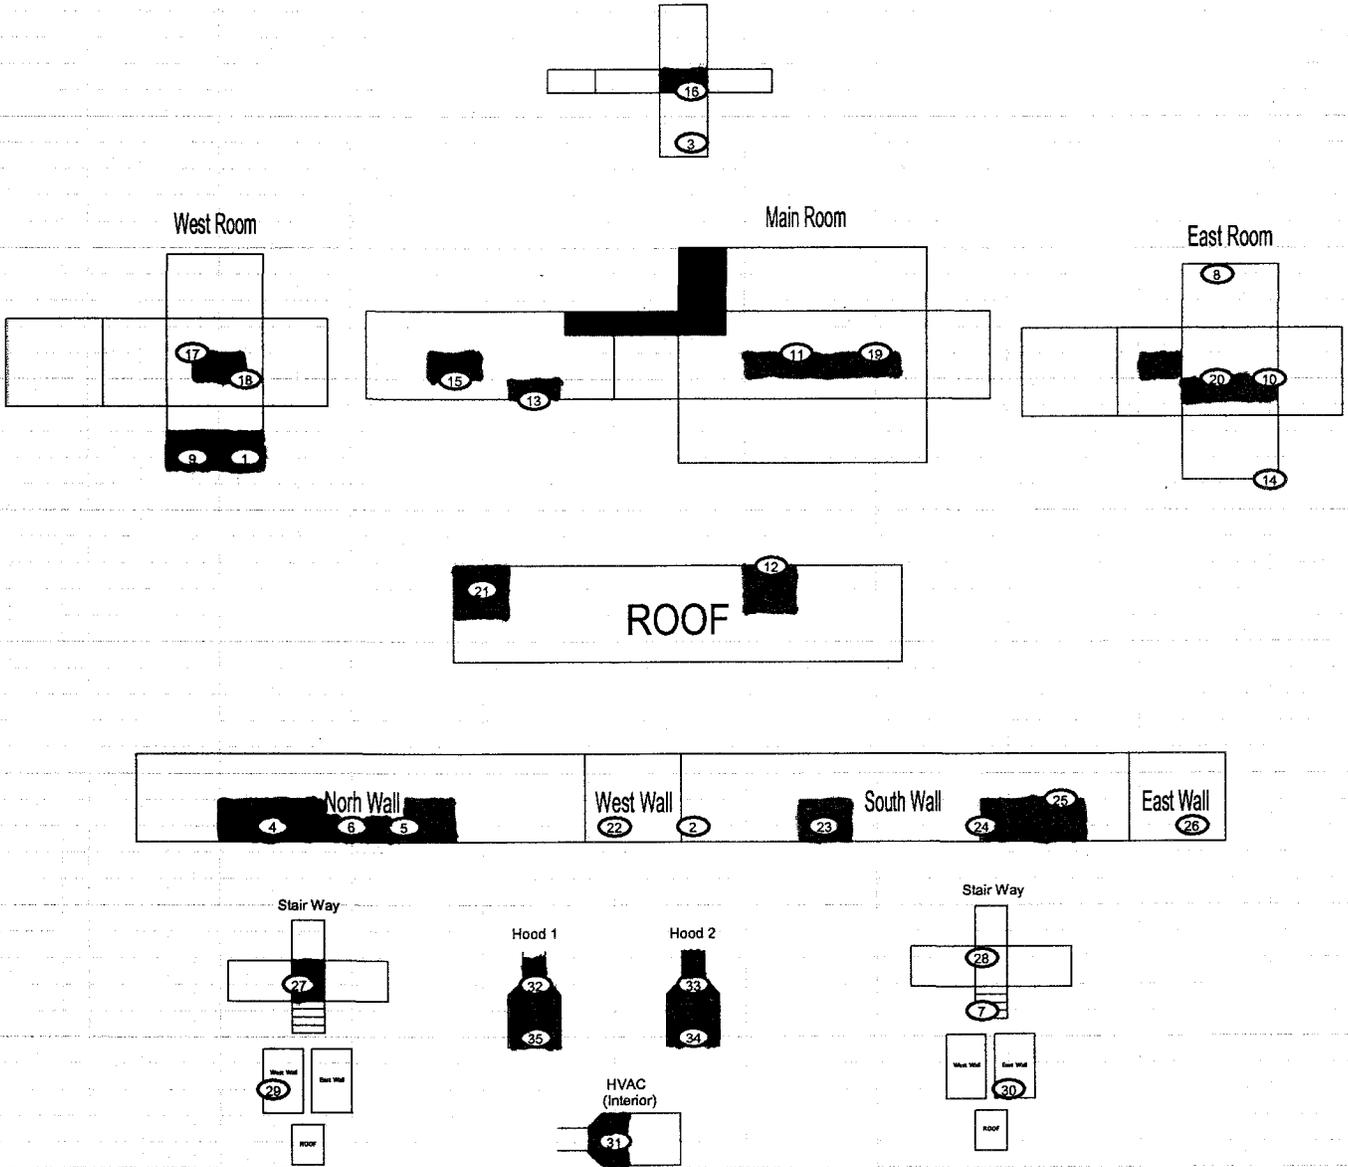
**T891V**

Survey Area: A      Survey Unit: GR9-A-004      Classification: 3  
 Building: T891V  
 Survey Unit Description: Interior & Exterior of T891V  
 Total Area: 493.6 sq. m.      Total Floor Area: 63.3 sq. m.

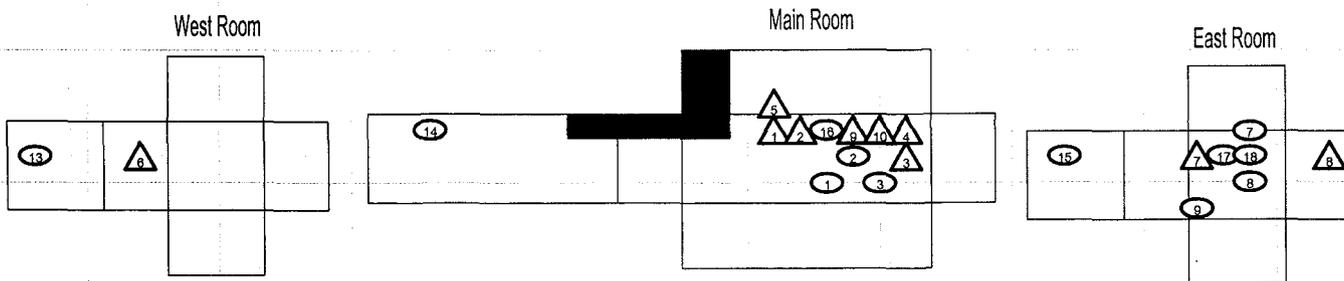
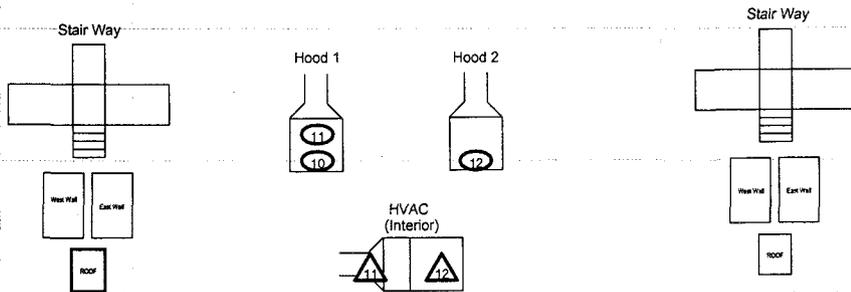
Survey Area: A      Survey Unit: GR9-A-004      Classification: 3  
 Building: T891V  
 Survey Unit Description: Interior & Exterior of T891V  
 Total Area: 493.6 sq. m.      Total Floor Area: 63.3 sq. m.

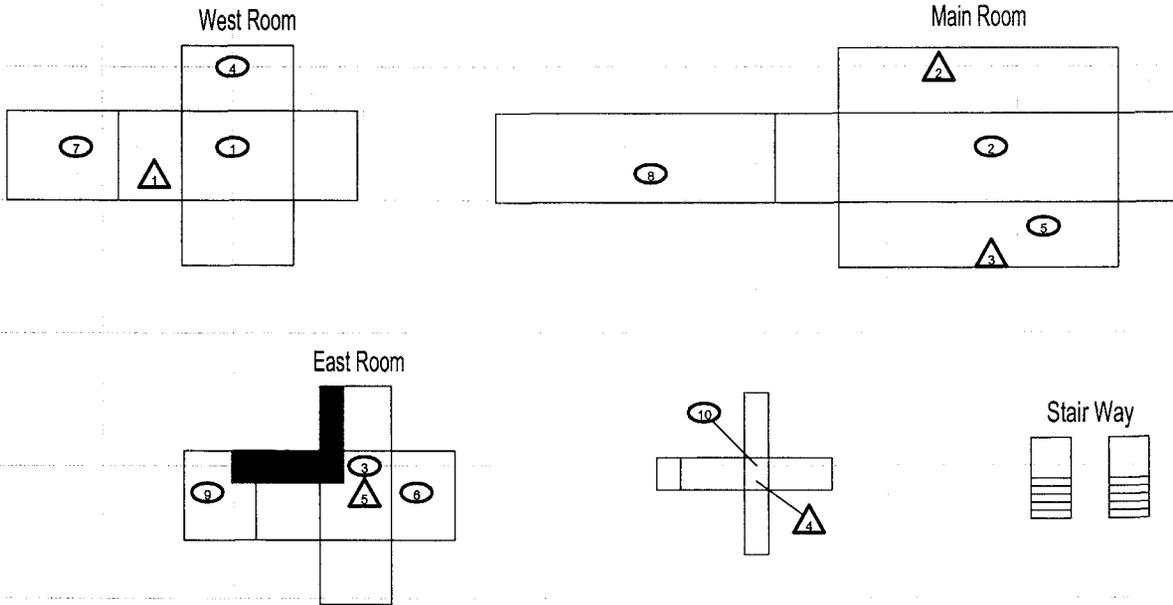
Survey Area: A      Survey Unit: GR9-A-001      Classification: 3  
 Building: T891G  
 Survey Unit Description: Interior & Exterior of T891G  
 Total Area: 509.1 sq. m.      Total Floor Area: 68.9 sq. m.

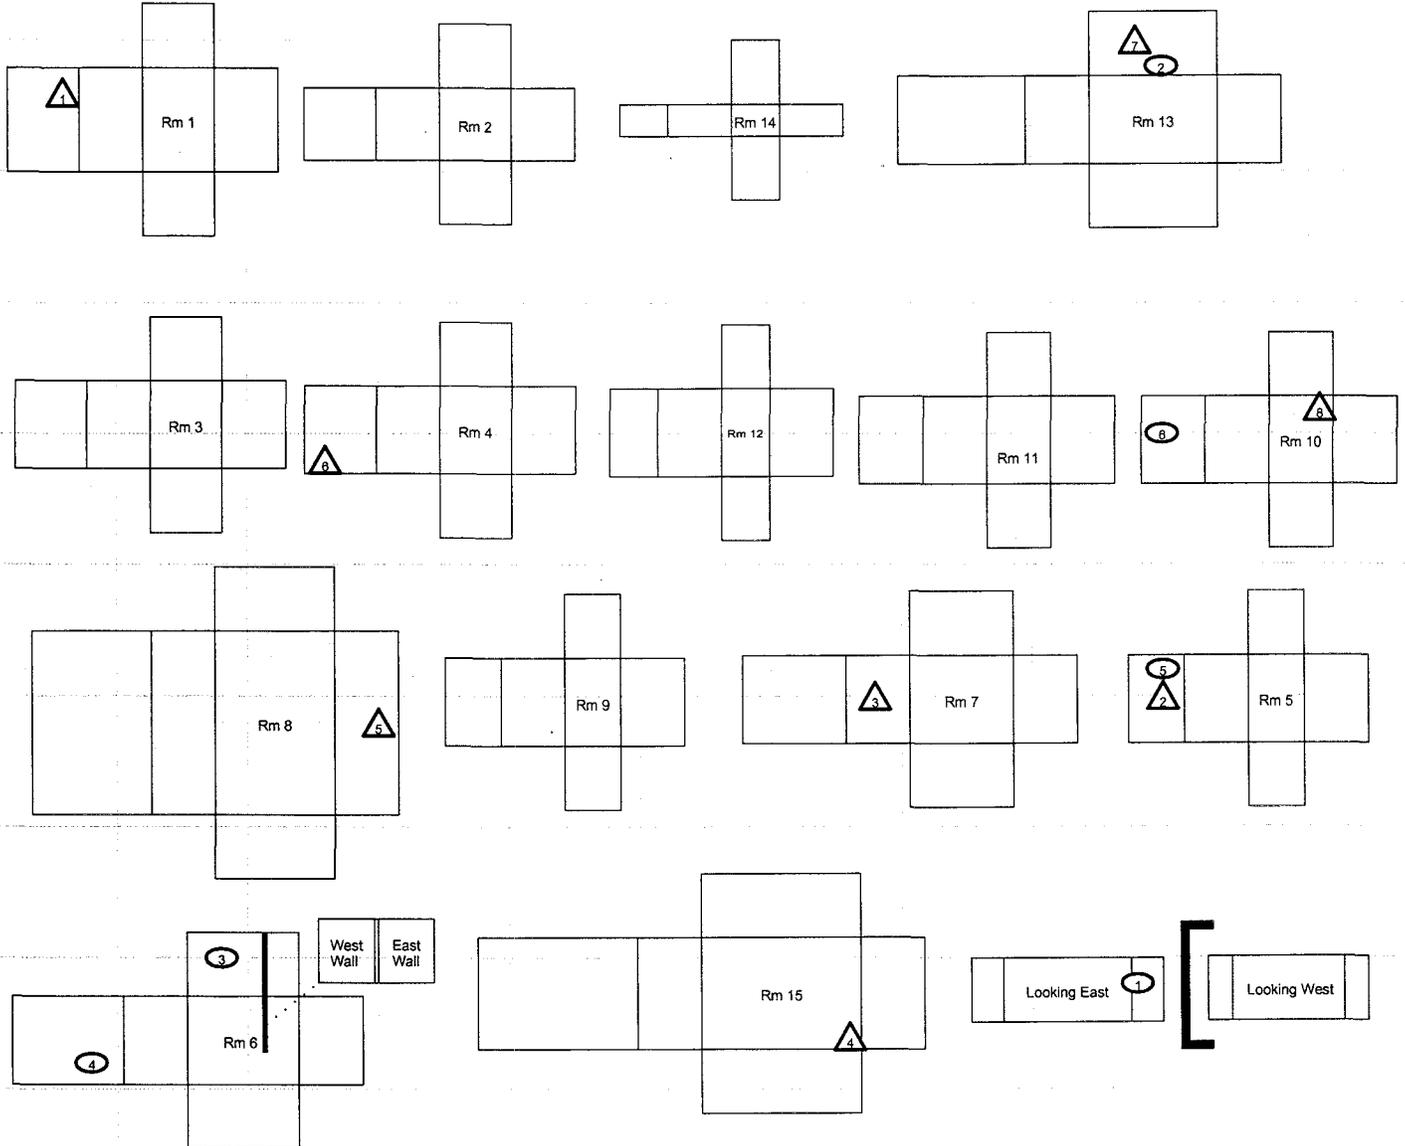
Survey Area: A      Survey Unit: GR9-A-002      Classification: 3  
 Building: T8910  
 Survey Unit Description: Interior & Exterior of T8910  
 Total Area: 963 sq. m.      Total Floor Area: 259 sq. m.

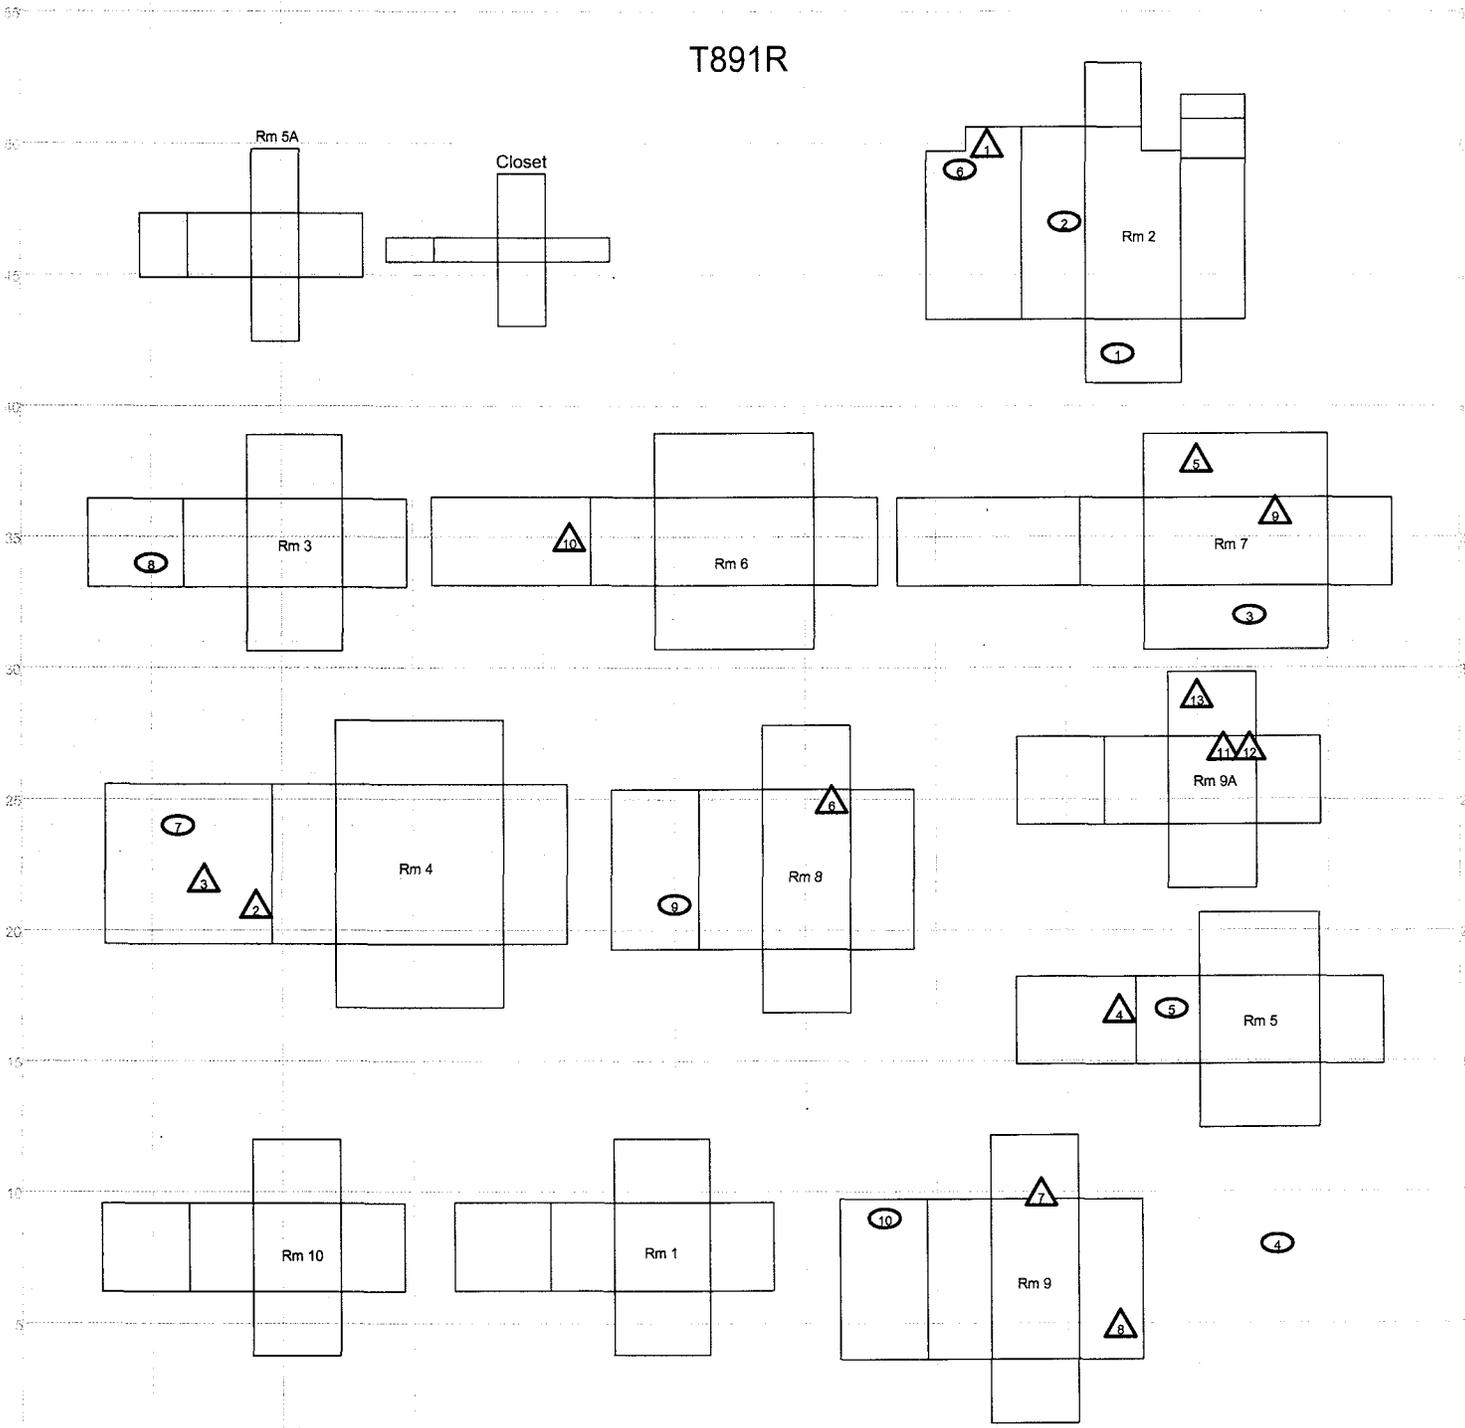
Survey Area: A      Survey Unit: GR9-A-003      Classification: 3  
 Building: T891R  
 Survey Unit Description: Interior & Exterior of T891R  
 Total Area: 1396 sq. m.      Total Floor Area: 256 sq. m.
