Final Project Closeout Report

Building 993 Closure Project

RECONNAISSANCE LEVEL CHARACTERIZATION REPORT (RLCR)

BUILDING 989, 992 & 993 CLOSURE PROJECT

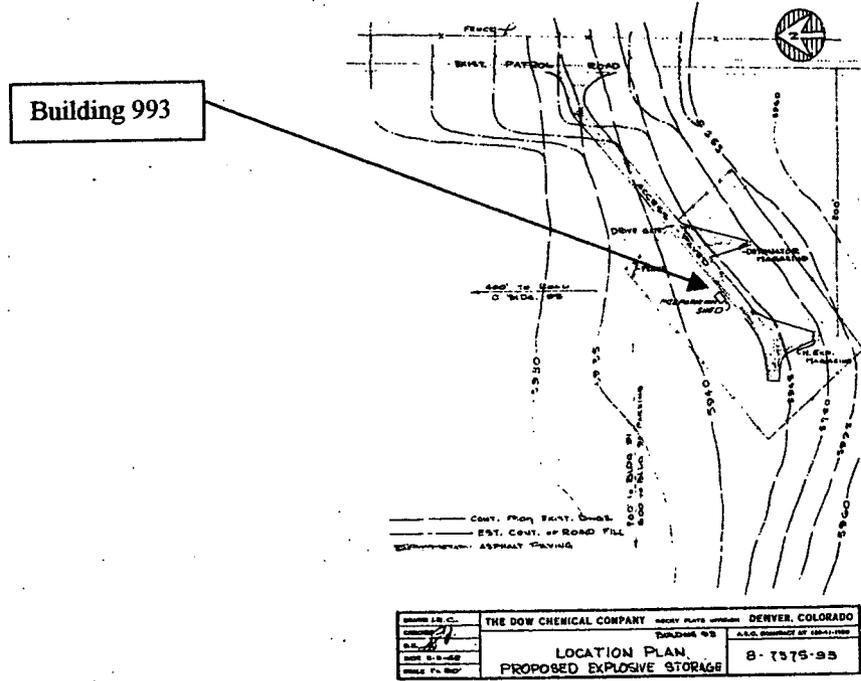
Final Project closeout Report
 Building 993 Closure Project
 Appendix 1, Article 2

Except for the floor slab and pit the building was demolished and removed. Underground utilities were removed to a minimum of 4 feet below surrounding grade. The portion of the site disturbed during demolition was re-graded to match surrounding grades, and will be seeded with natural

The floor slab, approximately 30' wide X 40' long, and a 12" diameter test pit previously filled with concrete were believed to be radiologically contaminated and left in place for Kaiser- Hill Company, L.L.C. Environmental Restoration Group to remove. The approximate quantity of concrete and reinforcing bar material anticipated as waste in the Reconnaissance Level Characterization Report (see Appendix 3, Article 1) was 5,000 cubic feet (~ 141.6 m³).

The Building 993 site was turned over to K-H Environmental Restoration Group with the floor slab and pit undisturbed. K-H Environmental Restoration Group will remove the floor slab and pit and dispose appropriately as radioactive waste.

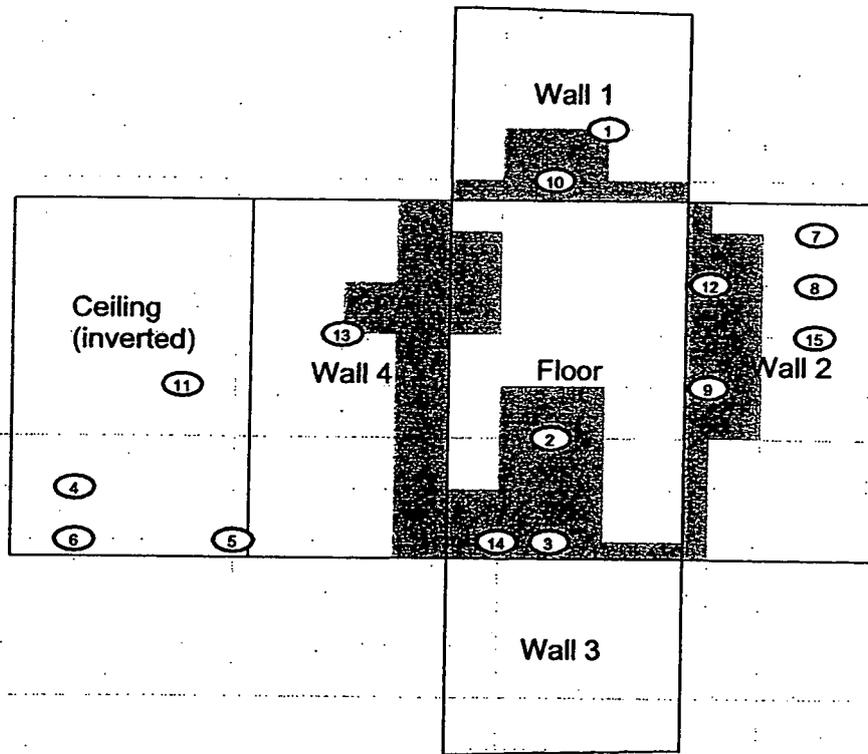
B989

Survey Area: A Survey Unit: 991-A-002 Classification: 3
 Building: 989
 Survey Unit Description: Interior of Building
 Total Area: 147 sq. m. Total Floor Area: 31 sq. m.

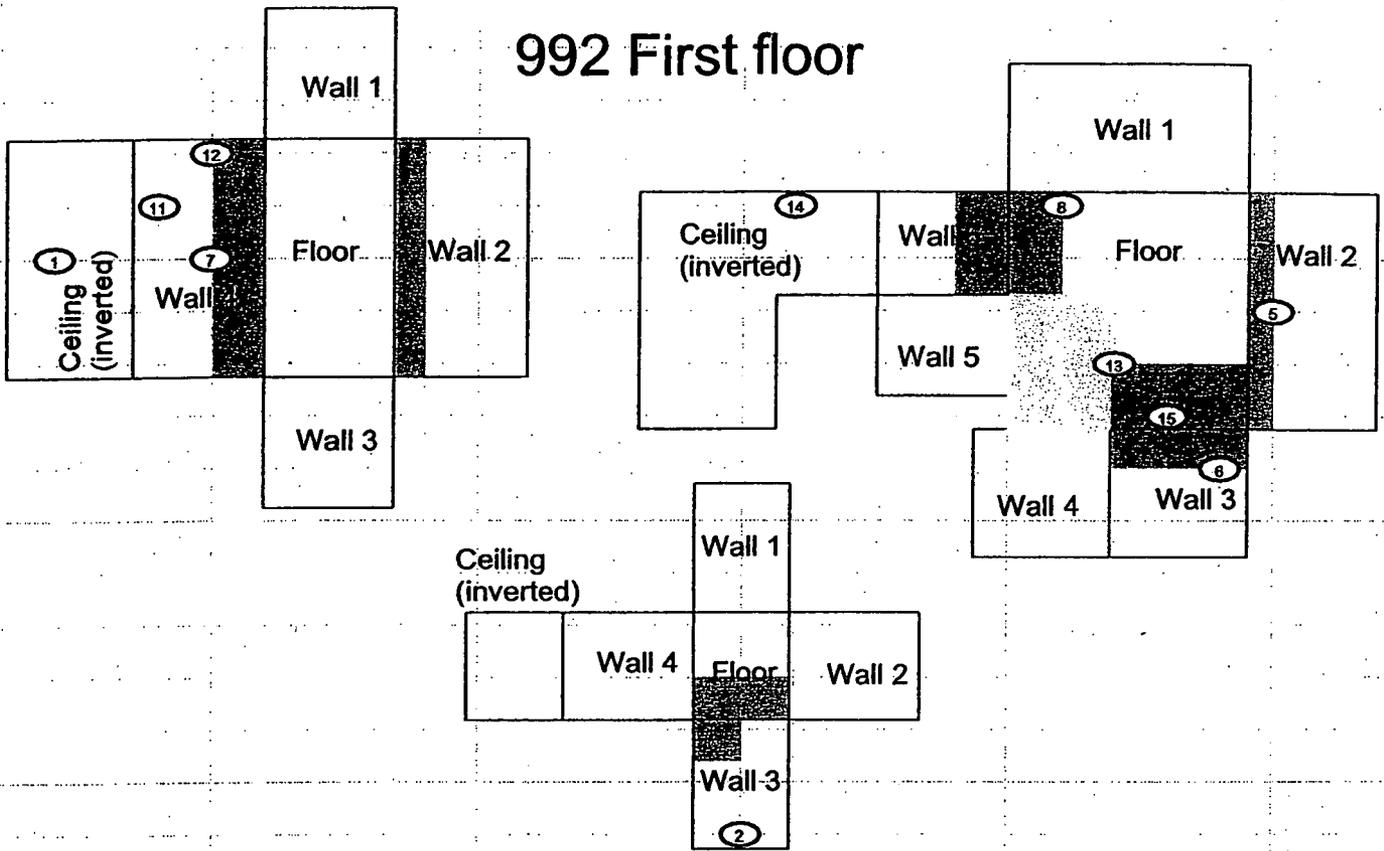
992 First floor

Survey Area: A Survey Unit: 991-A-003 Classification: 3
 Building: 992
 Survey Unit Description: Interior of Building
 Total Area: 203 sq. m. Total Floor Area: 38 sq. m.

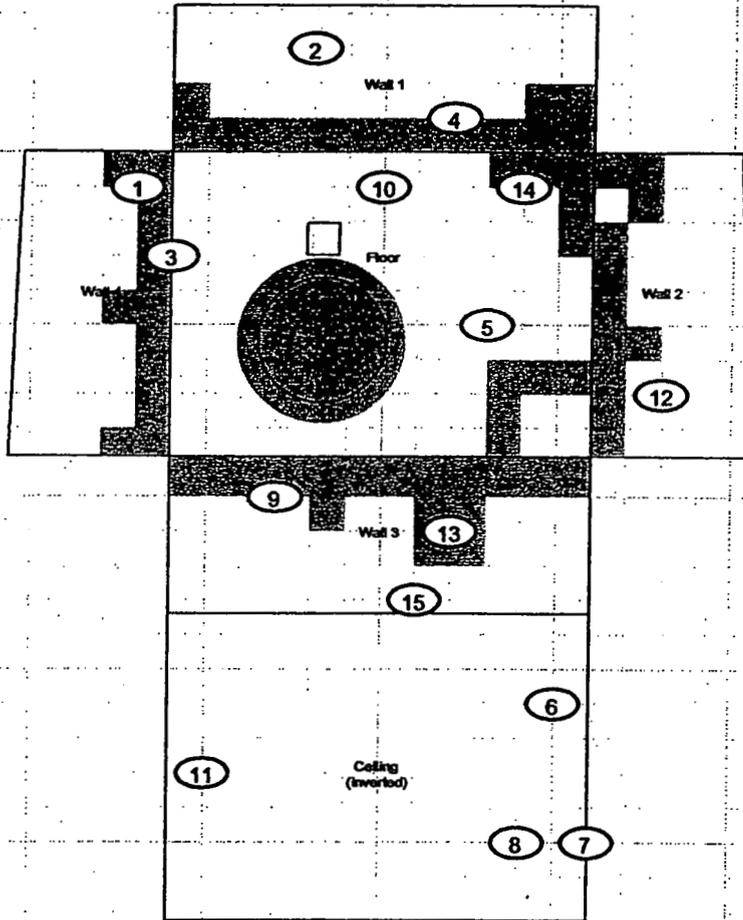
Building 993

Survey Area: A Survey Unit: 991-A-004 Classification: 3
 Building: 993
 Survey Unit Description: Interior of Building
 Total Area: 396 sq. m. Total Floor Area: 106 sq. m.

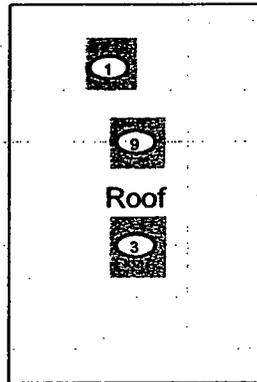
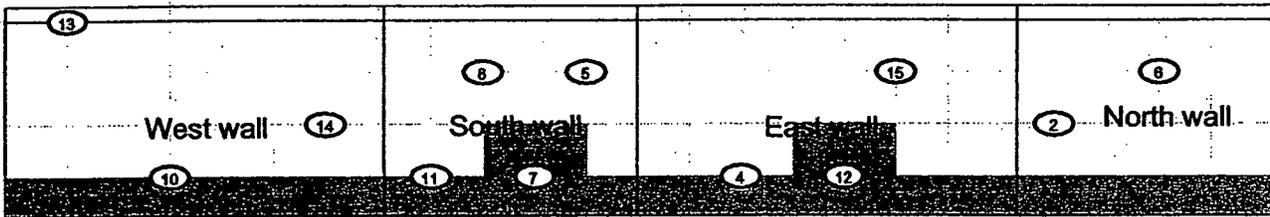
B989

Survey Area: B Survey Unit: 991-B-006 Classification: 3
 Building: 989
 Survey Unit Description: Exterior of Building
 Total Area: 134 sq. m. Total Roof Area: 36 sq. m.

¹ - Average LAB used to subtract from Gross Sample Activity
 * - The initial Sample Net Activity for Sample Location 11 was 133.8 dpm/100cm².
 Location 11 was allowed to decay. The re-survey results are reported.

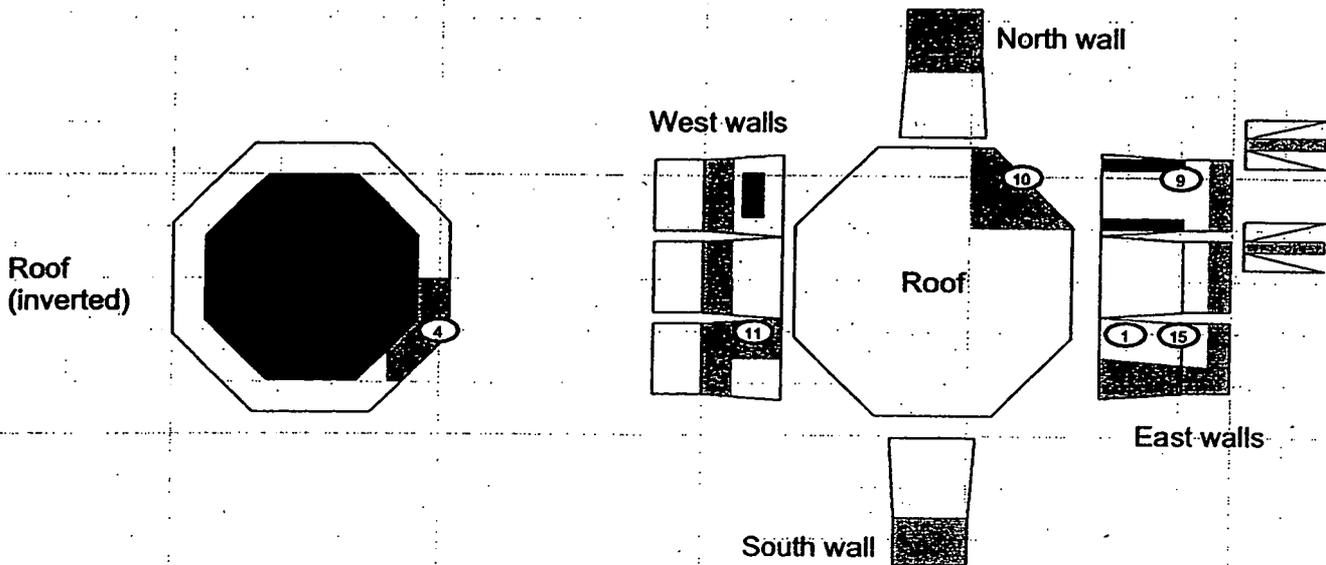
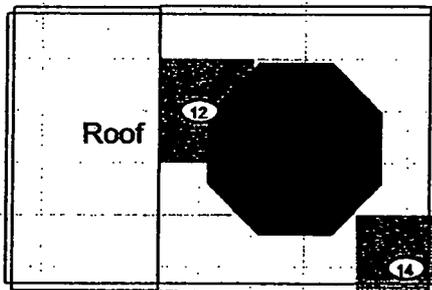
Second level

Survey Area: B Survey Unit: 991-B-007 Classification: 3
 Building: 992
 Survey Unit Description: Exterior of Building
 Total Area: 160 sq. m. Total Roof Area: 67 sq. m.

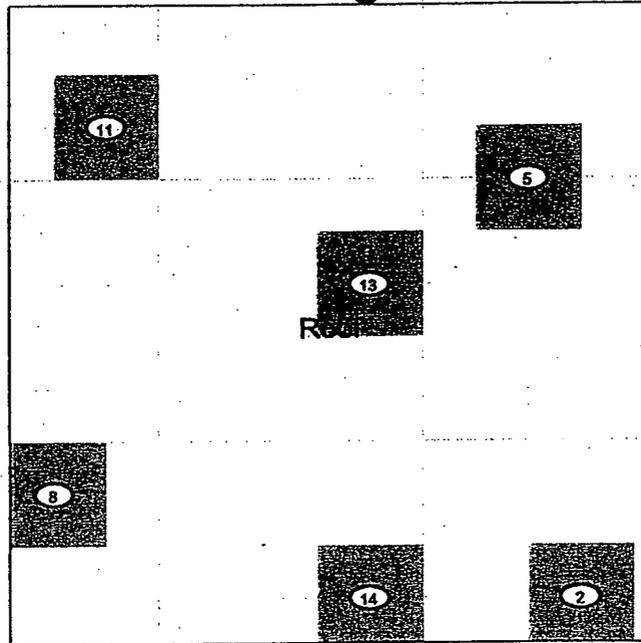
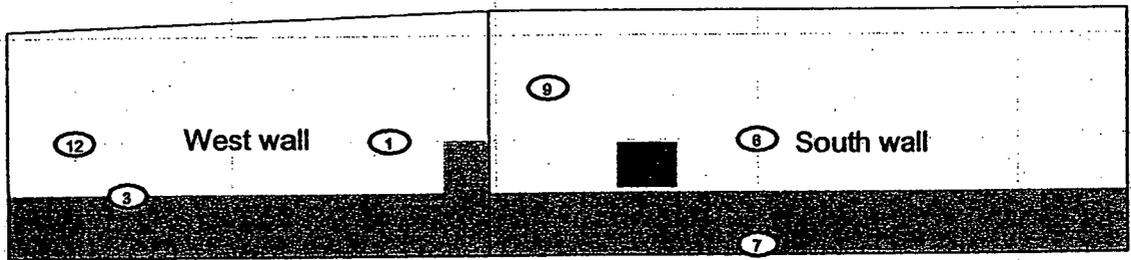
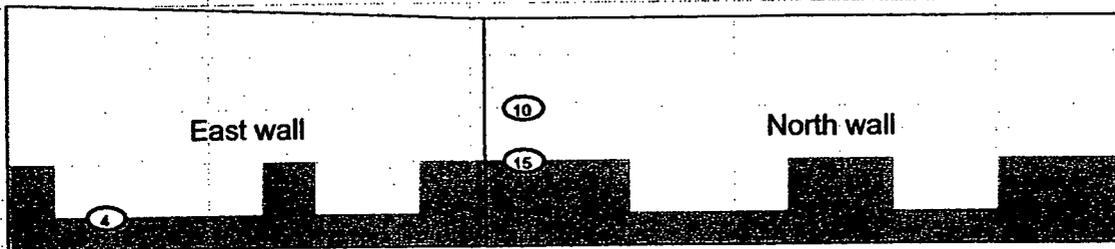
Building 993

Survey Area: B Survey Unit: 991-B-008 Classification: 3
 Building: 993
 Survey Unit Description: Exterior of Building
 Total Area: 340 sq. m. Total Roof Area: 148 sq. m.

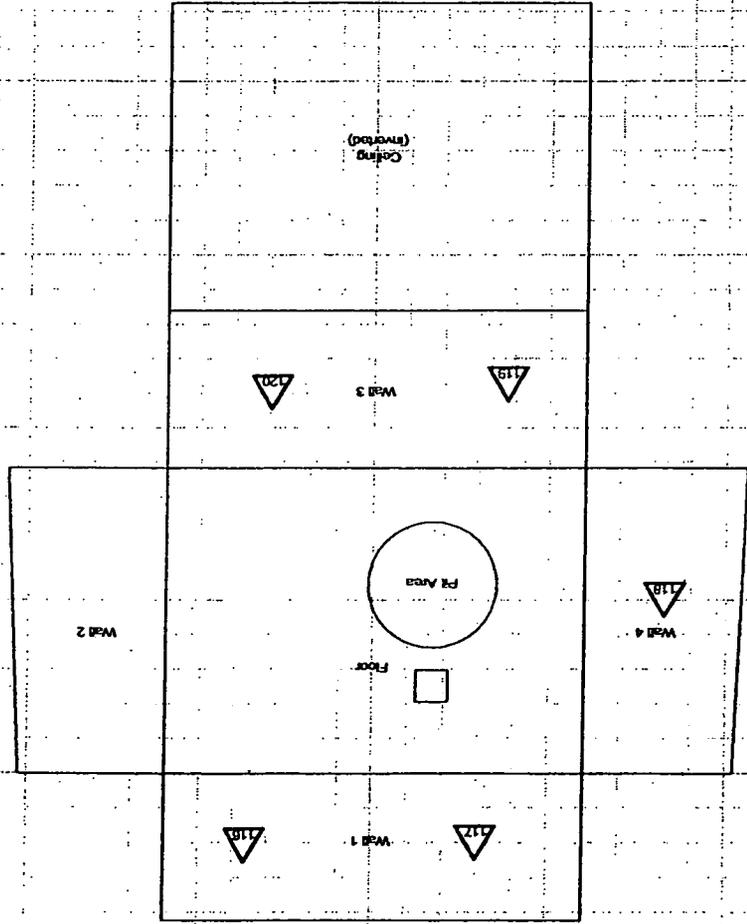
Building 993

CHEMICAL SAMPLE MAP
