**TYPE 1
RECONNAISSANCE LEVEL CHARACTERIZATION
REPORT (RLCR)**

BUILDING 566B CLOSURE PROJECT

REVISION 0

December 3, 2003

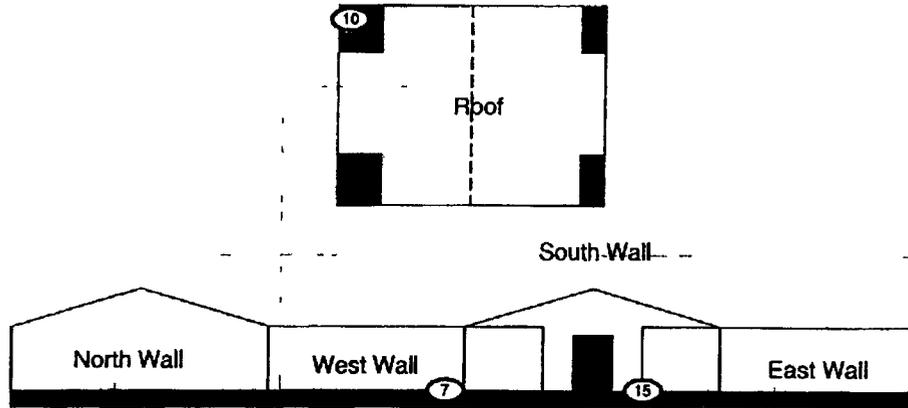
Building 566B Exterior

Survey Area 4 Survey Unit 566B-A-002 Classification 3
 Building 566B
 Survey Unit Description Interior - Exterior
 Total Area 252 sq m Total Floor Area 36 sq m

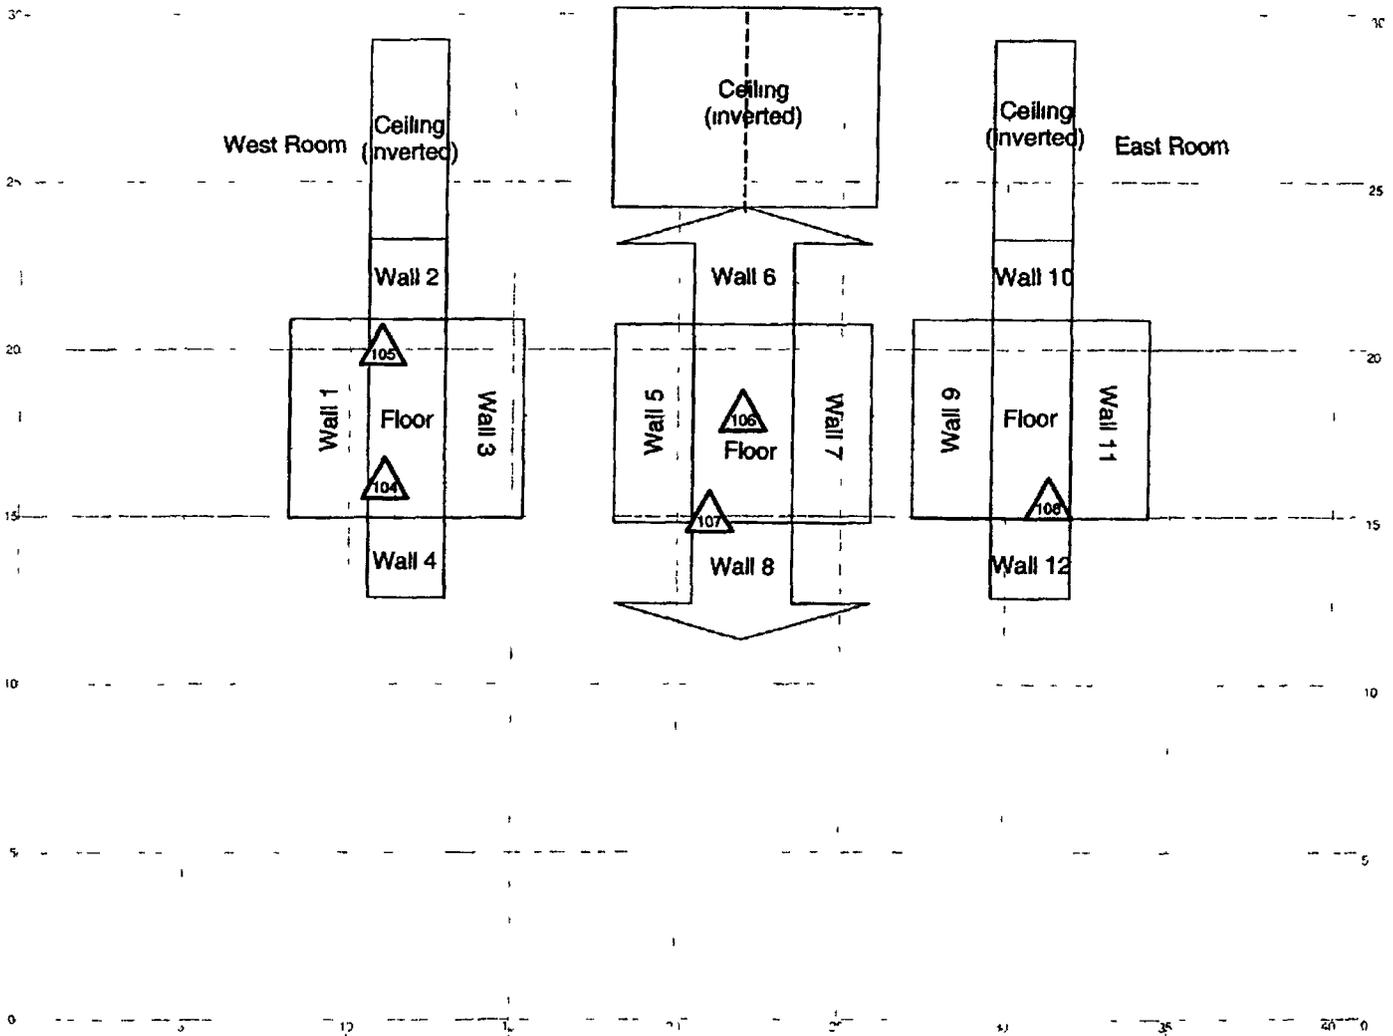
Building 566B Interior

All five (5) biased beryllium smear sample results were less than $0.1 \mu\text{g}/100\text{cm}^2$ and meet the unrestricted release limits. Beryllium laboratory sample data and location maps are contained in Attachment D, Chemical Data Summaries and Sample Maps.
