Rocky Flats Environmental Technology Site

TYPE 1 RECONNAISSANCE LEVEL CHARACTERIZATION REPORT (RLCR)

TRAILER 130B CLOSURE PROJECT

March 1, 2005

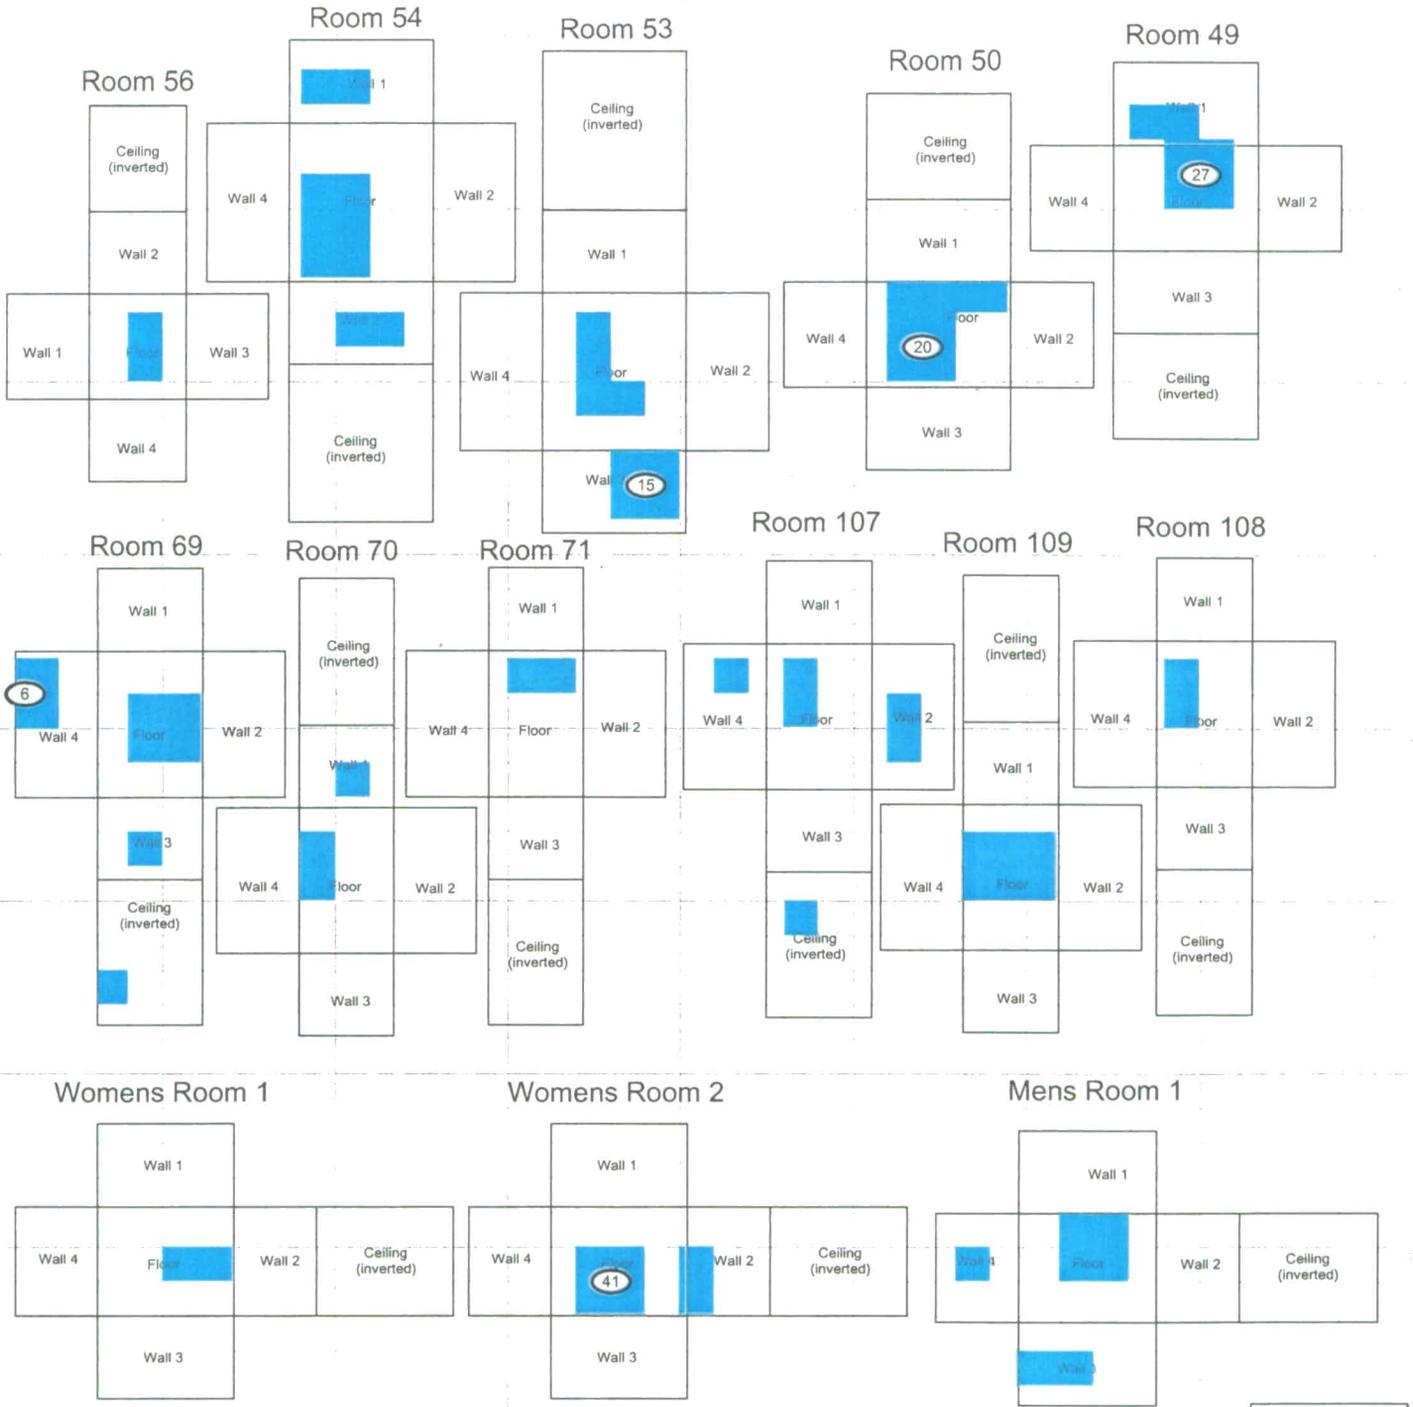
PRE-DEMOLITION SURVEY FOR T130B

Survey Area: 5 Survey Unit: 130B02 Classification: 3
 Building: T130B
 Survey Unit Description: Trailer 130B (Interior) all surfaces
 Total Area: 4592 sq. m. Total Floor Area: 1414 sq. m.
