# Rocky Flats Environmental Technology Site

## TYPE 1 RECONNAISSANCE LEVEL CHARACTERIZATION REPORT (RLCR)

### BUILDING T707E CLOSURE PROJECT

May 3, 2005

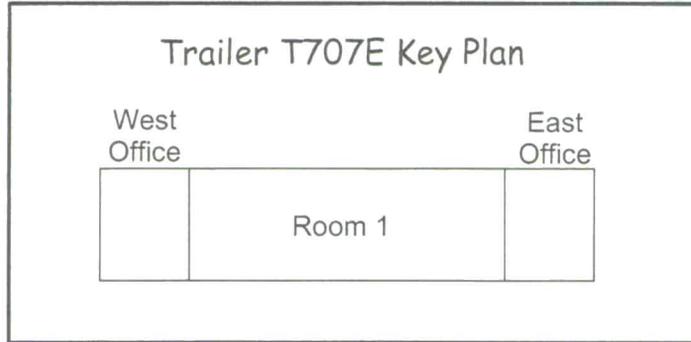
**PDS FOR T707E**

Survey Area: 0      Survey Unit: 707E01      Classification: 3  
 Building: T707E  
 Survey Unit Description: Trailer 707E (Interior & Exterior) all surfaces  
 Total Area: 357 sq. m.      Total Floor Area: 94 sq. m.
