2008 U. S. Fish and Wildlife Service Biological Opinion Annual Mitigation Monitoring Reports for the Rocky Flats Site

2008 East Shooting Range Remediation Project Report for the Rocky Flats Site

**Preble's Meadow Jumping Mouse Mitigation Monitoring Report for the
East Shooting Range Remediation Project at the Rocky Flats Site
2008 Annual Report
Biological Opinion: ES/LK-6-CO-04-032 (September 17, 2004)**

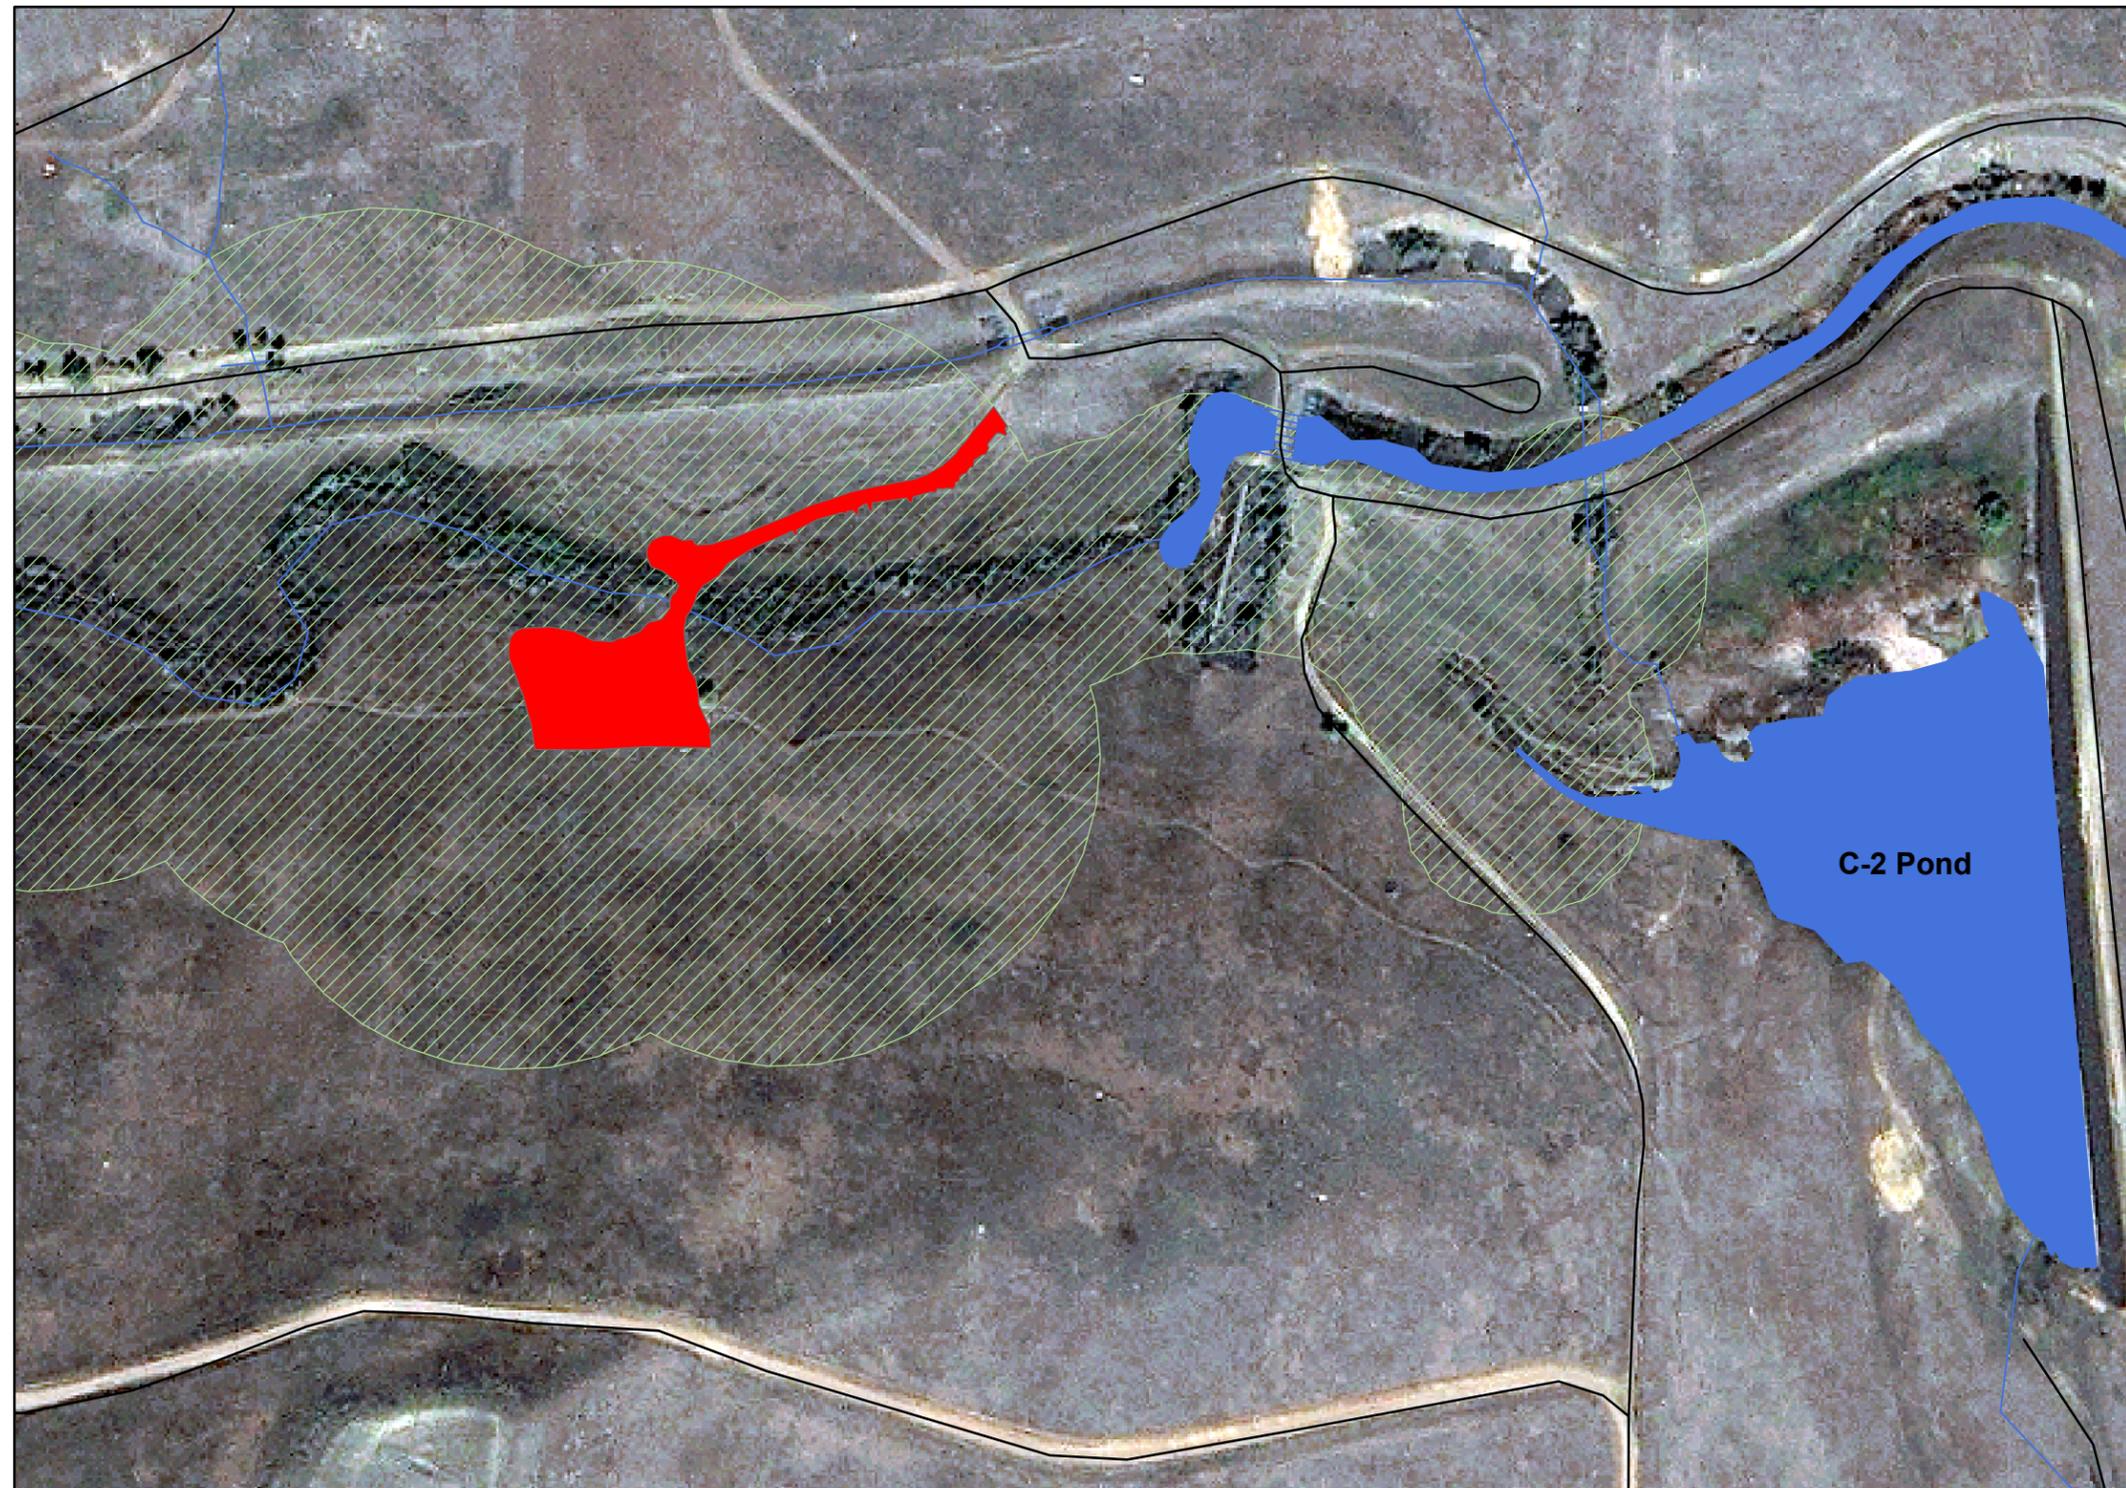
Figure 1

The location of the ESRR Project is shown in Figure 1. The methodology used for the monitoring was taken from the Mitigation Monitoring Plan, Part II of the PBA Appendix B. In accordance with the plan, qualitative monitoring was used for the ESRR Project because the total area that was disturbed and revegetated was less than one acre in size. Qualitative monitoring consisted of retaking photographs of the area (see Appendix A of the ESSR Project on the DVD) and conducting a qualitative assessment (see Appendix B of the ESSR Project on the DVD) to evaluate and document the revegetation efforts.

East Shooting Range Remediation Project Location

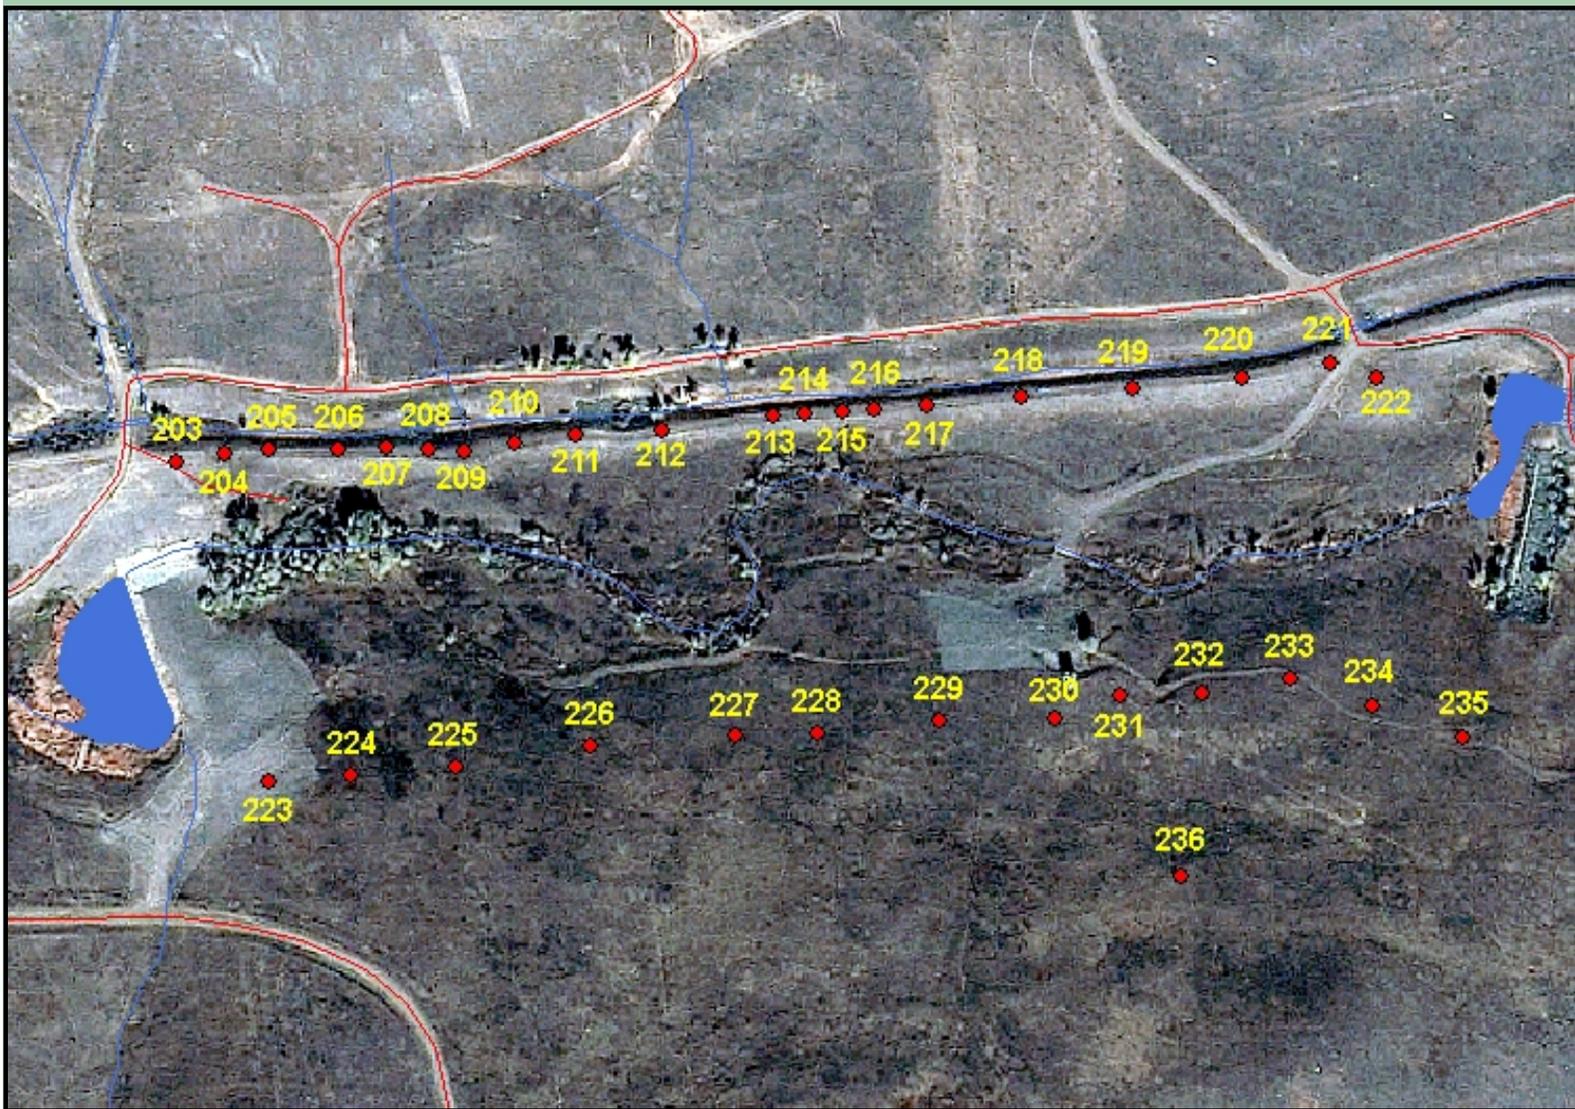
Photopoint 203

In general, the grasses are becoming well established and filling in across the revegetation area. The photo-monitoring results (provided in Appendix A for the ESSR Project on the DVD) show the increase in vegetation over time since project completion. With continued weed control, as needed, the entire area should be indistinguishable from the surrounding vicinity within the next year or two. On the south side of Woman Creek, the coconut matting erosion material continues to hide some of the grasses that are growing beneath it. The uneven ground surface has caused the matting to become elevated in some locations, thus causing the hillside to look unvegetated in spots from a distance. However, closer inspection reveals a good stand of grass becoming established beneath the matting. Hence, the area is doing quite well.
