# 2007 U. S. Fish and Wildlife Service Biological Opinion Annual Mitigation Monitoring Reports for the Rocky Flats Site

# 2007 East Shooting Range Remediation Project Report for the Rocky Flats Site

**Preble's Meadow Jumping Mouse Mitigation Monitoring Report for the  
East Shooting Range Remediation Project at the Rocky Flats Site  
2007 Annual Report  
Biological Opinion: ES/LK-6-CO-04-032 (September 17, 2004)**

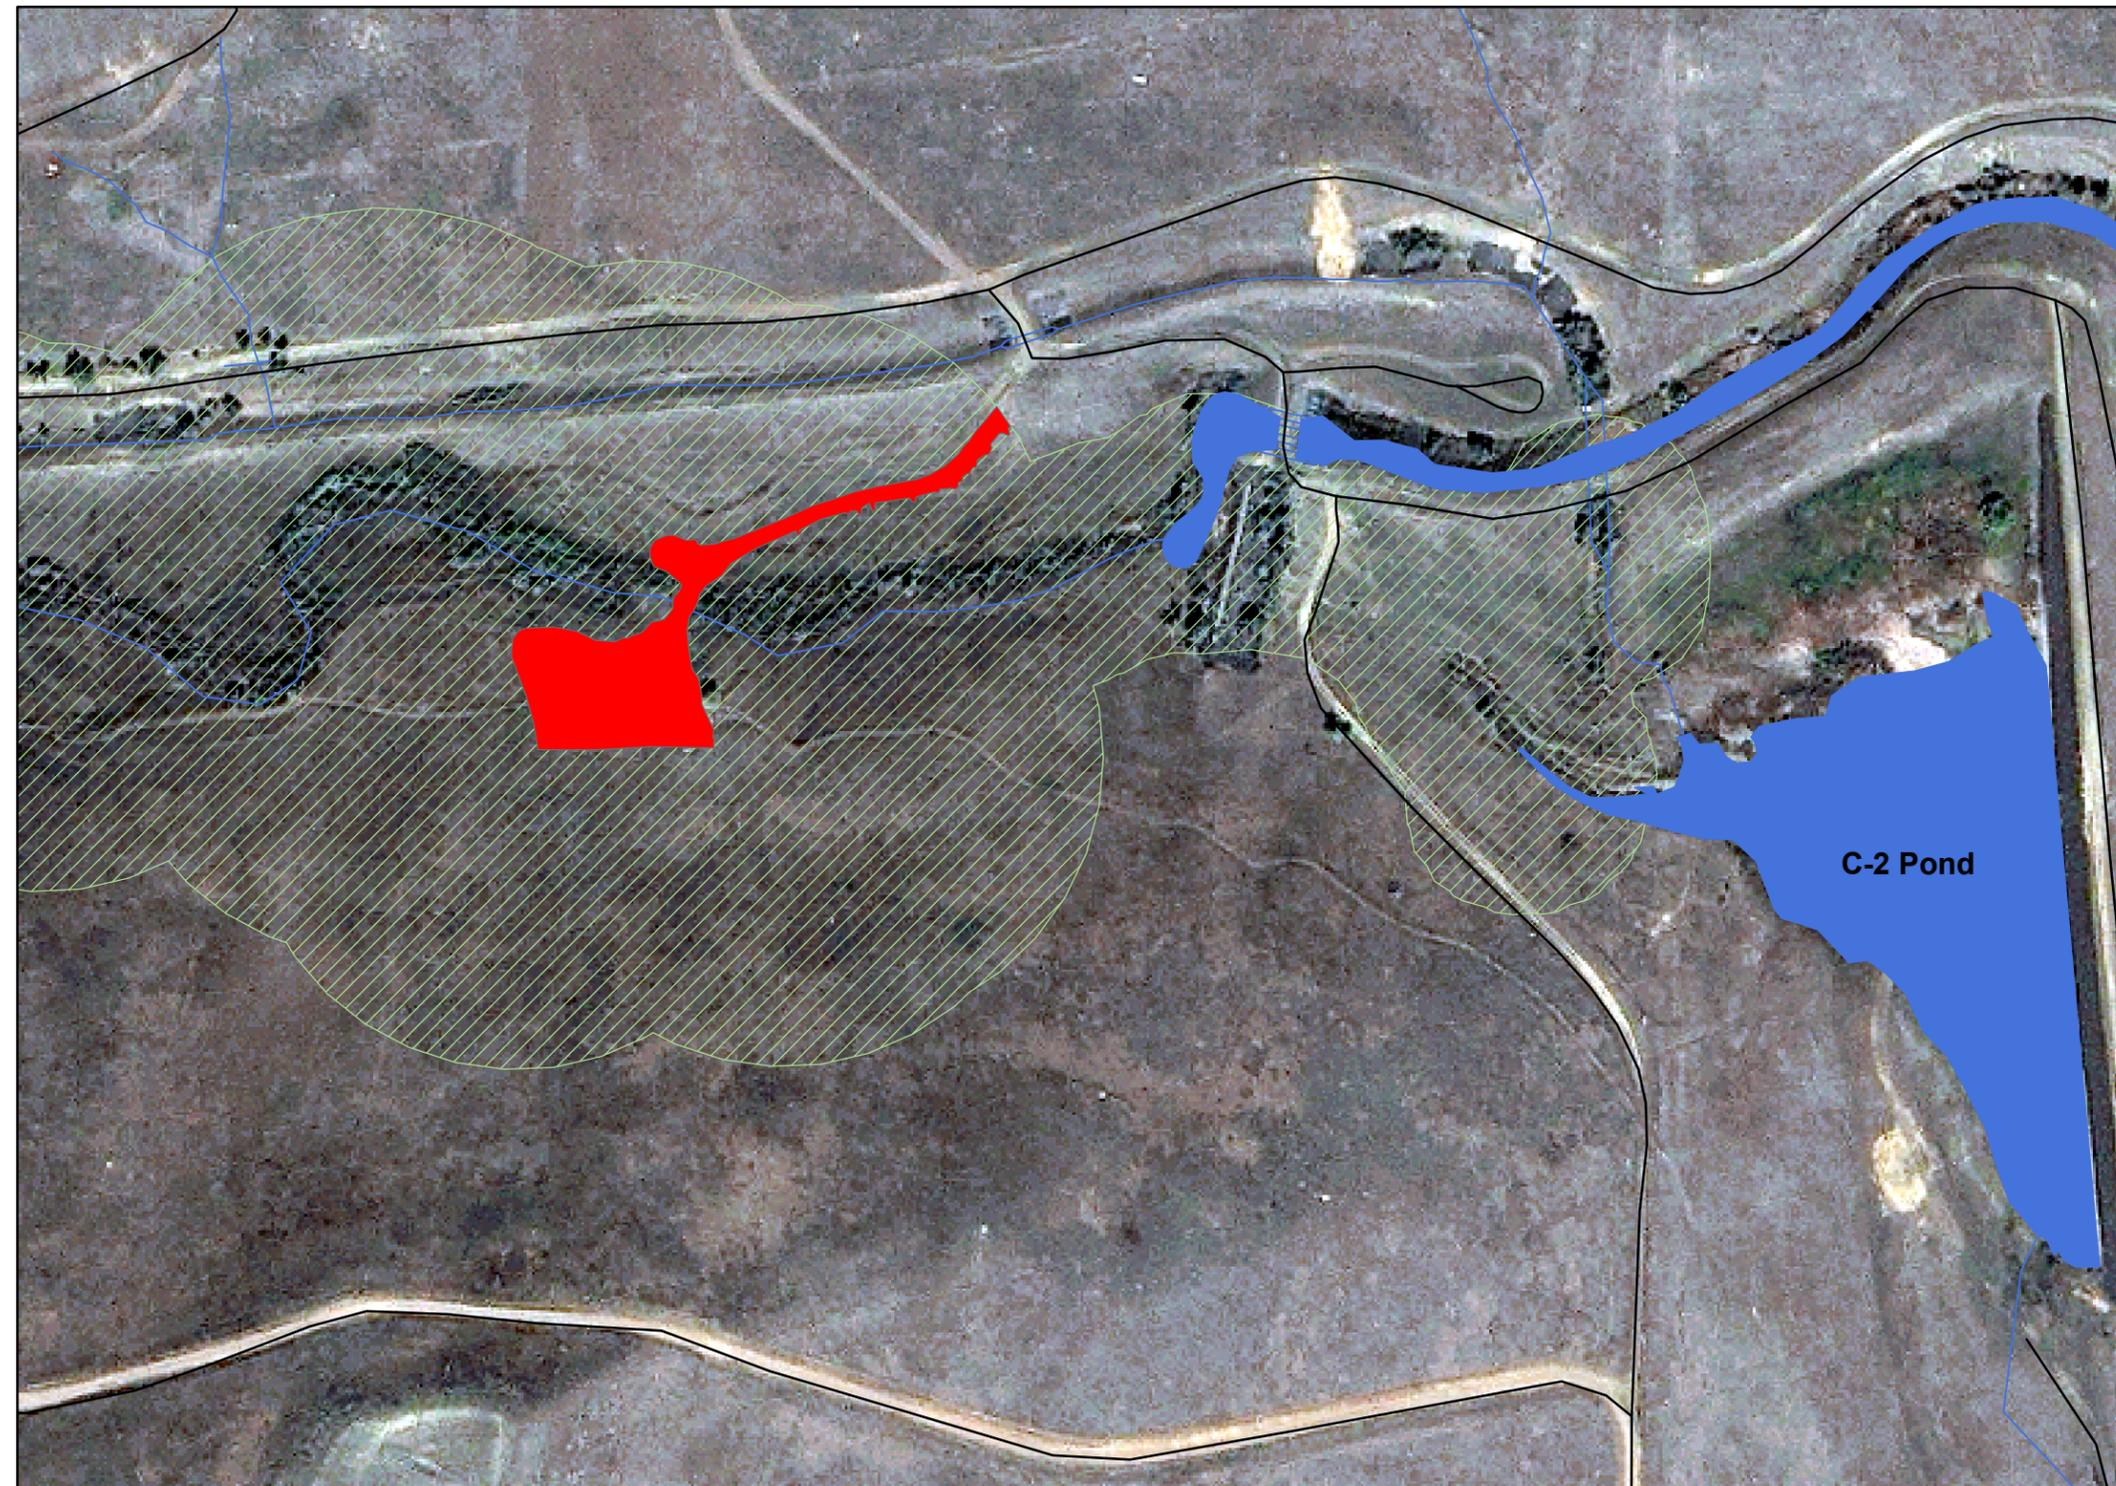
## Figure 1

The location of the ESRR Project is shown on Figure 1. The methodology used for the monitoring was taken from Appendix B in Part II of the PBA, the Mitigation Monitoring Plan. In accordance with the plan, qualitative monitoring was used for the ESRR Project because the total area disturbed and revegetated was less than one acre in size. Qualitative monitoring consisted of retaking photographs of the area (see Appendix A on the CD-ROM) and conducting a qualitative assessment (see Appendix B on the CD-ROM) to evaluate and document the initial revegetation efforts.

# East Shooting Range Remediation Project Location
