**ENVIRONMENTAL RESTORATION
RFCA STANDARD OPERATING PROTOCOL
FOR ROUTINE SOIL REMEDIATION
FY2002
NOTIFICATION #02-02**

Approval received from the Colorado Department of Public Health and Environment
March 13, 2002

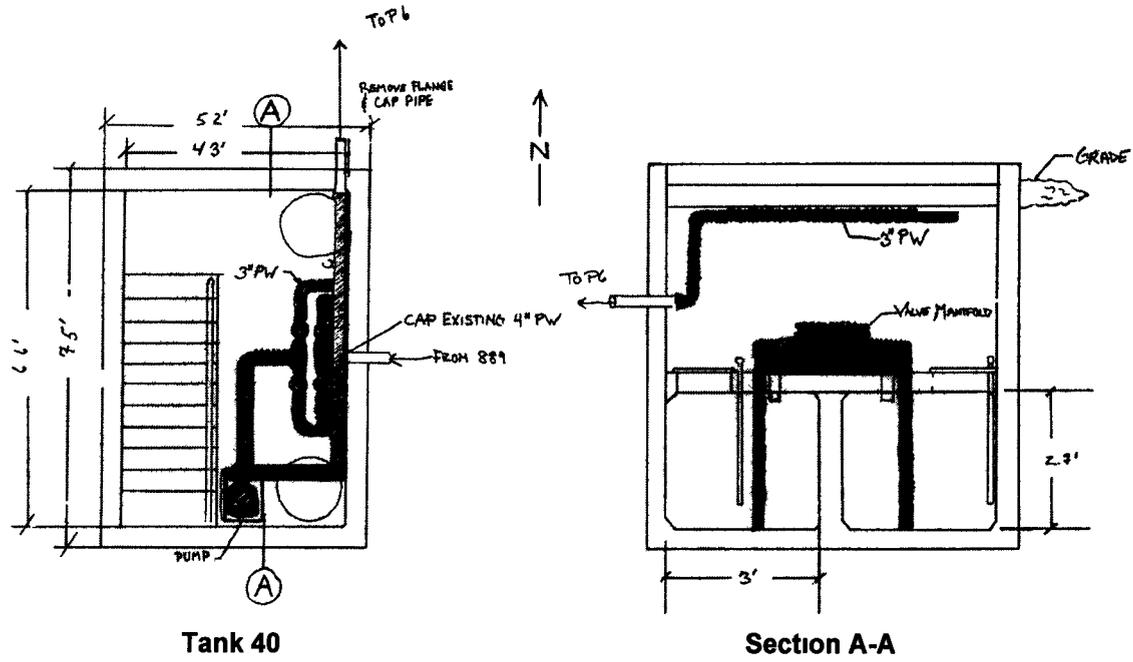
Figure 5
IHSS Group 800-6 RCRA Tank 40

IHSS Group 800-6 includes UBC 889 – Decontamination and Waste Reduction, IHSS 800 – 164 3 – Radioactive Site 800 Area Site #2 Building 889 Storage Pad, and IHSS 121 Original Process Waste Line (OPWL) Tanks 28 and 40. A map of IHSS Group 800-6 is shown in Figure 3. Figure 4 presents the locations of the OPWL and New Process Waste Lines (NPWL) associated with this IHSS Group. Tank 40, a RCRA Interim Status Unit is shown on Figure 5.

Tank 40 is a RCRA Interim Status Unit. Additionally, portions of NPWL and two valve vaults (Figure 4) are within IHSS 800-164 3. Tank 40 was emptied, rinsed, and foamed in 1996. The U.S. Environmental Protection Agency (EPA) waste codes for wastes managed in this unit include D003, D004, D005, D009, D011, F001, F002, F003, and F005 (DOE 1995). Tank 40 will be excavated for disposal. NPWL and the valve vault may be excavated. It is anticipated that waste from these units will be classified as low level mixed waste.

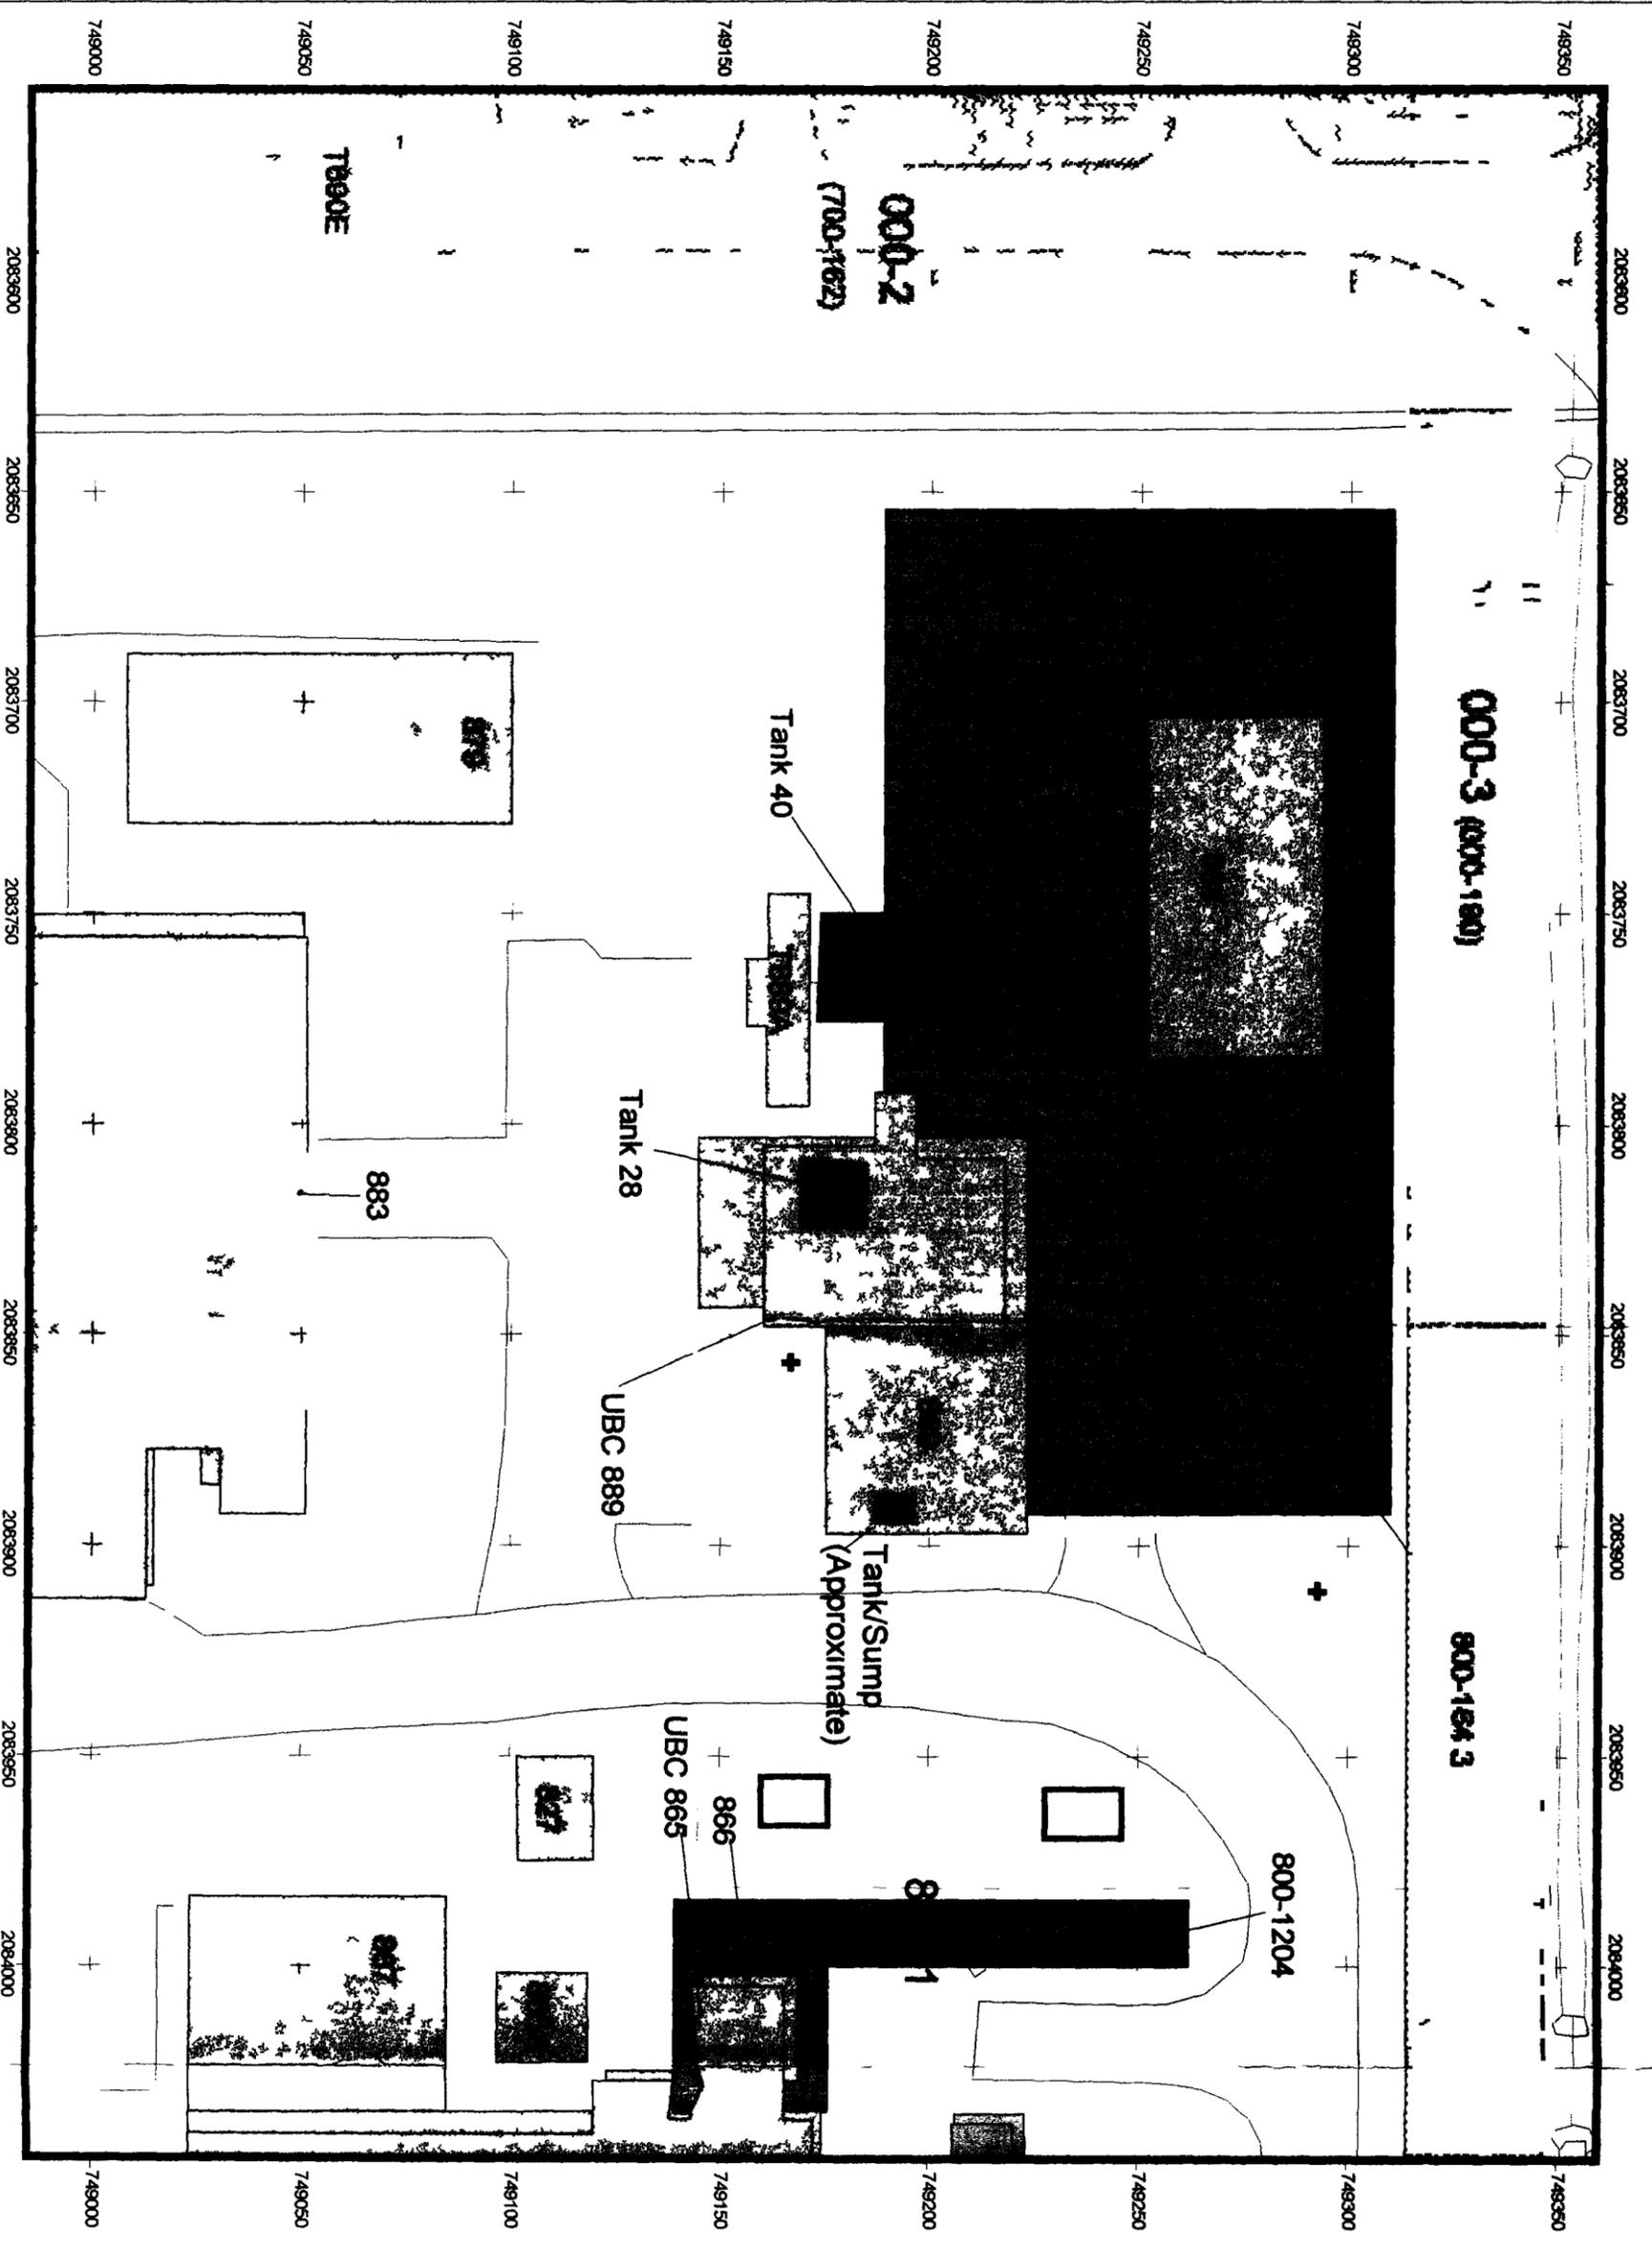
Figure 3
IHSS Group 800-6
(800 164 3, UBC 889, and
OPWL Tanks 28 and 40)

IHSS Group 800-6 is in the RFETS IA Nearby potential contaminant sources are IHSS Groups 800-1 (UBC 865), 800-3 (UBC 883), 000-3 (Central Avenue Ditch Caustic Leak), and 000-2 (Radioactive Site 700 Area) These sites are listed in Table 5 and shown on Figure 3

High-volume air samplers may be used at the remediation area consistent with work controls to determine airborne radioactivity concentrations. Approximate locations of air samplers are shown on Figure 3.

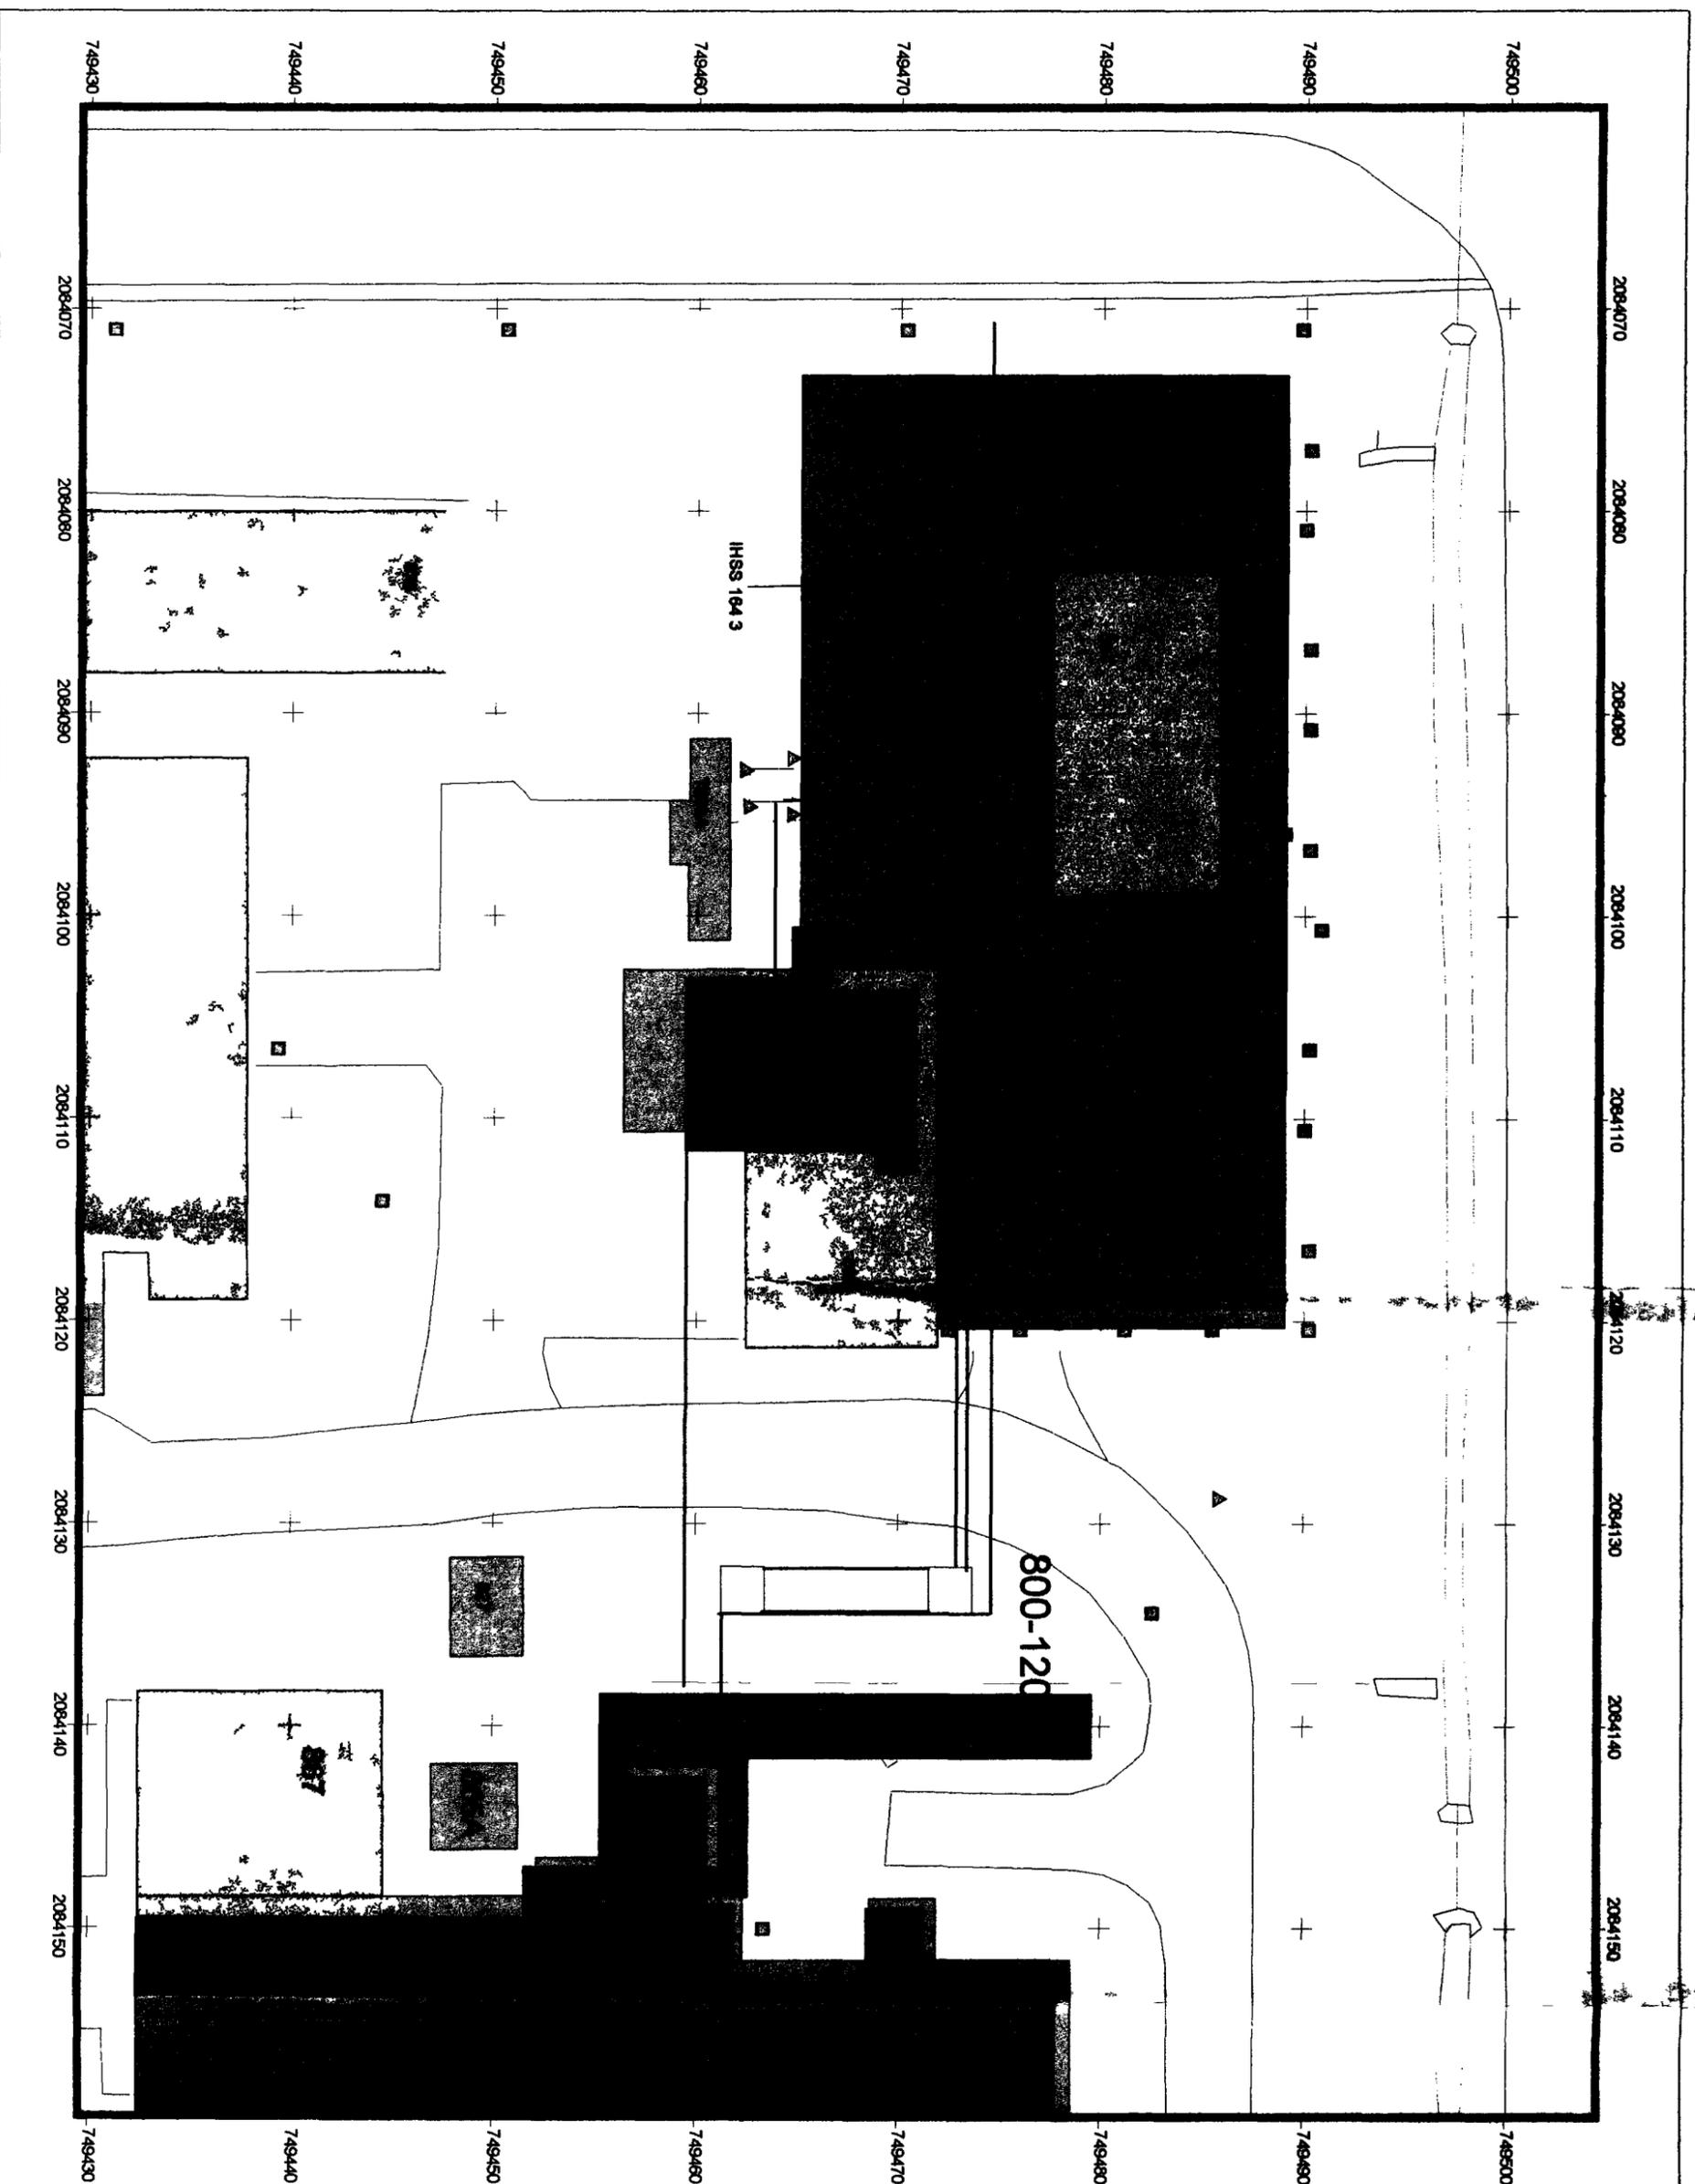
Figure 4
IHSS Group 800-6
OPWL and NPWL

OPWL will be removed and associated soil will be removed to below RFCA Tier I ALs (Figure 4) Tanks 40, 28, and the tank/sump beneath the eastern portion of the B889 slab if contaminated above RFCA Tier I ALs or if within 3 feet of the surface will be removed NPWL and Valve Vault 4 may be removed OPWL in IHSS Group 800-6 will be excavated as close as possible to Valve Vaults 5 and 6 (east of IHSS Group 800-6) and Valve Vault 3 (west of IHSS Group 800-6) The extent of this excavation will depend on access to the area, not contamination Additional remediation, if required, for Valve Vaults 3, 5, and 6 will be conducted when IHSS Group 000-2 is addressed Confirmation samples will be collected in accordance with the IASAP (DOE 2001a)
