Health Studies on
**ROCKY
FLATS**

PHASE I:
HISTORICAL
PUBLIC
EXPOSURES

Reconstruction of Historical Rocky Flats Operations & Identification of Release Points

AUGUST 1992

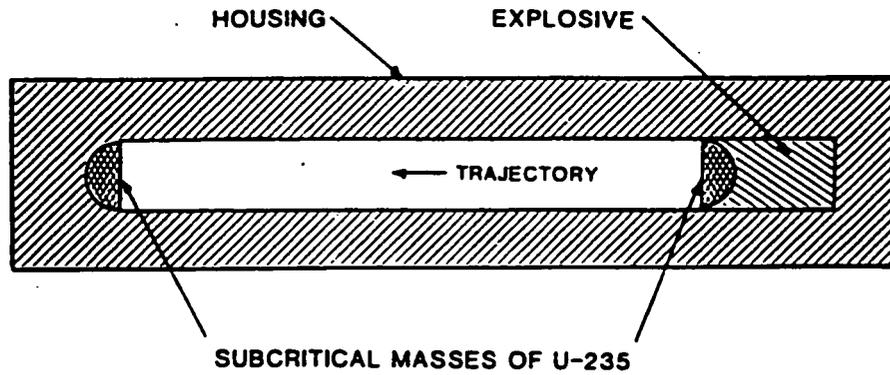
GUN TYPE NUCLEAR DEVICE

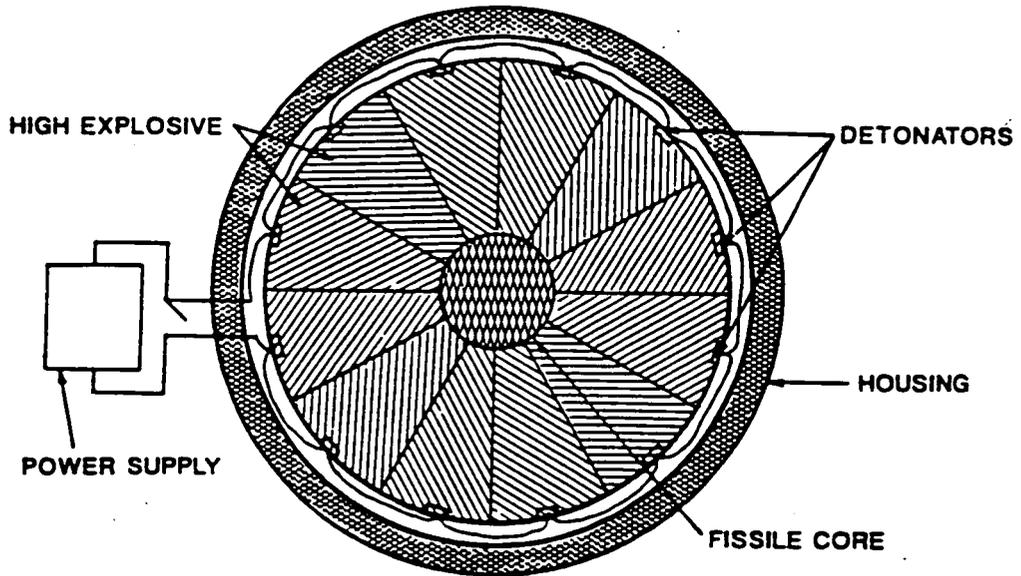
IMPLOSION TYPE NUCLEAR DEVICE

Since 1958, pit designs have remained largely the same, although the relative amounts of the materials used, dimensions, and a few other design features of the units have varied from model to model. The primary materials of construction have generally remained plutonium, uranium, beryllium, aluminum, and stainless steel, however the relative proportions have varied between models. Some models incorporated some more exotic materials, such as cadmium, vanadium, silver, and gold, but the amounts have been relatively minor in comparison to the primary five materials. The plant has also performed "Special Order" work. This type of work is outside the production of weapon components, but most often involved prototype development work. Special fabrication, testing, and assembly are provided for weapons development programs. For example, the work may involve the production of a prototype pit that incorporates different materials or geometries. In some cases, Special Order work has involved work indirectly related to war reserve programs, such as the development of safer shipping containers and transportation vehicles for nuclear materials and weapons (USDOE, 1980).

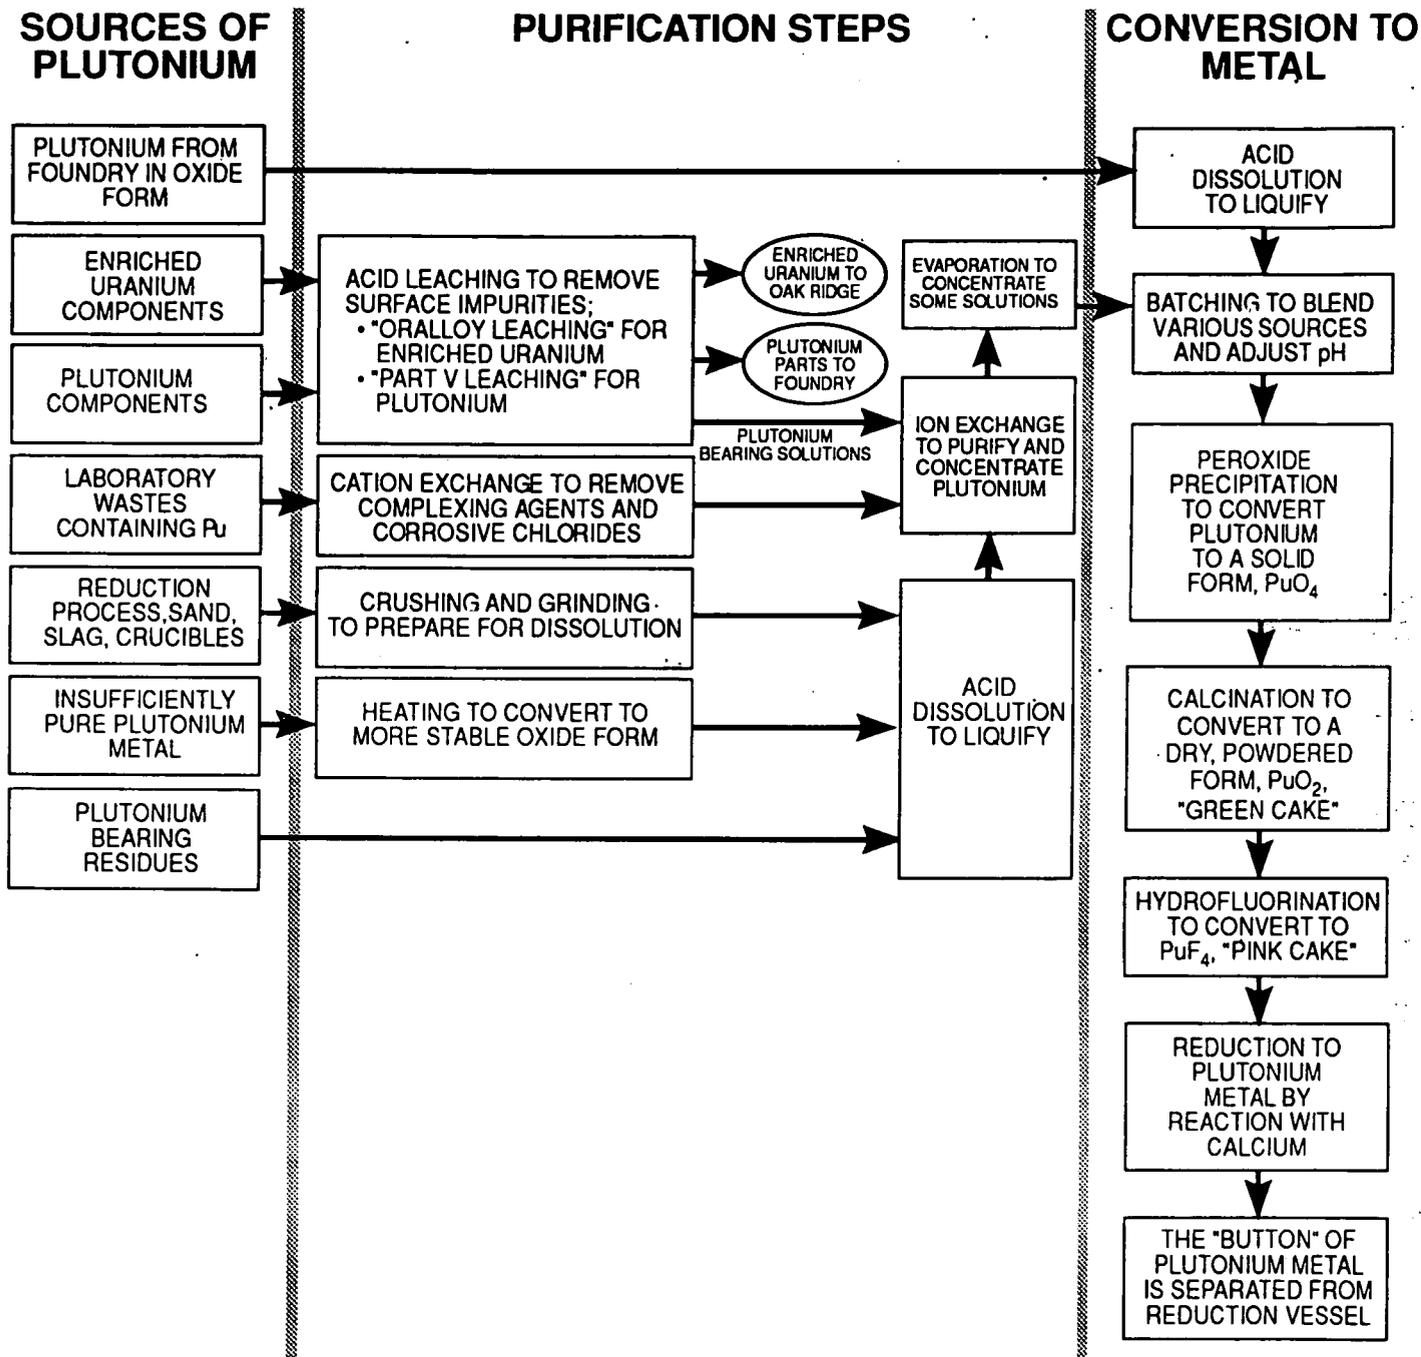
FIGURE 3-11
PLUTONIUM RECOVERY
PROCESS

Prior to implementation of the molten salt extraction process in 1968, almost all plutonium-bearing materials went through slow recovery operations, for example reactor generated plutonium, site returns, metal chips, and foundry skull and other forms of high purity metal residues generated by machining operations. These materials had to first be put into a plutonium nitrate form via the slow side operations and then introduced into the fast cycle line for conversion to a solid and reduction to metal. Since the introduction of the molten salt extraction (MSE) process in 1968, some of the essentially pure plutonium metal, such as the metal from site returns, has gone through MSE to remove americium ingrowth and has then been forwarded directly to plutonium foundry operations in Building 777 for casting and subsequent processing into plutonium components. The need for these materials to go through the chemical recovery process was eliminated. As a result, slow cycle recovery now receives materials such as effluents and waste products from the fast cycle, rags, paper goods, sweepings, and other wastes. It no longer processes the purer forms of plutonium. As before, though, materials which have gone through the slow recovery cycle are then sent through the fast cycle for further purification.

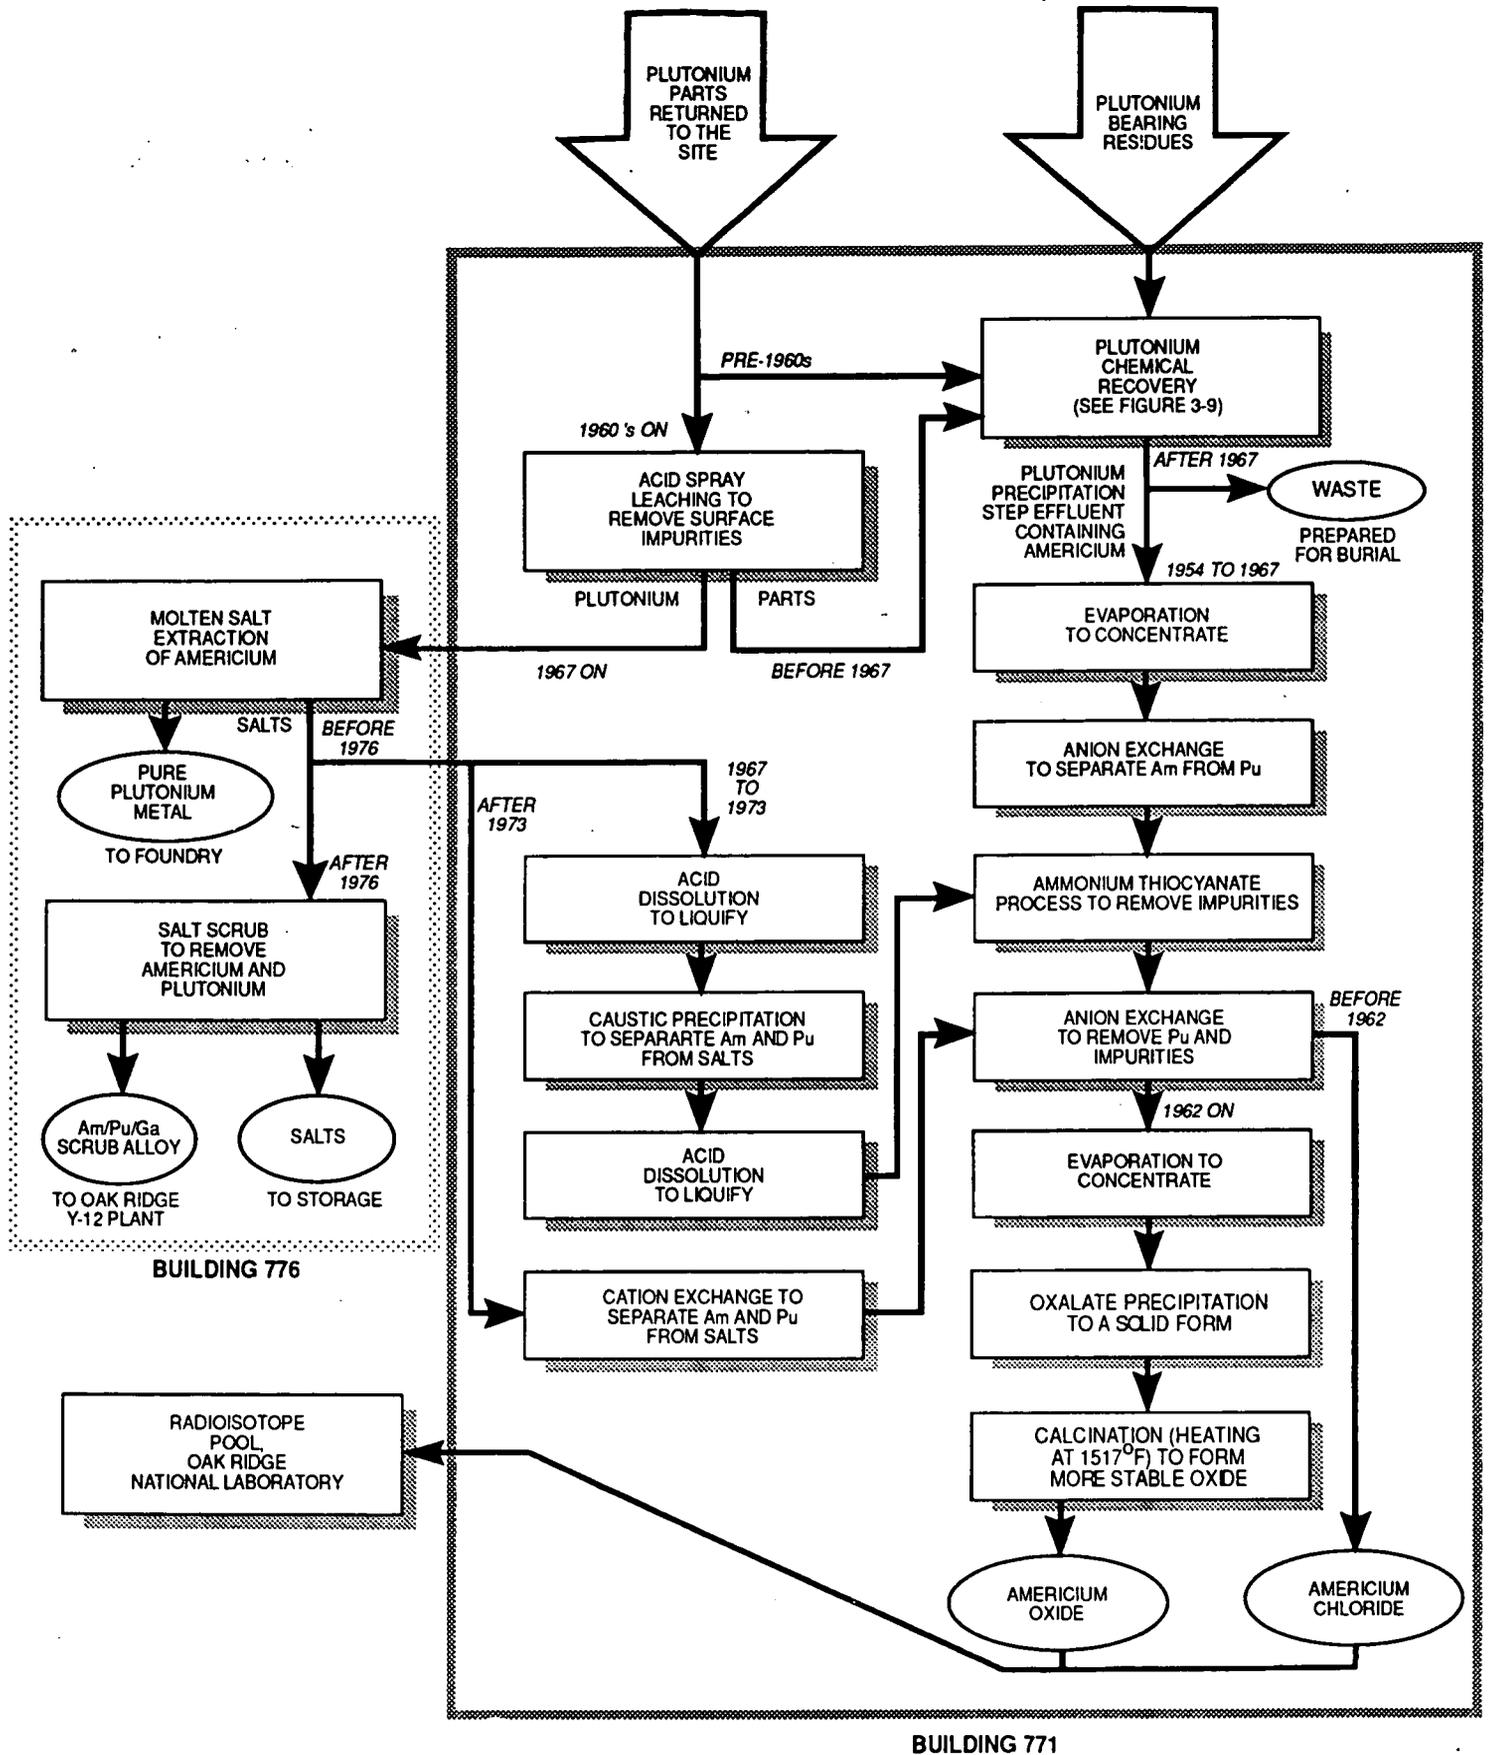
FIGURE 3-12
HISTORICAL AMERICIUM EXTRACTION,
RECOVERY, AND PURIFICATION PROCESSES

The processes historically used at Rocky Flats for extraction, purification, and recovery of americium are depicted in Figure 3-12. Americium operations have evolved through three methods of recovery and purification. From the time the americium recovery operation started up in 1957 to 1967, the feed for the process was the filtrate from the peroxide precipitation step on the plutonium recovery line. This was the era of the first method used for americium recovery and saw little change, except for the addition of a few additional steps in 1962 to create a more stable product form. In 1967, the feed for americium recovery became the salts from the new Molten Salt Extraction (MSE) process. From 1967 to the late 1970s, the processes used for americium recovery evolved. The original recovery process evaporated the plutonium peroxide precipitation effluent and separated the americium that remained in solution by anion exchange. The americium-containing column effluent went on to a very tedious and complicated operation known as the ammonium thiocyanate process. The resulting product was pale pink americium chloride.

A slight change was made to the ammonium thiocyanate process in 1962 by adding oxalate precipitation and calcination steps, which resulted in an americium oxide product that was preferred because of its stability. Nonetheless, the process during this entire period was "messy," resulted in a disproportionate amount of waste solutions, and created personnel exposure problems due to the relatively large amount of manual operations and maintenance required. Worst of all, the americium recovery rate was as low as ten to twenty percent (Crisler, 1991).

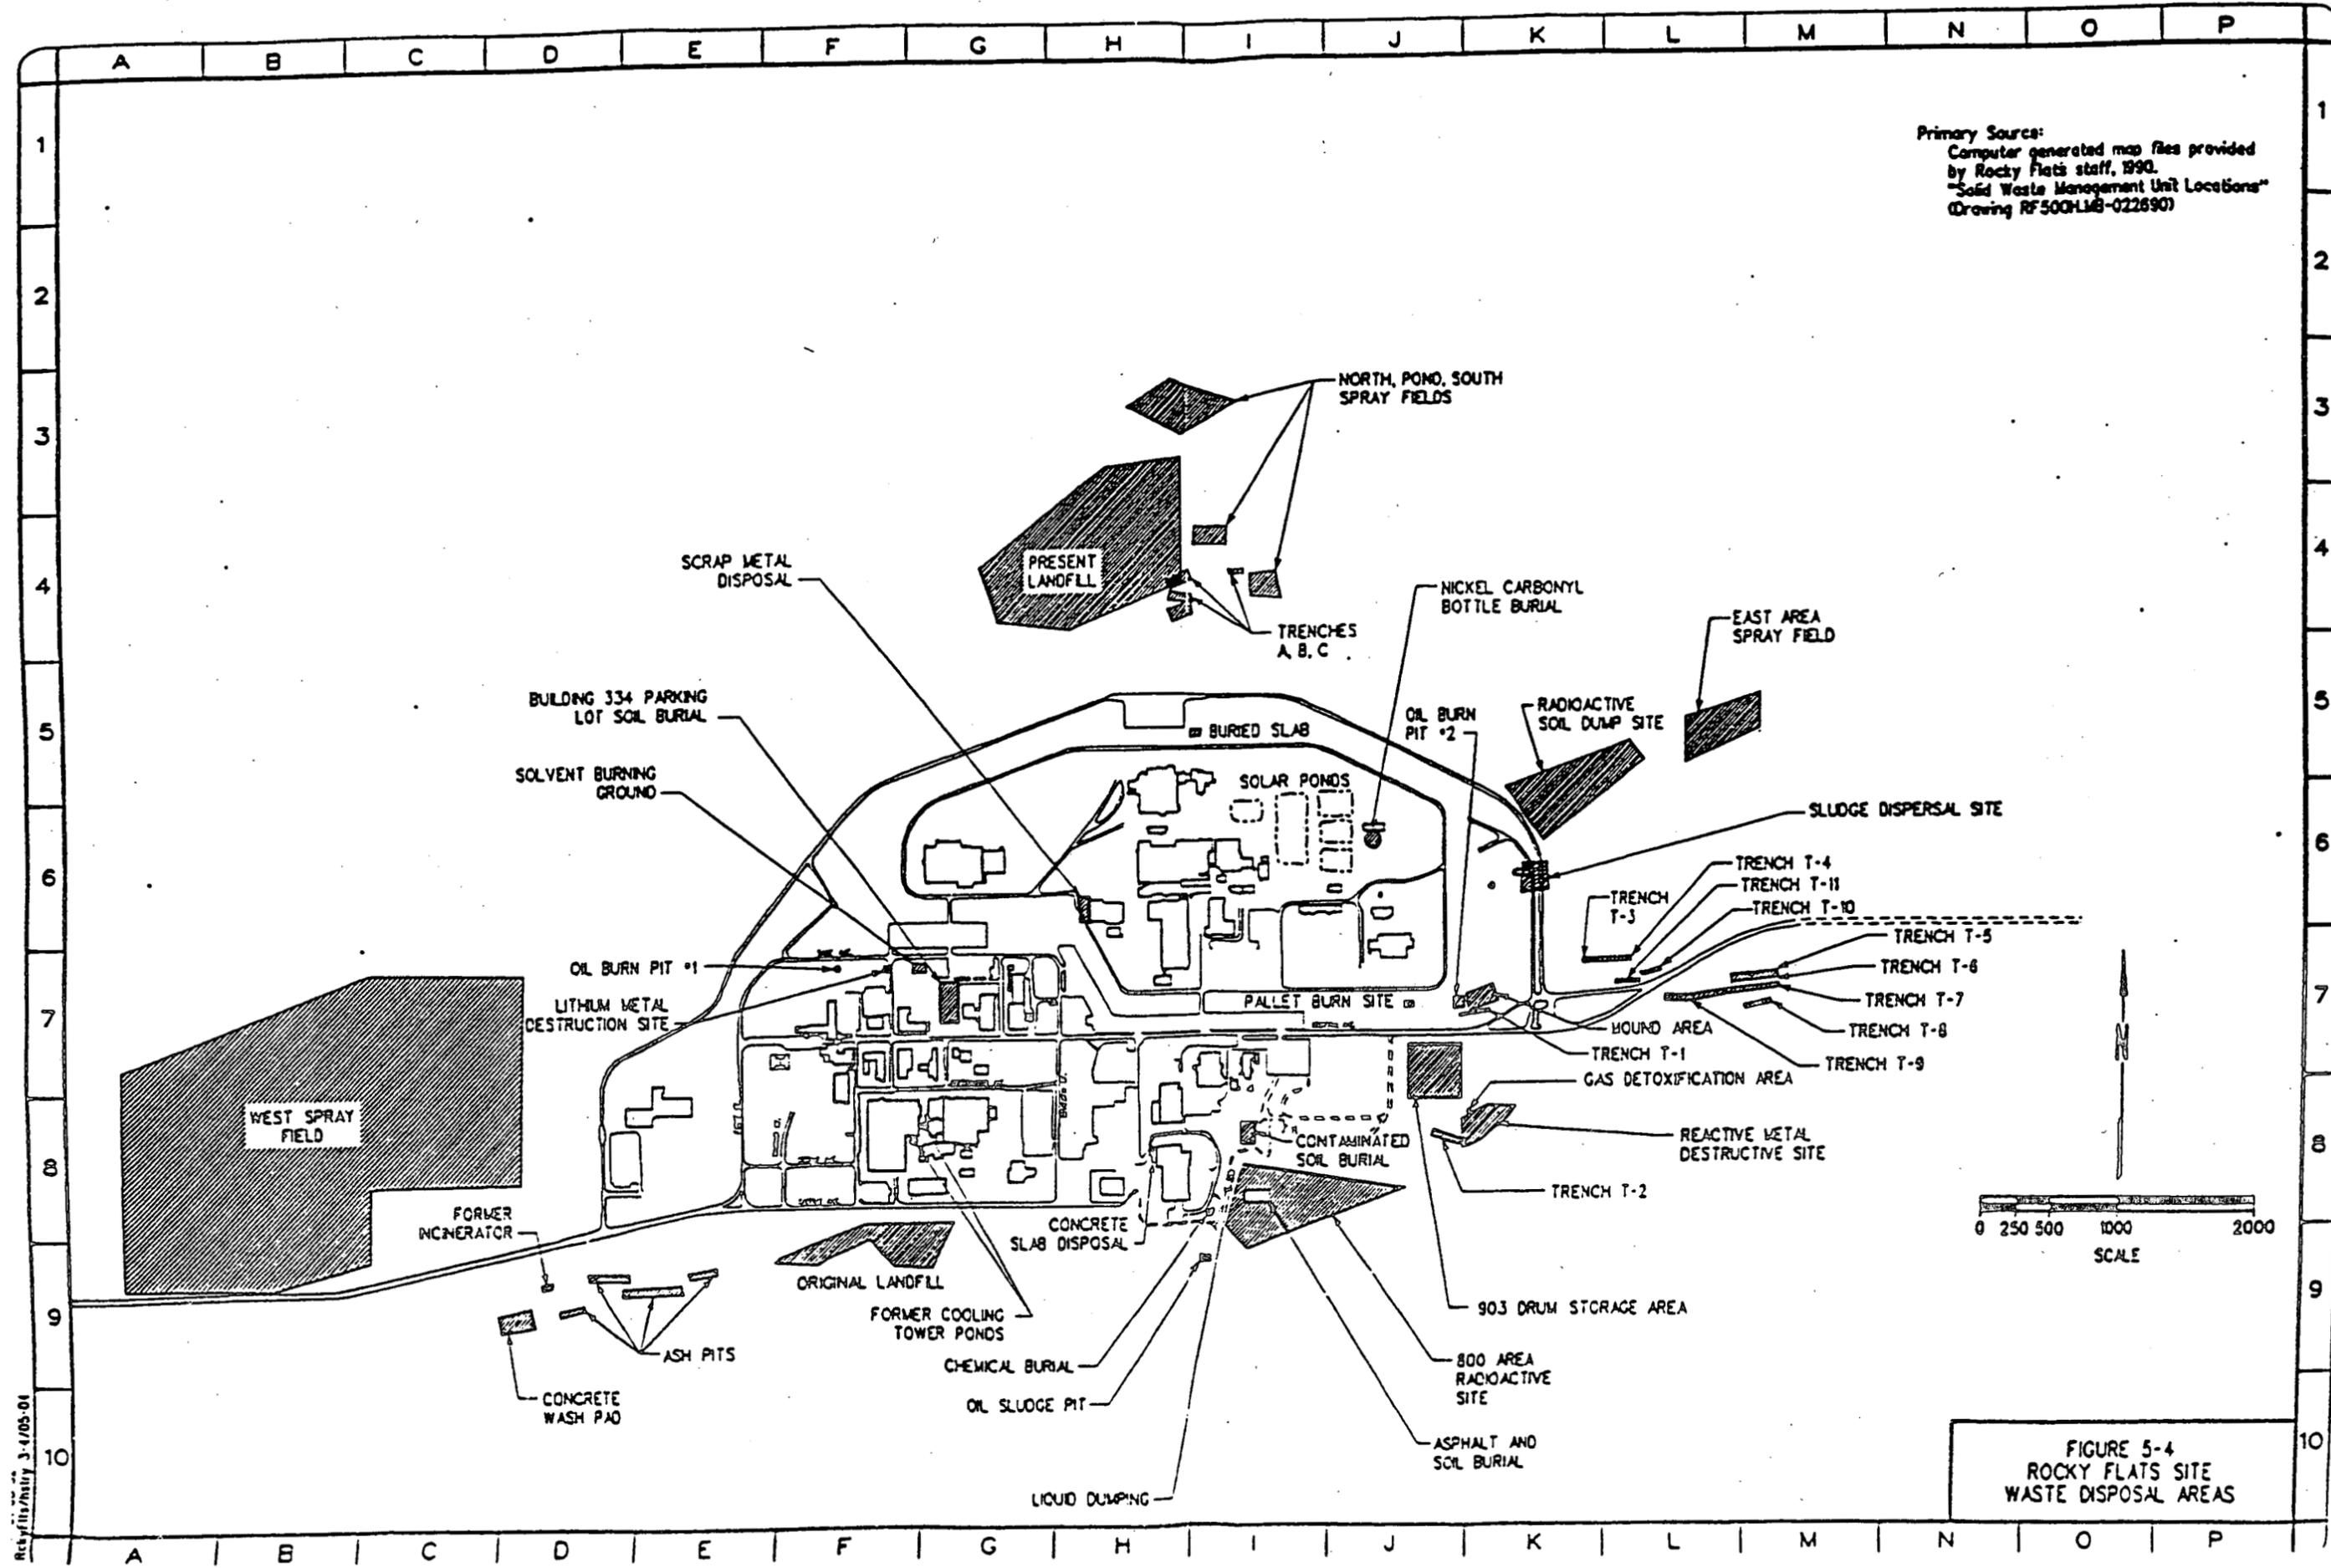
FIGURE 5-4
 ROCKY FLATS SITE
 WASTE DISPOSAL AREAS

Primary Source:
 Computer generated map files provided
 by Rocky Flats staff, 1990.
 "Solid Waste Management Unit Locations"
 (Drawing RF500HMB-022890)

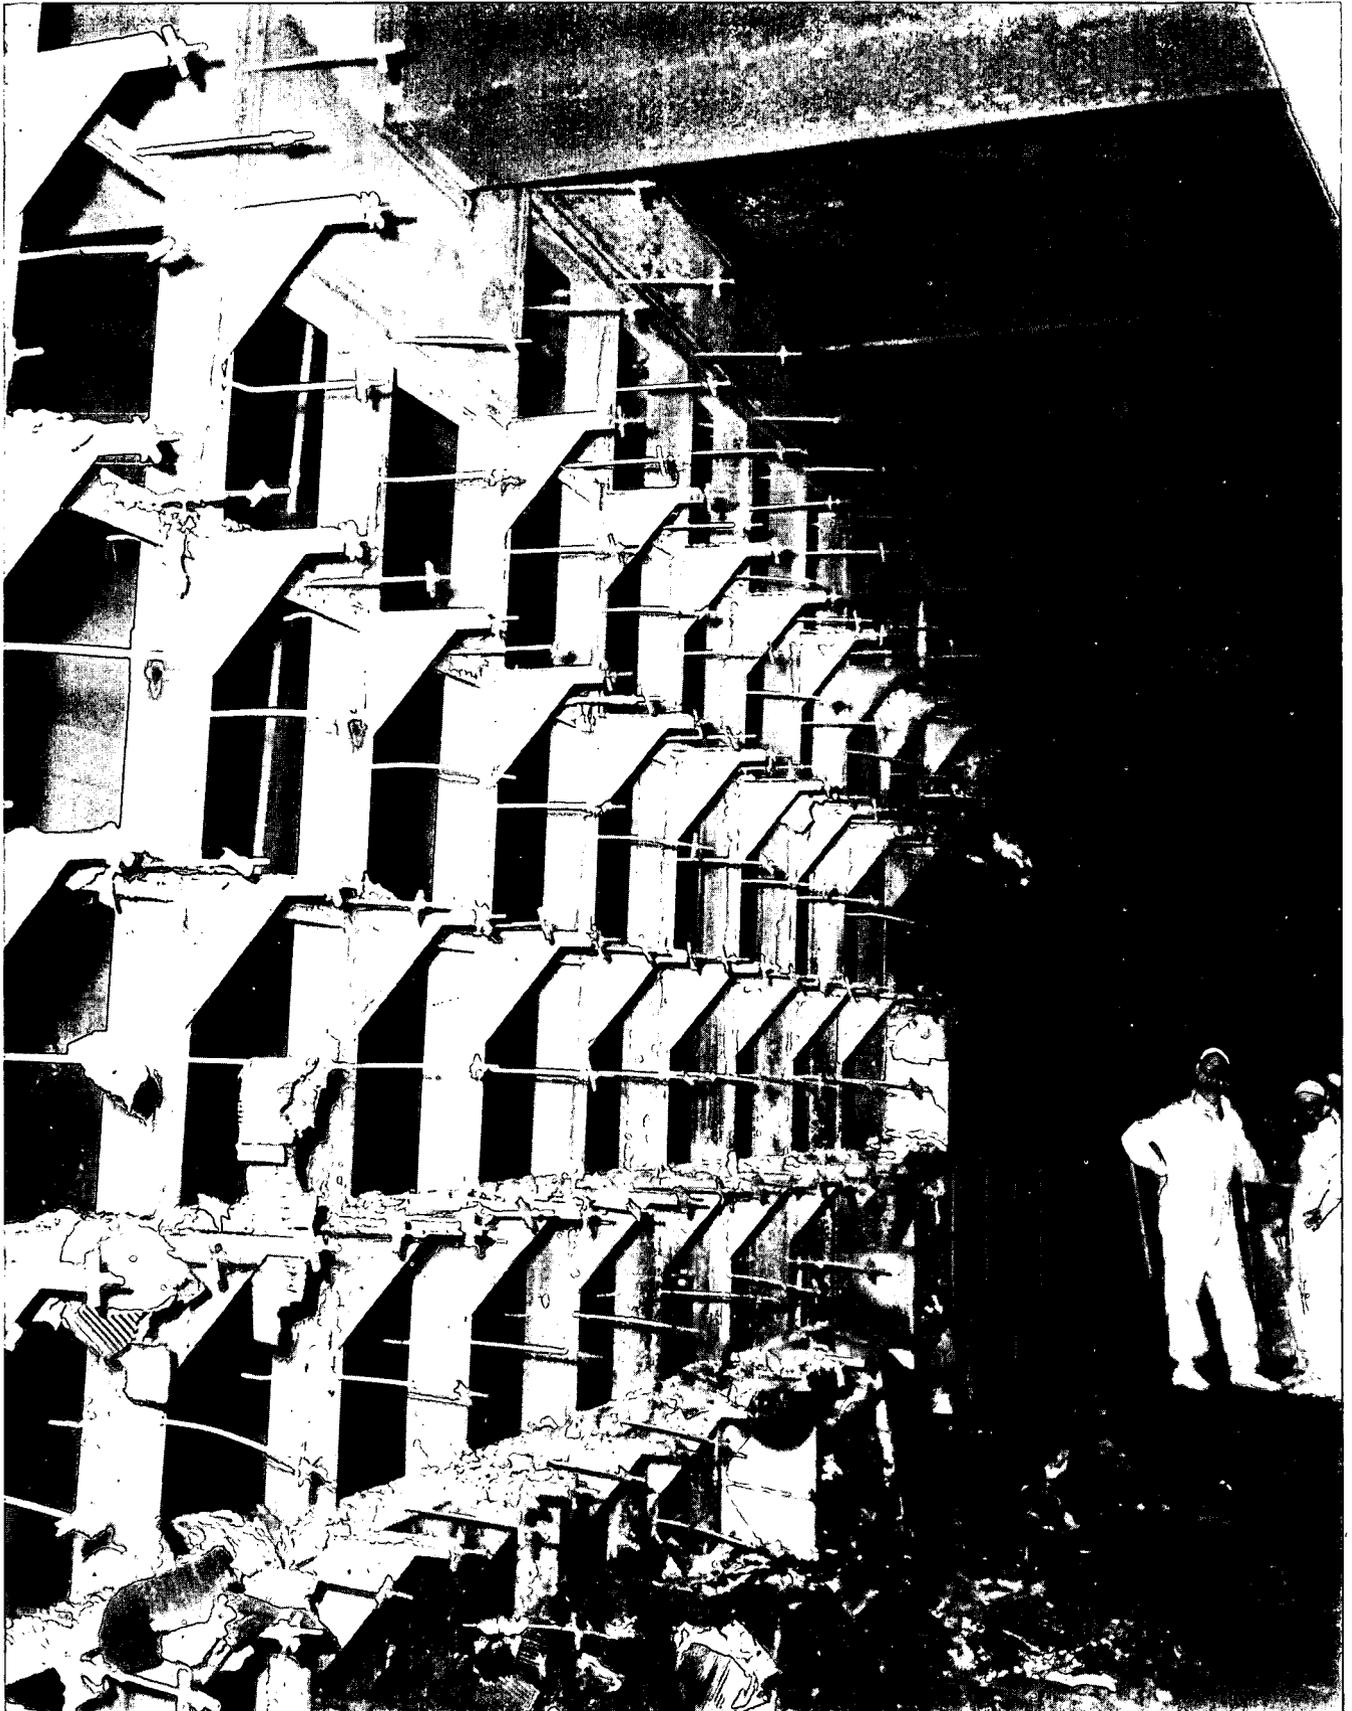
FIGURE 6-3. INTAKE SIDE OF BUILDING 771 EXHAUST FILTER BANK FOLLOWING THE 1957 FIRE. MANY OF THE FILTERS BURNED, AND SOME WERE PULLED OUT OF THEIR FRAMES TO LIMIT SPREAD OF THE FIRE. PARTIALLY BURNED FILTERS CAN BE SEEN ON THE FLOOR.

- 2:00 a.m. - Filter fire knocked down.
- 11:28 a.m. - Final fire out" (pages 14-17).
